Second Annual Monitoring Report
Tidal Wetland Restoration
159 Long Neck Point Road, Darien, CT
NAE-2007-1130
December 13, 2013

1) Project Overview

This is the second year of a five year monitoring program designed to monitor the restoration of an approximate $\frac{1}{4} \pm$ acre tidal wetland within a protected cove at 159 Long Neck Point Road in Darien, CT.

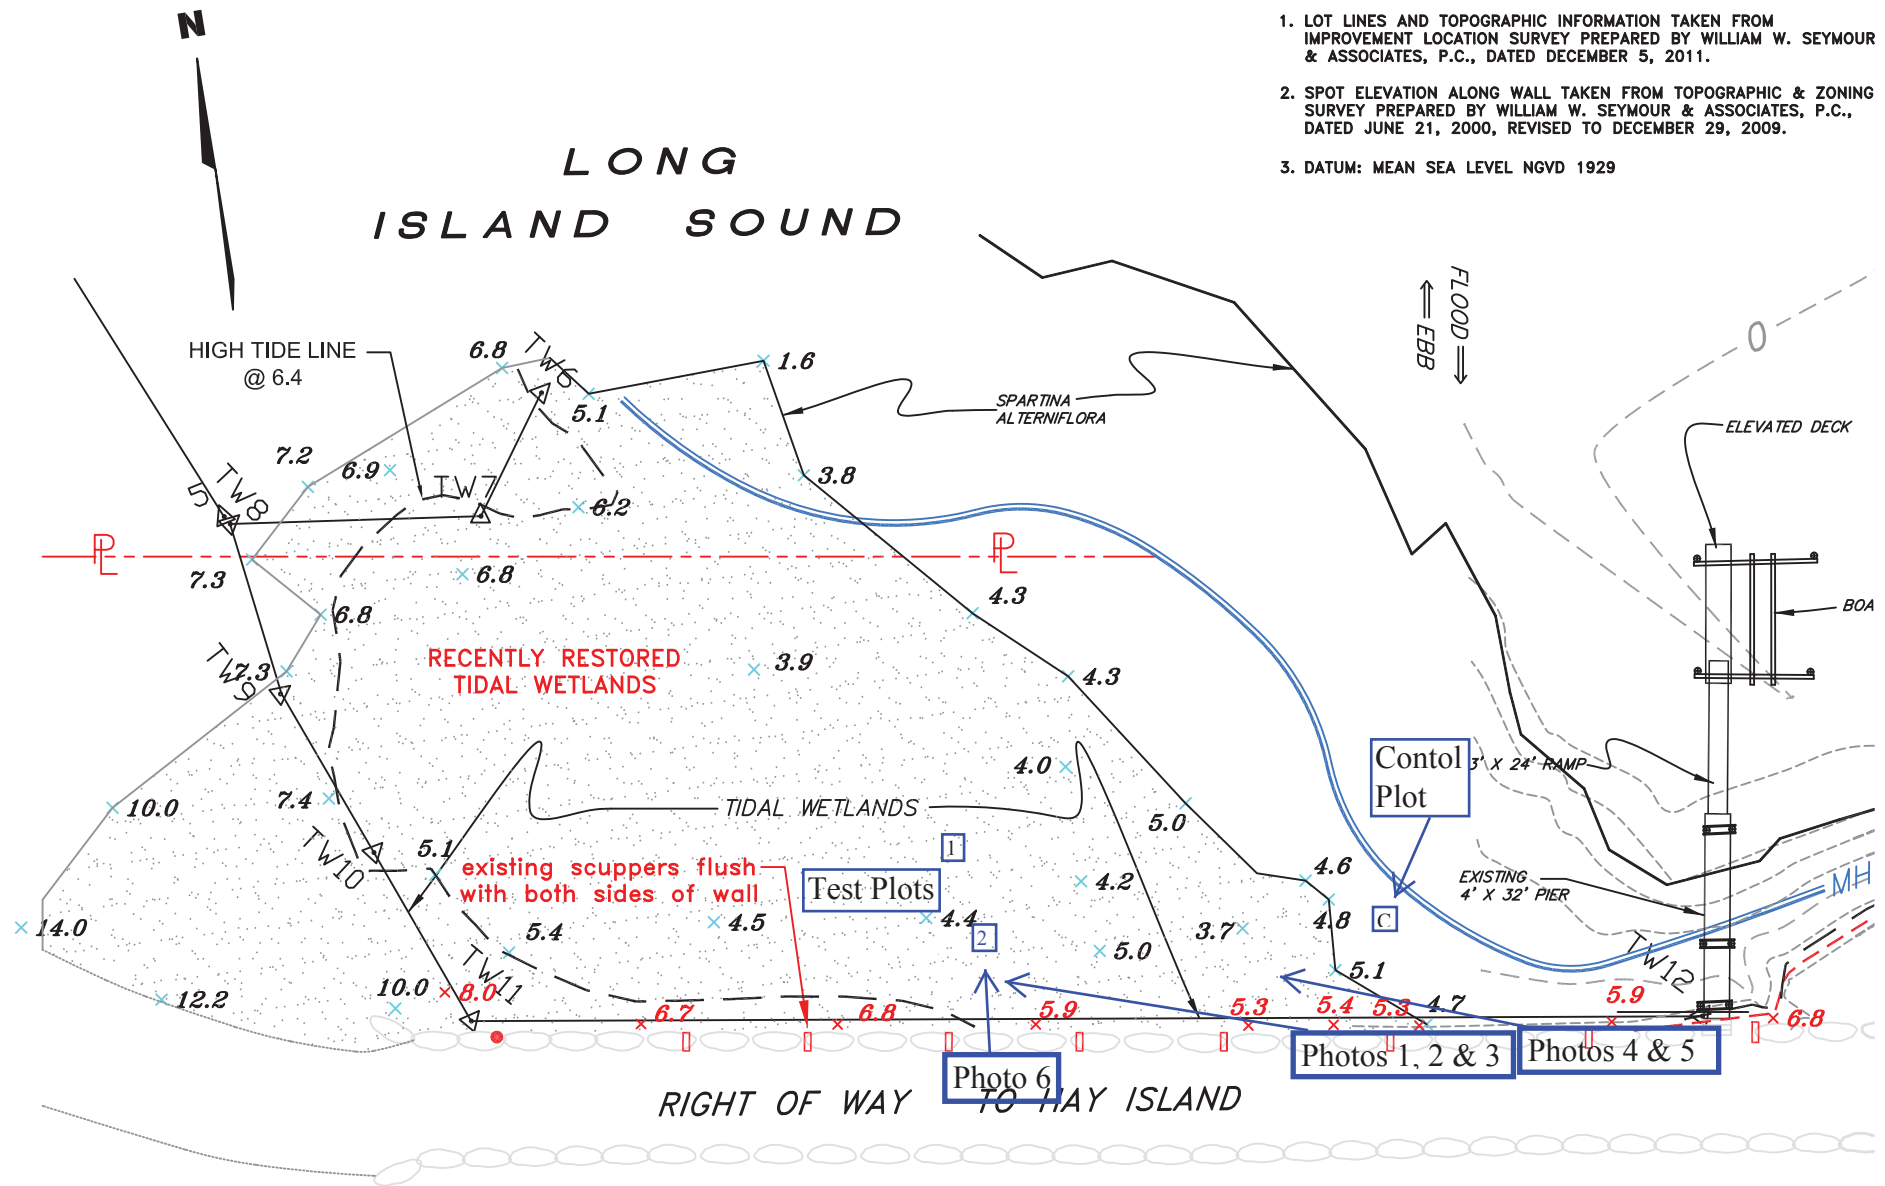
| | TITLE: TIDAL RESTORATION MONITORING PLAN | |

During the September 9th inspection, the *Spartina* population covered approximately 40 to 50% of the restoration area. The western portion and the lower areas were just starting to colonize. Abundant Atlantic marsh fiddler crabs (*Uca pugnax*) and burrows were visible. The approximate locations of the test and control plots are shown in the Tidal Restoration plan shown in Section 4.

Revised to Show Photograph Views and Plot Locations Referenced in
Report.

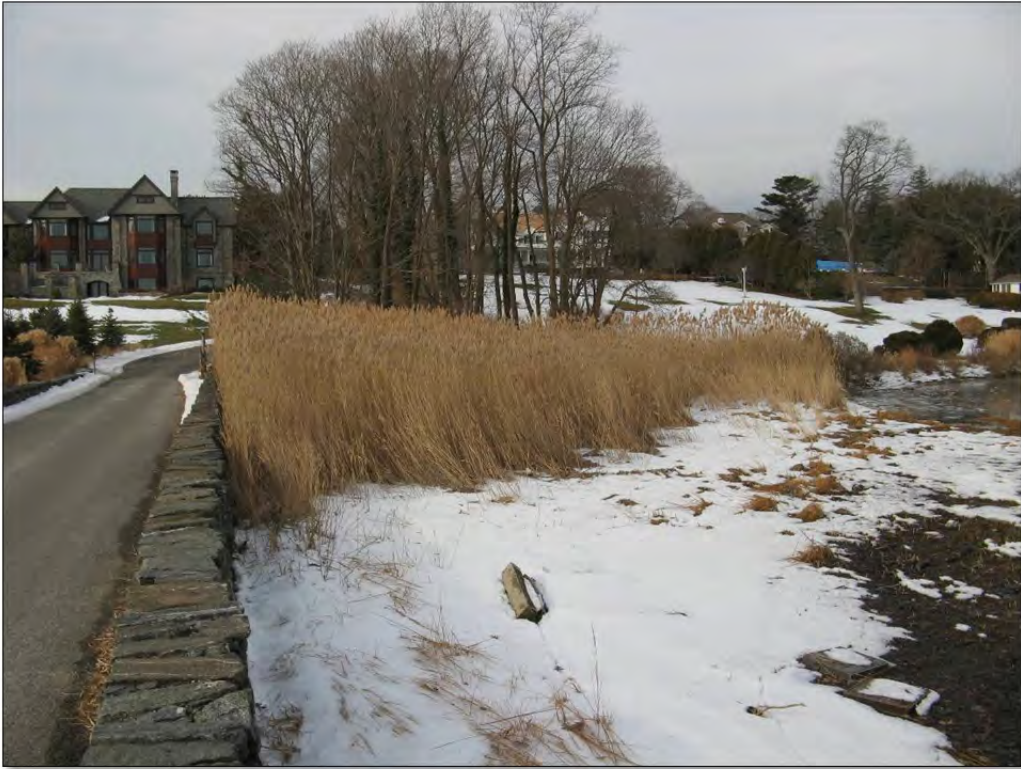
Photo 1 – Tidal restoration area facing west. Photo Taken January 6, 2011 Prior to Restoration Work. Photo shows Phragmites Population and Ground Elevation.

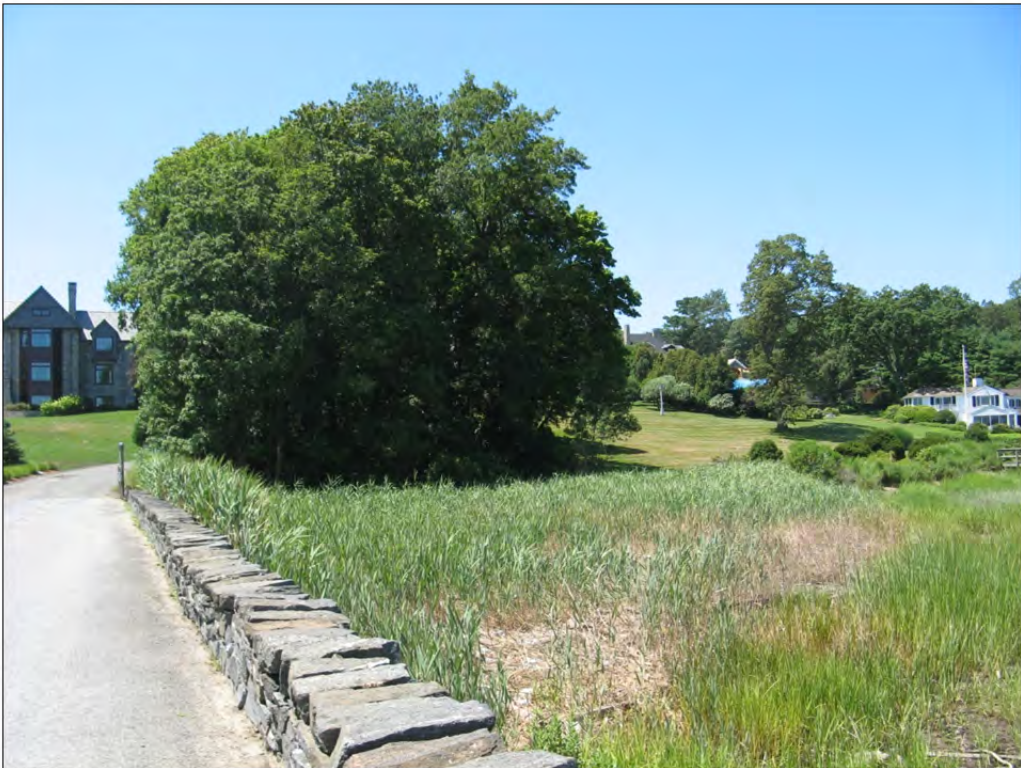
Photo 2 – Phragmites Population in Tidal Restoration Area on July 26, 2011 after Initial Herbicide Application but Prior to Regrading.

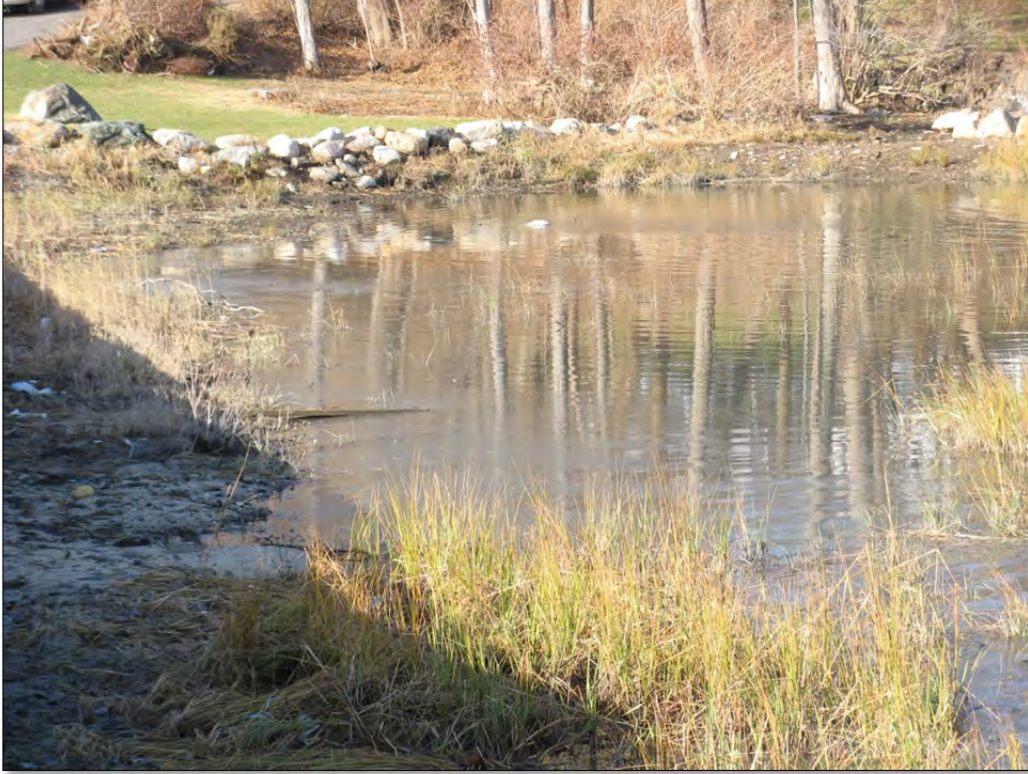
Photo 3 - Post Restoration, Facing West on November 28, 2012.

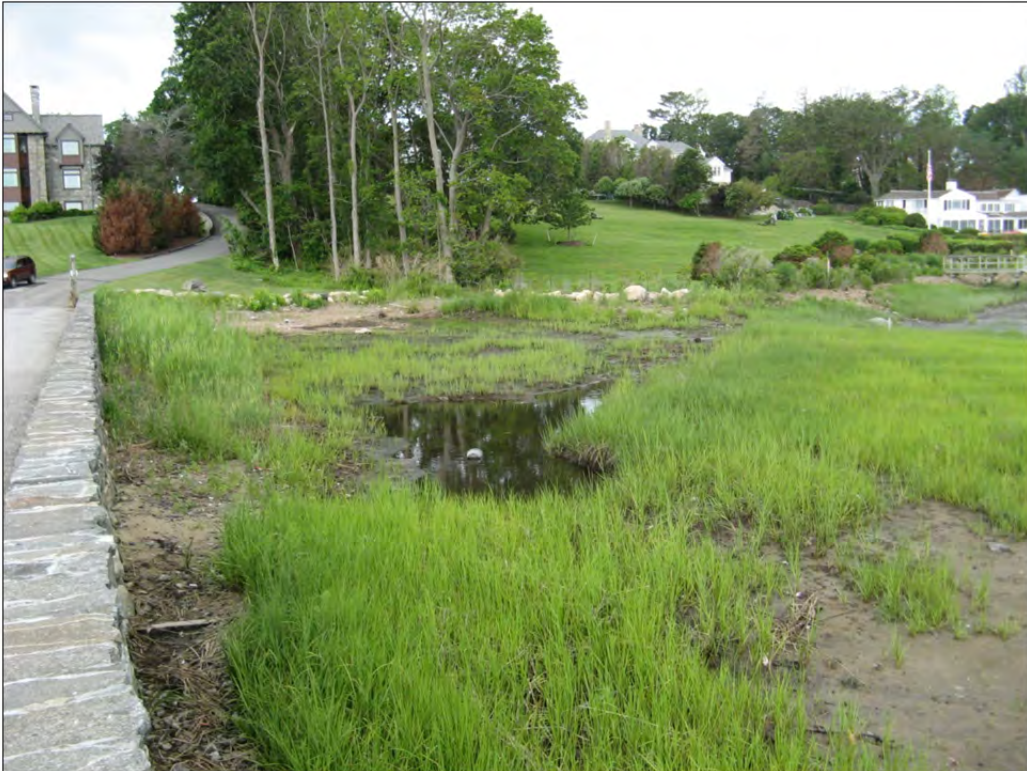
The June 28th site visit found *Spartina alterniflora* recolonizing approximately 20% of the restoration area. A small depression located along the eastern edge of the restoration area, contained little to no *Spartina* growth. The *Phragmites* population was successfully controlled within the basin however *Phragmites* had regrown within a narrow 12 foot wide area along the waterward side of the wall. A few of the northern bayberry (*Myrica pensylvanica*) planted in September 2012 in the western end of the restoration area were doing well with little evidence of stress but as reported in last year's report, most of the other native shrubs planted in 2012 have died.

Photo 4 – Spartina Starting to Recolonize the Wetland on June 28, 2013. Phragmites Population Present along Waterward Side of Wall.

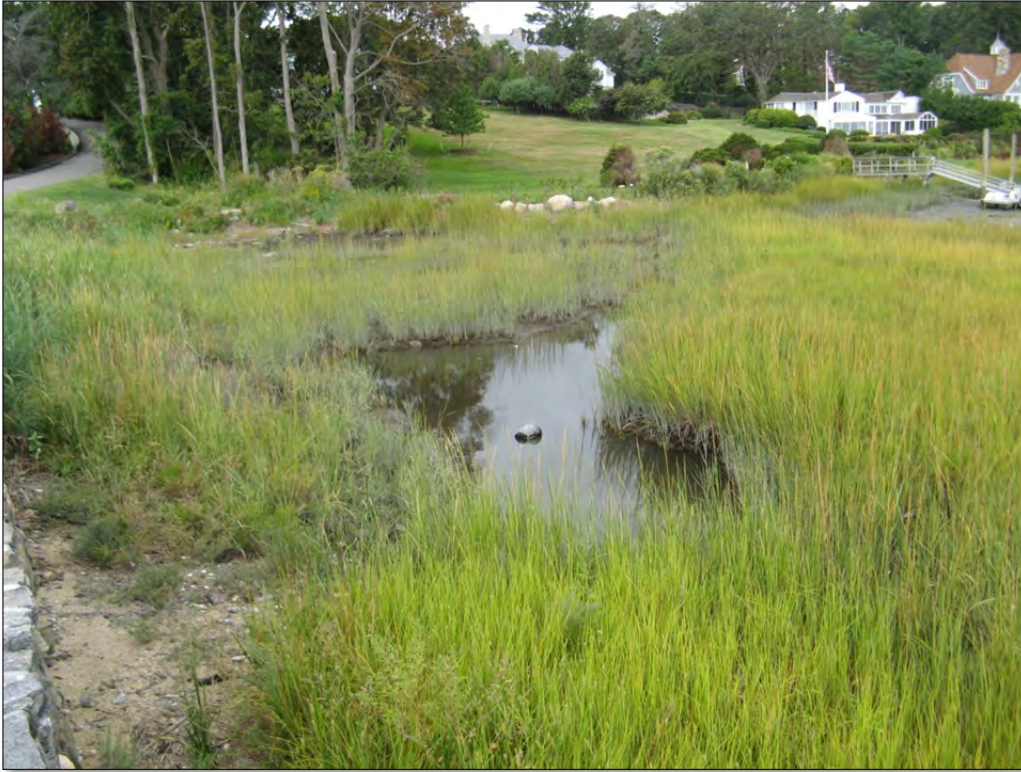
The invasive *Phragmites* population has been reduced to a small area, approximately 12 feet wide along the waterside of the stonewall. This population was spot treated with Polaris® in September 9, 2013, and will continue to be spot treated as necessary next year.

Photo 5 – Facing West on September 13, 2013. Phragmites Population at Far Left, Spartina Recolonization in Center and Undisturbed Spartina Population to Right.

Remedial actions were limited to the September 9, 2013 application of herbicide (Polaris®) by a licensed applicator to control the narrow band of *Phragmites australis* that has reestablished along the waterward side of the wall. The *Phragmites* were sprayed only four days prior to the September site inspection so no visible signs of stress were observed at that time.

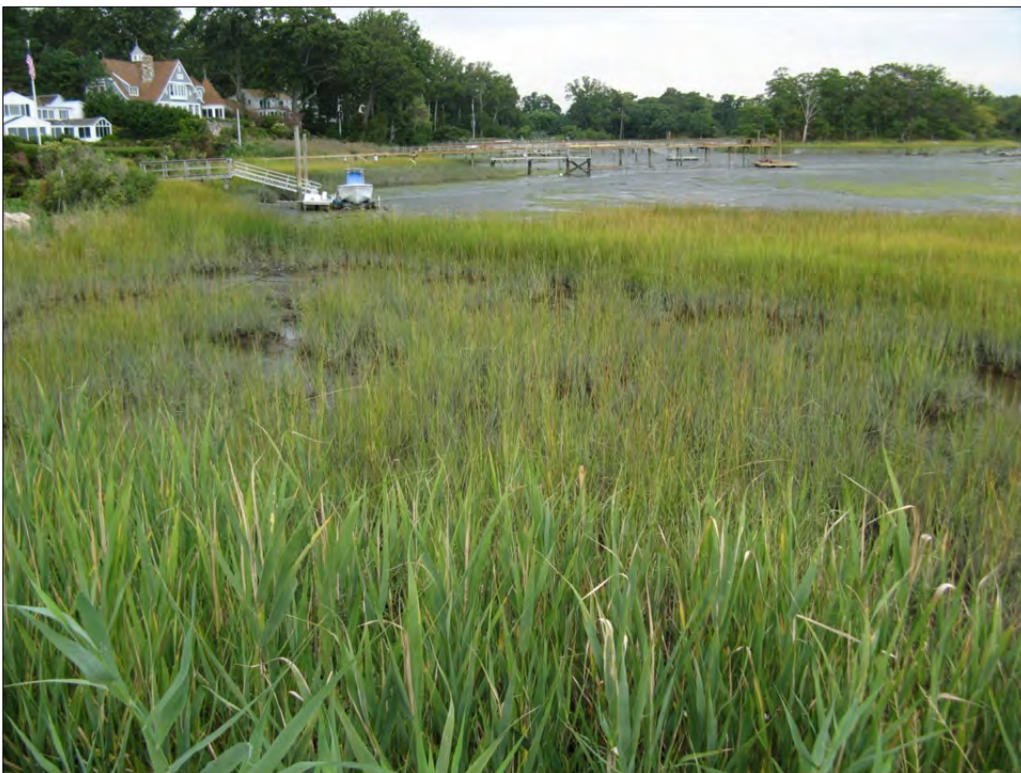
Test plot 2. This plot contained 84± *Spartina* stems (an approximate 40% coverage) and 28 common glasswort (*Salicornia depressa*) stems.

Photo 6 – Facing North on September 13, 2013. Phragmites Along Wall in Foreground, Recolonizing Population in Middle and Undisturbed Spartina Population in Background. Stake for Test Plot #2 is Observable Just Beyond the Phragmites
