Monitoring Cruise at the Morris Cove Borrow Pit

Disposal Area Monitoring System DAMOS

Contribution 129
June 2001

SAIC Report No. 520

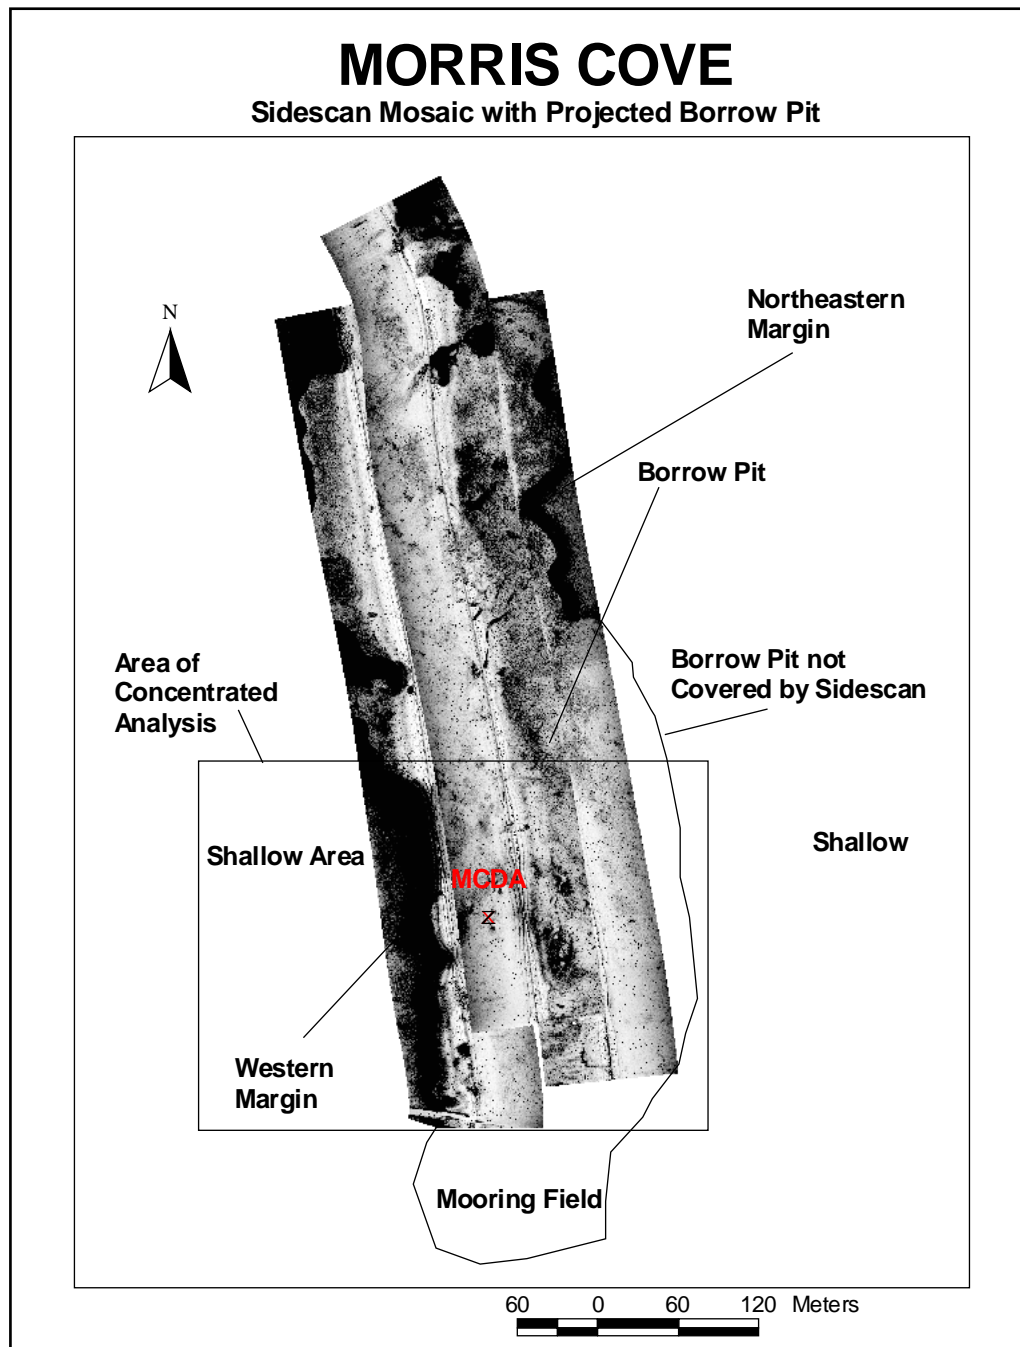
The western and northeastern margins of the borrow pit provided a strong sonar return to the transducer (represented by a thick, dark line) and were readily apparent in the mosaic (Figure 3-1). Soft sediment (weaker return) appears to have accumulated within both the northern and southern portions of the borrow pit. Approximately 14,200 m³ of sediment dredged from the USCG basin were deposited in the southern portion of the pit. Given the relatively small volume of dredged material disposed and position of the disposal point (southern portion), most of the fine-grained material detected within the confines of the pit is likely the result of natural deposition. This fine-grained material could be emanating from the Mill and Quinnipiac Rivers, advected from other areas of New Haven Harbor, or the product of multiple sources. The side-scan image shows a gradual strengthening of signal in close proximity to the margins of the pit, suggesting a coarsening of the sediments, relative to the center. This change in texture is probably related to an increase in the sand or shell content of the sediments located near the walls of the borrow pit.

Figure 3-1. Side-scan sonar mosaic of the three lanes occupied over the Morris Cove borrow pit

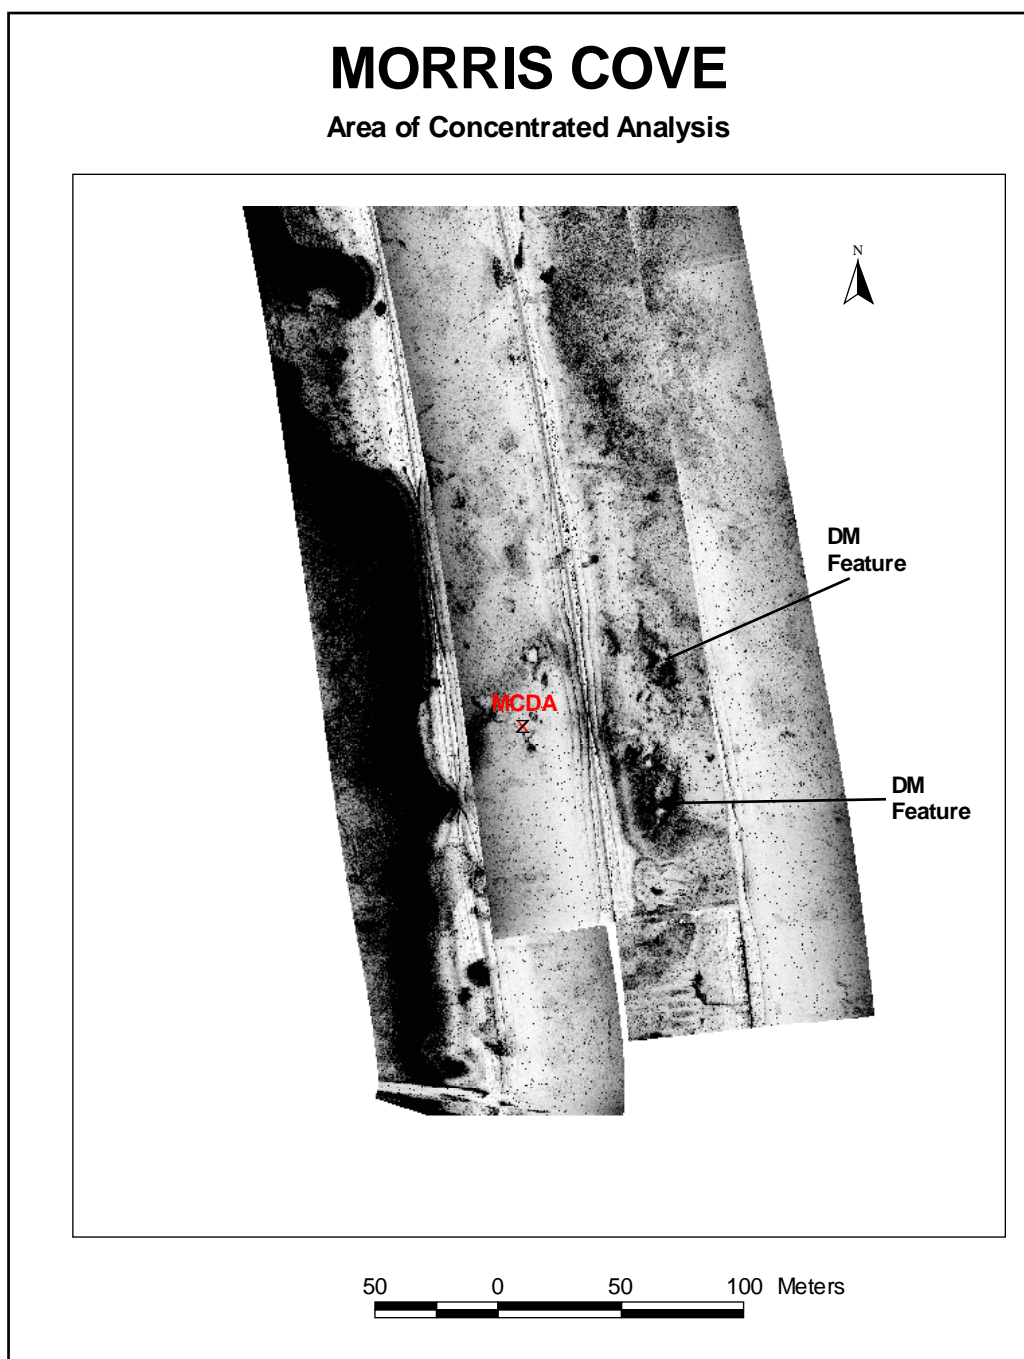
Slight differences in surface texture detected in close proximity to the MCDA buoy position, relative to the remainder of the sediments in the pit, provide subtle distinctions between the recently deposited dredged material and the ambient sediments (Figure 3-2). Multiple bottom features with vertical relief and increased surface roughness were detected within a 50 m radius of the central disposal point. The larger bottom features, approximately 30 m in diameter, were concentrated to the east of the MCDA disposal buoy. Based on their position relative to the disposal buoy and size, these features are attributed to dredged material deposition.

Figure 3-2. Side-scan sonar image displaying several acoustically detectable bottom features within the Morris Cove borrow pit in close proximity to the MCDA buoy position

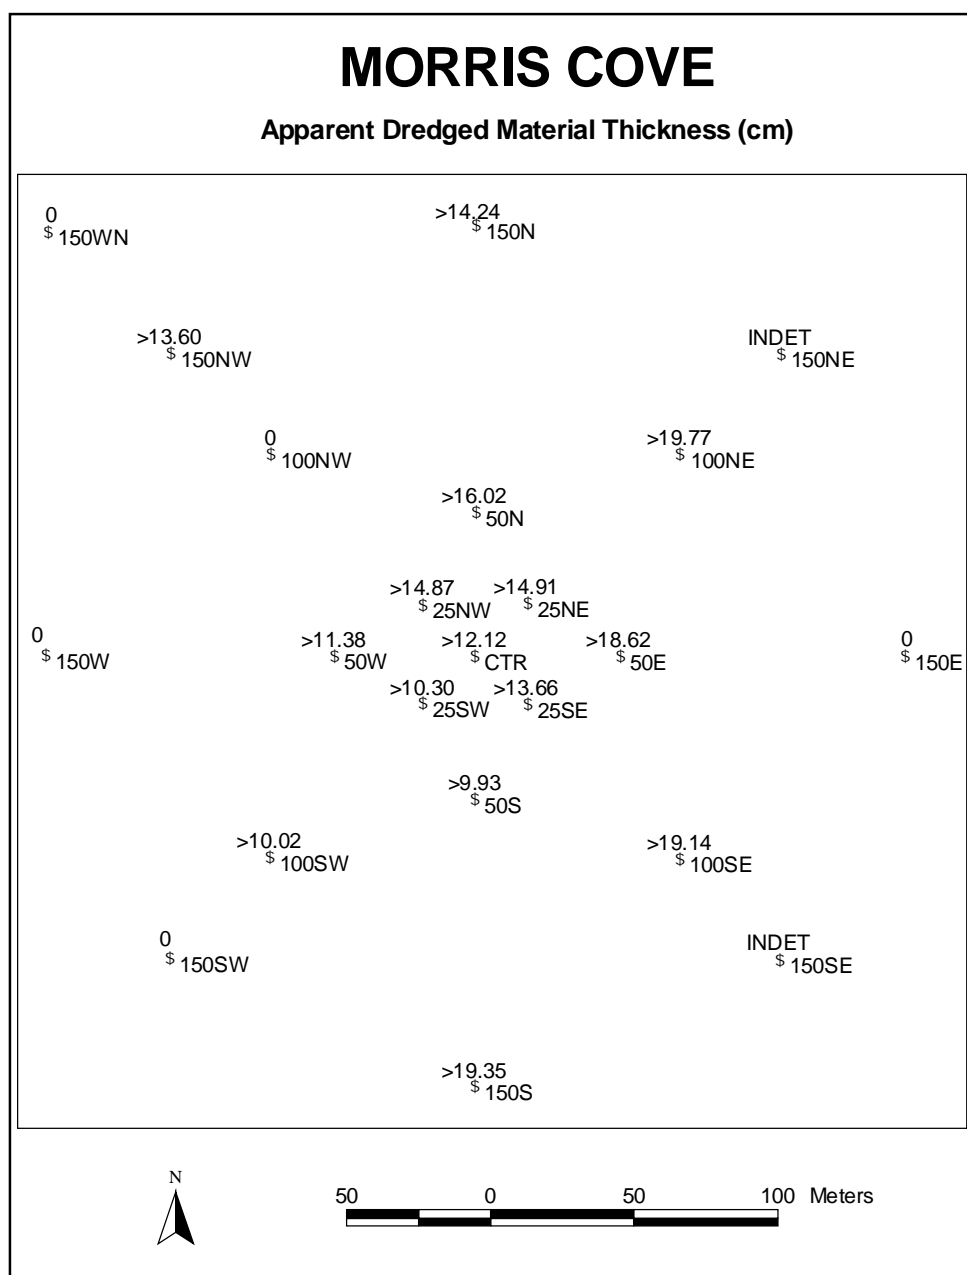
Dredged material was detected in the REMOTS® images at 15 of 22 borrow pit stations (Table 3-1; Figure 3-3). The dredged material layer extended from the sediment surface to below the imaging depth of the REMOTS® camera at all of these stations (i.e., dredged material greater than penetration, denoted by a “greater than” sign in Table 3-1 and Figure 3-3). Surface sediments considered to be ambient bottom (i.e., unaffected by dredged material disposal) were observed in the replicate images at Stations 100NW, 150E, 150SW, 150W, and 150WN located outside or on the presumed edges of the pit (Table 3-1; Figure 3-3). At Stations 150NE and 150SE, it could not be clearly determined from the images whether the material present was dredged material or ambient sediment (INDET = indeterminate in Table 3-1 and Figure 3-3).

Figure 3-3. Map showing the average thickness of the dredged material layer observed in replicate sediment profile images at each station. A “greater than” sign indicates that the dredged material layer extended below the imaging depth of the sediment profile camera.

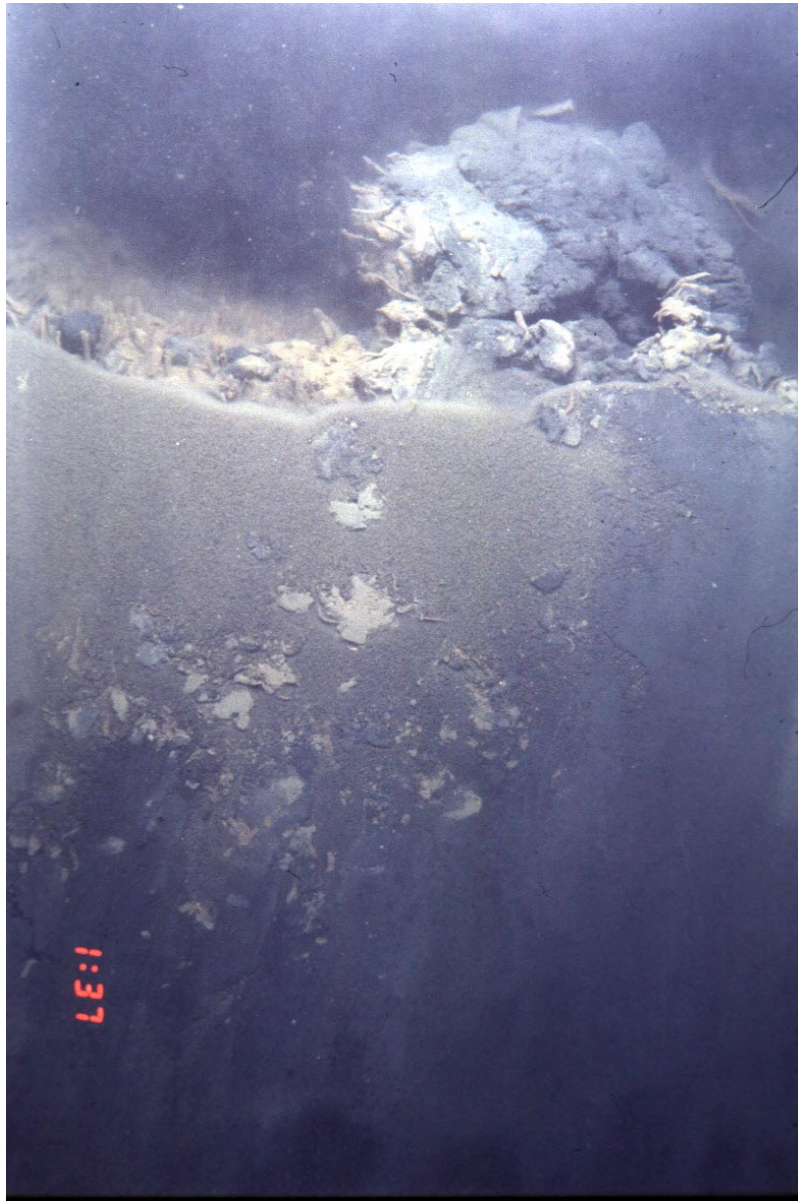
Figure 3-4. REMOTS® image from station 100SW within the Morris Cove borrow pit, showing a layer of fine-grained dredged material extending from the sediment-water interface to below the imaging depth of the camera (i.e., dredged material greater than penetration). A clump of cohesive clay measuring 7 cm in diameter is visible on the sediment surface, resulting in increased small-scale boundary roughness. Numerous Stage I polychaete tubes protrude from the clay clump, and a dense Ampeliscaid amphipod tube mat (Stage II) is visible on the left side of image.

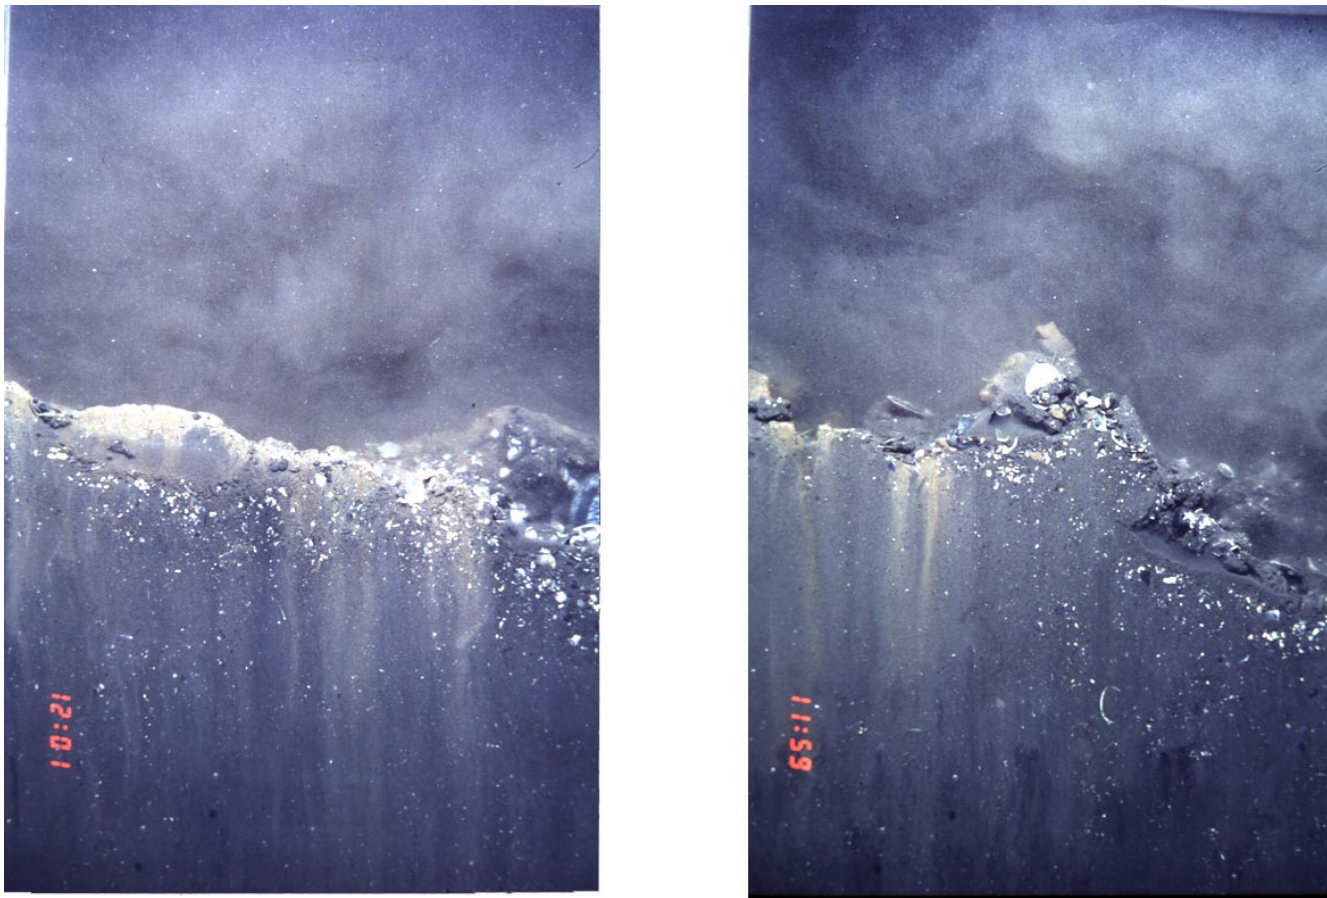
Figure 3-5. REMOTS® images from stations REF4 (left) and REF5 (right) illustrating the relatively soft, fine-grained sediment (grain size major mode of >4 phi) which characterized the reference area stations. Both images show a surface shell lag deposit, irregular topography, and an exceptionally thin RPD layer, possibly due to periodic scouring of the sediment surface by currents/waves.

The average small-scale surface boundary roughness for the reference area stations (3.5 cm) was higher than that observed at the stations within the borrow pit (2.33 cm). The reference stations are located in relatively shallow water, where the bottom may be affected by the scouring action of waves and currents during high-wind events or by fishing (oyster dredging) activity. The increased boundary roughness, presence of a surface shell lag deposit, and shallow RPD depths observed at several of the reference stations may reflect such periodic physical disturbance (Figure 3-5). However, it is notable that similar evidence of physical disturbance was not observed at the borrow pit stations.

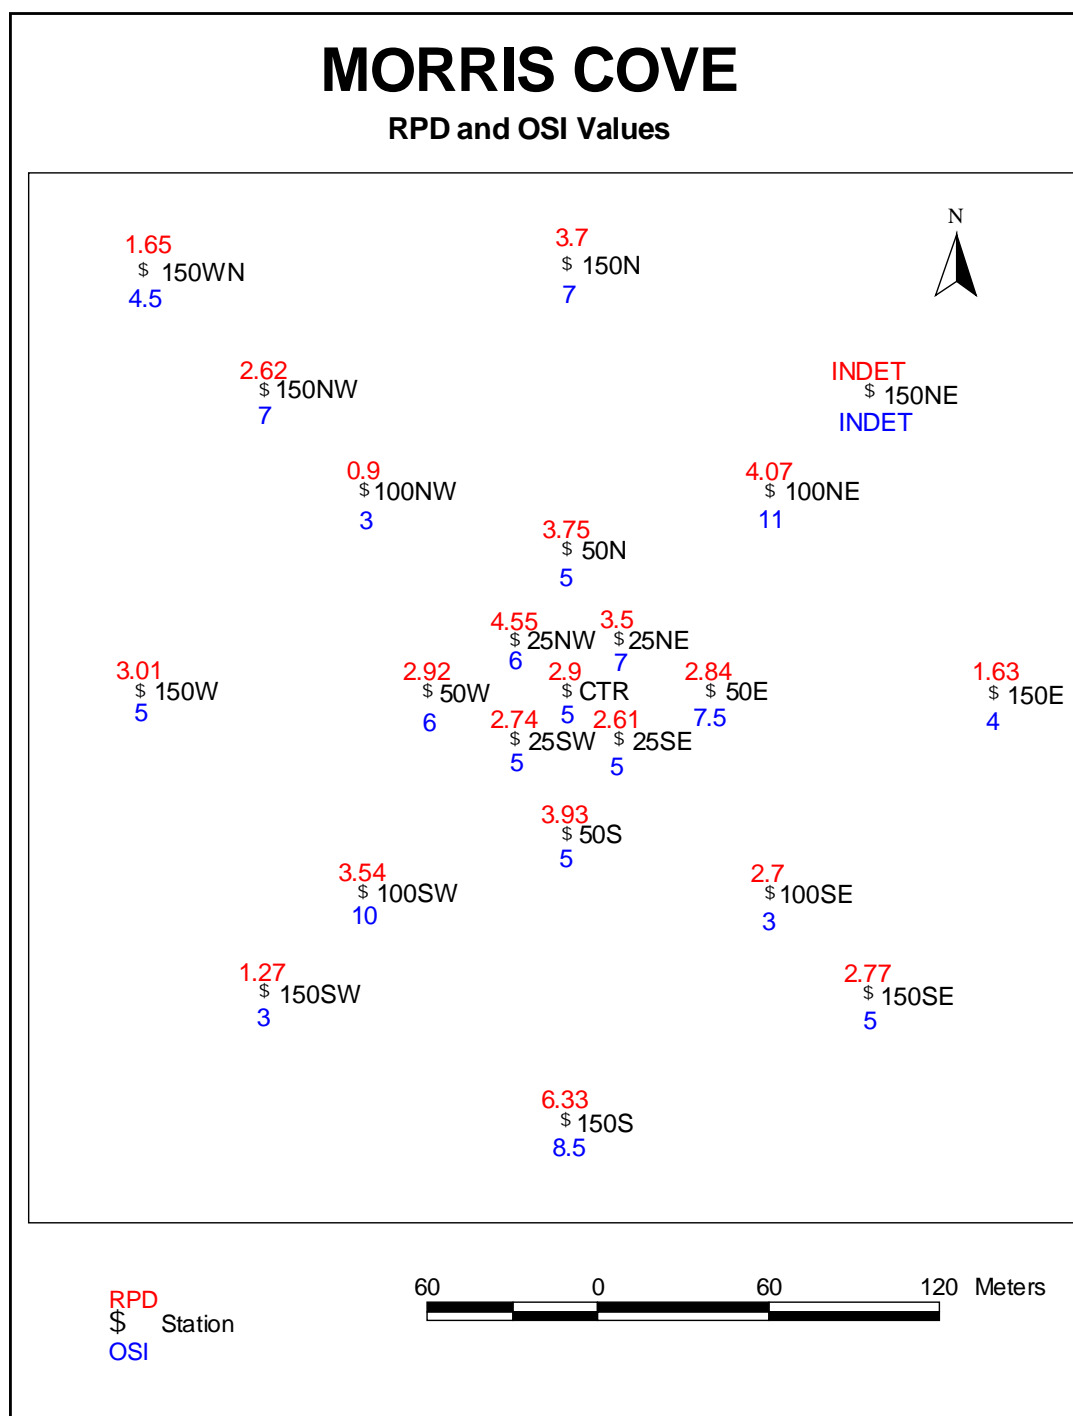
Figure 3-6. Map showing average RPD and OSI values at each borrow pit station.

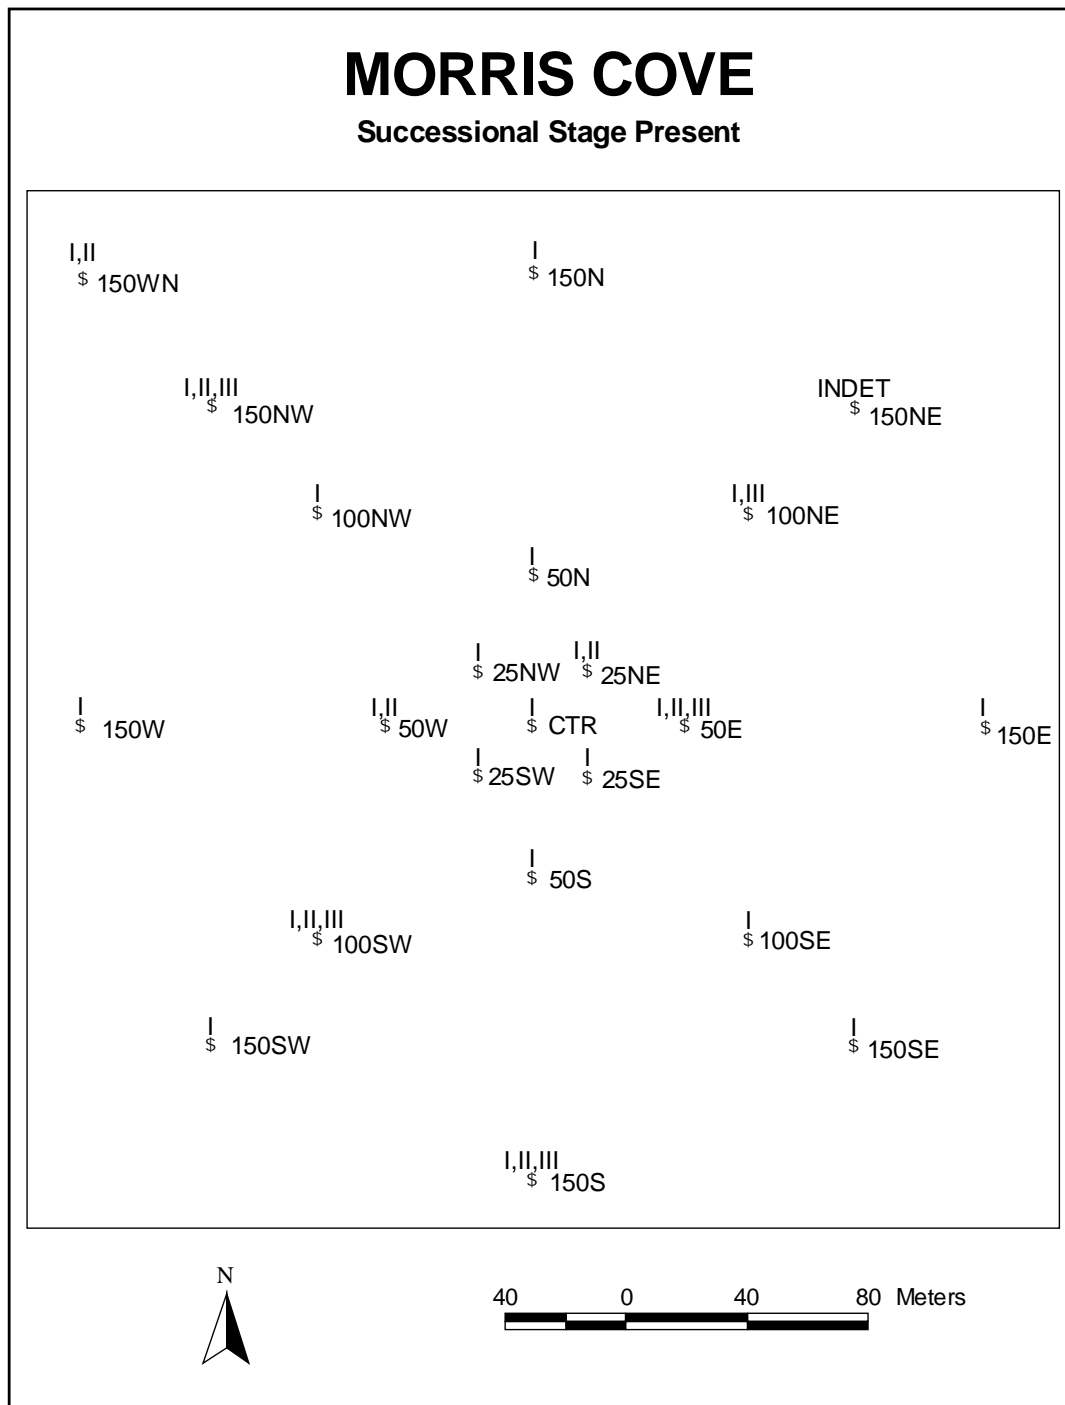
Figure 3-7. Map showing infaunal successional stages present at each borrow pit station.

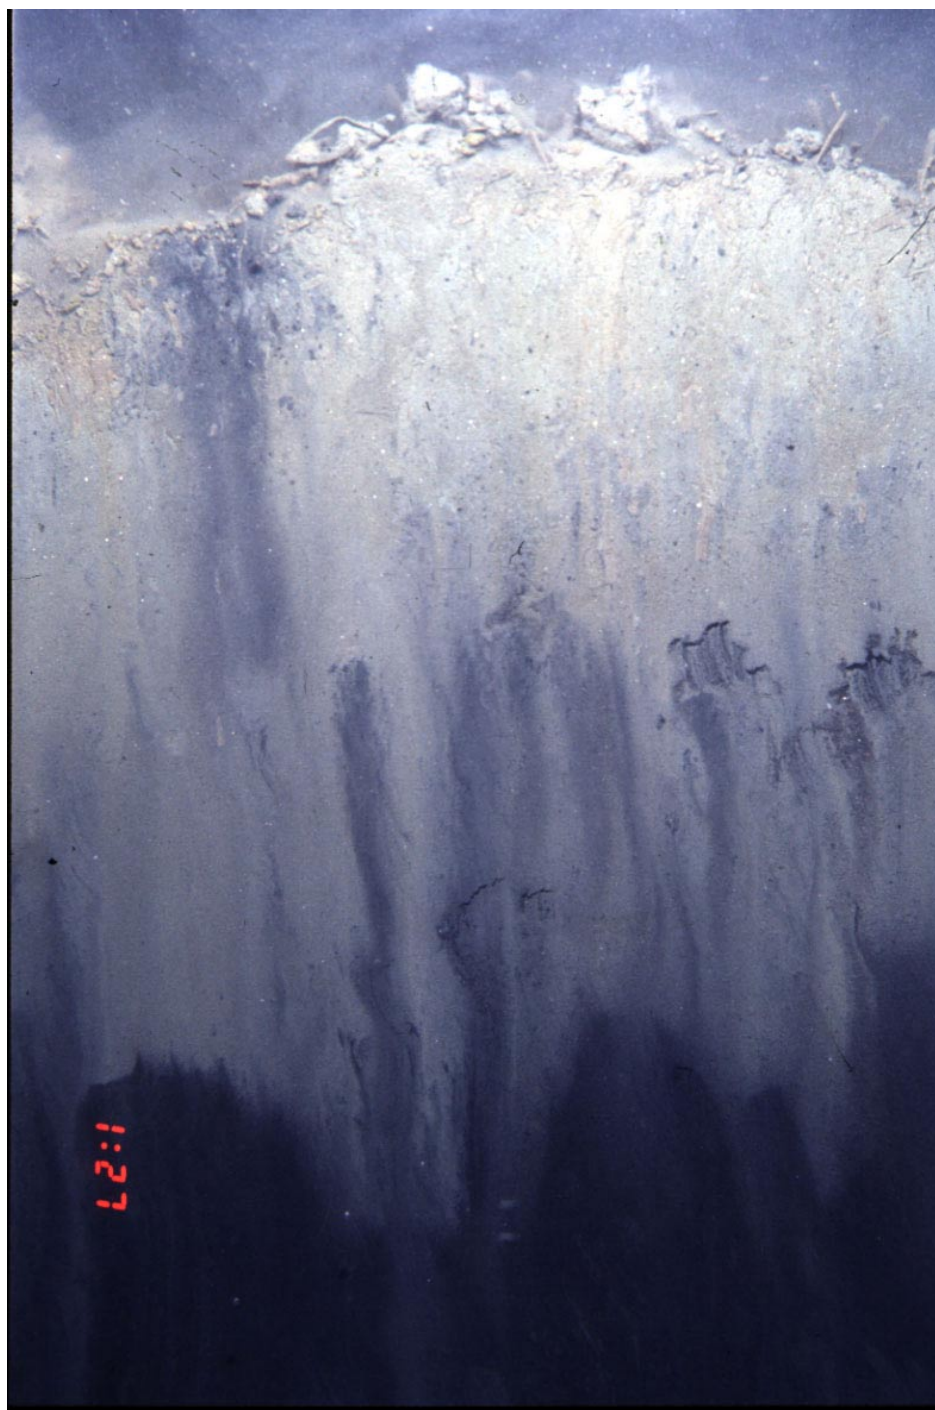
Figure 3-8. REMOTS® image showing small, tubicolous, opportunistic polychaetes (Stage I) present at the surface of fine-grained dredged material at station 100SW within the borrow pit.

polychaetes present at the sediment surface (Figures 3-7 and 3-8; Table 3-1). Tube-dwelling amphipods (*Ampelisca* sp), representative of Stage II, were observed at 7 of the 22 stations (Figures 3-7 and 3-9). Stage III activity, evidenced by active feeding voids produced by head-down, deposit-feeding infauna, was predominately noted in the subsurface at Stations 100NE, 100SW, 150NW, 150S, and 50E (Figures 3-7 and 3-9). Overall, the presence of a diverse mixture of Stages I, II and III organisms at the stations within the borrow pit indicate that benthic recolonization of this area was occurring as expected at the time of the September 2000 survey.

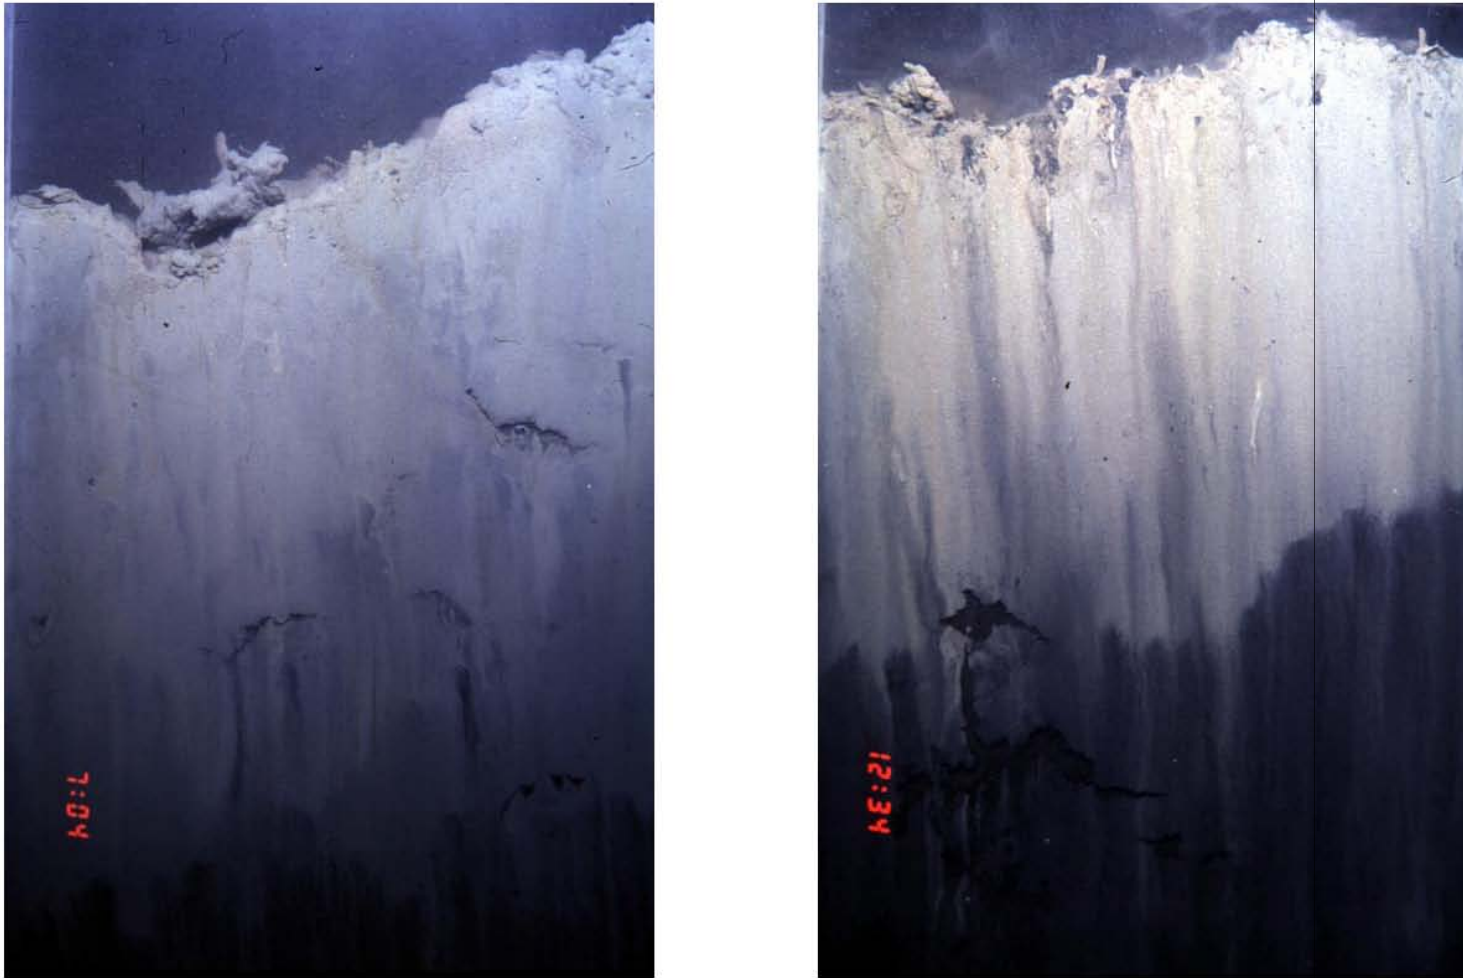
Figure 3-9. REMOTS® images from station 50E (left) and 150S (right) showing Stage I and II tubes visible at the sediment surface, and feeding voids (evidence of Stage III activity) at depth within the sediment.

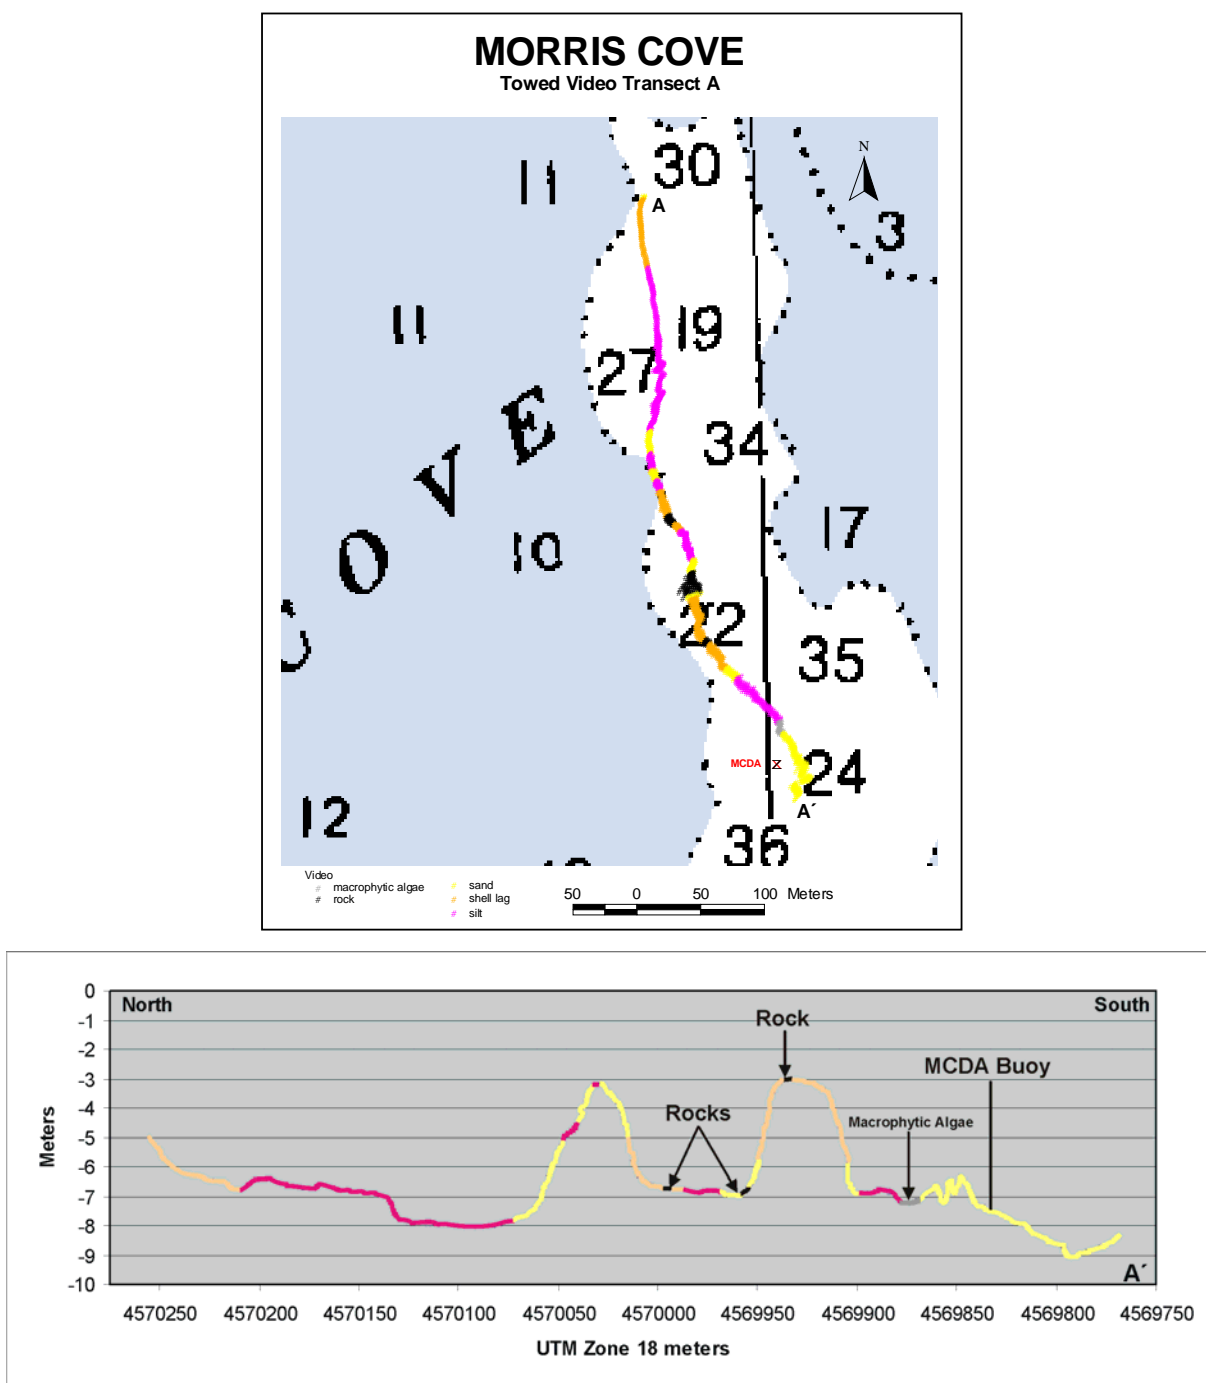
Transect A was a longitudinal pass within the boundaries of the borrow pit, concentrating on the western margin of the bottom feature (Figure 3-10). The starting point for this line was placed approximately 450 m north of the MCDA buoy position. Soft material was observed for the majority of this transect with silty sand and shell fragments observed as the video sled encountered the sloping walls of the pit. Silt was predominant in areas of low relief and tended to be found at water depths below 5 m. A few patches of pebble and cobble sized rock were also observed on the bottom, as the video sled was towed south and east through the pit. The seafloor within a 30 m radius of the MCDA buoy position was characterized as a silty sand, but showed no obvious differences from the surface sediments in the northern portion of the borrow pit.

Figure 3-10. Aerial perspective and profile view of surface sediment characterization data obtained for Transect A displaying distribution of fine sand (yellow), silt (magenta), shell lag (tan), rock (black) and macrophytic algae (gray).

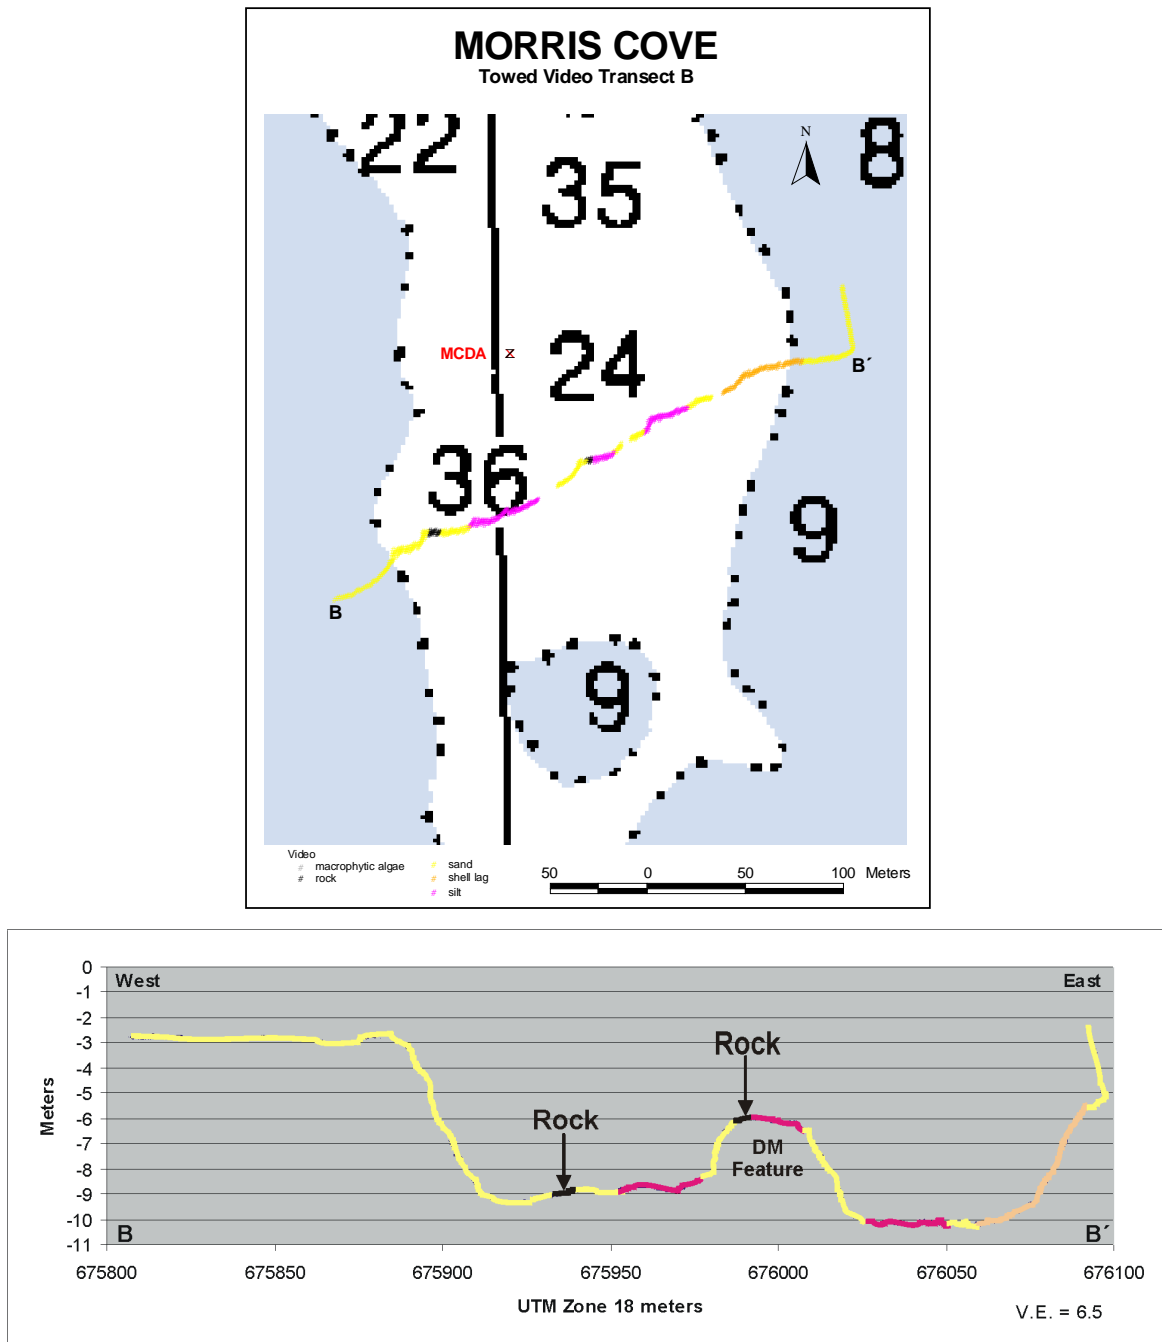
Transect B represents the first transverse route occupied over the Morris Cove borrow pit. The video sled passed approximately 60 m southeast of the disposal buoy position (Figure 3-11). Fine, silty sand was observed in the shallow areas on either end of the transect, and patches of silt were found at depth. Once again, a correlation with bottom slope was detected as the margins of the pit were composed of fine sand or fine sand with shell.

Figure 3-11. Aerial perspective and profile view of surface sediment characterization data obtained for Transect B displaying distribution of fine sand (yellow), silt (magenta), shell lag (tan), rock (black) and macrophytic algae (gray).

Silt tended to accumulate in the deeper (>5 m), low relief areas in the pit. A few small patches of rock were noted along this line, one of which was found on a bathymetric feature near the mid-point of the transect.

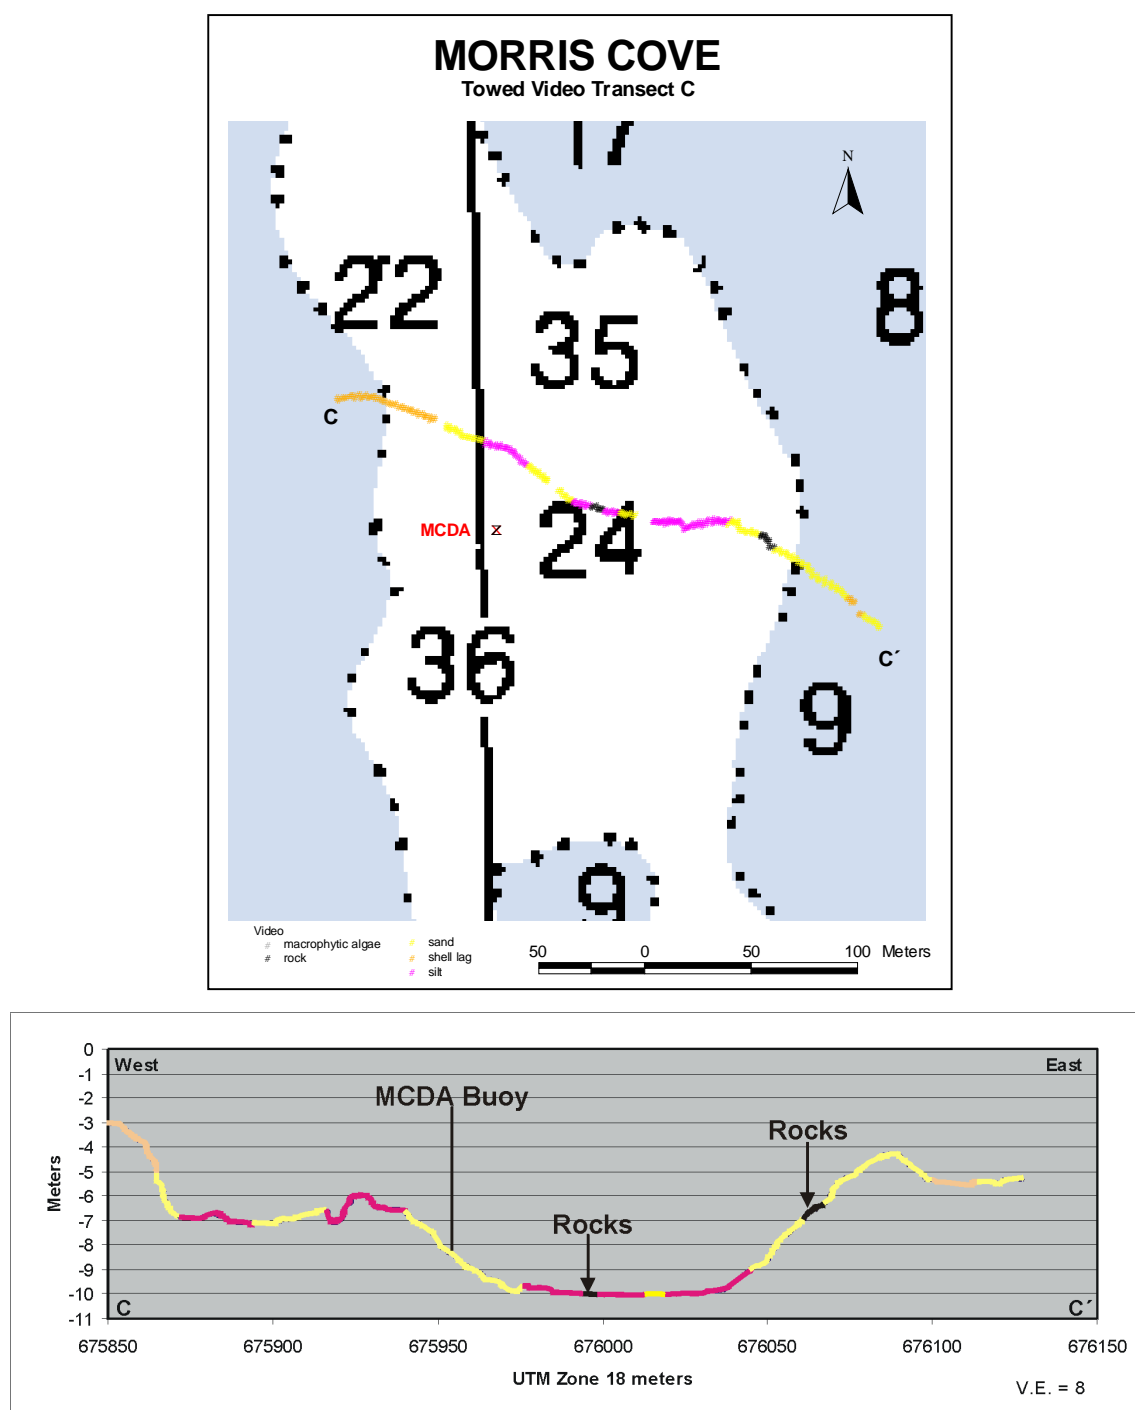
Figure 3-12. Aerial perspective and profile view of surface sediment characterization data obtained for Transect C displaying distribution of fine sand (yellow), silt (magenta), shell lag (tan), rock (black) and macrophytic algae (gray).

Transect C also represents a transverse pass over the borrow pit. Once again, small patches of silt, fine silty sand, fine sand with shell, and a limited amount of pebble and cobble sized rocks were observed within the video record (Figure 3-12). The video sled passed 20 m northeast of the disposal buoy position as it was towed east-southeast across the borrow pit. Similar to the interpretations of Transect A, the surface sediments in close proximity to the MCDA buoy position were characterized as fine, silty sand. No obvious visual distinctions were observed between ambient sediment and the surface of the recent dredged material deposit. The depth profile for Transect C showed limited vertical relief to the west of the buoy position before the bottom gradually sloped to the deepest portion of the pit (water depth of 10 m). Silt was the major constituent of the sediments within the deepest portion of the pit.

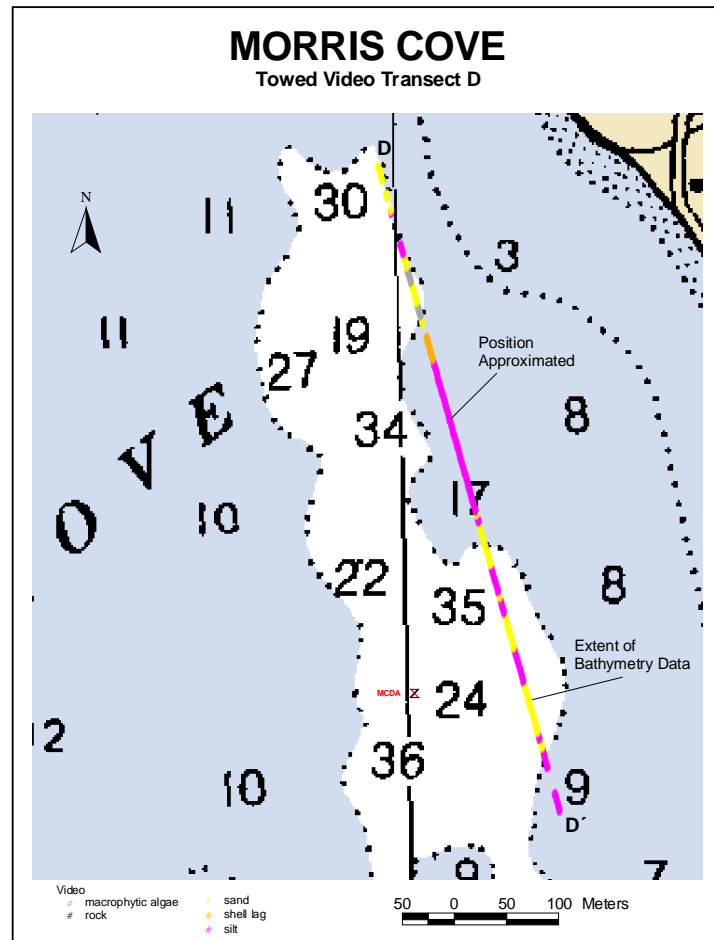
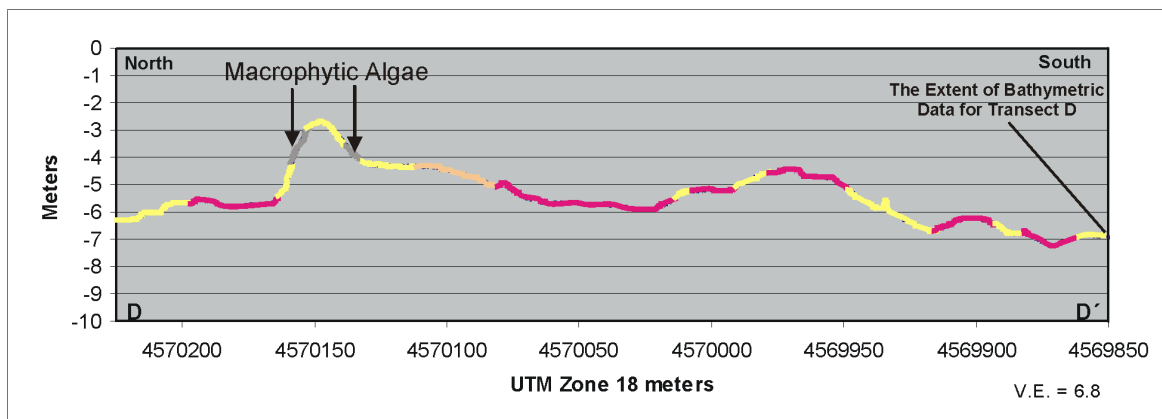
Figure 3-13. Aerial perspective and profile view of surface sediment characterization data obtained for Transect D displaying distribution of fine sand (yellow), silt (magenta), shell lag (tan), rock (black) and macrophytic algae (gray).

Transect D was the second longitudinal pass made over the Morris Cove borrow pit, and designed to document the composition of sediment along the eastern margin of the pit. Due to unreliable navigation data from the DGPS unit during the occupation of Transect D, the position of the video sled was approximated for the majority of this line. The bathymetric data were used in conjunction with the NOAA chart pictured in Figure 3-13 to place the line along the eastern margin of the borrow pit. Overall, a similar lithology and distribution of sediments were observed, relative to other transects. Fine sand with varying shell content was noted in areas near the walls of the pit and silt was found over the flat areas within the pit. The video data collected in the southern portion of the borrow pit suggested that seafloor composition east of the buoy position is quite patchy.

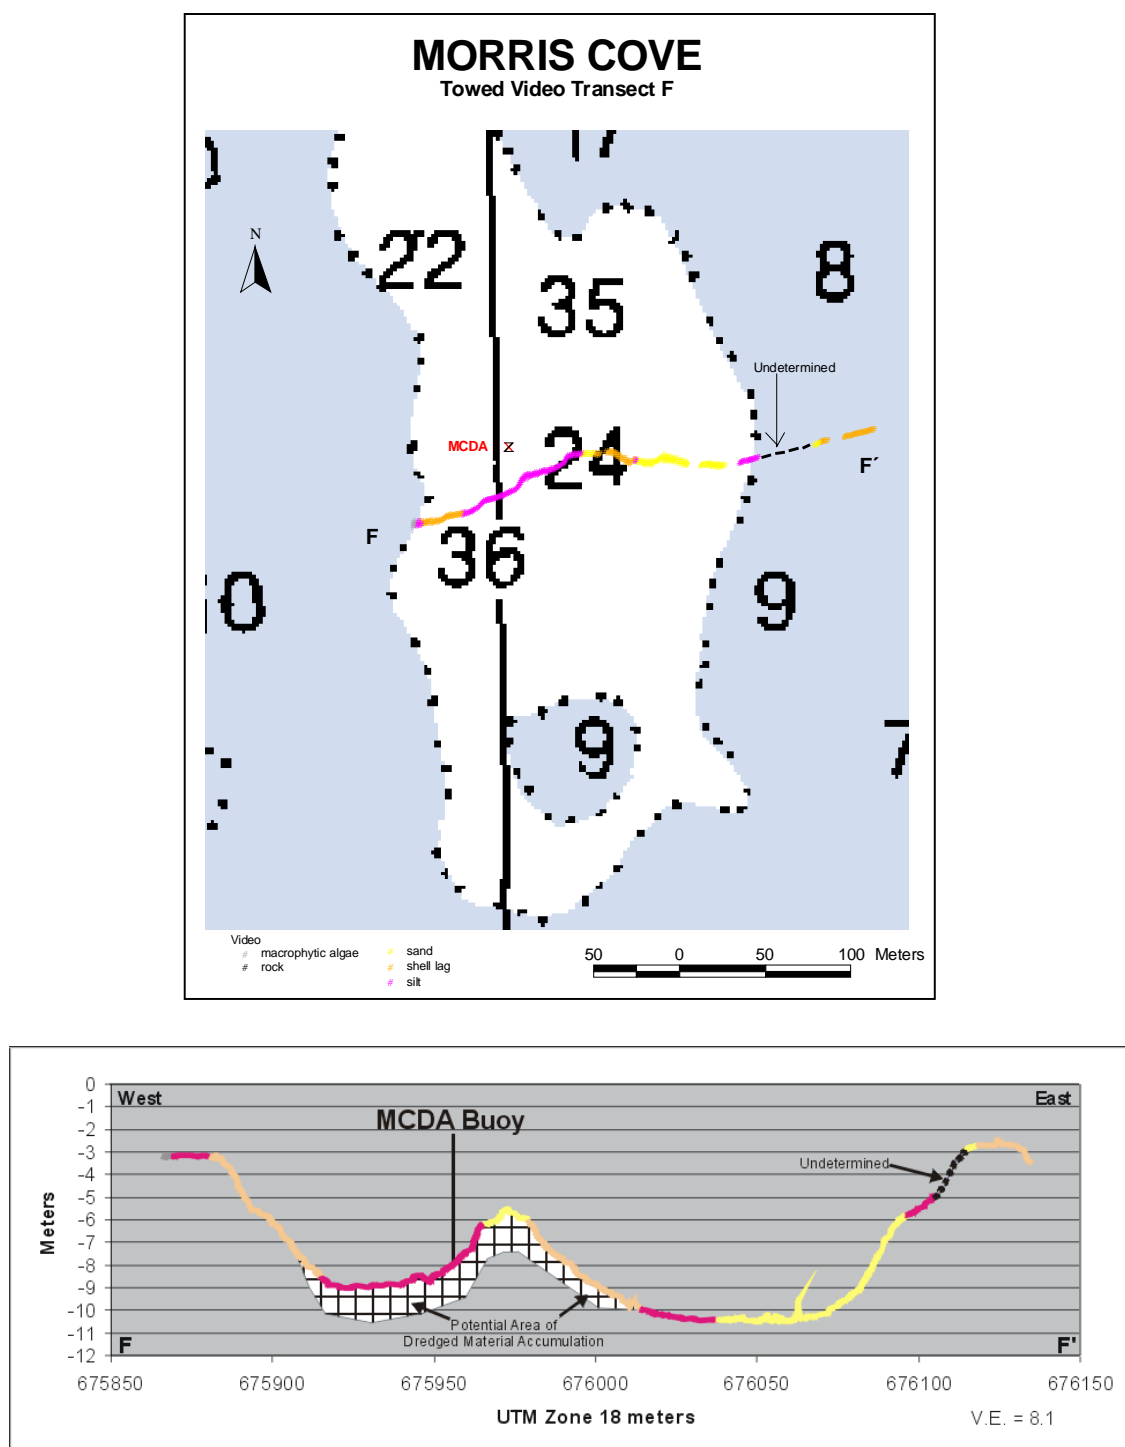
Figure 3-14. Aerial perspective and profile view of surface sediment characterization data obtained for Transect F displaying distribution of fine sand (yellow), silt (magenta), shell lag (tan), and macrophytic algae (gray).
