Monitoring Cruise at the Morris Cove Borrow Pit

Disposal Area Monitoring System DAMOS

Contribution 129
June 2001

SAIC Report No. 520

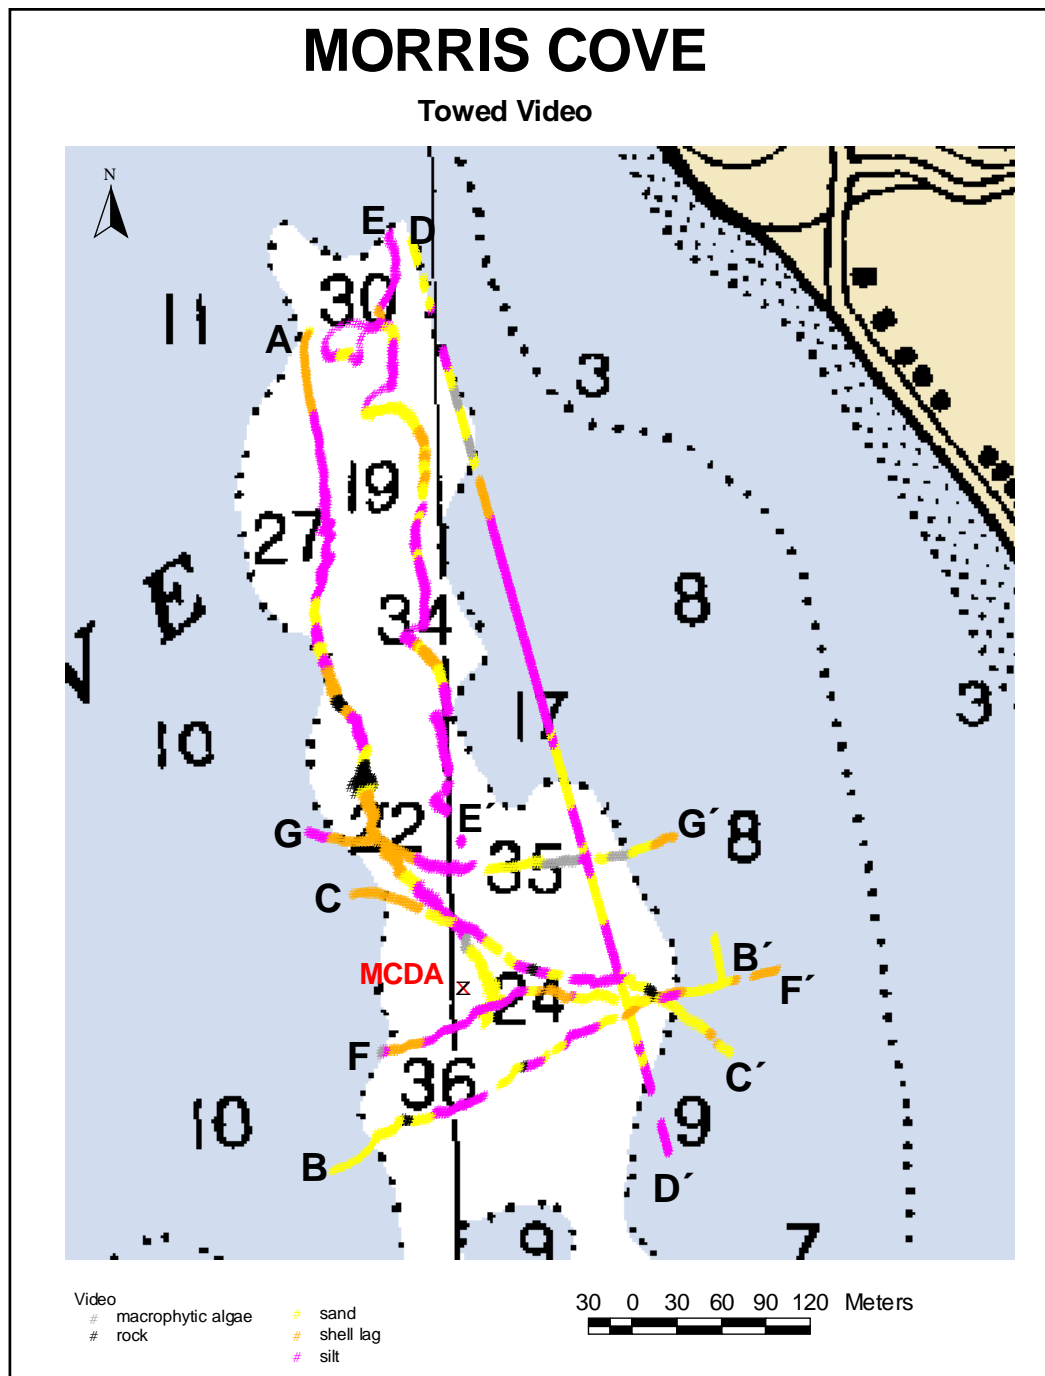
Figure 3-15. Aerial perspective of towed video Transects A through G showing agreement in sediment classification between overlapping and closely spaced tracklines.

Two additional transects (one longitudinal and one transverse) were occupied and results overlaid on the data from Transects A, B, C, D, and F (Figure 3-15). In general, strong agreement was observed in the classification of sediment along the margins and within the northern portion of the borrow pit. The surface sediment distribution within the southern portion of the borrow pit appeared more heterogeneous as differences in sediment classification were noted on several overlapping, or closely spaced tracklines (i.e. Transects A and F). This disagreement is likely the result of the chaotic nature of the dredged material and the many small patches of fine sand, silt, and shell on the surface of the deposit.
