NAE-2006-01350  
Earl's marina  
2014 report

## COTTONWOOD RD. MITIGATION PLAN MONITORING REPORT 10-05-14

Prepared for the Army Corps of Engineers

Prepared by: Roy E. Okurowski, P.E., C.H.

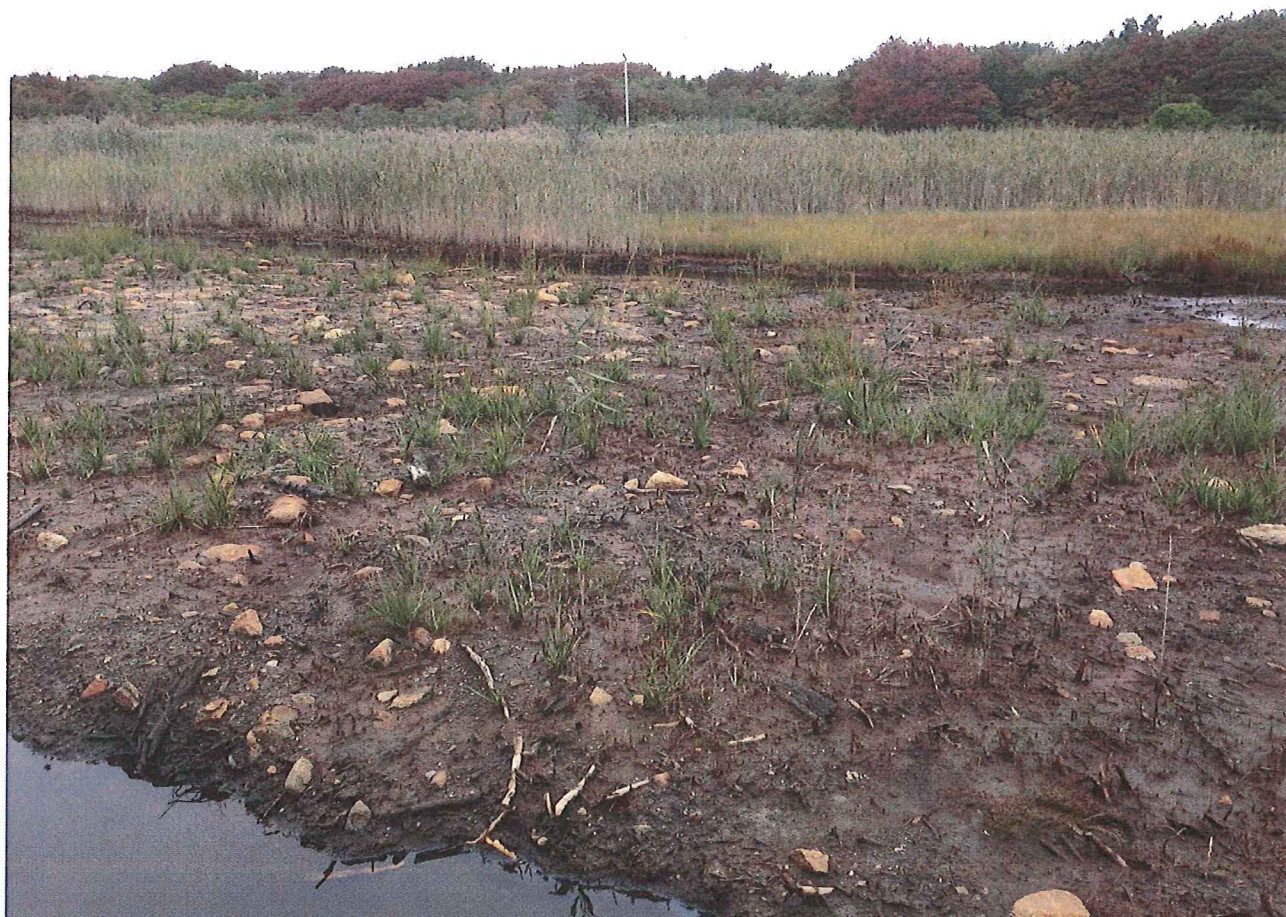
the South. There was a 50% survival rate from the original planting based on samples of counted plants. We recommend that more plants are planted in bare areas in the spring of 2015 to supplement the cover. The plants that did survive are doing well with one very healthy area. Salinity measurements were taken and the incoming tide does bring salt water with a comparable ppt for the survival of marsh grass. This is also evident by the extremely healthy stand of marsh directly south of the site.

VIEW OF SURVIVING MARSH

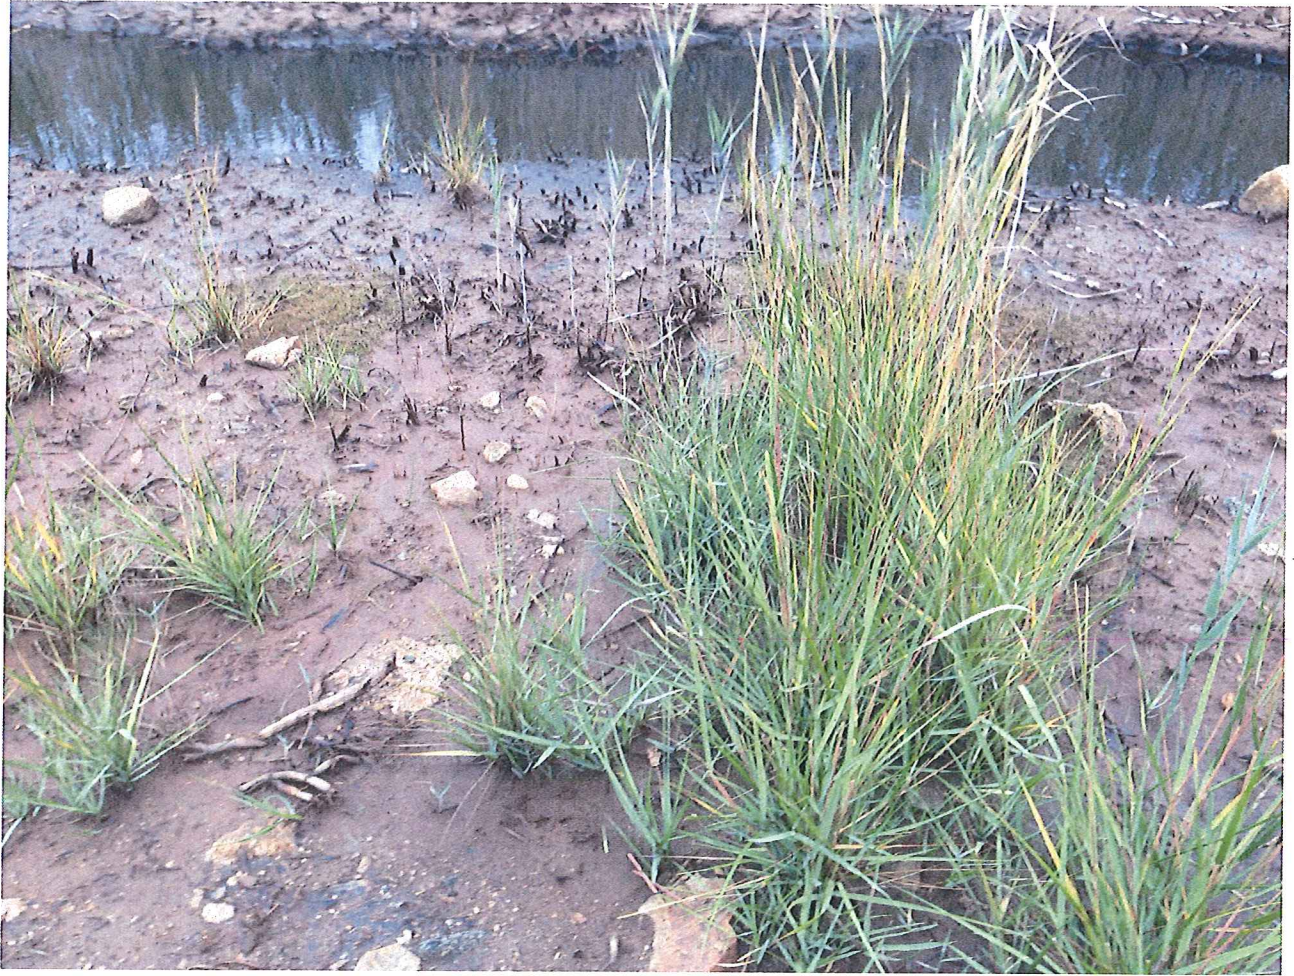
VIEW OF CLEANED OUT DITCH AND TIDAL WET AREA

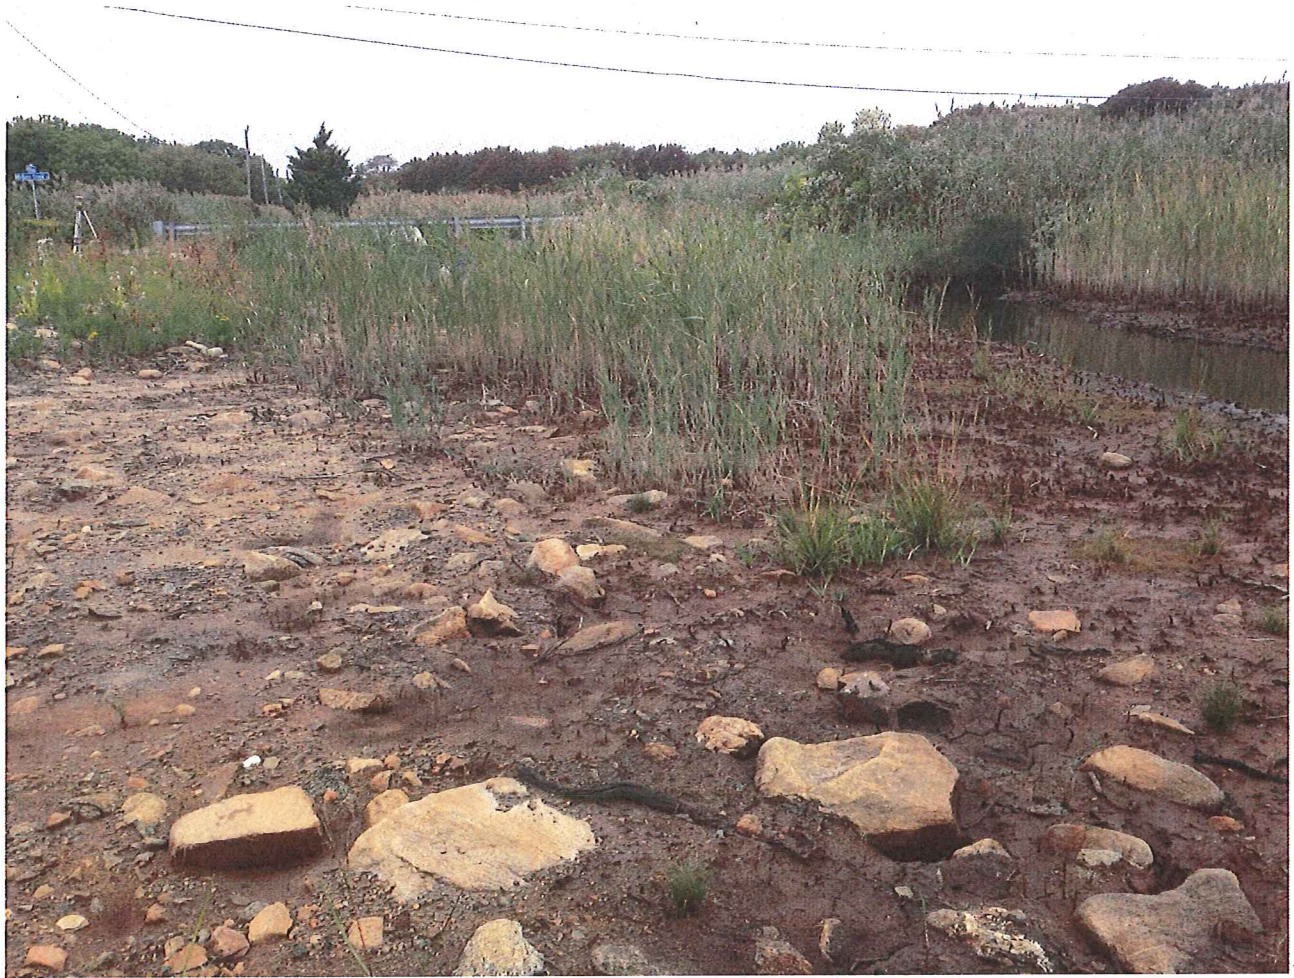
Our observations revealed that the previous project was not constructed properly and really did not function as originally designed. Both culverts that were installed by the NOAA project were installed to high and were to small and did not allow the proper flow of water to the marshes. They also allowed fresh water to build up on the North and South sides of Bass Creek Road which is helping the invasive species to grow rather than get rid of it. We highly recommend that both of the culverts be reconfigured to what was originally submitted to the town. All of the original mosquito ditches should also be cleaned out in order to improve the hydraulics of the marsh.

VIEW OF FRAG AT NORTH CULVERT AREA DUE TO FRESH WATER

The existing invasive species (Phragmites) in the project area were be removed and disposed of at an approved location. The remaining Phragmites surrounding the area will be introduced to more salt water and die back over the upcoming seasons. Any new invasive species that enter the growing area such as Phragmites or pepperweed will be removed by a qualified person at the appropriate time of year.

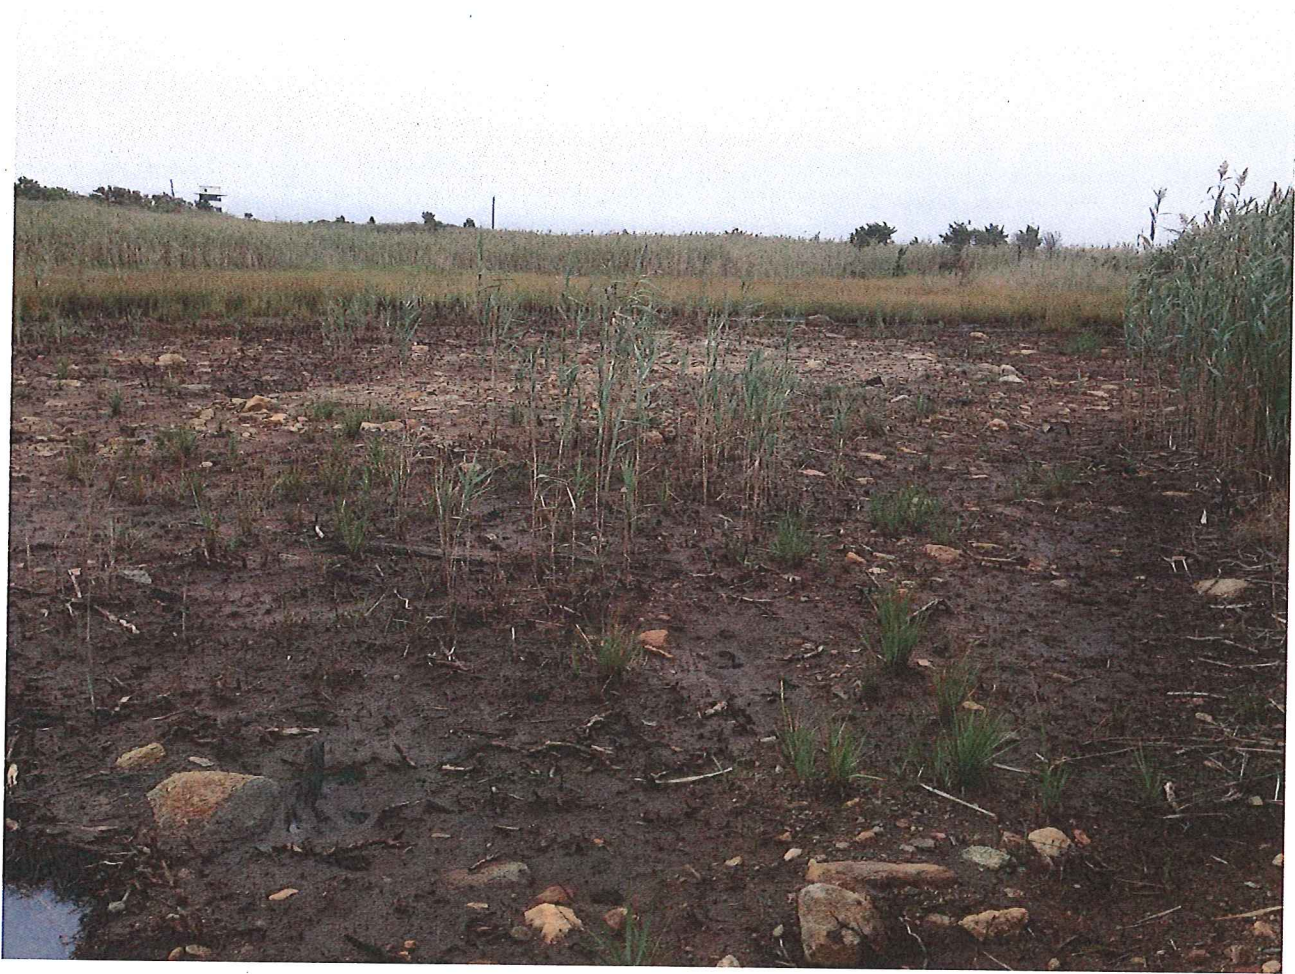
VIEW OF SOUTH END OF MARSH NEEDS REPLANTING

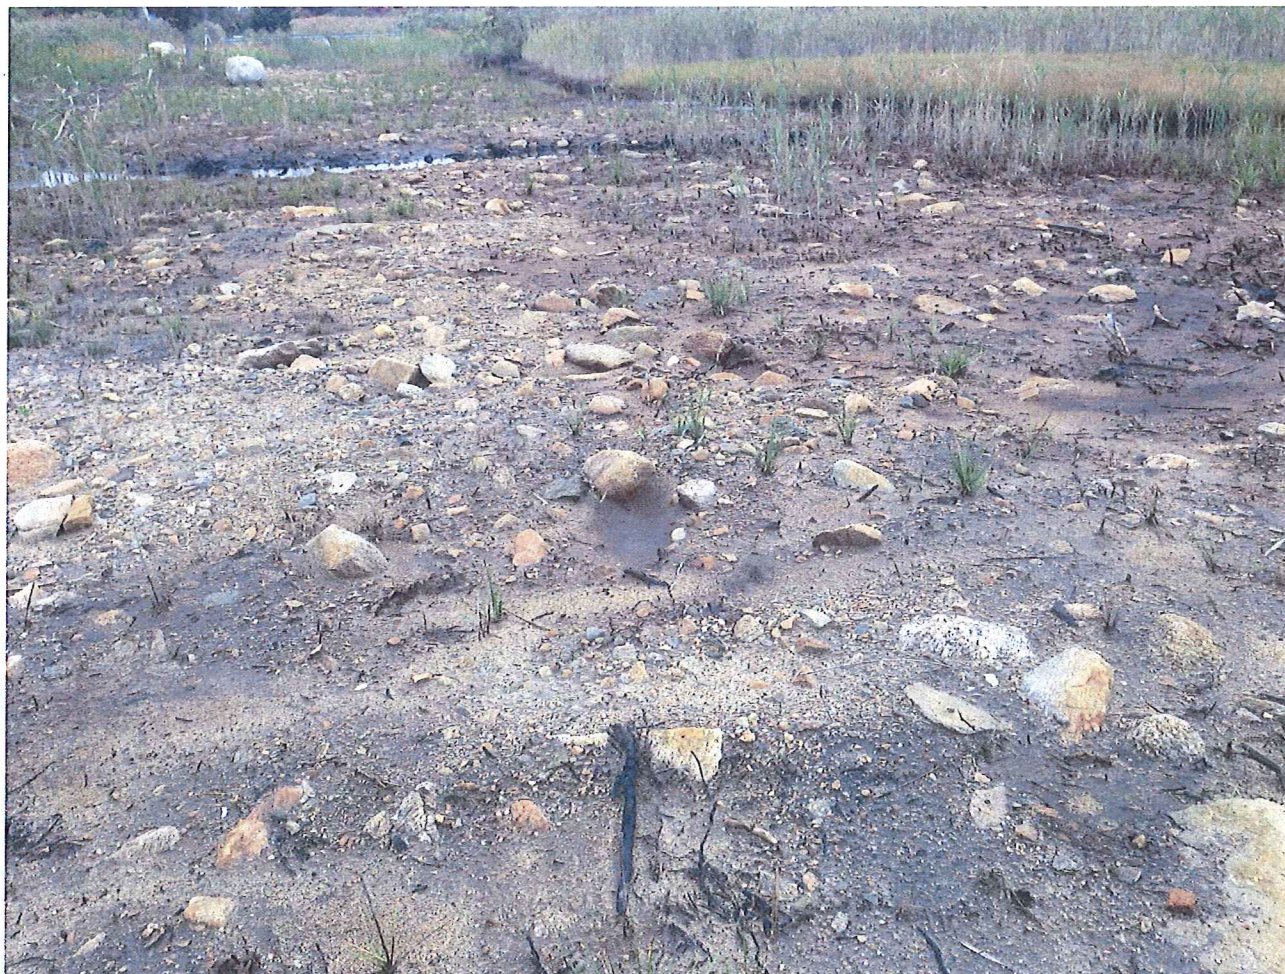
VIEW OF NORTH AREA TO BE PLANTED WITH HIGH MARSH GRASS

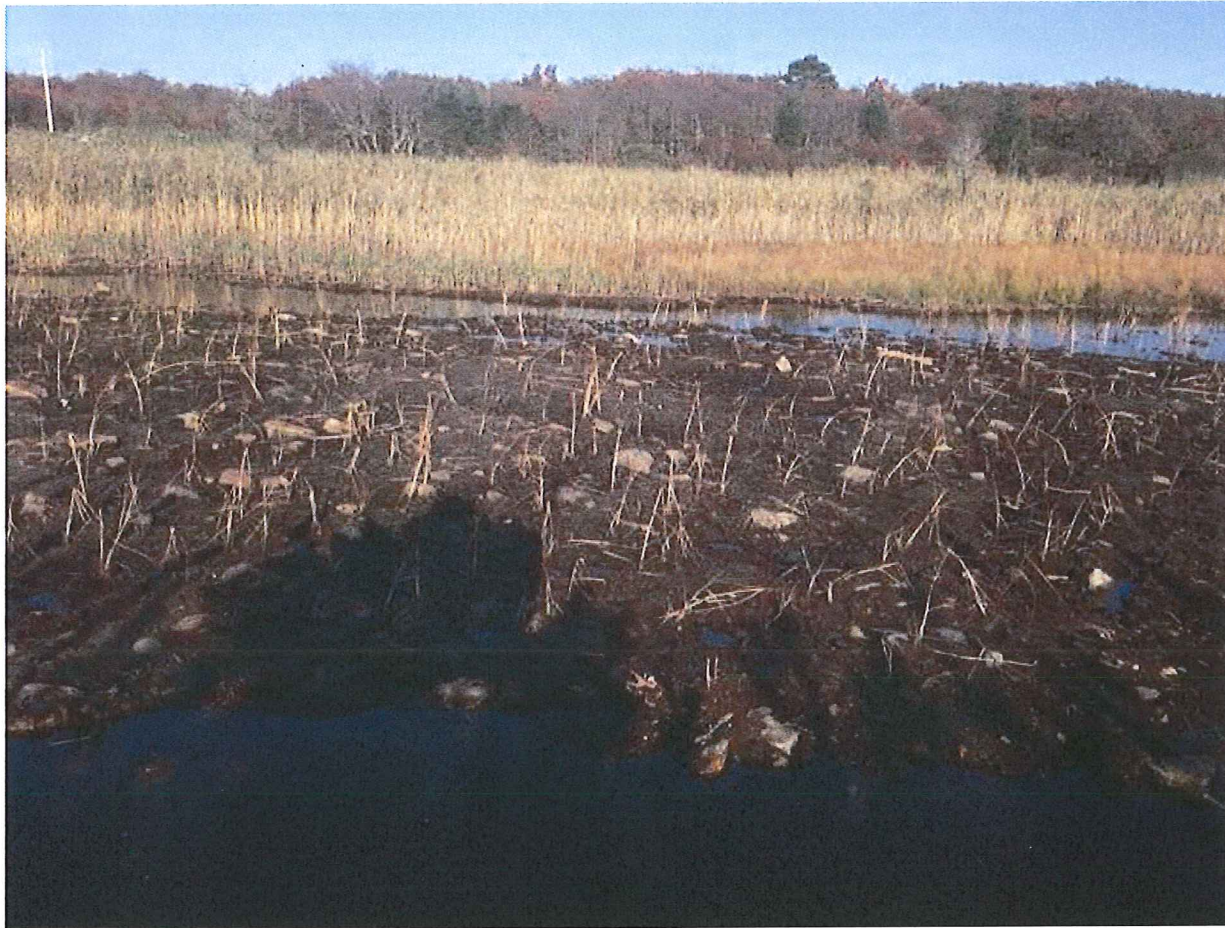
VIEW OF PATENS AND PHRAG ON EAST SIDE OF SITE

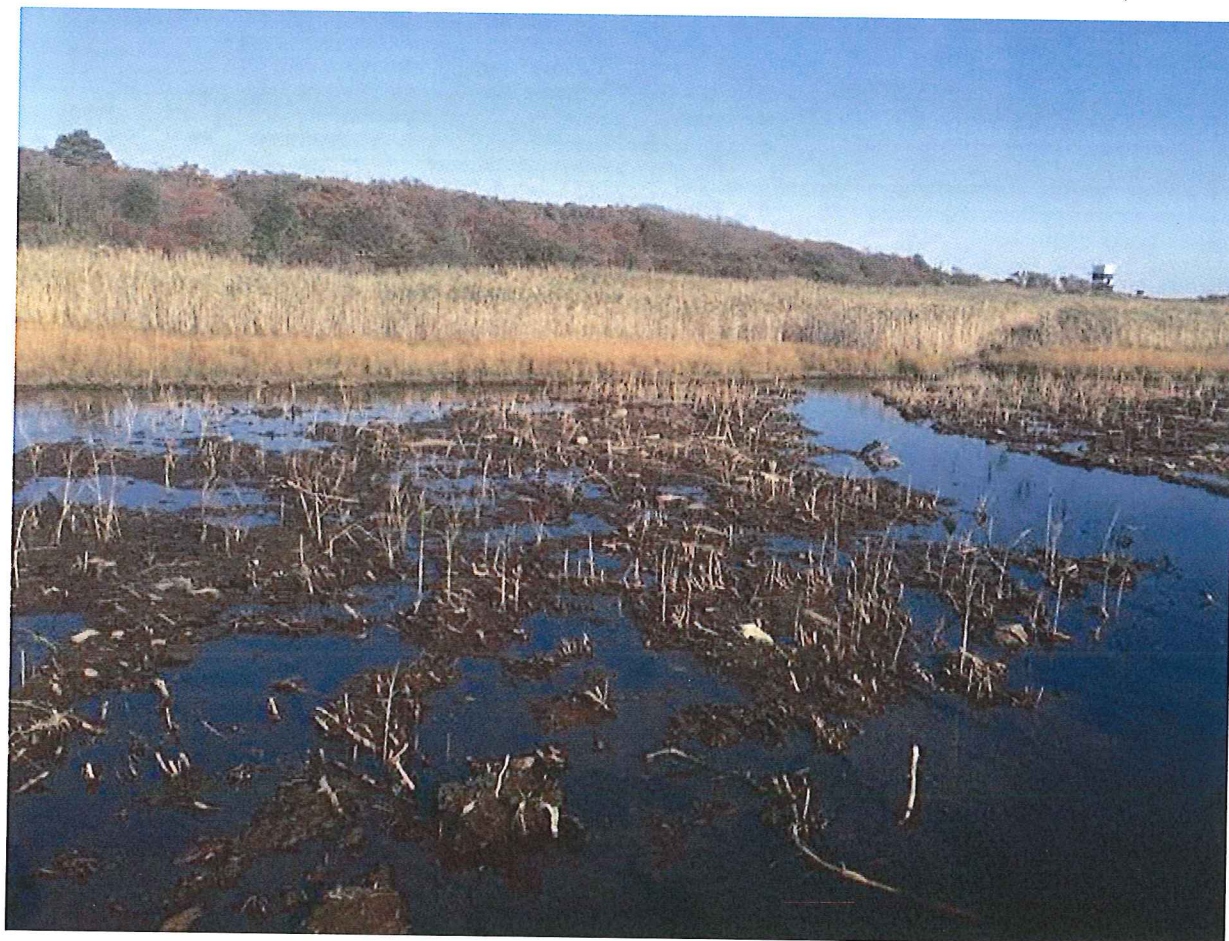
VIEW UPCOMING TIDE 2013
