NAE-2006-1350  
Earl's marina  
2015 report

## COTTONWOOD RD. MITIGATION PLAN MONITORING REPORT 09-09-15

Prepared by: Roy E. Okurowski, P.E., C.H.

# Earl's Marina Mitigation Report

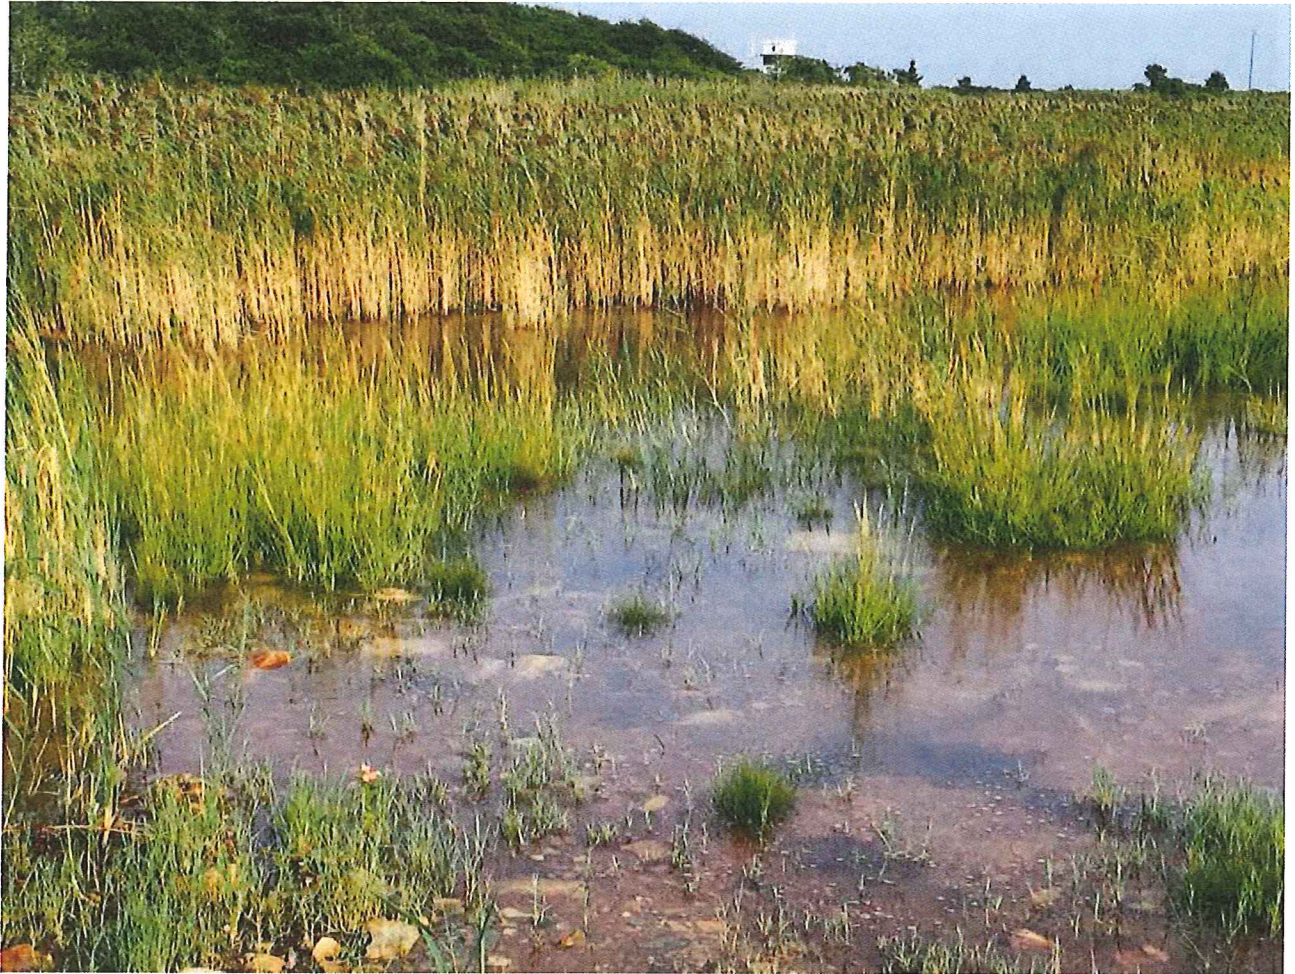
It is also evident that the ground has uplifted .2 to .3 tenths of a foot and some of the areas are too high to support a healthy marsh. We recommend these areas be replanted with *spartina patens* in these areas. The previous effort failed for unknown reasons.

VIEW OF POOR MARSH SURVIVAL AREA

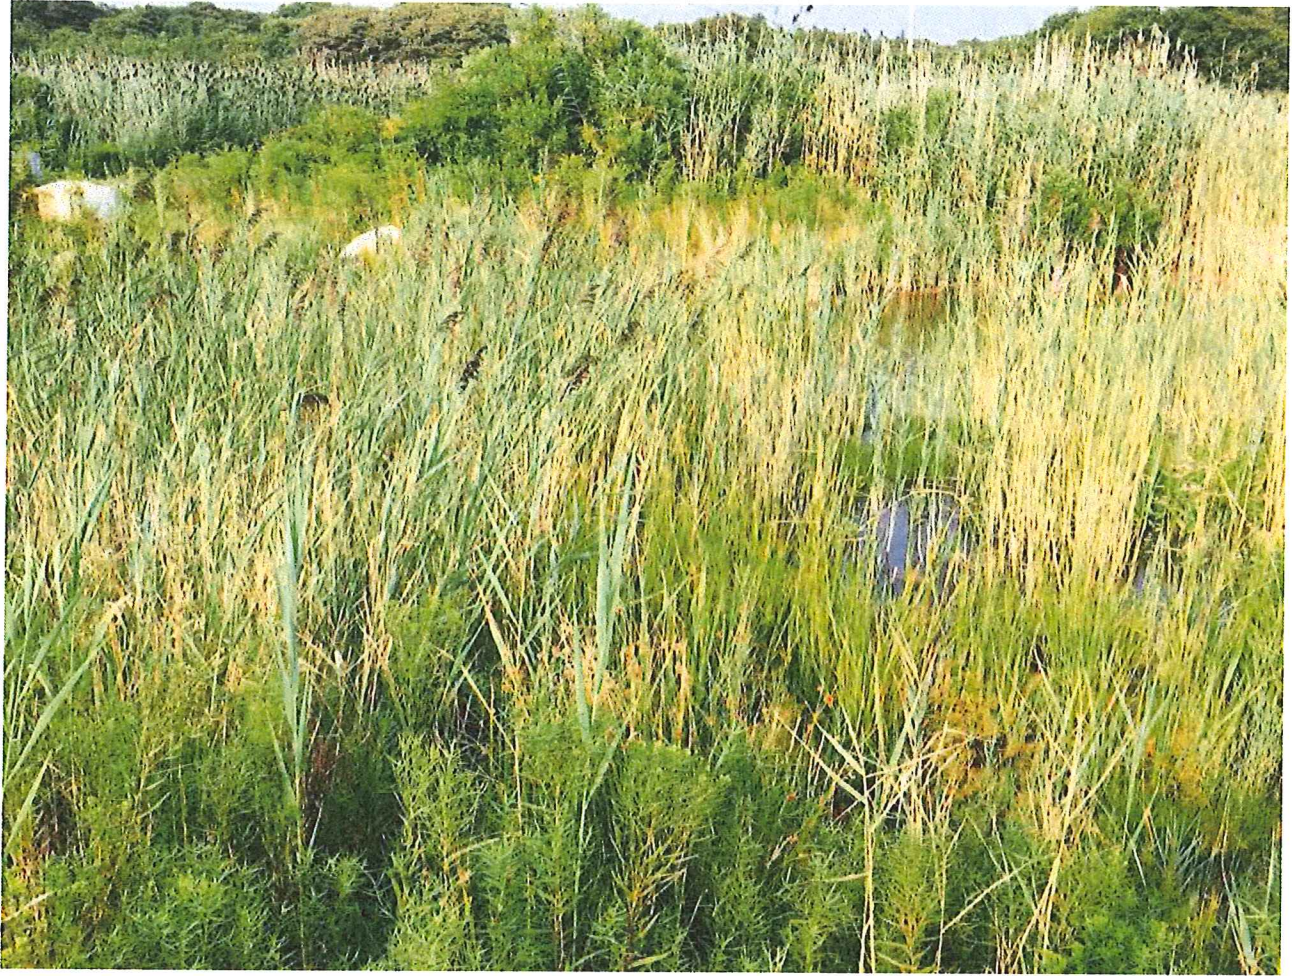
VIEW OF INLET AREA WITH INVASIVES STILL PRESENT

The existing invasive species (Phragmites) in the project area were to be removed and disposed of at an approved location. The remaining Phragmites surrounding the area will be introduced to more salt water and die back over the upcoming seasons. This will be done by cleaning out the long trench to the town beach. Any new invasive species that enter the growing area such as Phragmites or pepperweed will be removed by a qualified person at the appropriate time of year if it does not die back naturally. Due to the poor construction of the NOAA project and the inlet channel not being maintained the Phragmites continues to be a major problem in the entire marsh. We highly recommend that the channel from the bay to the marsh be dredged out to provide salt water to the marsh.

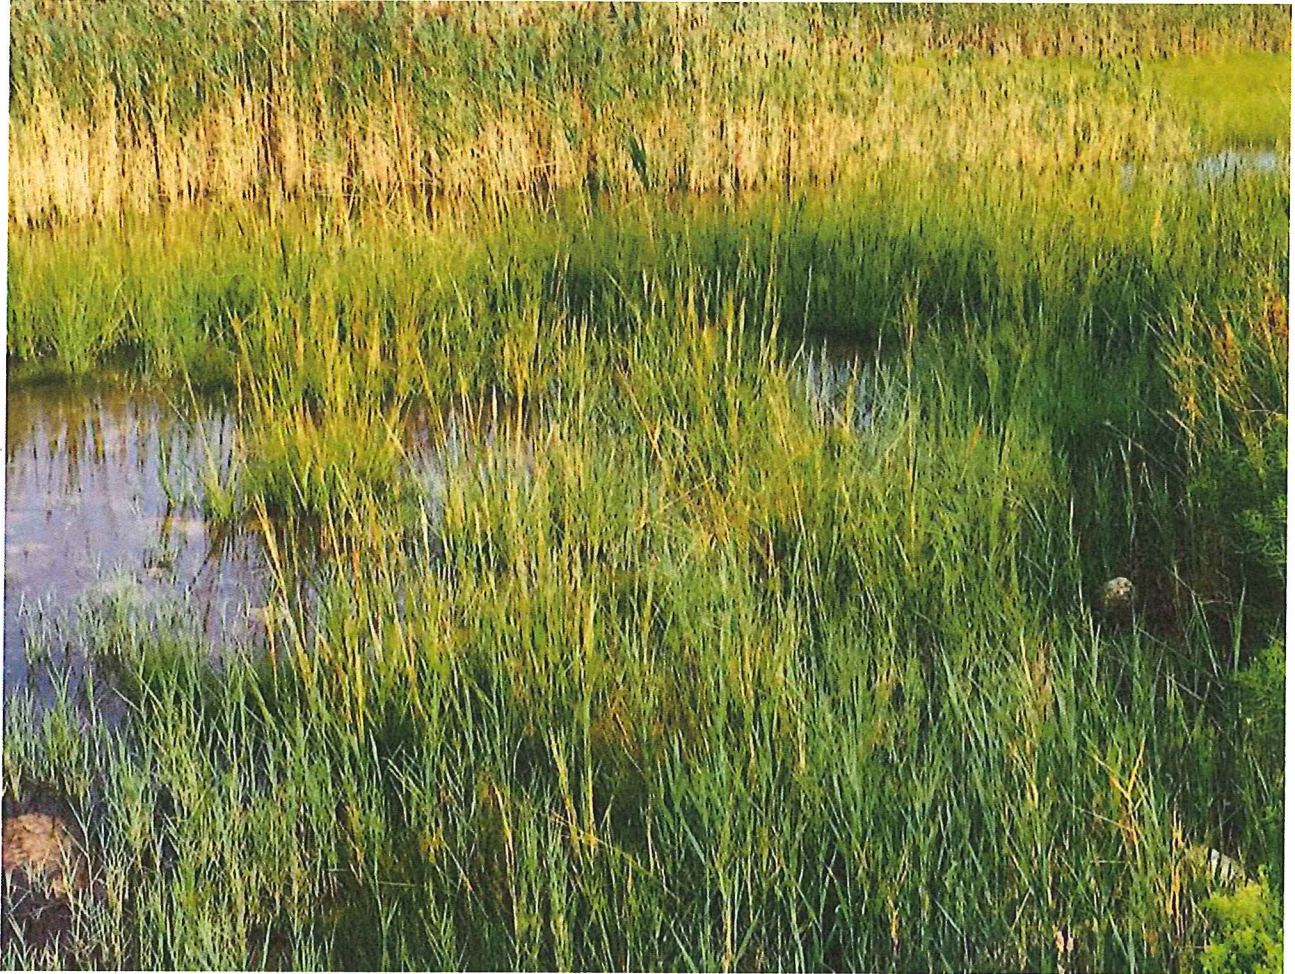
VIEW OF MARSH EXTENDING INTO DITCH WITH SEED PODS

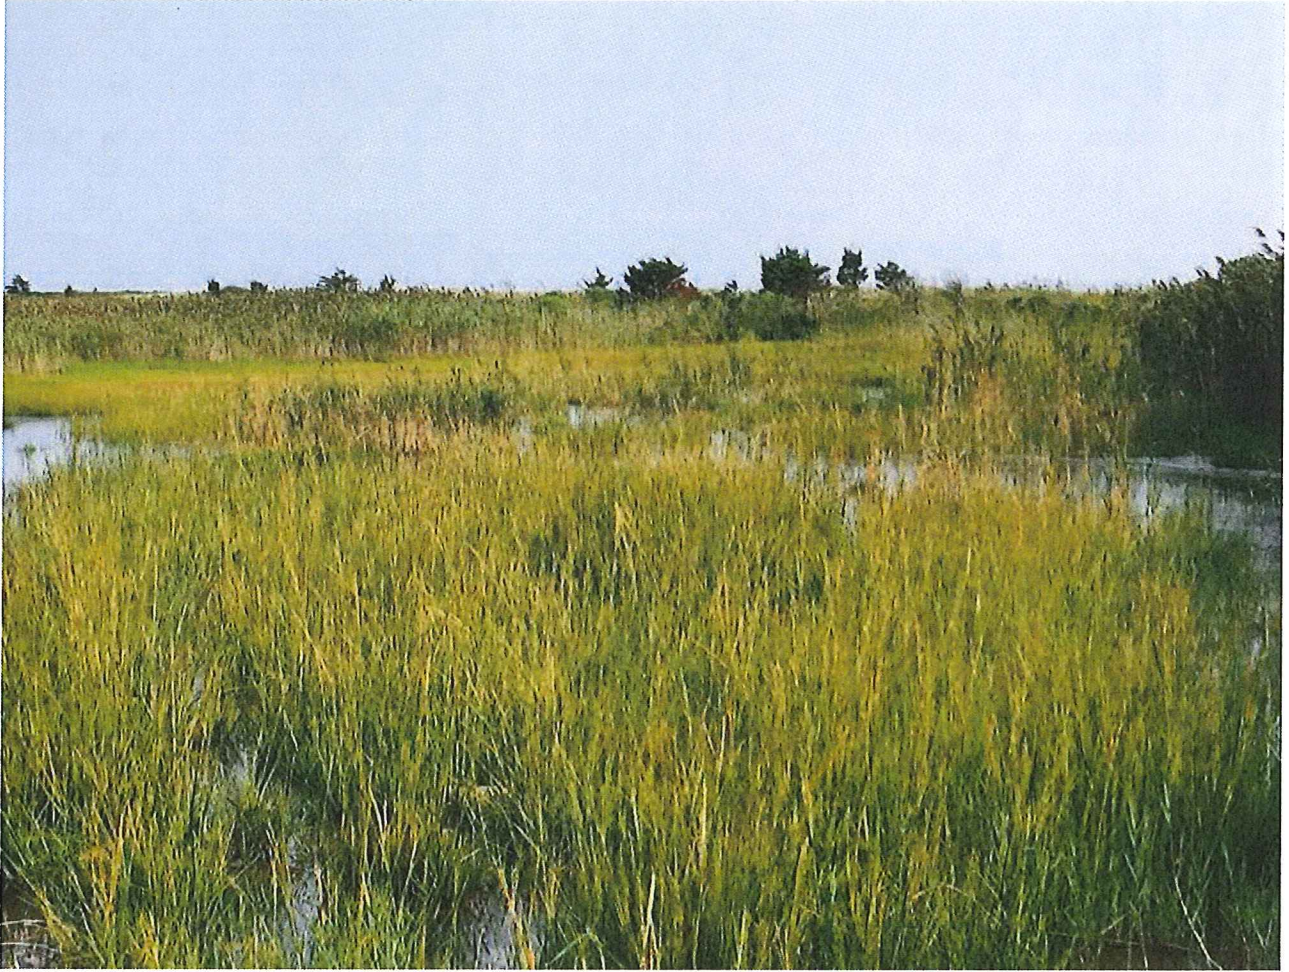
the South. In Fall 2015 there was a huge gain to 95% survival rate in the south section of the site from the original planting based on samples of counted plants. The North part of the project is still getting to much fresh water due to the town beach. This was not done as part of the original construction as we wanted to see if we could get enough water without the work. We feel that this will also eradicate a large amount of Phragmites that was not affected by the NOAA project. We recommend that all visible rocks are removed and more plants are planted in bare areas in the fall of 2015 to supplement the cover. The plants that did survive are doing well and are all active with seed pods at this time. Salinity measurements were taken and the incoming tide does bring salt water with a comparable ppt for the survival of marsh grass at high tide only. During spring and other rain events fresh water is not transported away from the marsh due to the blockage of the culvert by the town beach being poorly designed and also filled with sediment. This problem will continue to occur unless more extensive work is done in the project area.

VIEW OF SOUTH END OF MARSH 95% OVER 4,000 S.F.

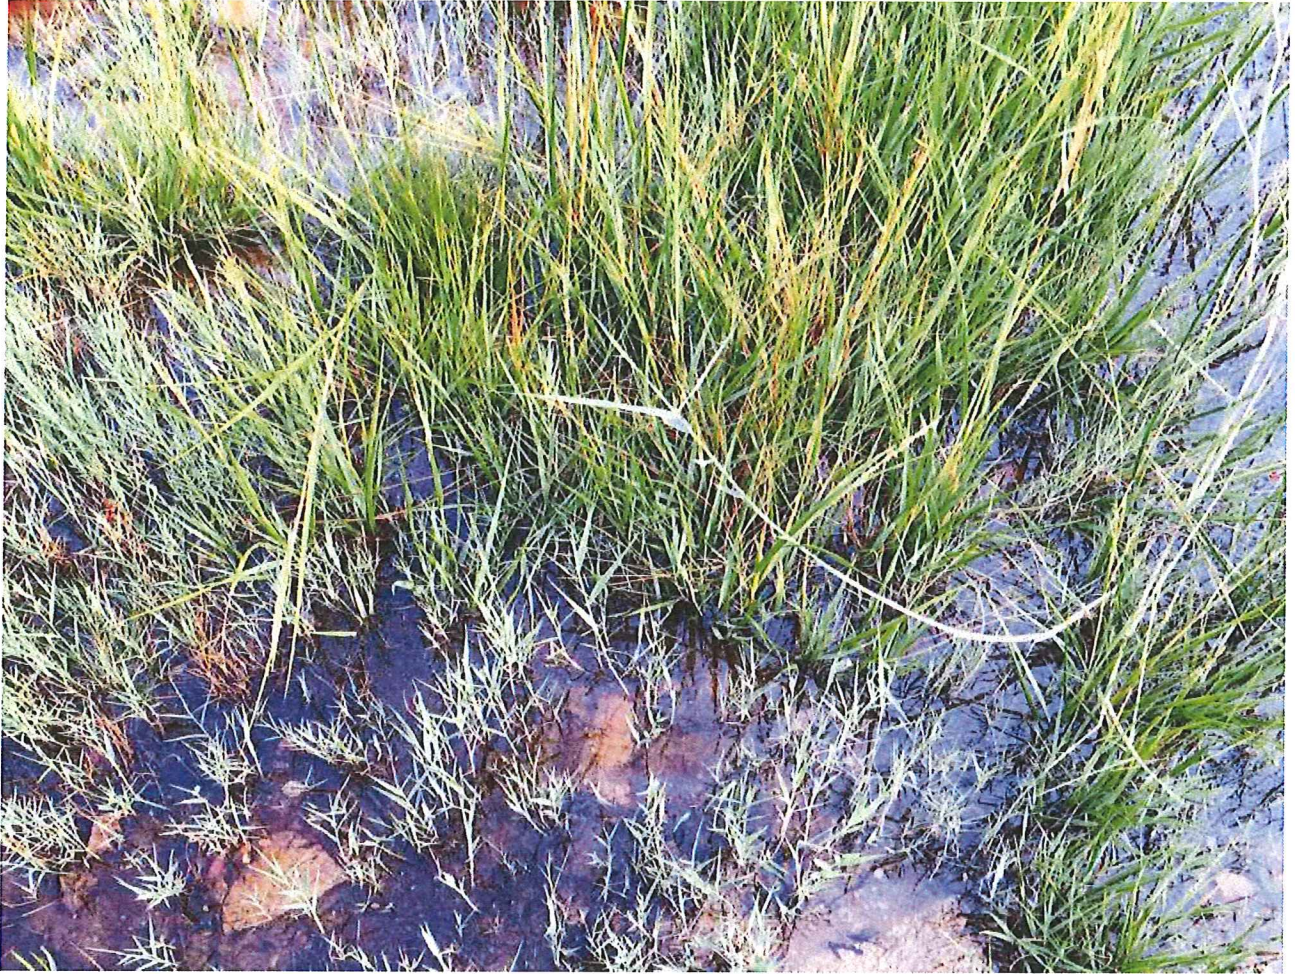
VIEW OF HEALTHY GRASS WITH SOME UPLAND VEGETATION

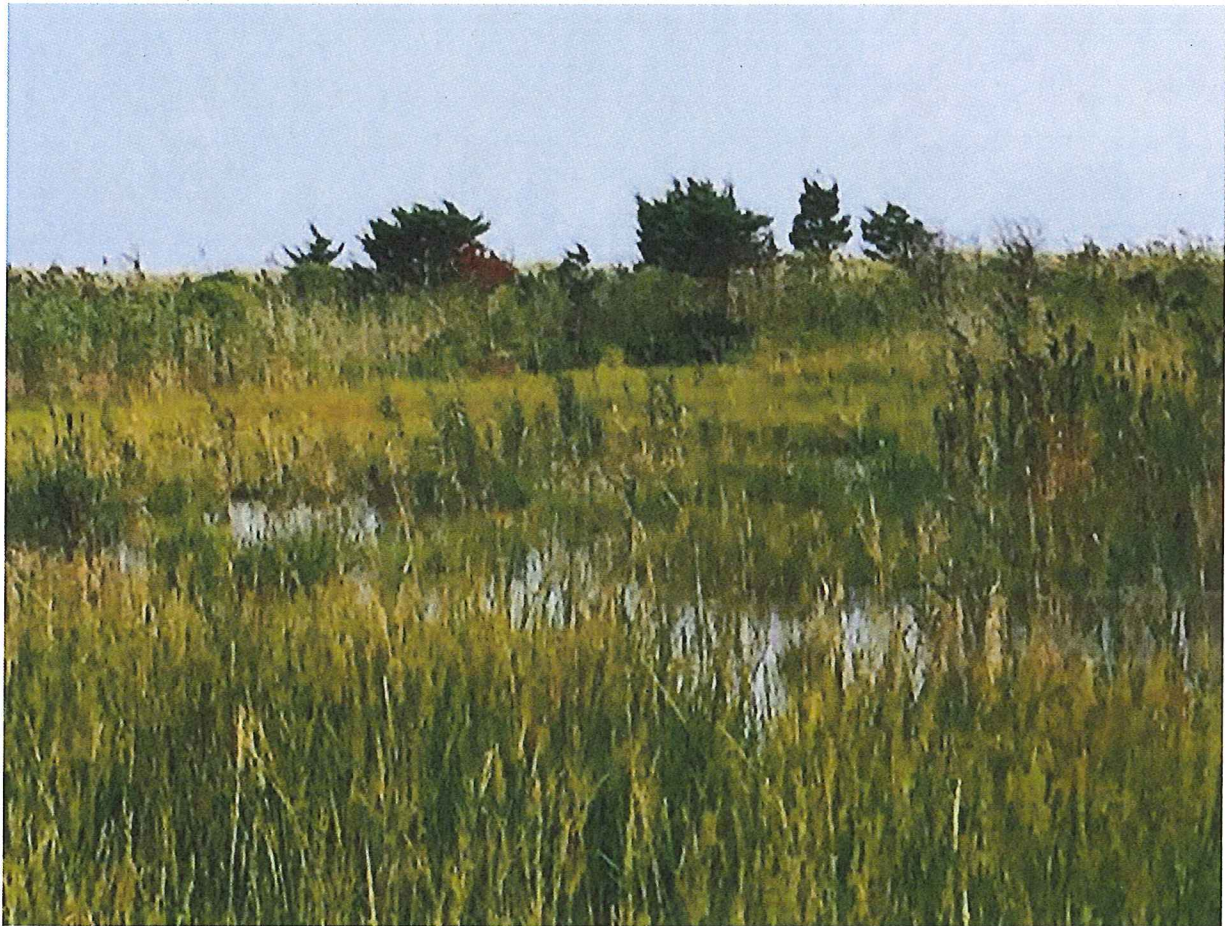
VIEW OF MARSH WITH HIGH TIDE

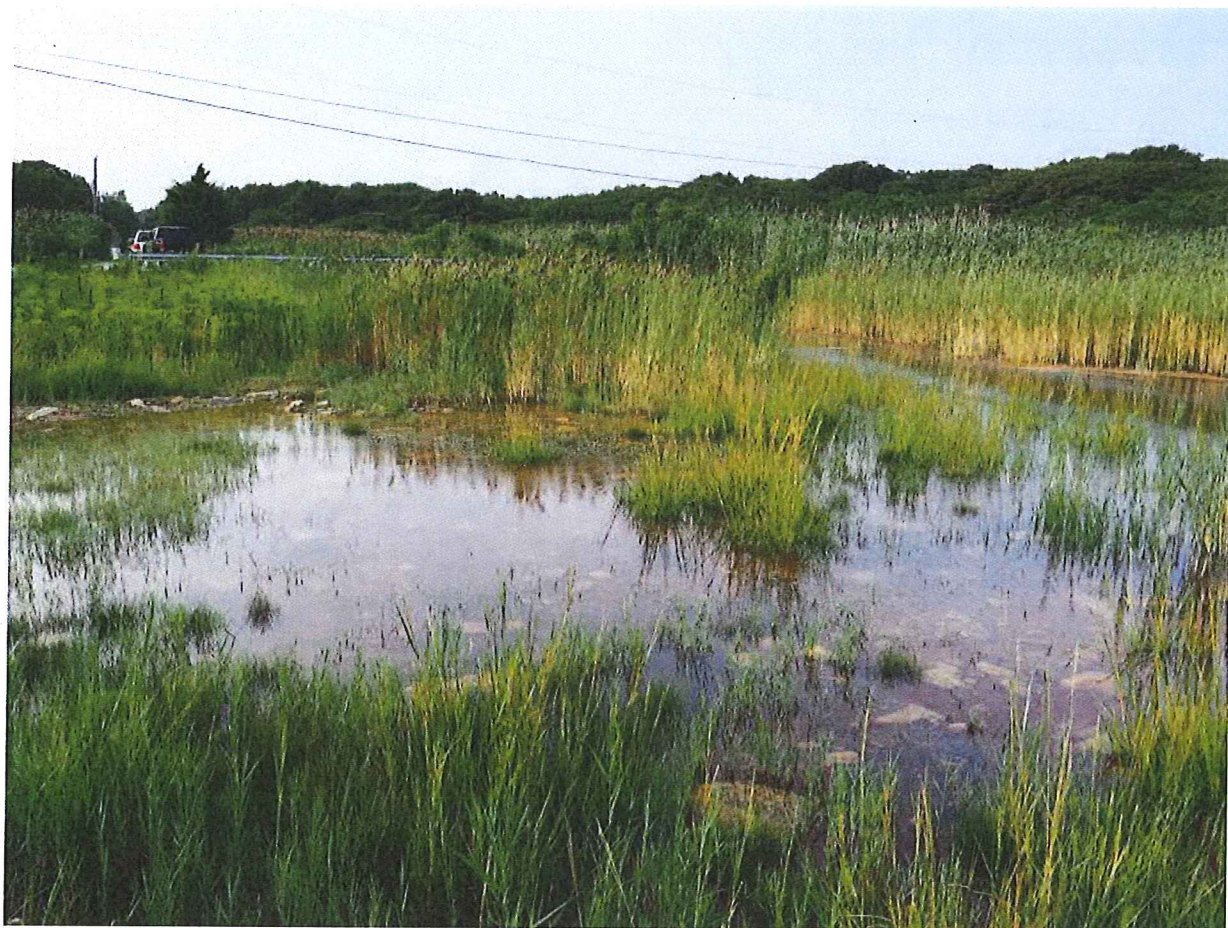
VIEW OF PATENS AND PHRAG ON NORTH SIDE OF SITE

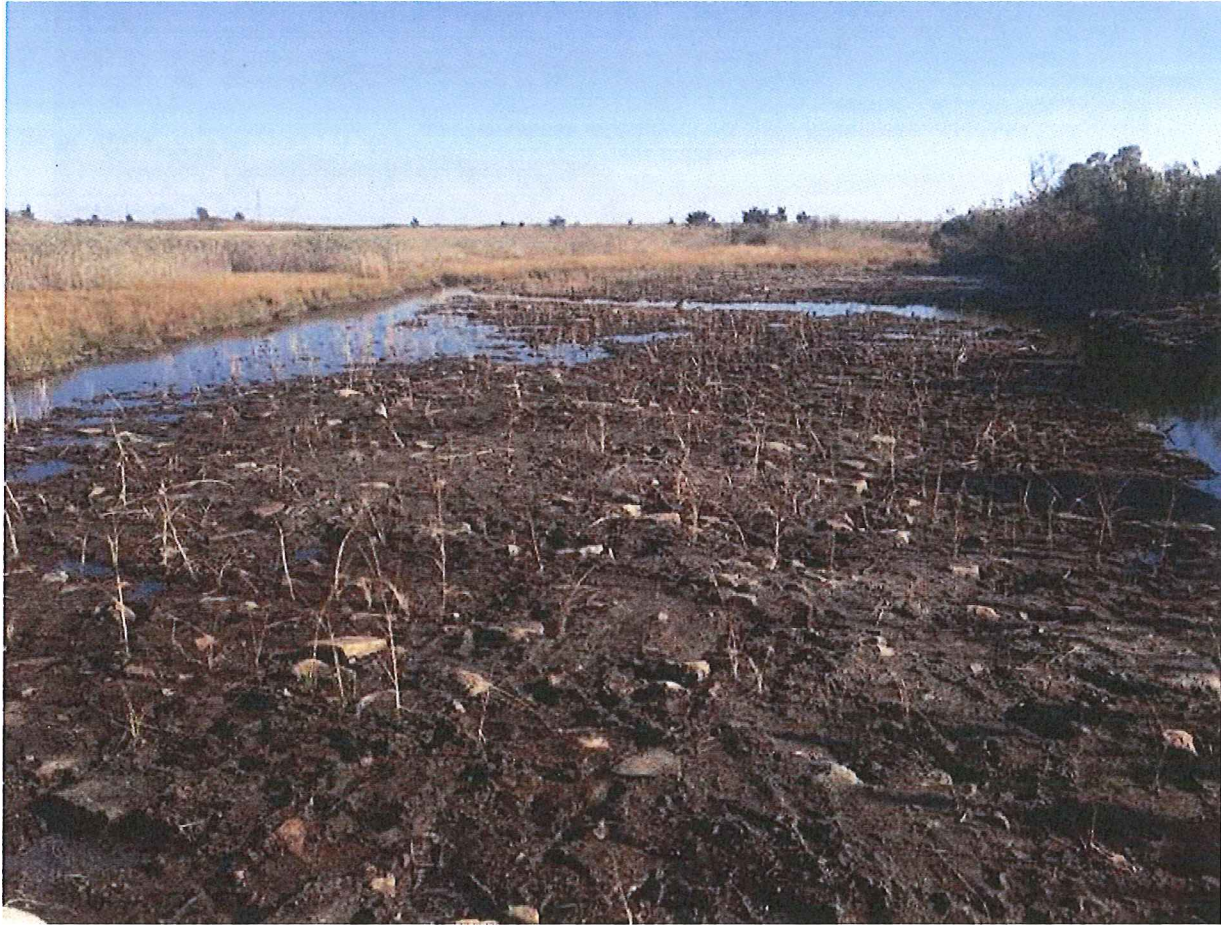
VIEW OF ORIGINAL PLANTING
