Maidstone Slide - STP 0271 (20)

Year 1 Report

Wetland and Invasive Species Monitoring and Control Recommendations

6 December 2013

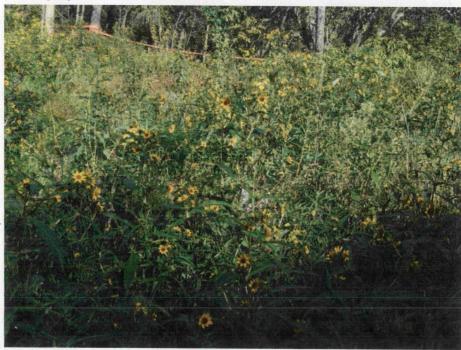
Figure 4. Vegetation of Plot 1. The prominent flowering plant is nodding beggar-ticks.

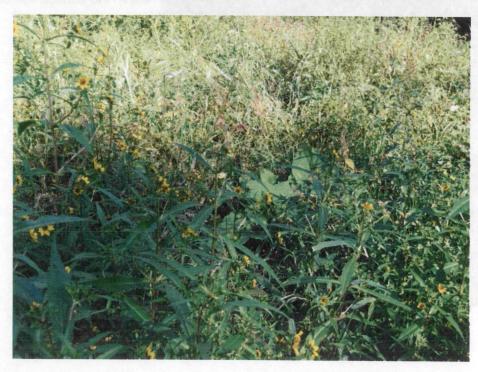
Figure 5. Vegetation of Plot 1. Nodding beggar-ticks, wild basil and the large leaves of burdock are apparent.

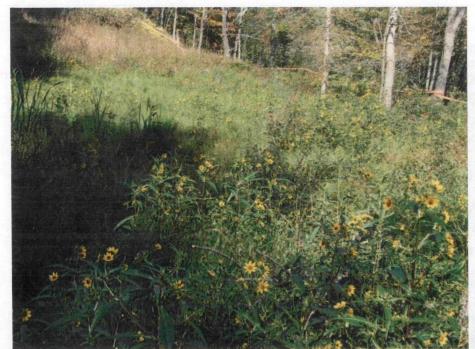
Figure 6. Vegetation of Plot 1. Wettest area with common soft rush is in the middle area, between the taller vegetation and the slope rise.

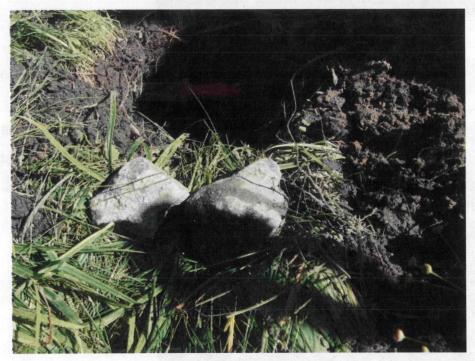
Soil pits were dug outside of the northwest corner of each of the vegetation plots. Plot 1 showed more disturbance to the soil than did Plot 2. Plot 1 is in the wettest area only about 10 m from the base of the upland slope where fill had apparently been deposited to ease the transition from sloping upland to level wetland. Disturbance to the soil in Plot 1 consisted of an apparent overburden of 10 cm of mucky loam placed atop what appeared to be a mucky fine sandy loam original surface horizon (Table 5). Within what seemed to be the 10 cm of replaced soil was approximately 20% of angular stone (2-10 cm length on the long axis) that was part of the removed roadbed. Despite the soil alterations in this wettest area of the roadway, soil restoration there is close to the natural condition. Slight hydrological impacts are discussed below in the "Wetland Functions" section.

Figure 7. Angular stone within the surface soil of Plot 1 soil pit.

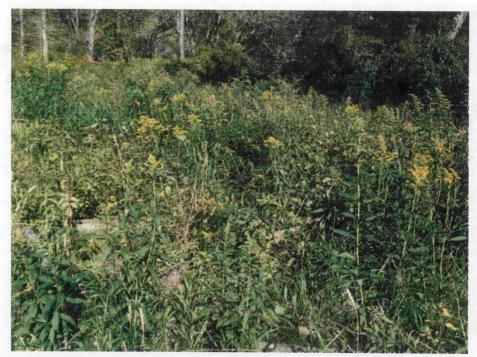
Figure 8. Vegetation of Plot 2. Flowering goldenrods are prominent.

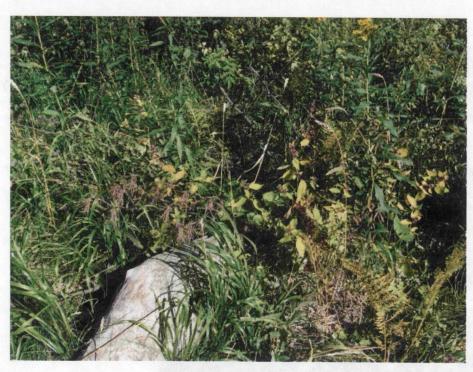
Figure 9. Vegetation of Plot 2. Mix of grasses, wild basil, lady fern and goldenrod is visible, along with coarse woody debris.

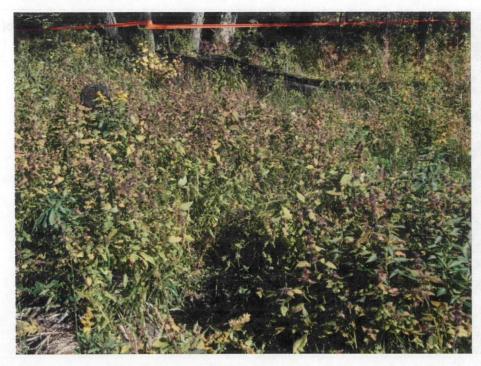
Figure 10. Vegetation of Plot 2. Dense growth of wild basil dominates the background, with grasses, lady fem and non-vegetated straw mulch in the foreground.

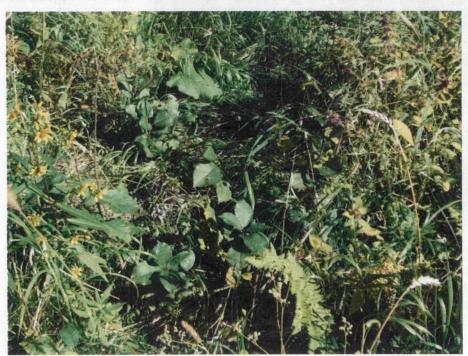
Figure 11. Vegetation of Plot 2. Choke cherry seedlings in the center with diverse herbaceous vegetation to left and right.

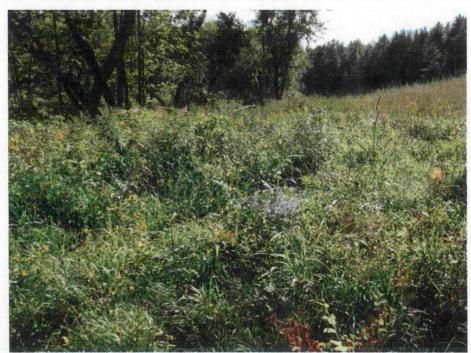
Figure 12. Terminus of roadway. Restored wetland in foreground with reconstructed slope at river's edge in the upper right and intact floodplain forest in upper left. Conifers in far right background are downstream of the reconstructed slope.
