**Fourth Annual Monitoring Report**  
**Tidal Wetland Restoration**  
**159 Long Neck Point Road, Darien, CT**  
**NAE-2007-1130**  
**December 31, 2015**

**1) Project Overview**

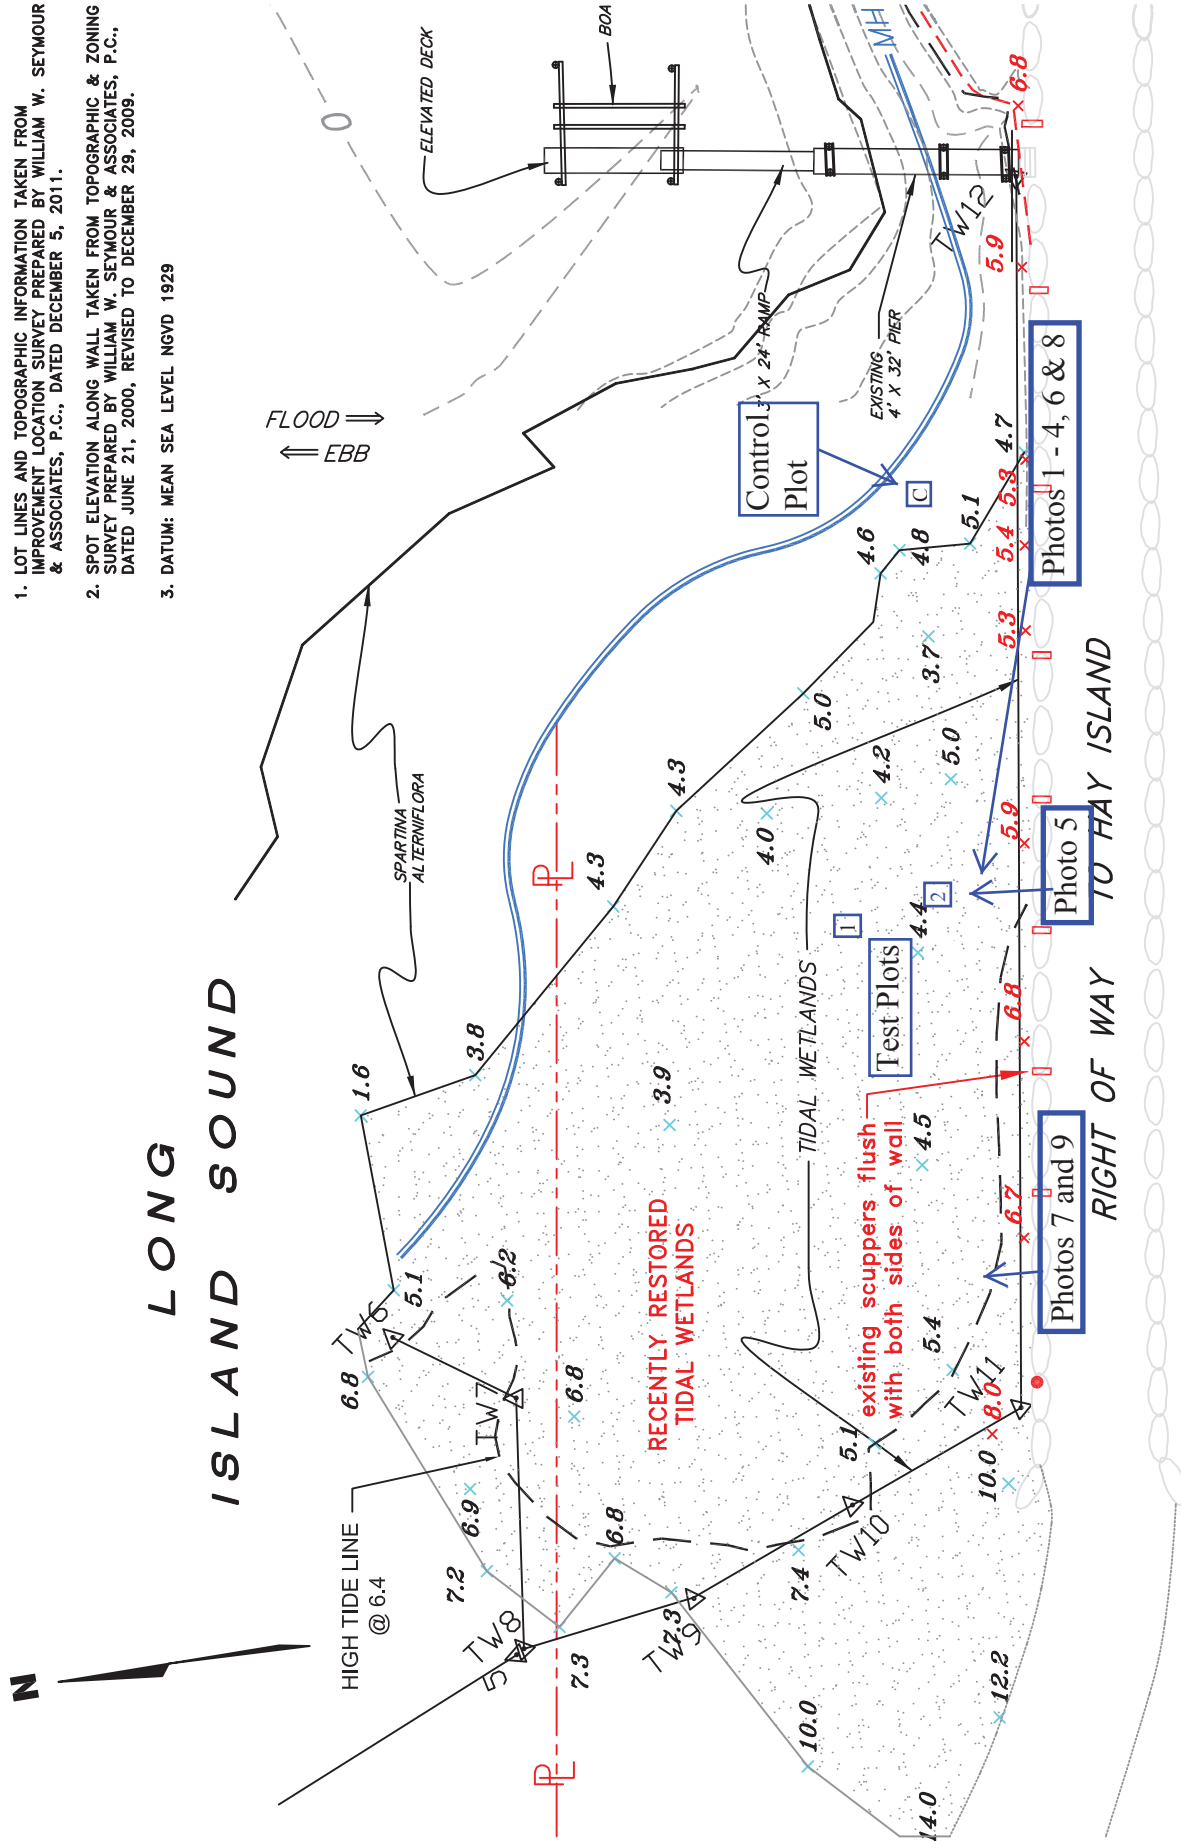
TITLE: TIDAL RESTORATION MONITORING PLAN

Approved Tidal Wetland Restoration Plan Revised to Show Photograph  
Views and Plot Locations Referenced in Report.

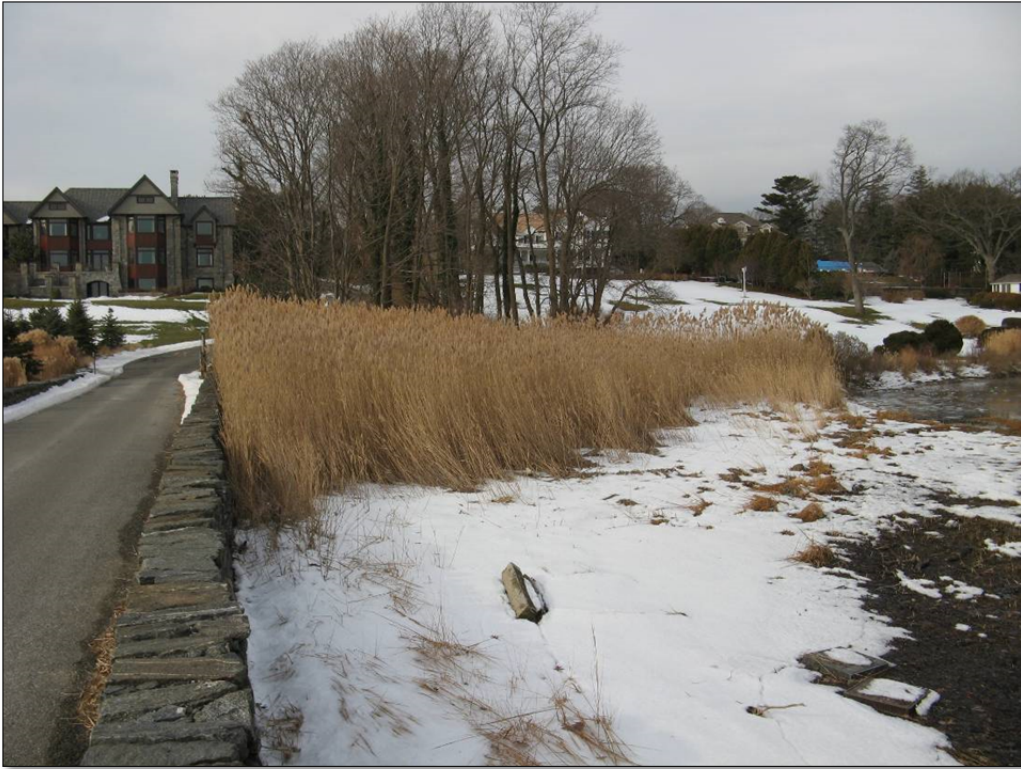
Photo 1 – Tidal restoration area facing west. Photo Taken January 6, 2011 Prior to Restoration Work. Photo shows Phragmites Population and Ground Elevation.

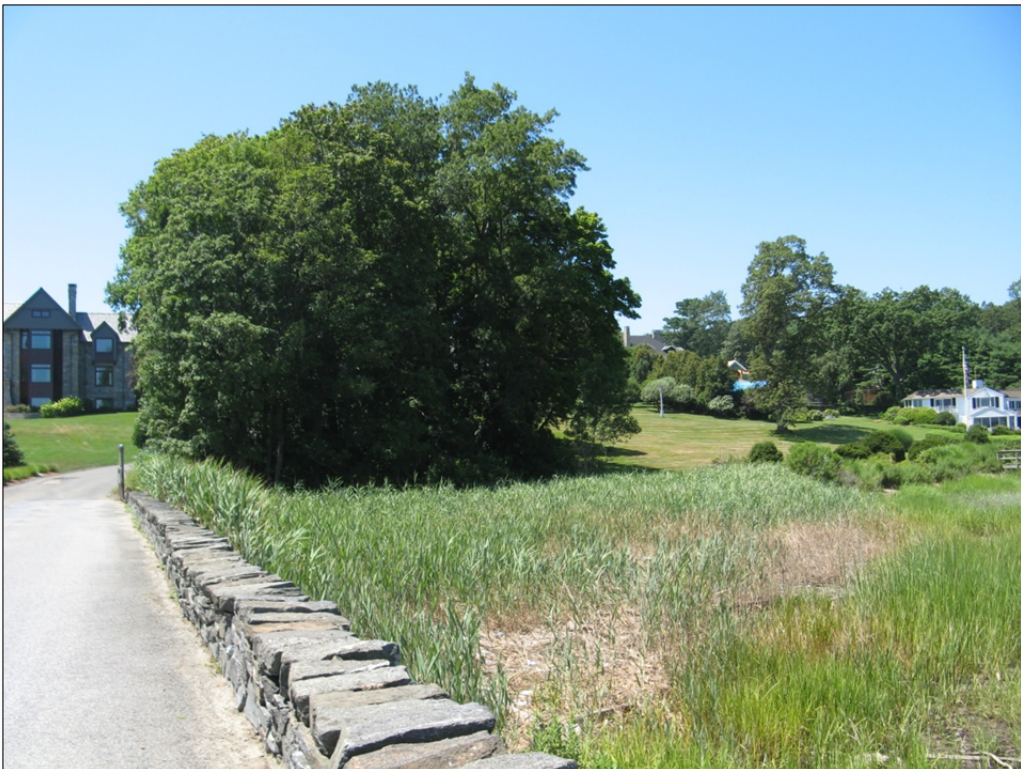
Photo 2 – Phragmites Population in Tidal Restoration Area on July 26, 2011 after Initial Herbicide Application but Prior to Regrading.

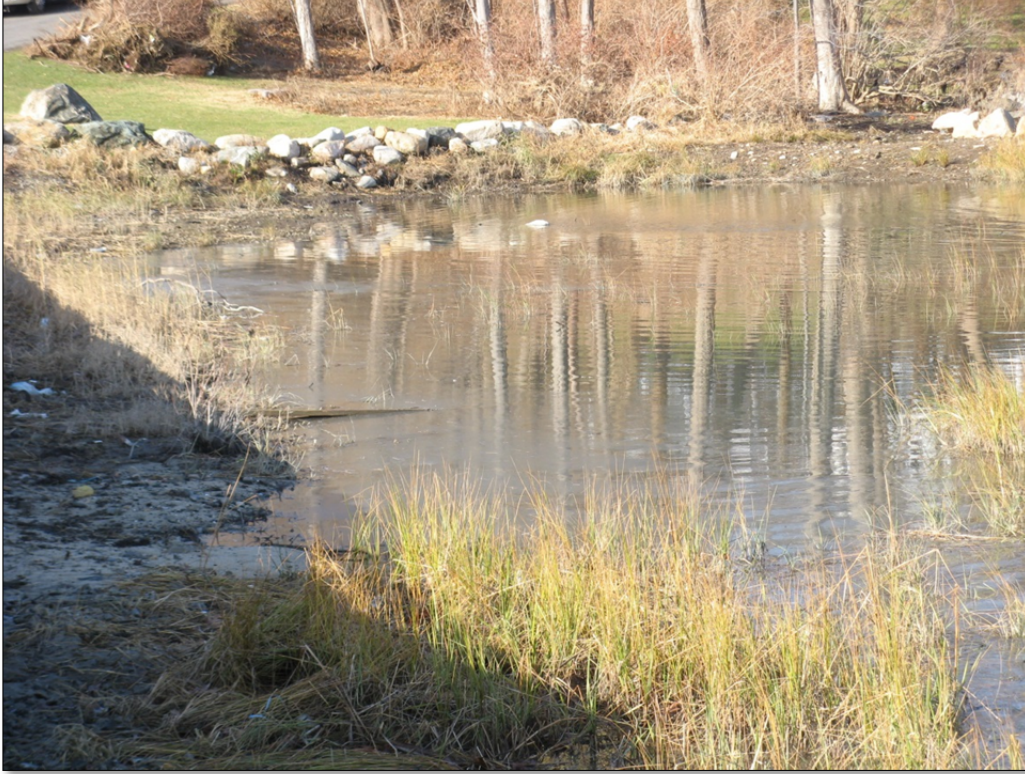
Photo 3 - Post Restoration, Facing West on November 28, 2012.

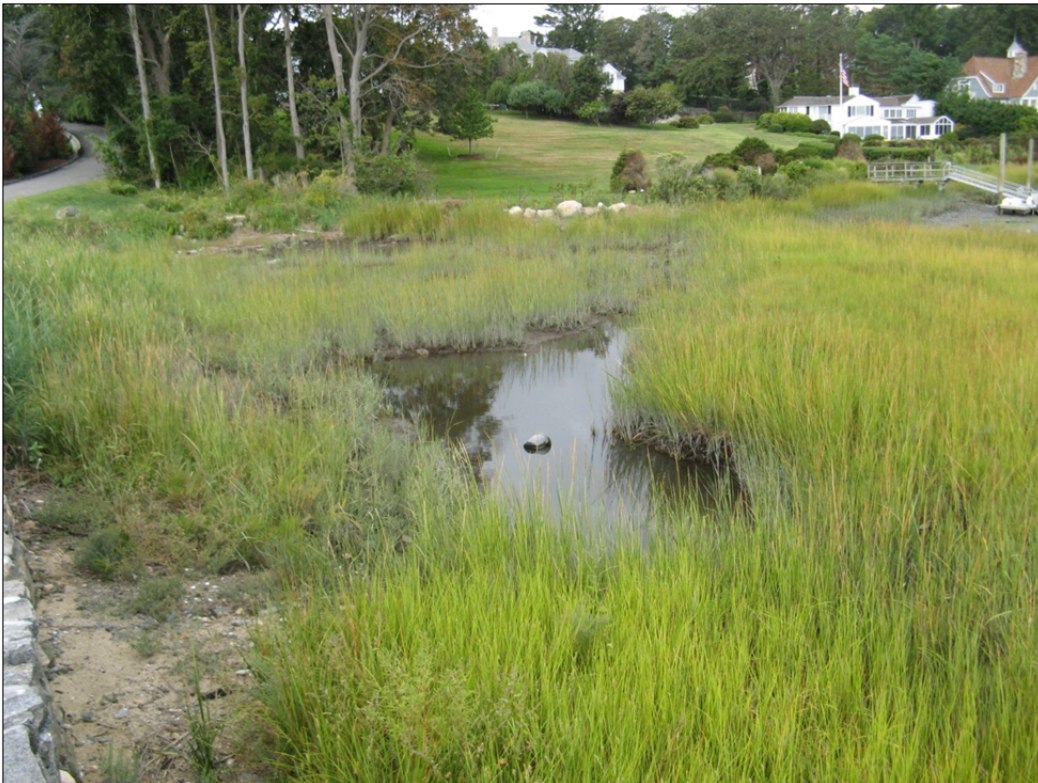
Photo 4 – Spartina Starting to Recolonize the Wetland on September 13, 2013. Phragmites Population Present along Waterward Side of Wall.

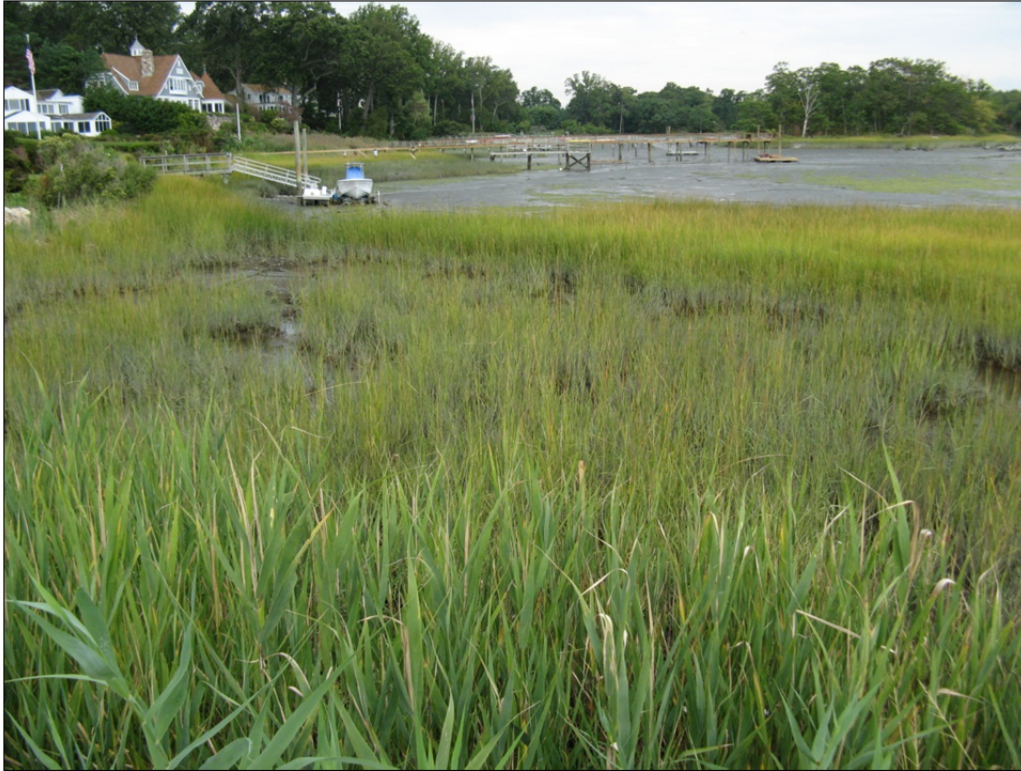
Photo 5 – Facing North on September 13, 2013. Phragmites Along Wall in Foreground, Recolonizing Spartina population in Middle and Undisturbed Spartina Population in Background. Stake for Test Plot #2 is Observable Just Beyond the Phragmites Population.

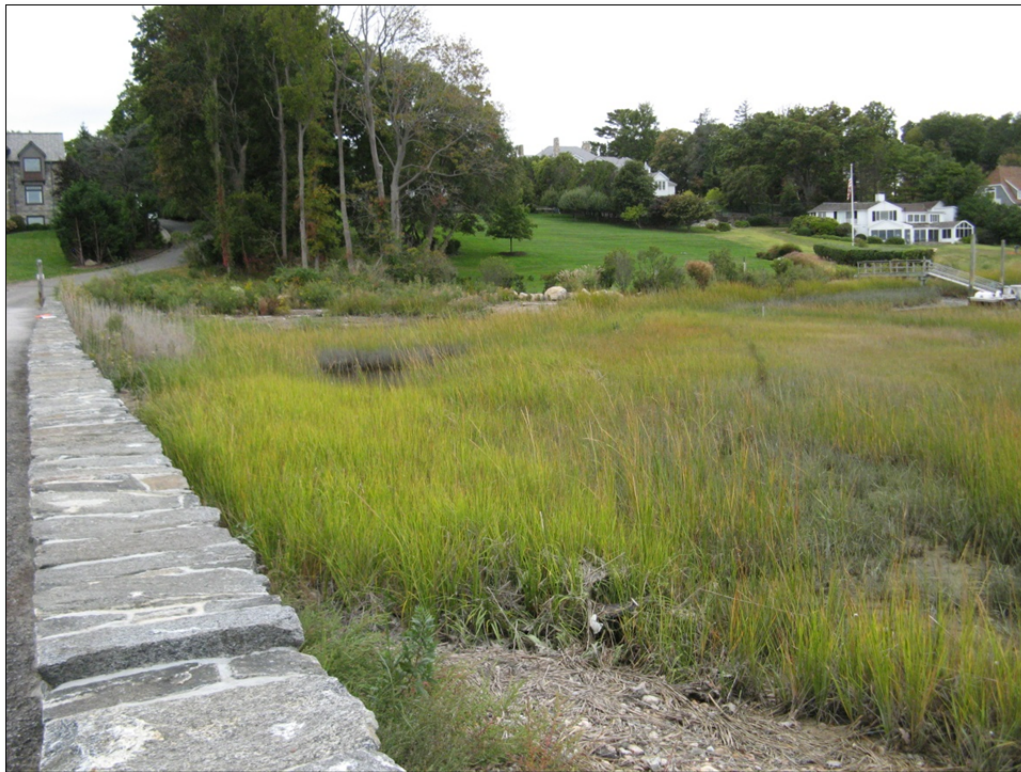
Photo 6 – Facing West on October 2, 2014. Dead Phragmites Located Along Wall in Upper Left of Photo.

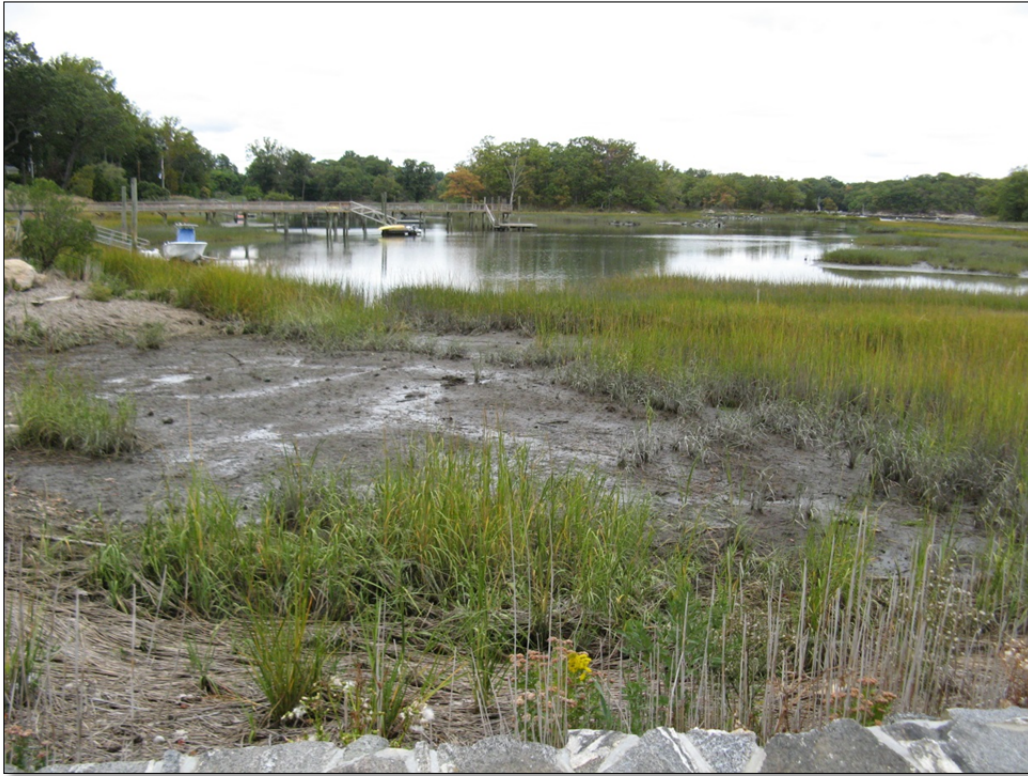
Photo 7 - Western Portion of Wetland Facing North on October 2, 2014. Dead Phragmites in Foreground. Spartina Slowly Colonizing the Lower Elevation areas in middle of Photo.

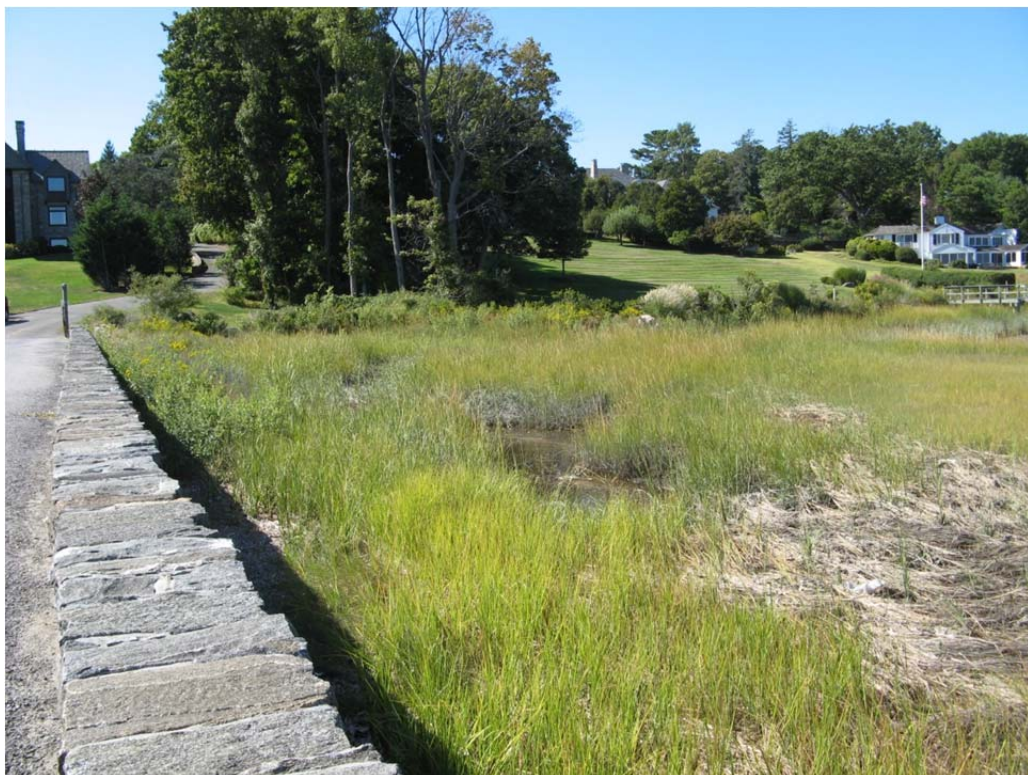
The 2015 data continue to show a successful restoration of the wetland. This year we saw the natural colonization of *Iva frutescens* (high tide bush), *Limonium carolinianum* (sea lavender), and *Solidago sempervirens* (seaside golden rod) along the waterward side of the wall. This natural colonization is what we were hoping for and means that as long as the native species survive and do well during the 2016 growing season that a replanting effort is not needed. With regards to the *Spartina* population, this species has grown more dense and has spread slightly using existing seed sources. Stem counts from the test and control plots are presented in the Summary Data section. Photos showing the recolonization are presented in Appendix C.

Photo 8 - Facing West on September 24, 2015. High Tide Bush and Seaside Goldenrod Shown Present Along Back Portion of Wall In Vicinity of Where Phragmites Population was in Photo 6.

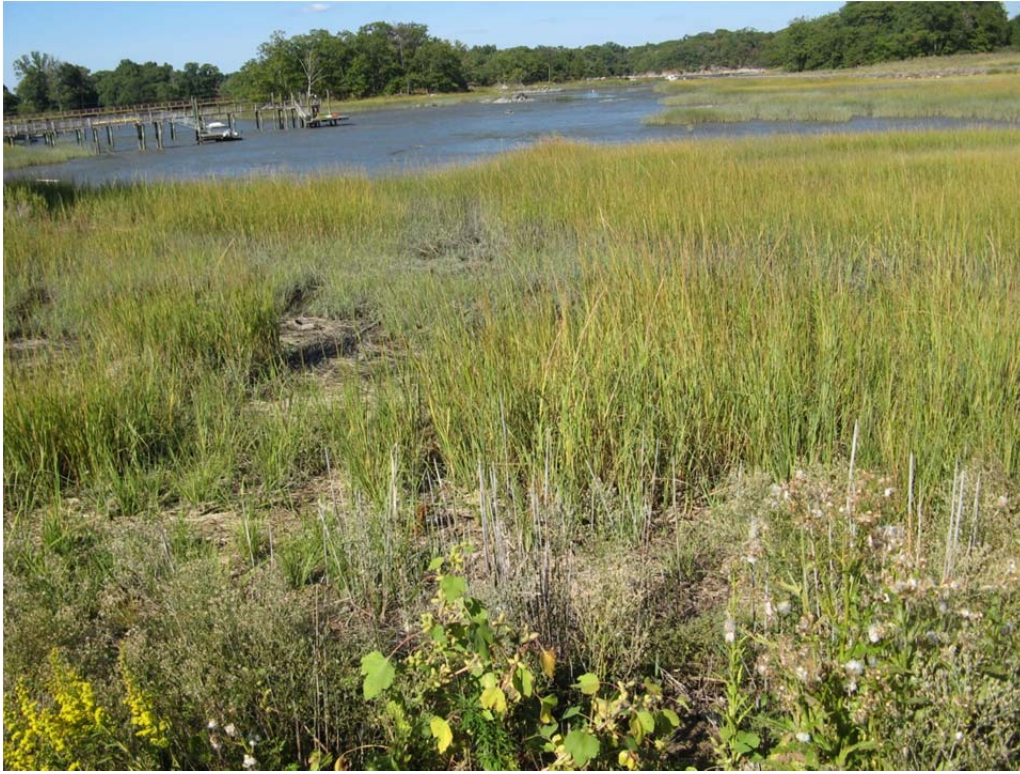
The June 4<sup>th</sup> site visit found that the *Spartina alterniflora* population coverage increased to approximately 80% of the restoration area. The majority of this increase is due to the installation of over 1,900 plugs of *Spartina alterniflora* which were planted in the small sparsely vegetated depression in the western portion of the restoration area on May 26<sup>th</sup>. The plugs were installed at a spacing of 9” on center.

Photo 9 – Facing North on September 24, 2015 Darker Green Shoots in Back Area of Marsh are the recently planted *Spartina alterniflora*.
