Routine Tower Inspection Report

90' Tower Mount Wachusett Princeton, MA

Mount Wachusett 90' Tower Princeton, MA Routine Inspection Report

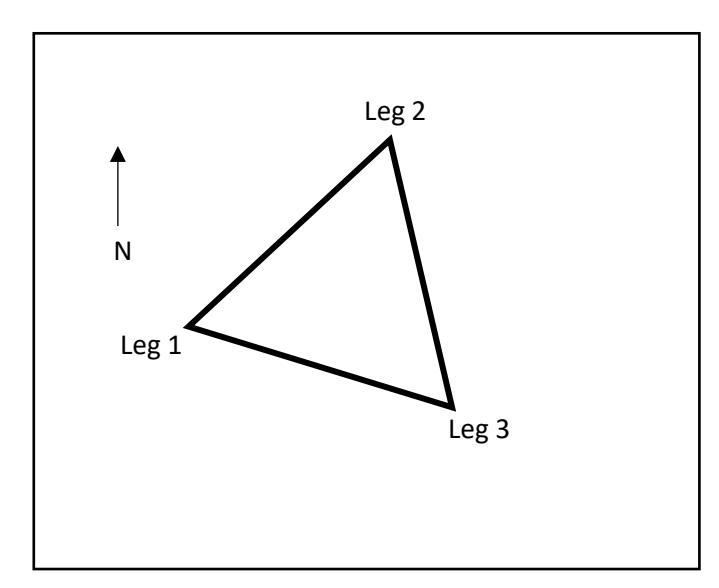
Figure 1 - Tower Leg Numbering

The tower is a self-supporting, galvanized steel lattice structure with three legs, which are numbered as shown in *Figure 1*. The date of construction of the tower is unknown and there is no known set of plans for the tower. All tower components appear to be galvanized steel painted with alternating white and orange sections.

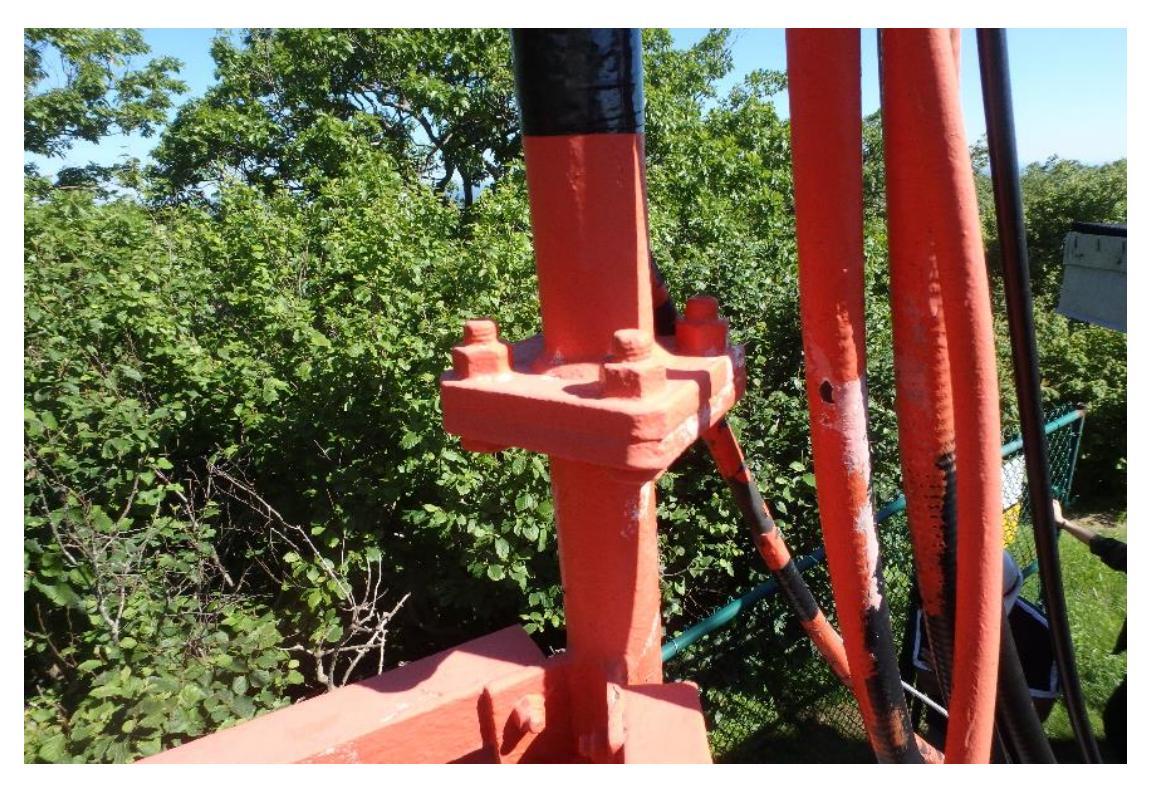
The tower is comprised of nine sections, each 10' high for an estimated total height of 90'. The sections are bolted to each other with four bolts (see Photo 1). The bracing members are bolted to plates welded to the pipe legs for Sections 1 through 4 (see Photo 2). For Section 5-9, there are 5/8" and 3/8" bars welded to the pipe legs (see Photo 3).

Photo 1 – Typical connection between tower sections

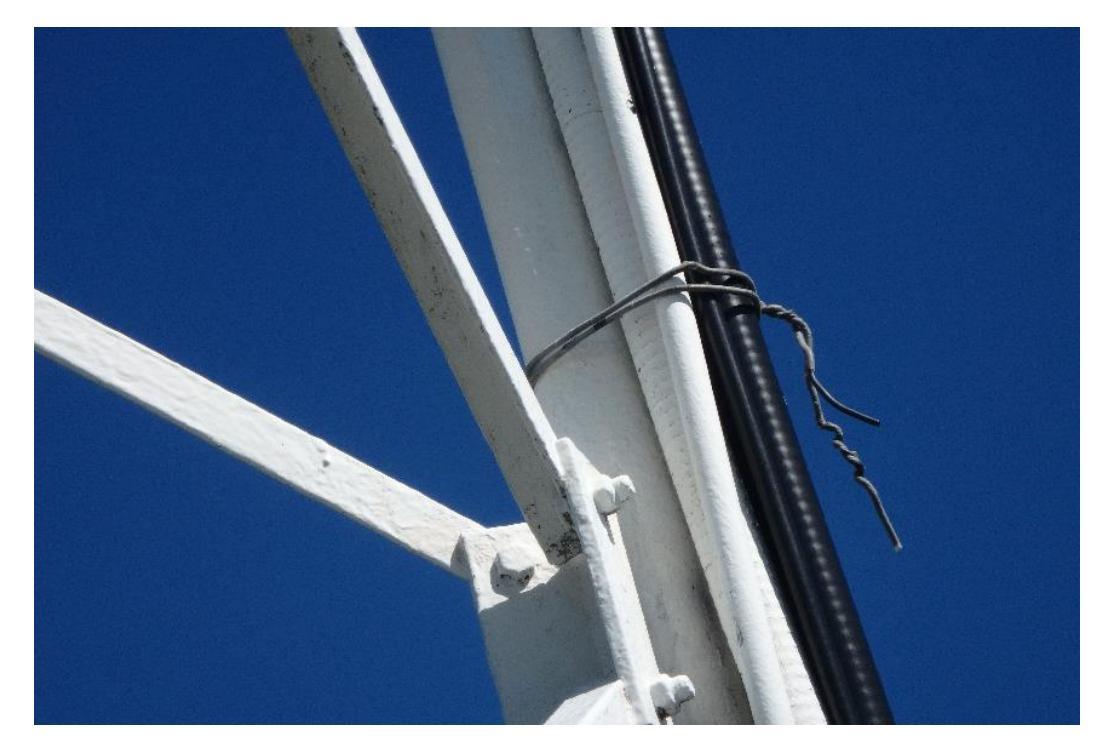
Photo 2 - Typical bracing connection for Sections 1 through 4

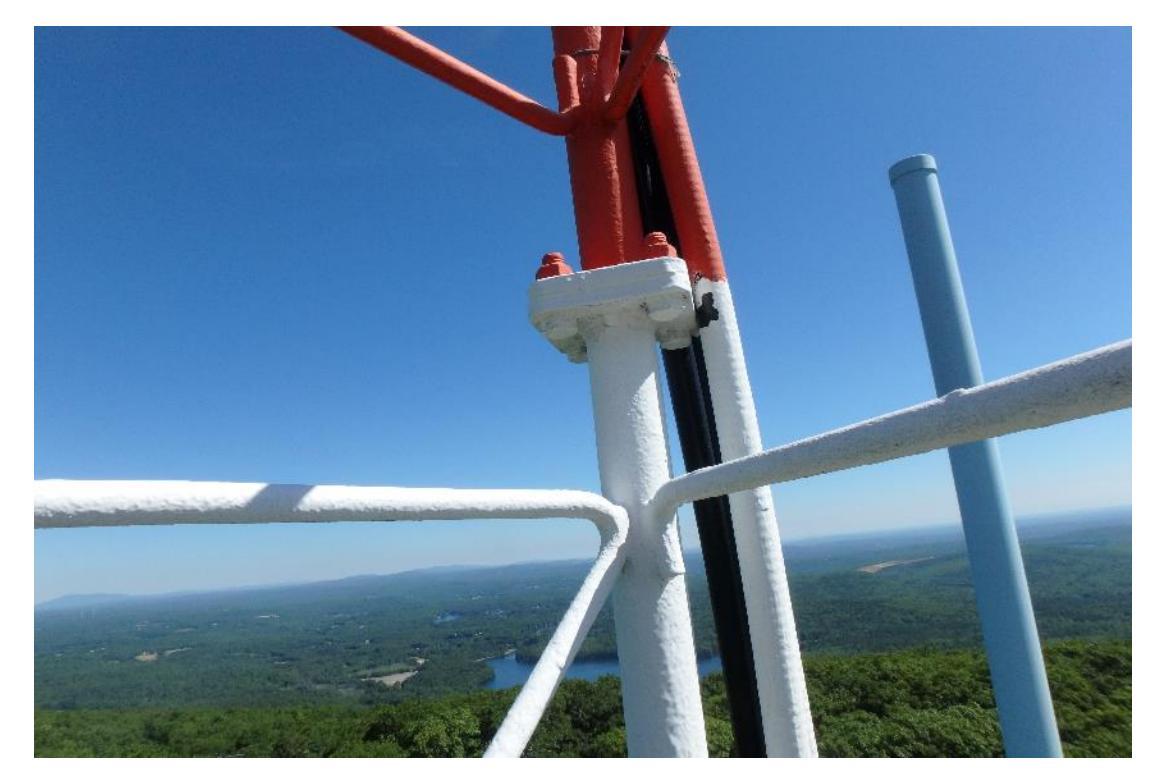
Photo 3 - Typical bracing connection for Sections 5 through 9

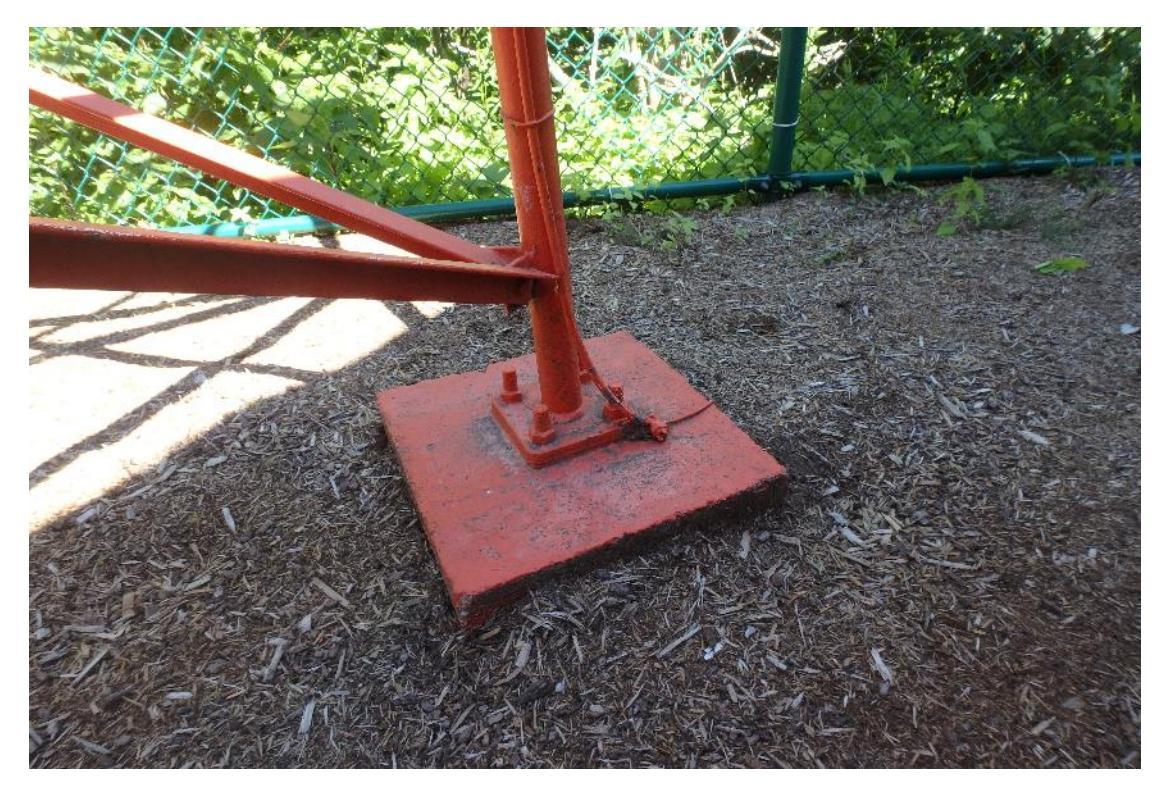
Each leg is anchored to a 16" square concrete base with four 5/8" diameter bolts (see Photo 4).

Each tower leg is securely connected to its respective concrete foundation (see Photo 4) and the concrete is in good condition. The area around the tower base has been cleared since the last inspection and a fence with locking gate installed for security (see Photo 5).

Photo 4 – Typical tower foundation connection

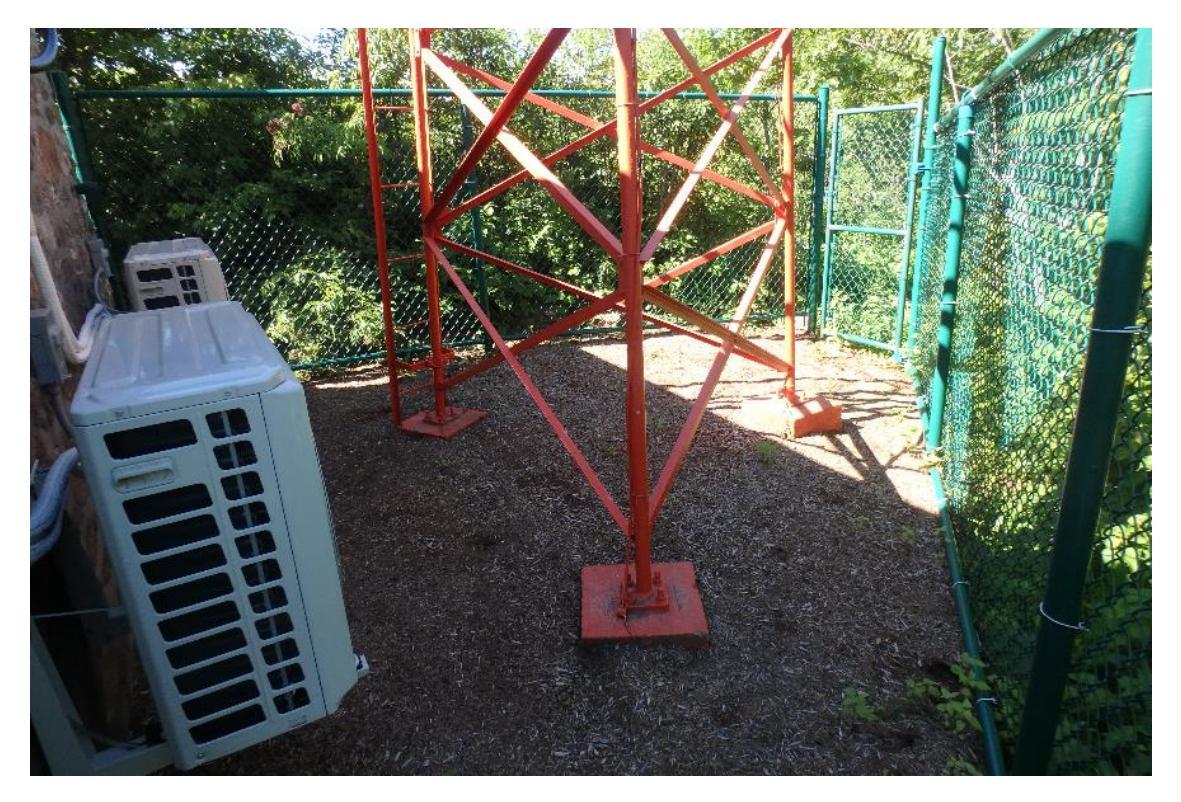
Photo 5 - Base of tower secured by fence with locking gate

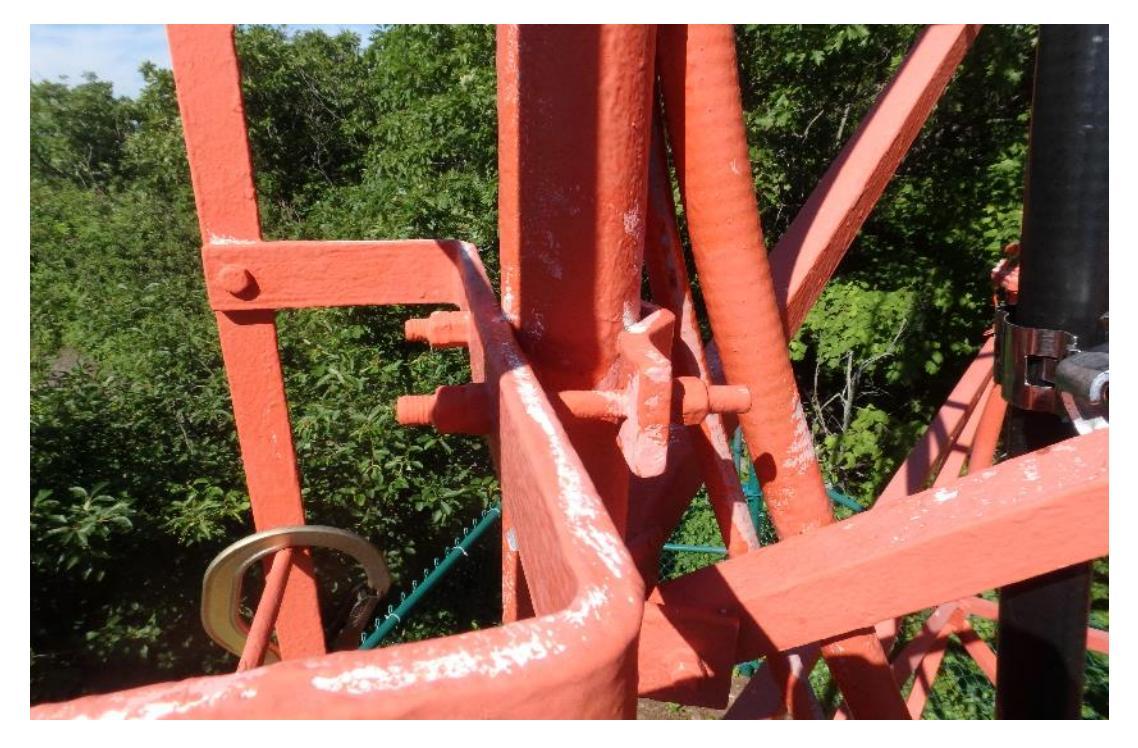
The superstructure coating system is in good condition, with only small areas of minor deterioration (see Photo 6). All cross bracing members are tightly attached and in good condition. All observed connections

Photo 6 - Typical condition of coating system

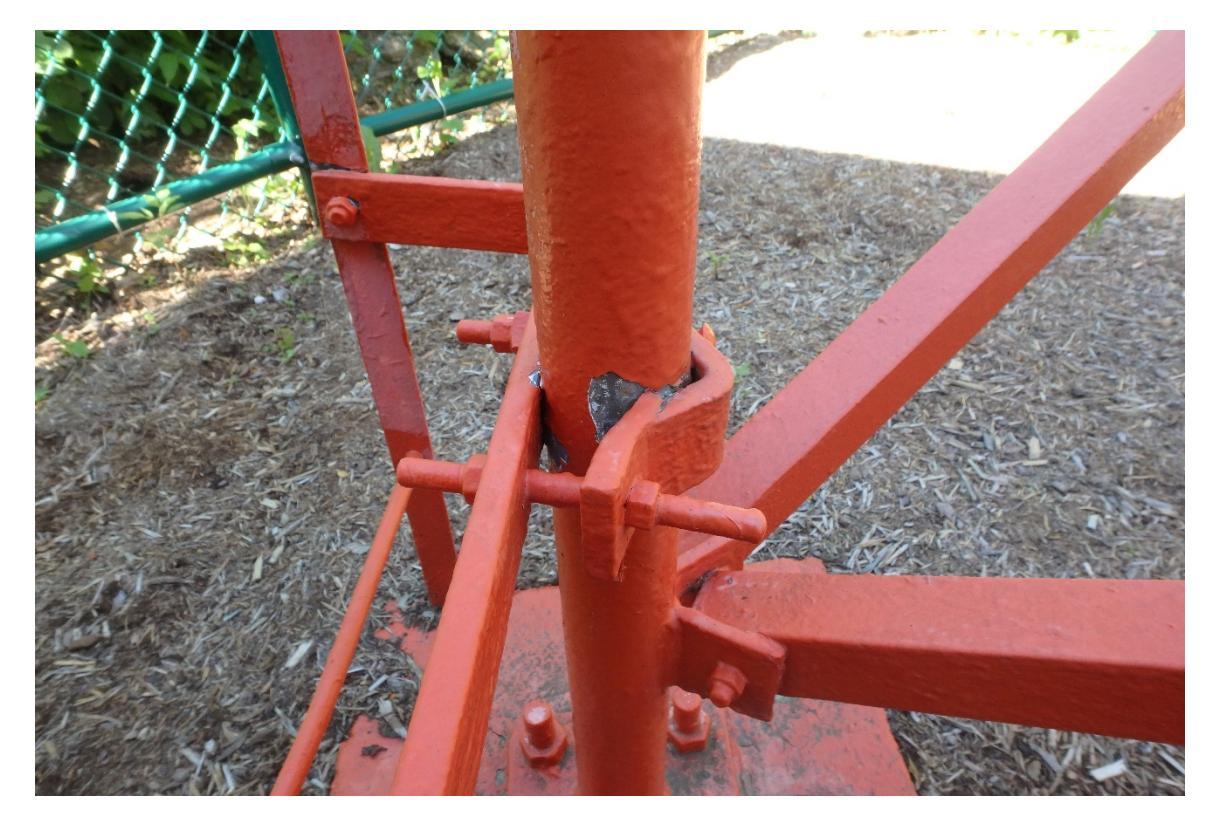
between tower sections were tight and showed no signs of movement or distress. No significant displacement, misalignment, or torsion of the structure was observed. The lower connection of the tower ladder is loose, allowing latter to rotate side to side when in use (see Photo 7)

Photo 7 - Loose ladder connection at base

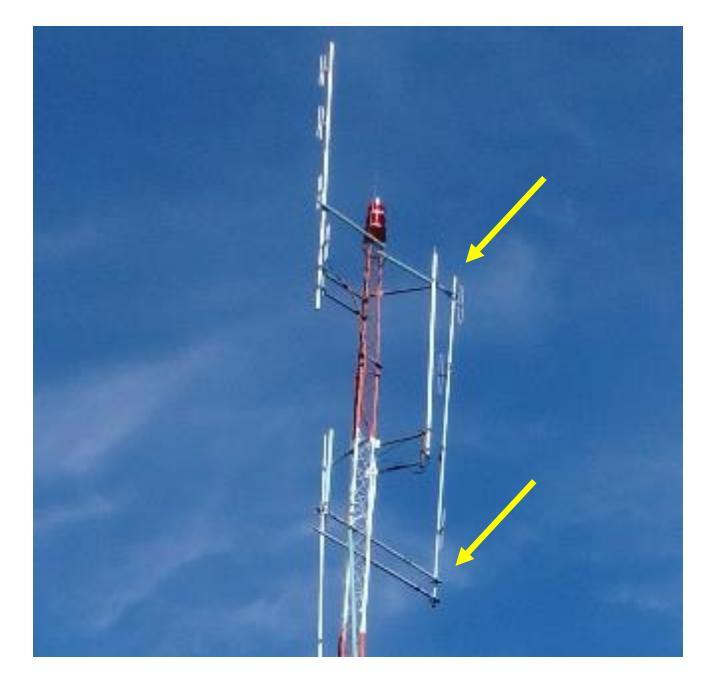
The 90ft tower has numerous whip antennas of various size. The majority of the antennas are securely attached, with larger antennas being secured at both the base and top (see Photo 8). One large whip antenna is cantilevered off the structure by approximately 6ft, and only attached at the base (see Photo 9). Mounting hardware is insufficient for the loads created by such a large cantilever and has torsionally racked under the load of the antenna (see Photo 10 and Photo 11). Project staff stated that this antenna is not Corps equipment and belongs to one of the other tower tenants.

Photo 8 - Larger antenna secured at both ends

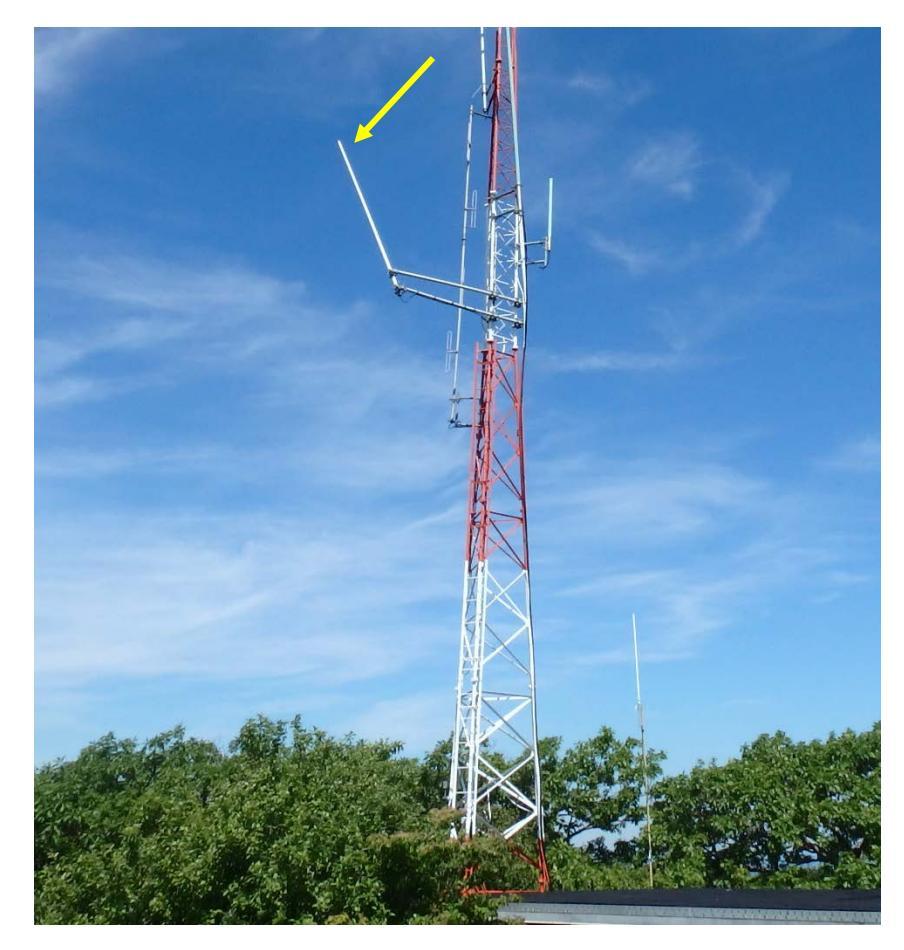
Photo 9 - Large cantilevered antenna without top support

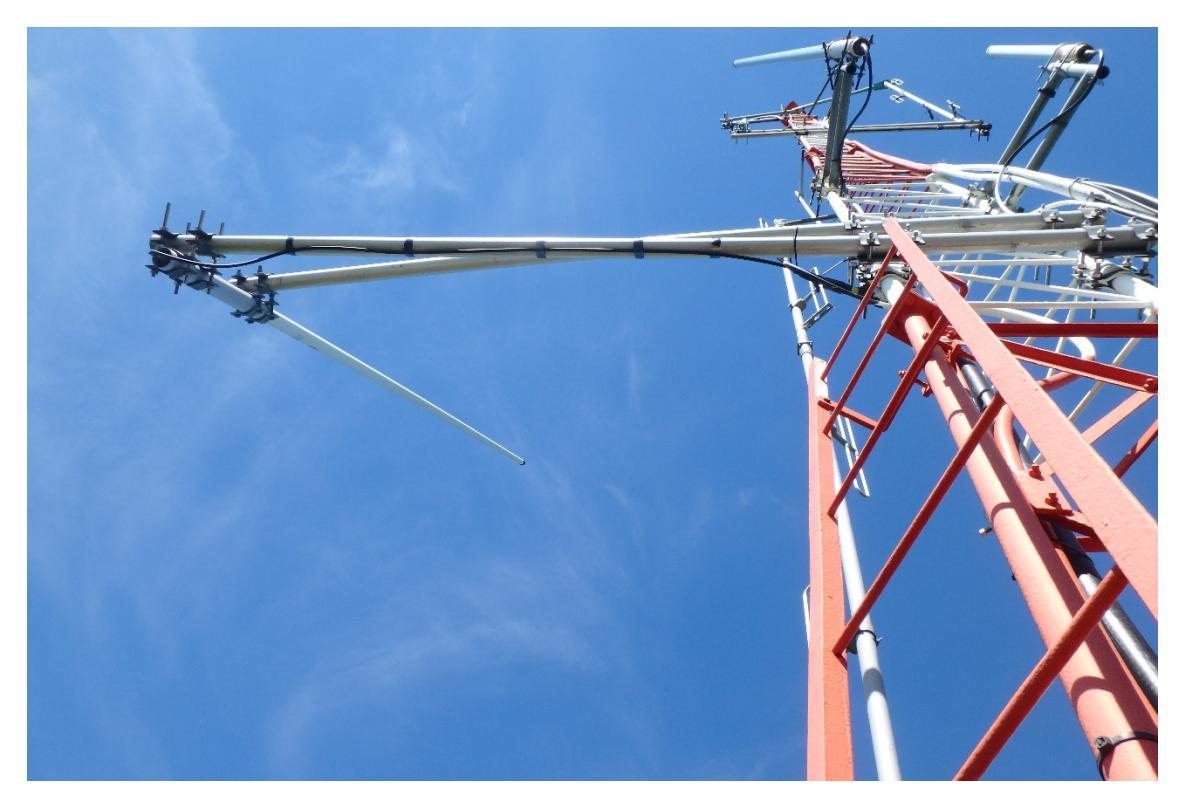
Photo 10 - Cantilevered antenna viewed from below showing misalignment and deflection due to load

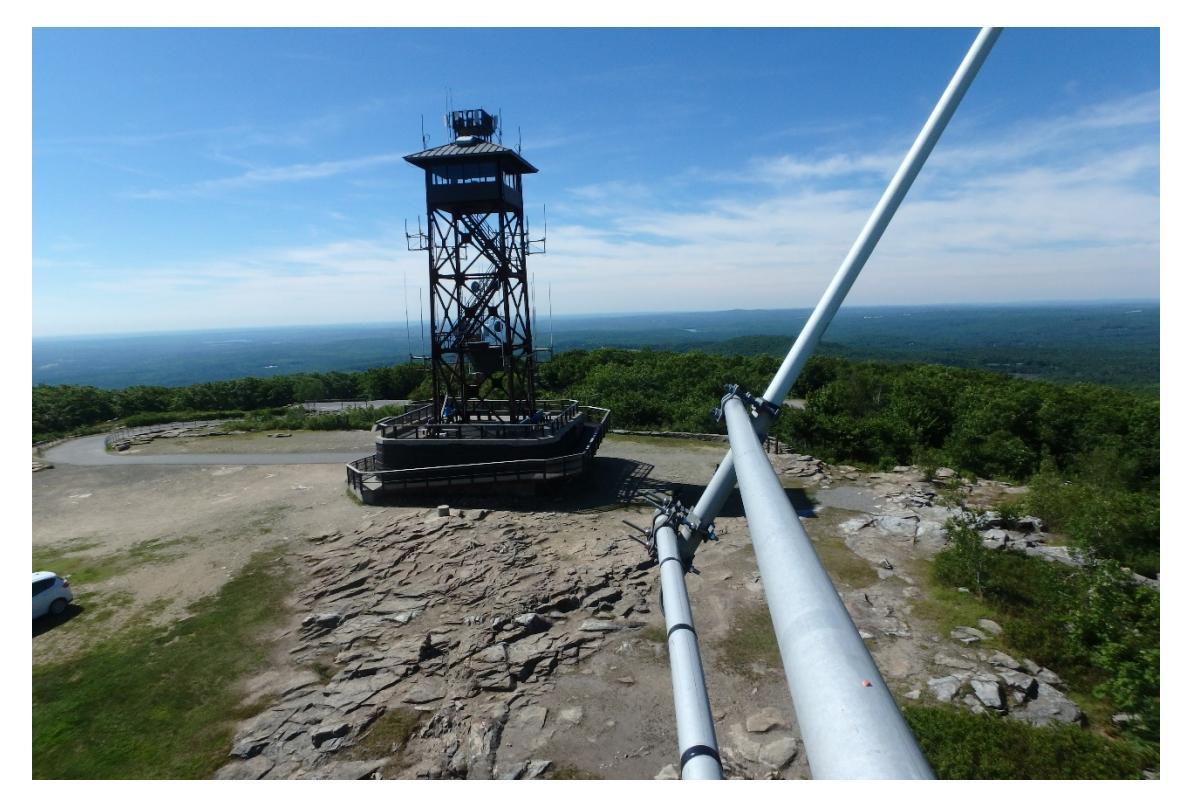
Photo 11 - Cantilevered antenna viewed from tower showing misalignment and deflection due to load
