AECOM Daily Report Durham Meadows Pipeline Installation

Project:	Durham Meadows Pipeline Installation	Date:	December 12, 2019
Location:	Middletown and Durham, CT	Day of Week:	Thursday
Project #:	AECOM: 60445033	Report No:	46
Contractor:	Ludlow Construction	Page:	2 of 14

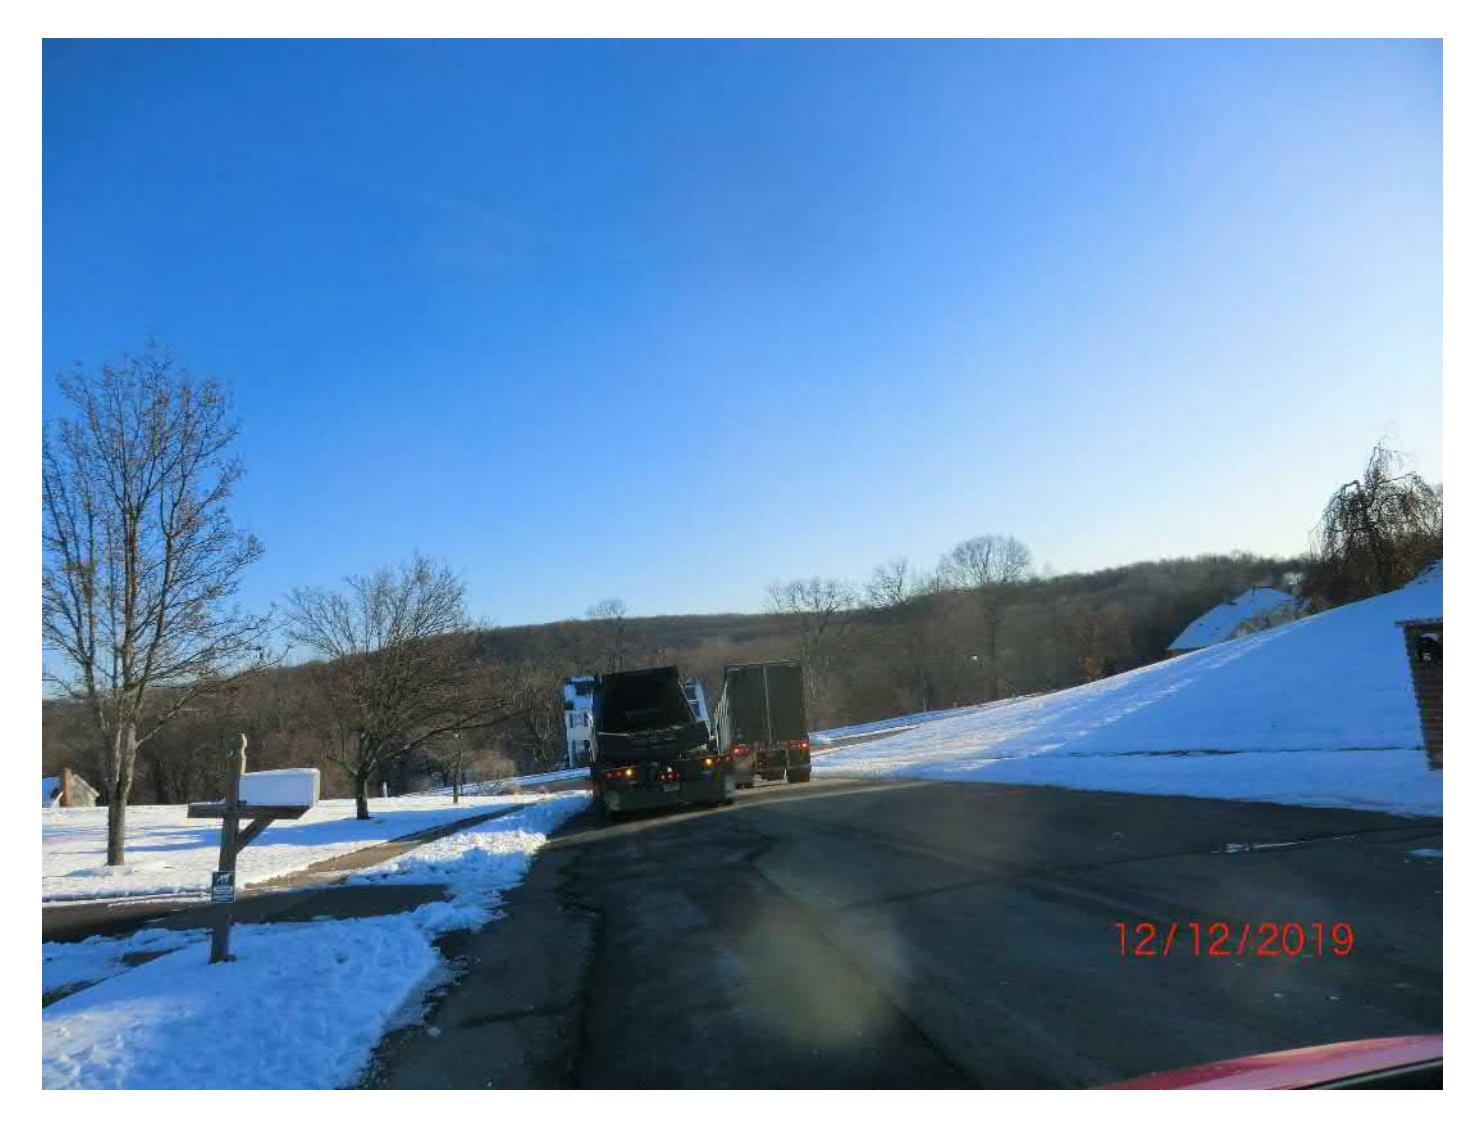
Figure 1 – Chipper and semi on upper Watch Hill preparing to deploy into the tank site.

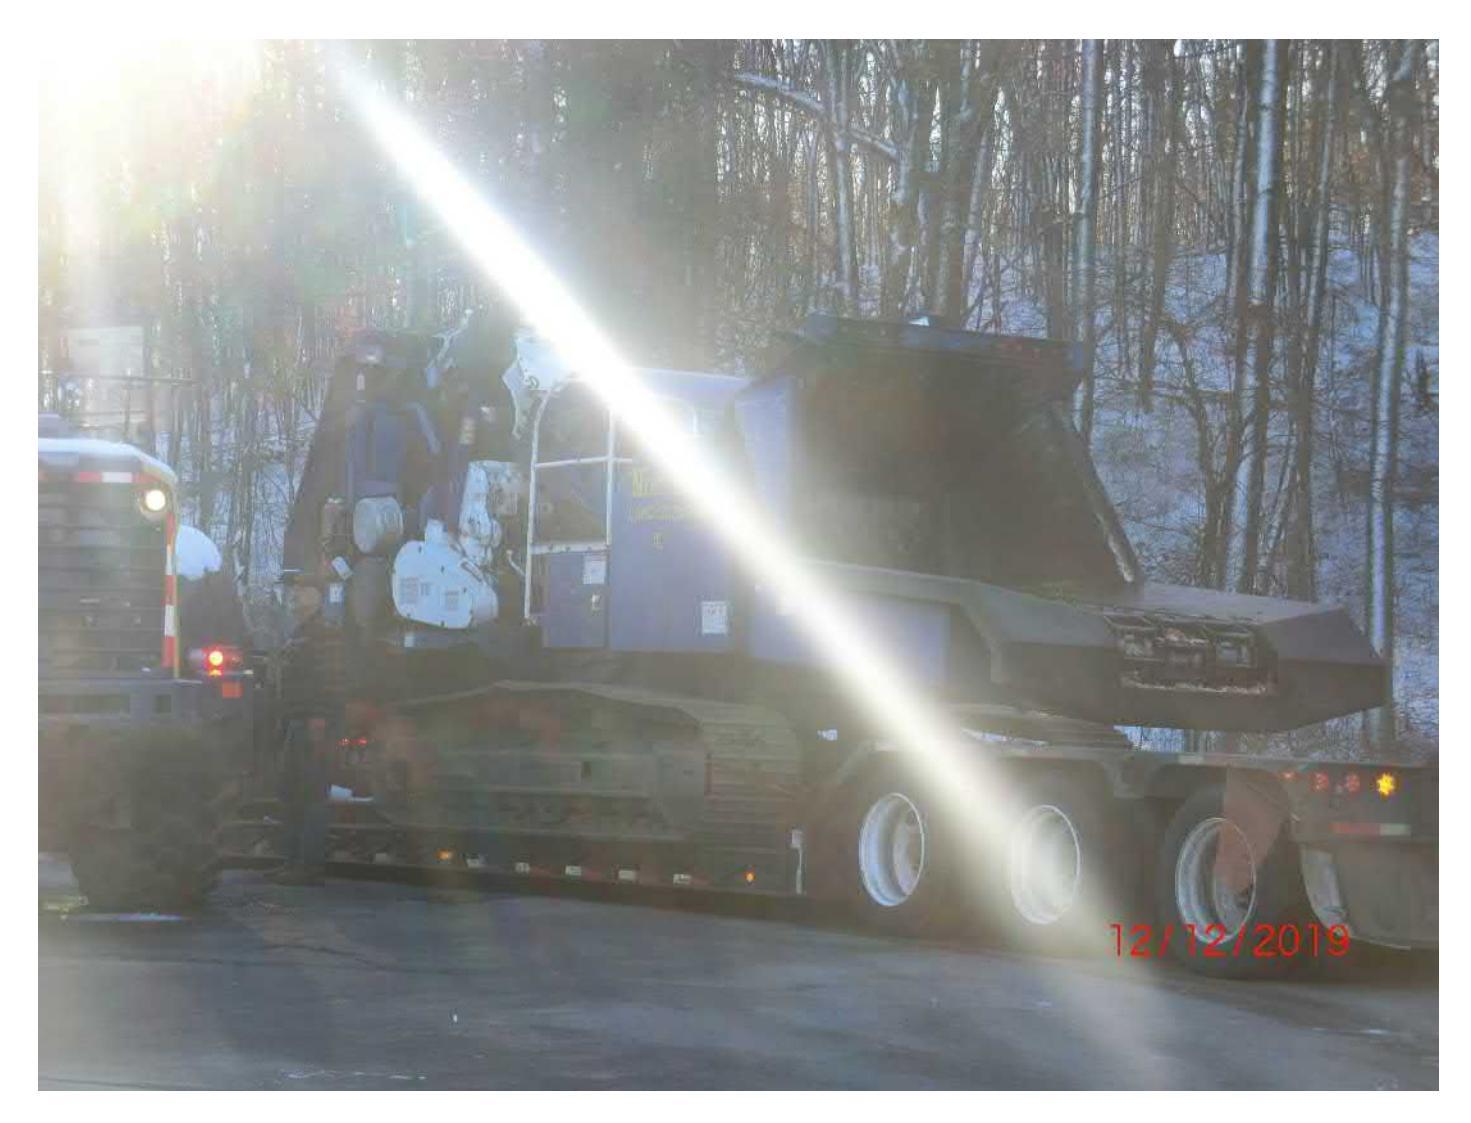
Figure 2 – Unloading the chipper in the cul-de-sac on Talcott Ridge.

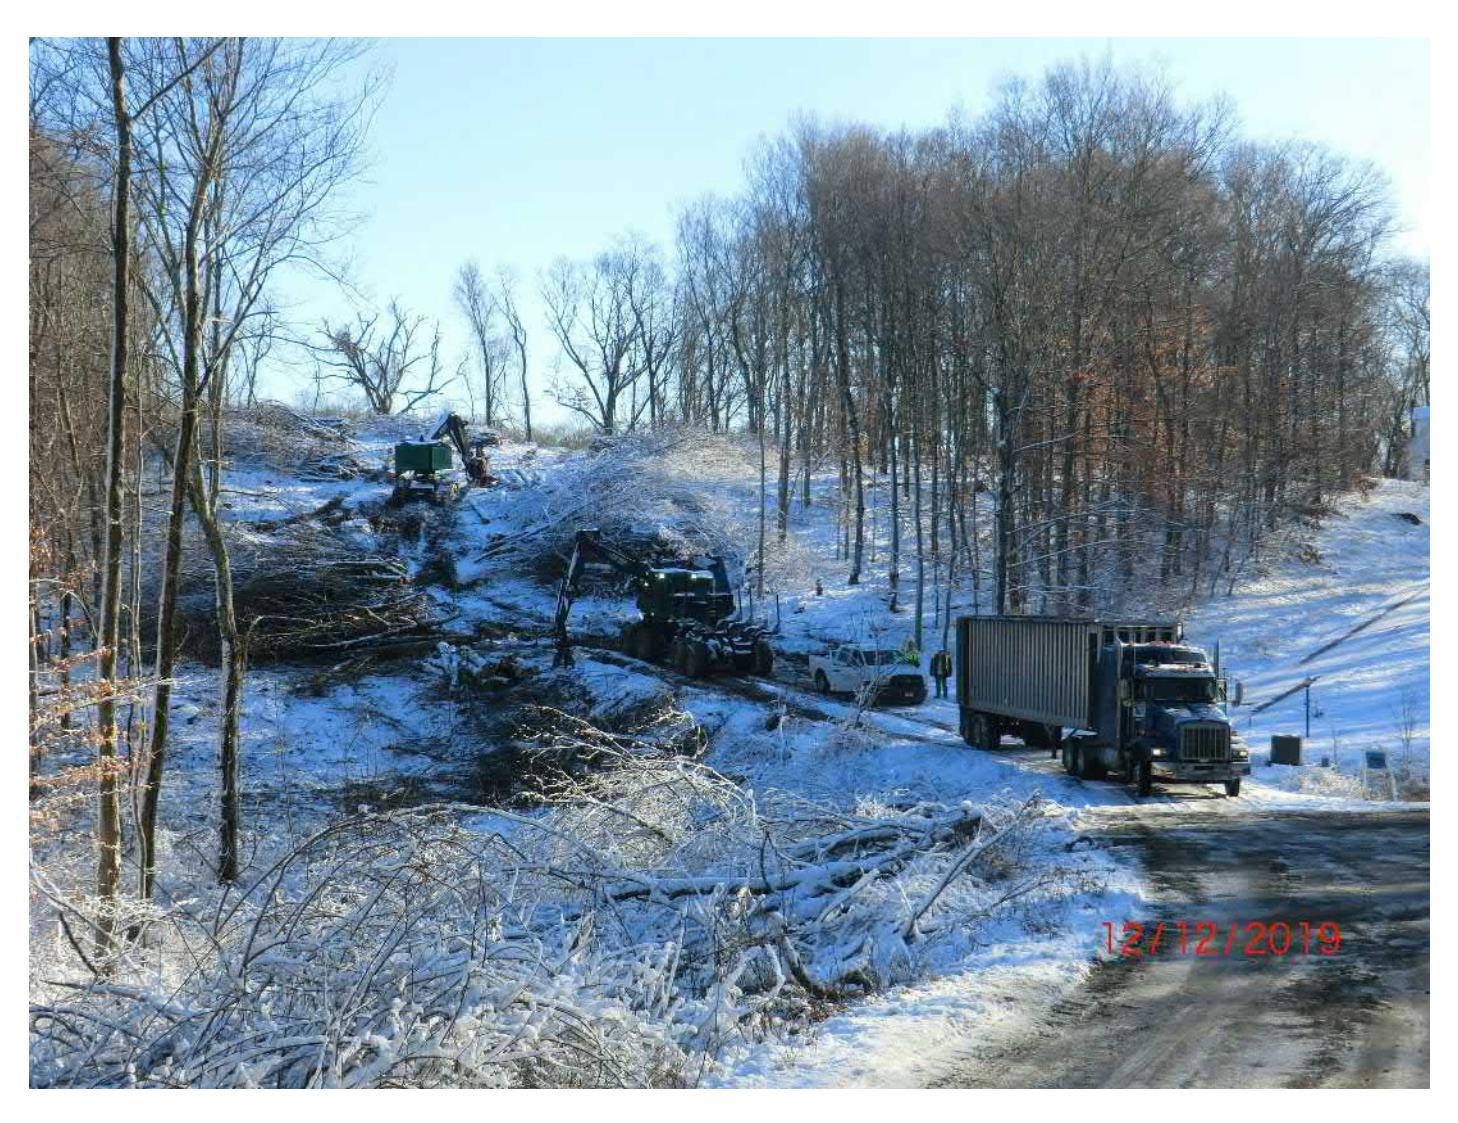
Figure 3 – Backing the semi into position to receive chipper output.

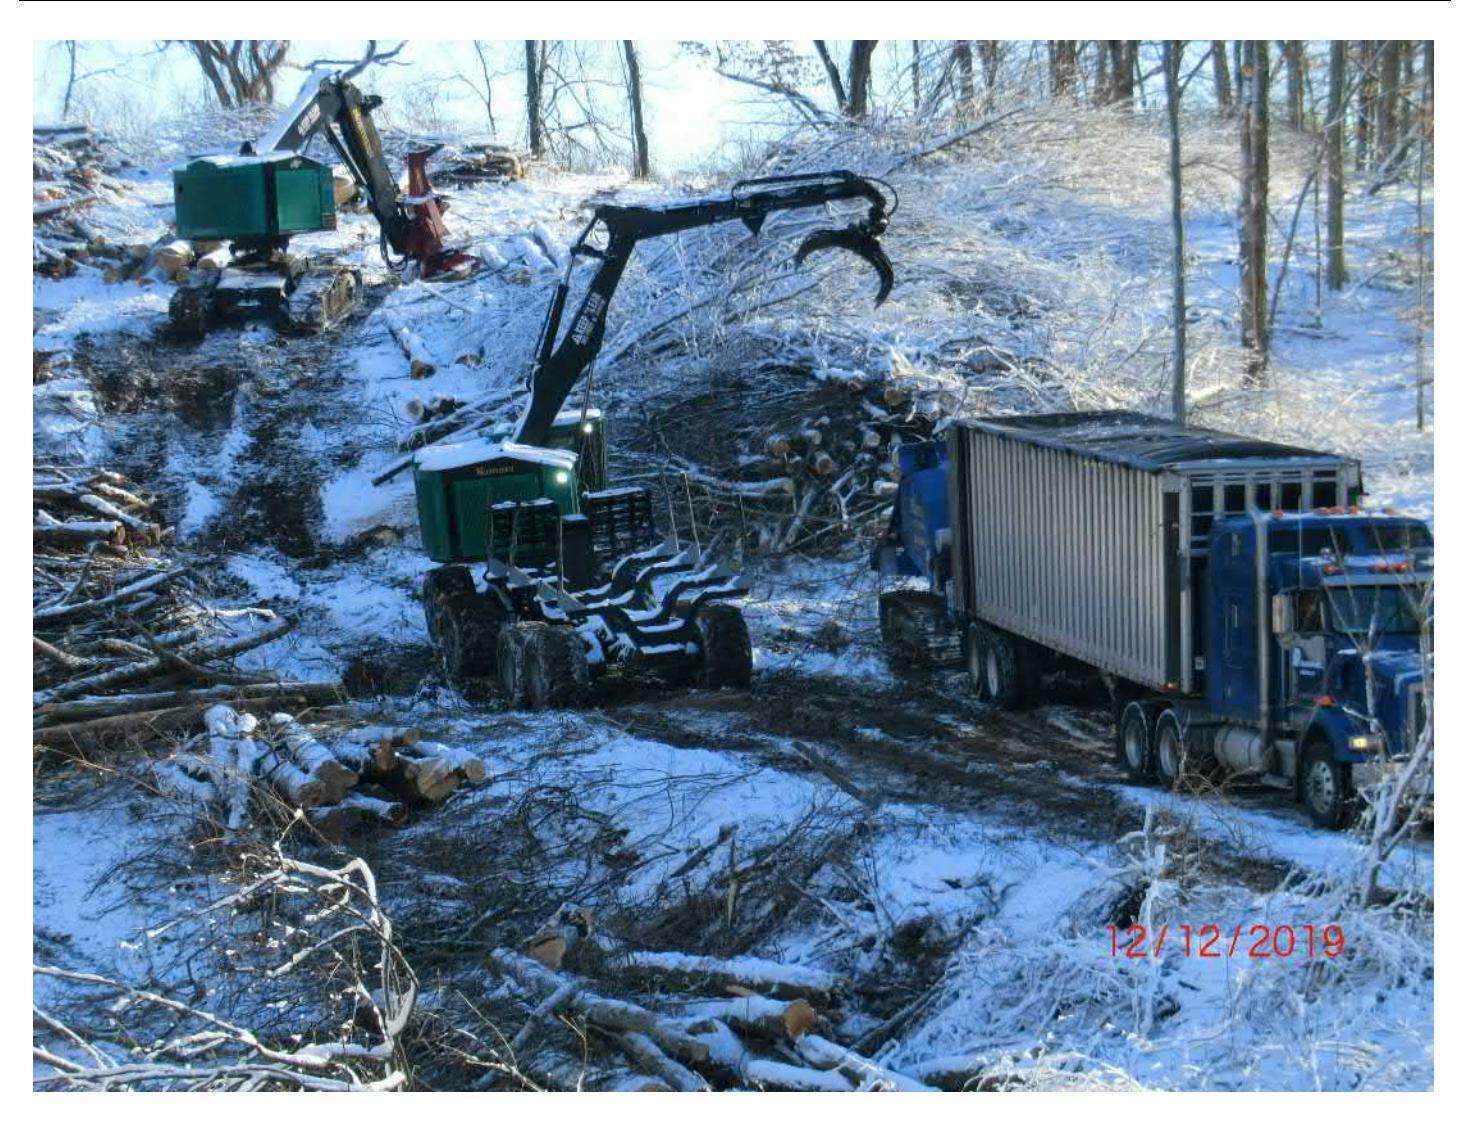
Figure 4 – Overview of the operation. Semi backed up to chipper, grapple feeding the pile into the chipper.

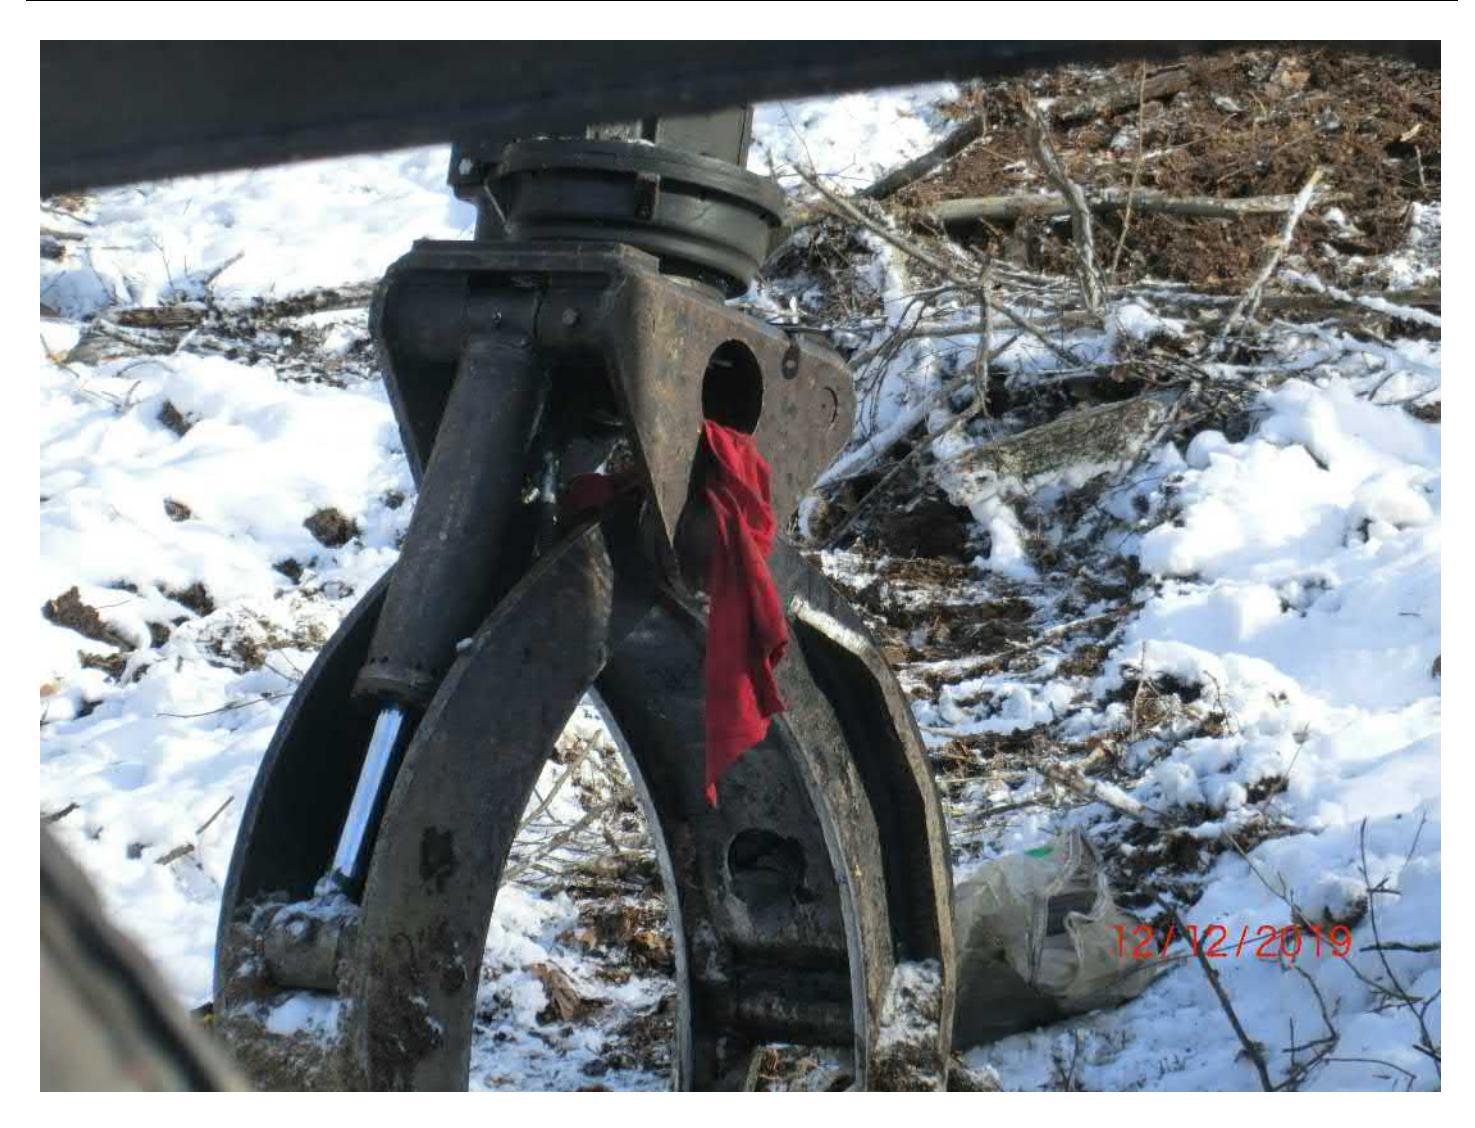
Figure 5 – Small hydraulic leak in the grapple delayed work by 1-2 hours while parts were retrieved to repair the leak. Note the 'diapers' on the ground behind the grapple; proper procedure was followed to minimize loss. Ludlow H&S stated it was a pin hole size leak that was caught right away.

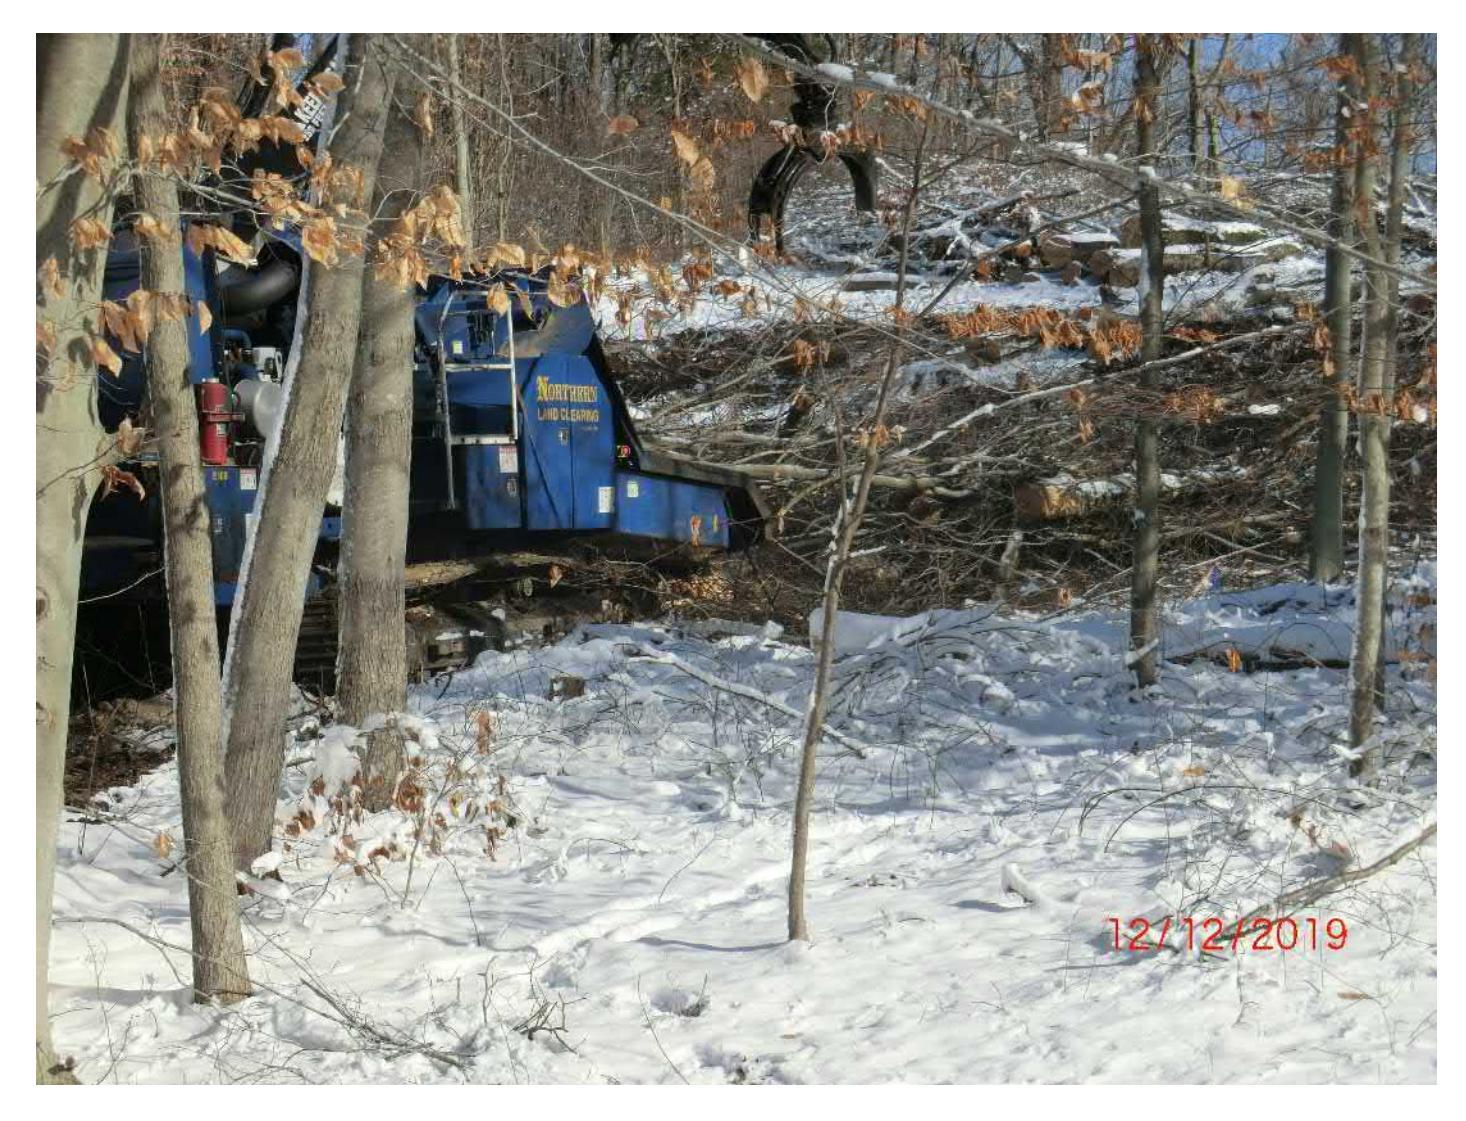
Figure 6 – Feeding the 'beast'. Track mounted chipper brought in to chip all the small stuff cut from the tank site.

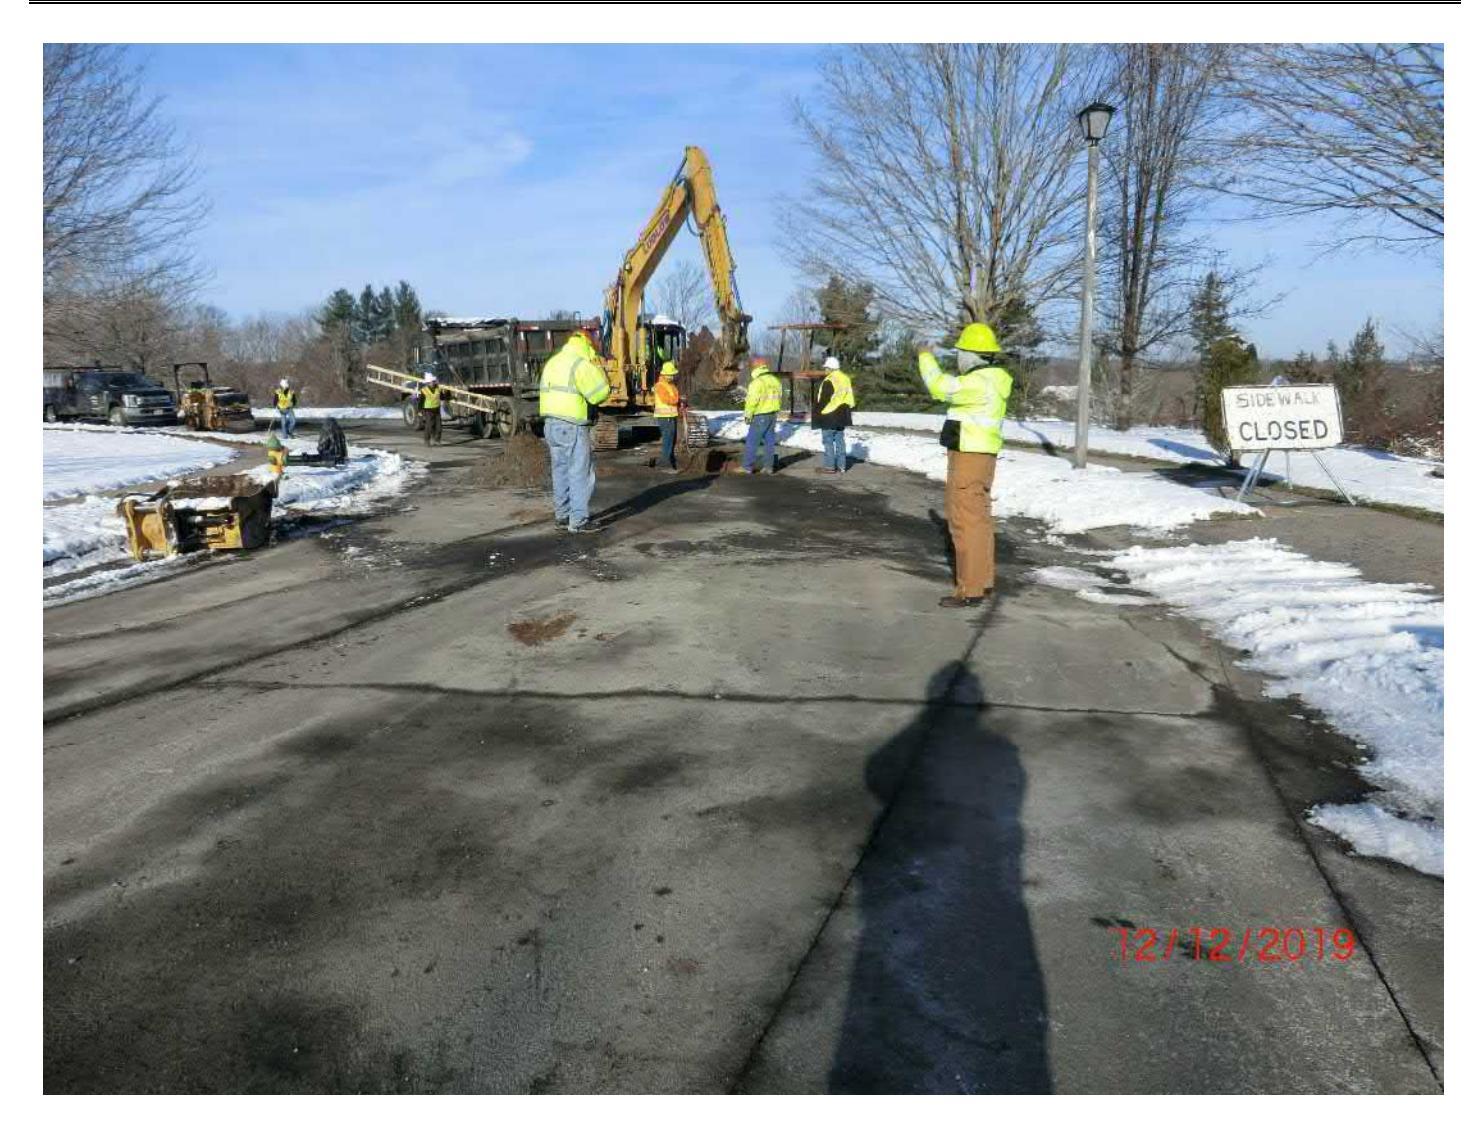
Valve Access Standpipe: The valve box for the 12" valve Tee, located at the bend in Talcott Ridge Drive, was not installed during the installation of the valve assembly. Ludlow excavated the assembly and installed the valve box. They then backfilled and compacted and hot patched the excavation.

Figure 7 – Facing northwest at the bend in Talcott Ridge, where excavation is just under way to install the stand pipe and valve riser for the 12" valve. The riser was omitted accidently when the assembly was installed

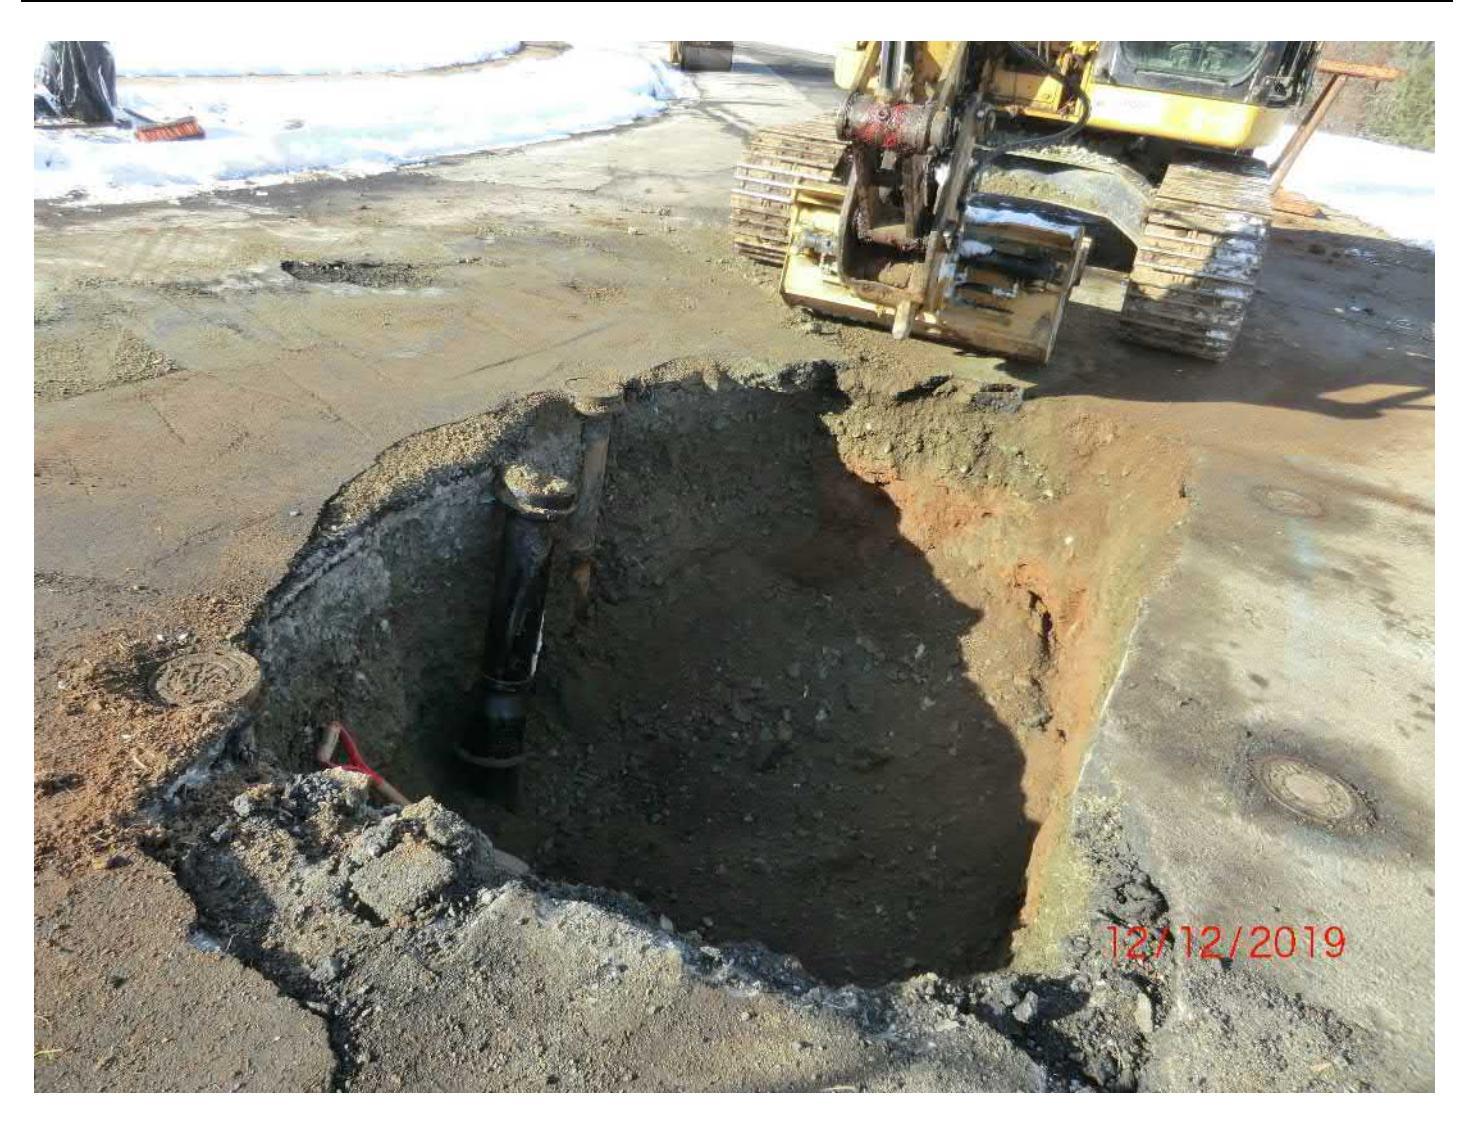
Figure 8 – Looking northwest at excavation and installation of valve box for 12" gate valve at tee.

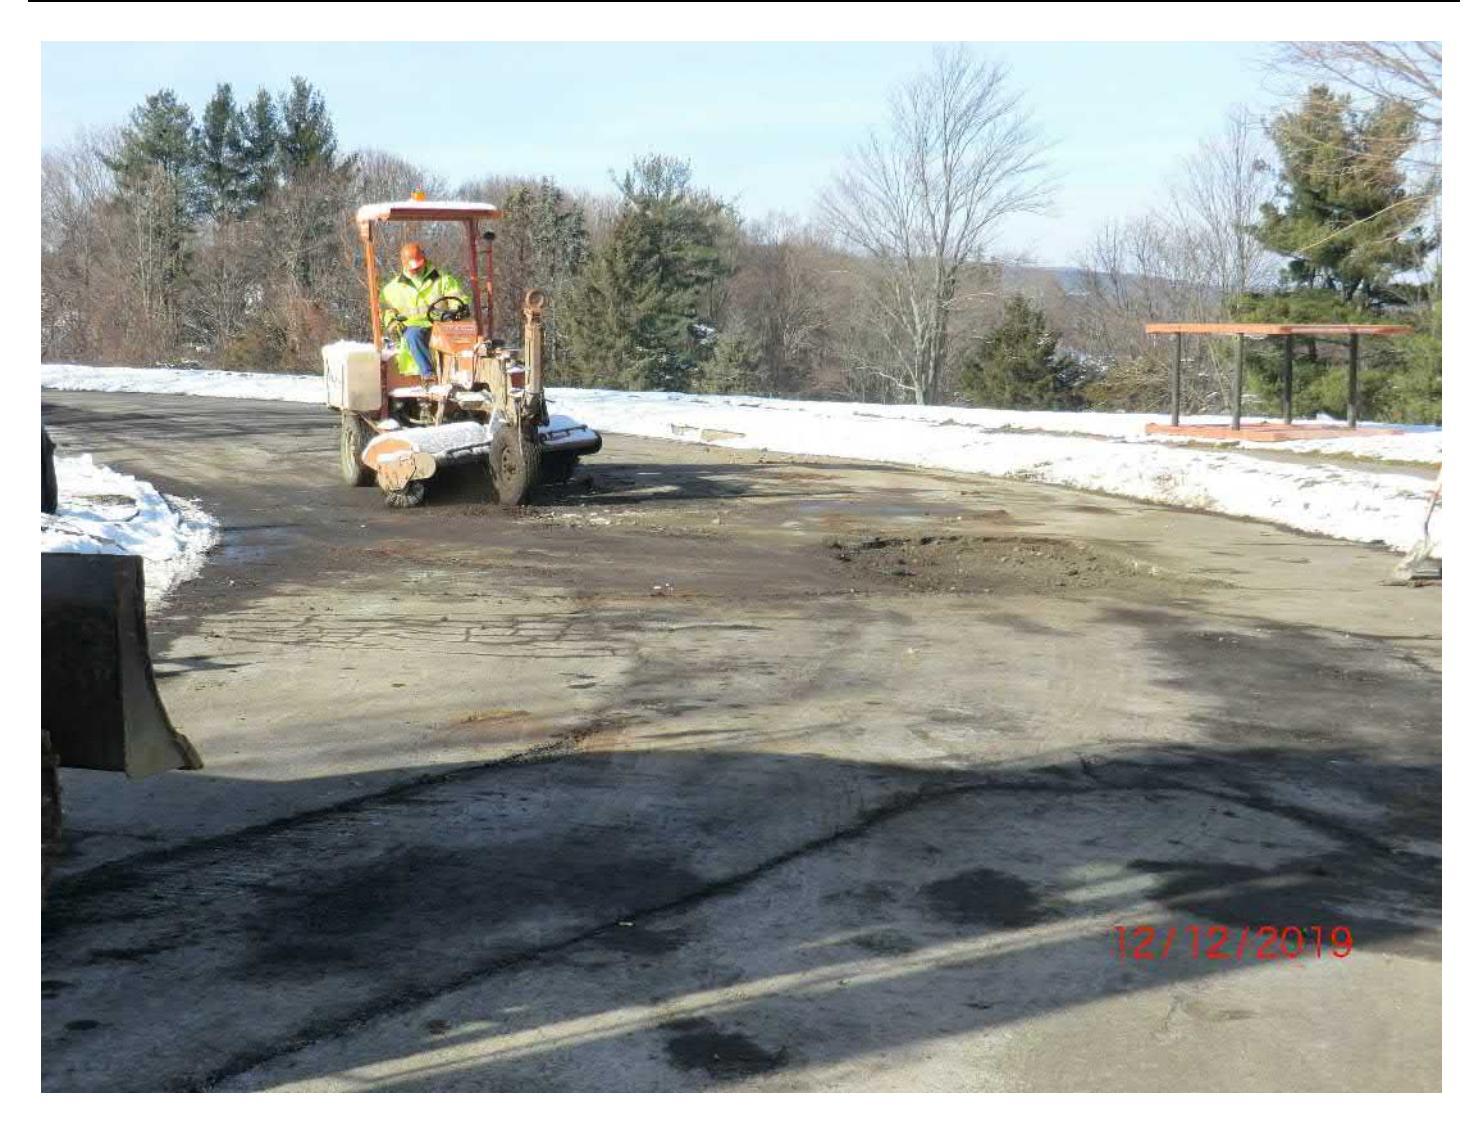
Figure 9 – Facing north, sweeping up after the valve box installation and before hot patch arrives.

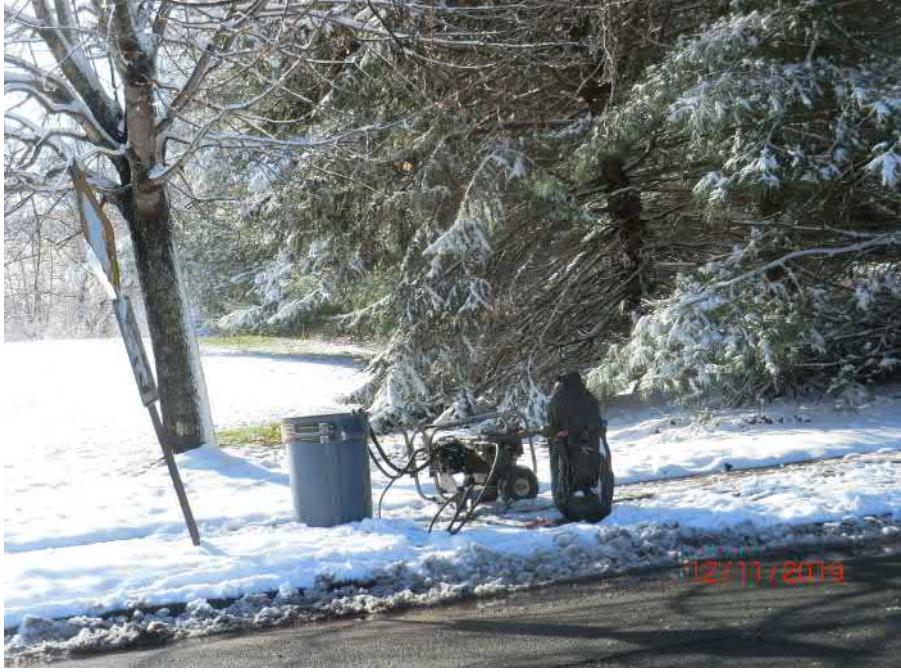
Figure 11 – Facing southwest, new hydrant located at bottom of Talcott Ridge and S. Main Street (below the repaired leak).

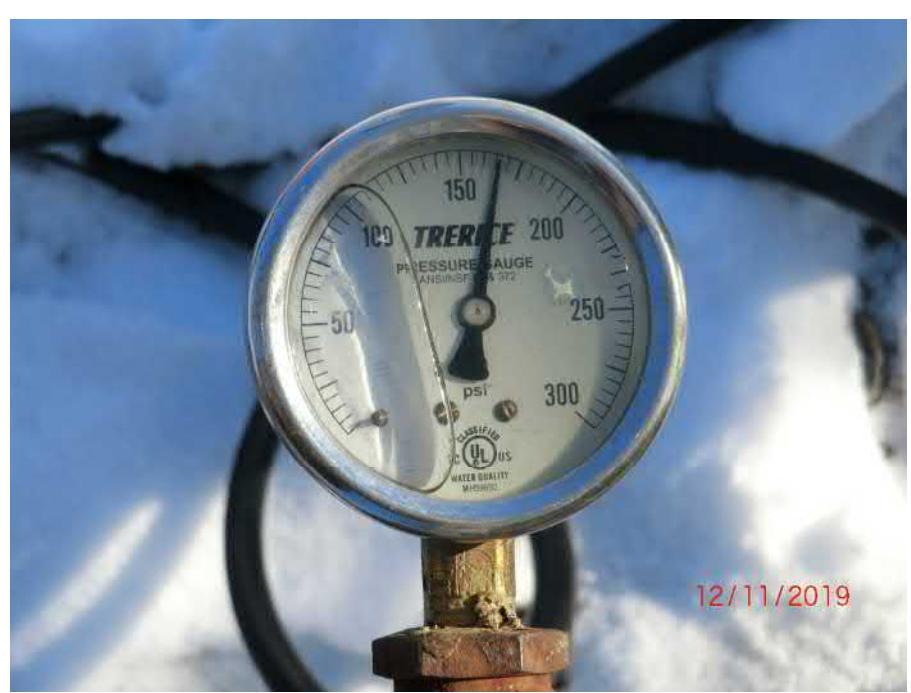
would be just under 4 gallons at 200 PSI. After some debate as to what pressure to set in the system – Town of Middletown requires a 200 PSI test and Ludlow indicated that the valves were only rated to 150 PSI - the system was pressurized to 170 PSI at the new hydrant located at Talcott and S. Main. A second gauge was placed at the new hydrant located on lower Watch Hill, which ready 157 PSI. This pressure was maintained without dropping over the next hour. During that time it was decided at the weekly meeting, after assurances from the Middletown water department that the valves could handle the 200 PSI, that the pressure should be raised to 200 PSI for the second hour of the test. This came via word of mouth from Chris Stinson – HDR – whom was at the meeting. Ludlow asked to wait for Middletown to return before raising the pressure. In the first attempt to raise the pressure, the gauge appeared to stop at 190 PSI + 2 PSI. Ludlow continued to pump water into the system to bring the pressure up and after approximately 30+gallons I was asked to check the other gauge on lower Watch Hill – which was pegged at over 300 PSI. At this point Ludlow release pressure, closed and reopened the hydrants and swapped out the gauge for a new gauge, thinking that the first one was faulty (at the Talcott/S. Main St. hydrant). Once this was done the system was established at 200 PSI and Ludlow moved to the upper portion of the system to set up Test 2. After setting up Test 2, Ludlow, Middletown, and myself started to monitor Test 1. From this point to the end of the day, The Test 1 section failed to maintain pressure despite attempts to get air out of the line and checking valves and covers. Pressure in the system would drop steadily after each time the system pressure was re-established. Eventually, the 16" DIP was shut off from everything east of lower Watch Hill Drive, including the Watch Hill 8" spur. The system continued to lose pressure even then. Note that the backside of the tri-valve at the junction of Talcott and S. Main was not full of water at the time. Another attempt will be made tomorrow, after letting the system settle overnight.

Figure 12 – Gauge on hydrant located at intersection of Talcott Ridge and S. Main Street. Reading 167 PSI.

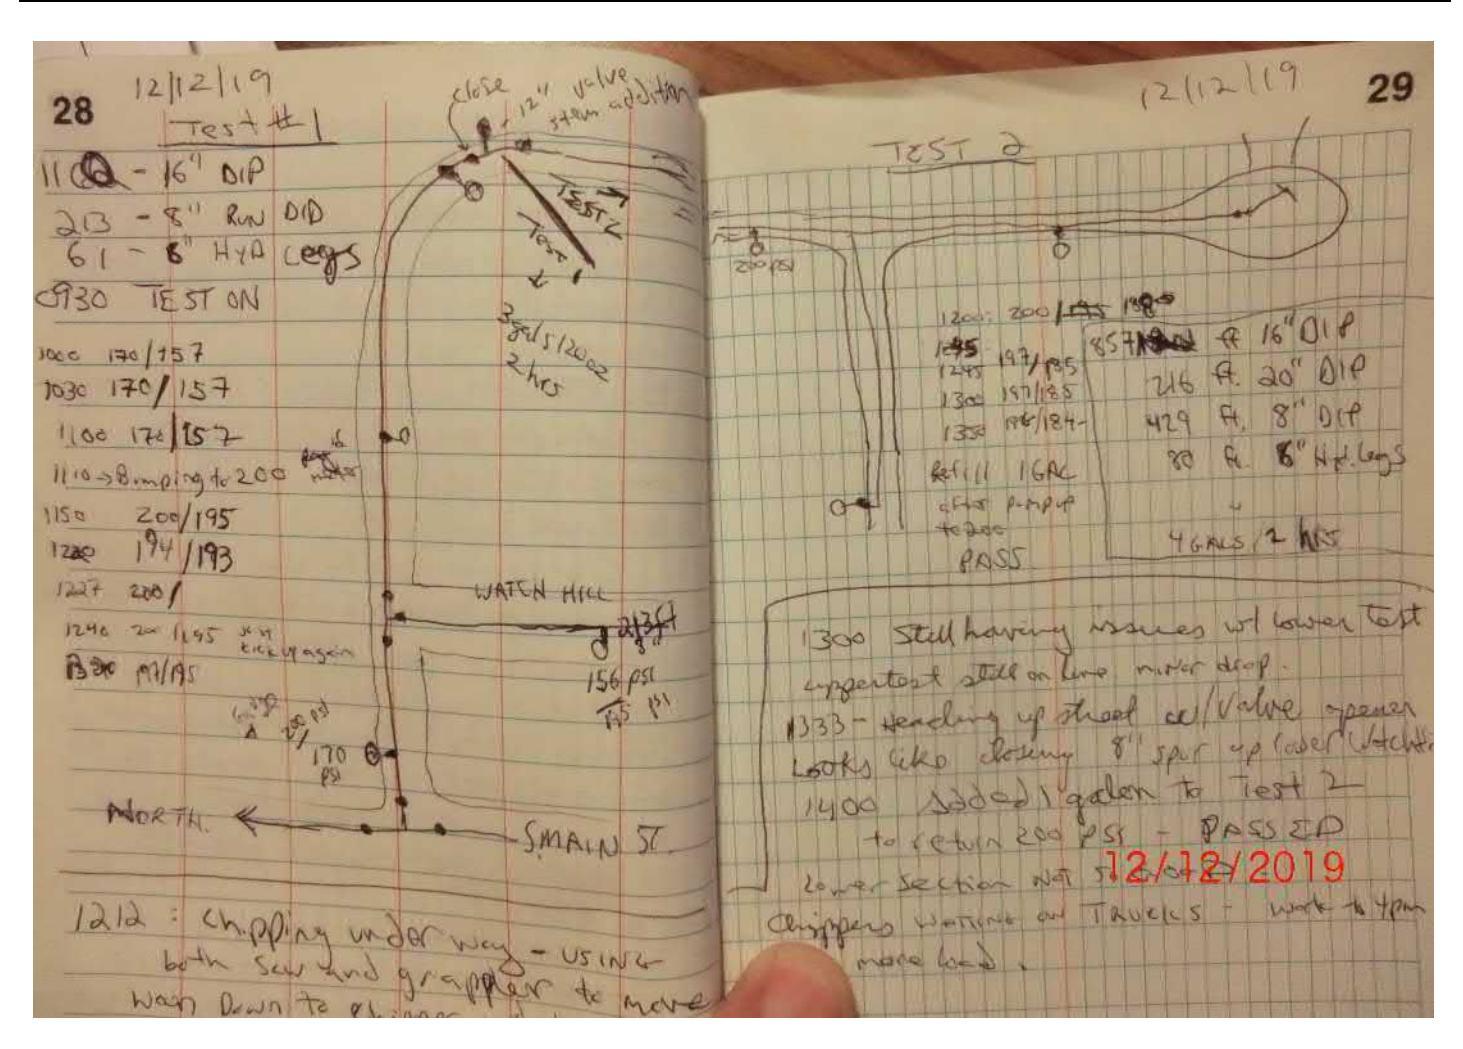
Test 1: Includes 1,160 feet of 16" DIP, 213 feet of 8" DIP, and 61 feet of 6" hydrant legs. According to standards acceptable leakage

Test 2: Includes 857 feet of 16" DIP, 216 feet of 20" DIP, 429 feet of 8" DIP, and 80 feet of 6" DIP Hydrant legs. Acceptable leakage at 200 PSI would be 4 gallons. This test was set to 200 PSI at the new hydrant located at the corner of Talcott Ridge and upper Watch Hill Drives. A second gauge was installed on the new hydrant on upper Watch Hill and was reading 188 PSI at the time of the test. After two hours, the gauges read 196 and 184 PSI respectively, or a drop of 4 PSI. Ludlow then returned the system pressure to 200 PSI at the Talcott Ridge/Watch Hill hydrant by adding water. Using a measured bucket, it was determined that the amount of water required to return the system to 200 PSI was 1 gallon. Test 2 passed without incident.

Figure 13 – Test 1 and Test 2 Note that Watch Hill connects all the way through, though it is not shown in this diagram.
