APPENDIX G (DRAFT):**FAIRFIELD AND NEW HAVEN COUNTIES, CT COASTAL STORM RISK
MANAGEMENT (CSRM) FEASIBILITY STUDY****USE OF I-95 EMBANKMENT IN NEW HAVEN, CT AS A CSRM FEATURE,
POTENTIAL FAILURE MODES ANALYSIS****1. Introduction**

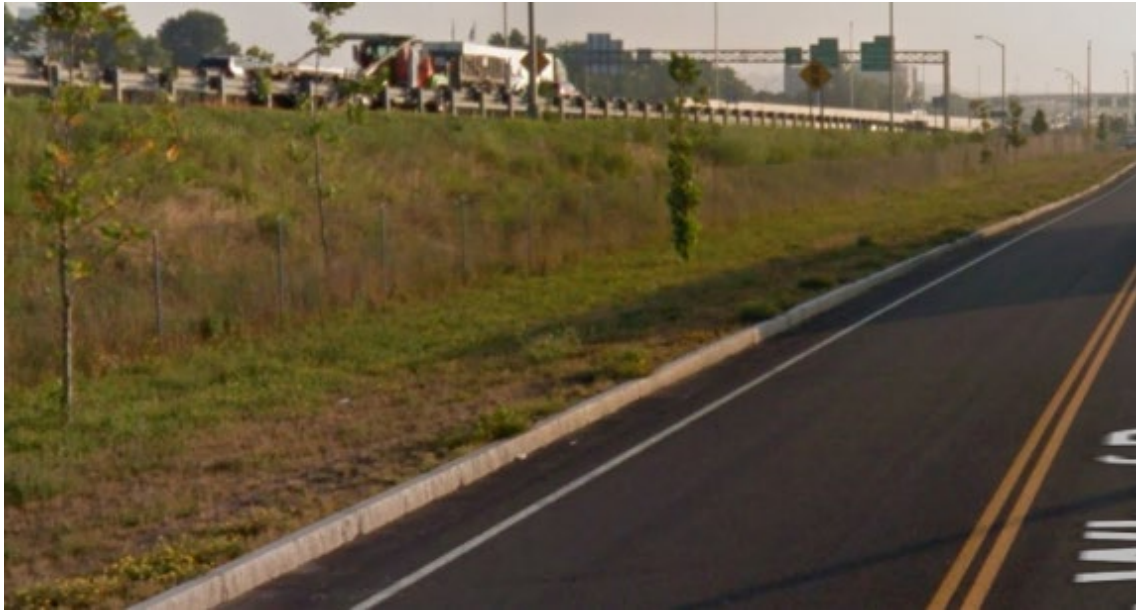
The crest of the embankment varies from approximately El. 8 to El. 31, resulting in embankment heights varying from approximately 4 feet up to 28 feet. Most of the embankment is higher than the El. 15 flood protection elevation, however a portion of the embankment is lower than El. 15 (Figure 2). A flood wall is being considered near the embankment along this area to meet the El. 15 flood protection requirement. The embankment width varies from approximately 150 feet to 300 feet. The slopes of the embankment vary from 1V:5H to 1V:2H. Slopes are vegetated, with no stone protection, and appear stable (Figure 4). Embankment cross sections are shown on Figure 5 through Figure 8.

Figure 4: View of ocean side of I-95 embankment from Long Wharf Drive overpass looking northeast.

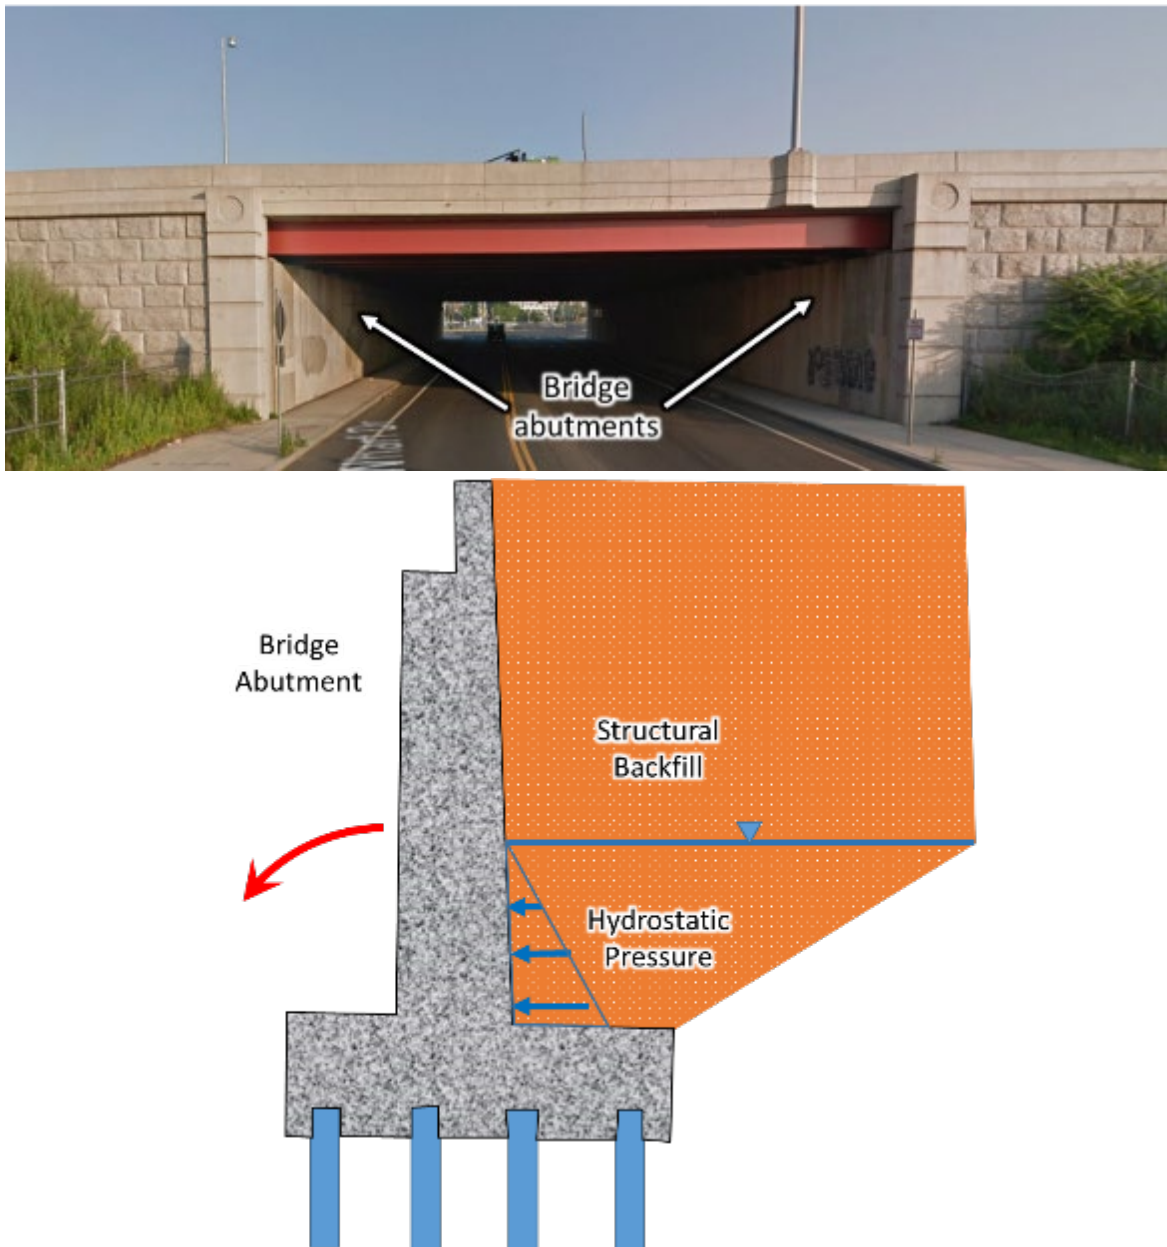
The team considered a conceptual failure mode that could occur during a severe storm. Wind setup during the storm increases the height of the still water level (SWL) during normal tidal cycles. The SWL rises above El. 8 (the base of the bridge abutments at Long Wharf Drive and

Canal Dock Road). Seepage initiates through the bridge abutment wing wall fascia and into the structural fill behind either of the bridge abutment walls. Over repeated tidal cycles during the storm the SWL approaches a maximum of El. 13. Hydrostatic pressure builds up behind the abutment walls. There are no weep holes in the abutment walls to reduce pressures. Hydrostatic pressures build to a point where the abutment walls become unstable. One or both of the walls rotates, destabilizing the embankment and wingwalls, creating an opening at the ends of the closure structure. Water flowing around the closure structures erodes embankment material, resulting in a larger opening for water to flow through and flood the interior.

Figure 12: PFM 1 Failure sketch (assumed configuration of abutments)

The duration of loading expected during an extreme storm event (above El. 8) would be short (less than 12 hours). The team considered that this duration of loading would not be sufficient to

saturate the structural fill behind the wall. Additionally, the maximum loading resultant would only extend a maximum of a third of the way up the wall, and would not be sufficient to cause the wall to fail. The bridges were also renovated within the last five years, and are assumed to have utilized the latest design and construction techniques. The team concluded that it was unlikely that the expected depth and duration of loading during an extreme event would be sufficient to result in instability of the abutment walls.

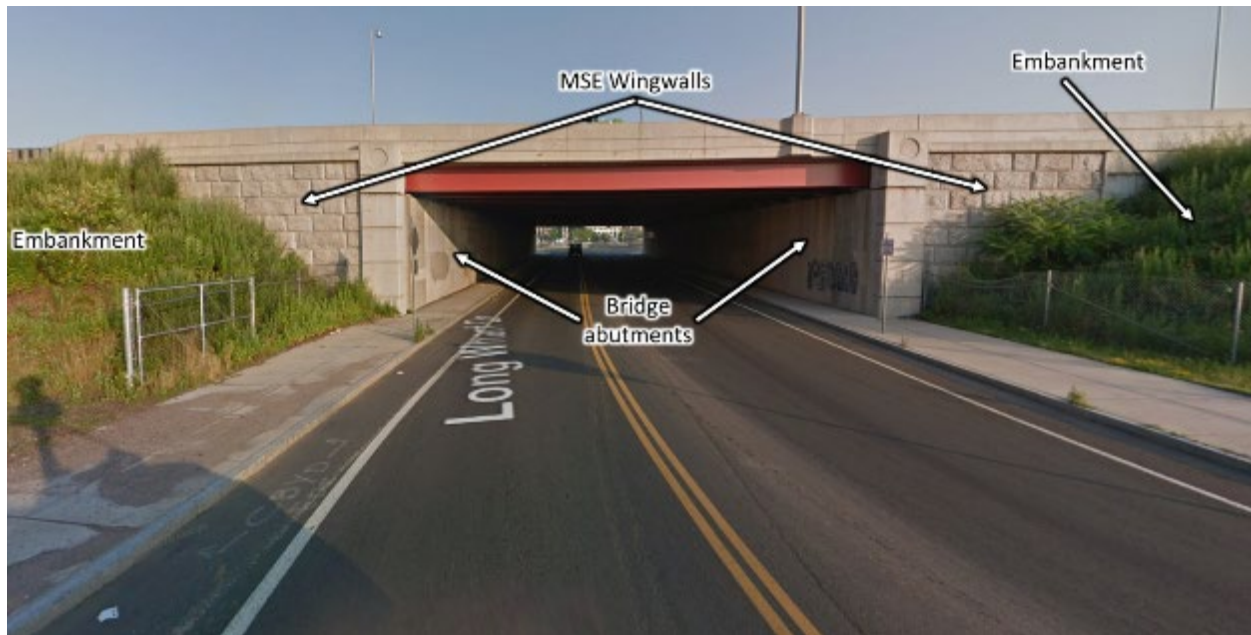
Figure 14: Photo showing location of MSE wingwalls

As discussed previously, the bridges have Mechanically Stabilized Earth (MSE) wingwalls at either end (Figure 14). An MSE retaining wall is a composite structure consisting of alternating layers of compacted backfill (possibly lightweight fill) and soil reinforcement elements, fixed to a wall facing (Figure 14). The wall facing is relatively thin, with the primary function of preventing erosion of the structural backfill.

The team considered whether the MSE facing would be pervious enough to allow water to enter the backfill (which may be lightweight fill) resulting in excess hydrostatic pressures within the backfill that would lead to MSE wall instability. The team concluded that while it was possible that some seepage could enter the joints in the fascia during high water loading, the duration of loading would not be sufficient to fully saturate the wall. Additionally, the MSE wall structure has multiple layers of geogrid within the backfill that would provide resiliency. The team therefore concluded that it was very unlikely that loading during an extreme event would lead to instability of the MSE walls.

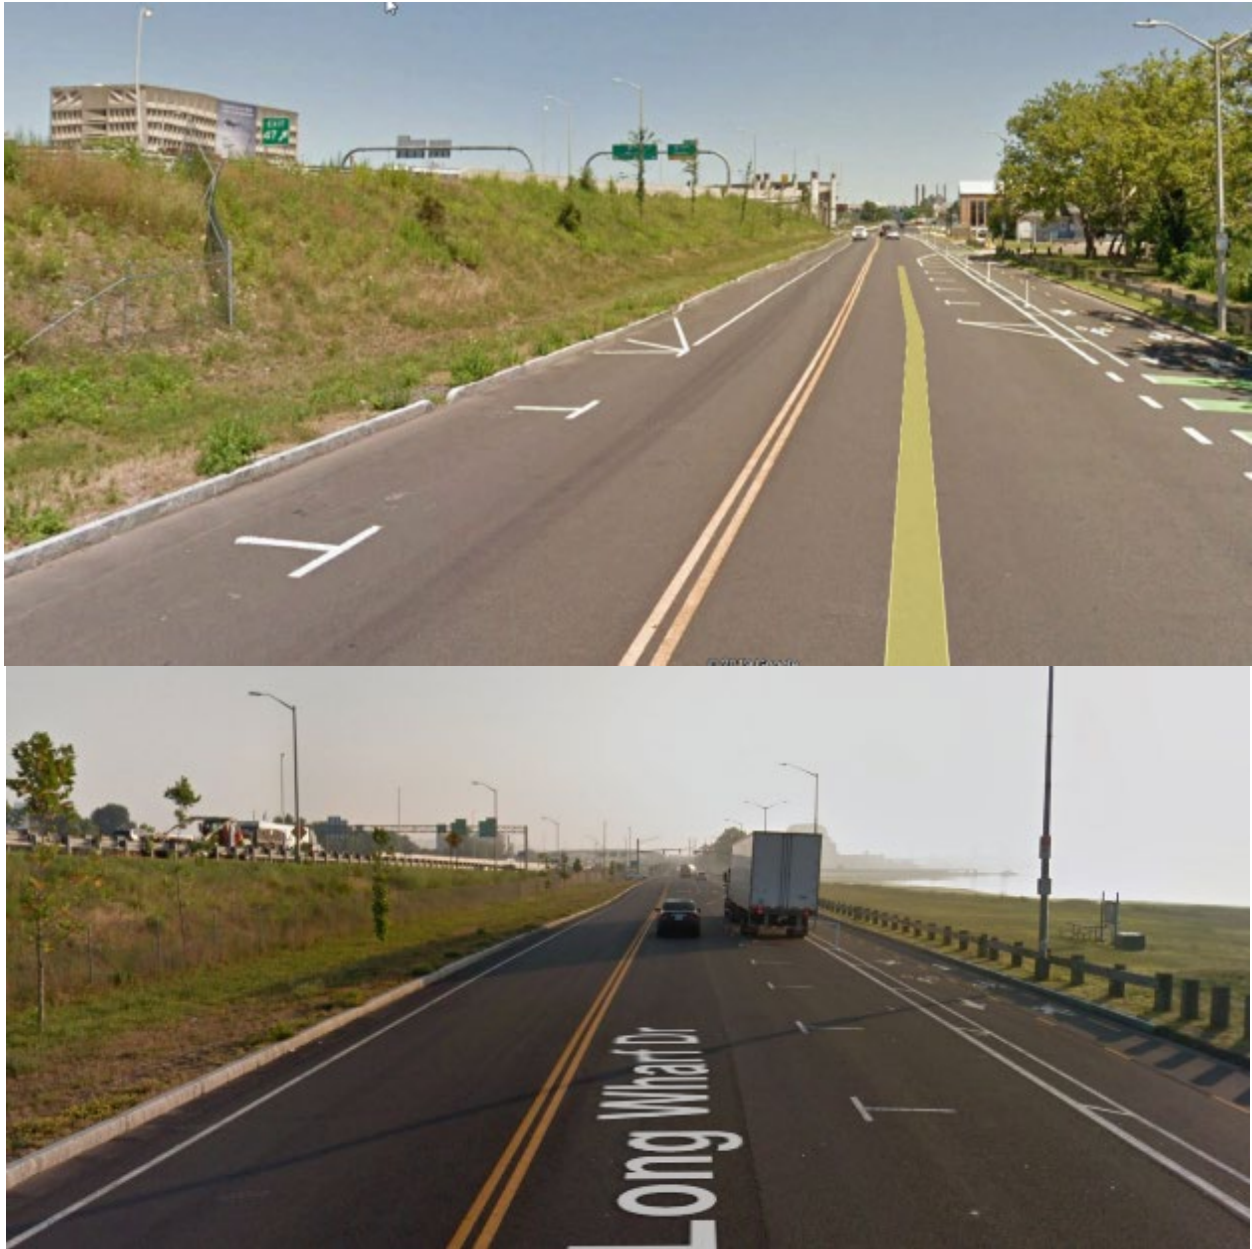
The PFMA team concluded that the embankment would be vulnerable to wave attack. However, given that there is anywhere from 150-300 ft of land seaward of the toe of the embankment, waves that impact the embankment would have already broken and lost most of their energy. Additionally, waves would only be impacting the embankment for a relatively short duration (mid-to-peak tide cycle) and would be more likely to wash against the embankment rather than break on the embankment. Finally, even if erosion of the embankment did occur, the duration of wave attack would not be sufficient to erode through the entire 150-300 ft of embankment.

Figure 16: Typical condition of seaward face of I-95 embankment

The team therefore concluded that it was unlikely that wave loading during an extreme event would lead to breach of the embankment. Damage due to wave attack could be effectively controlled by installing slope protection on the seaward slope of the embankment.

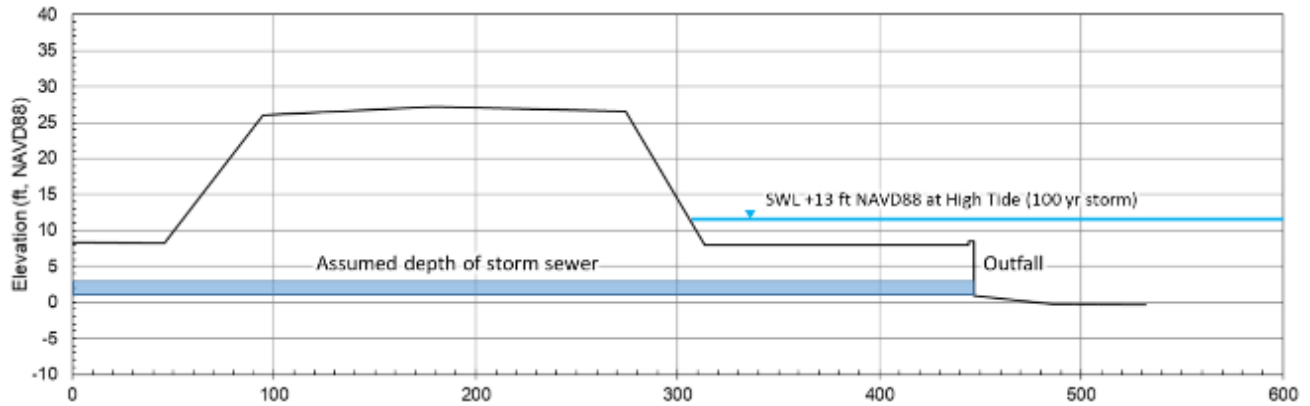
As shown previously on Figure 3, there are several known storm sewer outfalls along the I-95 embankment. Based on limited as-built information available during the PFMA, as well as visual inspection of some of the outfall locations, it appears that these outfalls all pass well below the I-95 embankment (Figure 17). The PFMA team concluded that for this PFM to occur, a penetration would have to extend through the entire embankment at the base (maximum loading). Whether penetrations that meet this criteria exist along the embankment is unknown. The embankment is assumed to consist primarily of a silty sand that may have sufficient fines to hold a crack open. However, maximum gradients at future predicted high tide (with sea level rise) are very low (0.025) and would not be sufficient to initiate concentrated leak erosion. The duration of loading during the 100 year storm would not be sufficient to fully saturate the embankment, which would be required for this PFM to progress.

The team concluded that the probability that CLE along a penetration during an extreme event would lead to breach of the embankment was very unlikely primarily due to the low gradients and the short duration of loading.

Figure 17: Storm sewer outfall near Long Wharf Drive Bridge under I-95 embankment (other outfalls similar)

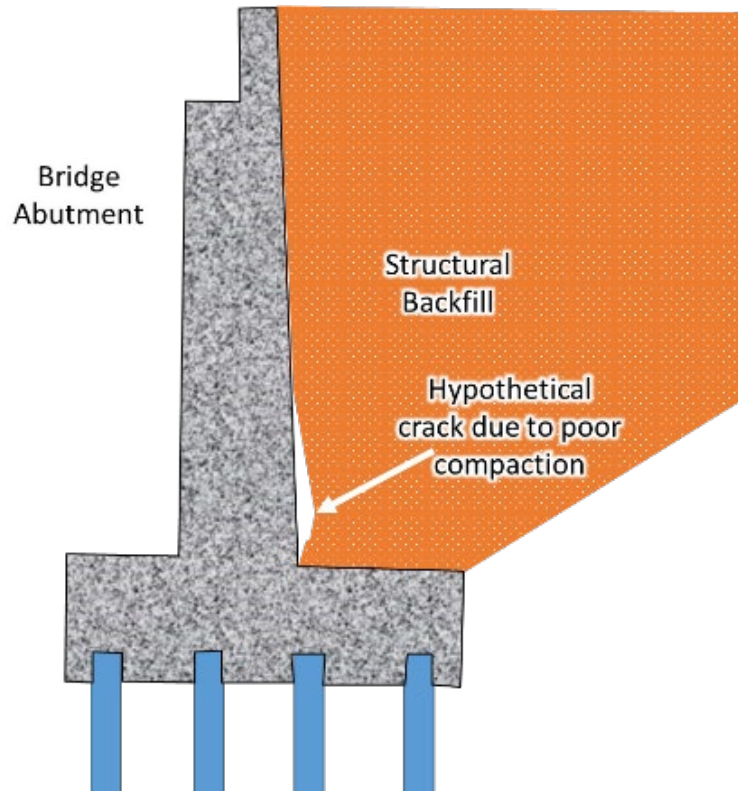
This PFM is similar to PFM 7, however a crack due to poor compaction of structural backfill along the backfill/bridge abutment contact is considered (Figure 18). During the 100-year storm, the SWL rises above El. 8 (the base of the bridge abutments at Long Wharf Drive and Canal Dock Road). Concentrated seepage begins to flow through the crack, eroding soil along the crack. There is no landward side filter to hinder the movement of particles. Over repeated tidal cycles during the storm the SWL approaches a maximum of El. 13, the rate of erosion increases, and the crack continues to grow. Increasing flow through the crack leads to gross enlargement of the crack and downcutting of the embankment. The embankment breaches, resulting in flooding of the interior.

The nature of the structural backfill material is not known, however it is assumed to be a free draining granular material that would likely not hold a crack. Wingwalls at the landward side would prevent exit of eroded embankment material (crack would not be able to enlarge). Maximum gradients at future predicted high tide (with sea level rise) are very low (0.025) and would not be sufficient to initiate concentrated leak erosion. Bridges were rebuilt in the last five years and assumed to utilize the latest design and construction techniques, therefore poor compaction or defects are unlikely.

The team concluded that the probability that CLE along the bridge abutment / embankment interface during an extreme event would lead to breach of the embankment was very unlikely given the available information.

Figure 18: Section of bridge abutment showing hypothetical crack through structural backfill along face of bridge abutment.

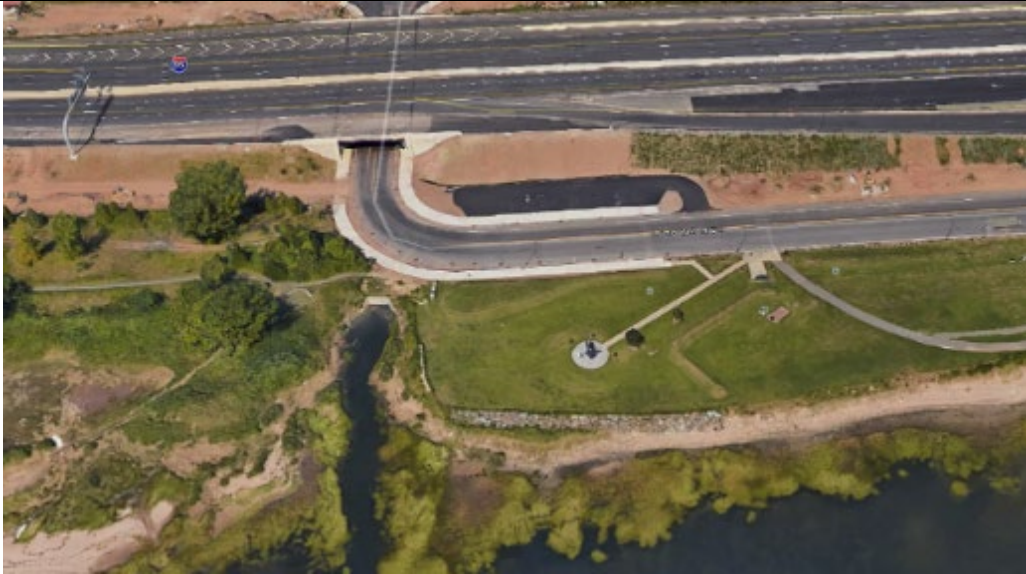
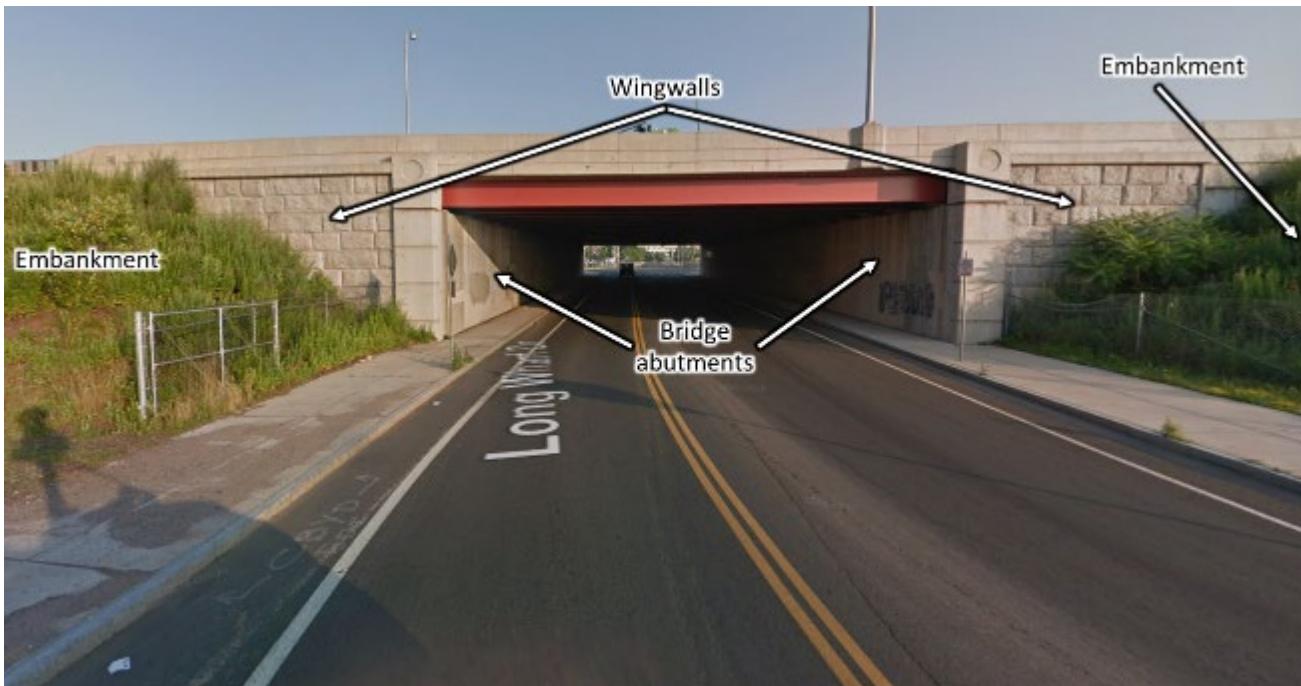
Figure 19: Long Wharf Drive Bridge Overpass, I-95 embankment

Detailed Description of Failure Mode: An approaching storm results in storm surge (wind setup) which increases the height of the still water level (SWL) during normal tidal cycles. The SWL rises above El. +8 ft NAVD88 (the base of the bridge abutments at Long Wharf Drive and Canal Dock Road). Seepage initiates through the bridge abutment wing wall fascia and into the structural fill behind either of the bridge abutment walls. Over repeated tidal cycles during the storm the SWL approaches a maximum of El. +13 ft NAVD88, hydrostatic pressure builds up behind the abutments. There are no weep holes in the abutment walls to reduce pressures. Hydrostatic pressures build to a point where the abutment walls become unstable. One or both of the walls rotates, destabilizing the embankment and wingwalls, creating an opening at the ends of the closure structure. Water flowing around the closure structures erodes embankment material, resulting in a larger opening for water to flow thorough and flood of the interior.

Conditions making PFM Likely Or Unfavorable Factors	Conditions making PFM Unlikely Or Favorable Factors
<ul style="list-style-type: none"> • Likely not designed for excess hydrostatic pressures, as there are no apparent drainage features (e.g. weep holes) in the visible portion of the wall • Structural fill behind the walls are pervious granular materials that would saturate more rapidly • Relatively short seepage path from embankment/wingwall face to abutment walls • MSE wall fascia are modular and joints between fascia would allow seepage to enter 	<ul style="list-style-type: none"> • Storm duration would only be a few days. • Tidal fluctuations would make the period of maximum loading very short, making full saturation of the fill behind the wall less likely • Wing walls may be more pervious and would allow excess pressures to dissipate when tides recede. • Limited information about embankment fill suggest that it is a silty sand that would be less pervious • Bridges were rebuilt in the last five years and assumed to utilize the latest design and construction techniques • Maximum loading would only extend a third of the way up the abutment wall (at high tide and peak of storm) • Wingwall fascia may not be very pervious, and therefore may only allow limited seepage

- Install weep holes in abutment walls to relieve hydrostatic pressure

- Obtain As-built drawings for bridge abutments and wingwalls
- Obtain additional information on the nature of the embankment and structural fill materials

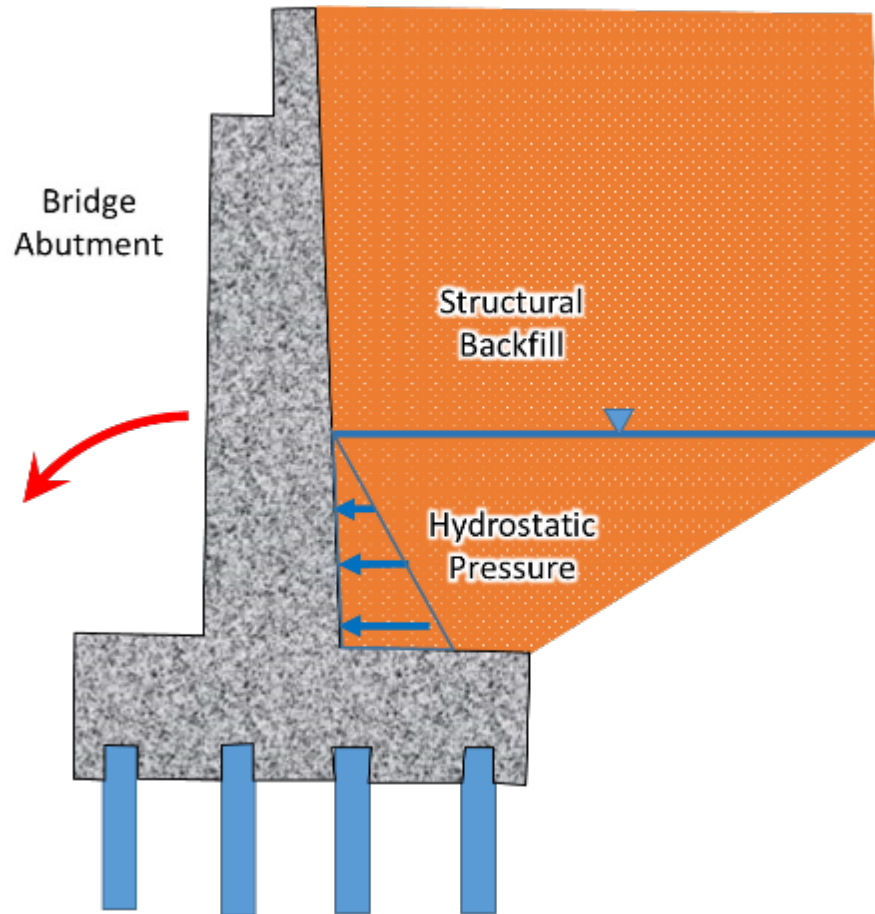
Figure 20: Potential Failure mode sketch

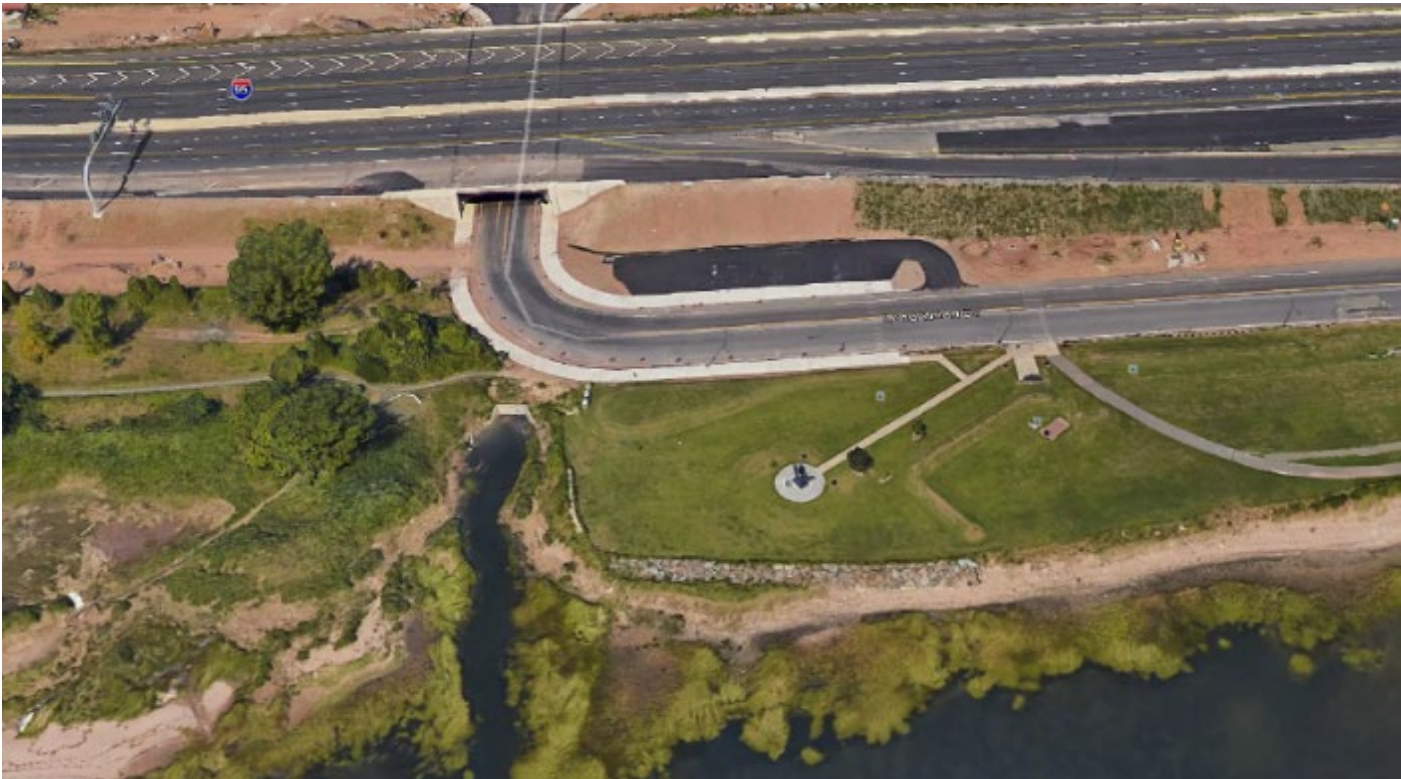
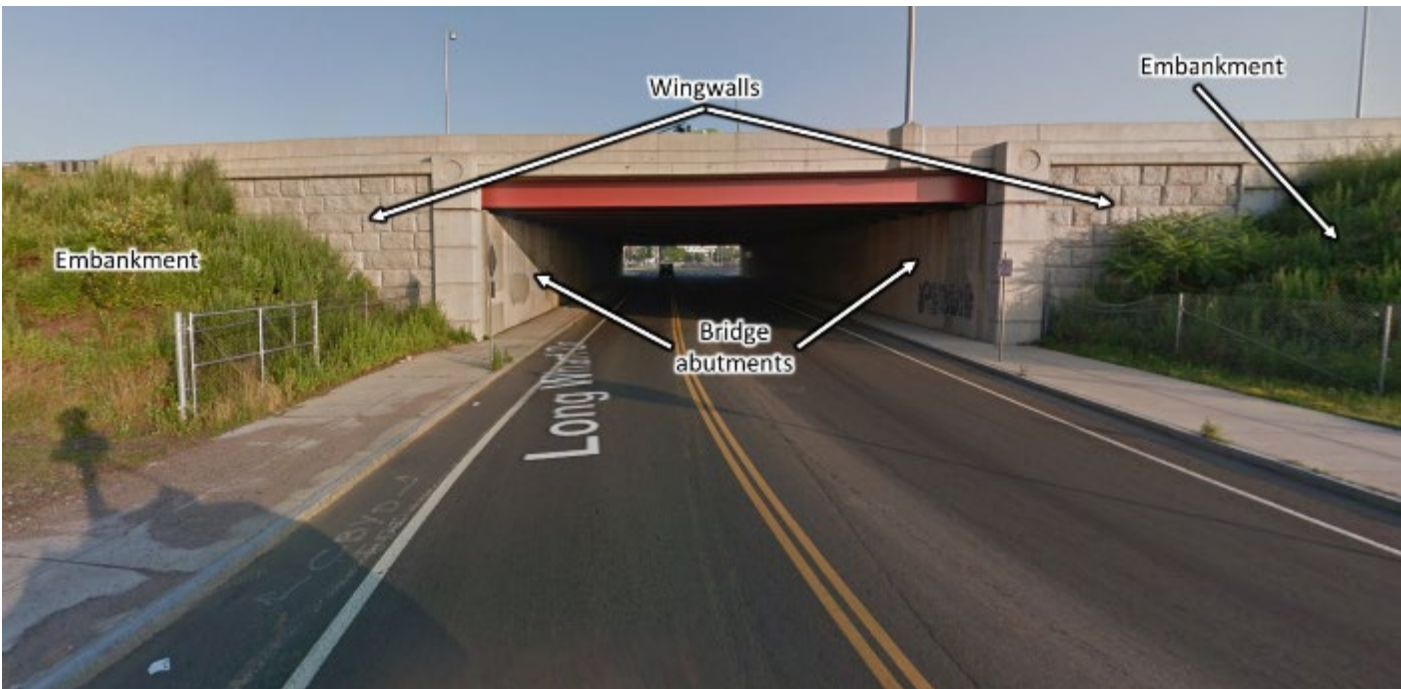
Figure 22: Long Wharf Drive Bridge under I-95 embankment

Detailed Description of Failure Mode: An approaching storm results in storm surge (wind setup) which increases the height of the still water level (SWL) during normal tidal cycles. The SWL rises above El. +8 ft NAVD88 (the base of the bridge abutments at Long Wharf Drive and Canal Dock Road). Seepage initiates through the bridge abutment wing wall fascia and into the structural fill behind either of the bridge abutment walls. Over repeated tidal cycles during the storm the SWL approaches a maximum of El. +13 ft NAVD88. Hydrostatic pressure builds up within the MSE backfill over repeated tide cycles, resulting in instability and failure of the MSE wall. Failure of the MSE wall exposes the embankment material and structural fill behind the wall to wave attack. The embankment then fails due to wave erosion, causing flooding of the interior.

- Likely not designed for excess hydrostatic pressures
- Embankment soil and structural fill behind the walls are pervious granular materials that would saturate more rapidly
- MSE wall fascia are modular and joints between fascia would allow seepage to enter
- MSE wingwall has never experienced the level of loading of concern

- Install weep holes in MSE bridge wingwalls to relieve hydrostatic pressure

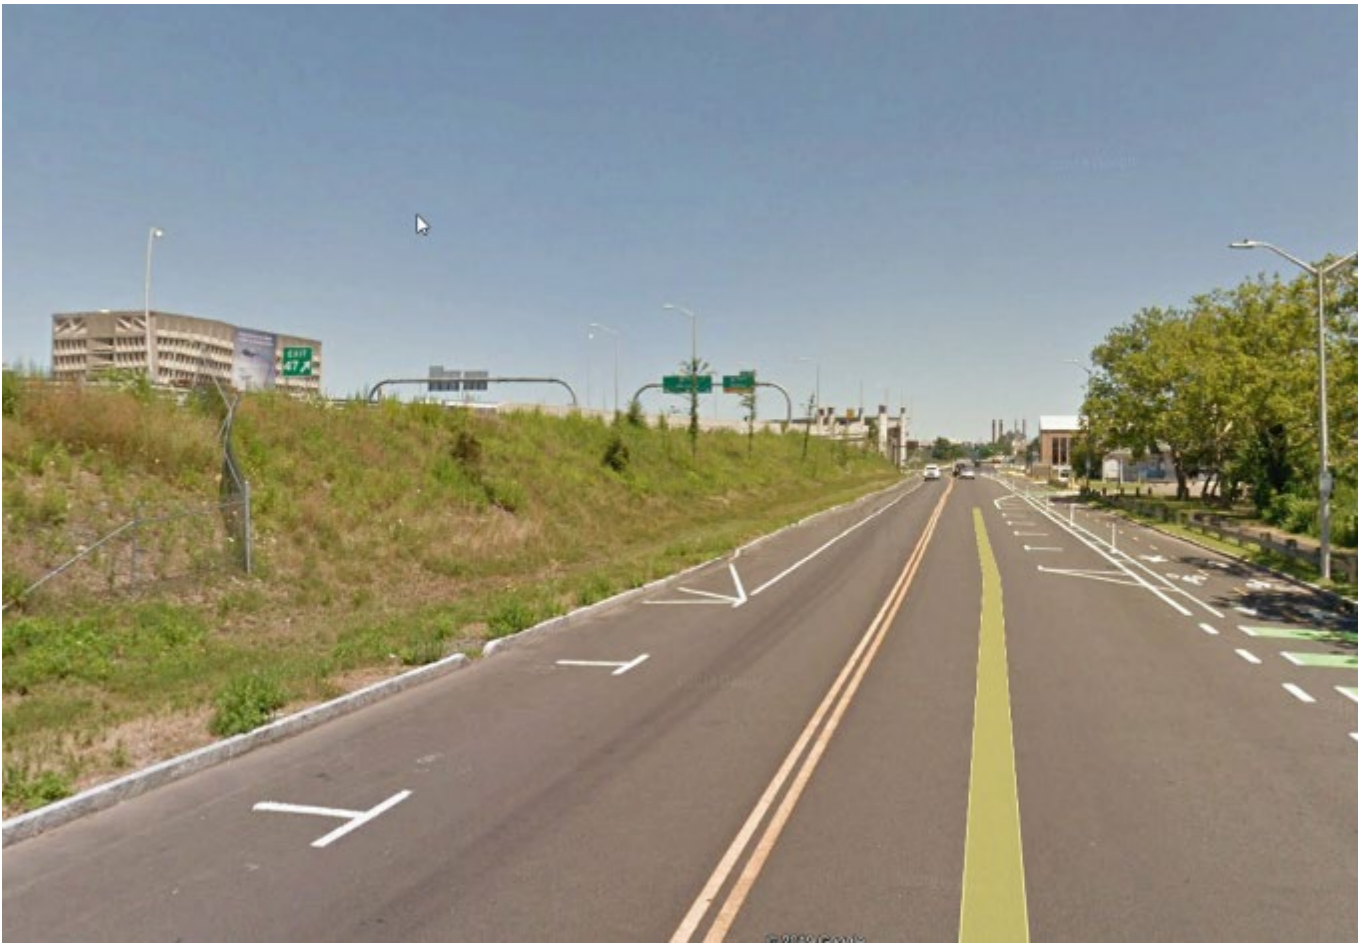
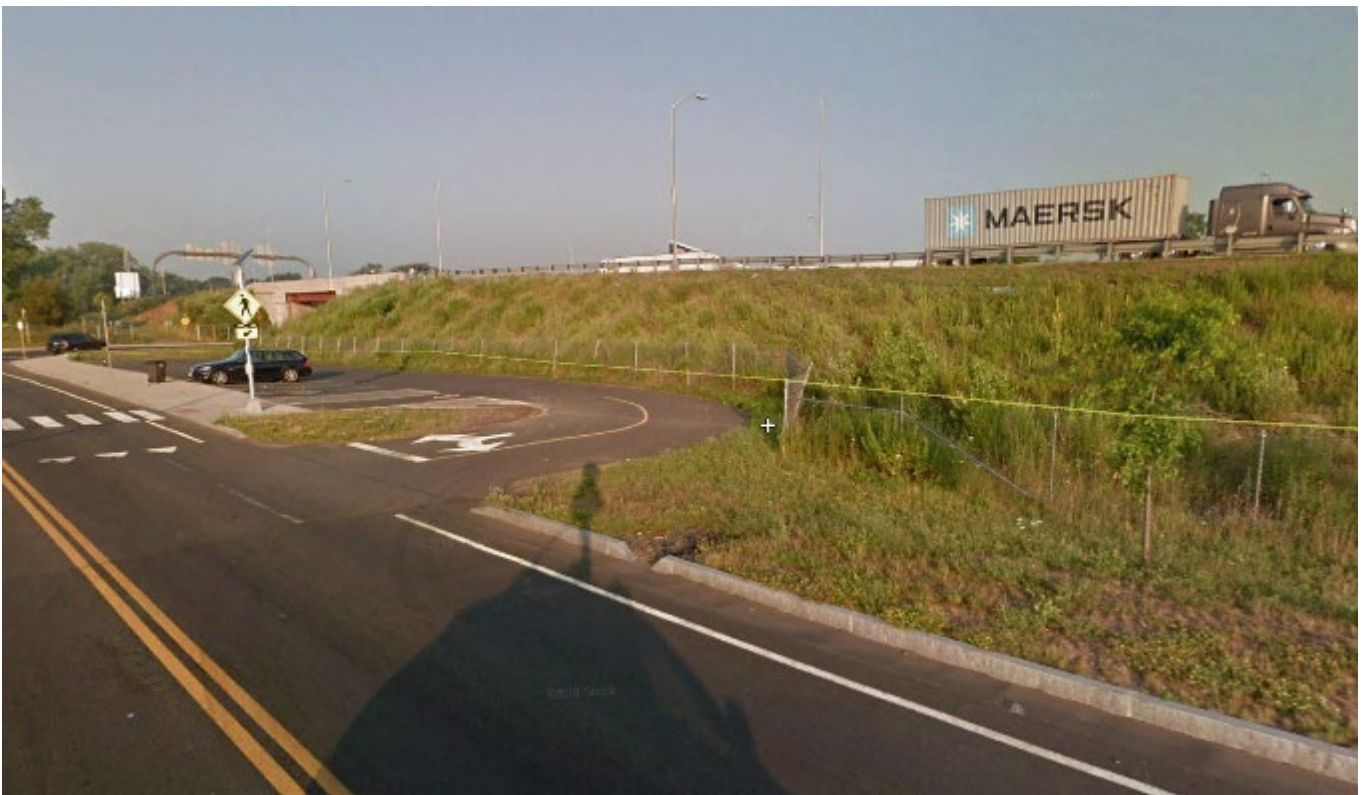
Detailed Description of Failure Mode: An approaching storm results in storm surge (wind setup) which increases the height of the still water level (SWL) during normal tidal cycles. As the SWL rises above El. +8 ft NAVD88 (the toe of the I-95 embankment) and water from breaking waves begins attacking the I-95 embankment. Wave energy impacting the slope is sufficient to erode the embankment surface, which has no riprap protection. The granular materials of the embankment are vulnerable to erosion. The seaward slope is undermined at the water level, resulting in progressive sloughing of the embankment. As the SWL rises further to El. +13 ft NAVD88, wave attack accelerates and sloughing continues to the landward side of the embankment. The embankment is breached, resulting in flooding of the interior.

- Waves would already be broken when impacting the embankment, resulting in less energy.
- Embankment is over 200 ft wide, resulting in a much longer time of wave attack that would be needed to breach the embankment.
- Cyclical loading during a storm event could allow for intervention at low tide
- The relatively short duration of wave loading would damage the embankment slope, but would not be sufficient to breach the embankment.
- Most waves would be depth limited and would have broken before reaching the road embankment.
- Embankment slope fairly shallow (1V:2H)

Figure 24: Typical condition of I-95 embankment

- Initial erosion damage could be mitigated during the storm by dumping stone in areas that are experiencing wave erosion

- Perform site specific wave analysis
- Obtain additional information regarding embankment material properties

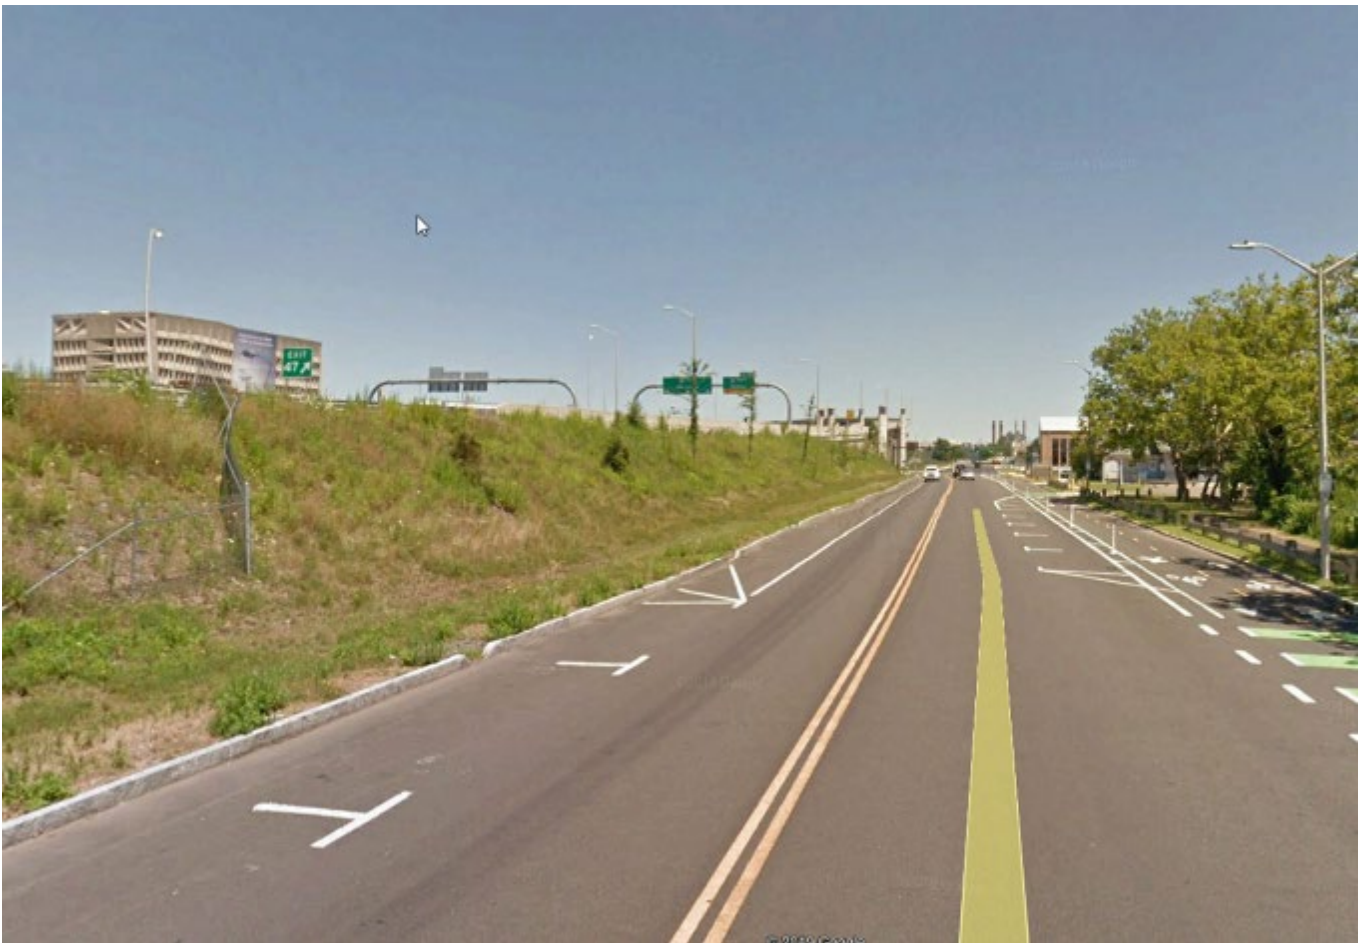
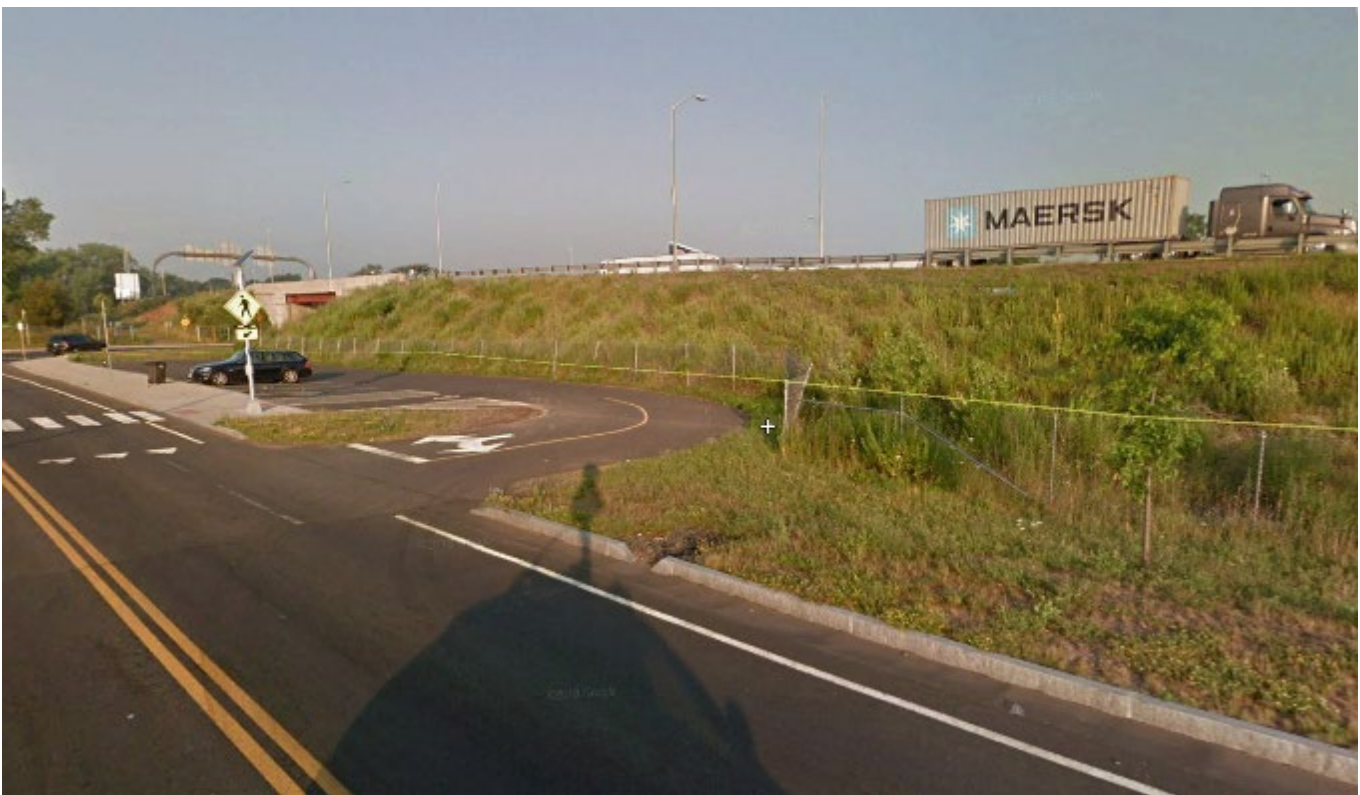
Detailed Description of Failure Mode: An approaching storm results in storm surge which increases the height of the still water level (SWL) during normal tidal cycles. As the SWL rises above El. +8 ft NAVD88 (the toe of the I-95 embankment) and water from breaking waves begins washing up on the I-95 embankment. As the SWL increases, runup exceeds the embankment crest, and embankment overwash occurs. As the SWL continues to increase, wave overwash increases. Erosion of the embankment at the crest initiates. As overwash continues, downcutting of the embankment accelerates and continues to the landward side of the embankment. The embankment is breached, resulting in flooding of the interior.

- The mean level of expected runup is only 2 ft above the design level of protection, and would only occur at the peak of the storm
- Most of embankment is paved with asphalt, which would slow the rate of erosion
- Embankment is over 200 ft wide, resulting in a much longer time of wave overwash that would be needed to breach the embankment.
- Cyclical loading during a storm event could allow for intervention at low tide (such as placing jersey barriers)
- The relatively short duration of wave overwash would damage the embankment crest, but would not be sufficient to breach the embankment.
- Most waves would be depth limited and would have broken before reaching the road embankment.
- Embankment slope fairly shallow (1V:2H)

Figure 25: Typical condition of I-95 embankment

- Initial erosion damage could be mitigated during the storm by dumping stone in areas that are experiencing wave erosion

- Perform site specific wave analysis
- Obtain additional information regarding embankment material properties

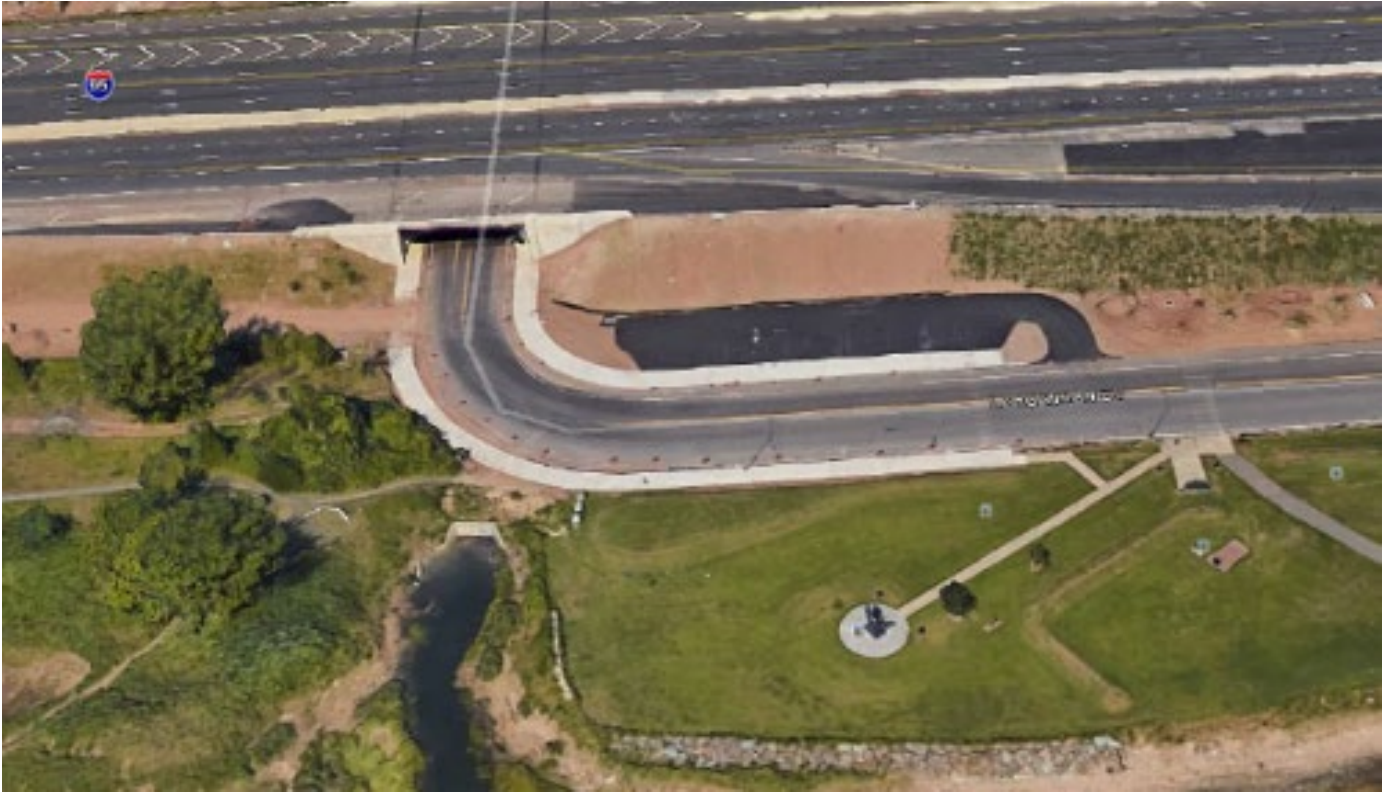
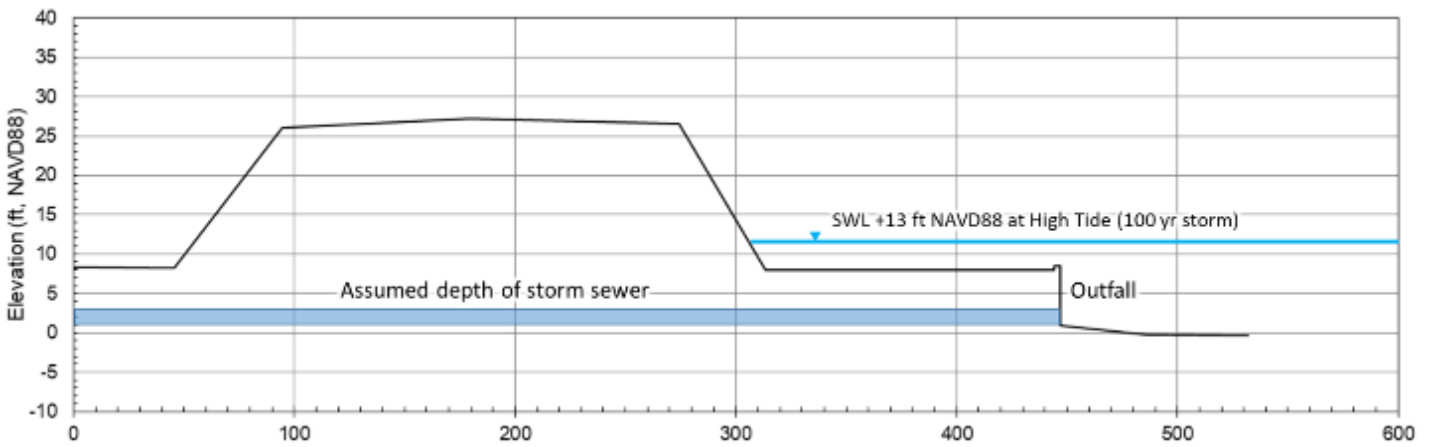
Detailed Description of Failure Mode: Poor compaction around a conduit through the I-95 embankment results in loose or poorly compacted zones around the perimeter and along the length of the conduit. An approaching storm results in storm surge which increases the height of the still water level (SWL) during normal tidal cycles. The SWL rises above El. +8 ft NAVD88 (the base of the I-95 embankment). Concentrated seepage begins to flow through the loose zones along the pipe. Sufficient gradients and velocities exist to move particles, resulting in erosion of soil along the pipe. Flow exits unfiltered on the landside of the I-95 embankment. The embankment materials are able to support a roof, or the pipe itself acts as a roof. Crack filling/self-healing does not occur, and a flow limiter is not present. The rate of erosion increases as the pipe continues to enlarge. The embankment breaches, resulting in flooding of the interior.

- Many utilities cross underneath the embankment. Given the intense development in the area it is likely that there are unknown penetrations that pass through the embankment.
- Difficult to compact backfill around utilities leading to possible loose zones

Figure 26: Storm sewer outfall near Long Wharf Drive Bridge under I-95 embankment (other outfalls similar)

- Obtain As-built drawings and specifications for all utilities/pipes/penetrations crossing the embankment
- Obtain additional information on the nature of the embankment and structural fill materials behind the bridge structures
