APPENDIX G (DRAFT):**FAIRFIELD AND NEW HAVEN COUNTIES, CT COASTAL STORM RISK
MANAGEMENT (CSRM) FEASIBILITY STUDY****USE OF I-95 EMBANKMENT IN NEW HAVEN, CT AS A CSRM FEATURE,
POTENTIAL FAILURE MODES ANALYSIS****1. Introduction**

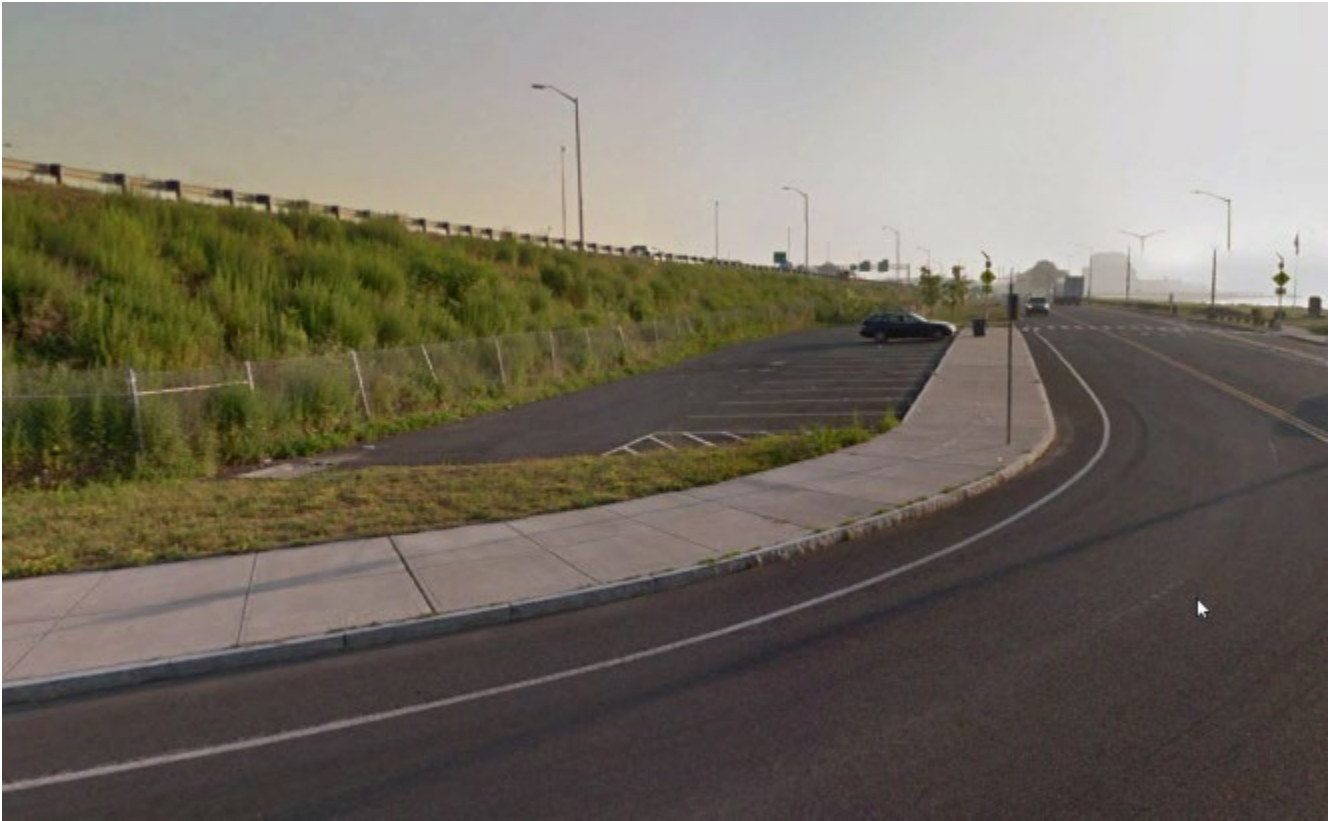
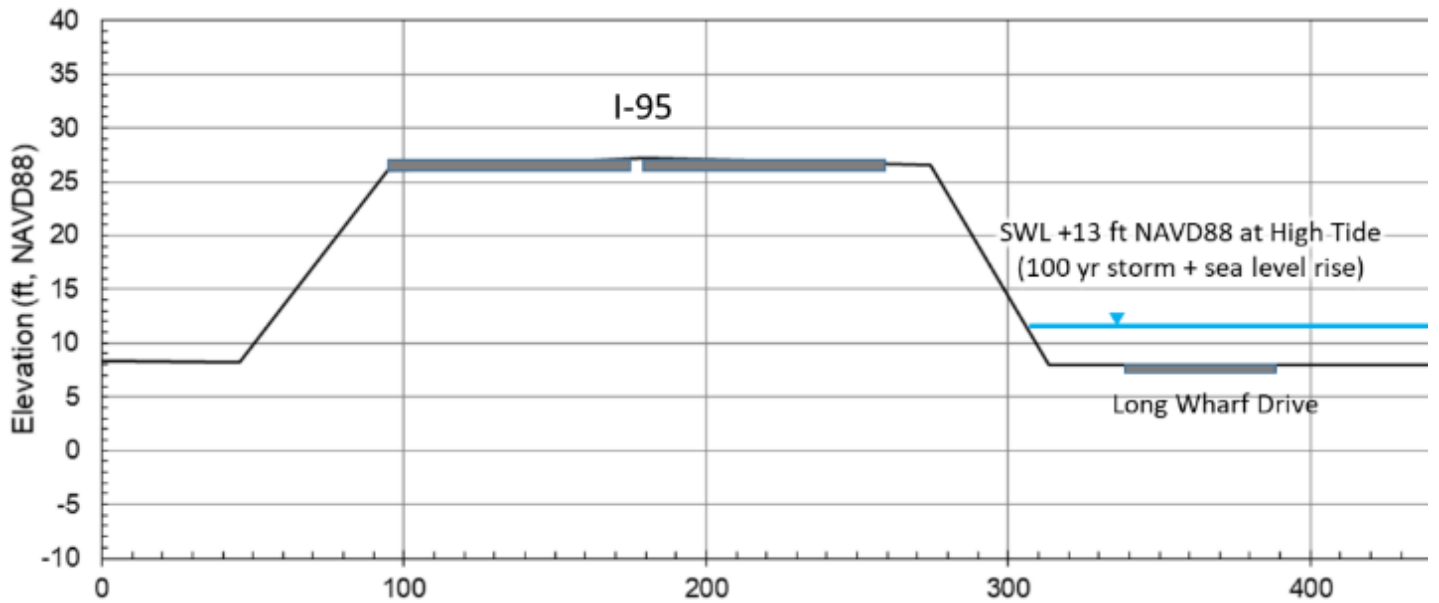
Figure 30: Typical condition of I-95 embankment near southern limit of study (top) and cross sectional profile at this location (bottom)

- Obtain additional information on the nature of the embankment fill materials
