**U.S ARMY RESERVE 99TH REGIONAL SUPPORT COMMAND
MAURICE ROSE ARMED FORCES RESERVE CENTER CONSTRUCTION AND
BOARDMAN LANE COMPENSATORY WETLAND ENHANCEMENT SITES
MIDDLETOWN, CONNECTICUT**

**COMPENSATORY WETLAND ENHANCEMENT SITES
MONITORING REPORT
FALL 2013**

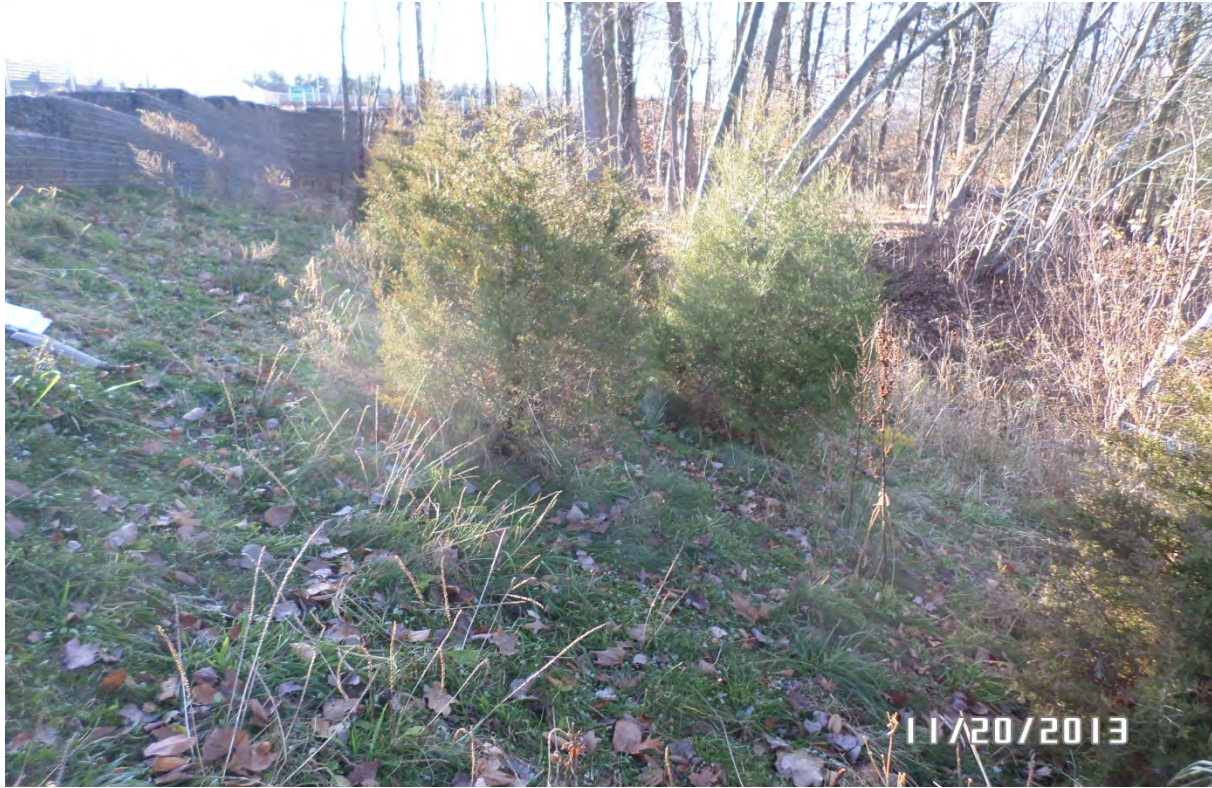
Photo 1: Red Cedar (*Juniperus virginiana*) first planting area from northern location (14 counted).

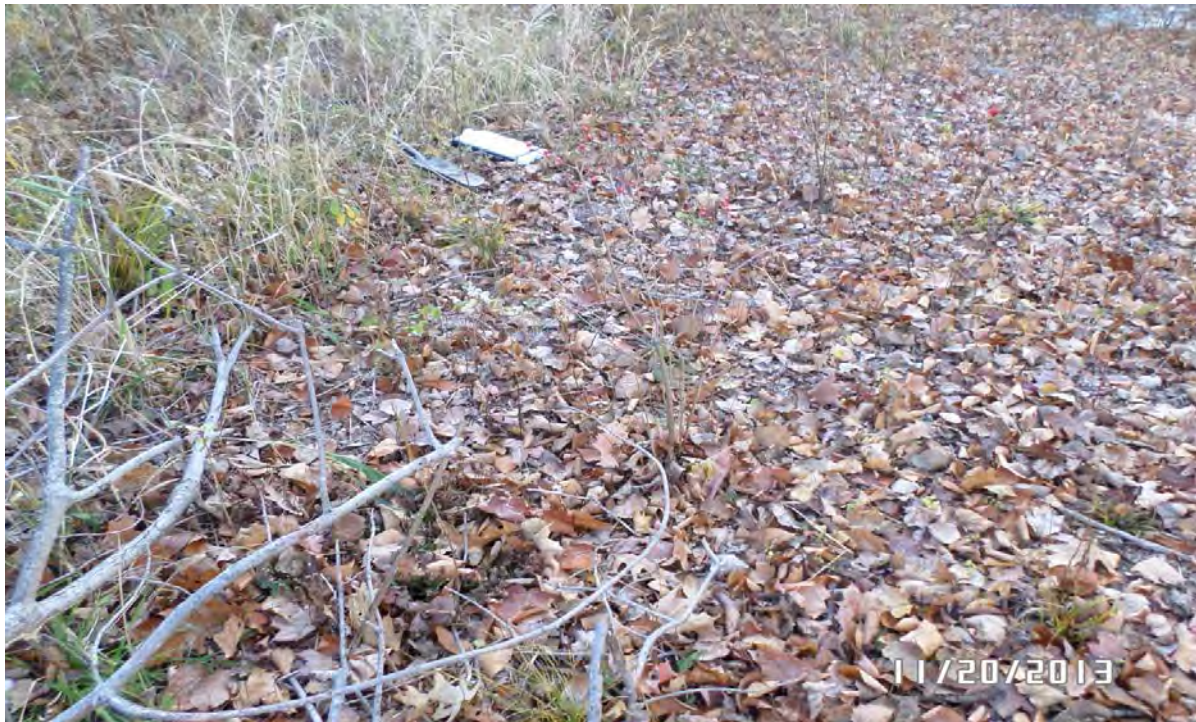
Photo 2: Winterberry Holly (*Ilex verticillata*) second plantings from northern location (7 counted). Reed Canary-Grass (*Phalaris arundinacea*) and Poison Ivy (*Toxicodendron radicans*) were identified adjacent to this area.

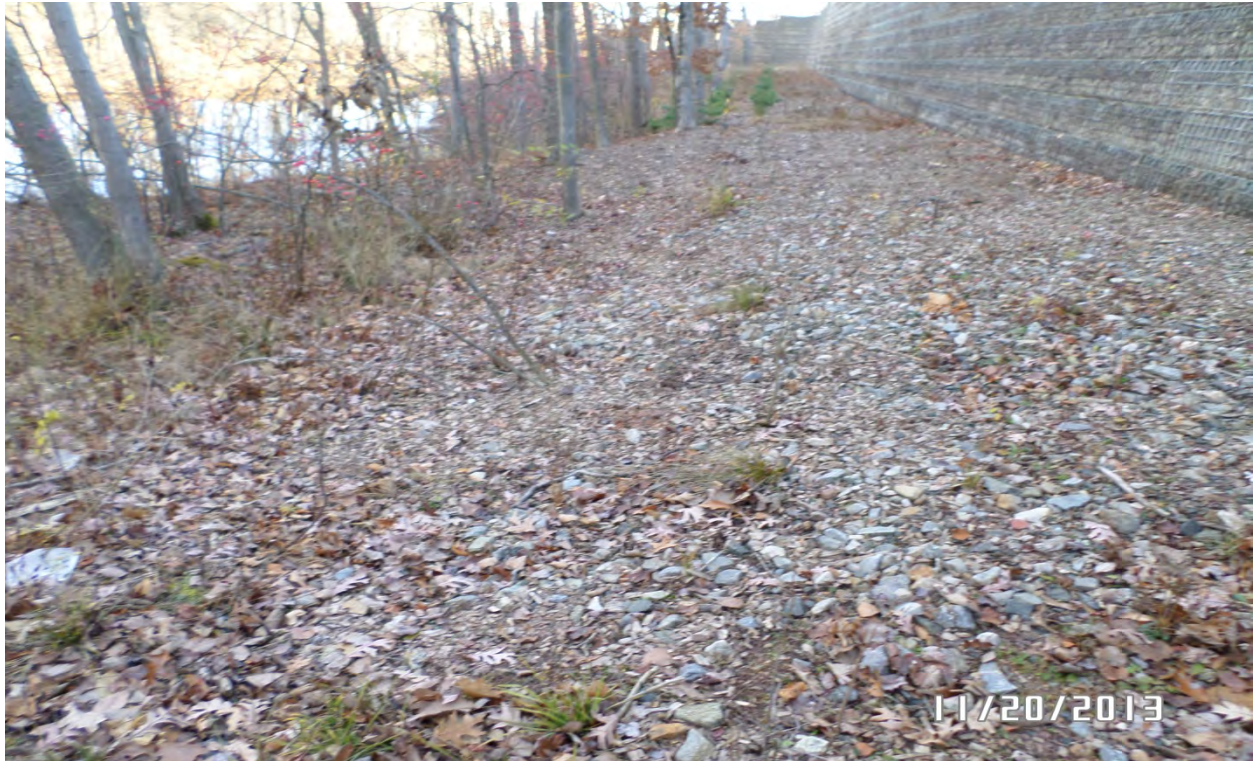
Photo 7: Winterberry Holly (*Ilex verticillata*) seventh planting area from northern location. Pre-existing holly plant seen in photo (left). Enhancement plantings are difficult to see (19 counted).

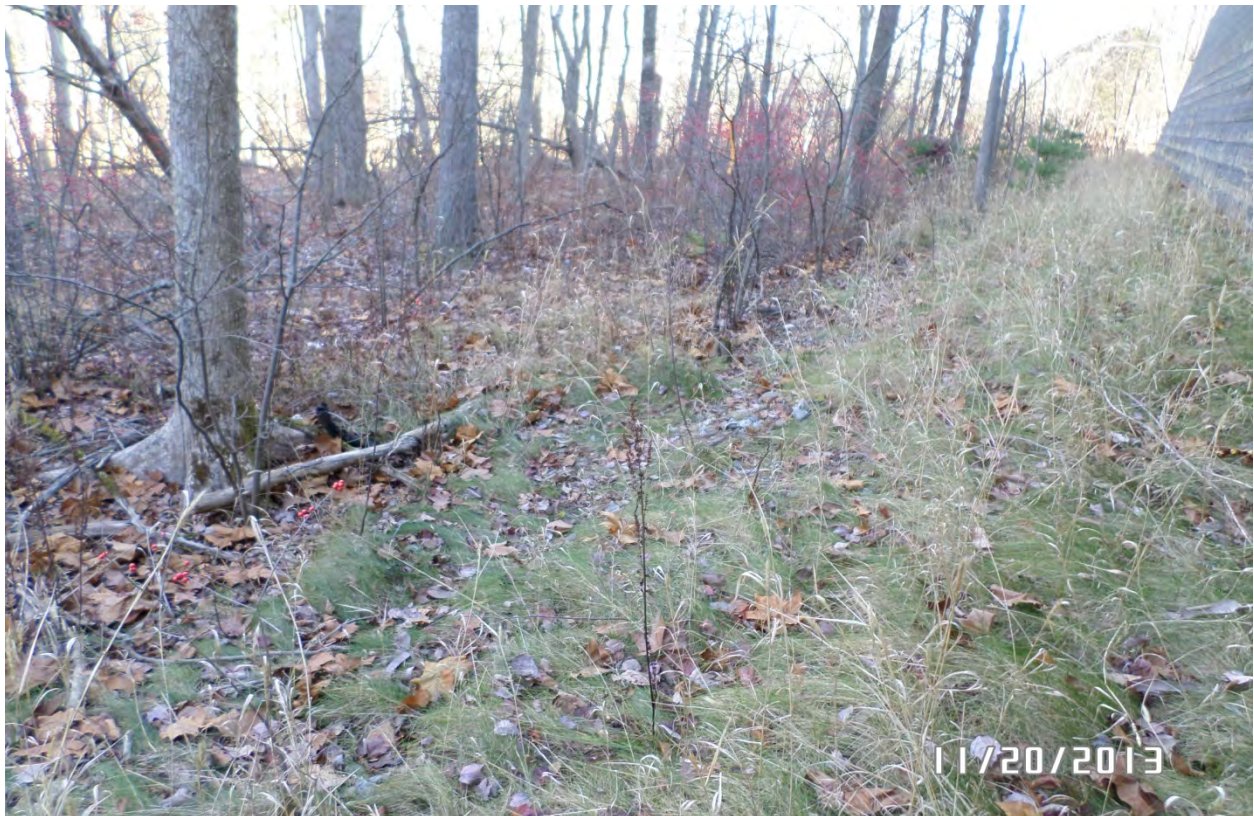
Photo 15: Winterberry Holly (*Ilex verticillata*) twelfth planting area. Planting can be seen at lower left of photo. Others are difficult to see (7 counted). Volunteer holly plants are seen in background.

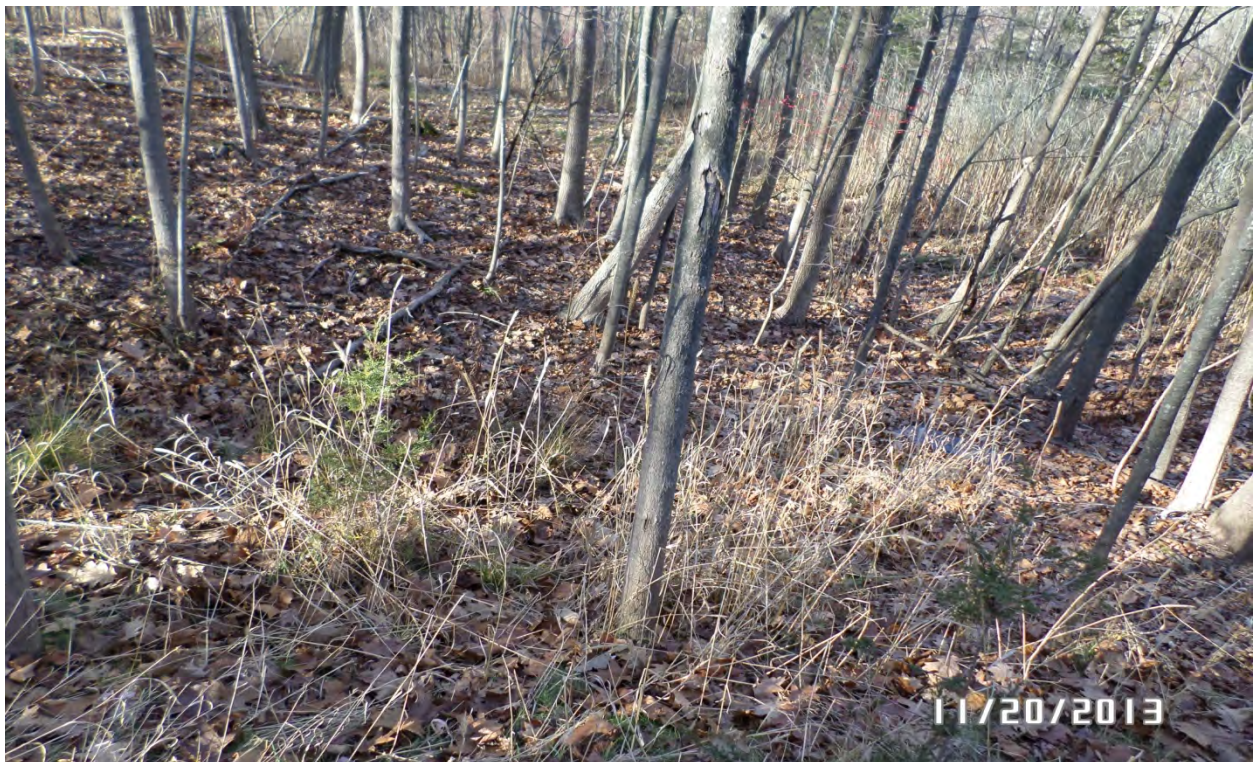
Photo 30: Red Cedar (*Juniperus virginiana*) nineteenth planting area (cont'd) from northern location. Reed Canary-Grass (*Phragmites australis*) stand is seen in the upper right of the photo.

1. Evaluate the plantings, and replace the plantings that did not survive in accordance with the planting plan (Appendix A, Figure 4).
2. Eradicate the common reed stand located to the southwest of the buffer plantings area and as indicated on the enclosed map (Appendix C, Figure 1). The stand can be seen in the photo taken at the site identified as Photo 30.
3. Eliminate the invasive species identified adjacent to the buffer plantings.
4. Continue regular monitoring to ensure removal of invasive species and survival of buffer plantings.

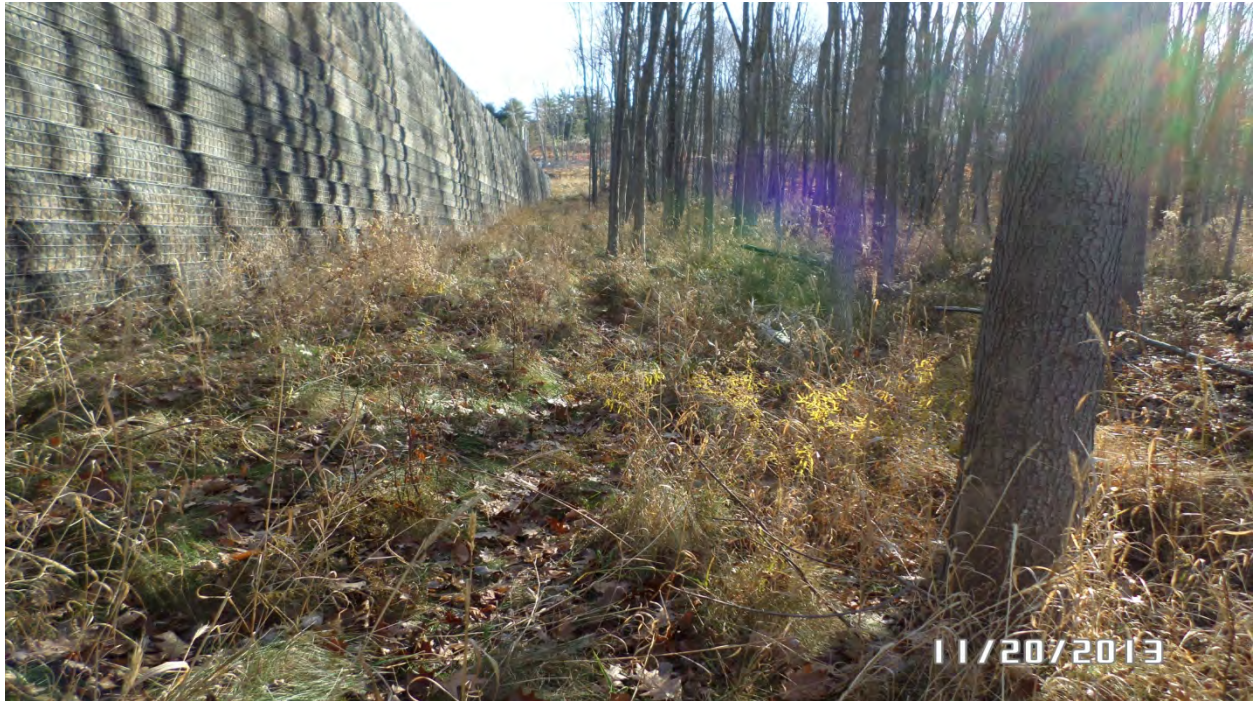
Photo 31: Sweet Pepperbush (*Clethra alnifolia*) twentieth planting area from northern location (7 counted). Plantings are very difficult to see in photo.

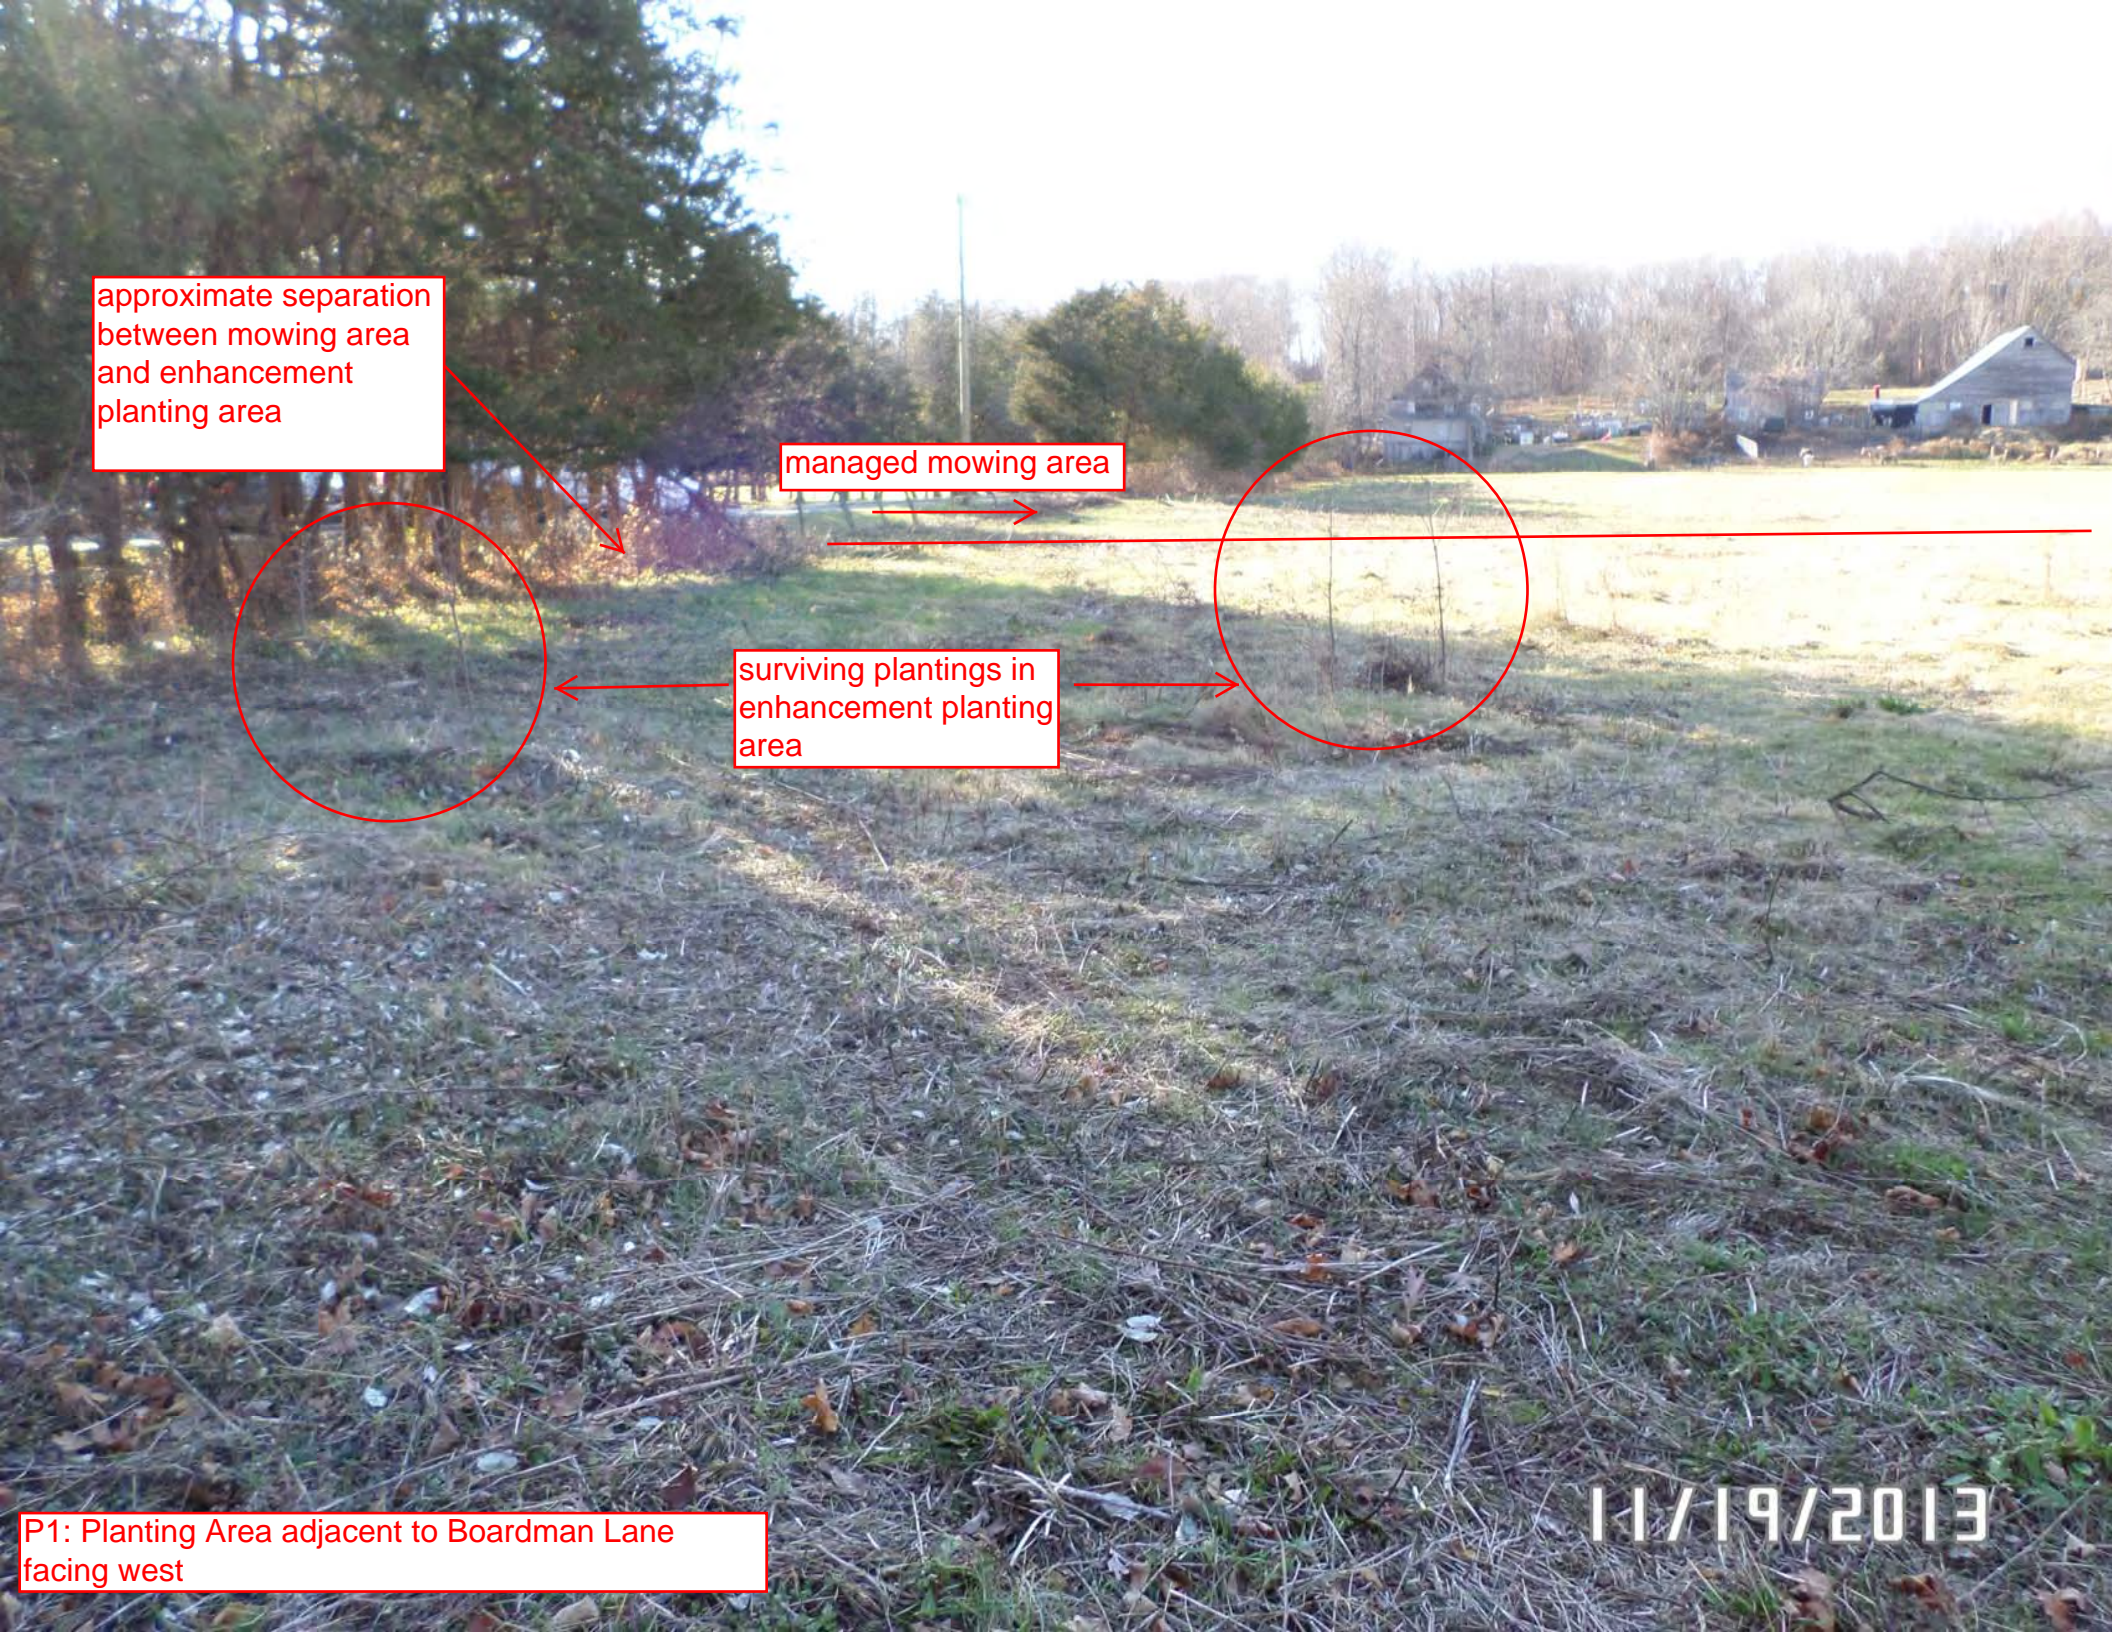
P1: Planting Area adjacent to Boardman Lane
facing west

Approximate separation between managed mowing area and enhancement planting area per the mitigation plan.

Area which is overtaken by invasive species and other species. This area is within the enhancement planting area per the mitigation plan.

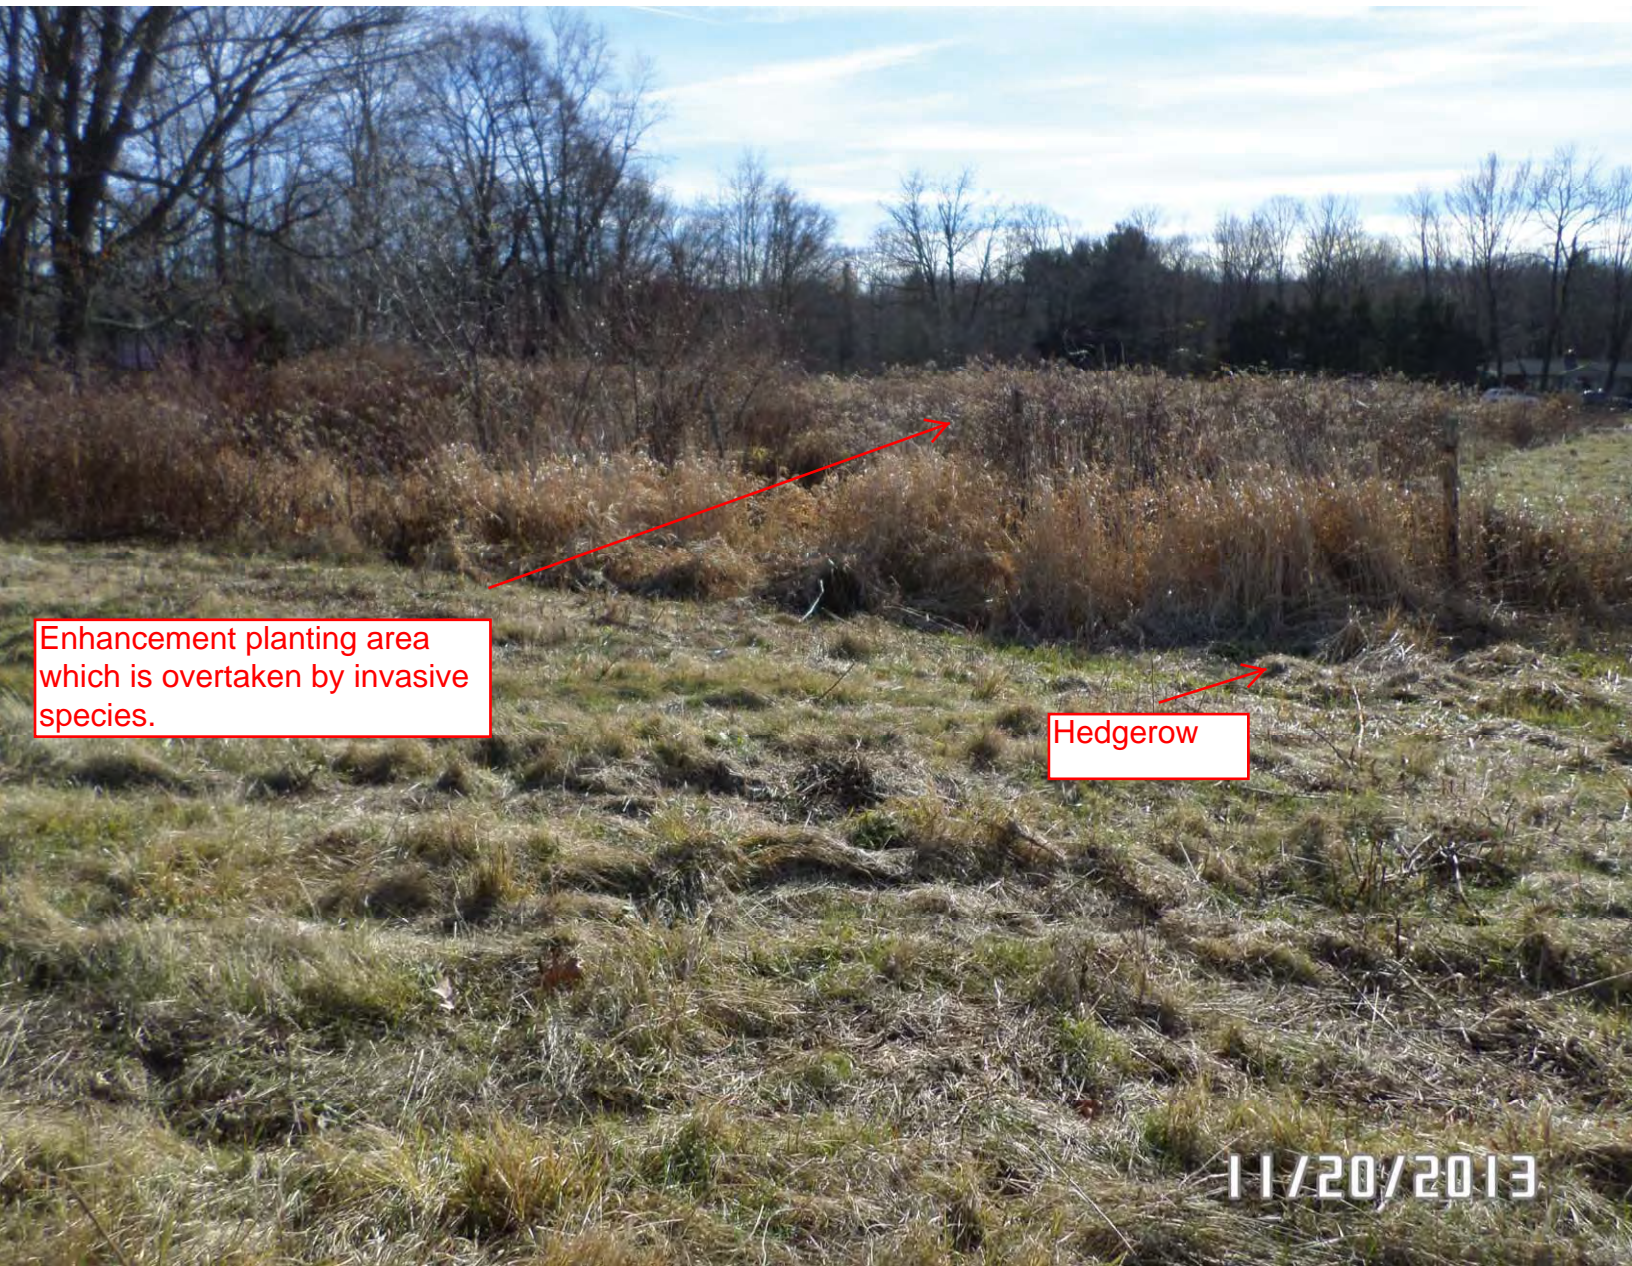
Enhancement planting area which is overtaken by invasive species.

P5: Enhancement planting area with a portion having been mowed and a portion overtaken with invasive species. Hedgerow is seen in center of photo. Photo taken facing south toward Boardman Lane.

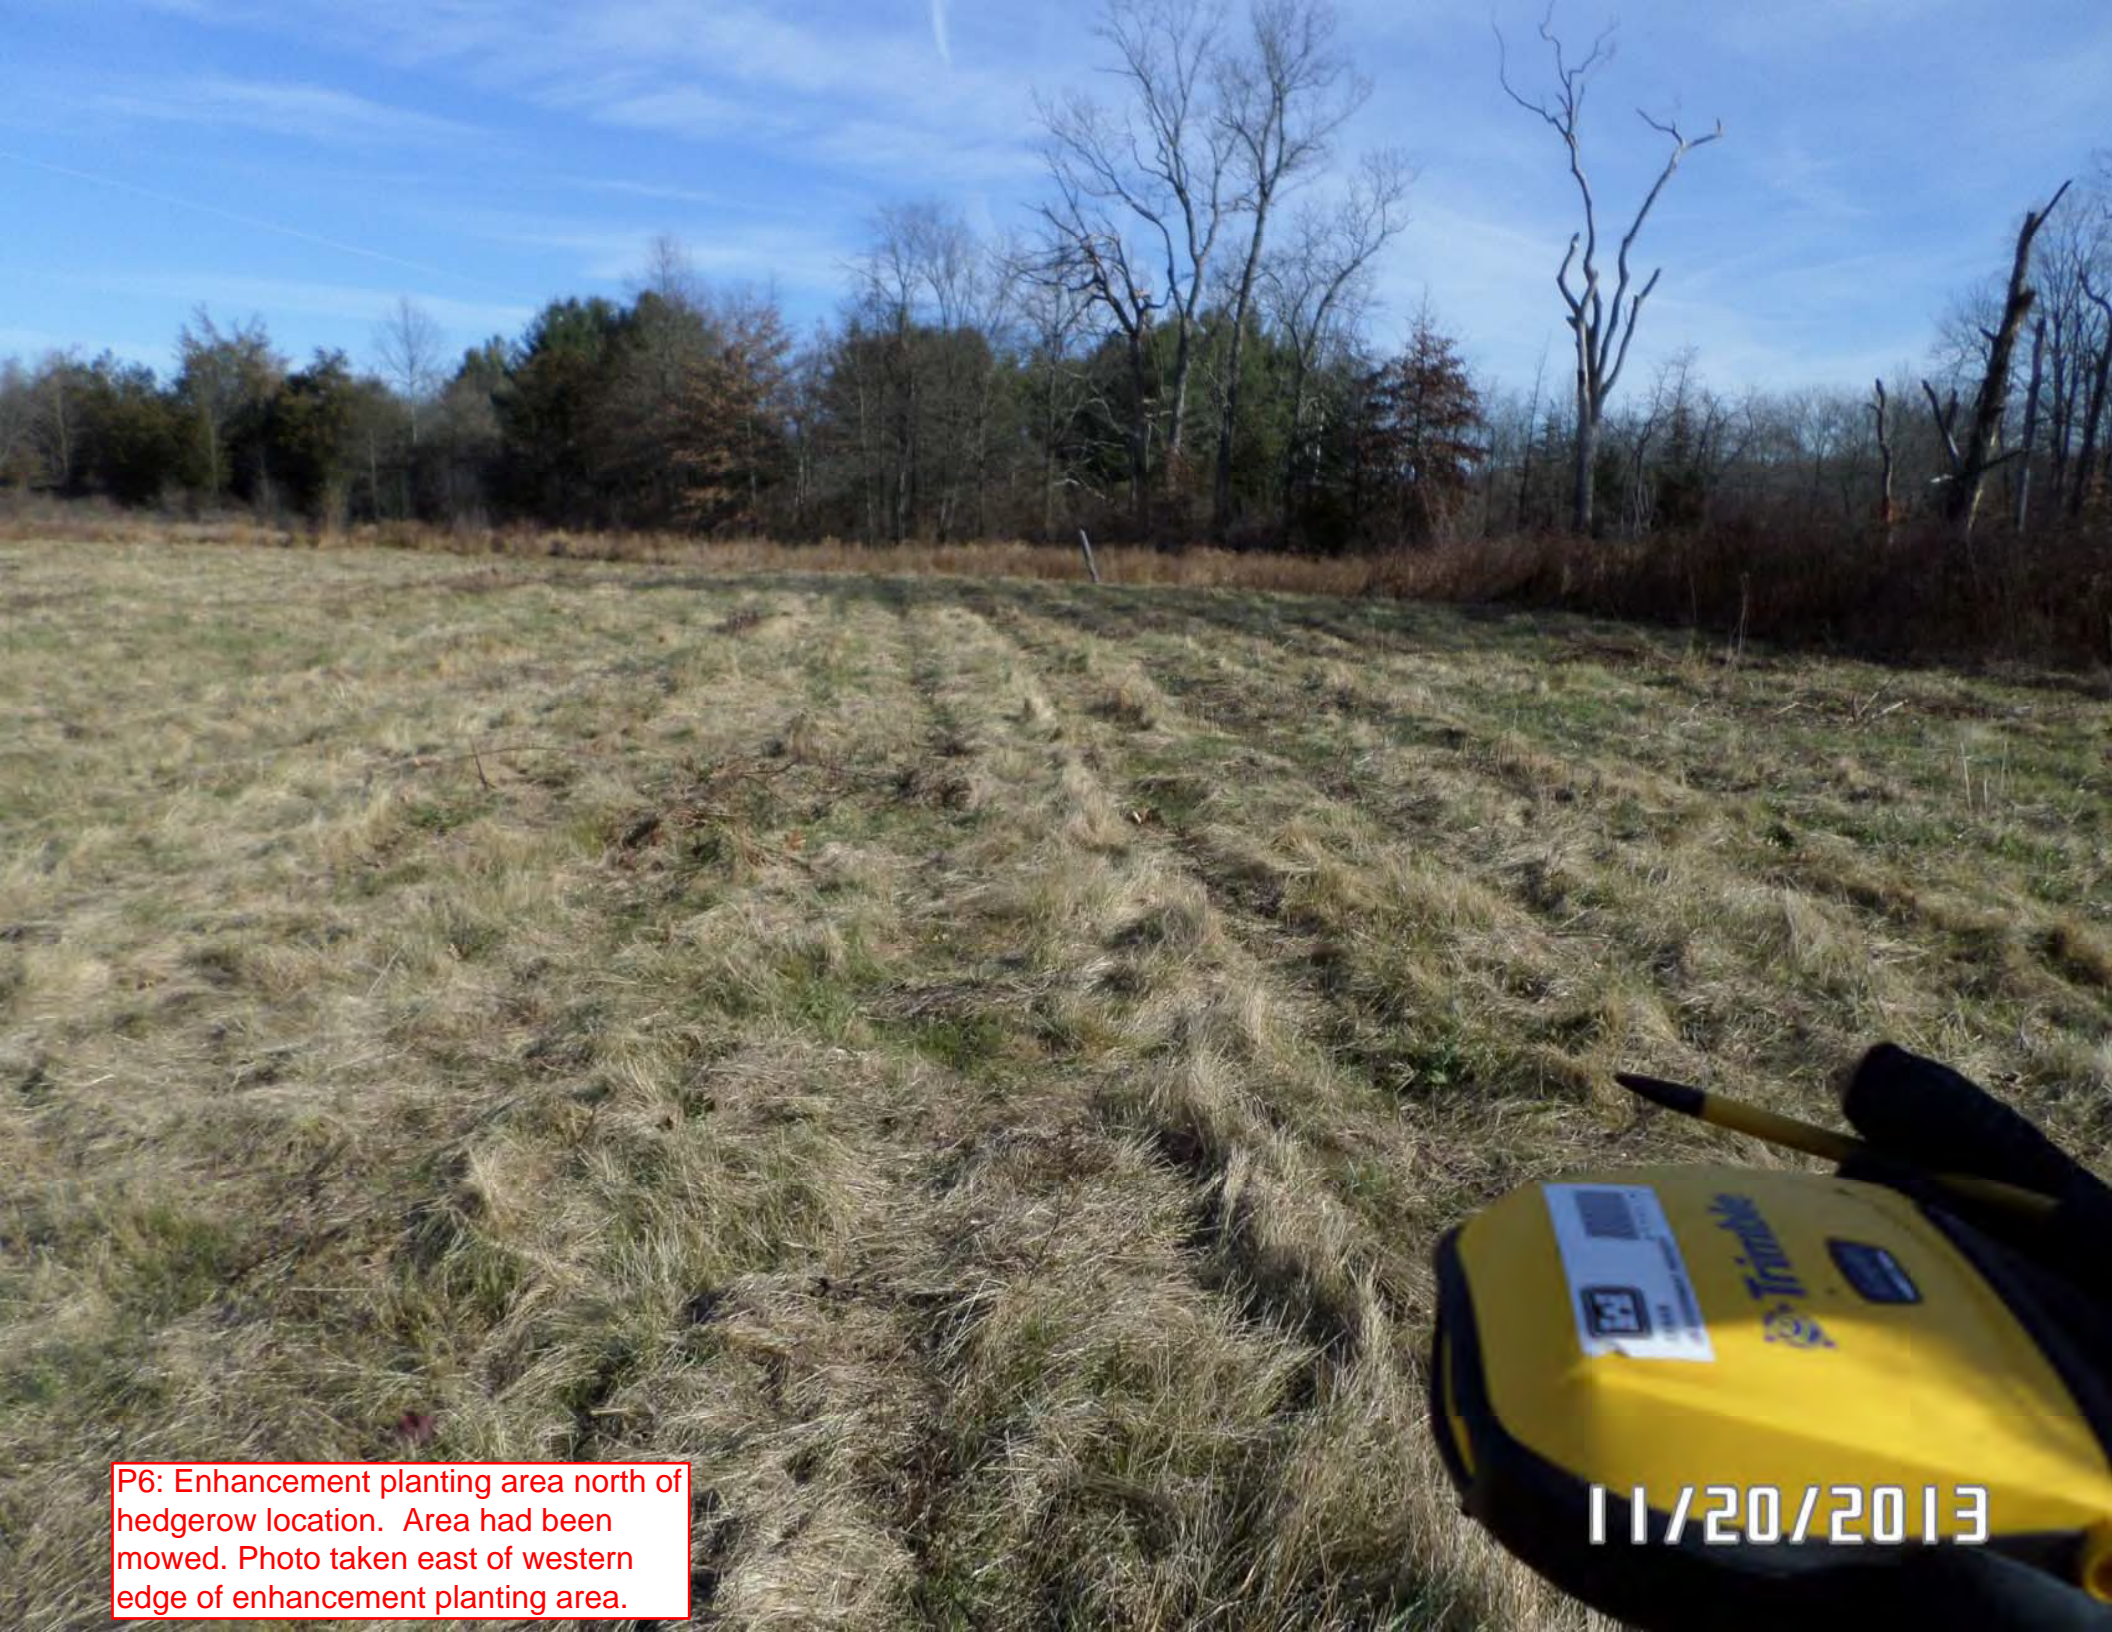
P6: Enhancement planting area north of hedgerow location. Area had been mowed. Photo taken east of western edge of enhancement planting area.

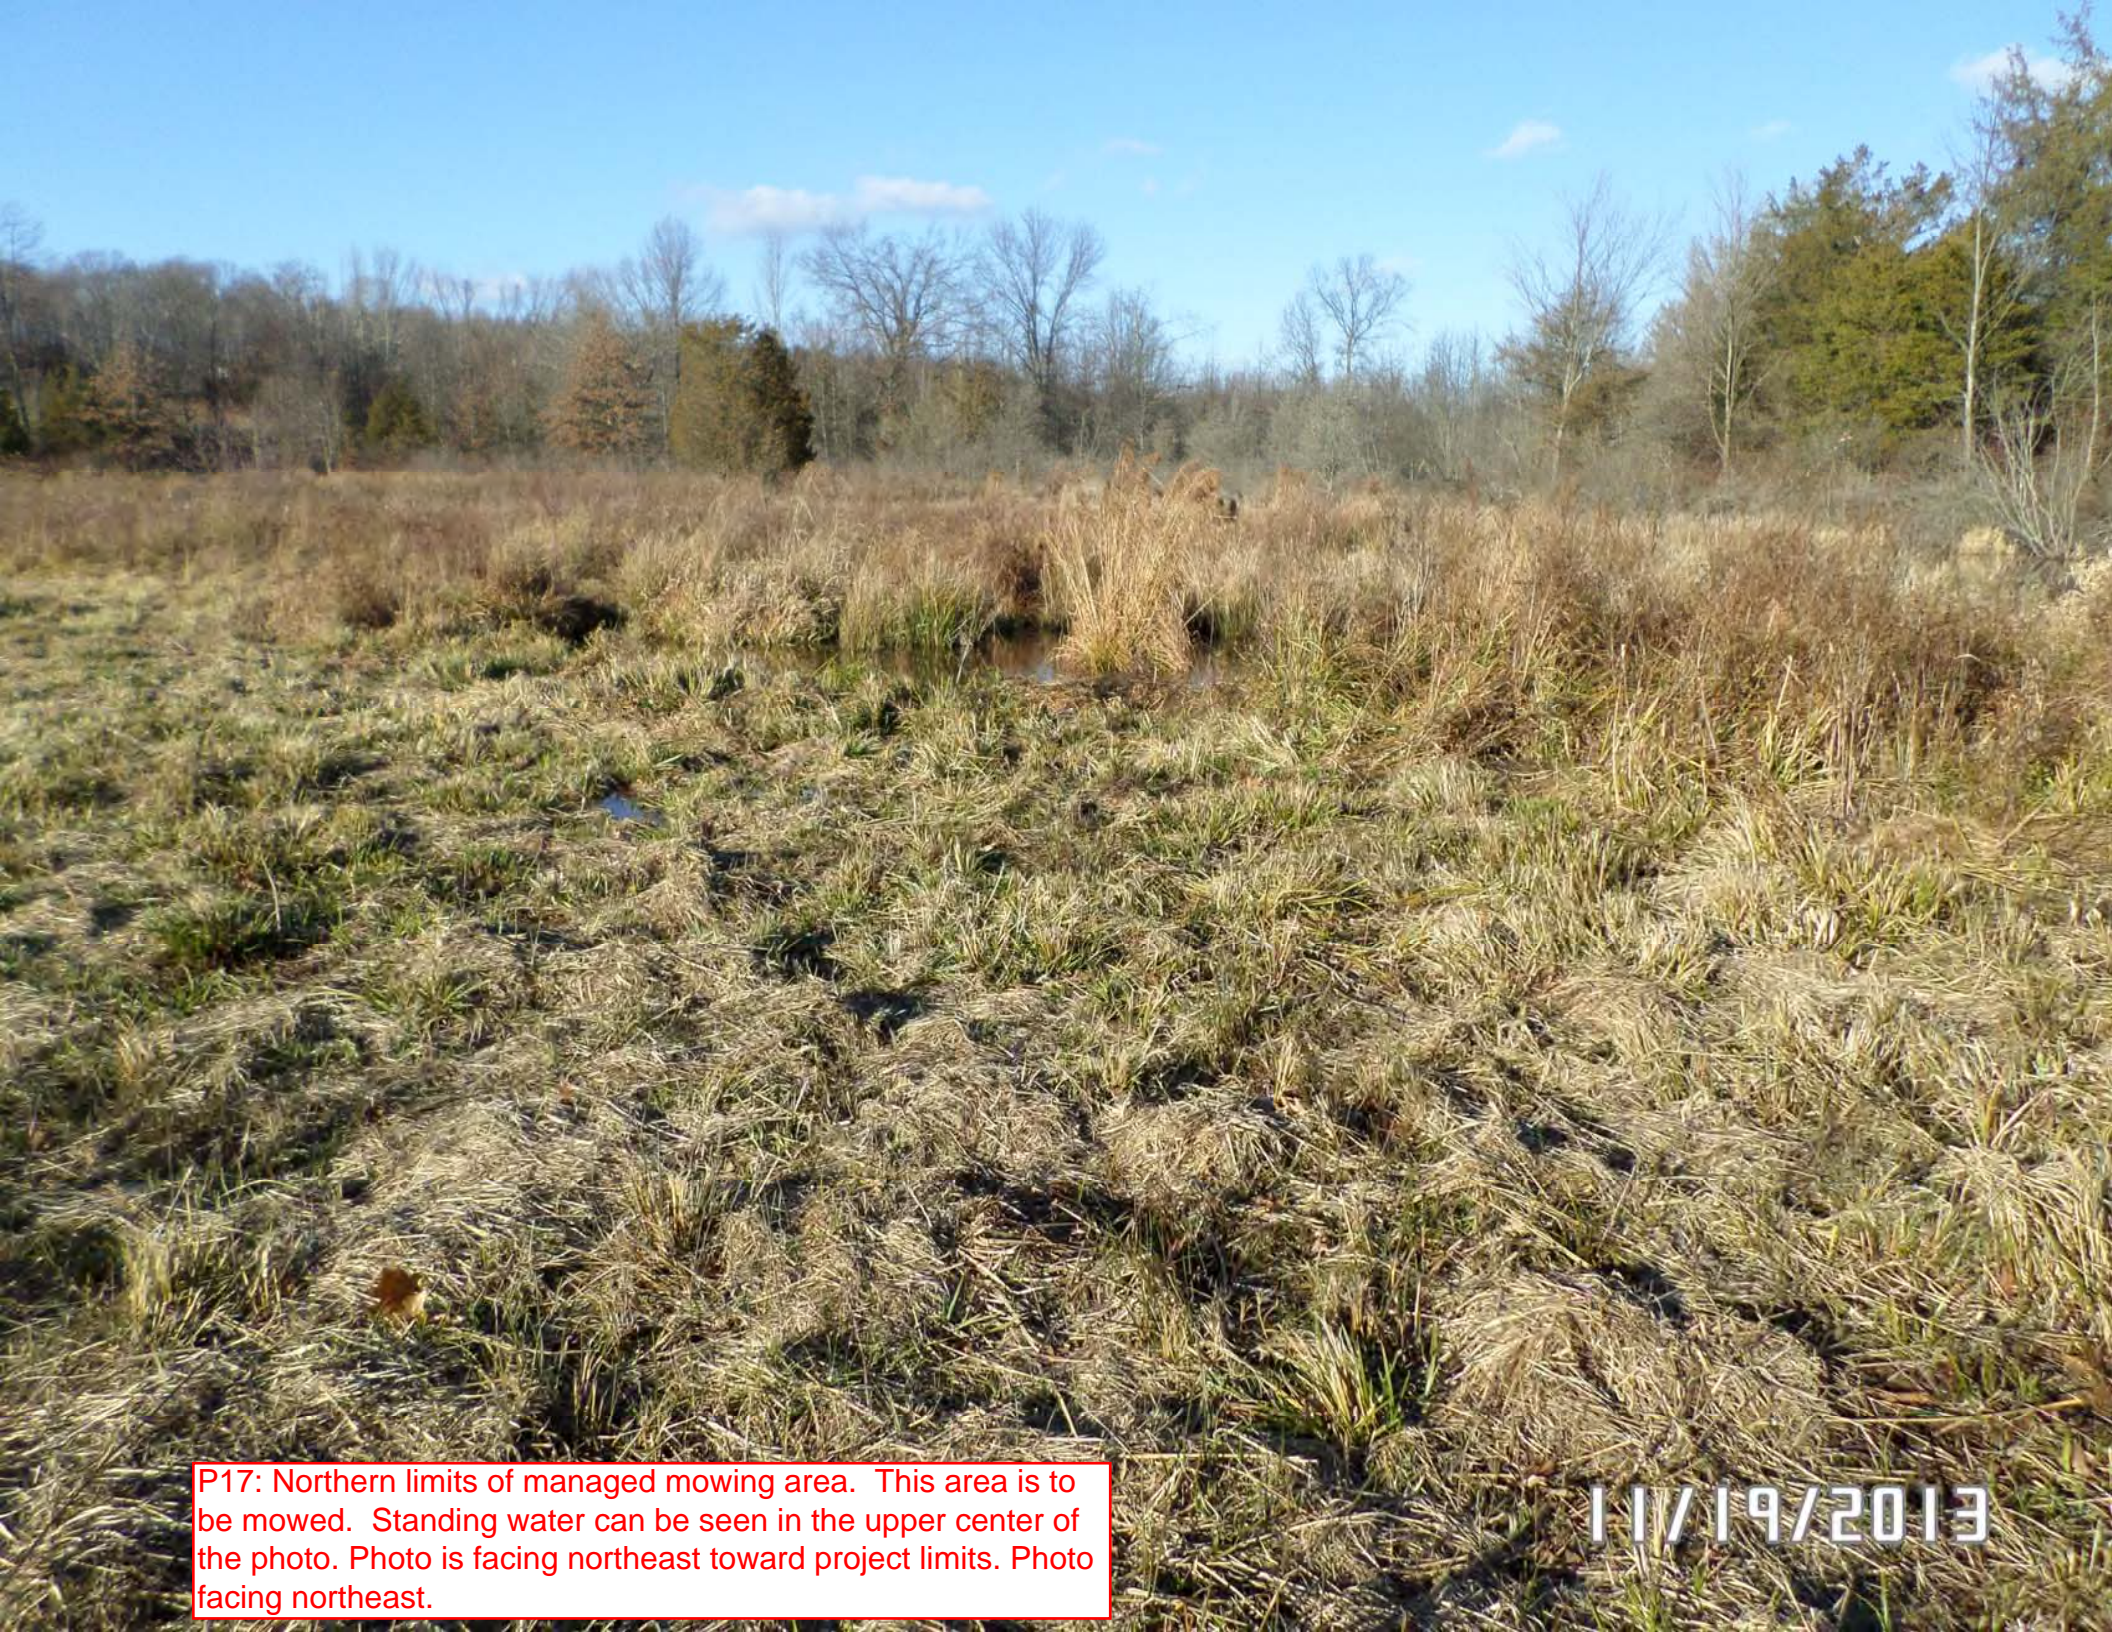
P17: Northern limits of managed mowing area. This area is to be mowed. Standing water can be seen in the upper center of the photo. Photo is facing northeast toward project limits. Photo facing northeast.

3. Evaluate the area at the northeast limit of the invasive species control and managed mowing area to determine if this area should remain unmowed due to the wet conditions or if this area should be mowed in accordance with the mitigation plan and in coordination with the New England District Corps Regulatory Branch.
4. Monitor the site on a regular basis to ensure survivability of plantings and control of invasive species.
