Mitigation Monitoring Report

Year 1-2006

**Lasell Island Dredge Project
Permit # WL-0062 Lasell Island LLC
Penobscot Bay Maine**

Compensation for Impacts to 18,800 sf of eelgrass (*Zostera marina*)

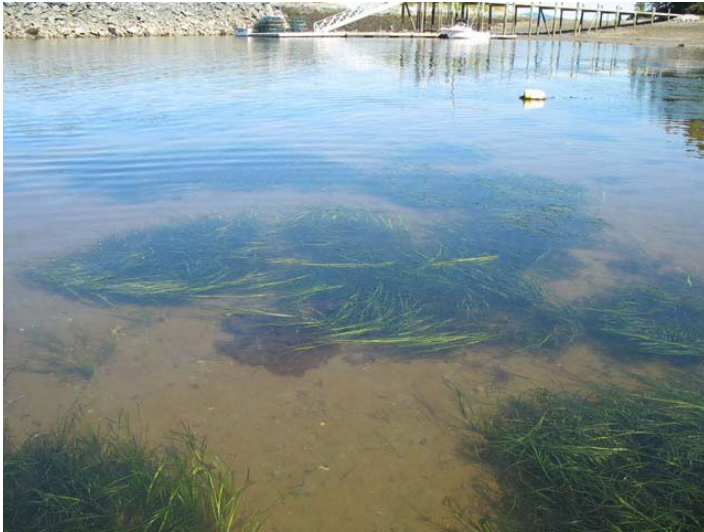
Photo 3. Eelgrass transplanted in 2005 as it appears in June 2006 outside the dredge area in a cove on Lasell Island, Penobscot Bay, Maine. PCL 6/06

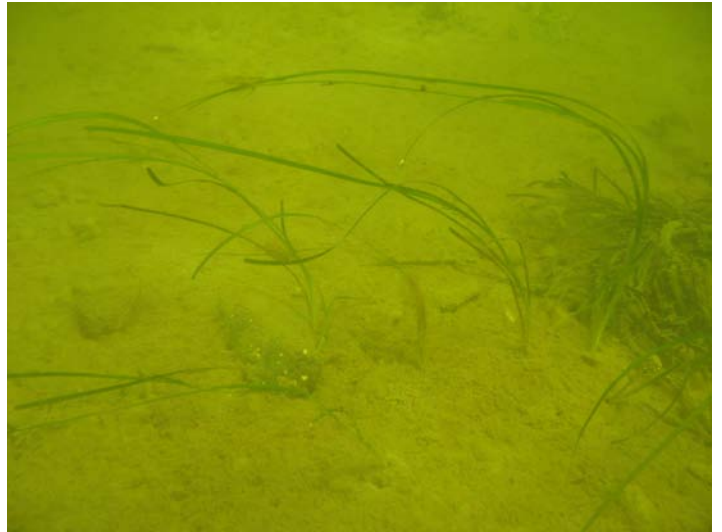
Photo 4. Example of sparse transplanted eelgrass in good condition growing within the dredge area in a cove on Lasell Island, Penobscot Bay, Maine. PCL 6/06

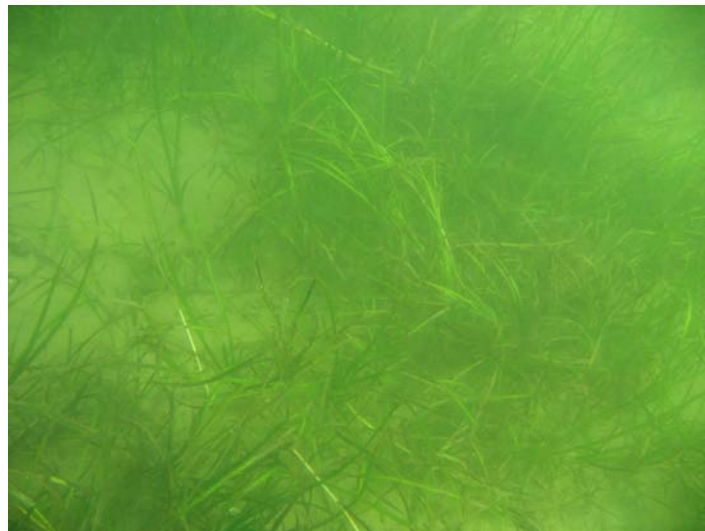
Photo 5. Example of dense transplanted eelgrass growing outside the dredge area in a cove on Lasell Island, Penobscot Bay, Maine. PCL 6/06

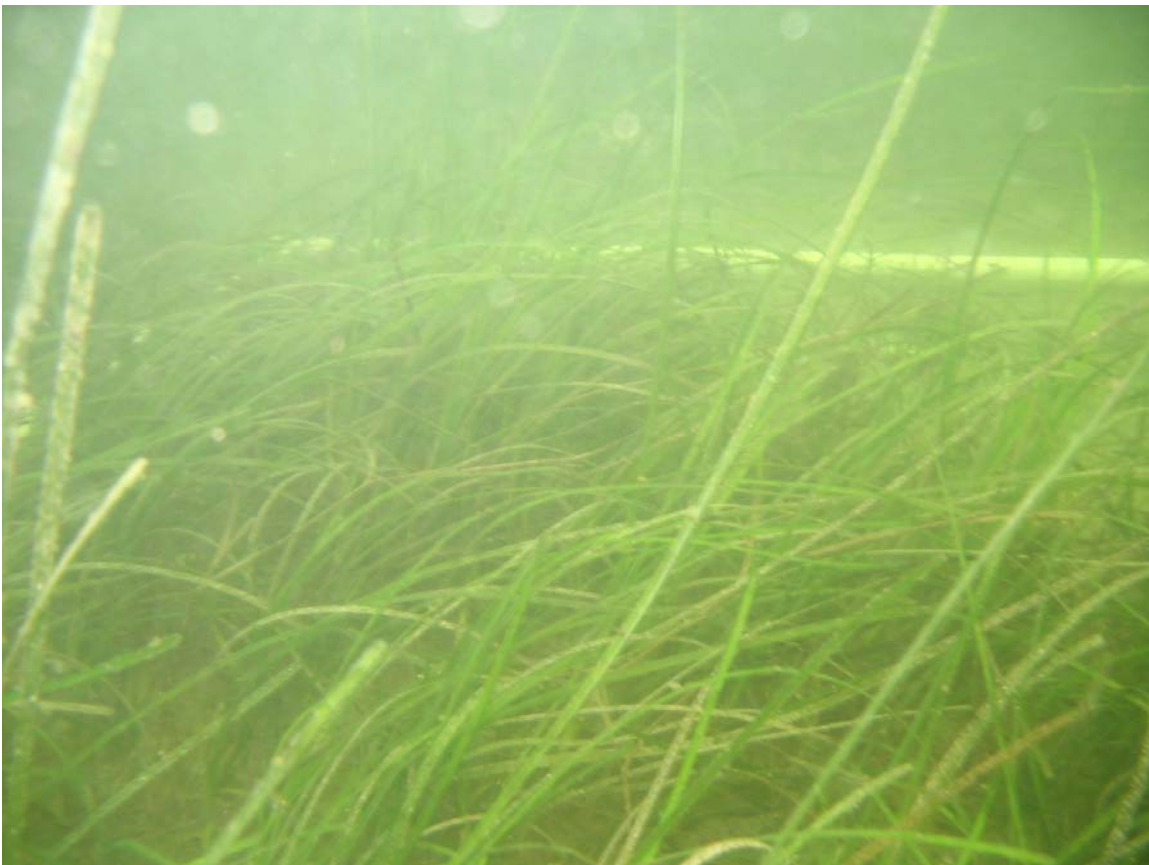
The results show that there is approximately 19,300sf of medium to high density eelgrass meadow in the cove (Figure 3). This meadow is primarily located on southern side of the cove although two small patches exist near the pier on the northern side. These are areas outside the dredge window where 40 transplant frames were placed and allowed to overwinter as well as along the southern edge of the dredge area (where approximately one-third of the original 120 frames were located). This calculated area does not include 2200sf of the original eelgrass that was not impacted by the dredging. The estimated leaf cover of the eelgrass meadow is between 40% and 100% (Photos 6).

Photo 6. Example of transplanted eelgrass cover approaching 100% outside of dredge area. PCL 10/06

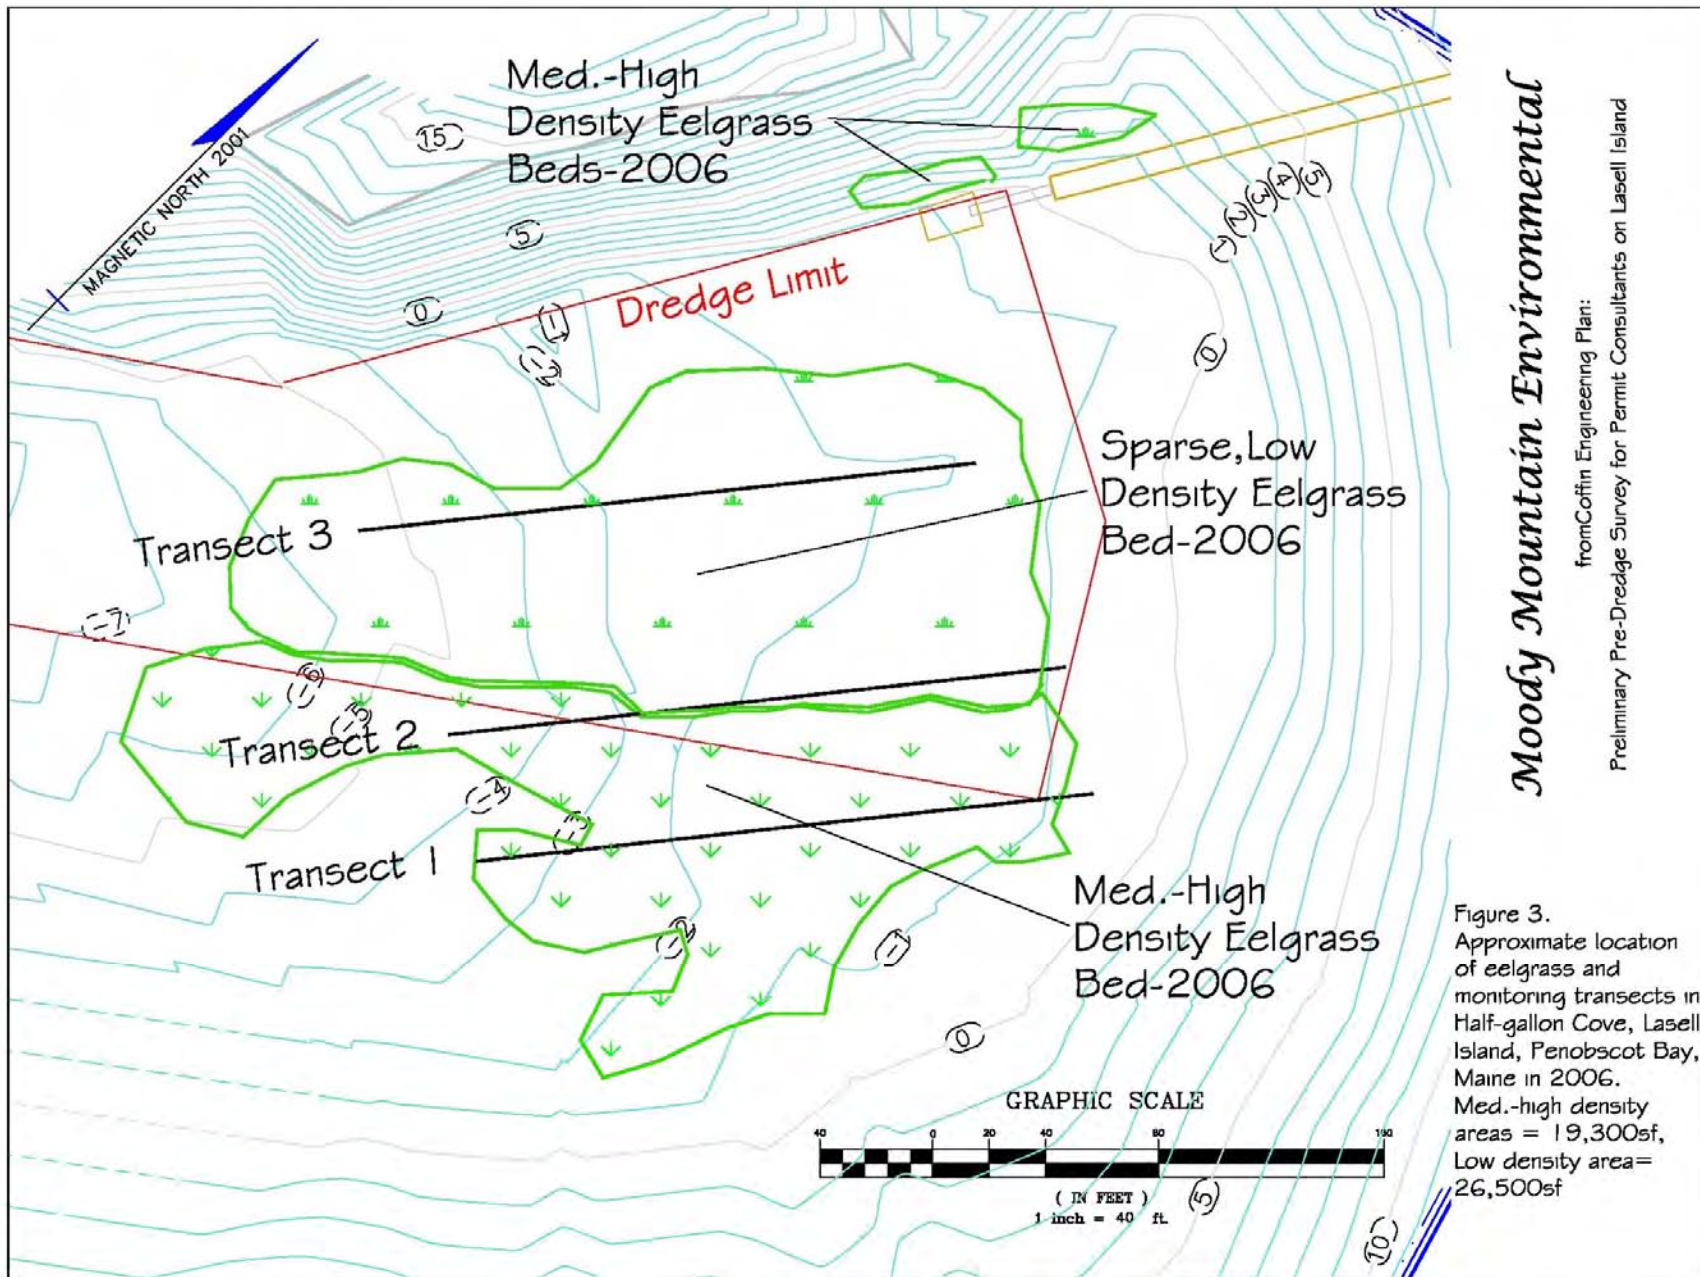
Figure 3. Approximate location of eelgrass and monitoring transects in Half-gallon Cove, Lasell Island, Penobscot Bay, Maine in 2006. Med.-high density areas = 19,300sf, Low density area = 26,500sf

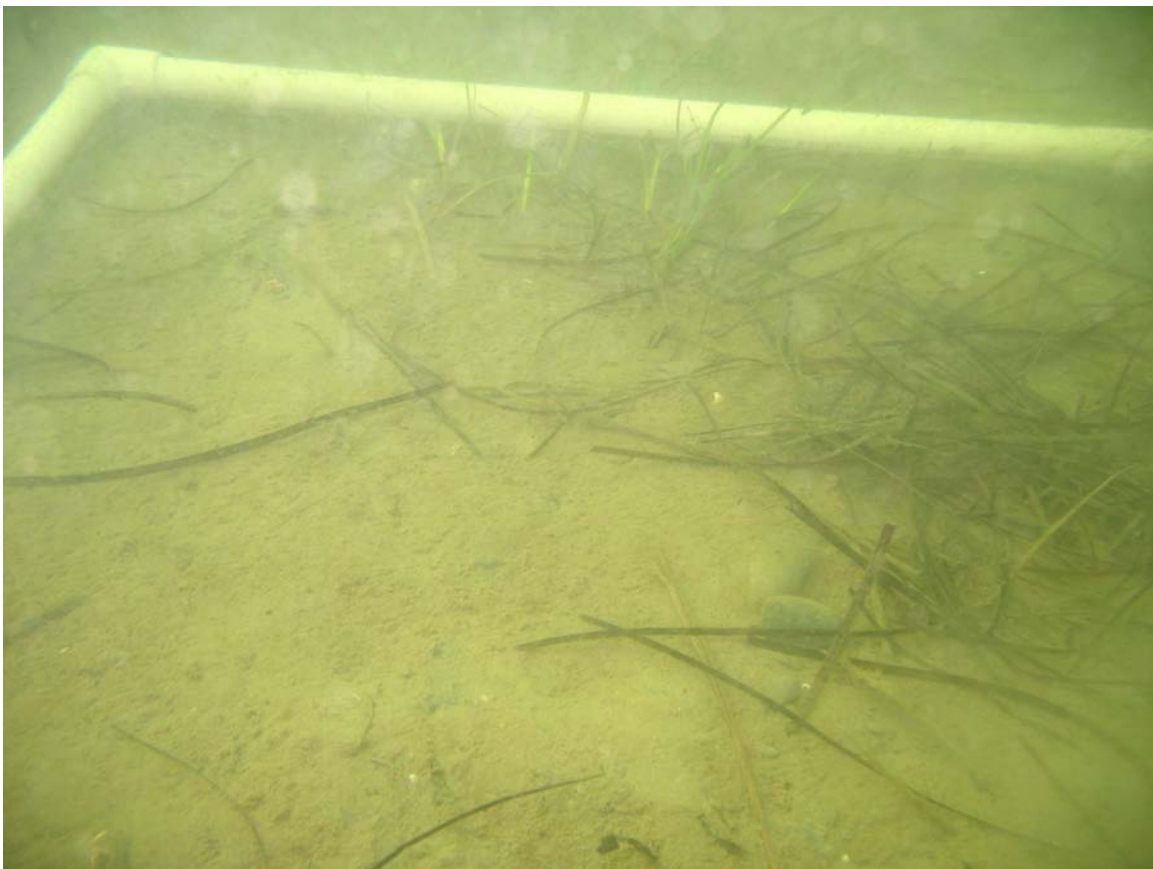
Approximately 26,500sf of the dredge footprint is also colonized with sparser density of eelgrass (Photos 7). This area has small clumps of eelgrass and individual plants. Percent leaf cover in this area was estimated between 0% and 30%. Most of the small clumps are from the TERFS plantings and the individual plants appear to be colonizing naturally. The plants appear healthy and are spreading via rhizome expansion. Table 2 shows the results of the quadrat sampling. The enclosed CD has edited video showing typical conditions along all three (3) transects.

Photo 7. Example of transplanted eelgrass cover (approx. 10%) inside the dredge area. PCL 10/06

The reasons for the greater success outside the dredge footprint are somewhat unclear. The dredge footprint area is obviously deeper than the undredged area; and the substrate in the footprint is finer (silty clay) than the original substrate. But the dredge area is shallow enough to support eelgrass (Short pers. comm.) and eelgrass is thriving on the sides of the footprint in the finer substrate. The cove does become turbid, especially during low tide and winds and waves from the south. It may be that turbidity is shading the deeper dredge footprint area to the extent that the success of eelgrass transplants is reduced.
