POST DREDGE EEL GRASS MONITORING REPORT #3

The Moorings Breakwater Trust (MBT) completed (end of November 2007) maintenance dredging activities of marine sediment from an area of approximately 16,630 square feet from its mooring basin and slips in Sippican Harbor at Converse Point in Marion, Massachusetts. This monitoring report has been submitted in compliance with the conditions of the US Army Corps of Engineers Permit, NAE2005-257 specifically the "Eelgrass Monitoring & Mitigation Plan". In order to document the effects of dredging, or lack thereof, the eelgrass bed adjacent to the mooring basin was surveyed prior to dredging, within 10 days of completion of the dredging and to date, three times during the subsequent growing season. This report is the fourth and final post dredge eel grass monitoring report.

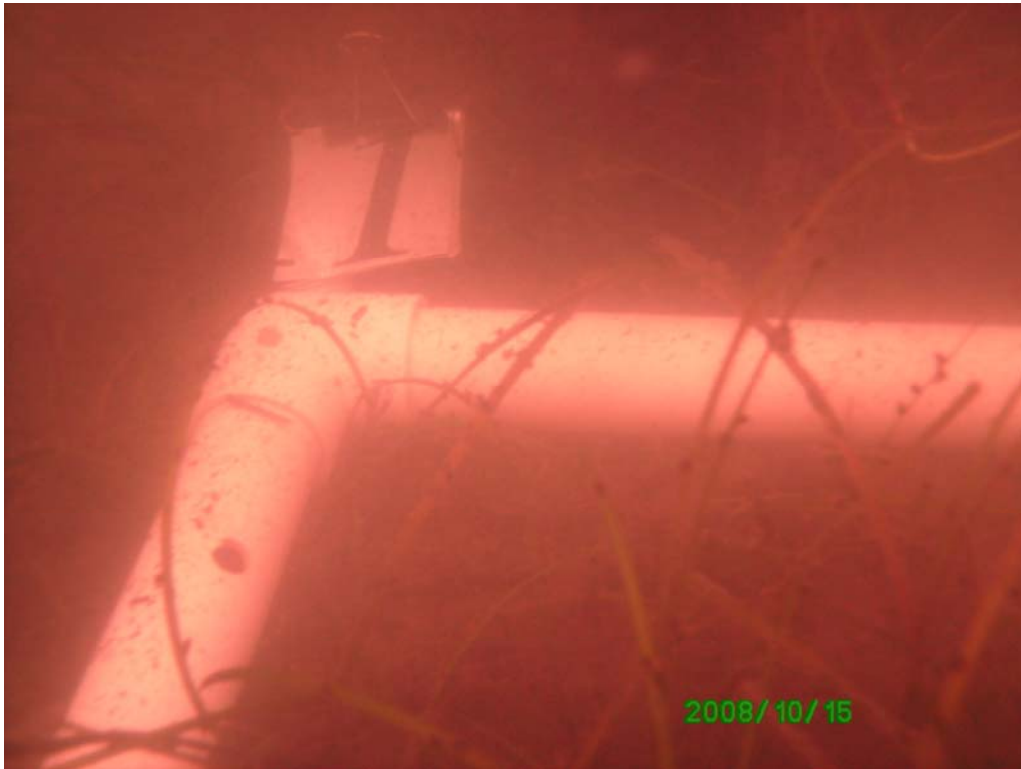
M 1 on 10/15/08 Monitoring Survey 4

Date	Stem Density #/s.f.	Length inches	Relative Turbidity	% coverage epiphytes
9/13/07	25	18	Low	NR
12/06/07	12	12	High	50%
06/20/08	30	28	Moderate	20%
08/01/08	40	20	Low	<5% *
10/15/08	10	18	Low	75%

* 10% of surface at Plot M 1 was covered with green filamentous algae, all plots exhibited barnacle growth on eel grass stems.

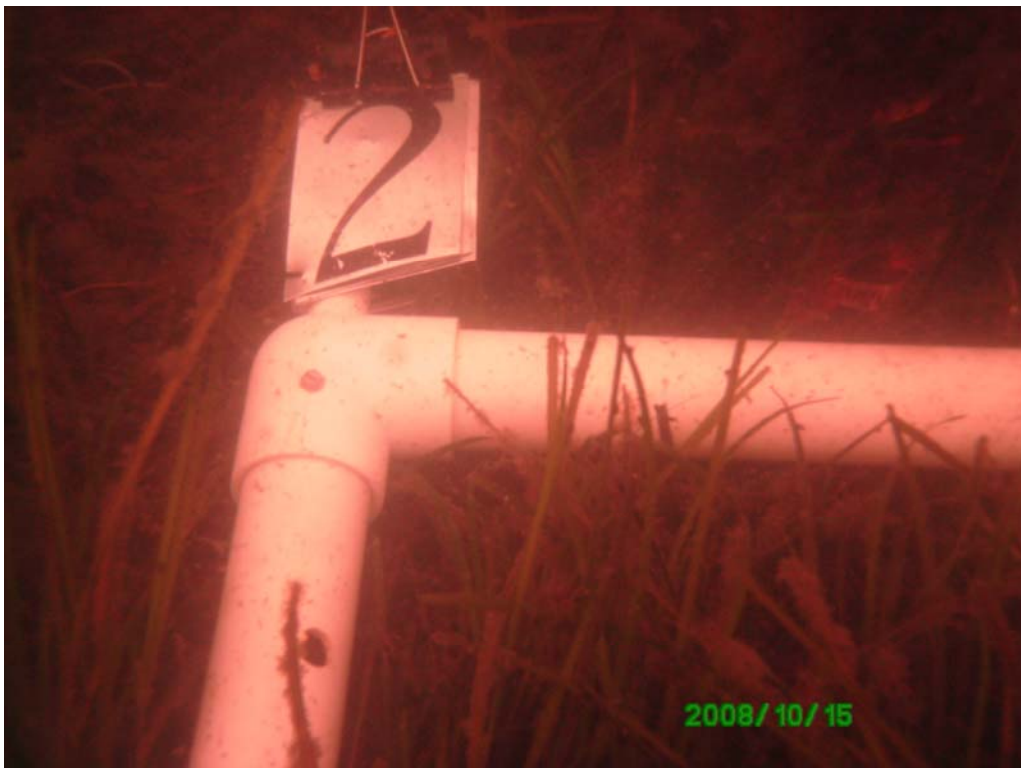
M 2 on 10/15/08 Monitoring Survey 4

Date	Stem Density #/s.f.	Length inches	Relative Turbidity	% coverage epiphytes
9/13/07	25	16	Low	NR
12/06/07	12	10	Low	75%
06/20/08	30	18	Low	0%
08/01/08	25	26	Low	0%
10/15/08	25	12	Low	75%

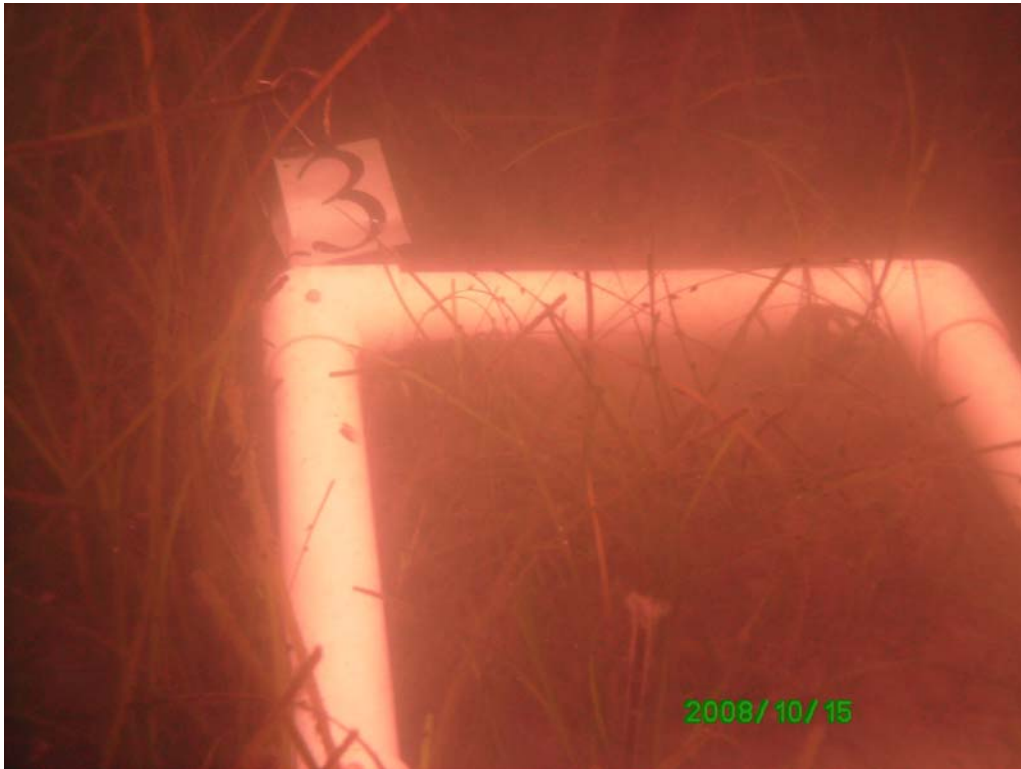
M 3 on 10/15/08 Monitoring Survey 4

Date	Stem Density #/s.f.	Length inches	Relative Turbidity	% coverage epiphytes
9/13/07	16	16	Low	NR
12/06/07	10	10	Low	30%
06/20/08	30	22	Low	20%
08/01/08	16	26	Moderate	0%
10/15/08	36	18	Low	25%

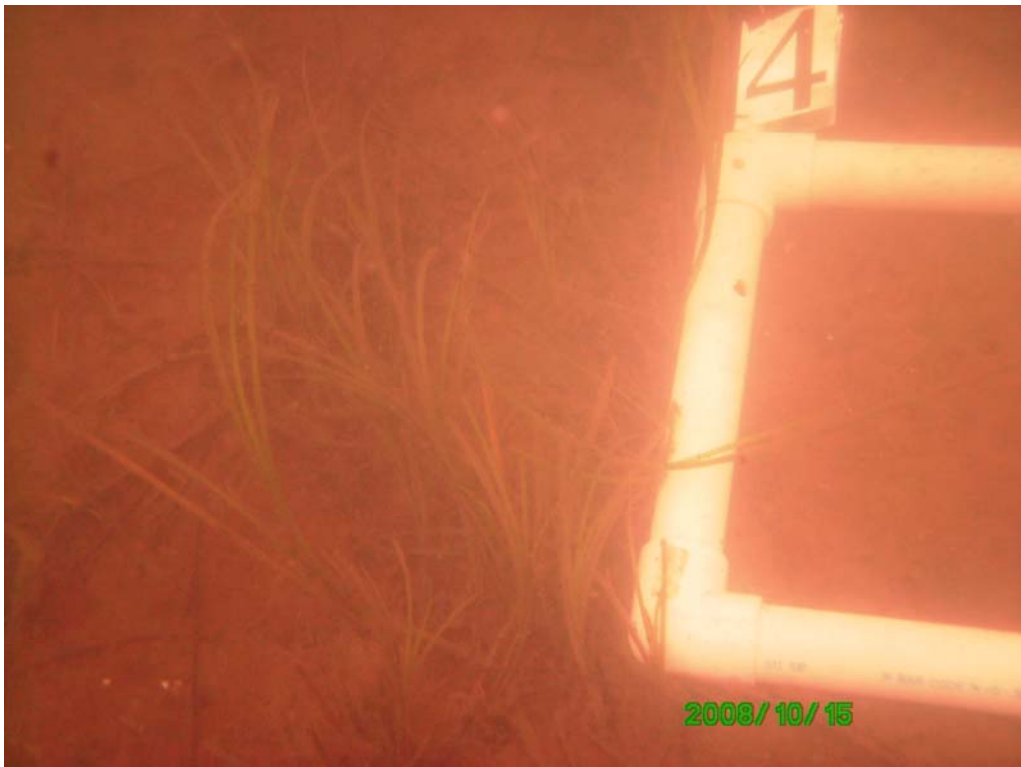
M 4 on 10/15/08 Post Dredge Survey 4

Date	Stem Density #/s.f.	Length inches	Relative Turbidity	% coverage epiphytes
9/13/07	20	24	Low	NR
12/06/07	4	12	High	50%
06/20/08	4	20	High	10%
08/01/08	6 (~ 20 w/in 1' of sample location)	28	Moderate	0%
10/15/08	16	13	Low	75%

¹ Within one foot of location M4, the stem density increased to 20 stems per square foot. The edge of a very dense bed of eel grass bed was noted 8' to the north of M 4 on 10/15/08
