# Monitoring Survey at the Rhode Island Sound Disposal Site, October 2021

## Disposal Area Monitoring System - DAMOS

Contribution 215  
January 2023

CONTRIBUTION #215

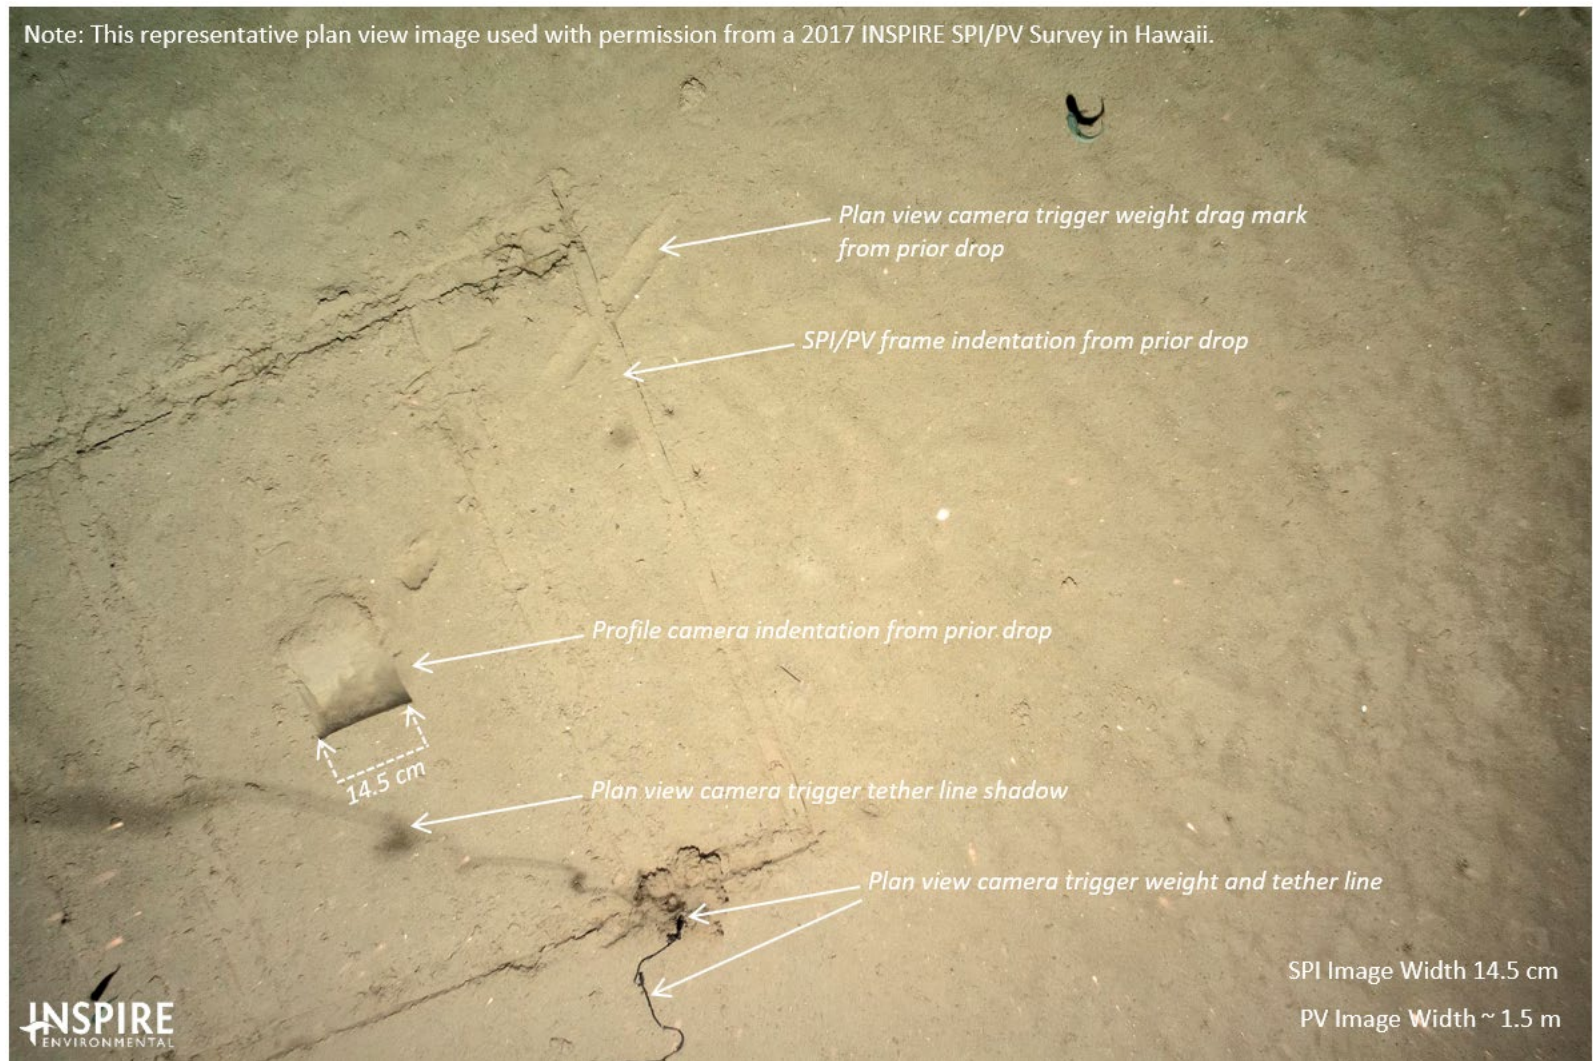
Figure 2-5. This representative plan view image shows the sampling relationship between plan view and sediment profile images. Note: plan view images differ between surveys and stations and the area covered by each plan view image may vary slightly between images and stations.

The PV images provided a much larger field of view than the SPI images and provided valuable information about the landscape ecology and sediment topography in the area where the pinpoint “optical core” of the sediment profile was taken (Figure 2-5). If coastal bivalve shells were observed in the PV imagery of the short-dump survey area, the data could be corroborated with evidence of potential dredged material in the sediment column detected in SPI imagery.

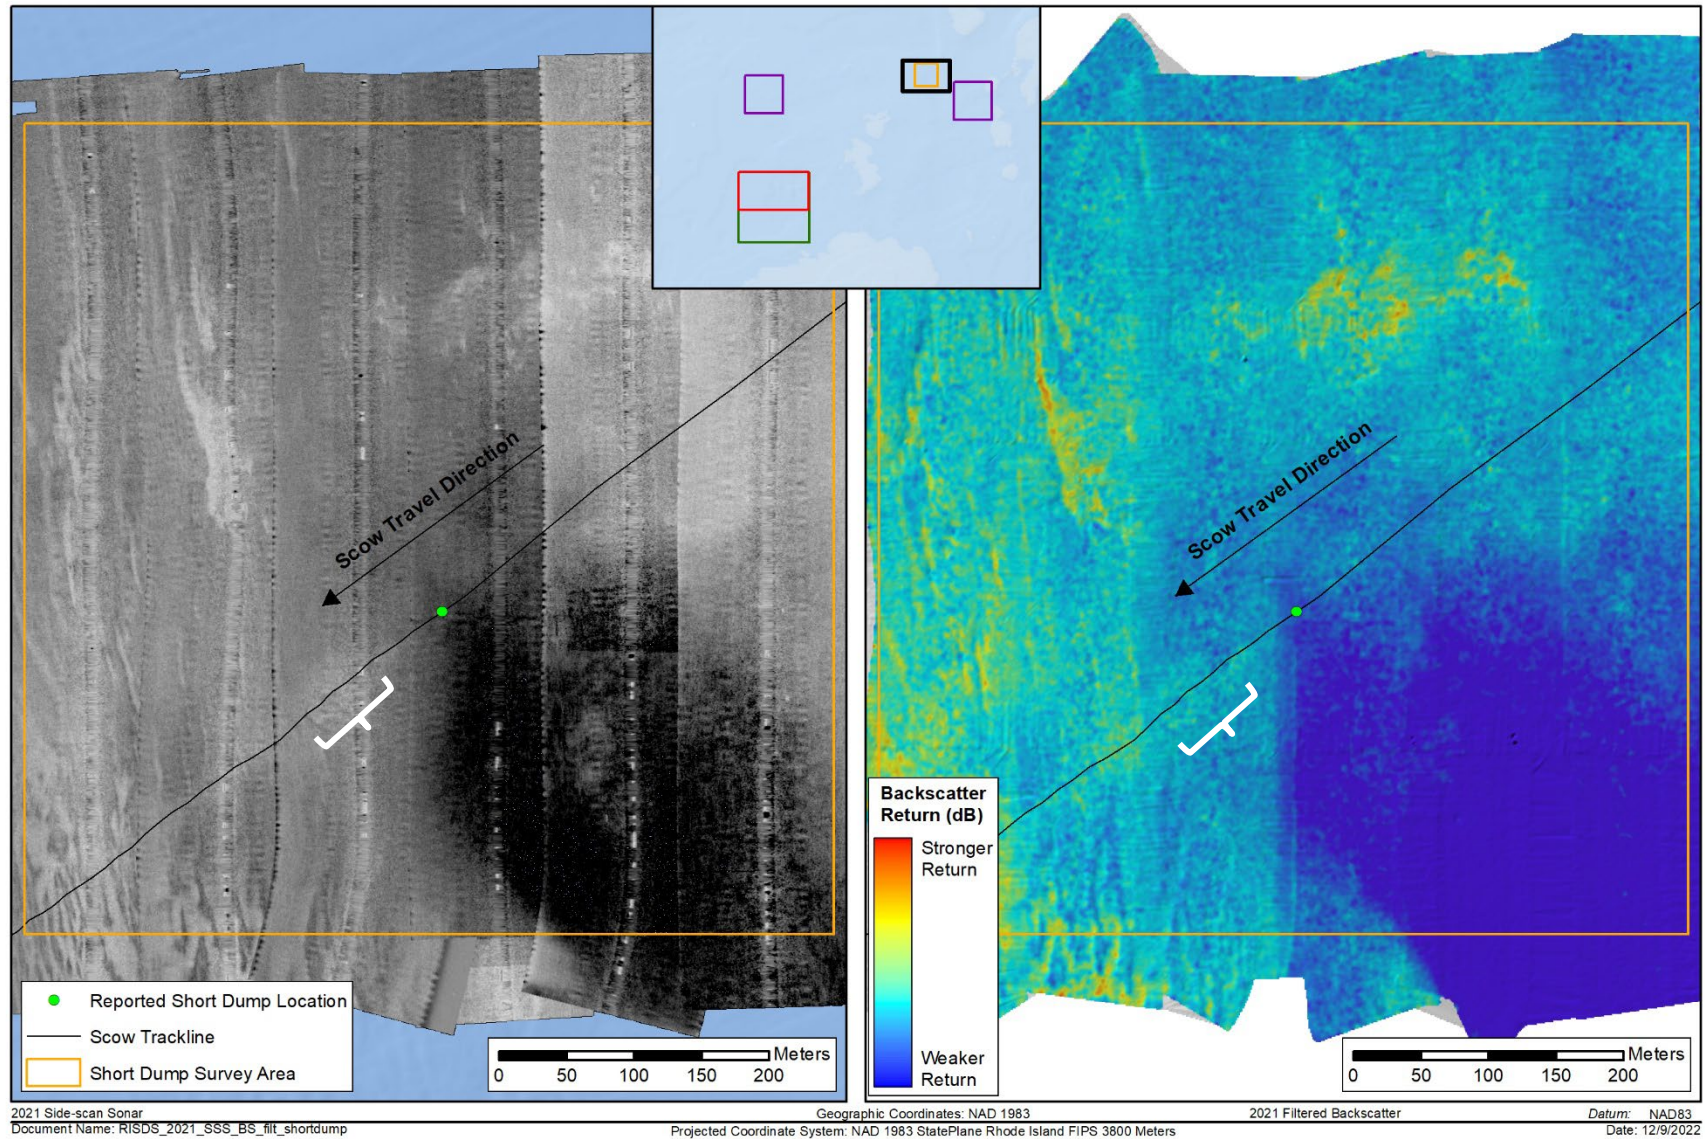
approximately 150 m x 50 m was observed to the west of the trough and was considered a potential signature of the short-dump placement event during preliminary, field analyses of the backscatter and side-scan sonar mosaics (Figure 3-12).

Figure 3-12. Side-scan sonar mosaic (left) and filtered backscatter over acoustic hillshaded relief (right) of the short-dump survey area - Oct 2021. Area of anomaly (possible dredged material signature) indicated by bracket.

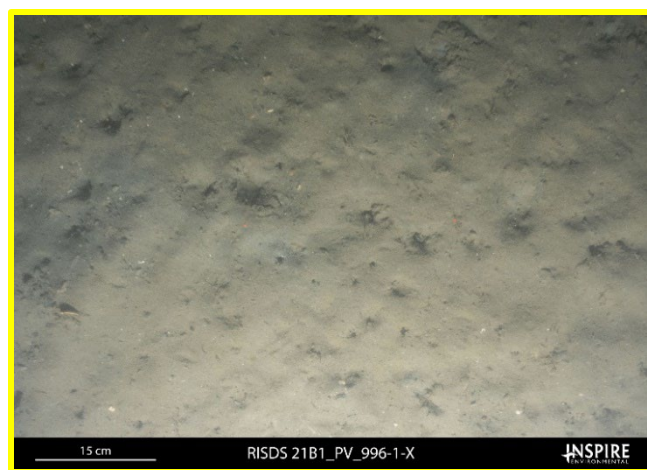
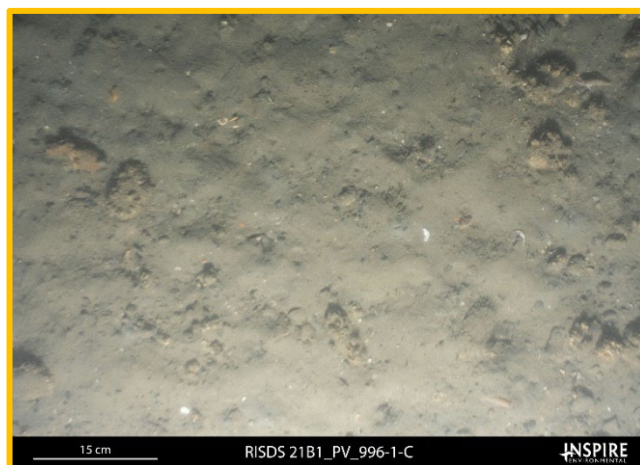
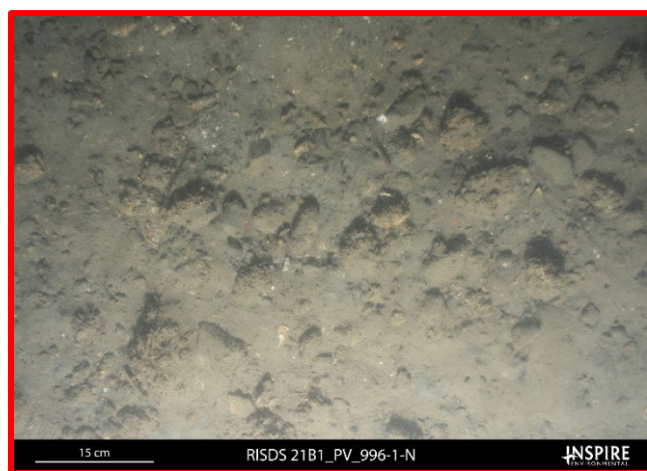
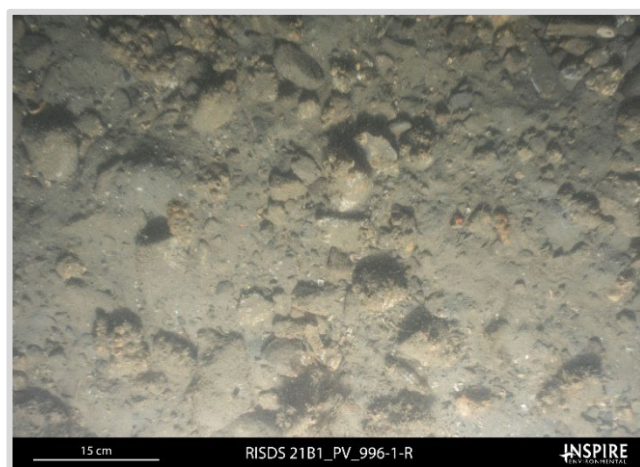
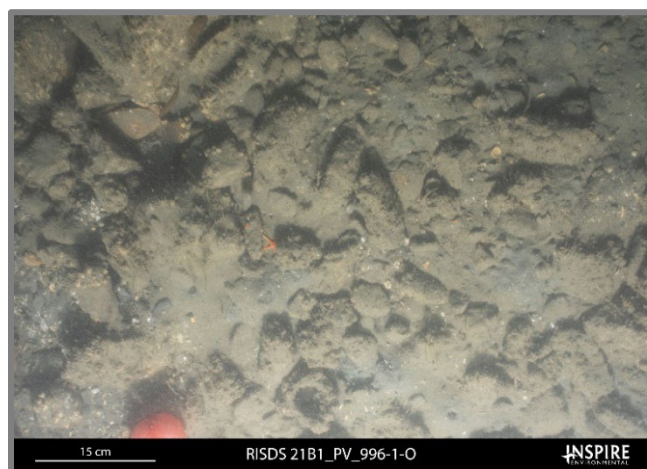
(A) Sand ●

(B) Gravelly Sand ●

(C) Sandy Gravel ●

(D) Pebble/Granule ●

(E) Cobble ●

Figure 3-21. Representative PV images collected at the western potential new reference area depicting the range of benthic habitats characterized by CMECS Substrate Subgroup including (A) Sand; (B) Gravelly Sand; (C) Sandy Gravel; (D) Pebble/Granule; and (E) Cobble

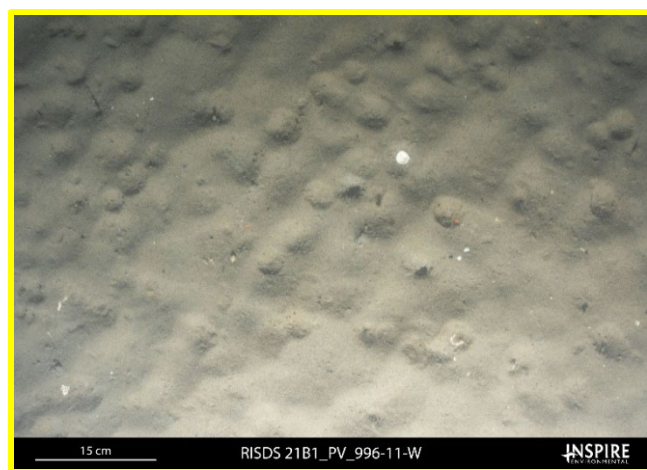
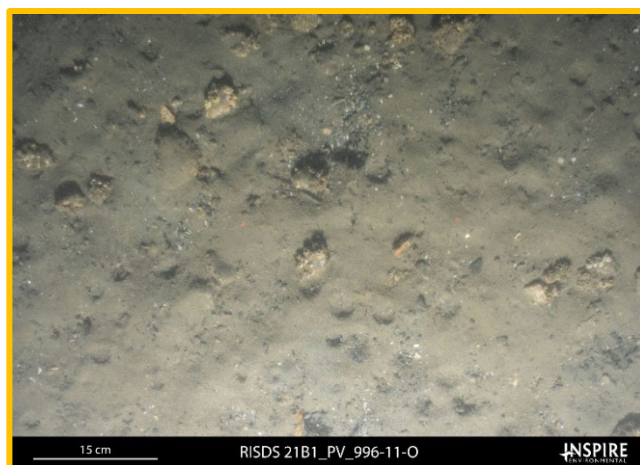
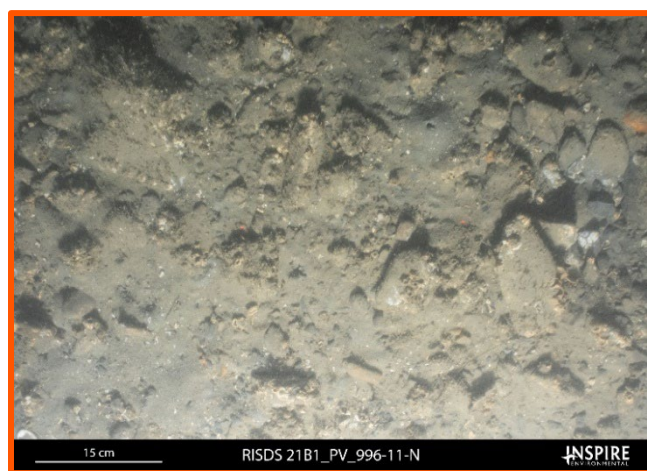
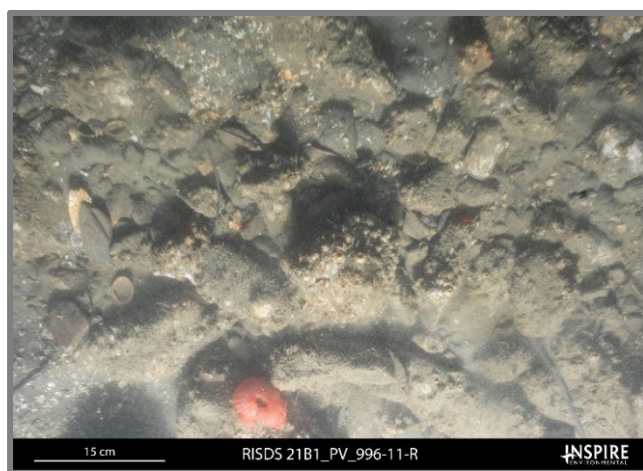
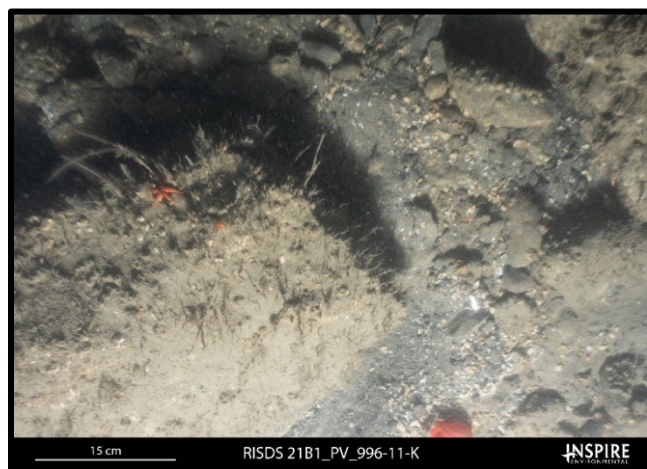
(A) Sand ●

(B) Gravelly Sand ●

(C) Sandy Gravel ●

(D) Cobble ●

(E) Boulder ●

Figure 3-22. Representative PV images collected at the eastern potential new reference area depicting the range of benthic habitats characterized by CMECS Substrate Subgroup including (A) Sand; (B) Gravelly Sand; (C) Sandy Gravel; (D) Cobble; and (E) Boulder
