Daily Report

Project:	Durham Meadows Pipeline Installation	Date:	November 6, 2020
Location:	Main Street, Durham; Shared Access Driveway, Middletown	Day of Week:	Friday
Project #:	AECOM: 6061487	Report No:	196
Contractor:	Ludlow Construction	Page:	1 of 12

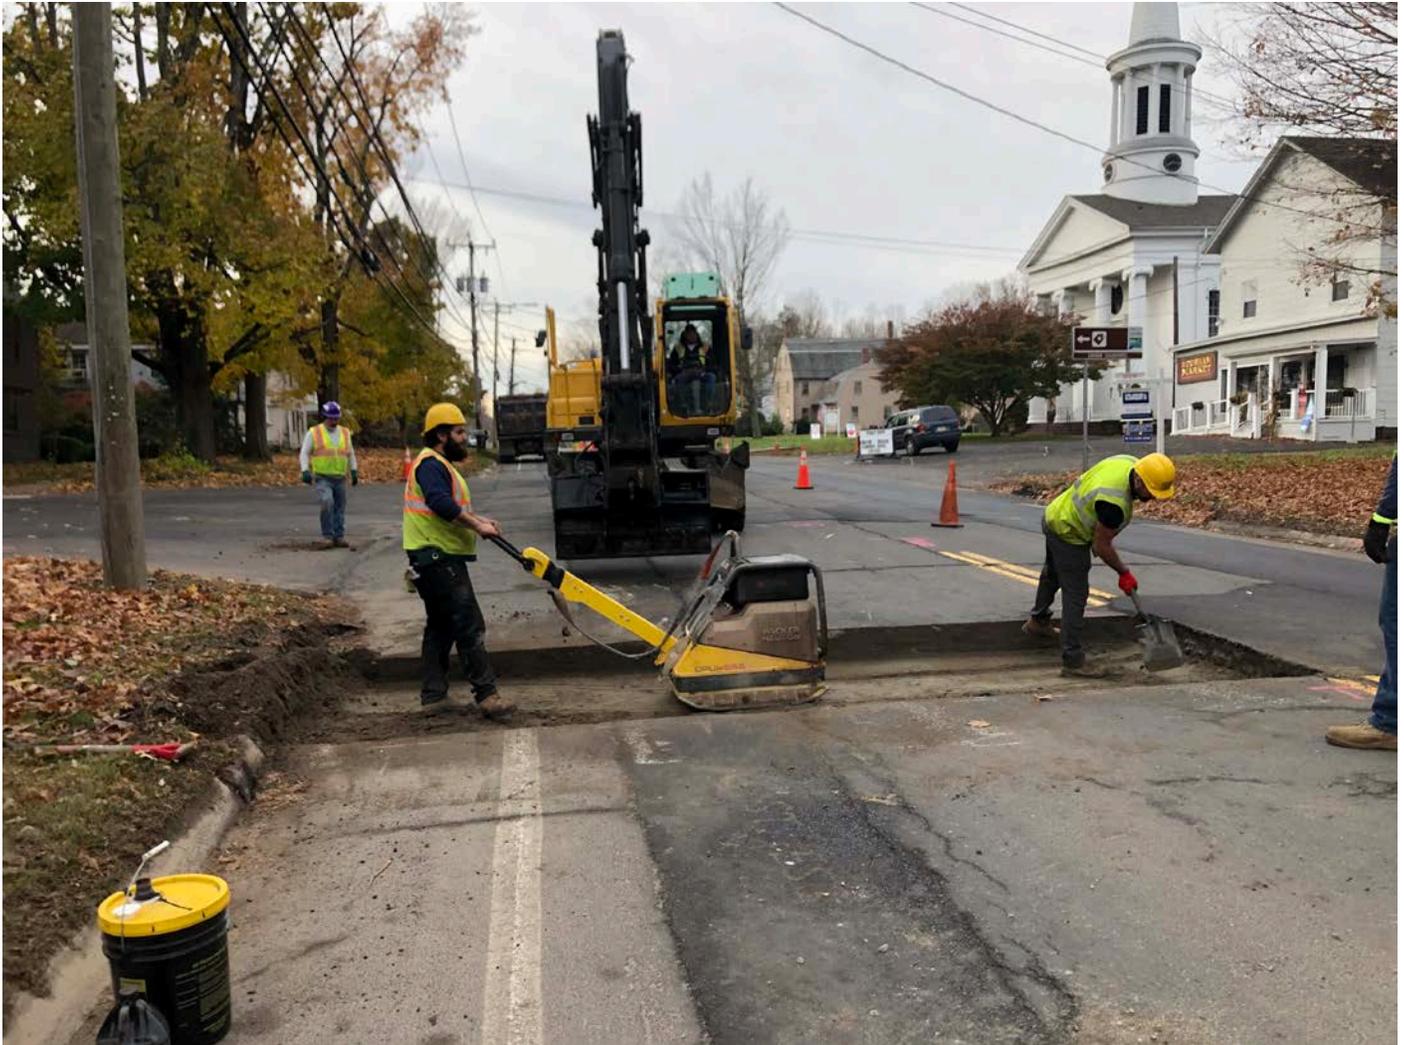
Picture 1: Ludlow compacting soil on a curb stop overcut on the northbound lane of Main Street, Durham. View to the south.

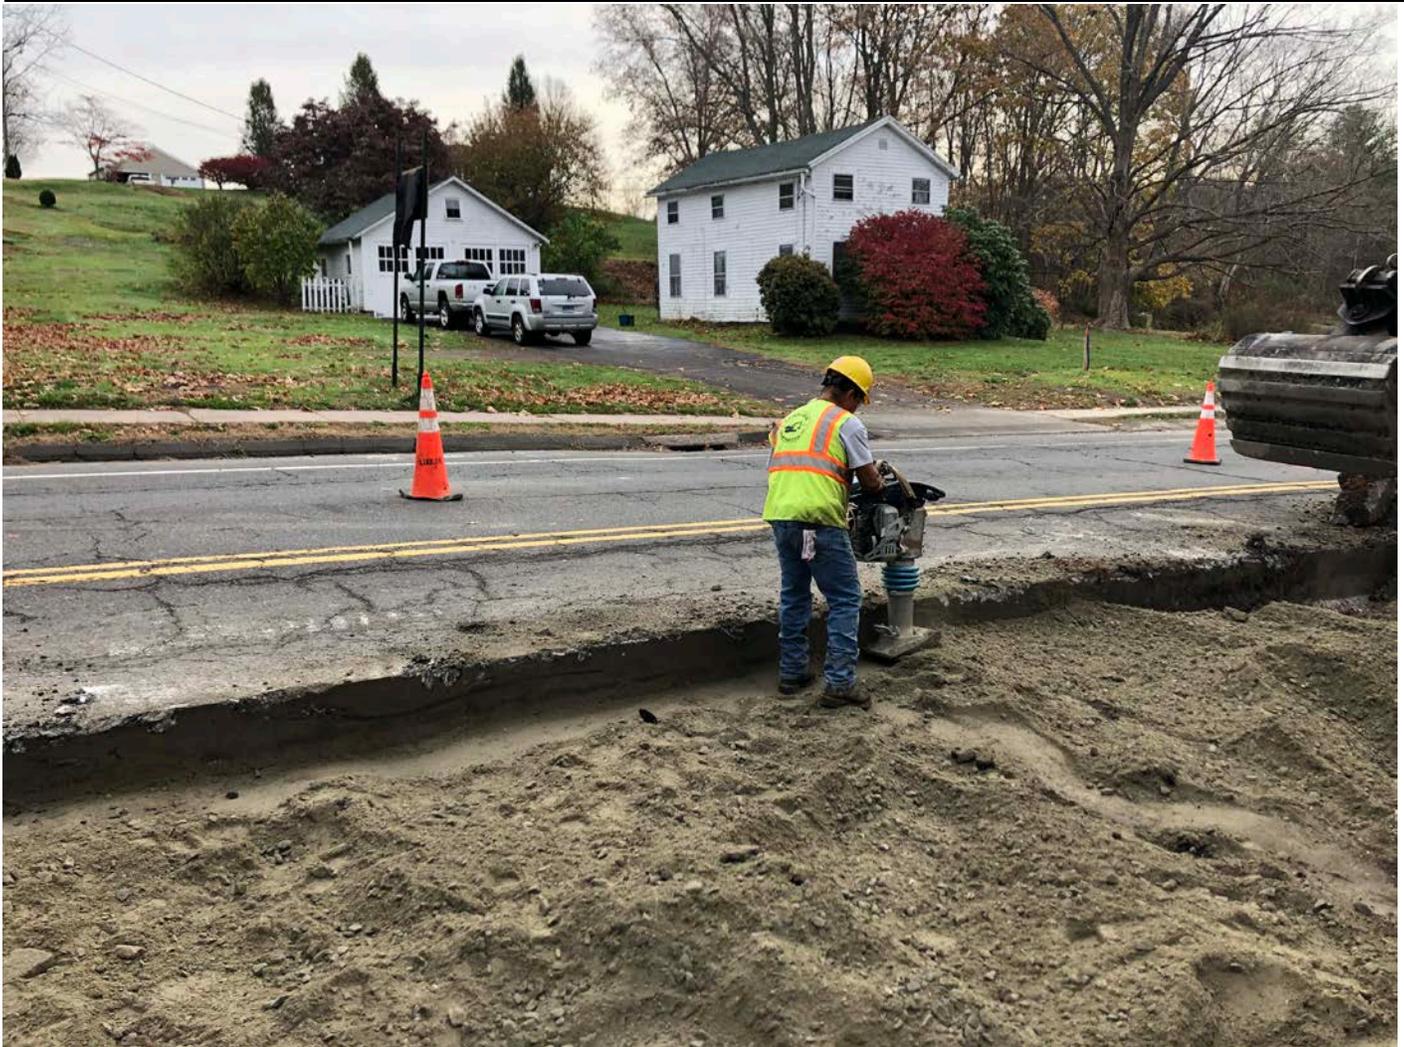
Picture 2: Ludlow compacting soil on the trench overcuts on the southbound lane of Main Street, Durham as part of permanent paving activities. View to the south.

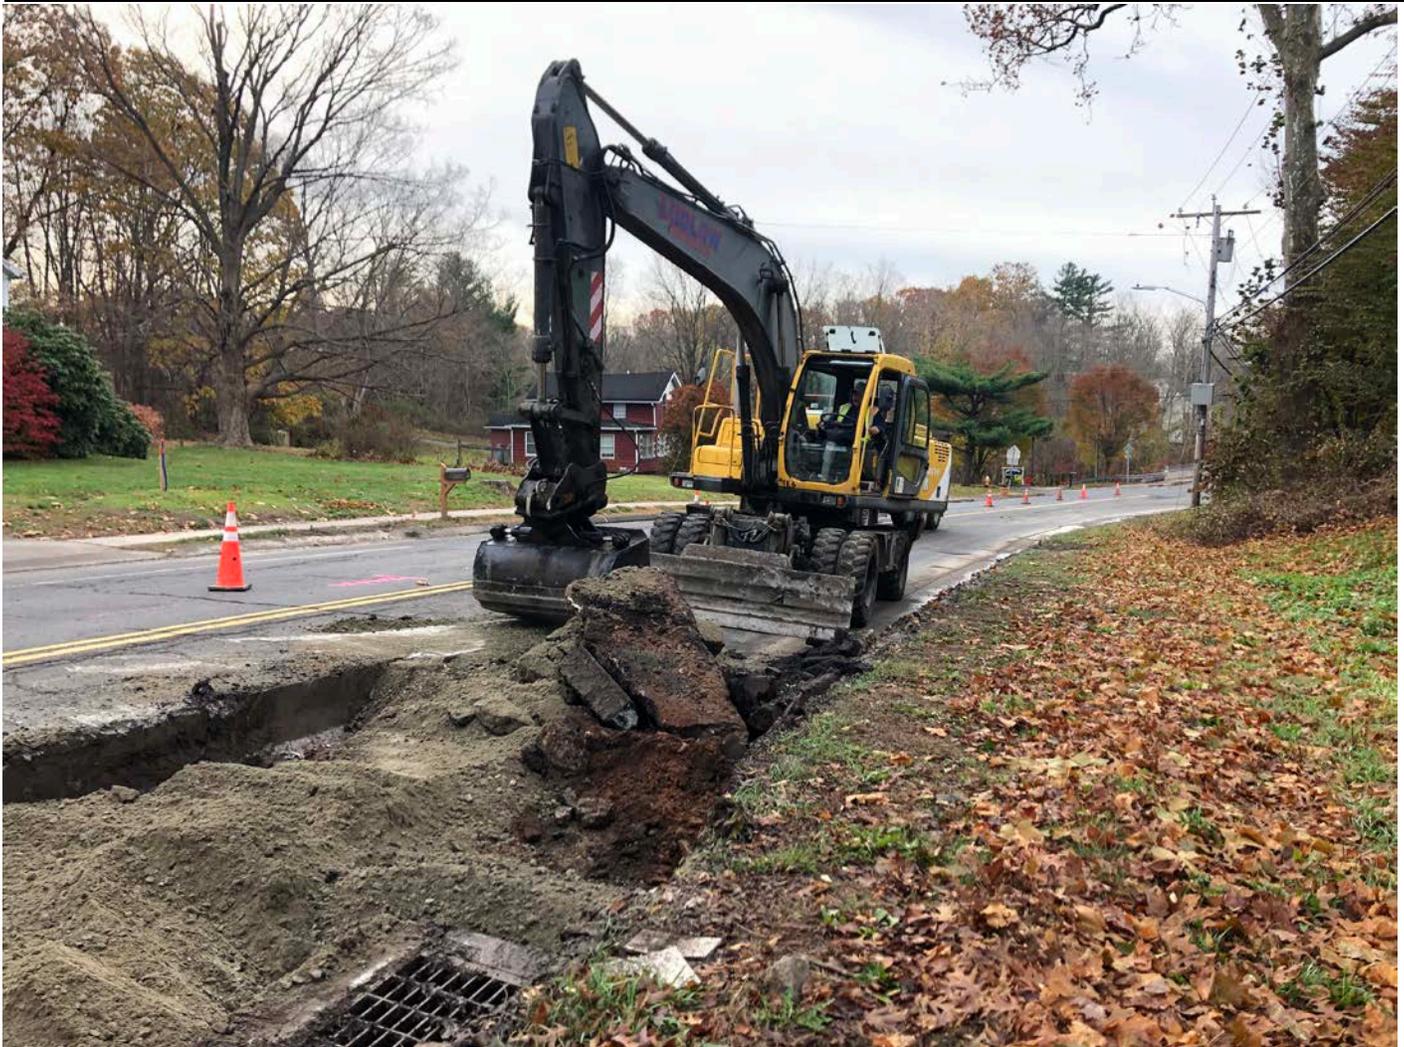
Picture 3: Ludlow stripping pavement from trench overcuts between Stations 204+80 and 207+90 as part of permanent paving activities on the southbound lane of Main Street, Durham. View to the southeast.

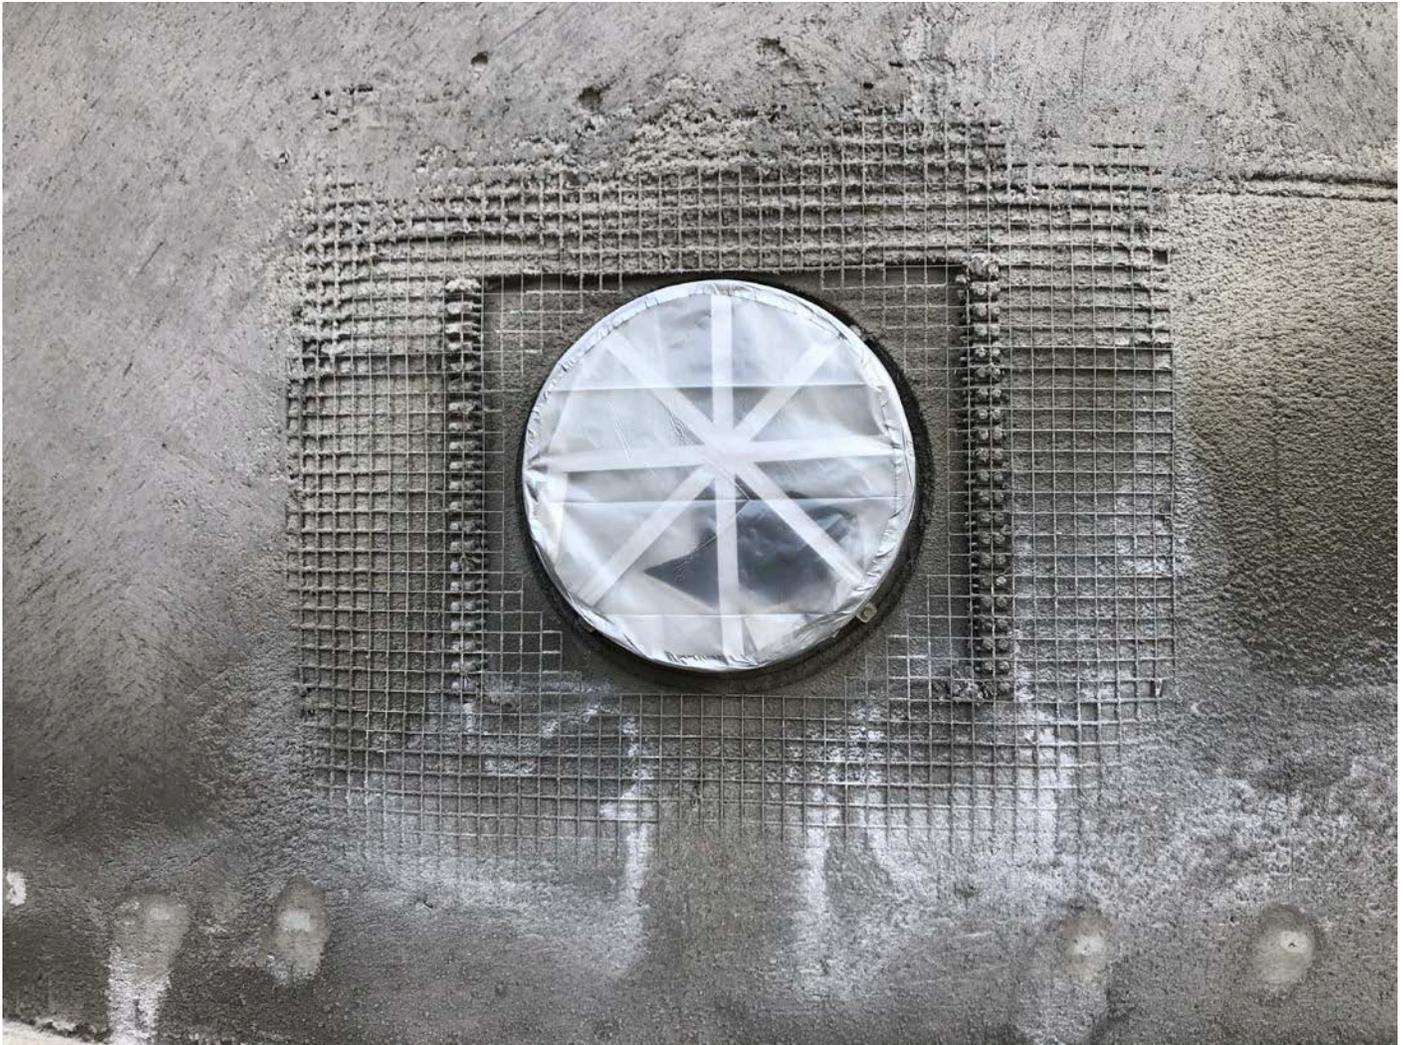
Picture 4: Manway on the east side of the water tank located east of the Shared Access Driveway, Middletown that is ready for final coat of shotcrete. View to the east.

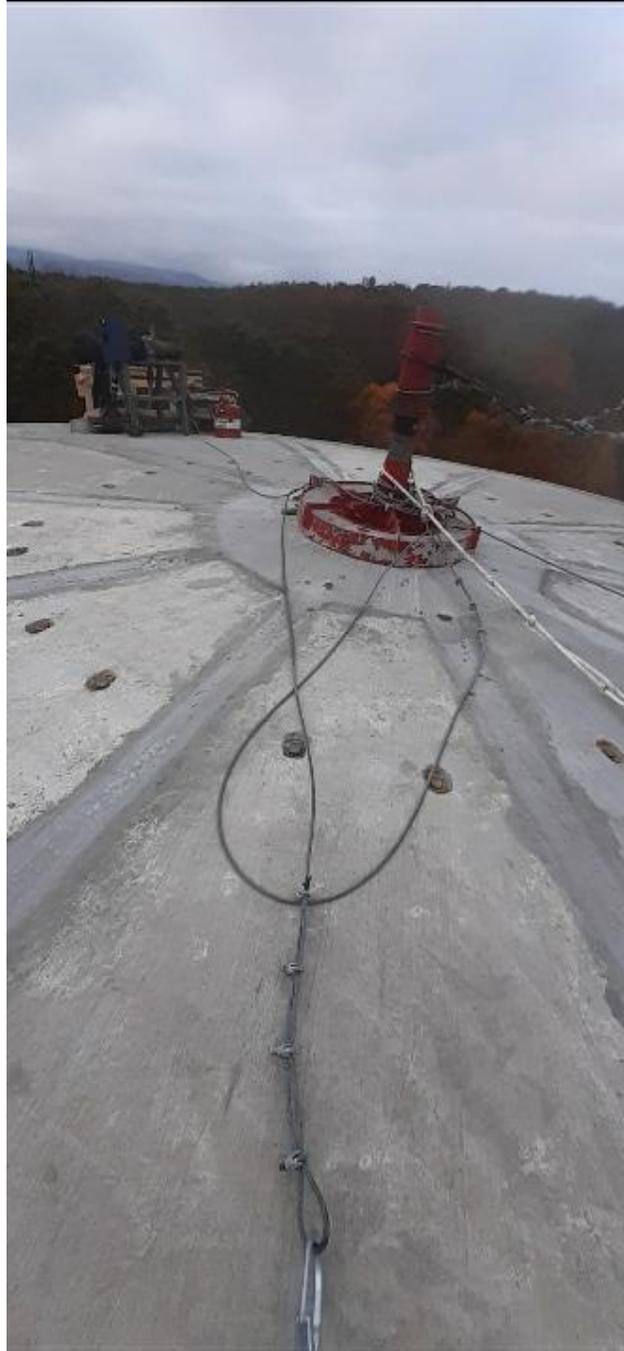
Picture 5: View of the top of the water tank from several weeks ago. The maypole that was used in the placement of prestressed wire around the sides of the water tank is visible on the center of the tank dome. View to the west.

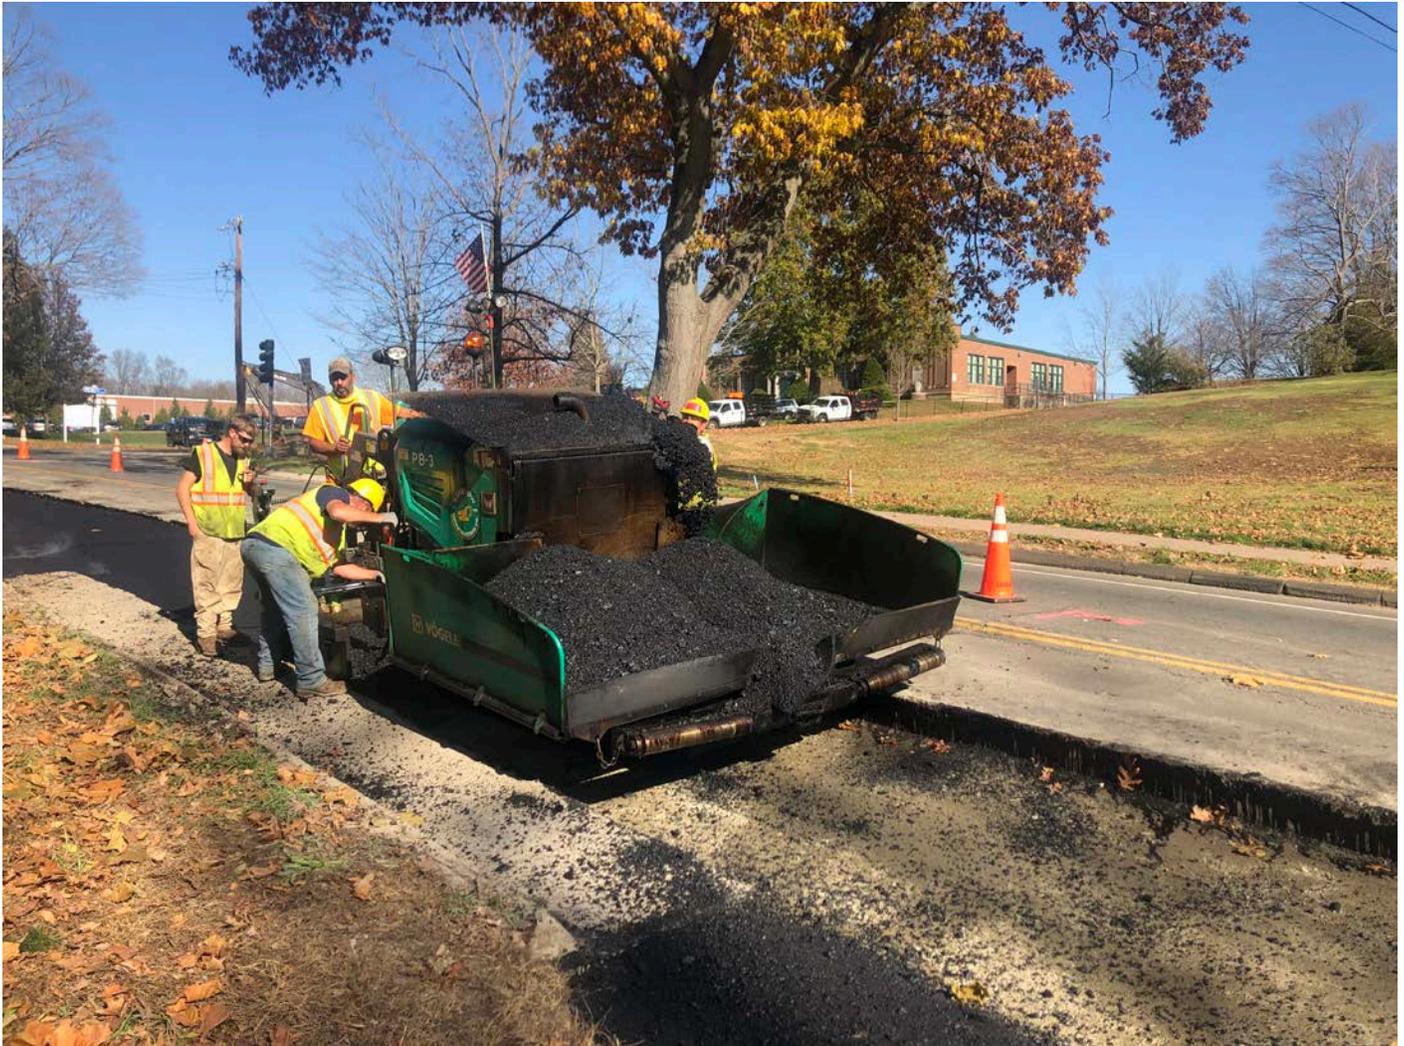
Picture 6: Ludlow placing the first of three 3” lifts of pavement between Stations 204+80 and 207+90 as part of permanent pavement activities on the southbound lane of Main Street, Durham. View to the northeast.

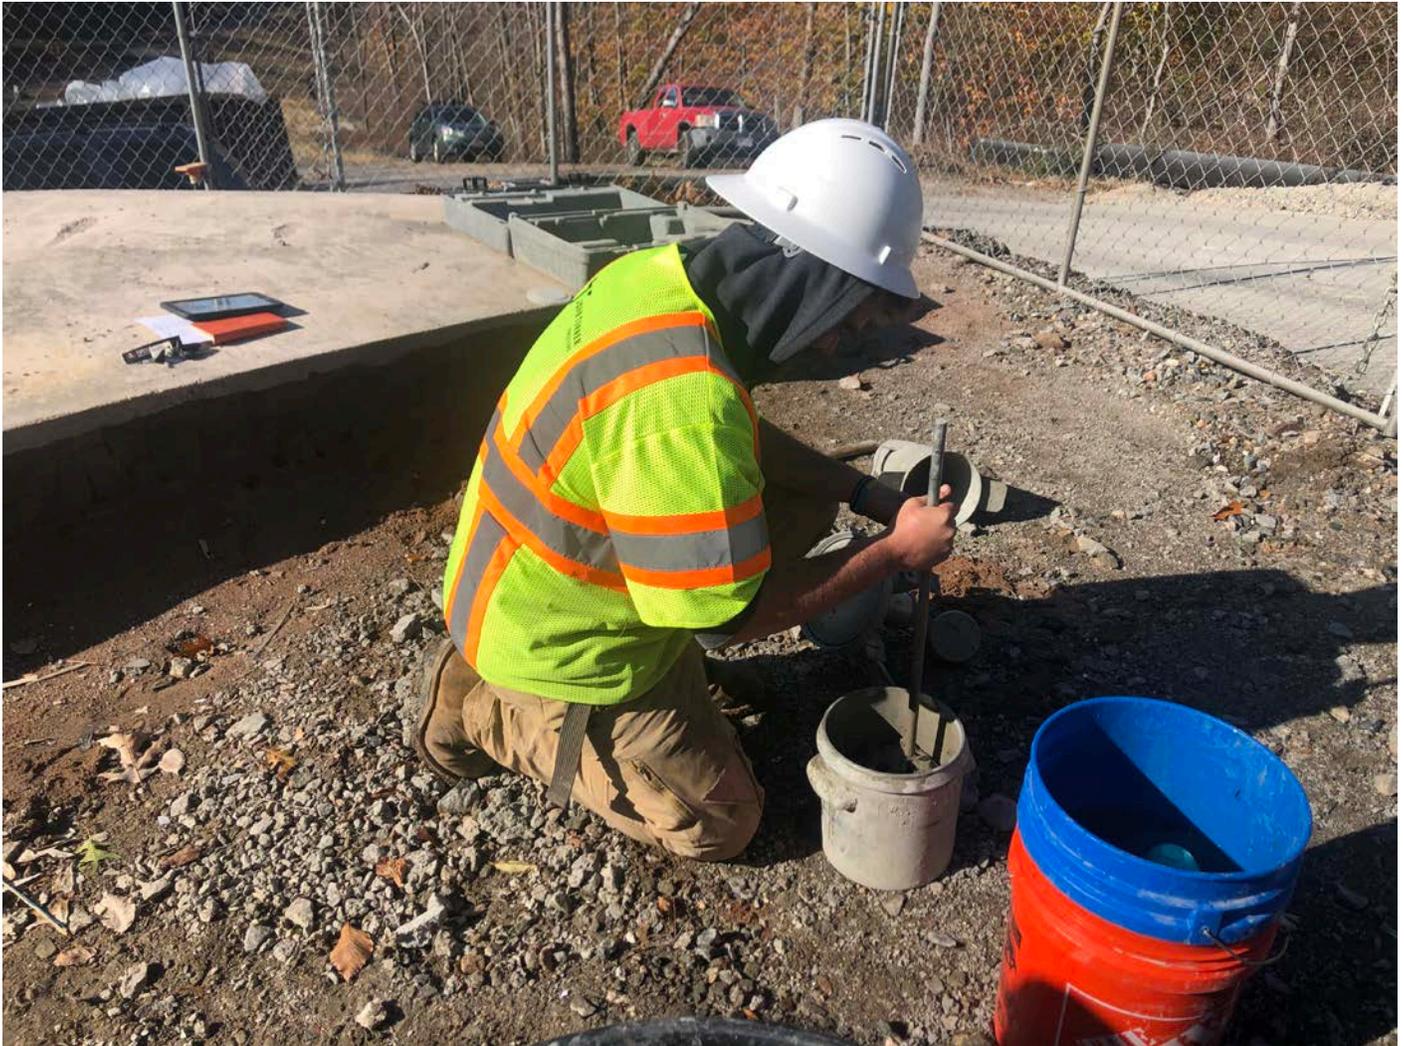
Picture 7: JTC collecting an entrained air sample from the first load of shotcrete that was delivered to the water tank work zone as DN Tanks prepared to apply final coat of shotcrete to the exterior of the water tank.

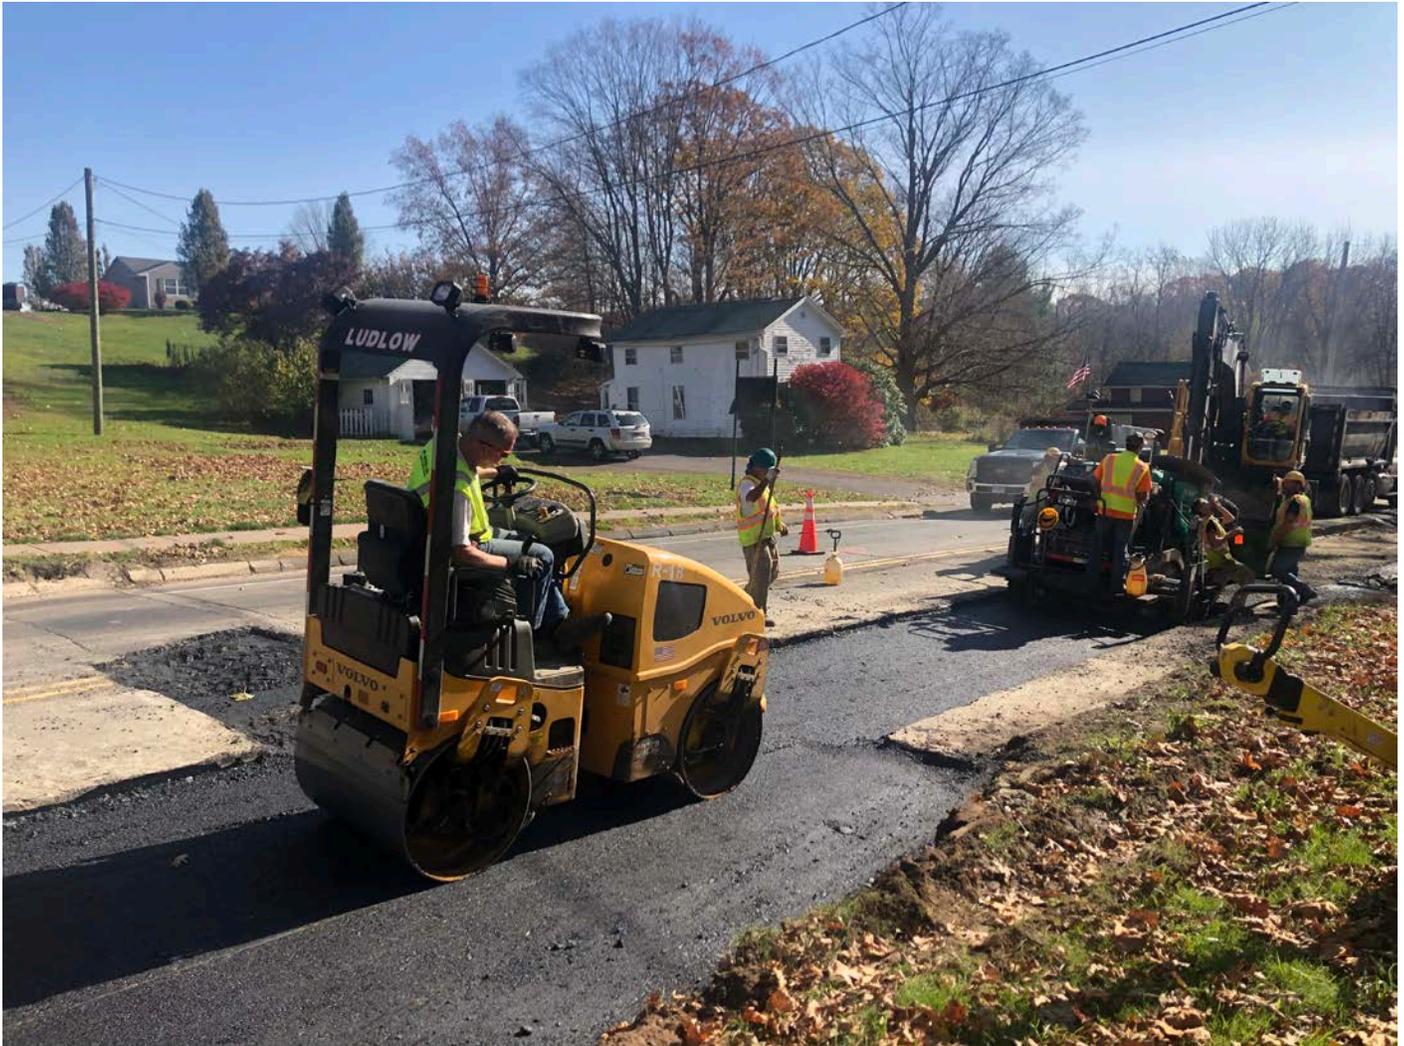
Picture 8: Ludlow compacting asphalt on the trench overcuts between Stations 204+80 and 207+90 on the southbound lane of Main Street, Durham. View to the southeast.

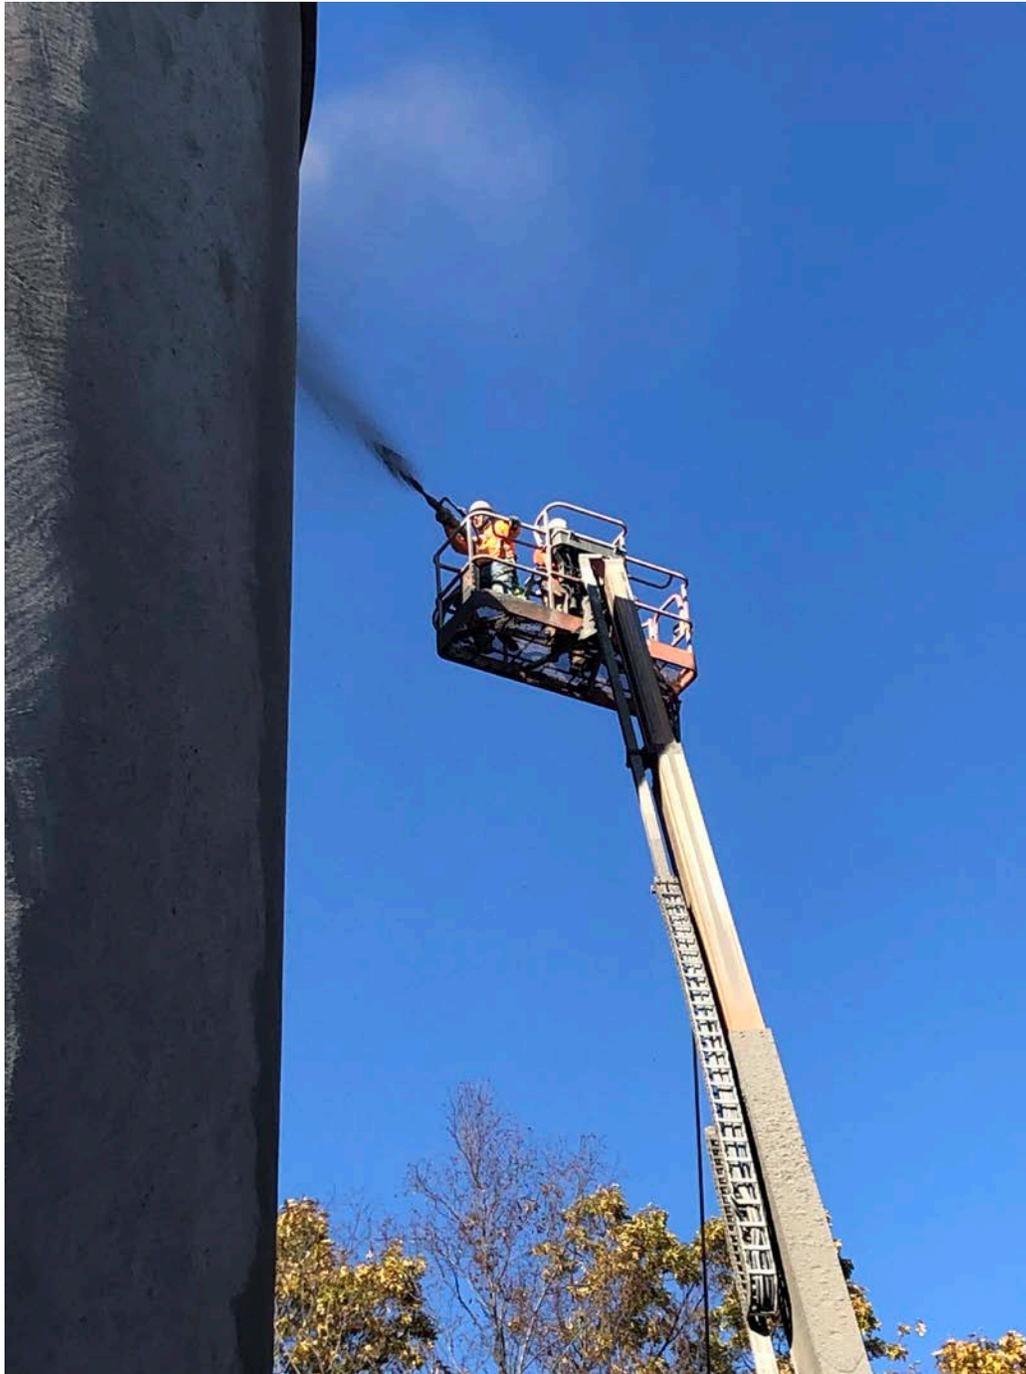
Picture 9: DN Tanks applying the final coat of shotcrete to the exterior of the water tank located east of the Shared Access Driveway, Middletown. View to the north.
