Daily Report

Project:	Durham Meadows Pipeline Installation	Date:	November 9, 2020
Location:	Main Street and Maple Avenue, Durham; Shared Access Driveway, Middletown	Day of Week:	Monday
Project #:	AECOM: 6061487	Report No:	197
Contractor:	Ludlow Construction	Page:	1 of 12

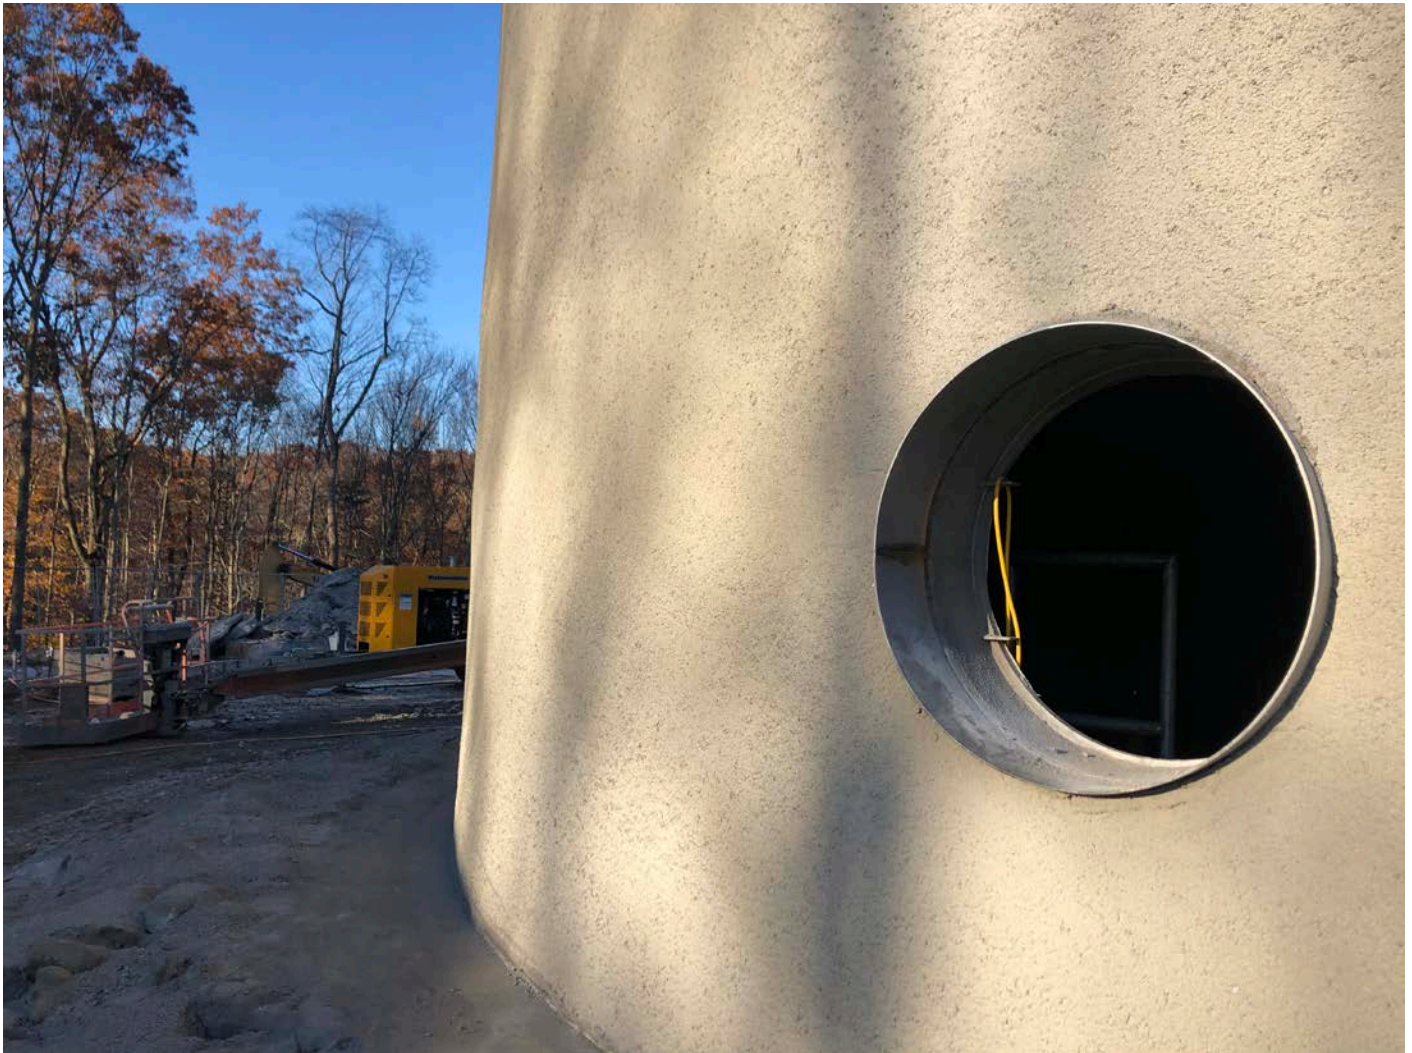
Picture 1: Manway on the east side of the water tank located to the east of the Shared Access Driveway, Middletown. View to the west.

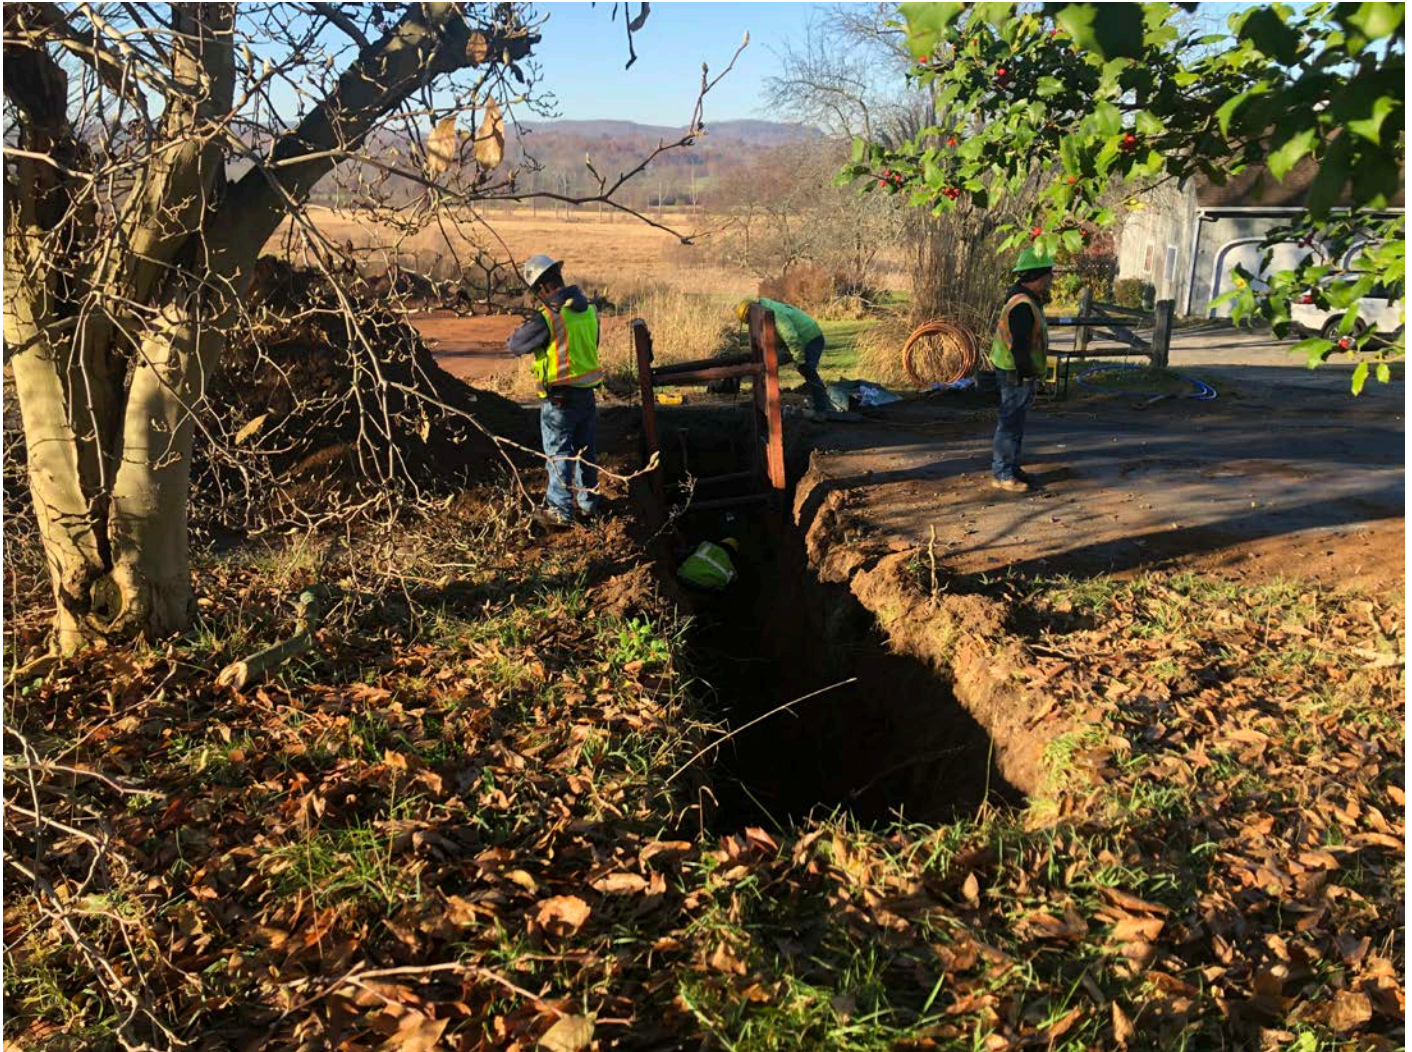
Picture 2: Ludlow installing a curb stop for the empty lot located adjacent to, and immediately north of, 133 Maple Avenue, Durham at Station 917+60. View to the west.

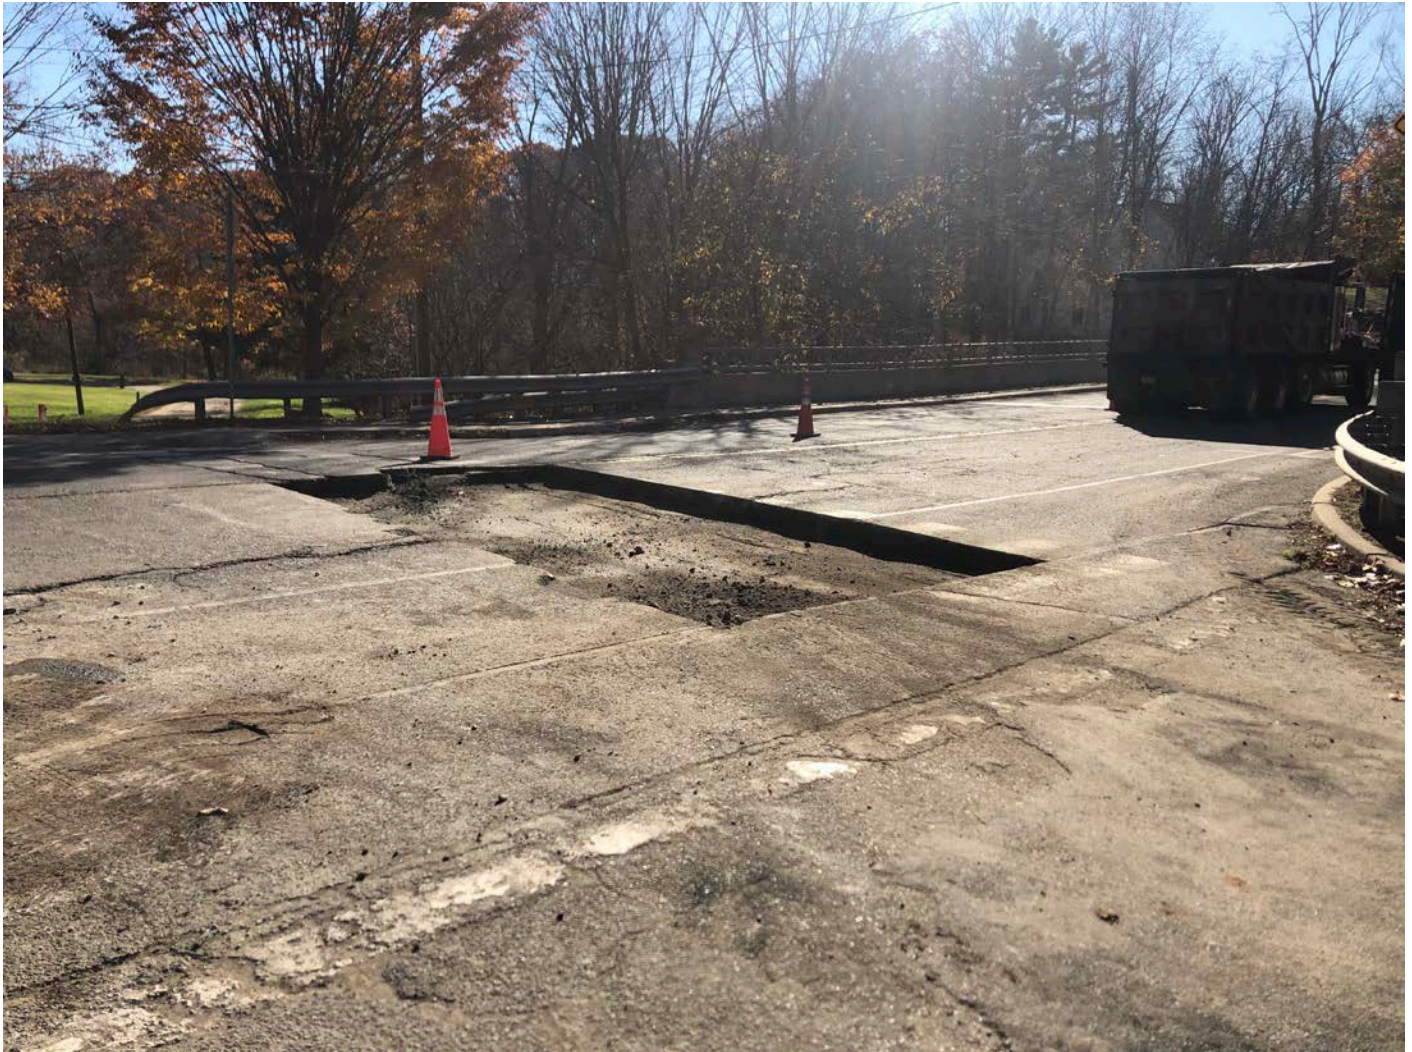
Picture 3: Curb stop overcut located at Station 209+51 that Ludlow excavated as part of permanent paving activities on the northbound lane of Main Street, Durham. View to the southeast.

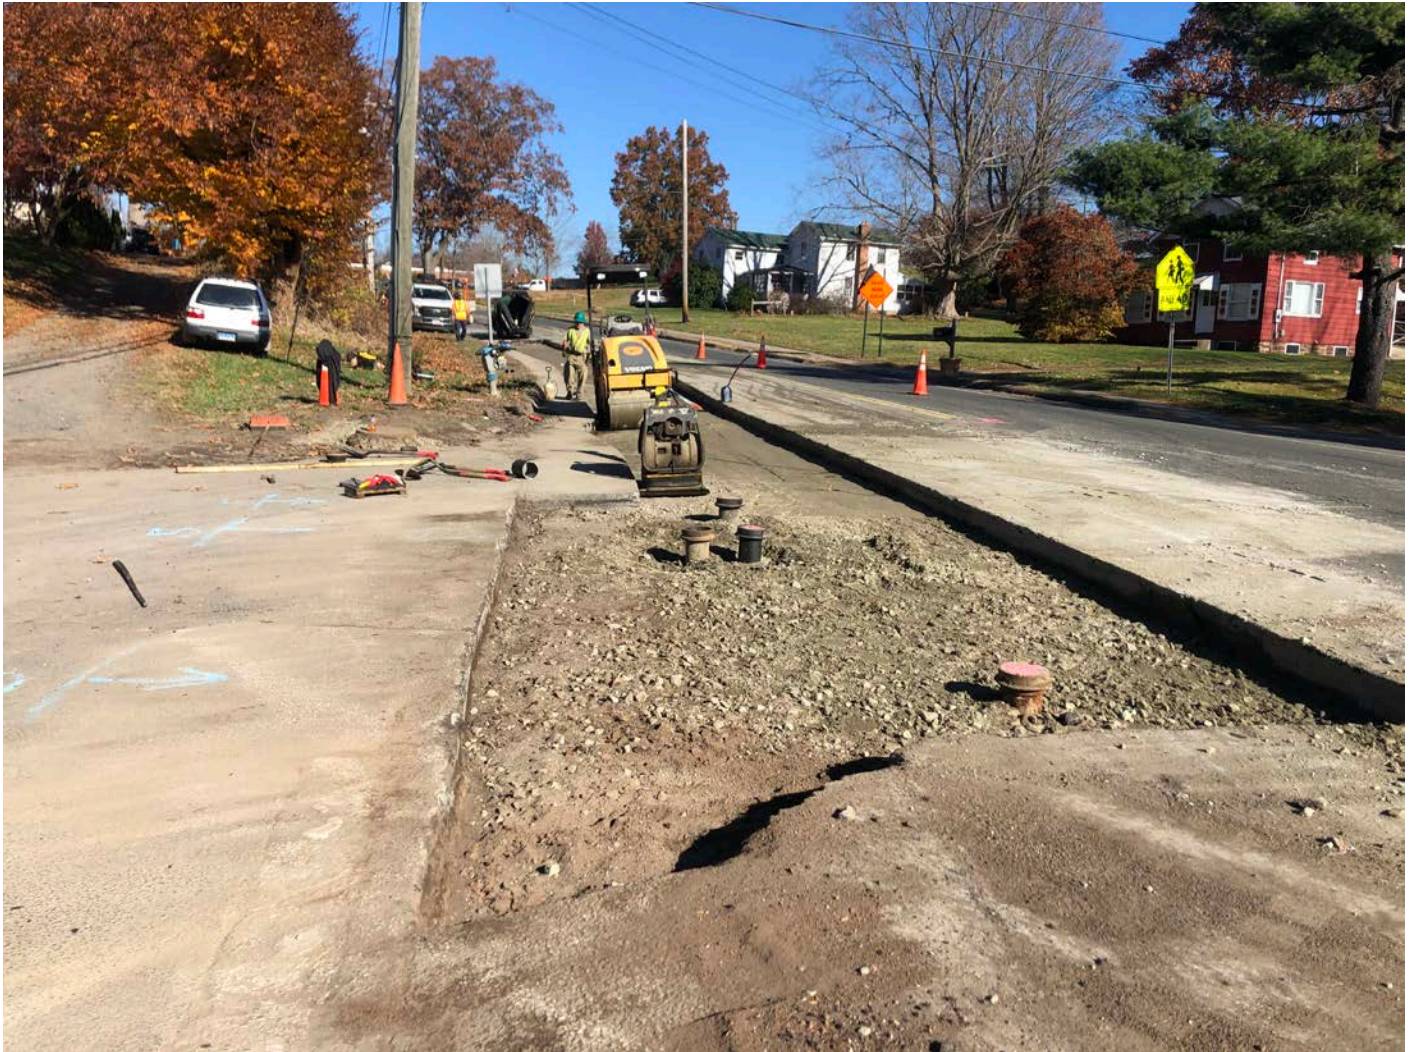
Picture 4: Pavement stripped from trench overcuts between Stations 207+90 and 209+41 on the southbound lane of Main Street, Durham as part of permanent paving activities. View to the north.

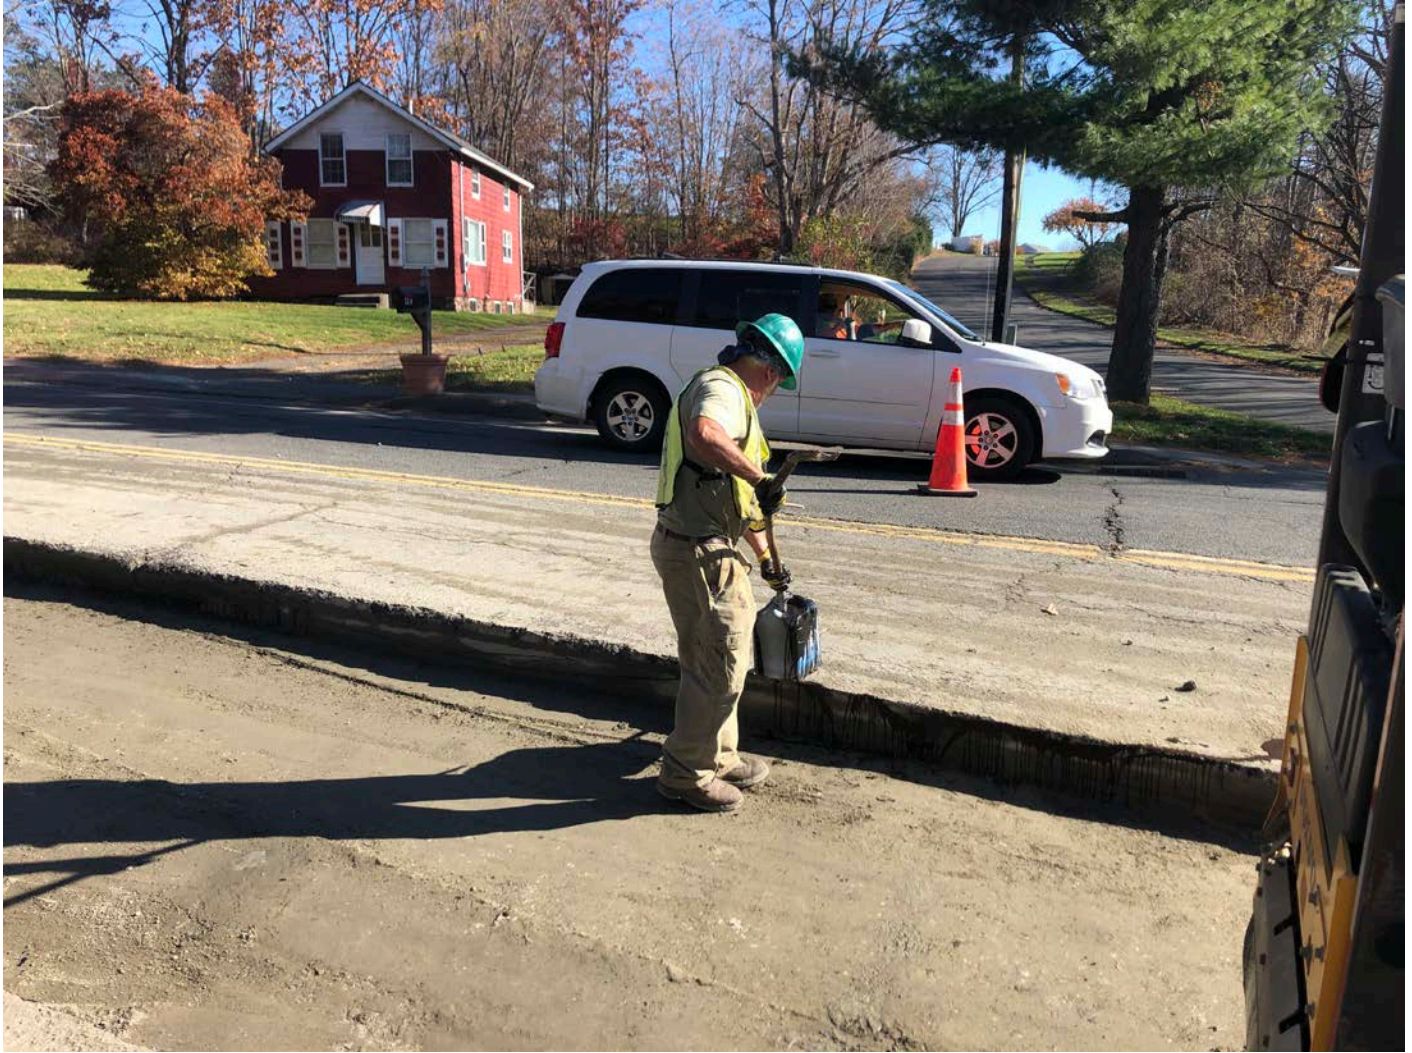
Picture 5: Ludlow apply tack coat to the edges of cut pavement as part of permanent paving activities between Stations 207+90 and 209+41 on the southbound lane of Main Street, Durham. View to the east.

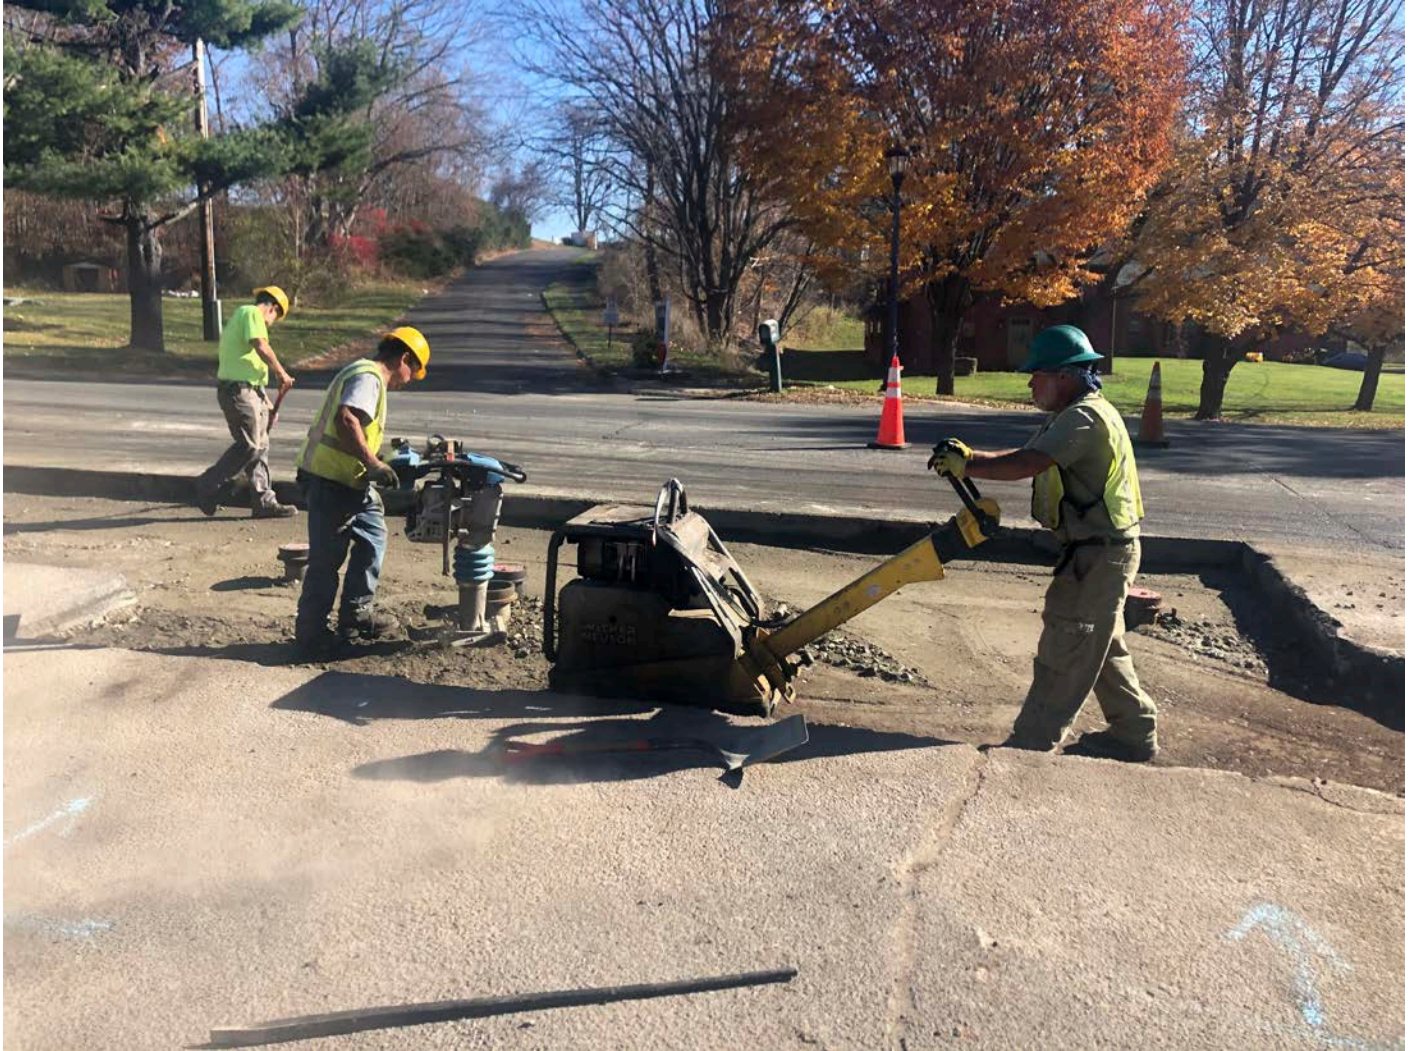
Picture 6: Ludlow compacting 1.5" processed gravel as part of permanent paving activities between Stations 207+90 and 209+41 on the southbound lane of Main Street, Durham. View to the east.

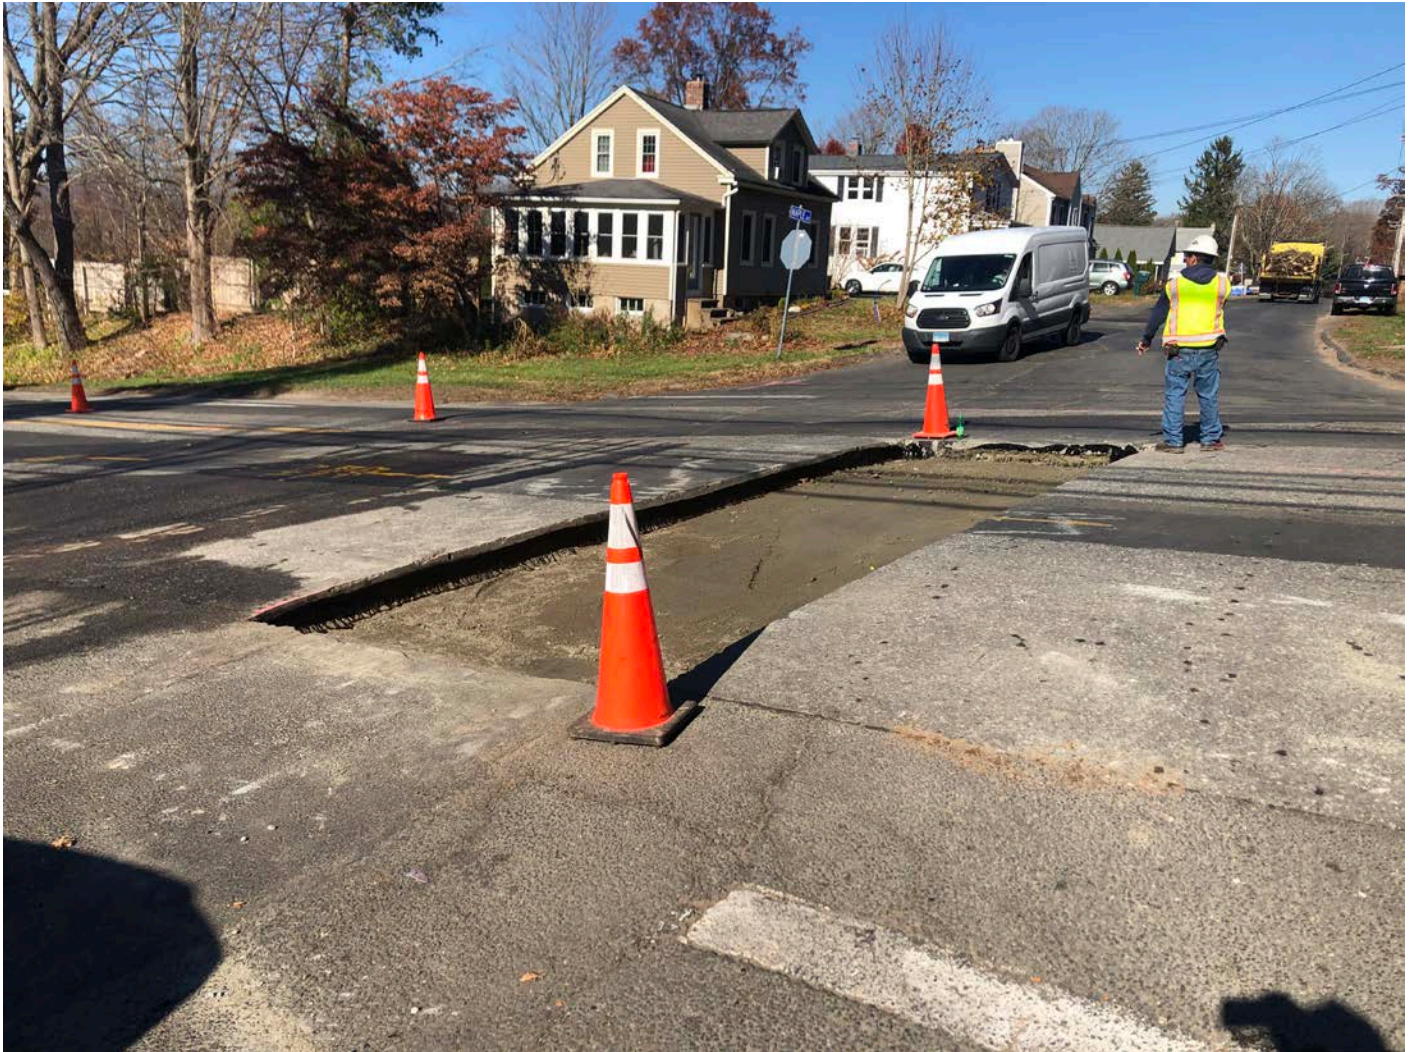
Picture 7: Trench overcut that Ludlow excavated as part of permanent paving activities on the eastbound lane of Route 68, Durham where it intersects with Maple Avenue, Durham at Station 606+65.

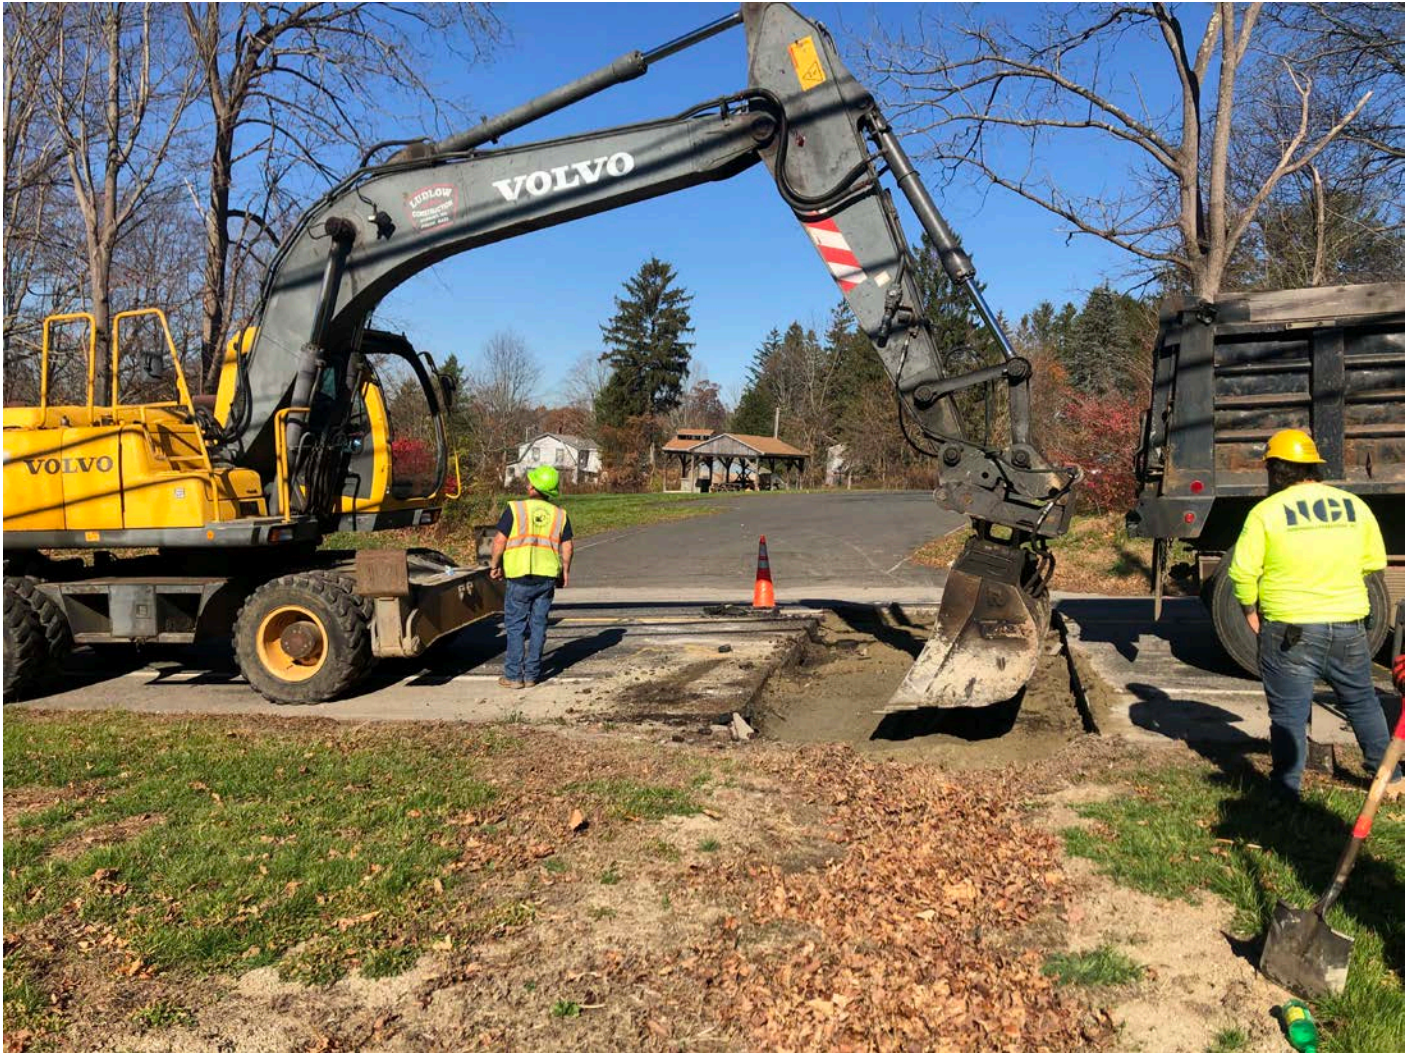
Picture 8: Ludlow placing and compacting 1.5” processed gravel at the curb stop overcut located at Station 604+61 on the eastbound lane of Route 68, Durham as part of permanent paving activities. View to the north.

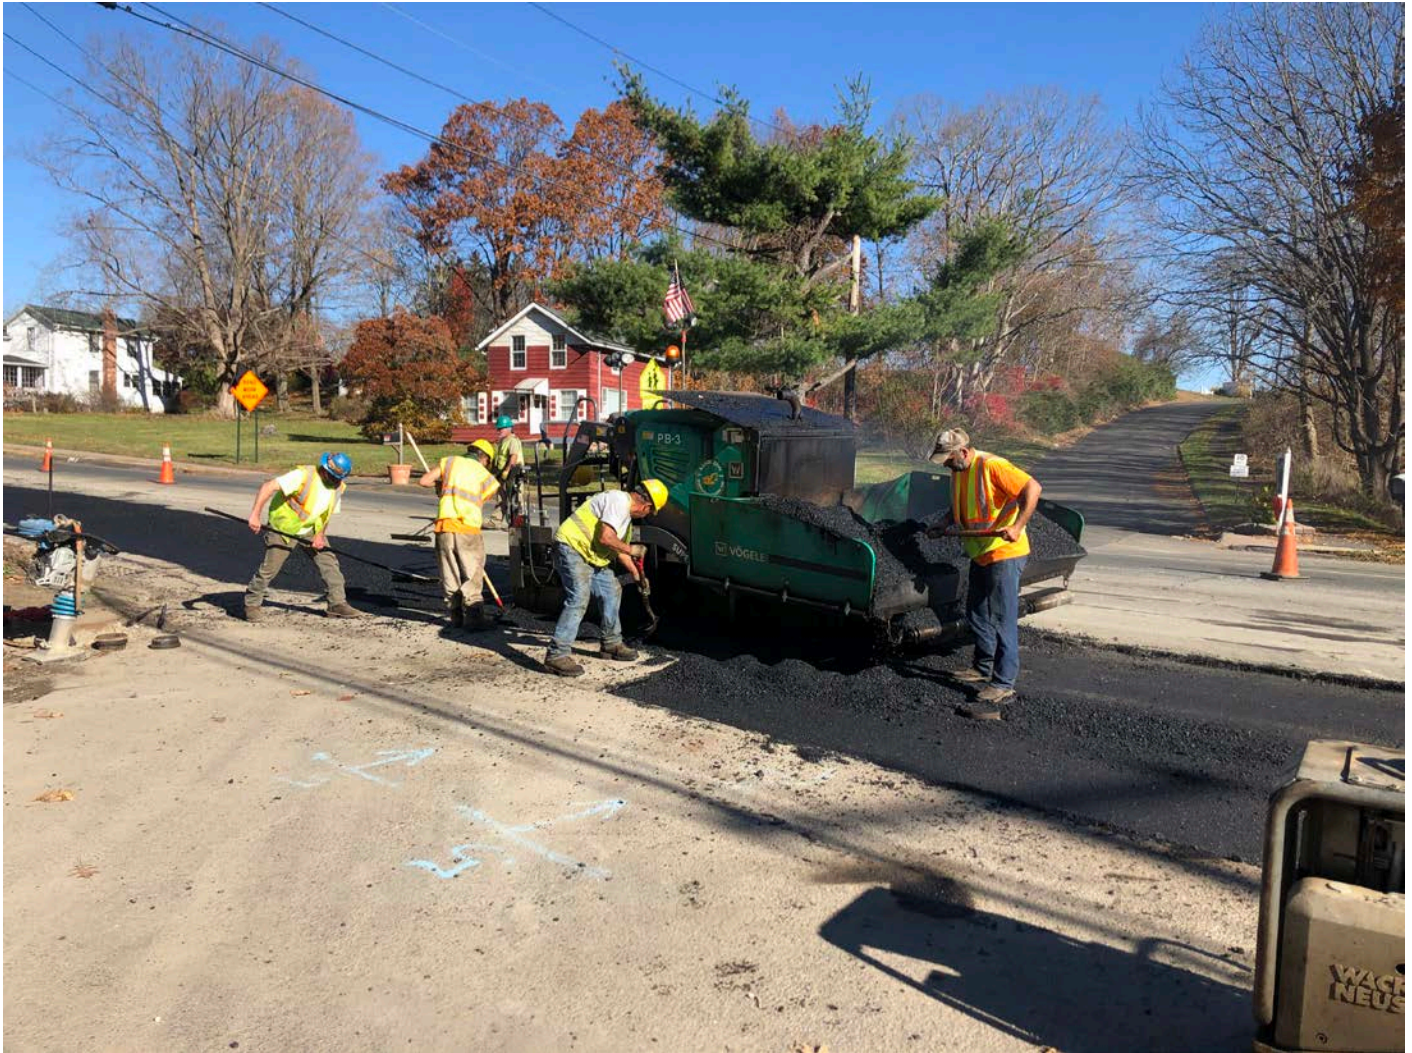
Picture 9: Ludlow placing the third of three 3" lifts of asphalt as part of permanent paving activities between Stations 207+90 and 209+41 on the southbound lane of Main Street, Durham. View to the northeast.
