Muddy River Flood Damage Reduction Project
Phase 2 Construction Activities Next 90 Days
May 2023

June 2023 through August 2023 Period:

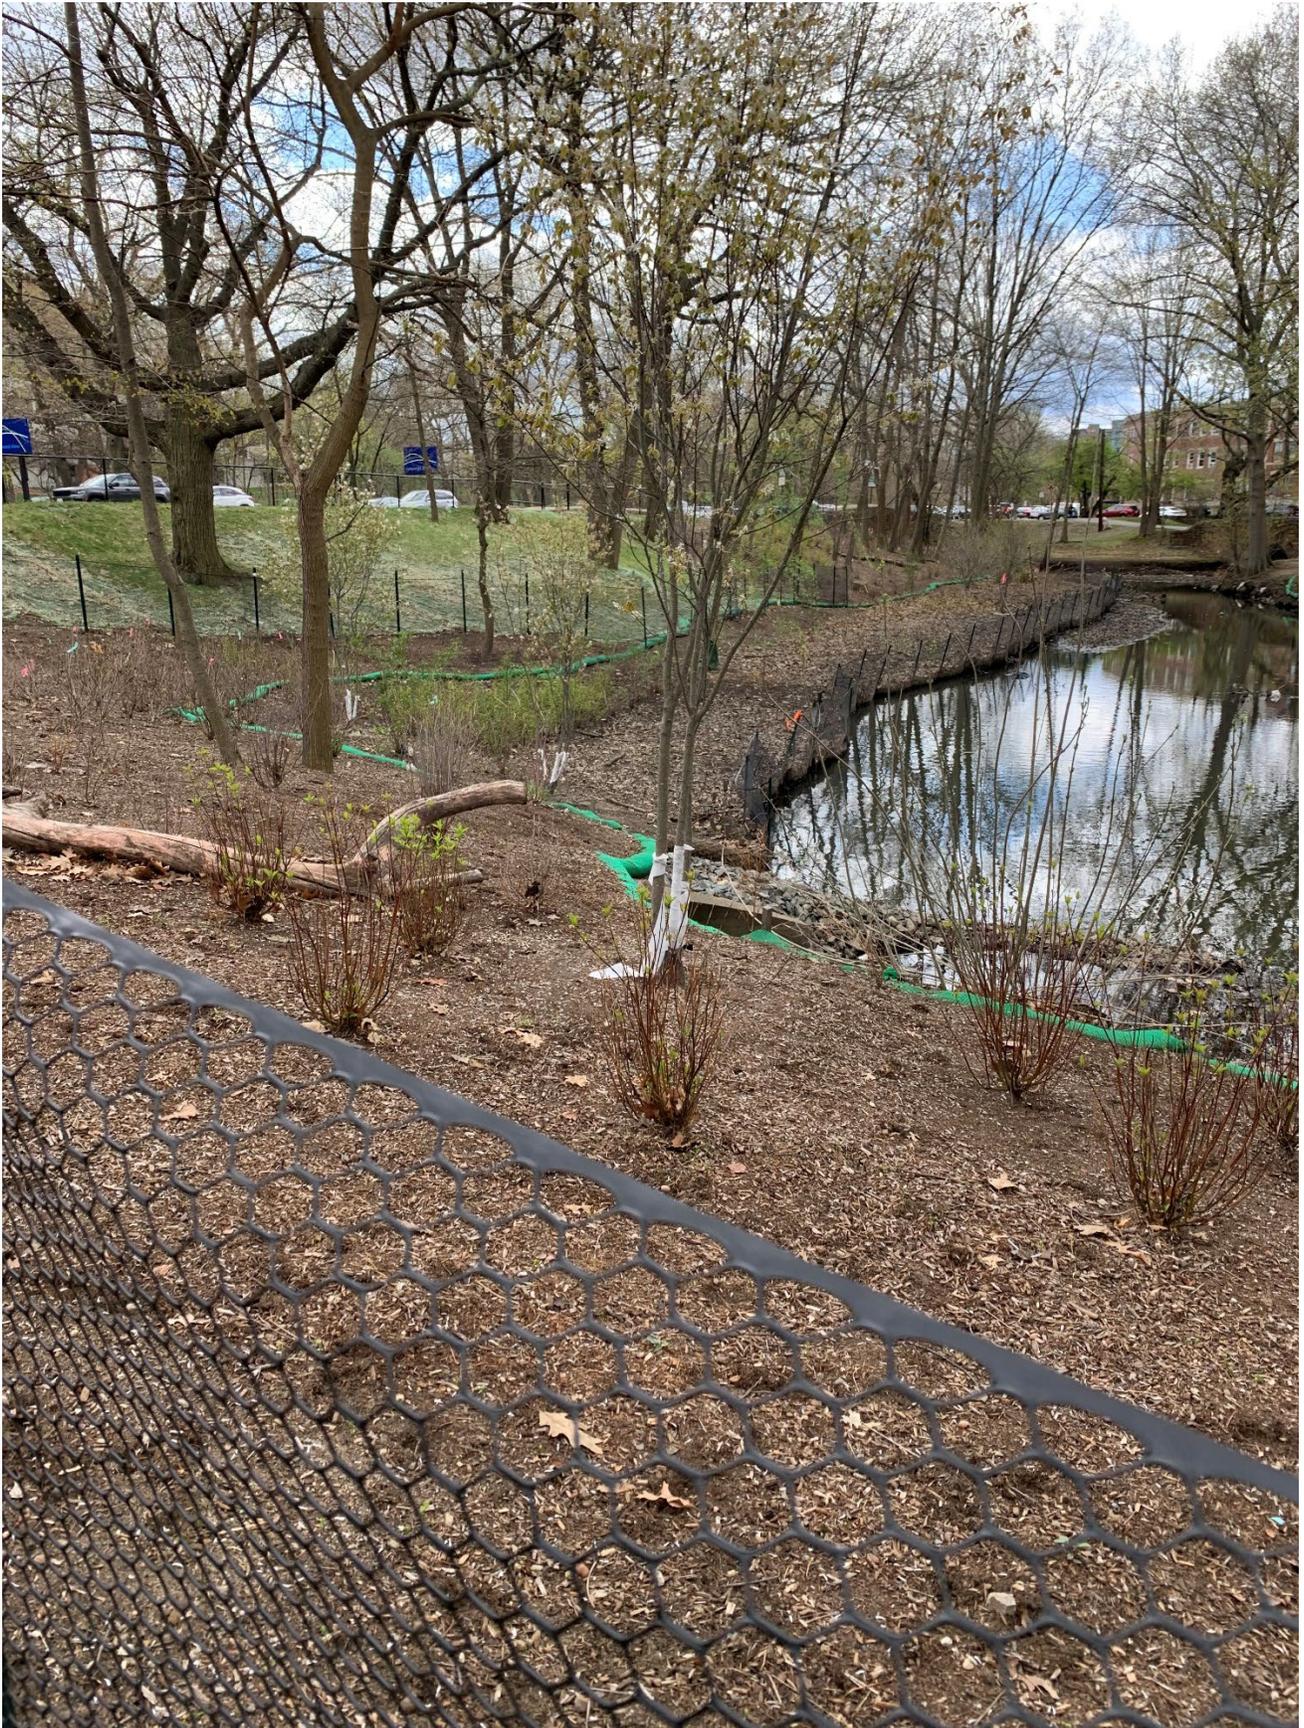
Work Area #3 – section of river at Brookline Avenue, the Riverway, and Netherlands Road – near Beth Israel Deaconess Hospital – view of the plantings and the turf coming back to life with the Spring weather.

- **Work Area #3** – section of river at Brookline Avenue, the Riverway, and Netherlands Road – near Beth Israel Deaconess Hospital – the contractor completed dredging this section late-March 2021. Surveying was done in May to confirm new flood risk management cross sections. Since that time, a review of the as-dredged conditions has taken place to confirm plant locations and topsoil quality to optimize planting success. All trees, upland planting, and seeding were completed in October 2021. Stonedust path restoration and landscape protection fence installation took place in mid-May 2022. Wetland plants were installed late-May 2022 and will be maintained to September 2024. Maintenance of the rest of the planting will continue to October 2023 during the two-year plant guarantee period.

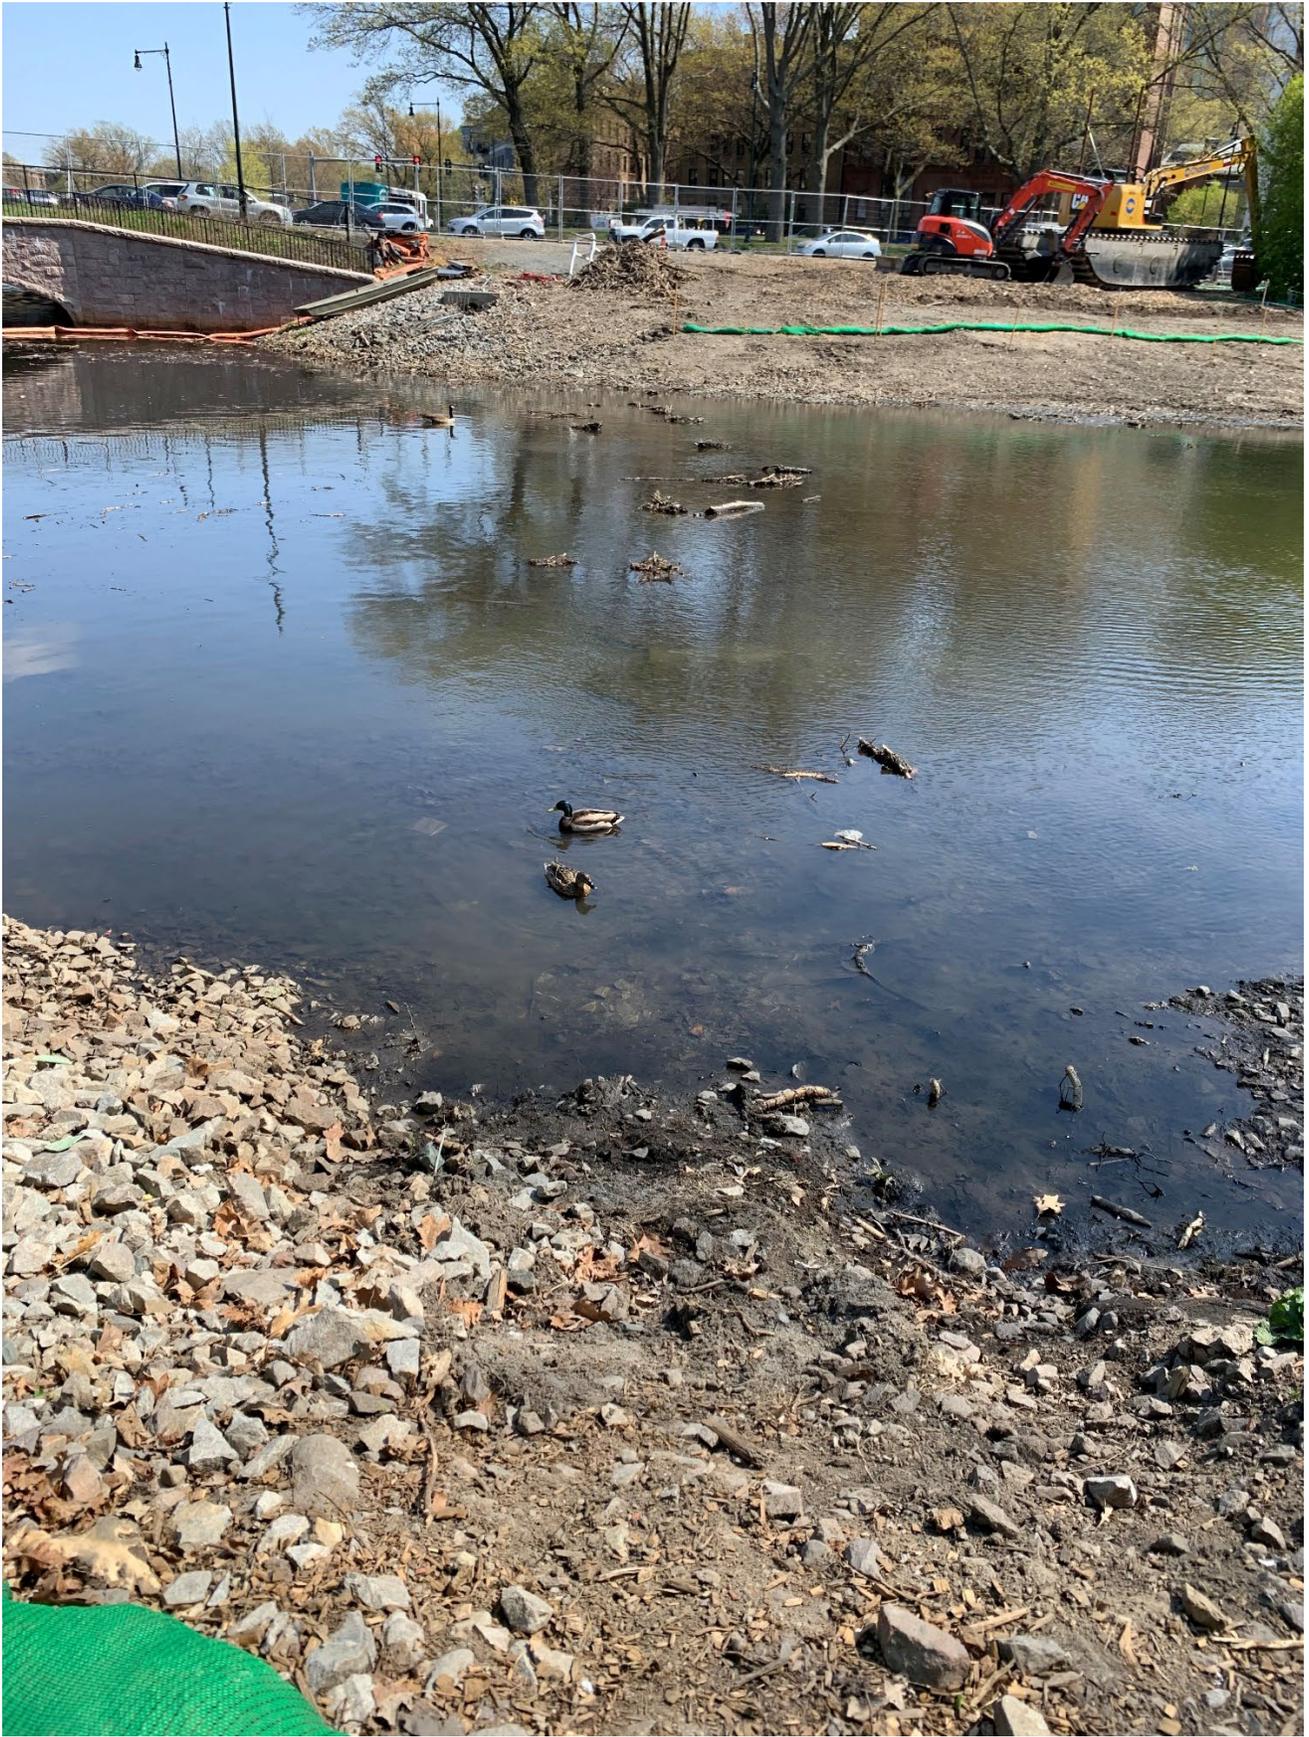
Work Area #6 – section of river by Back Bay Yard – FRCS cut to the final elevation and the last of the sediment dredged.

- **Work Area #6** – section of river by Back Bay Yard – near the intersection of Park Drive and Riverway – Dredging upstream of the MWRA easement for the existing sewer lines was completed in June 2022. In January 2023, the removal of the phragmites along the banks that

were encroaching into the river within the MWRA easement was completed. Since that time, the contractor mobilized in mid-February to begin cutting the temporary Flow Restriction Control Structure (FRCS) ahead of the restoration and planting within this work area. The FRCS was installed under Phase 1 to mimic the effect of the former twin 72" culverts underneath The Riverway until the downstream areas of dredging were completed. The FRCS was cut to the final elevation and the last of the sediment was dredged in the vicinity in early April 2023. Site restoration (herbivore fence and coir log) has begun, and plantings will be installed mid- to late-May during the Spring 2023 planting window.

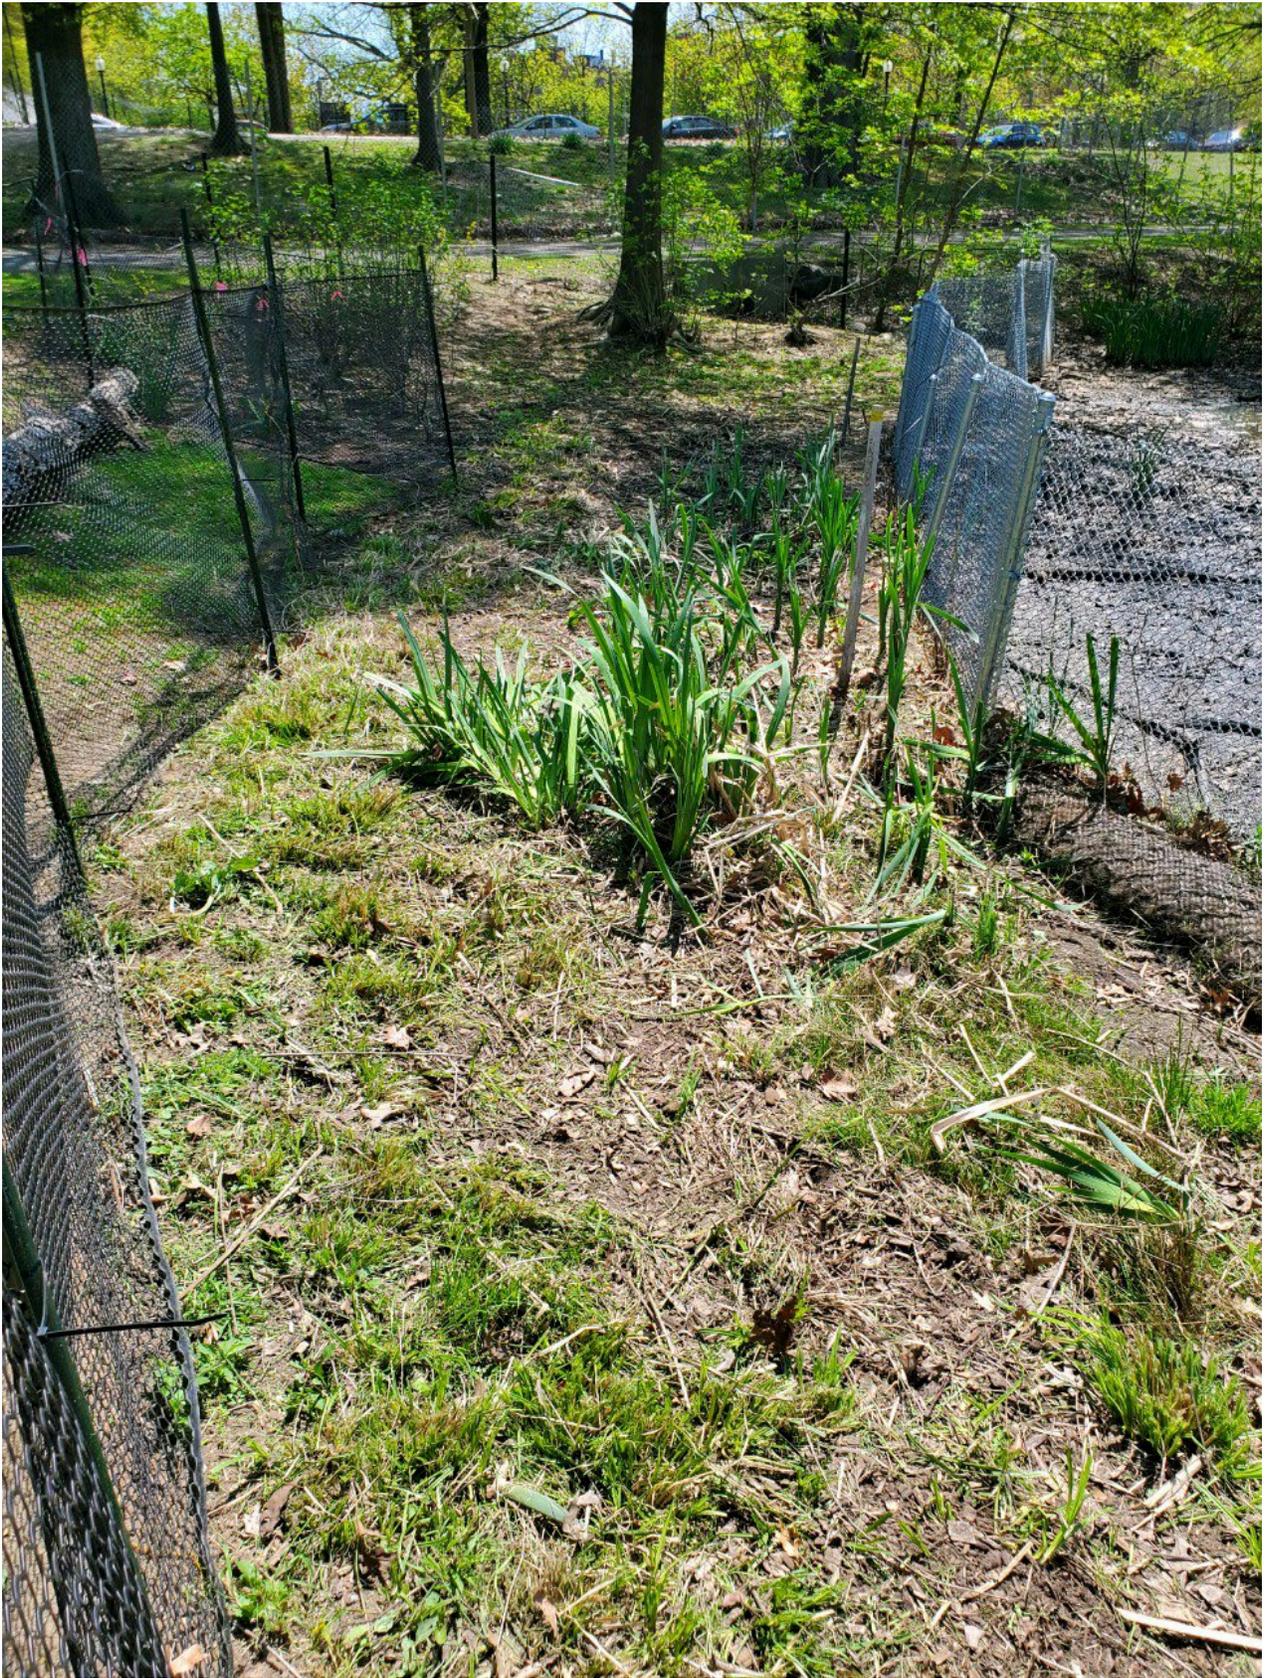
Work Area #9 – section of river immediately downstream of Work Area #8 – constructed wetland shelf coming back to life with the Spring weather.

- **Work Area #9** – section of river immediately downstream of Work Area #8 – the contractor completed dredging this section mid-April 2021. Surveying was done in late June 2021 to confirm new flood risk management cross sections. Since that time, a review of the as-dredged conditions has taken place to confirm plant locations and topsoil quality to optimize planting success. Grading of the site and wetland construction and all trees, upland planting, and seeding were completed by October 2021. Stonedust path restoration was completed late-November 2021. Maintenance of the planting will continue to October 2023 during the two-year plant guarantee period.

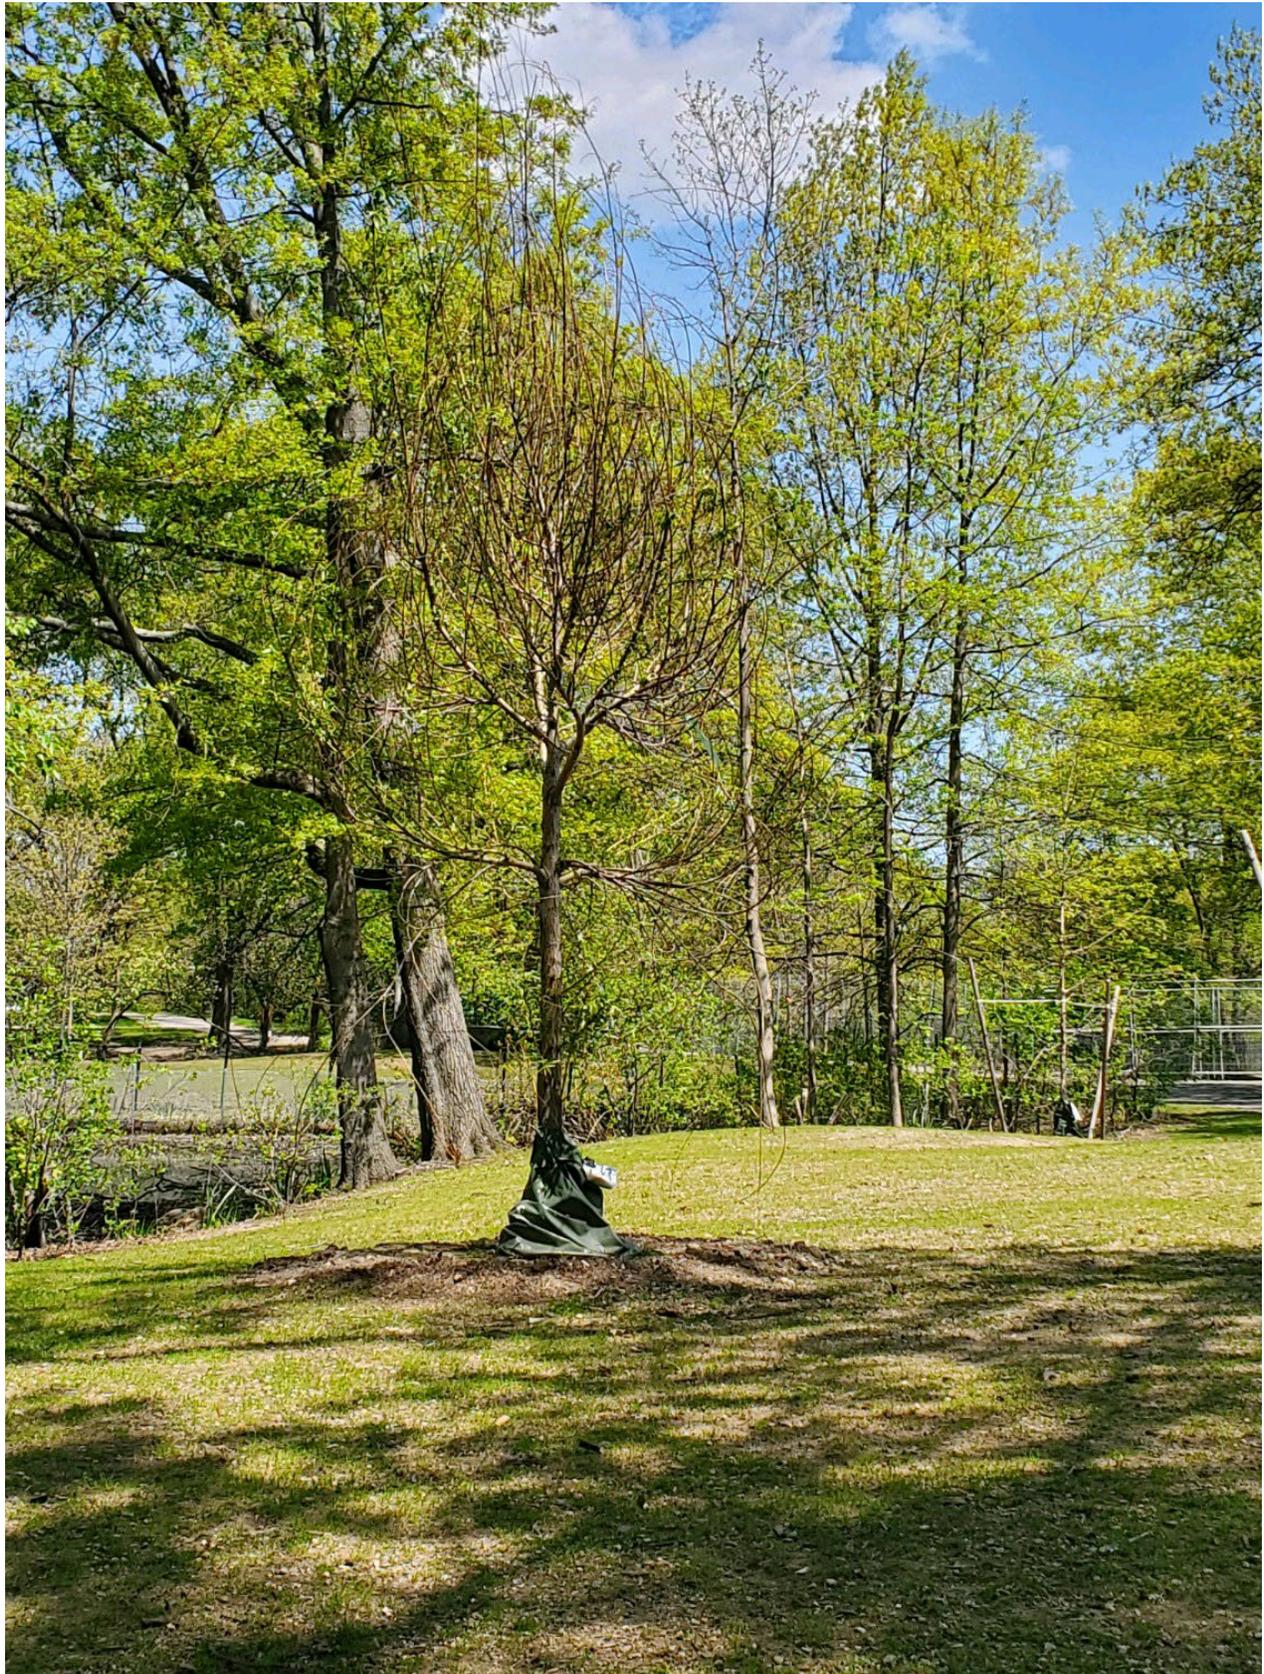
Work Area #9 – section of river immediately downstream of Work Area #8 – planted tree and turf coming back to life with the Spring weather.

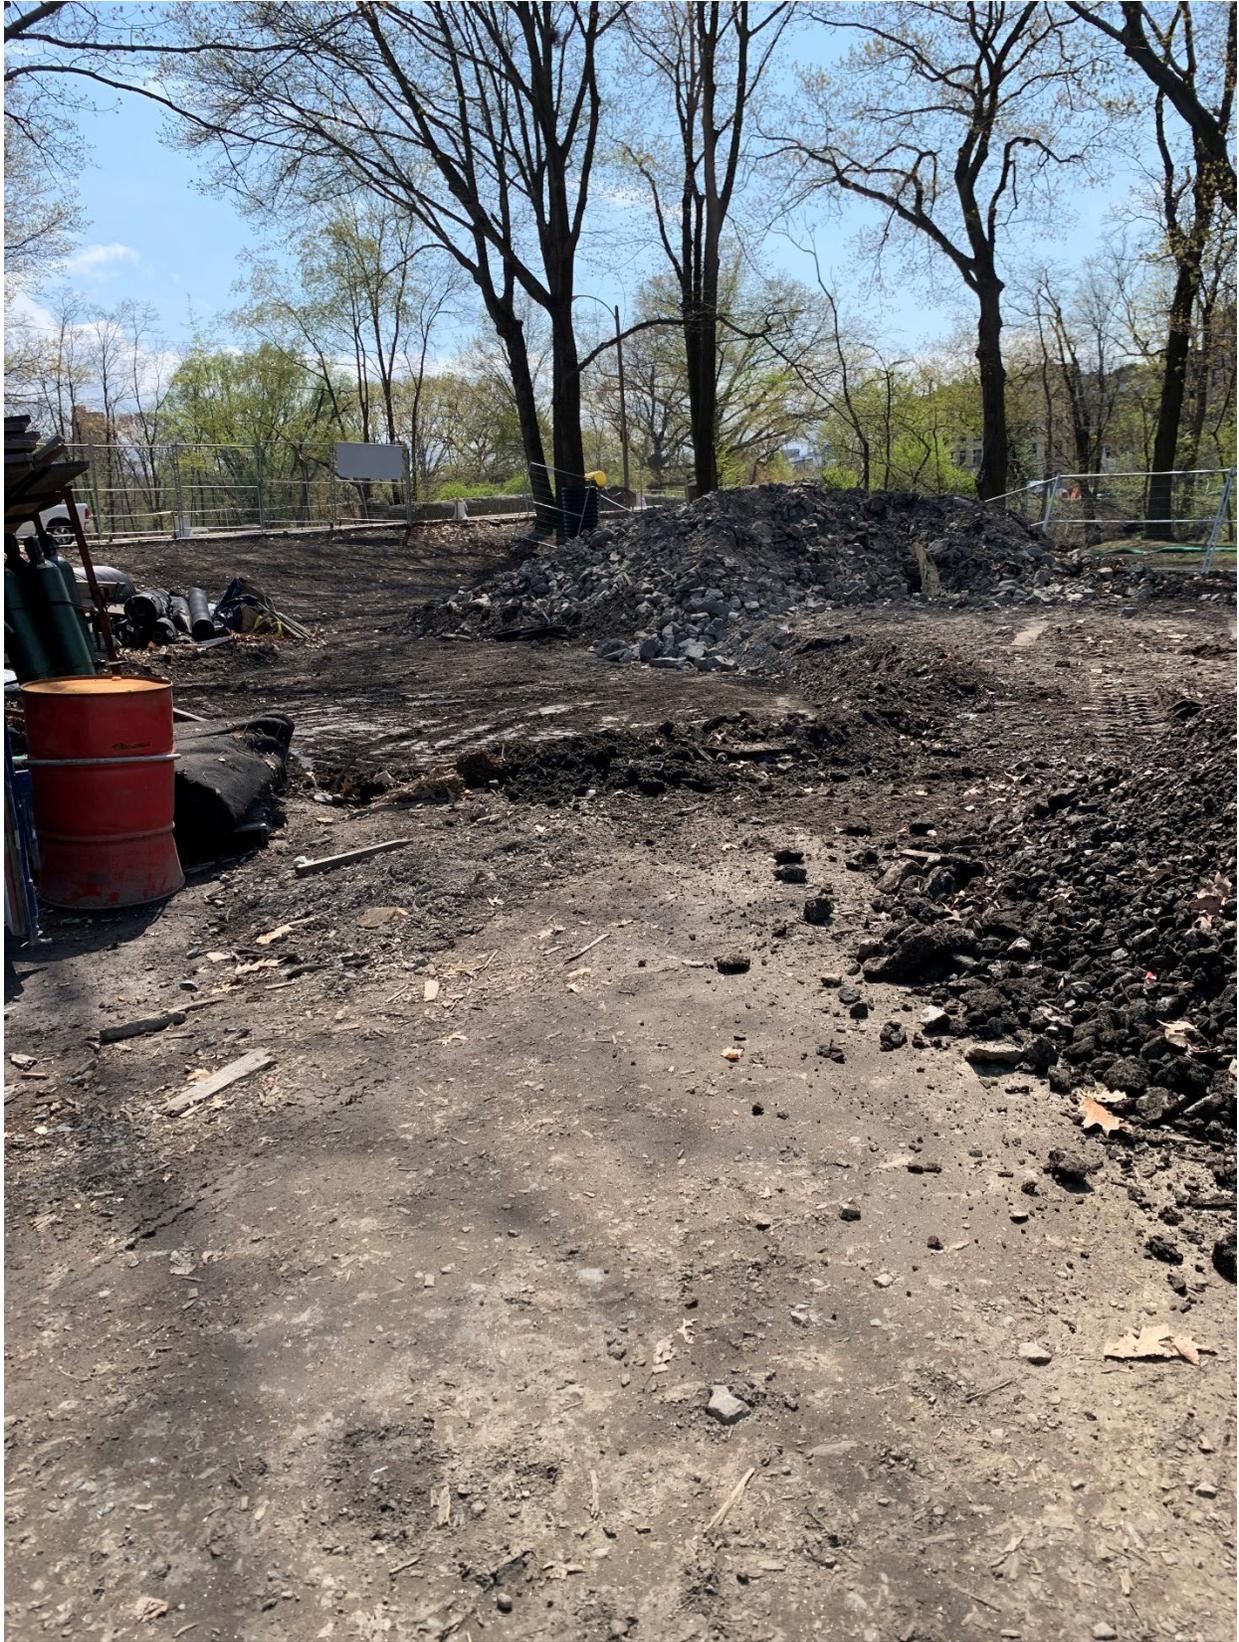
Work Area #11 – Additional Phragmites Removal – section of the river near Duck House – Removal of materials and equipment from the Central Processing Area by the Duck House in preparation of restoration and plantings.

- **Additional Phragmites Removal in Work Areas #5, #6, #11, and #12** – at the request of and the funding provided by the Sponsors, additional phragmites were removed from within the footprint of Work Areas #5 and #6 and the area restored/planted late August into early September 2022. In Work Areas #11 and #12, additional phragmites removal began mid-October and was completed at the end of December 2022. The phragmites removal is not required for the Flood Risk Management project; however, the removal will provide additional environmental restoration benefits to the system as well as provide maintenance benefits for the dredged channel. Site preparation and wetland shelf creation were completed late April. Plants were delivered in early May for installation. Maintenance of the planting will begin immediately during the two-year plant guarantee period.

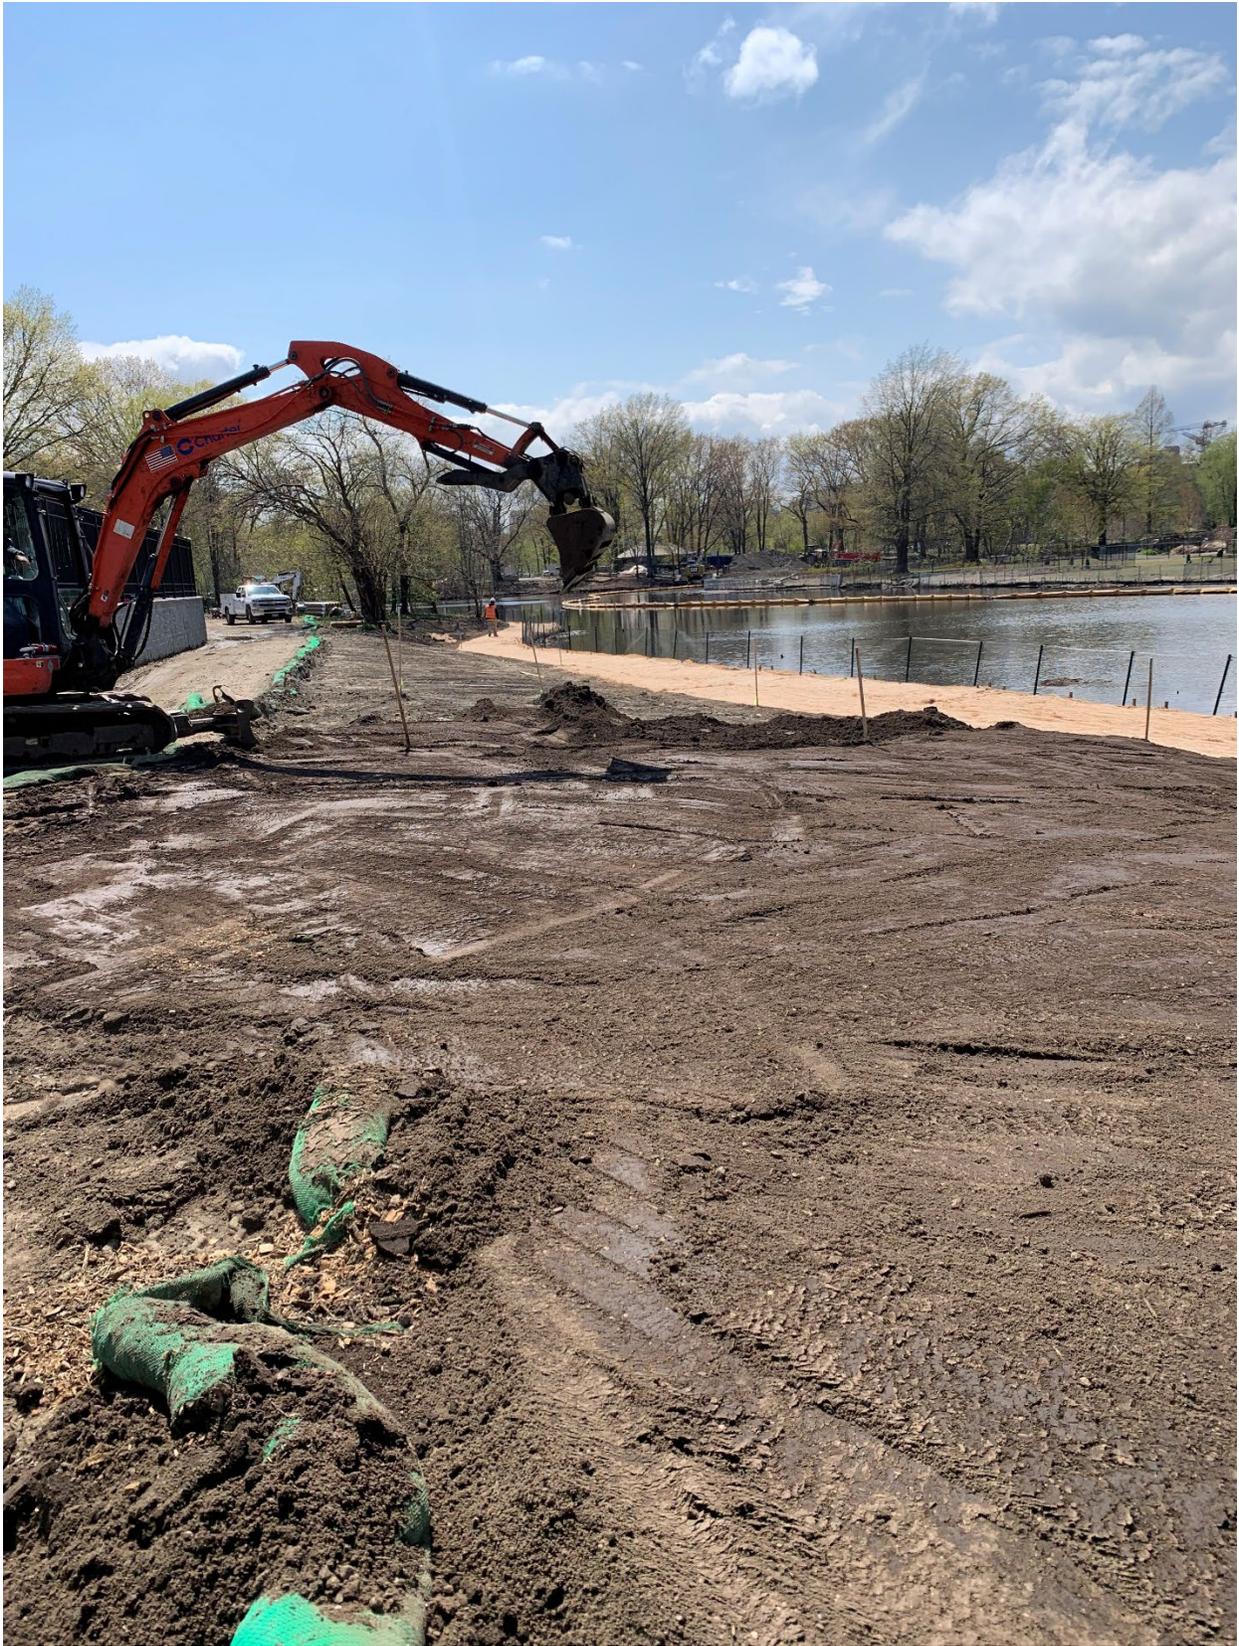
Work Area #12 – Additional Phragmites Removal – section of the river near BFD Building – Equipment spreading loam ahead of plantings for the restoration in this area.

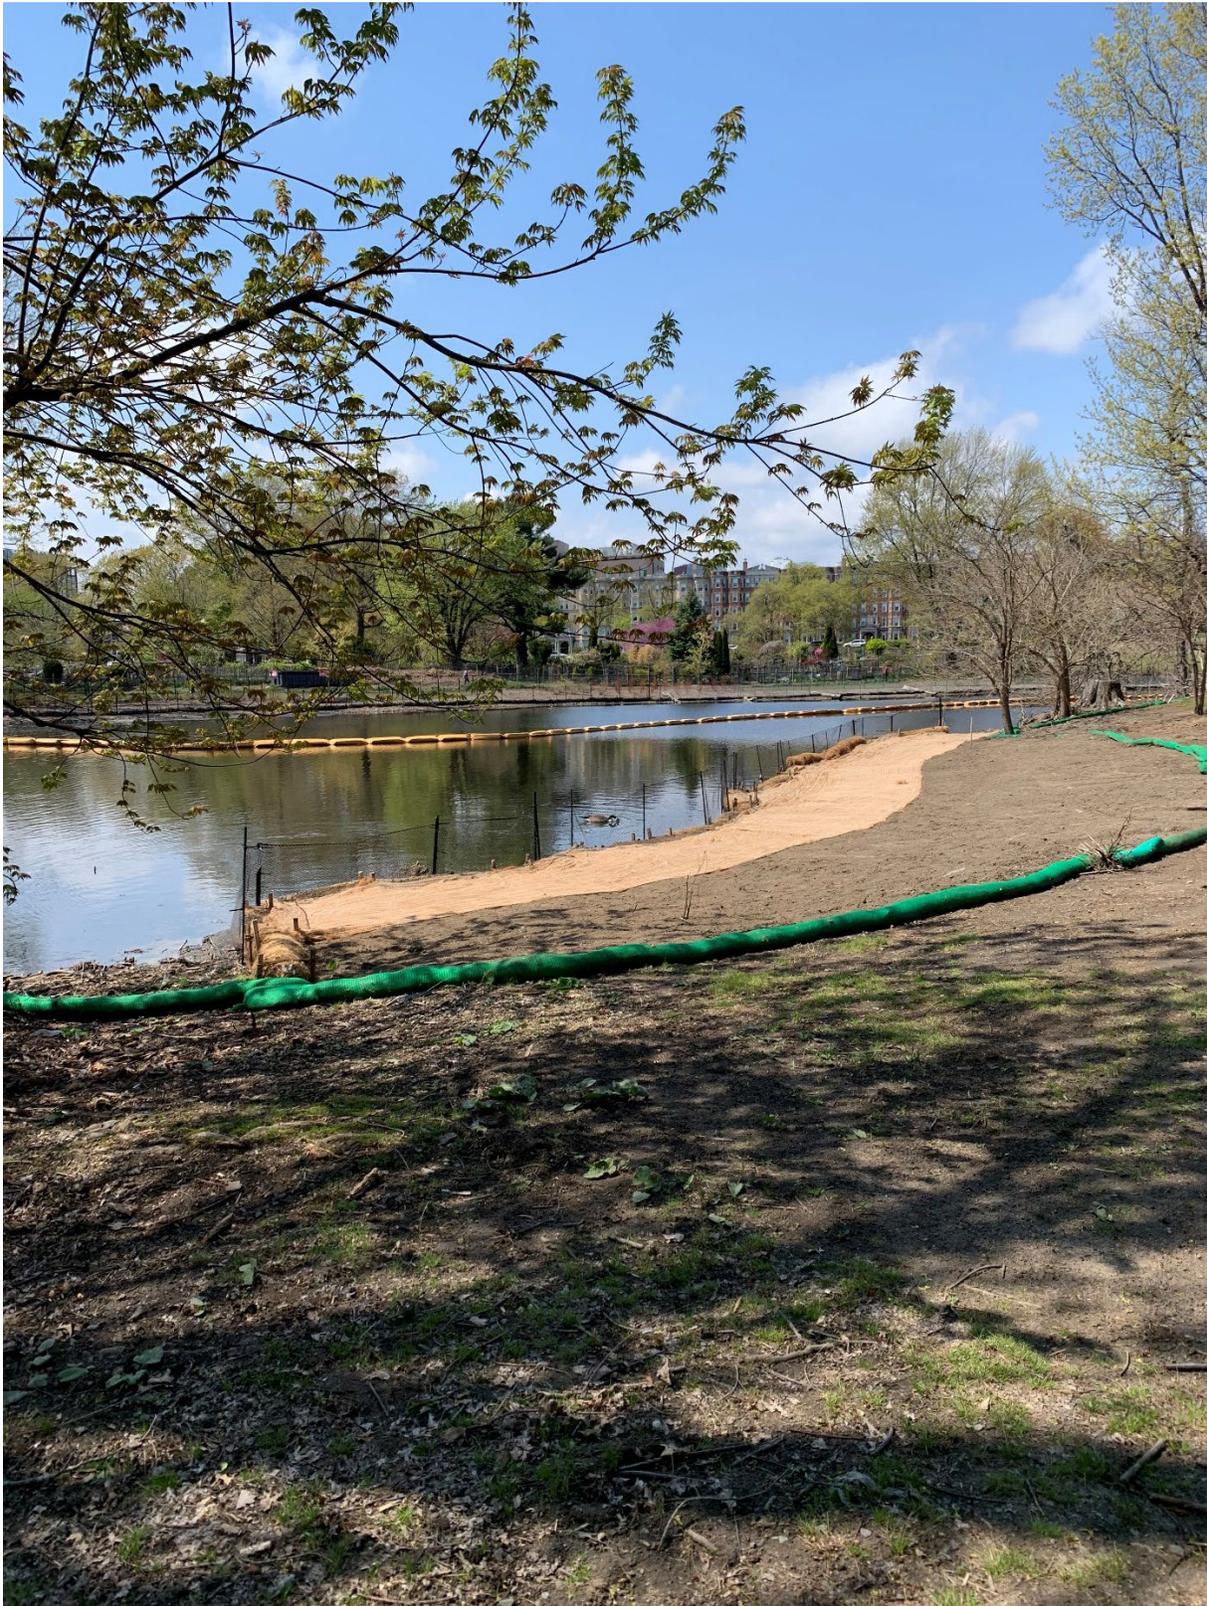
Work Area #12 – Additional Phragmites Removal – section of the river near BFD Building – Prepared area with loam, turf reinforcement mat (TRM) and herbivore fence installed ahead of plant installation.

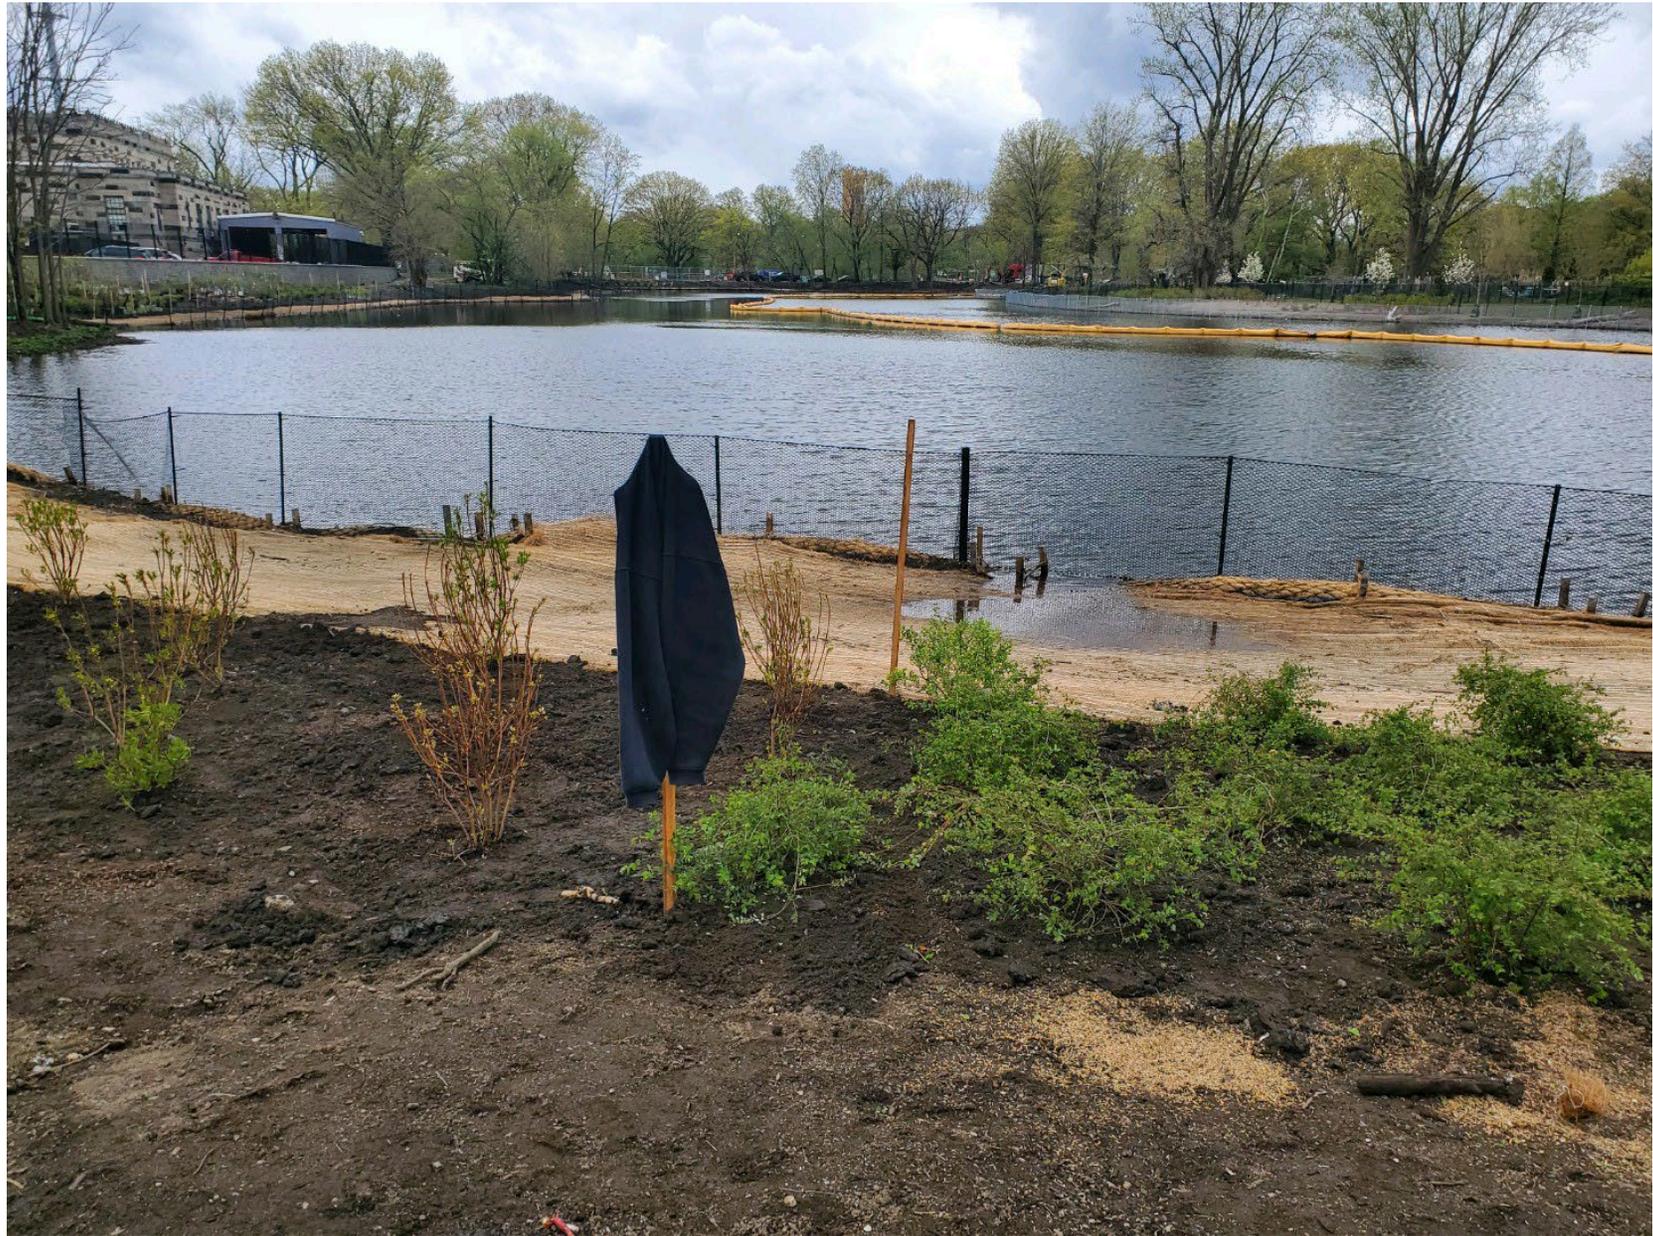
Work Area #12 – section of the river near Boylston Street Bridge – Upland shrubs installed and wetland seed spread in the TRM as part of the bank restoration.

- **Work Areas #11 and #12** – Victory Gardens Area – dredging in the section of the river downstream of Agassiz Road Bridge began in late-December 2021 and was completed mid-May 2022. Planting and restoration of Work Areas #11 and #12 began mid-September and was completed mid-October to coincide with the Fall planting window. Stonedust path restoration was completed early December 2022. Maintenance of the planting will continue to October 2024 during the two-year plant guarantee period. The contractor began removing the sediment processing bins in mid-February and the last of the steel sheeting was removed by end of March 2023. Removal of equipment and cleanup near the Duck House is finishing up as the site preparation and planting is beginning to take place during this Spring planting window.
