US ARMY CORPS OF ENGINEERS

NEW HAVEN HARBOR DEEP DRAFT NAVIGATION IMPROVEMENT PROJECT

Project Studies

January 2018

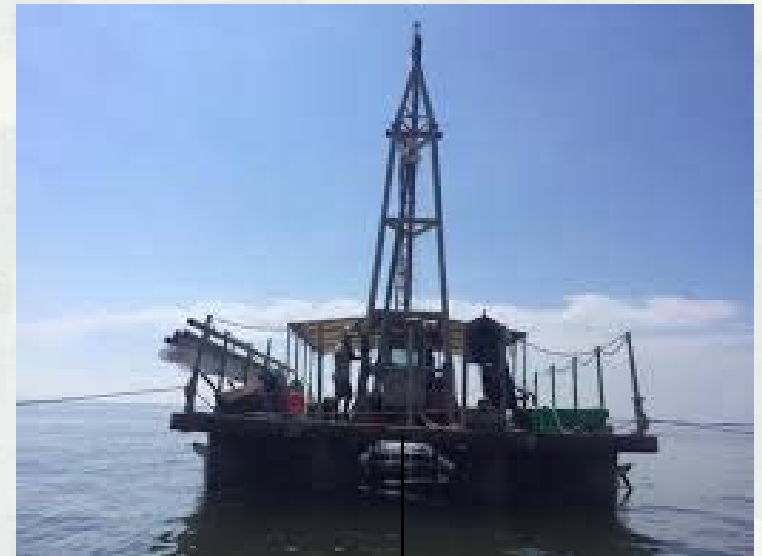
Vibracore sampling to deepest project depth
alternative (-42 feet MLLW + -2 feet)

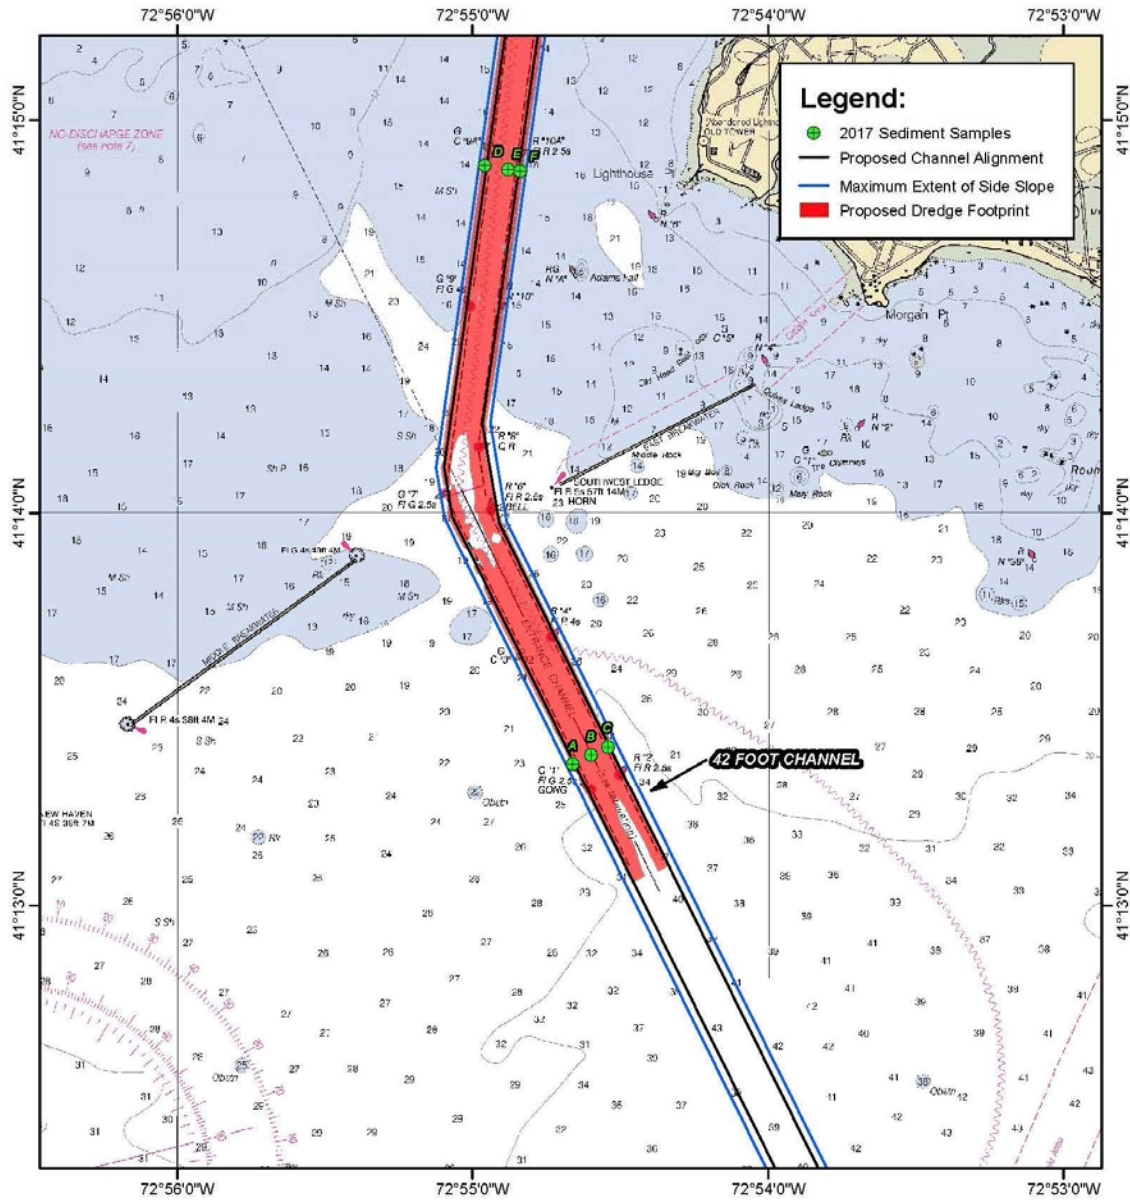
Outer Harbor

- 2 transects
- 6 stations

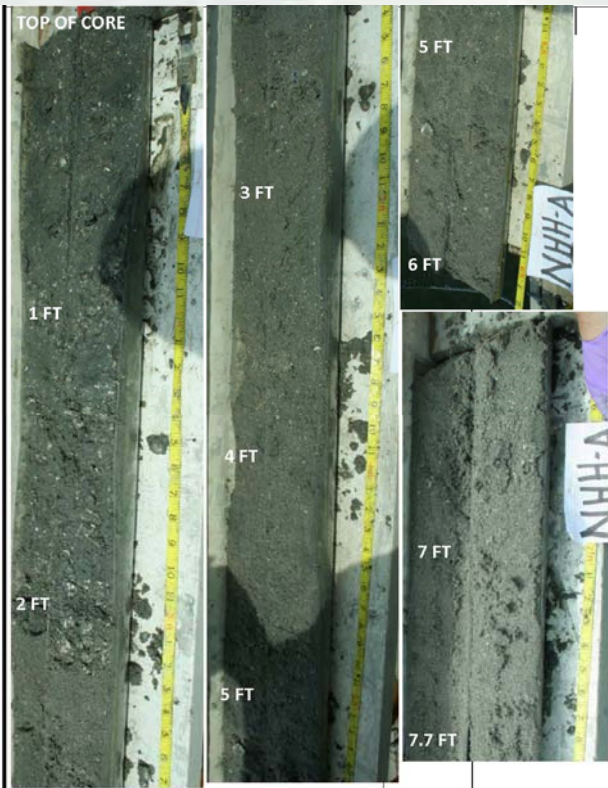
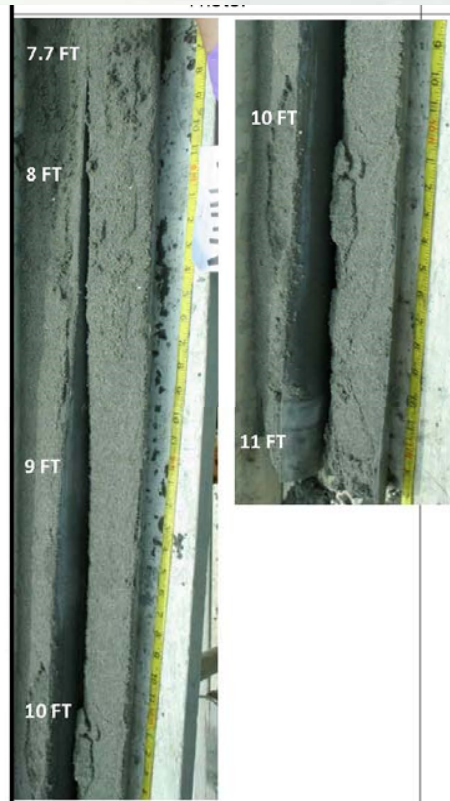
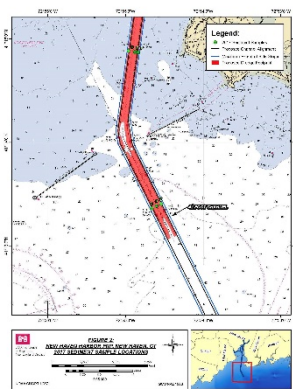
0 - 2.2' - Dark grey fine/ medium sand with trace silt and shells. SW-SM

2.2' - 6.2' - Tan fine/ medium sand with shells. SP

6.2' - 7.7' - Tan fine/ medium sand. SP

7.7' - 11.0' - Tan fine/ medium sand. SP

Core Log from Station A - material type = all fine sand

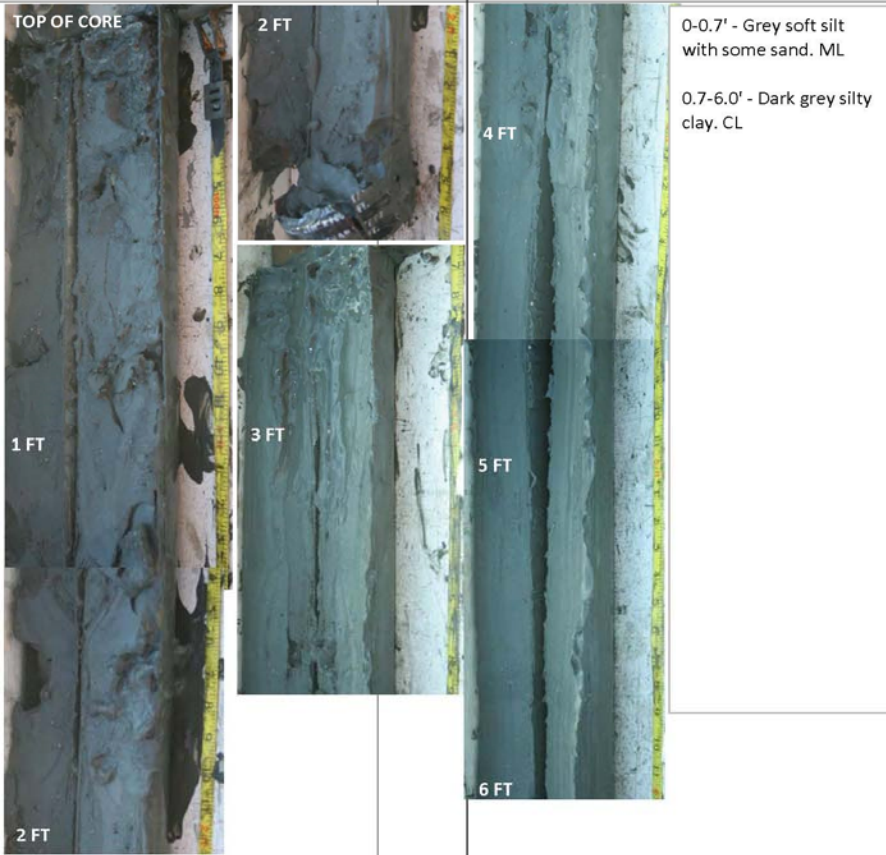
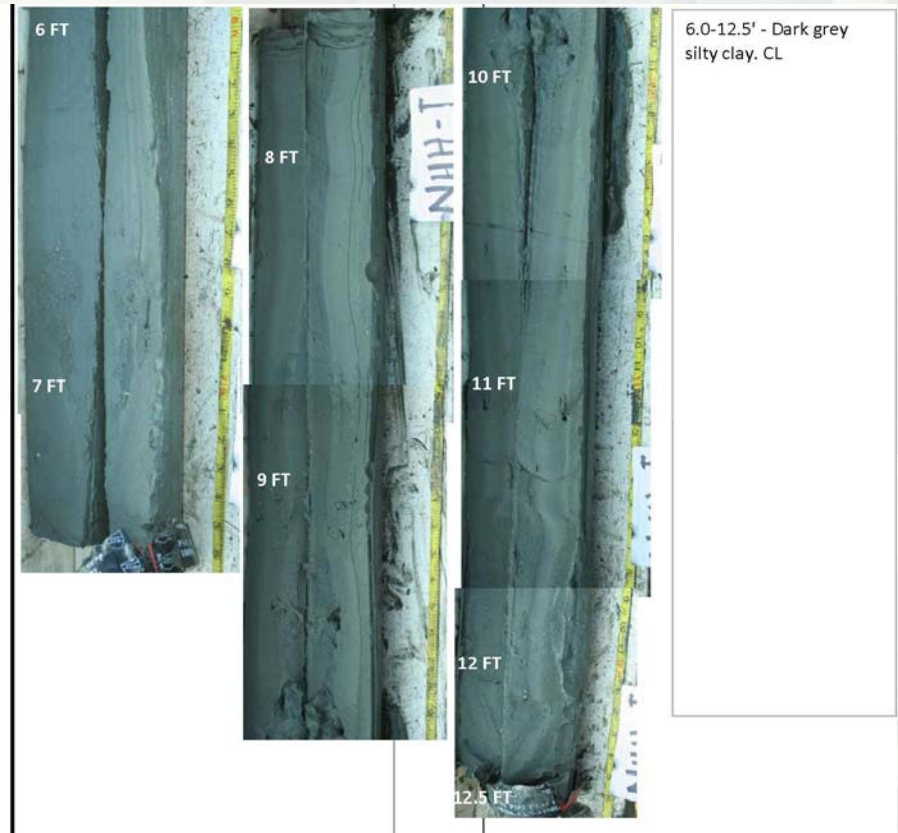
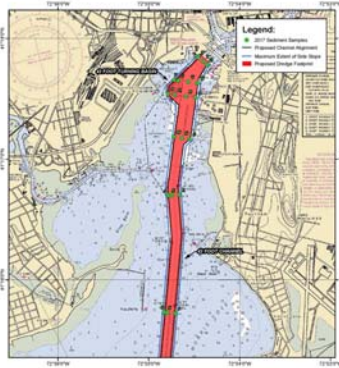
Core Log from Station I - material type = silt and clay

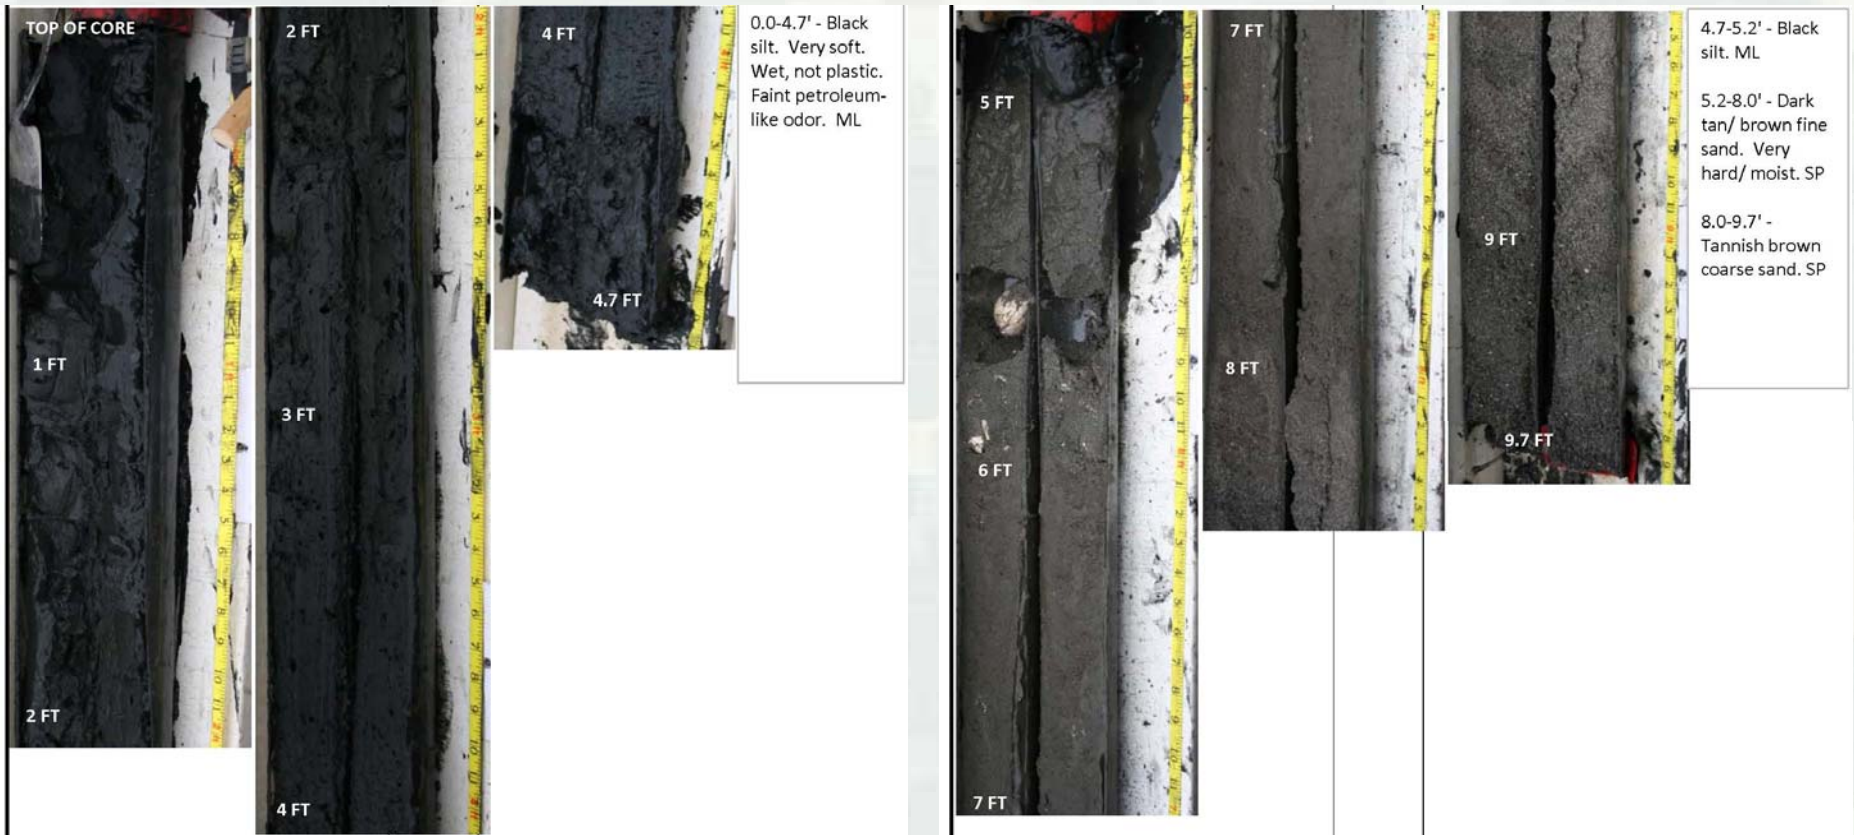
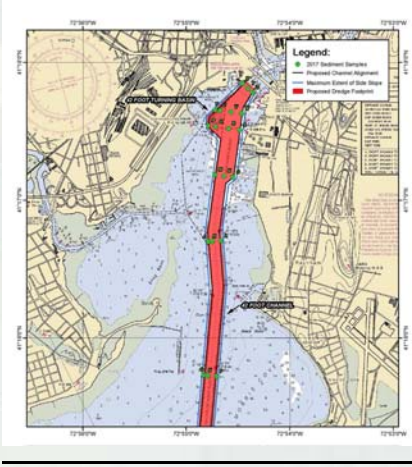
Core Log from Station X – material type = silt and clay from sediment-water interface to 5.2 ' / silty sand below

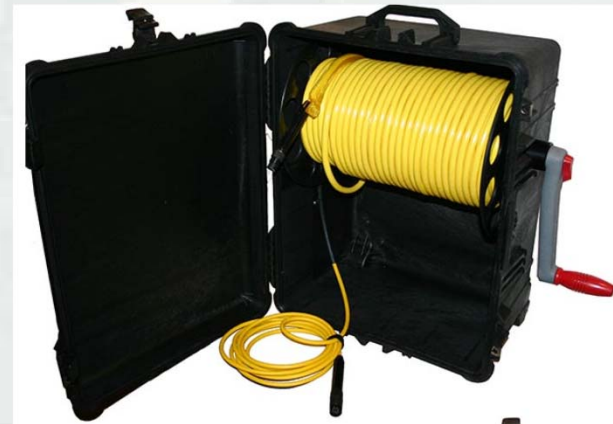
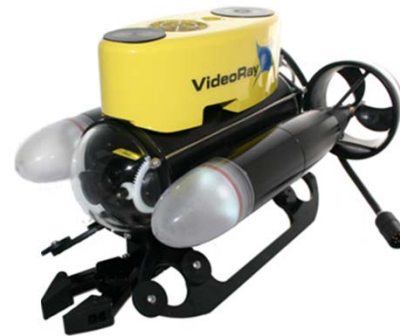
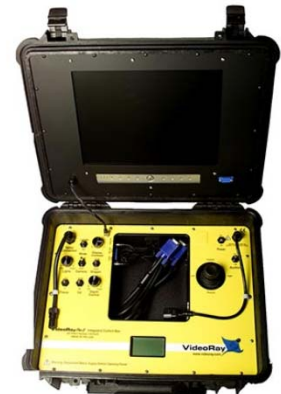
- **Remotely Operated Underwater Vehicle (ROV)** deployed from the same survey platform used during hydroacoustic surveys.
- **VideoRay Pro3 GTO** used to investigate a subset of targets identified through interpretation of side scan sonar data from the project area.
- Video feed viewed in real time and recorded to DVR for review and analysis.

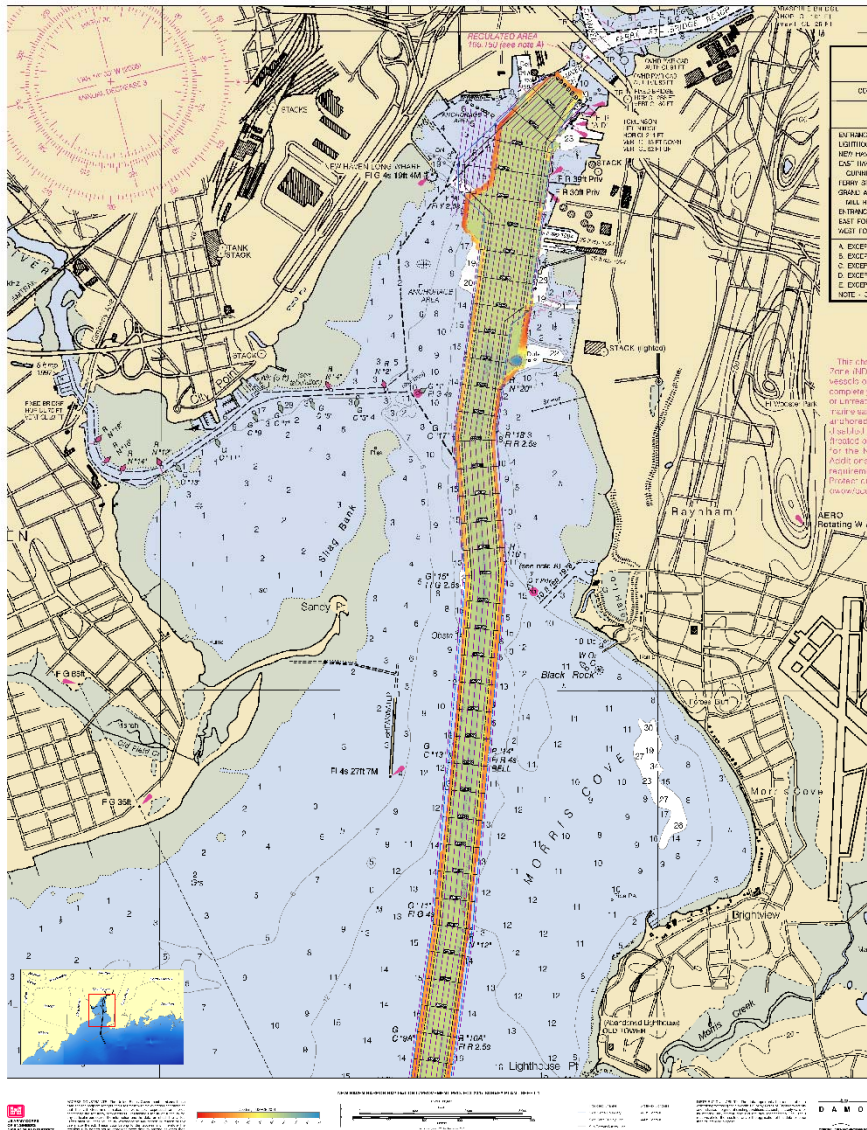
Survey Plan

- Side scan sonar survey lines laid out parallel to the channel boundary using a line spacing of 100 feet.

→ 22 lines totaling 68.8 survey miles

- All lines run at a speed of 4kts in alternating directions to minimize non-recording time

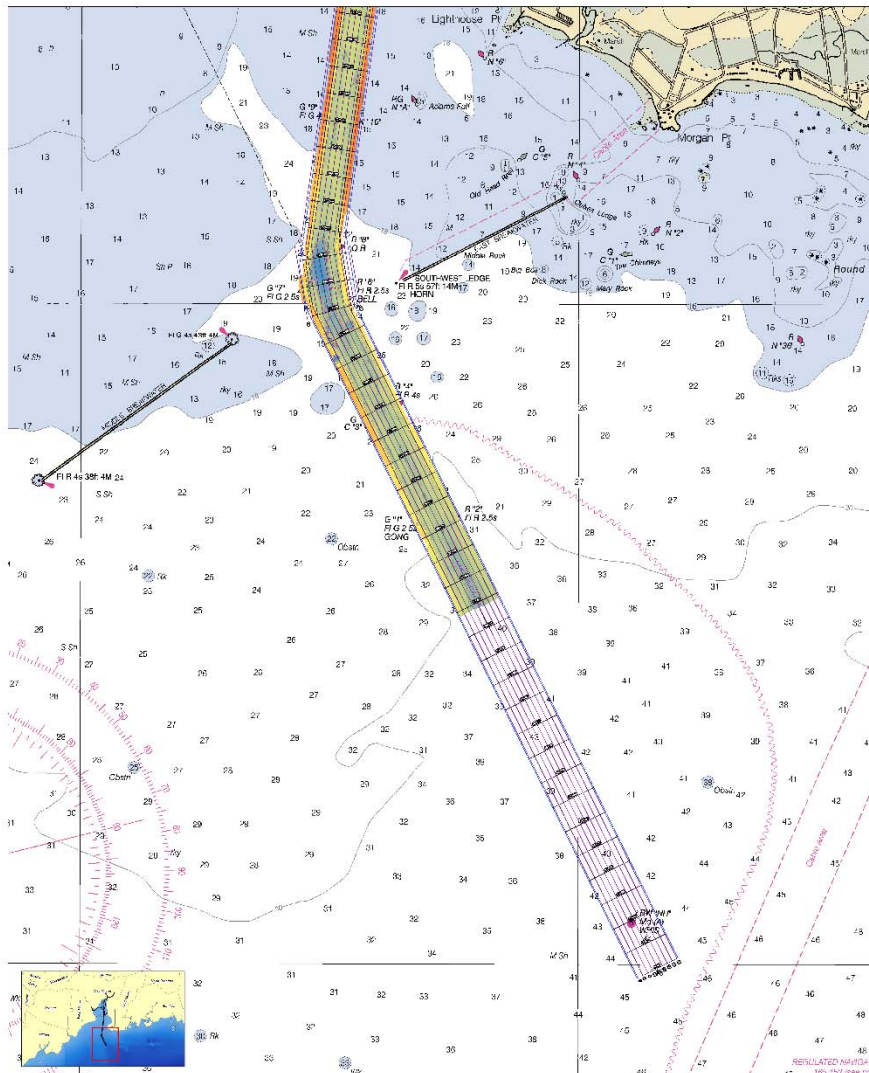
Survey Plan

- Side scan sonar survey lines laid out parallel to the channel boundary using a line spacing of 100 feet.

→ 22 lines totaling 68.8 survey miles

- All lines run at a speed of 4kts in alternating directions to minimize non-recording time

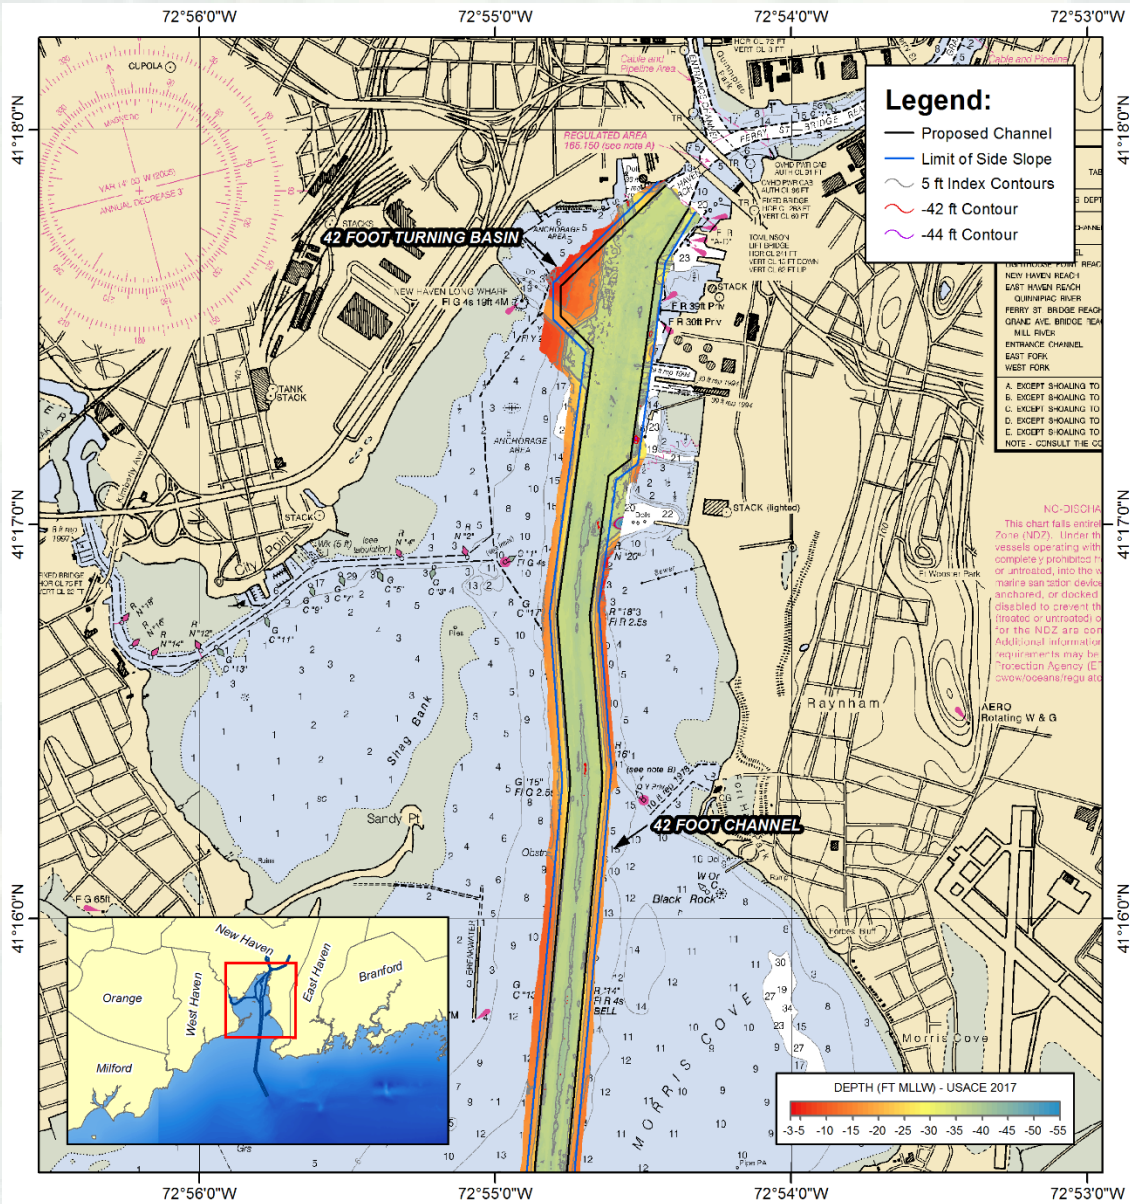
Inner Harbor Bathymetry

- 200kHz bathy data processed using Hypack- Hysweep Editor
- 3x3 averaged matrix consisting of 1,048,576 processed points exported to ArcGIS for further analysis and for map creation.
- Achieved full coverage of the proposed project area with exception of the eastern half of entrance channel between G1/R2 and NH sea buoy.

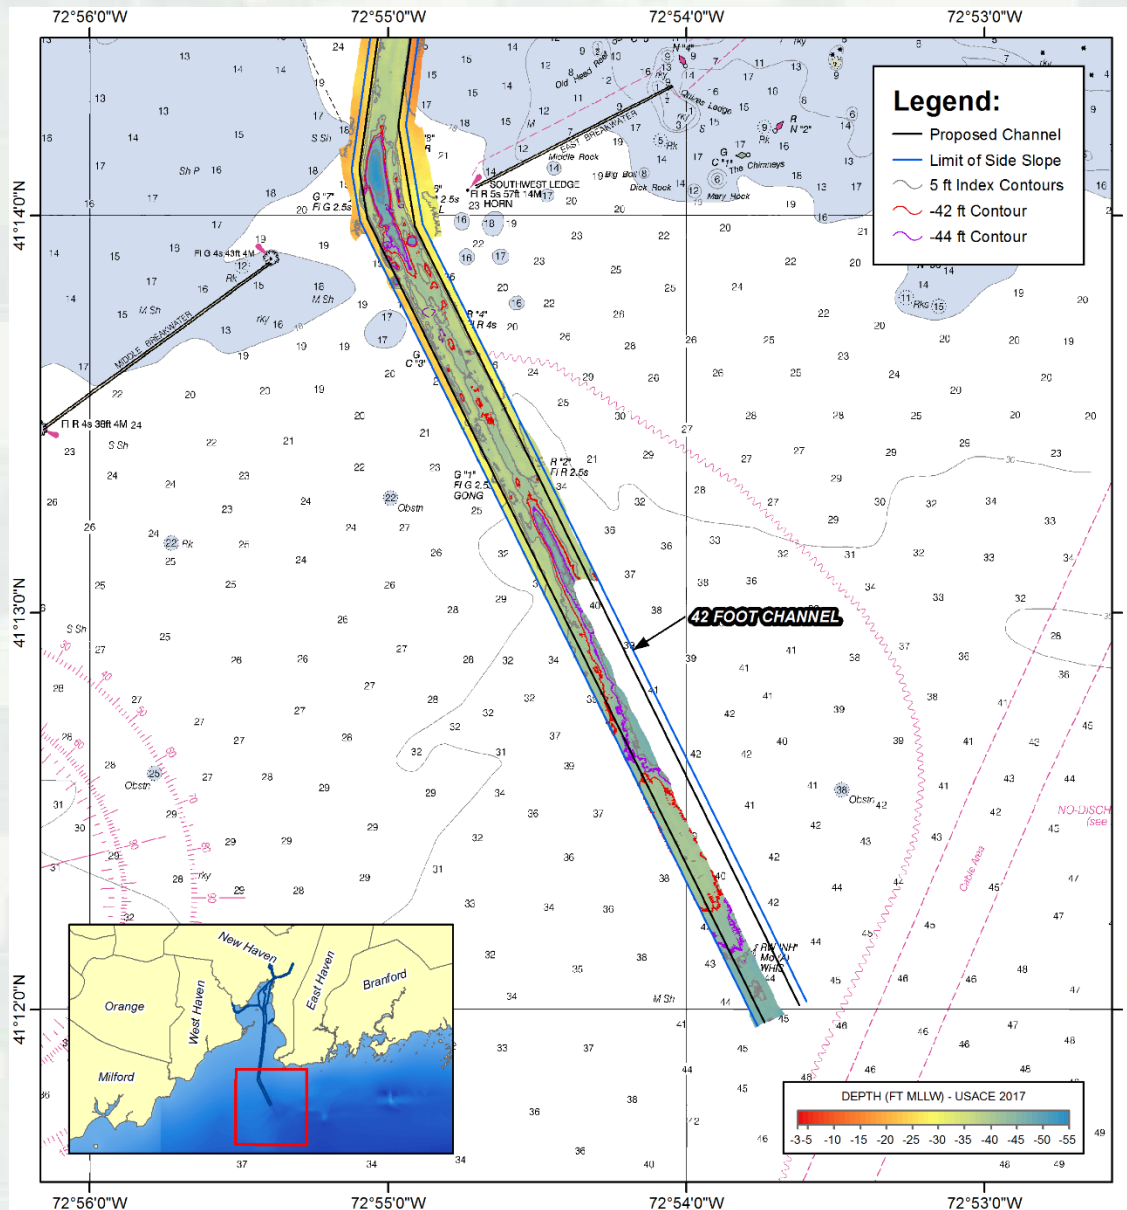
Outer Harbor Bathymetry

- 200kHz bathy data processed using Hypack- Hysweep Editor

- 3x3 averaged matrix consisting of 1,048,576 processed points exported to ArcGIS for further analysis and for map creation.

- Achieved full coverage of the proposed project area with exception of the eastern half of entrance channel between G1/R2 and NH sea buoy.

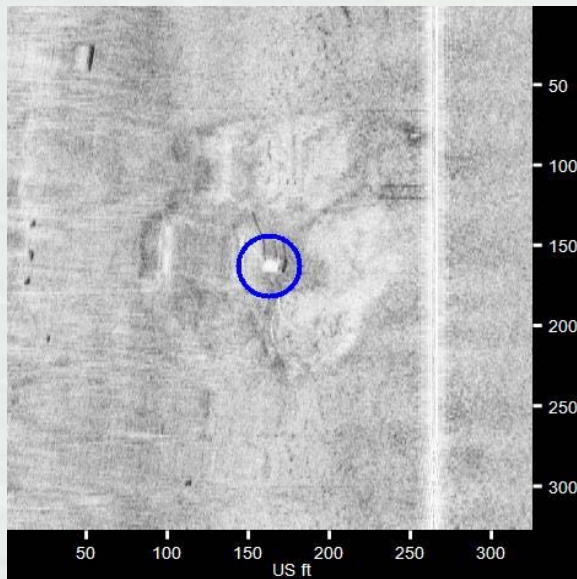
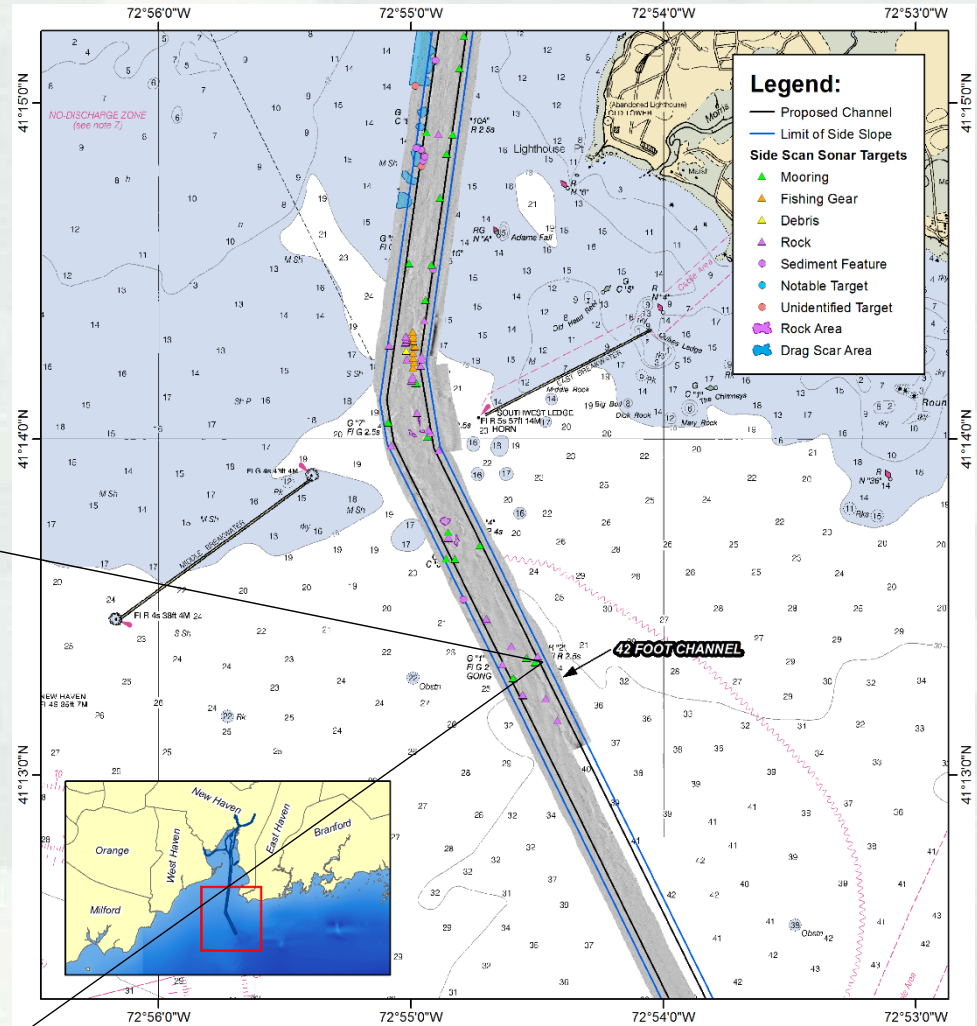
Target NHH013

Classification: Mooring

- Lat 41.222242 Lon -72.9084532
- Length: 5.7 ft Width: 6.2 ft
- Description:

Mooring for R2. Line visible. Match with location on NAV chart. Possible derelict mooring to NW.

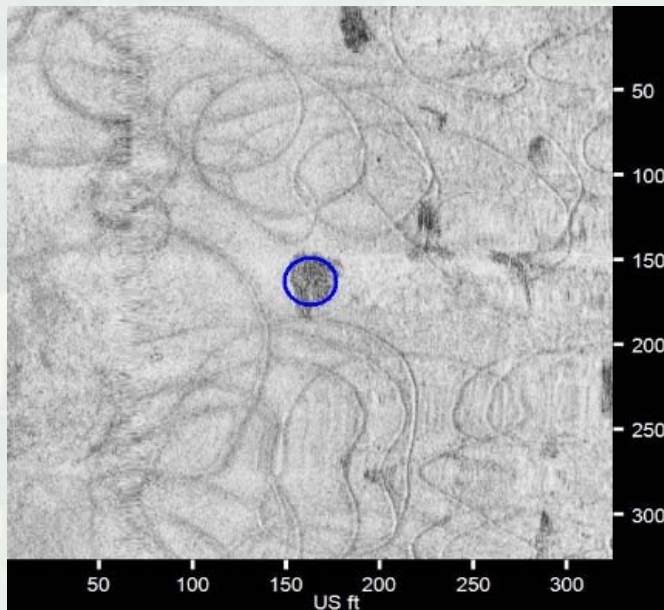
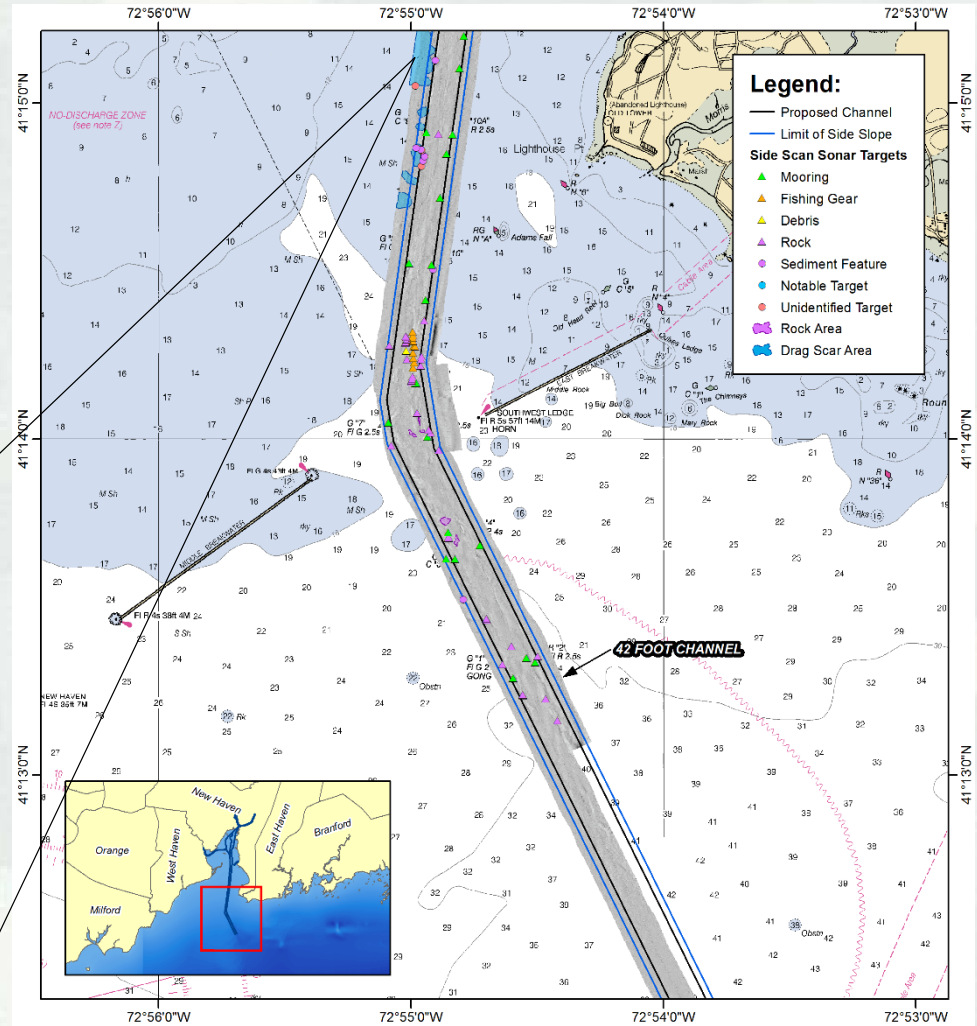
Target NHH0090

Classification: Drag scars

- Lat 41.252210 Lon -72.915926
- Length: 1040.7 ft Width: 329.8 ft
- Description:

Area of drag scars and disturbed sediment along western side of channel.

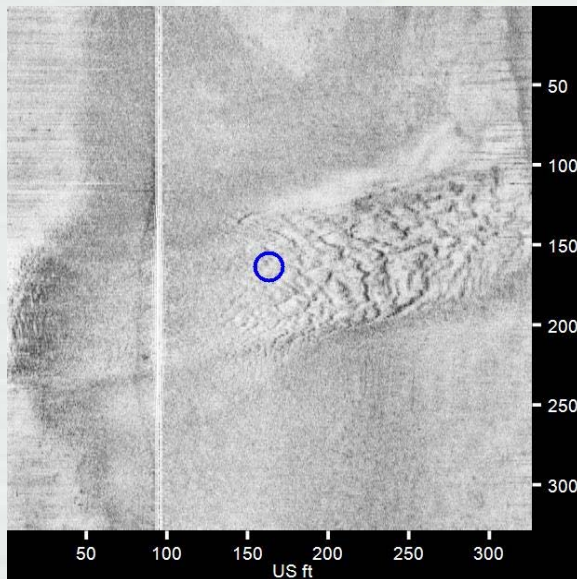
Target NHH0201

- Classification: Sewer Outfall
- Lat 41.281354 Lon -72.910219
- Length: 737.6 ft Width: 76.5 ft
- Description:

Sediment feature corresponding to sewer outfall on nav chart.

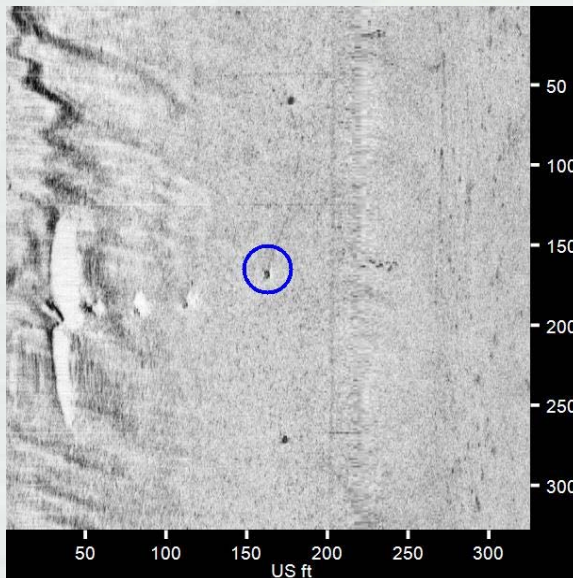
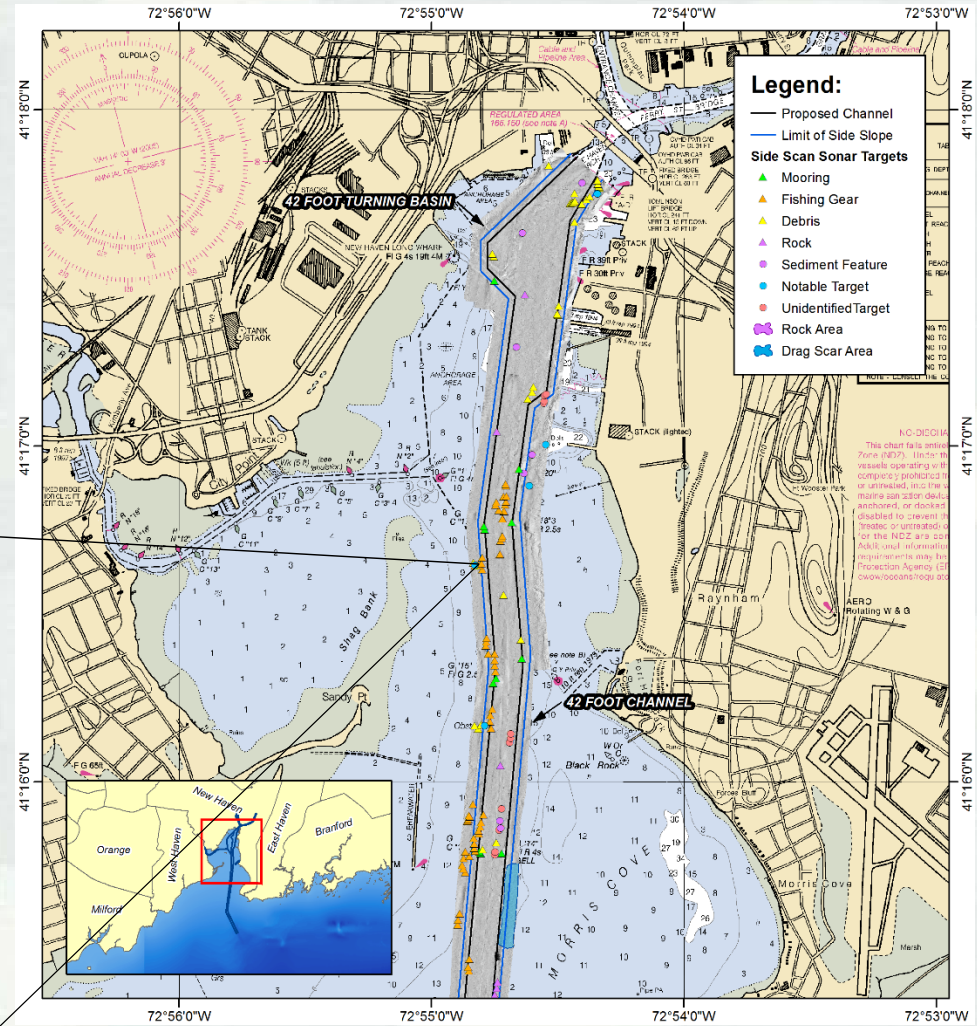
Target NHH0178

- Classification: Fishing gear
- Lat 41.277485 Lon -72.913345
- Length: 3.5 ft Width: 2.9 ft
- Description:

String of rectangular targets adjacent to channel. Line visible. Likely derelict fishing gear.

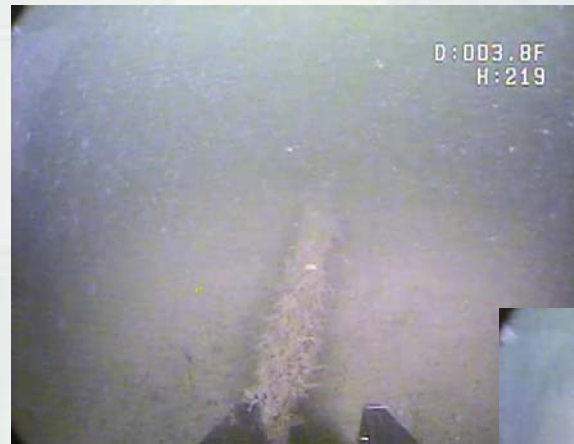
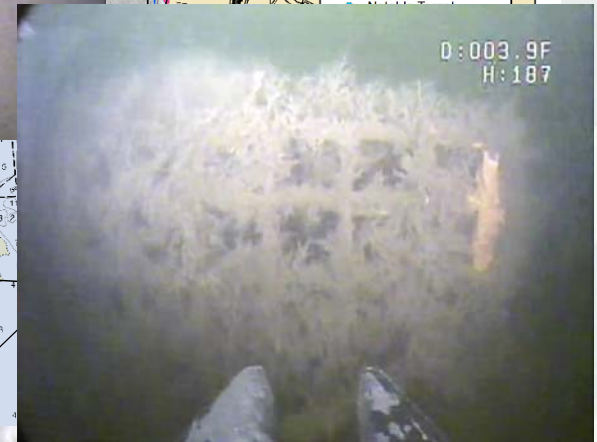
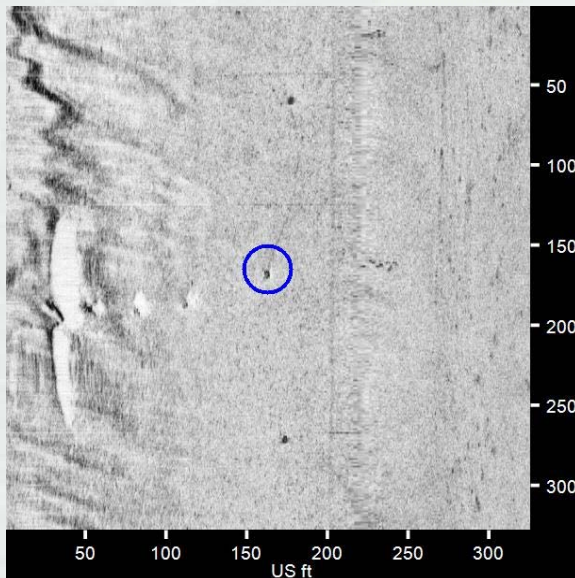
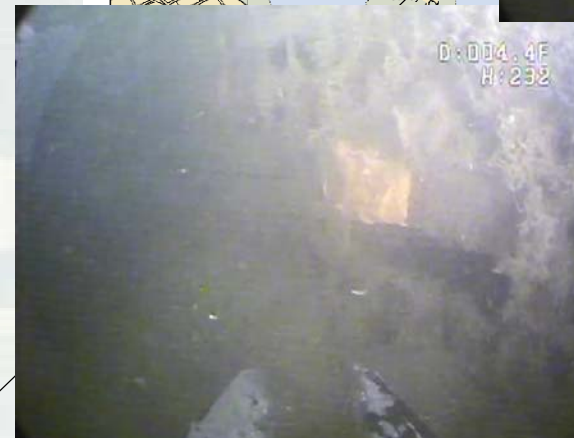
Target NHH0178

- Classification: Fishing gear
- Lat 41.277485 Lon -72.913345
- Length: 3.5 ft Width: 2.9 ft
- Description:

String of rectangular targets adjacent to channel. Line visible. Likely derelict fishing gear.

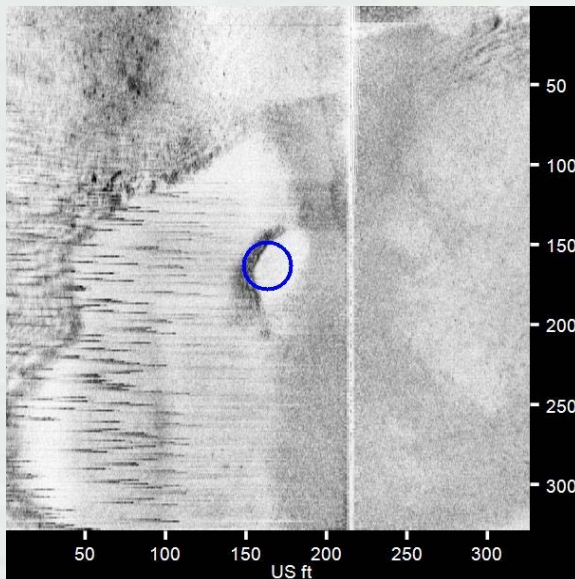
Target NHH0203

- Classification: Area of coarse material
- Lat 41.281970 Lon -72.910550
- Length: 53.1 ft Width: 15.3 ft
- Description:

Large gravel/shell reef adjacent to edge of channel.

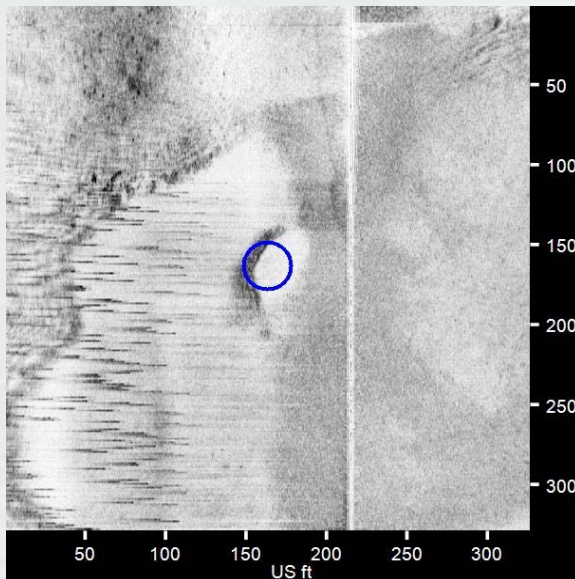
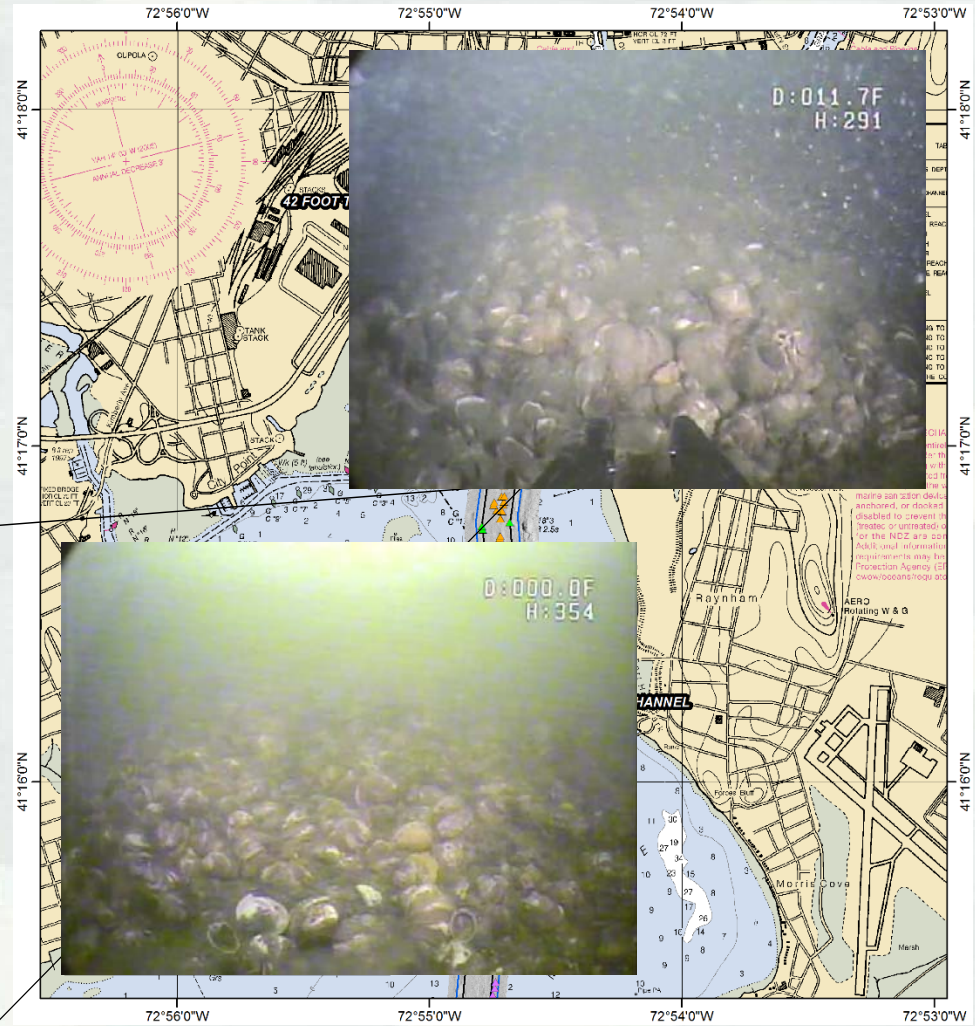
Target NHH0203

- Classification: Area of coarse material
- Lat 41.281970 Lon -72.910550
- Length: 53.1 ft Width: 15.3 ft
- Description:

Large gravel/shell reef adjacent to edge of channel.

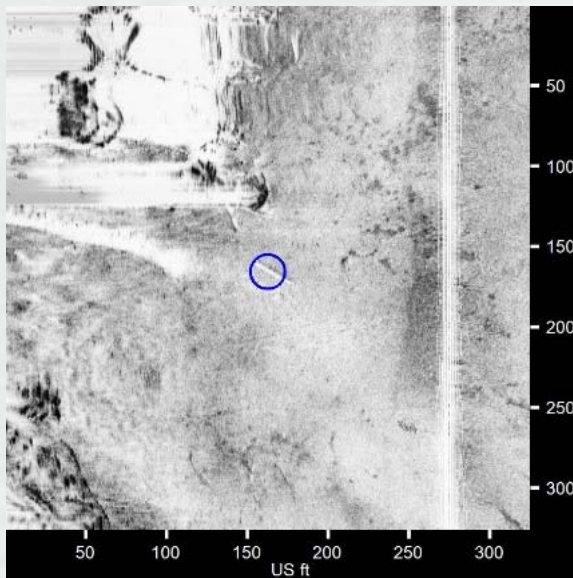
Target NHH0242

- Classification: Debris, piling
- Lat 41.297225 Lon -72.908892
- Length: 26.8 ft Width: 1.3 ft
- Description:

Linear target on seafloor in vicinity of pier.
Likely piling.

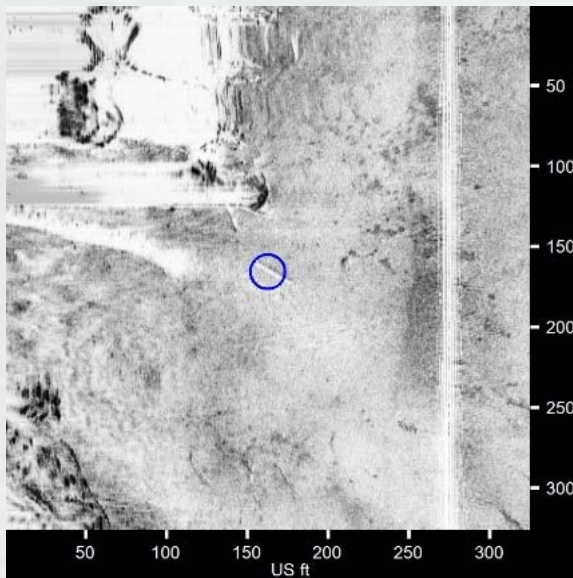
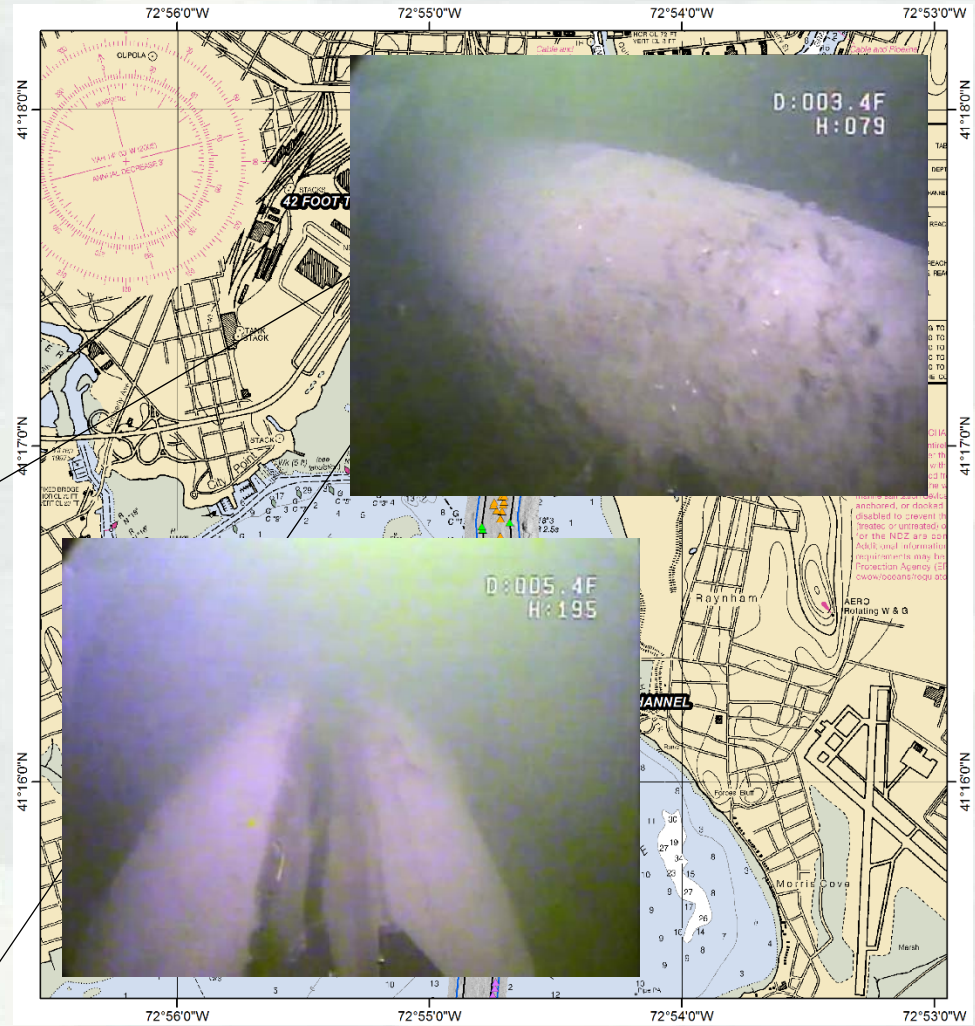
Target NHH0242

- Classification: Debris, piling
- Lat 41.297225 Lon -72.908892
- Length: 26.8 ft Width: 1.3 ft
- Description:

Linear target on seafloor in vicinity of pier.
Likely piling.

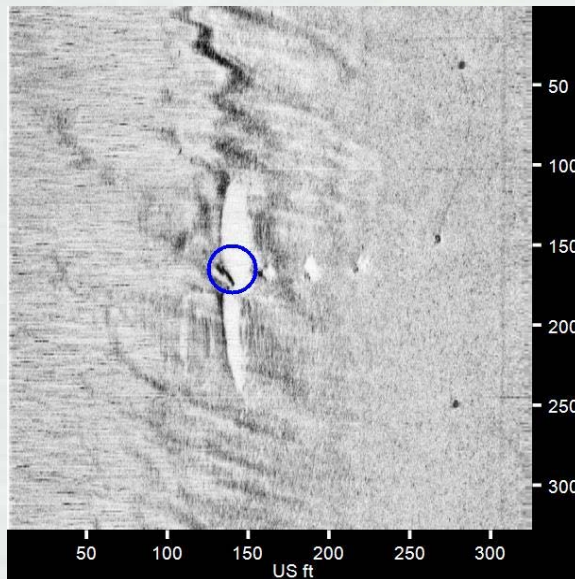
Target NHH0176

- Classification: Debris, possible shipwreck
- Lat 41.277411 Lon -72.913807
- Length: 129.0 ft Width: 19.8 ft
- Description:

Large irregular target adjacent to channel.
Partially buried. Likely wreckage or debris.
Visible on multiple survey lines.

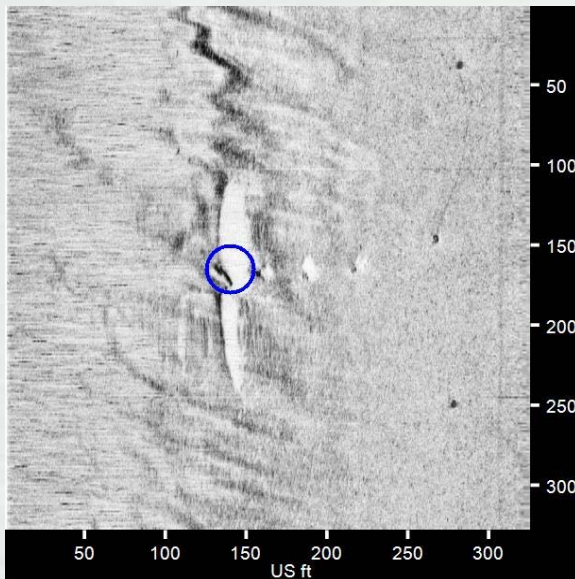
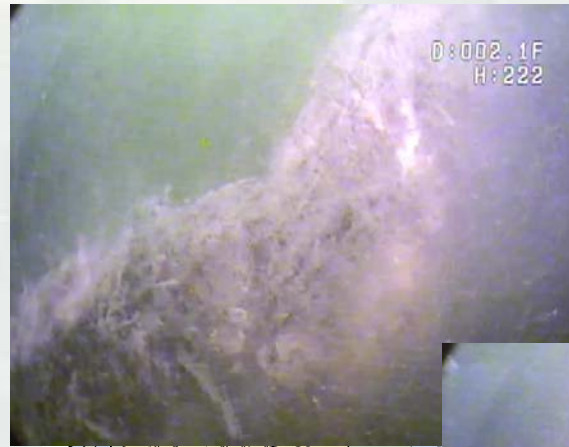
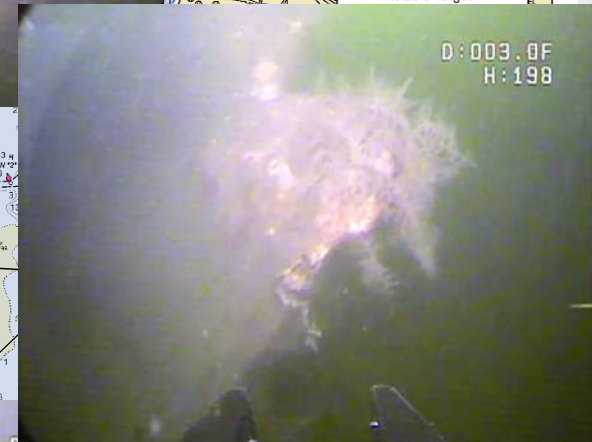
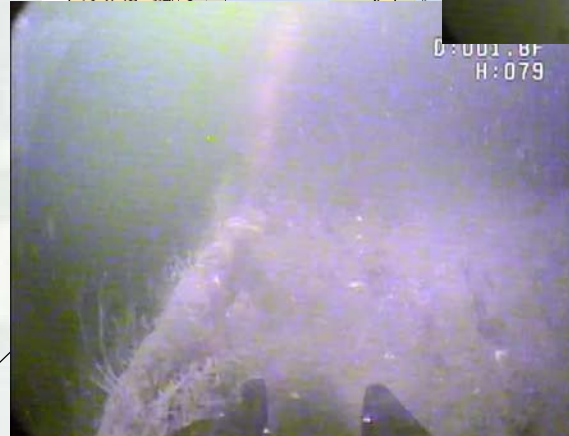
Target NHH0176

- Classification: Debris, possible wreck
- Lat 41.277411 Lon -72.913807
- Length: 129.0 ft Width: 19.8 ft
- Description:

Large irregular target adjacent to channel.
Partially buried. Likely wreckage or debris.
Visible on multiple survey lines.
