Part 2: Overview of Dredged Material Disposal at the Proposed Penobscot Bay Site

- History of aquatic placement of dredged material
- Current techniques for placement of dredged material in the aquatic environment and tools for monitoring
- Overview of the proposed Penobscot Bay Site

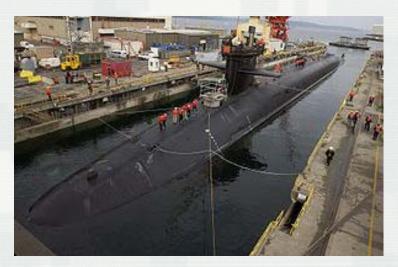
Disposal Area Monitoring System (DAMOS) was initiated in 1977 focused on monitoring material dredged from the Trident sub base

- Targeted placement of material to minimize impacts
- Monitoring to track site recovery

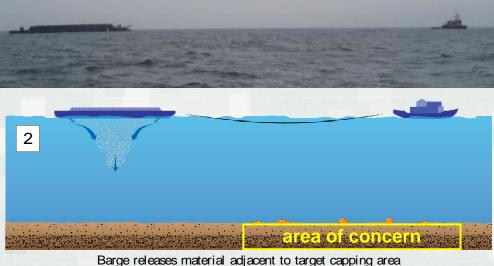
- GPS allows for tracking tug/scow over full disposal trip
- hull and draft sensors allow for tracking release of material from the scow

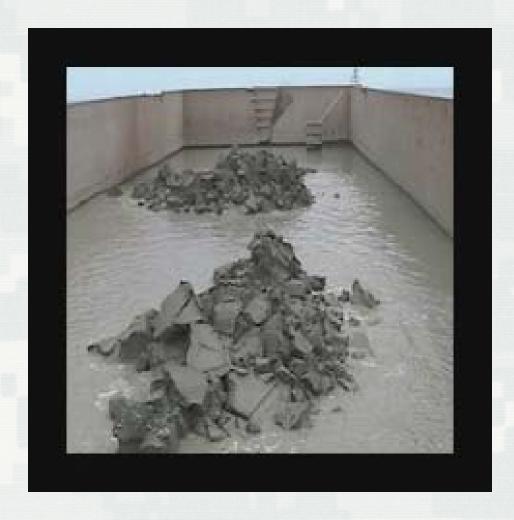
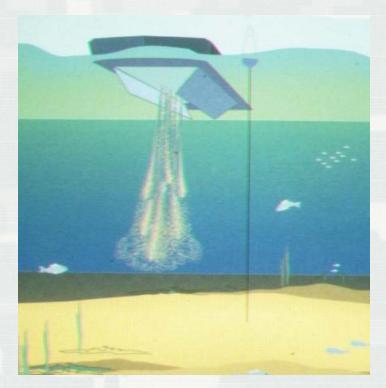
Scow releasing material over CAD concerns about release of disposed cell in Providence Harbor material have triggered detailed monitoring and research over the past several decades 2 PARENT MATERIAL schematic of placement of unsuitable material into a **Confined Aquatic Disposal** FEET (HORIZONTAL) (CAD) cell

Field measurements and analyzed water samples support the finding of limited release to the water column

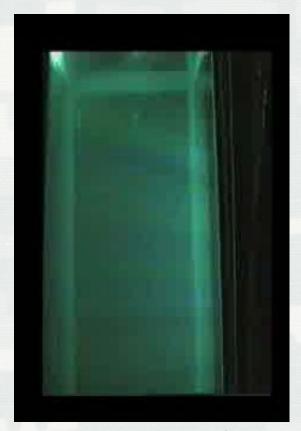
MIT laboratory simulation of release of material from a scow using scaled fluorescent beads in a ~10 ft tank (Ruggaber 2000)

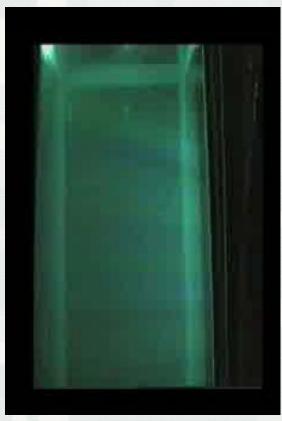
MIT laboratory simulation of release of material from a scow using scaled fluorescent beads in a ~10 ft tank (Ruggaber 2000)

- released material reaches the bottom of the relatively shallow depths of NE sites before the material spreads out through the water column
- supports the field measurements of limited release to the water column

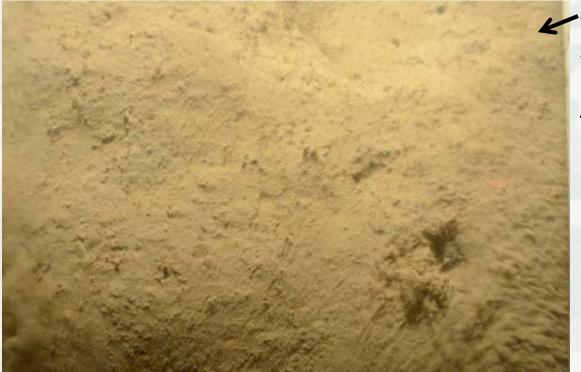
example plan view image of seafloor in a pit within the proposed disposal area (~2 ft across)

example profile view image across the sediment water interface in a pit within the proposed disposal area (~6 inches across)

- bathymetry revealed pits with relatively steep sides and extending well below the surrounding seafloor
- uniform fine-grained sediments
- clusters of deep pits within the site appear ideal for limiting the footprint of the placed dredged material
