The Massachusetts Division of Marine Fisheries

Conservation Boat Mooring Recommendations in Eelgrass and Other Sensitive Aquatic Habitats

June 10, 2019

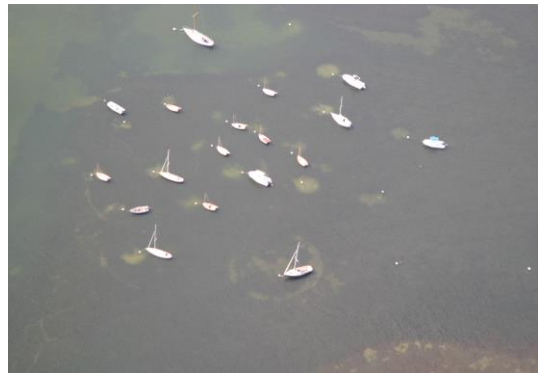
Figure 1. Aerial image of boat mooring scars in an eelgrass meadow in West Falmouth. Photo credit: DMF and Lighthawk, 2014

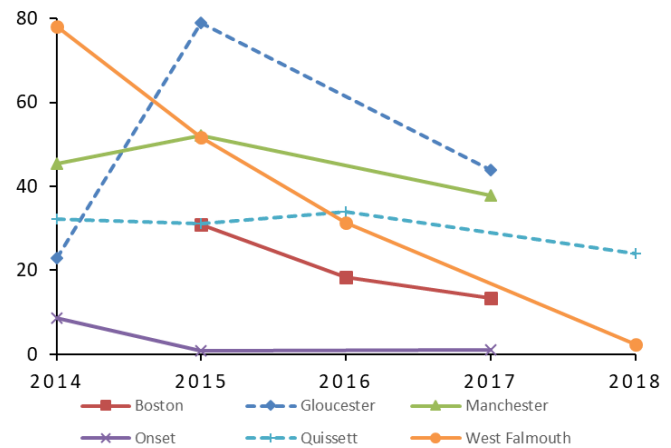
Figure 3. Average scar size decreased after Eco-moorings were installed in the six surveyed sites from 2014 to 2018. Note: Moorings monitored through Massport grant.

MA DMF's monitoring data show that in the majority of cases the conservation moorings were effective at reducing the size of eelgrass scars after a minimum of three years (Figure 3). Of all the moorings monitored, 67% showed a reduction in scar size after at least three years of monitoring, while 33% had an increase in scar size during the same time period. There were no cases where the scar size stayed the same, however, some scars changed very little (ex. 21m² to 20m² after three years).

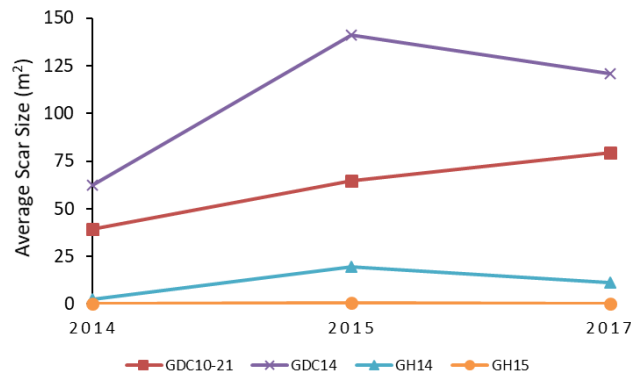
Figure 4. Scar expansions recorded at multiple Gloucester moorings caused by excess rode

Mooring scars expanded rapidly when the mooring dragged on the seabed. In certain cases, scar expansions were attributed to improperly sized moorings that were not sized correctly for the site or the vessel, causing the mooring to drag (Figure 4). Scar expansions were also recorded when a conservation mooring was converted back to a chain mooring; and also when the helix and mooring were installed in the vegetated meadow next to the mooring scar, rather than in the unvegetated scar where the former chain mooring had previously been placed. In addition, when conservation moorings were installed in eelgrass,
