WETLAND REFORESTATION MITIGATION ANNUAL MONITORING REPORT

**RENTSCHLER FIELD MONITORING REPORT 2 OF 3
USACE PERMIT NO. CENAE-R-2000-00741**

December 16, 2011

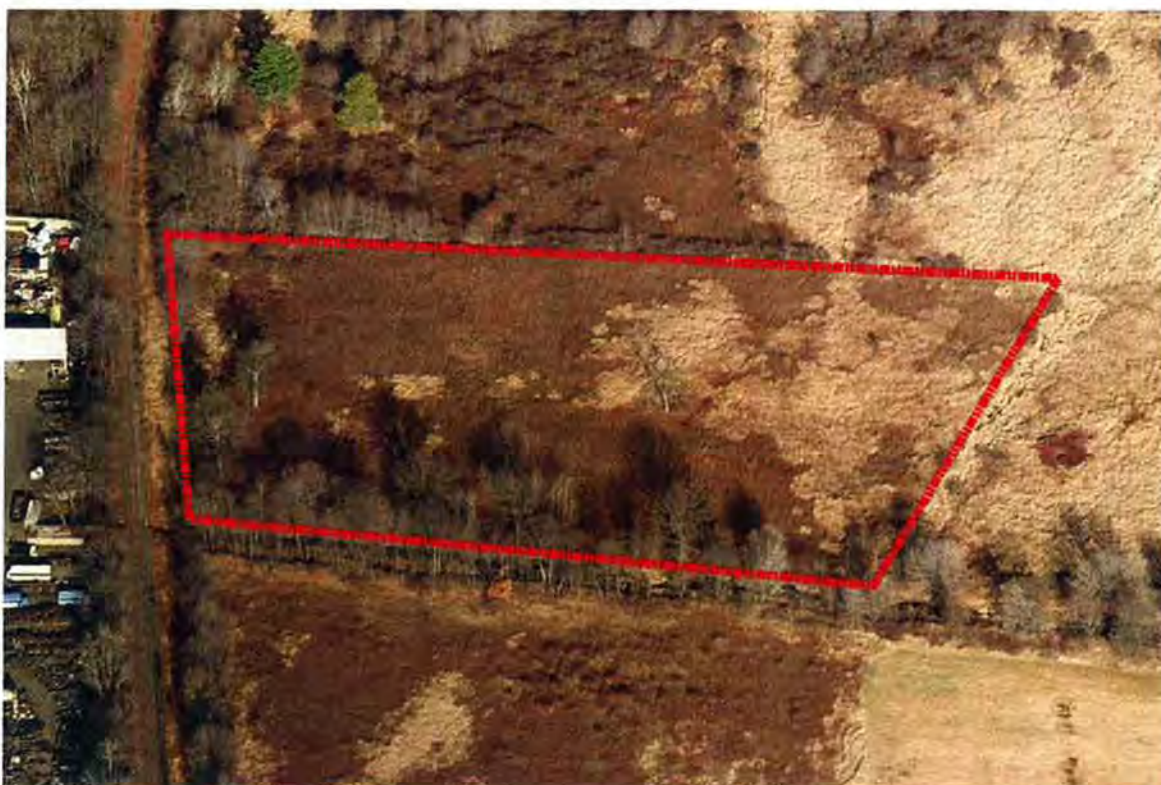
Figure 2

The project area is entering into the earliest phases of forest succession. The following color aerial photo, Figure 2, was downloaded from the 2010 <http://maps.live.com> website and represents the wetland reforestation mitigation area. This aerial photo was taken in late December 2006.

Five-Acre Wetland Reforestation Area – December 2006 Aerial

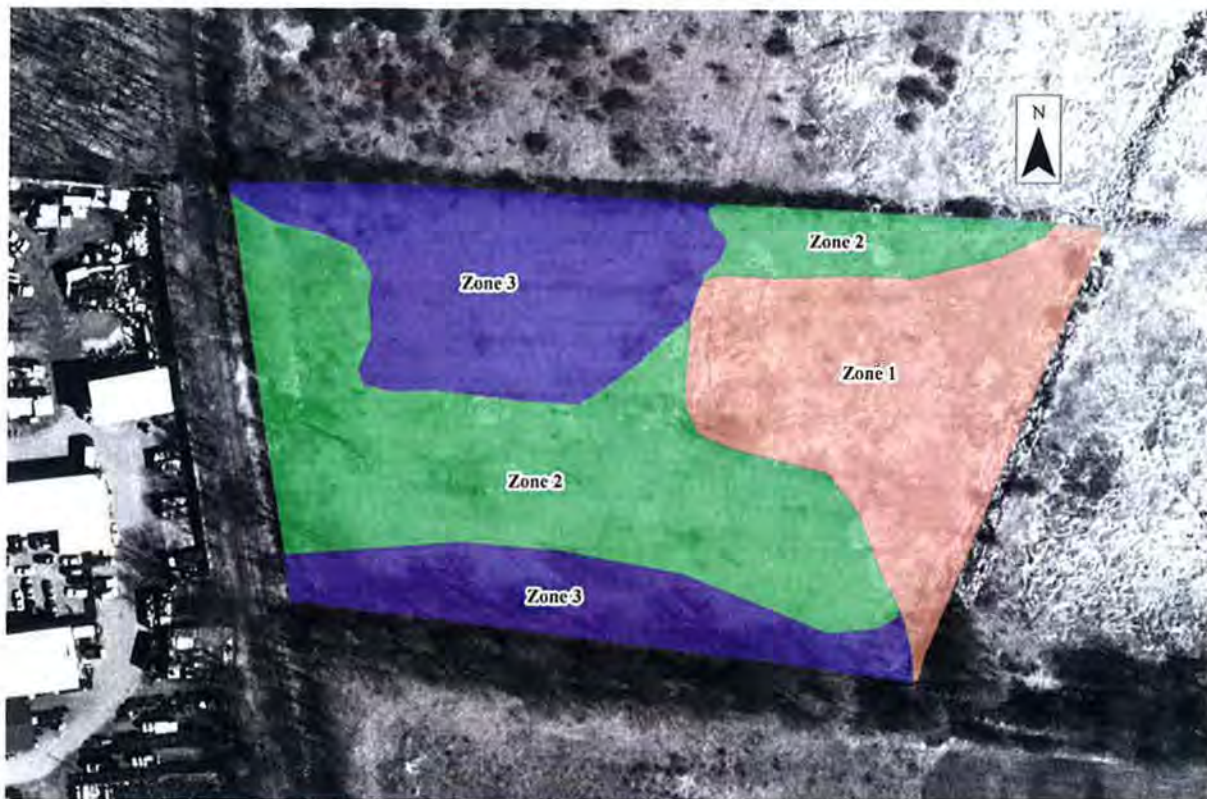
Figure 3

Representative Vegetation Zones Within Reforestation Mitigation Area

Plant Zone 1 represents the wetter portions of the existing field and is dominated by reed canary grass, woolgrass, sensitive fern, and pockets of goldenrod. Zone 2 represents a slightly drier zone than Zone 1 and is dominated by goldenrod, wild grape, grasses, and sensitive fern. Zone 3 is the driest zone and includes shagbark hickory, staghorn sumac, quaking aspen, goldenrod, and grasses.

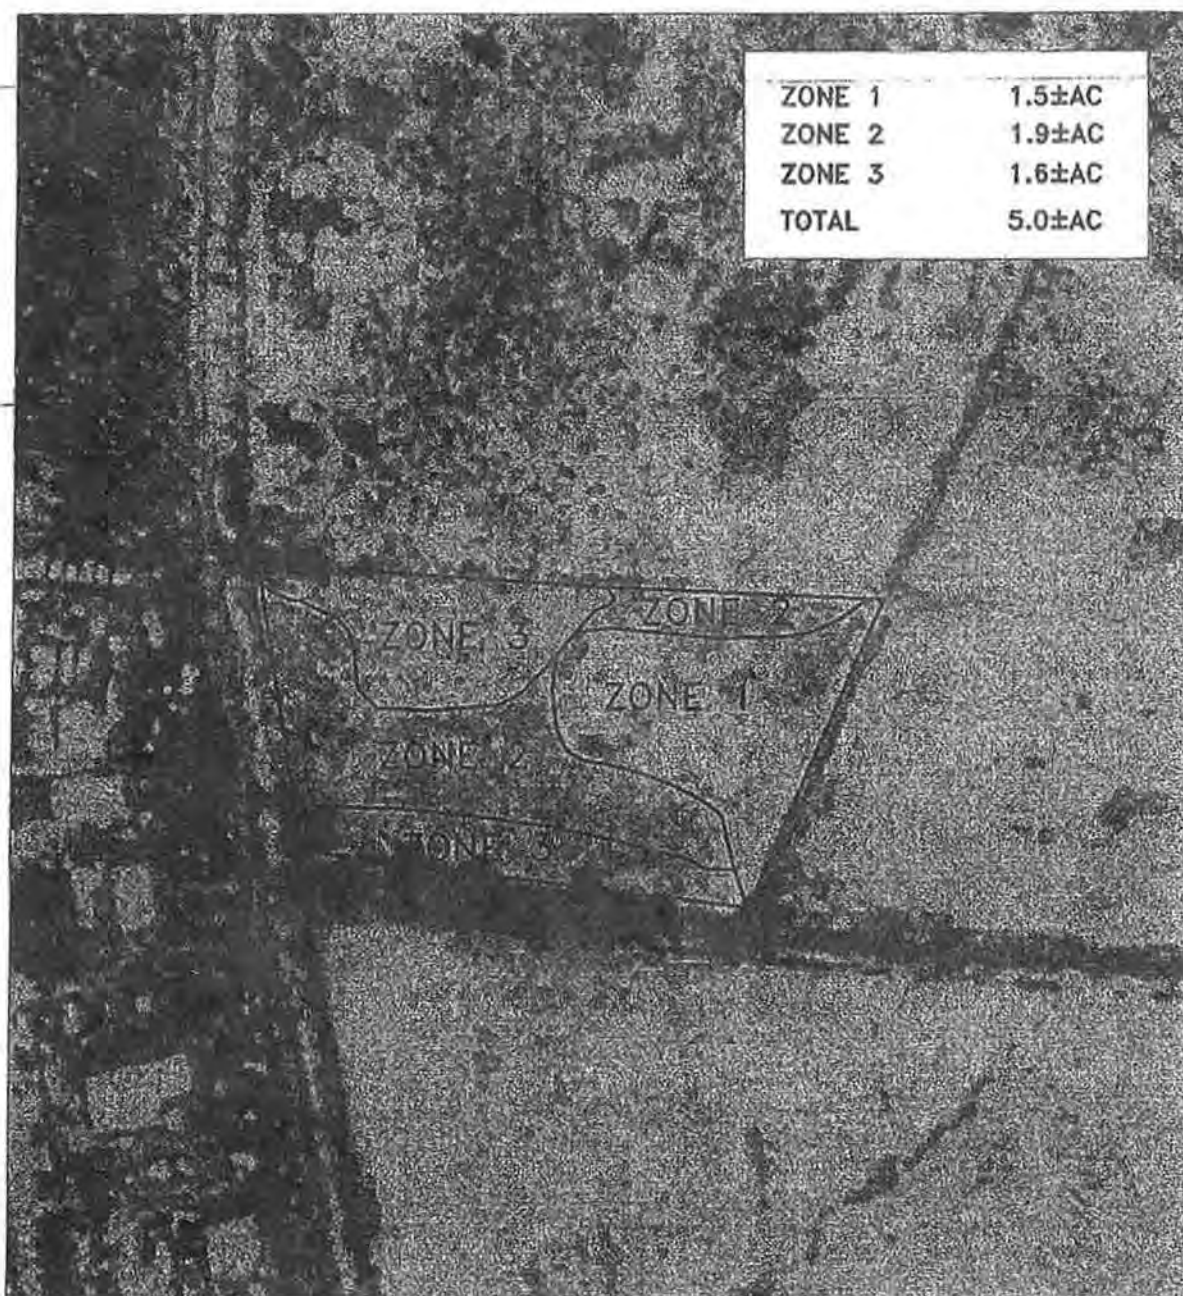
FIGURE 2

WETLAND PLANTING PLAN
FOR
GRASSLAND BIRD HABITAT
MITIGATION PLAN

Work within this area will consist of planting of 1200 individual trees and shrubs of various species to encourage the succession of a wet meadow area into wooded wetland. The planting schedule is presented in Table 2. The trees and shrubs will be planted in three different zones, reflecting minor differences in seasonal hydrology (Figure 2). The demarcation of the zones is approximate and planting will be supervised in the field by a wetlands scientist. Shrubs and trees will be planted in a generally random pattern within each zone. No long term maintenance is anticipated in this area, except to monitor tree and shrub survival within the first growing seasons following planting. Additional trees and shrubs will be planted to replace non-survivors as necessary to encourage transition to a wooded wetland.

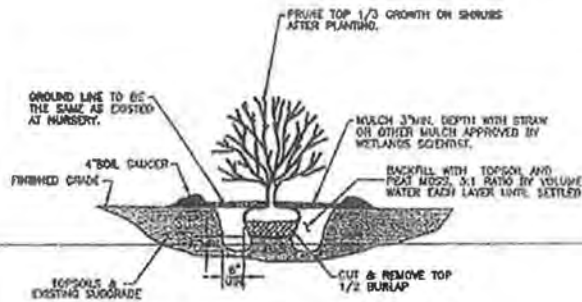
SHRUB PLANTING DETAIL
NTS

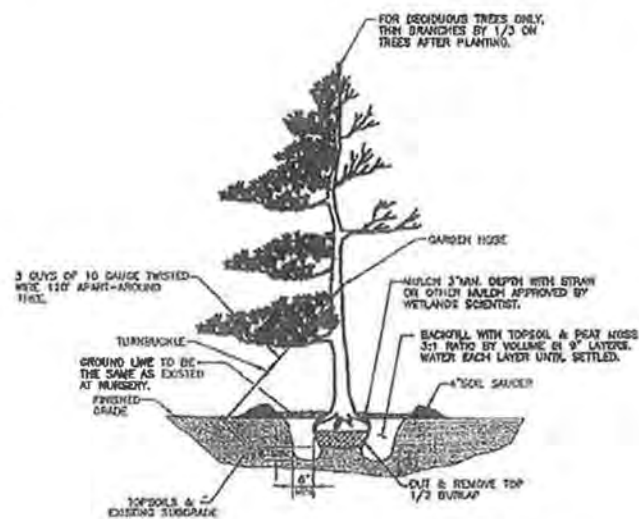
TREE PLANTING DETAIL
NTS

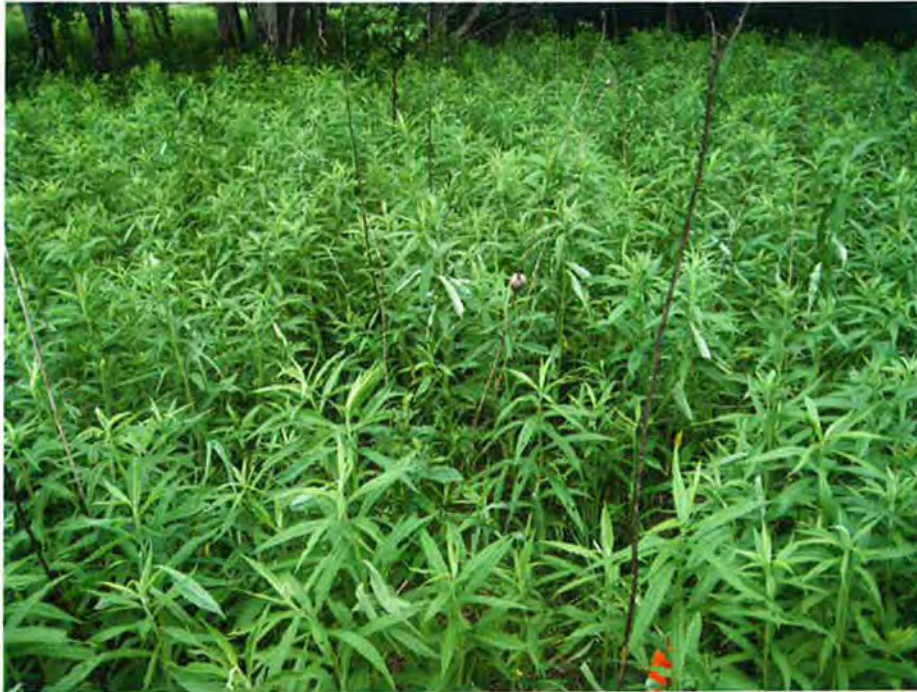
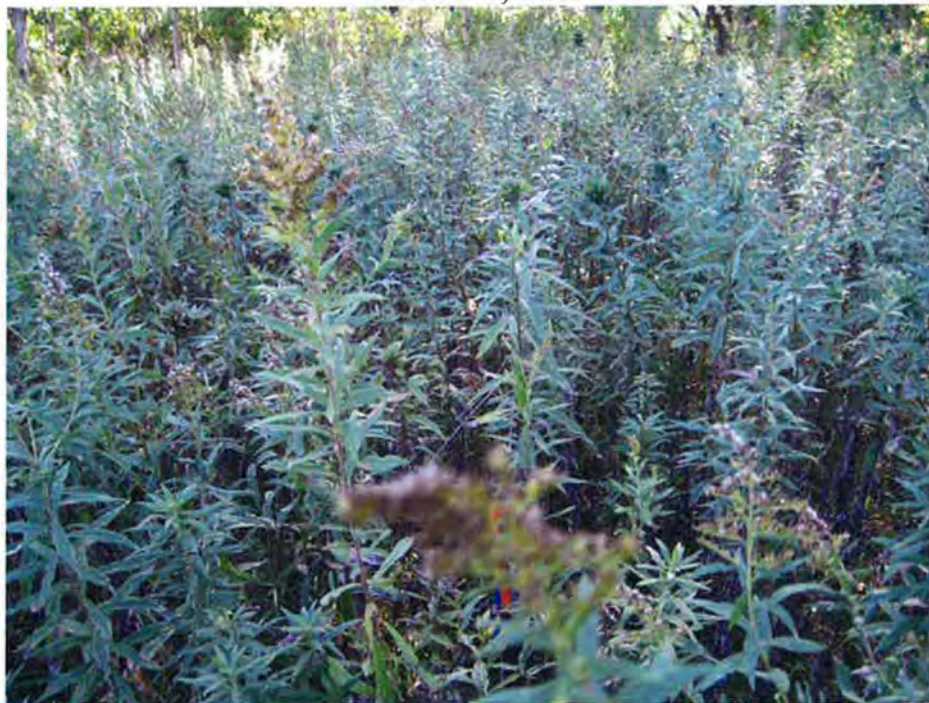
Vegetation Zone 3 - Vegetation Plot 2
June 13, 2011

During the 2011 field visits, the herbaceous vegetation within all three plant zones was lush, dense, and green. The vegetation plots are 100% dominated by herbaceous plants. Vegetation Plot #1 is dominated by goldenrod and grasses; Vegetation Plot #2 is dominated by reed canary grass, sensitive fern, and woolgrass; and Vegetation Plot #3 is dominated by goldenrod and grasses. Trees and shrubs within all vegetation plots grew a little over the 2010 growing season but do not dominate the stratum in any of the vegetation plots. It will be several years before any of the trees become a dominant stratum plant.
