2007 Wetland Mitigation Monitoring Report Scarborough High School Scarborough, Maine

March 2008

PROJECT SUMMARY

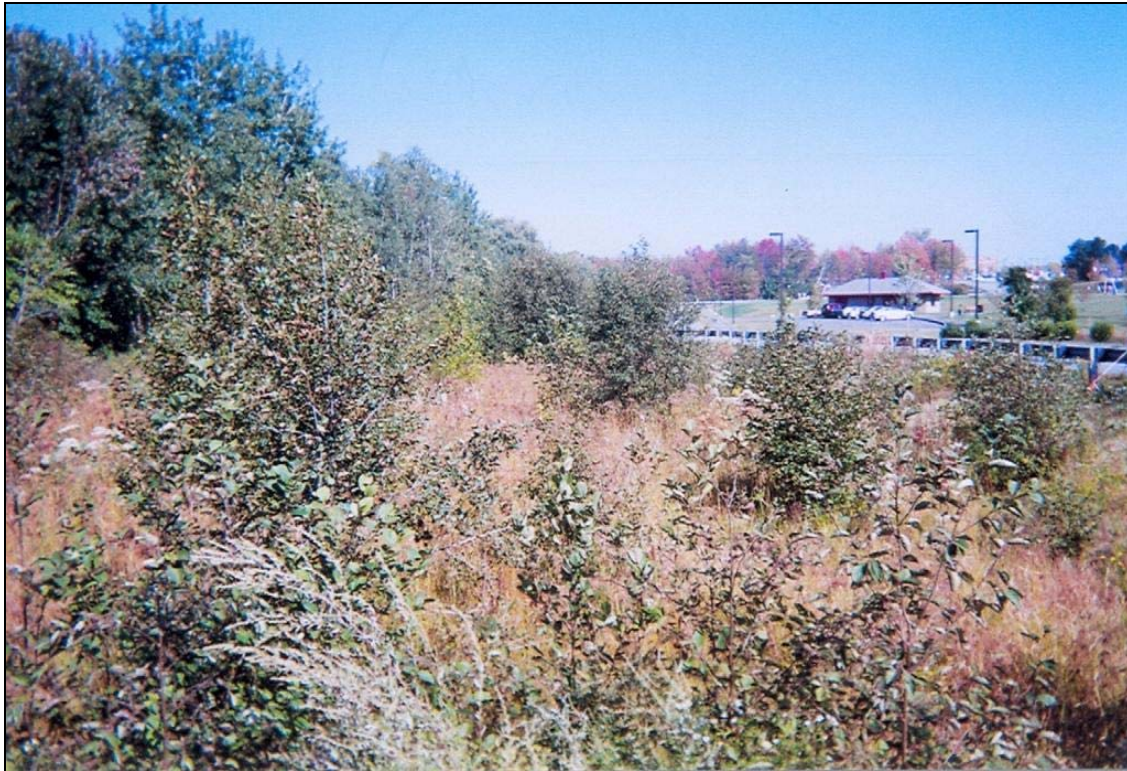
Cover Photo: View east of wetland mitigation area M-1. Stantec Consulting. September 20, 2007.

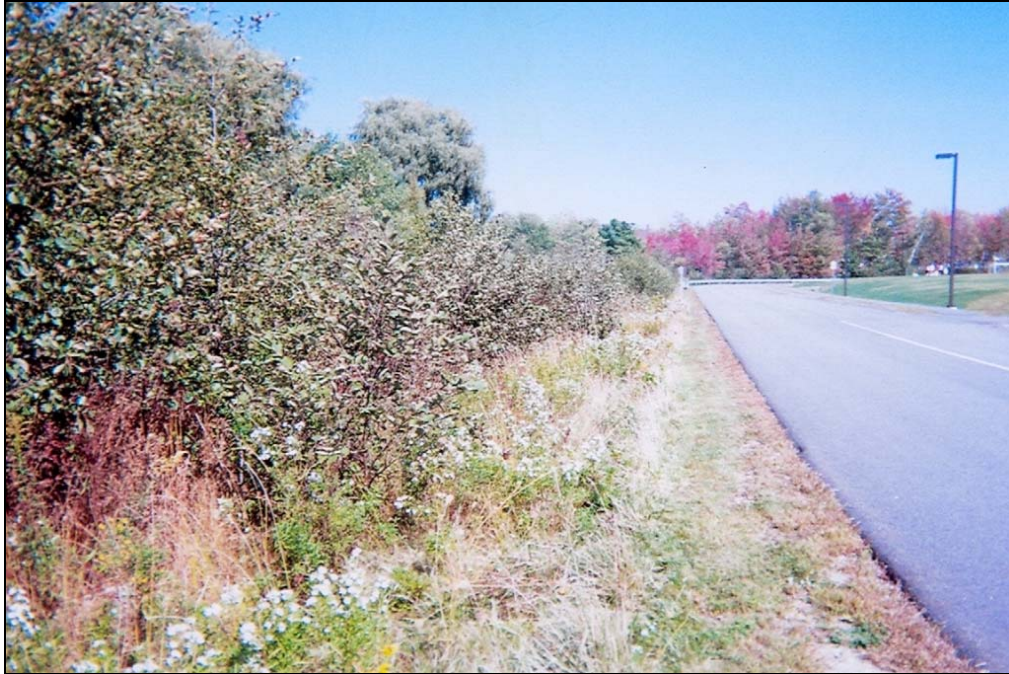
Photo 1. Wetland mitigation areas M-1 and M-2. View east along local access road.
Woodlot Alternatives, Inc. September 20, 2007.

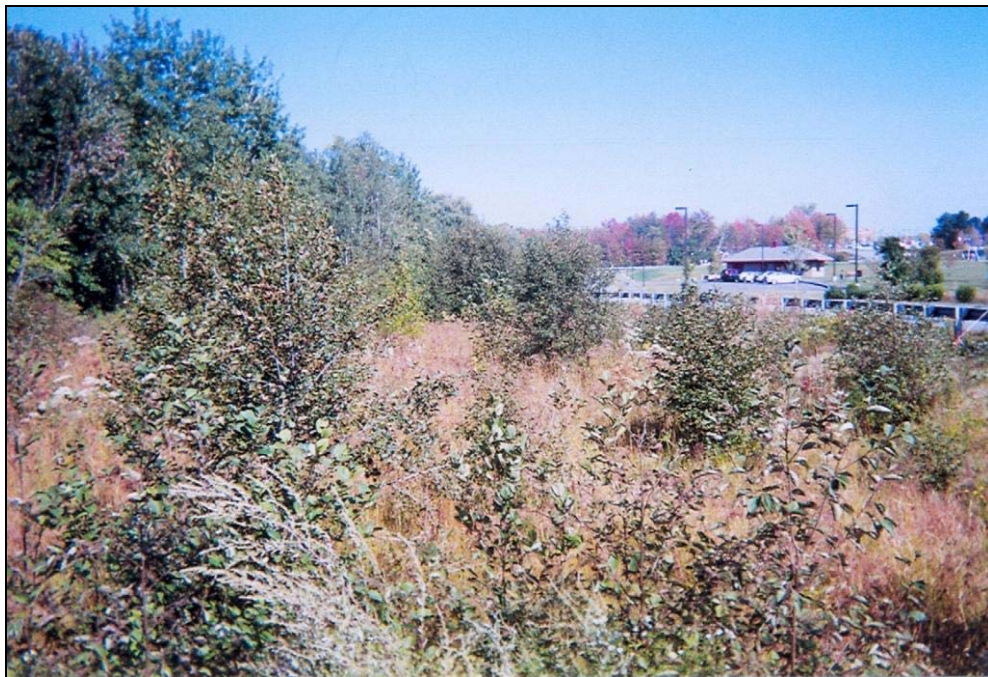
Photo 2. Wetland mitigation areas M-1 and M-2. View east along local access road.
Woodlot Alternatives, Inc. September 20, 2007.

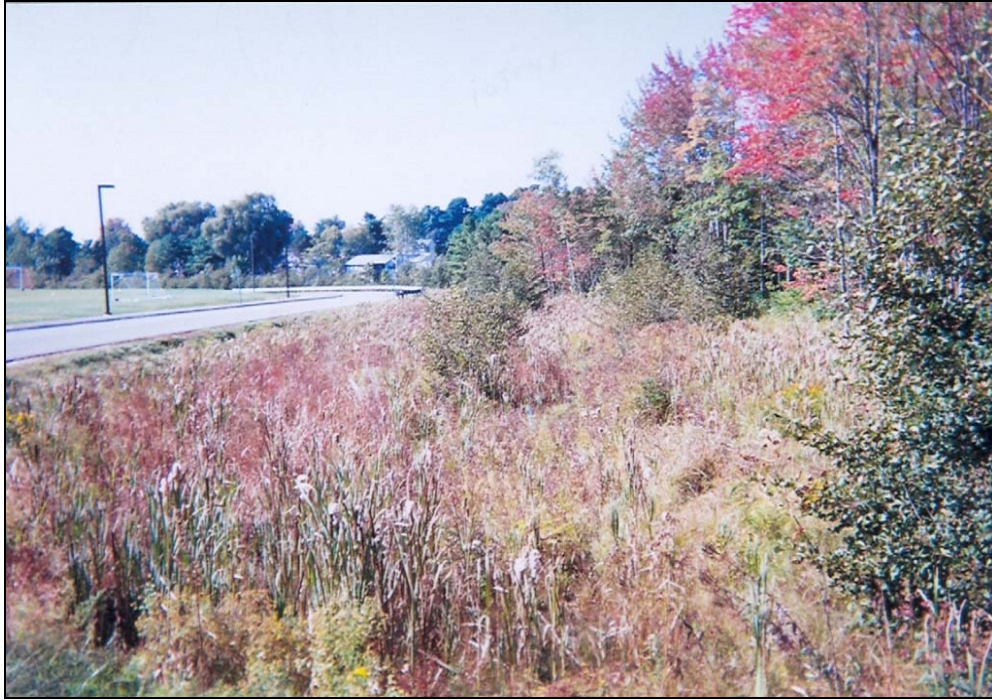
Photo 3. Wetland mitigation areas M-3 and M-4. View west along local access road. Woodlot Alternatives, Inc. September 20, 2007.

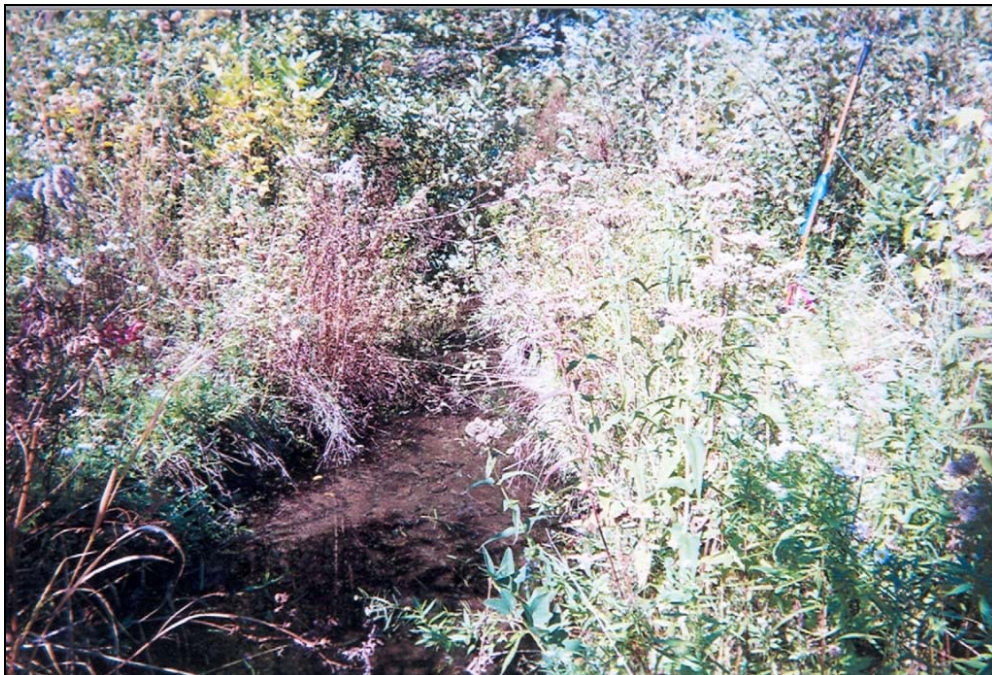
Banks and drainage channels in the mitigation areas have been successfully stabilized, and no detrimental erosion was observed in 2007.

Photo 4 Wetland mitigation areas M-1 and M-2. View northeast of channelized drainage. No detrimental erosion was observed. Woodlot Alternatives, Inc. September 20, 2007.

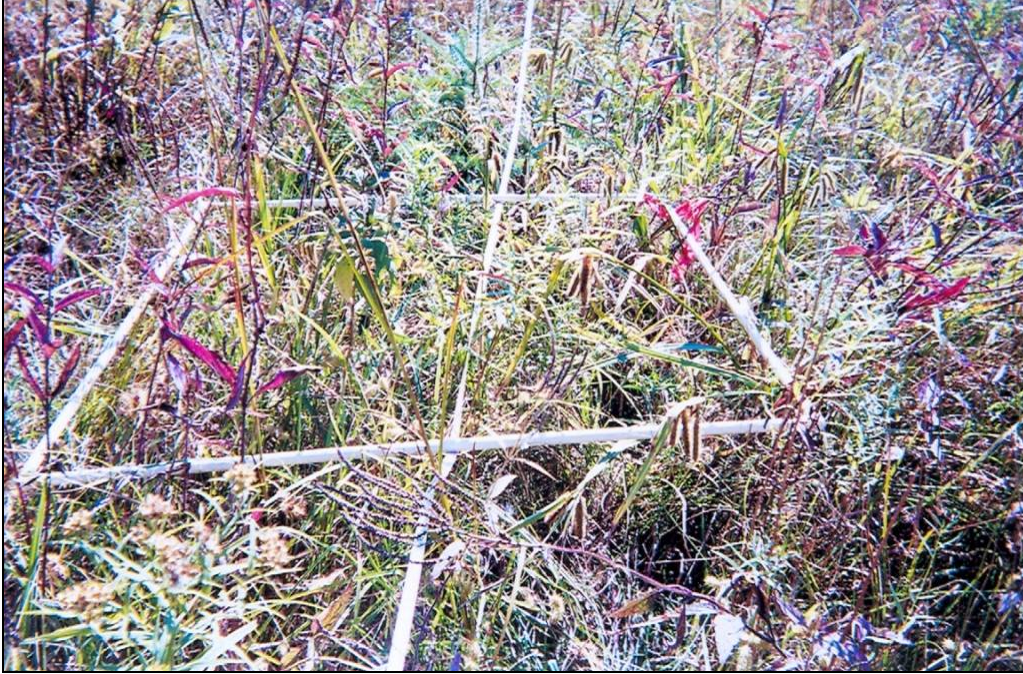
Photo 5. Transect through wetland mitigation area M-4. View looking west along transect at Plot 2. Dominant plant species are sallow sedge (*Carex lurida*), cyperus-like sedge (*Carex pseudocyperus*) and blue vervain (*Verbena hastata*). Woodlot Alternatives, Inc. September 20, 2007.

1. Install 31 slender willows (*Salix petiolaris*) in the remediation area so that the number of woody stems matches the original number of 53 woody stems that were planted in this area.
2. Conduct quantitative assessment of woody stem density in the remediation area.
3. Continue to monitor invasive species.
4. Continue to contract a licensed herbicide applicator to control invasive species.
5. Conduct meander surveys of the mitigation areas for a qualitative assessment of woody stem density and vigor.
6. Conduct meander surveys for qualitative assessment of vegetation composition and density in areas M-5 and M-6.
7. Continue to assess common cat-tail density and plant diversity in areas M-1 through M-4 by monitoring percent areal cover along an east to west transect through these areas.

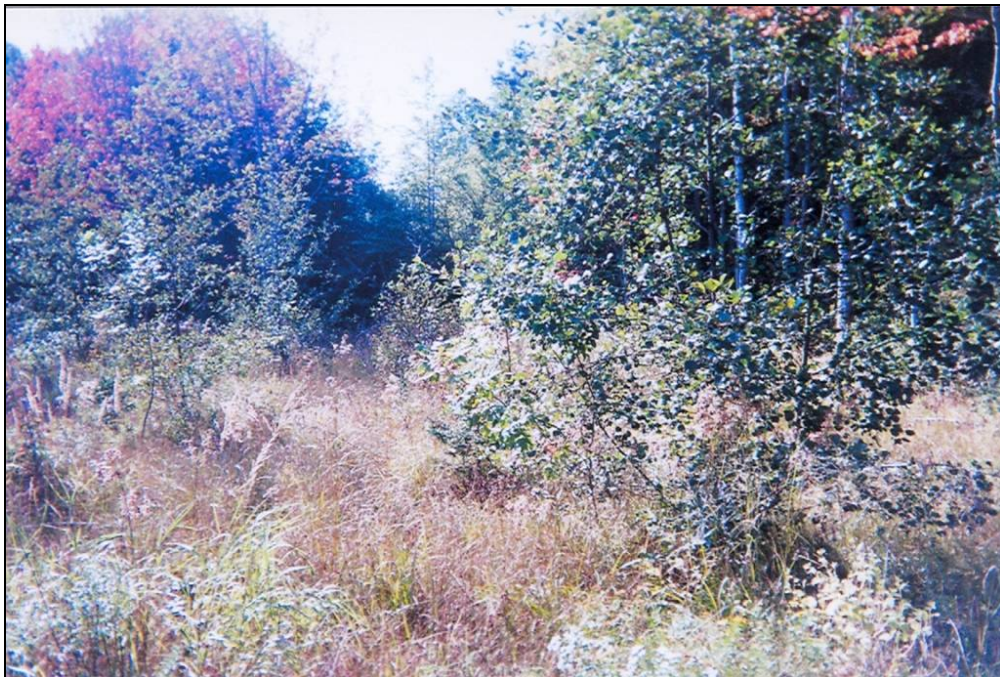
Mitigation Area M-6: Areal cover exceeded 100 percent, and the area was dominated by native wetland species such as wool-grass, soft rush, sallow sedge, pointed broom-sedge (*Carex scoparia*), and speckled alders. Planted green ash (*Fraxinus pennsylvanica*), speckled alder, and balsam fir (*Abies balsamea*) appeared healthy, and volunteer gray birch (*Betula populifolia*), quaking aspen (*Populus tremuloides*), and speckled alder were present. Approximately a dozen European alders also were present.

Photo 6. Wetland mitigation area M-6. View northwest. Vigorous planted woody stock and dense herbaceous layer of naturally occurring grasses, sedges and rushes. Woodlot Alternatives, Inc. September 20, 2007.

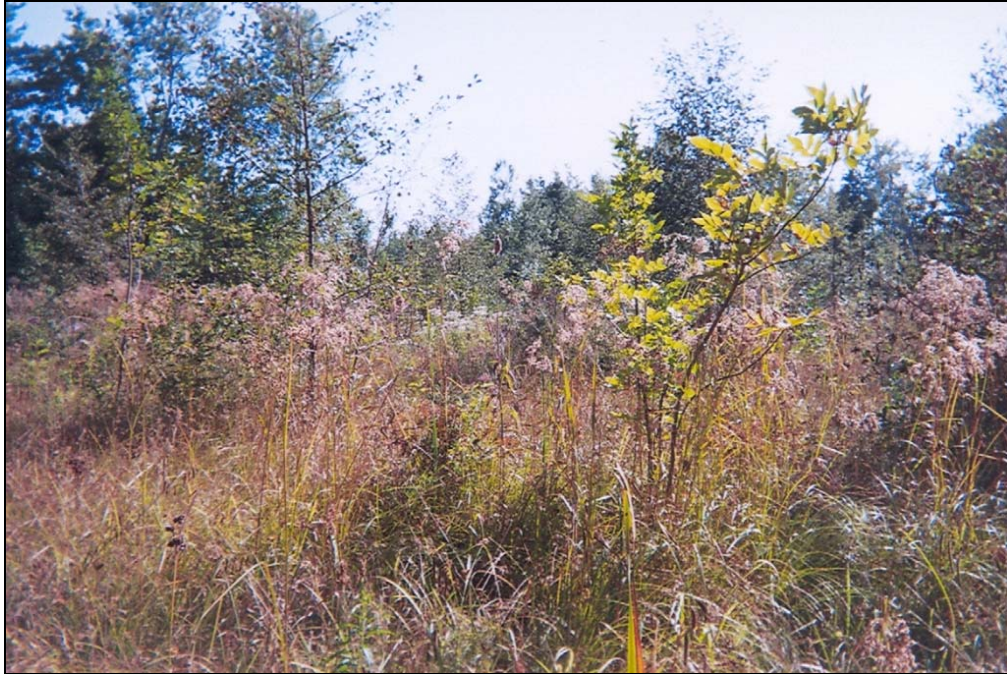
Photo 7. Wetland mitigation area M-6. View southwest of mitigation site. Herbaceous vegetation consists of dense native sedges, rushes, and wool-grass (*Scirpus cyperinus*).
Woodlot Alternatives, Inc. September 20, 2007.

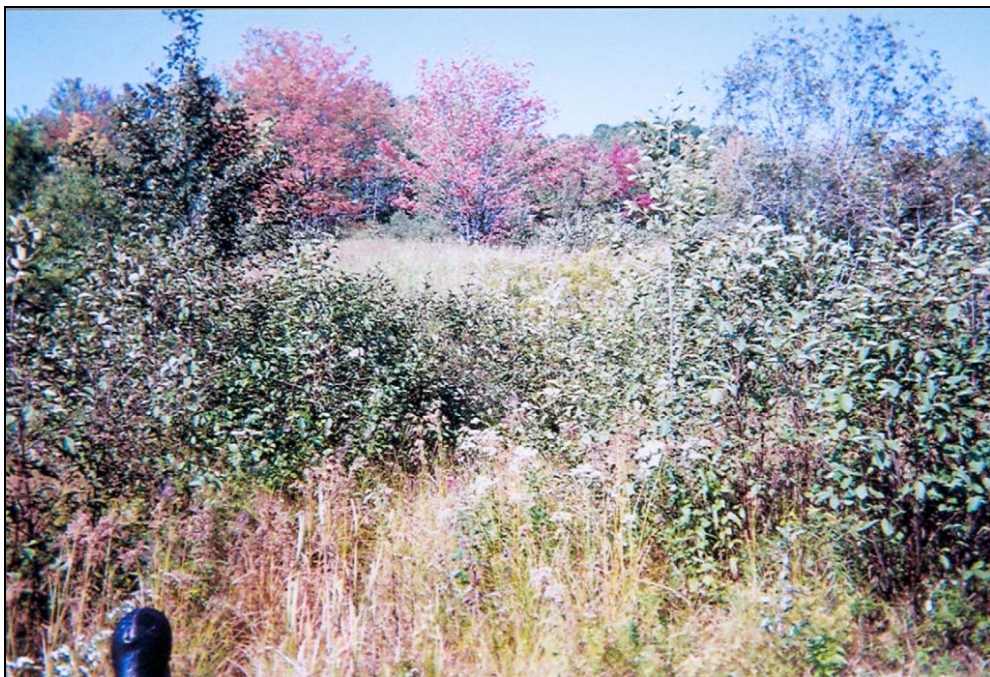
Mitigation Area M-5: Areal cover on the upland berm was greater than 100 percent and was dominated by Canada goldenrod (*Solidago canadensis*, FACU), deer tongue grass (*Panicum clandestinum*, FAC+), calico aster (*Symphotrichum lateriflorum*, FAC), eastern lined aster (*S. lanceolatum*, NI), and American mannagrass (*Glyceria grandis*, NI). The wetland area north of the M-5 berm is dominated by cat-tails. Speckled alders are colonizing the surrounding area, and soft rush, orange touch-me-not, purple loosestrife, and bur-reed (*Sparganium* sp, OBL) also were observed.

Photo 8. Wetland mitigation area M-5. View north across mitigation area M-2 to mitigation area M-5.
Woodlot Alternatives, Inc. September 20, 2007.

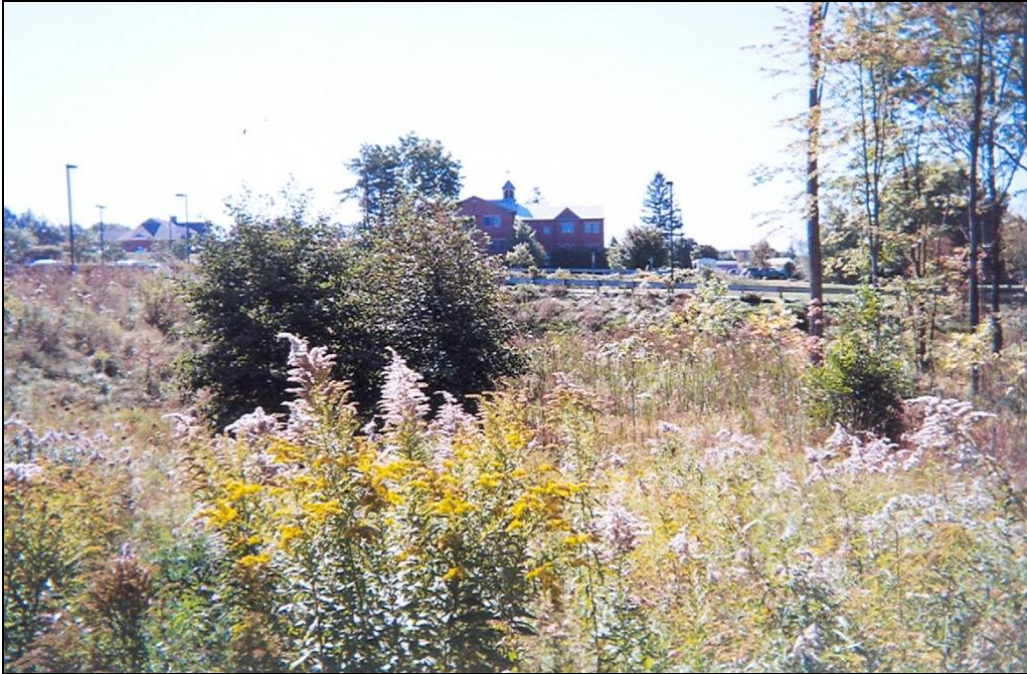
Remediation Area: Woodlot conducted a thorough meander survey of the remediation area and counted trees and shrubs. Twenty-nine stems were found, which represents a stem count of approximately 230 stems per acre. This is a decrease of seven stems (i.e., four green ashes, two arrowwood [*Viburnum dentatum*] and one silky dogwood [*Cornus amomum*]) since the 2006 monitoring. In addition, this count included seven stems of European alder. Eliminating the European alder brings the stem count to twenty-two, which represents 174 stems per acre. This is below the performance standard of 420 stems per acre for this area.

European alder that was labeled as speckled alder at the time of the planting was identified within the mitigation areas and the remediation area. The Scarborough Schools Maintenance Department has contracted Stantec to design and implement a plan for the control of this invasive species. Based on the 2006 stem counts, mitigation area M-6 will continue to exceed the success standard for woody stem density after the European alder is removed. Mitigation areas M-1 through M-4 will continue to exceed or meet this standard. As volunteer native trees and shrubs continue to colonize these areas, it is not anticipated that additional plantings will be needed.

Photo 9. Remediation Area. View south across remediation area. Planted European alder (*Alnus glutinosa*) on left. Woodlot Alternatives, Inc. September 20, 2007.

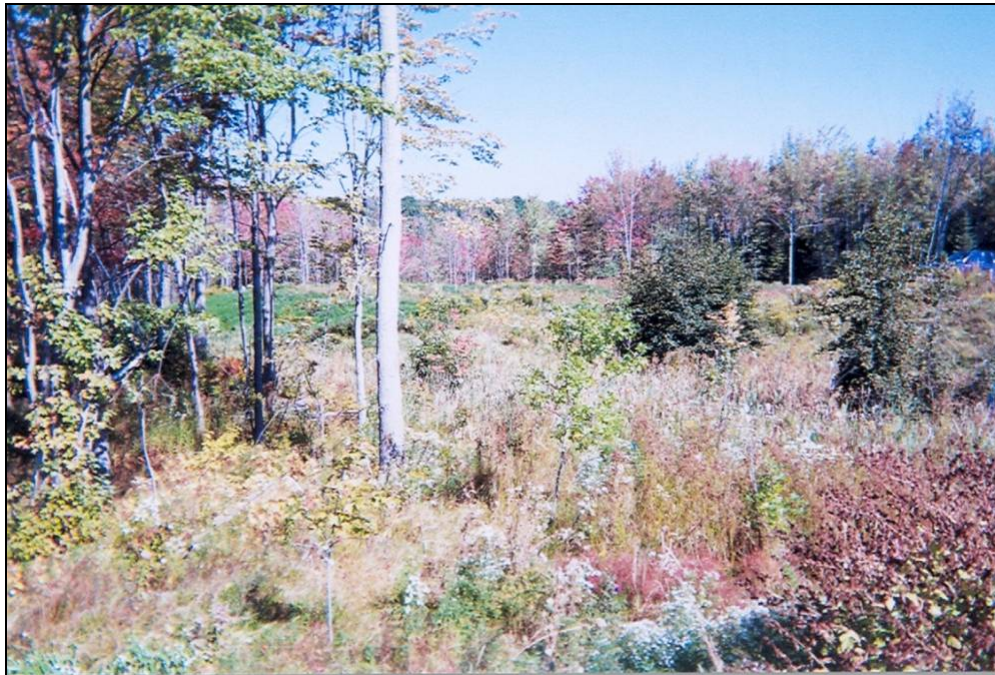
Photo 10. Remediation Area. View northeast across remediation area. Woodlot Alternatives, Inc. September 20, 2007.

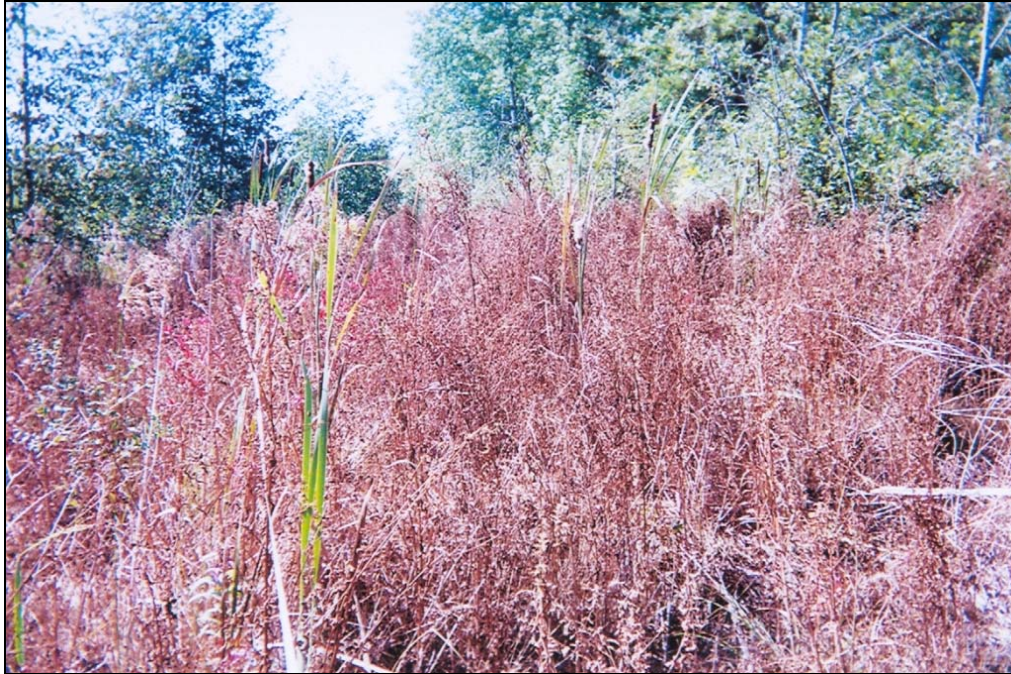
The purple loosestrife was treated with herbicide in July and August 2007 prior to monitoring. Live stems of purple loosestrife occurred in 26 percent of the vegetation sample plots but represented only 1.5 percent of the total areal cover. The percent areal cover of dead purple loosestrife stems in the plots also was estimated for comparison. Dead purple loosestrife stems occurred in 34 percent of the sample plots and accounted for 13 percent of the total areal cover. This is comparable to the results of the 2006 monitoring where purple loosestrife occurred in 52 percent of the vegetation sample plots and accounted for 10 percent of the total areal cover.

Purple loosestrife: A licensed applicator conducted herbicide treatment of the purple loosestrife in August 2007. The treatment involved two separate rounds of herbicide application, which were completed approximately four weeks apart. The purple loosestrife was treated with a two percent solution of Rodeo® and water that was applied as a foliar spray using either a backpack sprayer or a hand sprayer. During the second application, the seed/flower heads on the purple loosestrife were cut from the plant, bagged, and removed from the site prior to spraying the plants. The application reduced the estimated areal cover of purple loosestrife by approximately 90 percent in the sample vegetation plots.

Photo 11. Wetland mitigation areas M-1 and M-2. Results of herbicide application to control purple loosestrife (*Lythrum salicaria*). Woodlot Alternative, Inc. September 20, 2007.

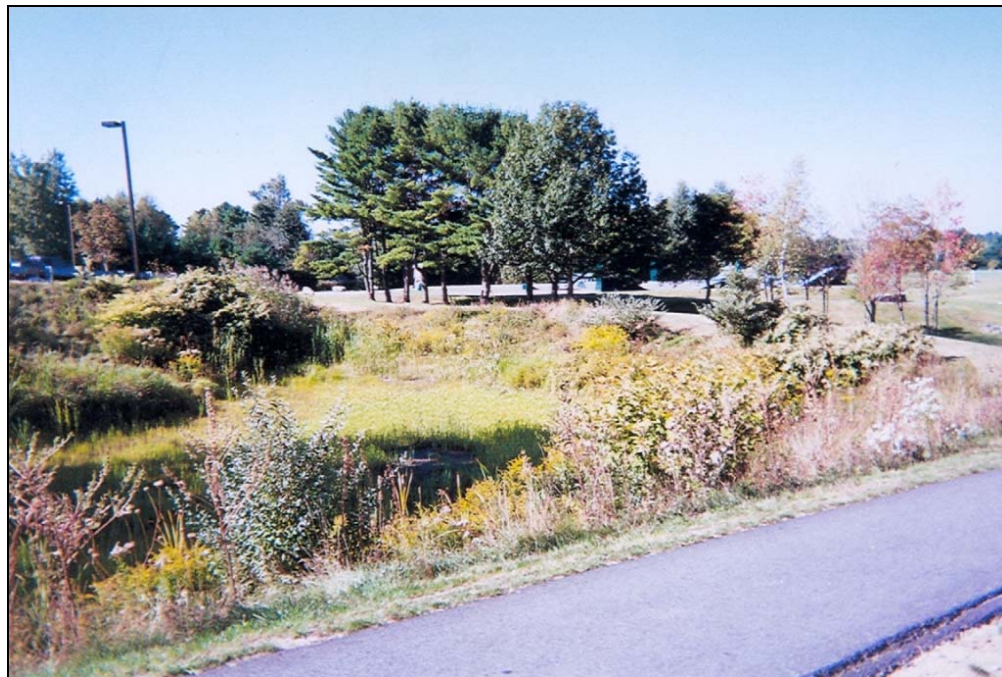
Japanese knotweed: The Scarborough Recreation Department substantially reduced the seed source for Japanese knotweed by removing the majority of the plants from the border of the retention pond on their property in 2006. They also have continued to mow the border of the retention pond, as close to the pond as practical, to limit the presence and potential seed source of this species. In addition, the licensed applicator applied a 50 percent solution of Rodeo® and water to the few plants along the berm north of the remediation area and along the edge of the parking lot east of the remediation area. The herbicide was applied by cutting the stems and filling the hollow of the stem with the herbicide solution.

Photo 12: Department of Recreation retention pond showing continued control of Japanese knotweed (*Fallopia japonica*). Woodlot Alternatives, Inc. September 20, 2007.
