Re: **Maine DOT Gorham Bypass Wetland Mitigation Project at Larrabee Farms Wetland Mitigation Site – YEAR THREE (2010) MONITORING REPORT**

ATTACHED MITIGATION REPORT TITLE: Maine Department of Transportation Gorham Bypass: Third Year Wetland Mitigation Monitoring Report

Corps Permit No.: NAE-2005-4220 **Maine DEP NRPA Project Number:** L-23402-TH-A-N
Mitigation Site Name: Larrabee Farms Wetland Mitigation Site: MaineDOT Gorham Bypass Mitigation
Monitoring Report: Year 3 of 10

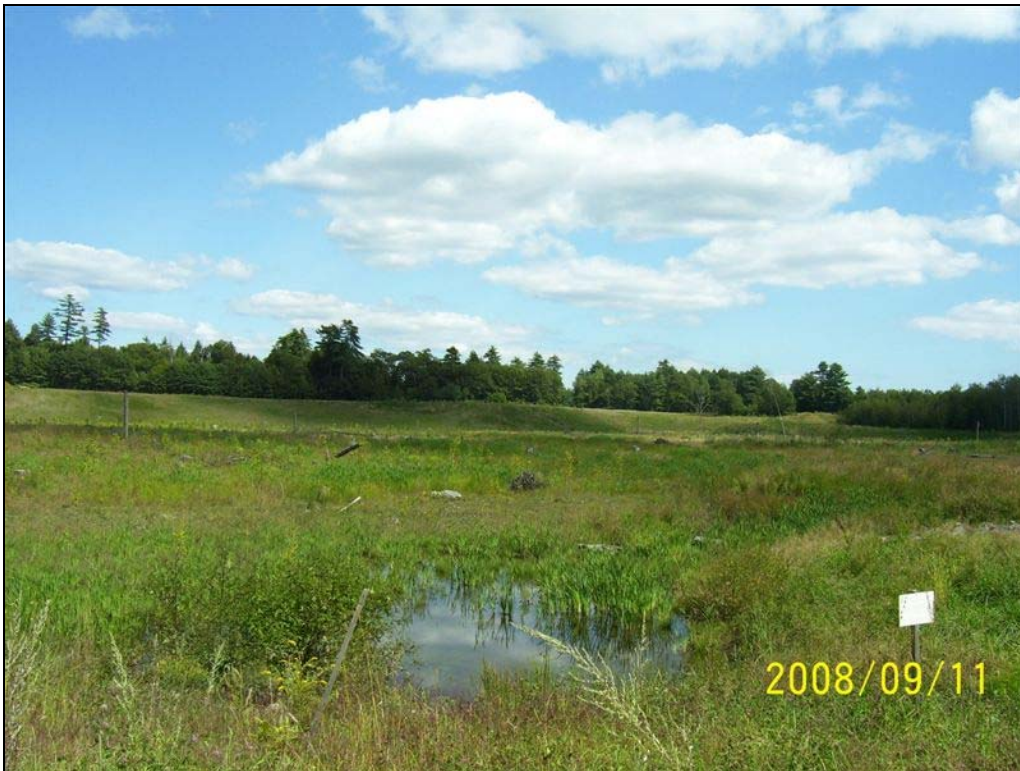
Photolocation 1 (Year 1). Facing northeast across PEM, PSS and PFO creation areas, snags are evident in the background, 11-Sep-2008.

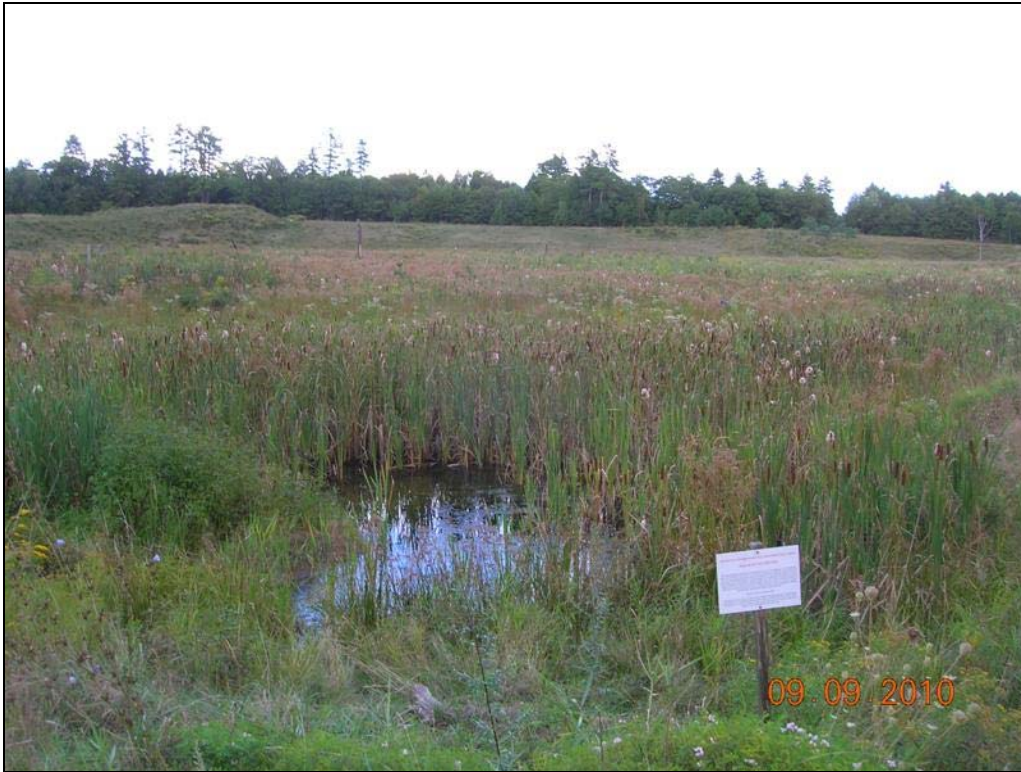
Photolocation 1 (Year 3). Facing northeast across PEM, PSS and PFO creation areas,, 9-Sep-2010.

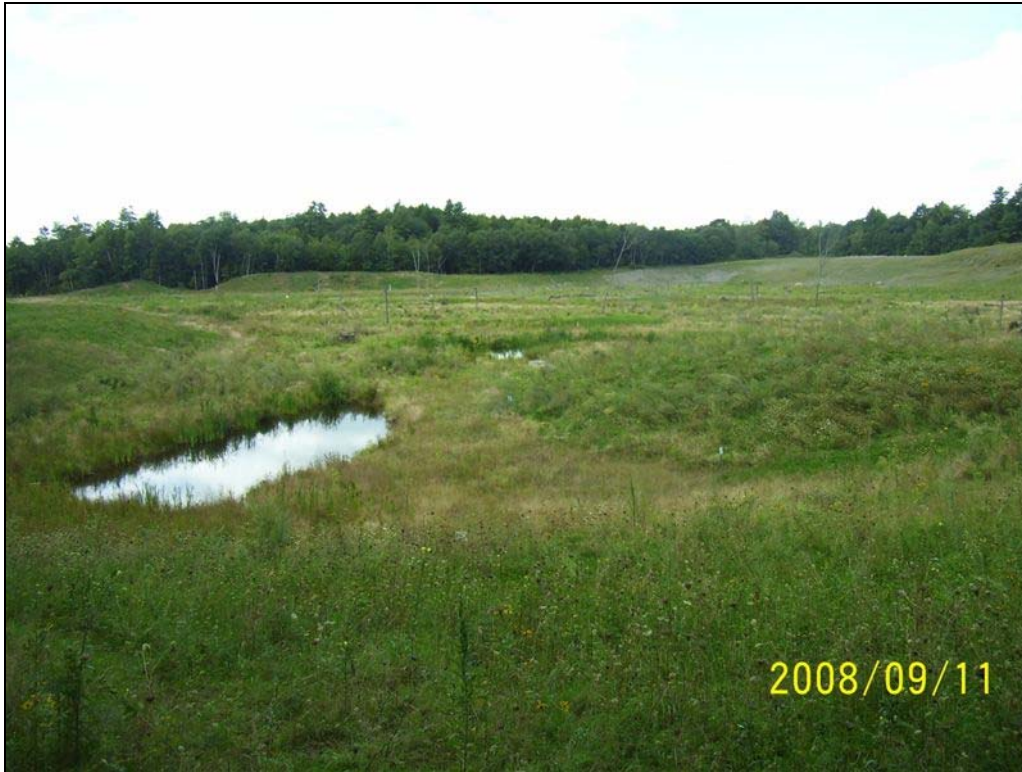
Photolocation 2 (Year 1). Facing northwest across PSS and PFO creation areas and southernmost ephemeral pool, shrubs and trees are still difficult to discern amongst the herbaceous growth, 11-Sep-2008.

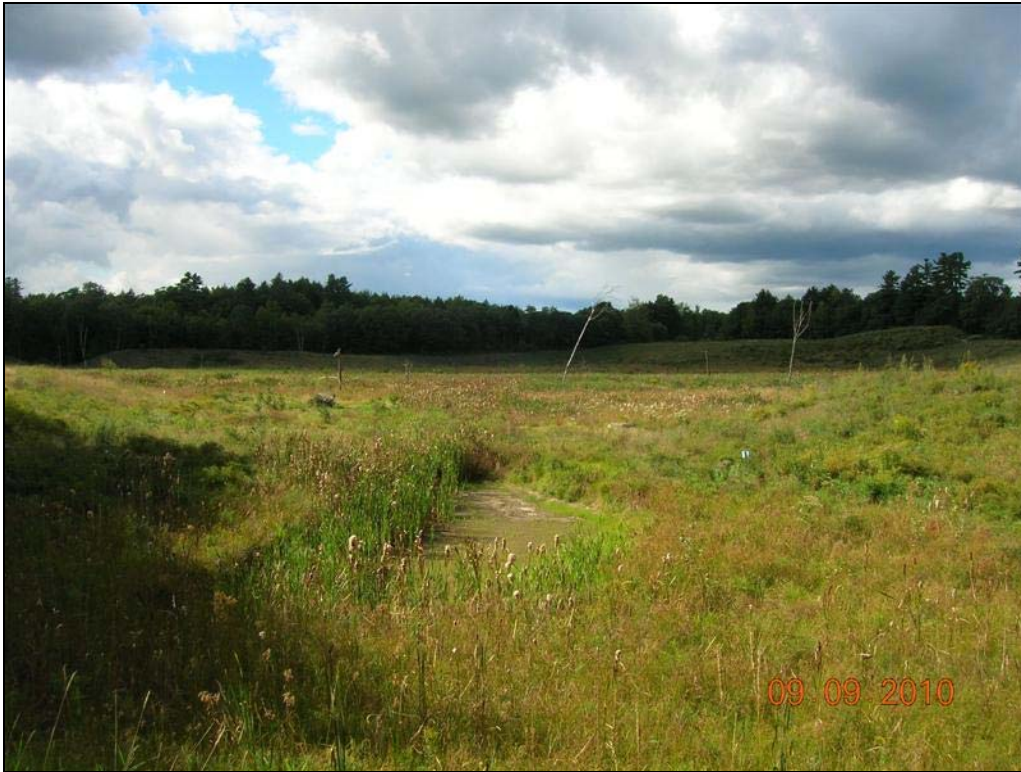
Photolocation 2 (Year 3). Facing northwest across PSS and PFO creation areas and southernmost ephemeral pool, pool dried completely in 2010, 9-Sep-2010.

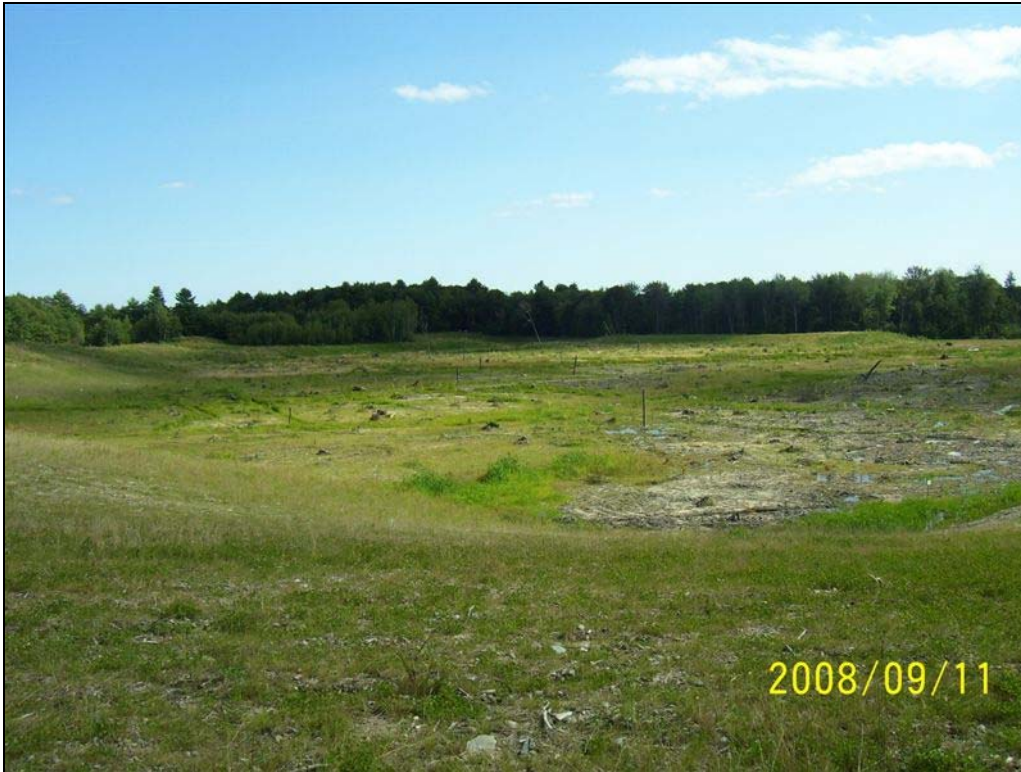
Photolocation 5 (Year 1). Facing east across PFO creation area at an area that was re-seeded in 2009, 11-Sep-2008.

A few of the wetland creation areas were re-seeded in the summer of 2009. These areas were reviewed during the 2010 monitoring effort and are now meeting the aerial cover requirement. Hydrology seems to be adequate to support these plants as those found were healthy and robust.

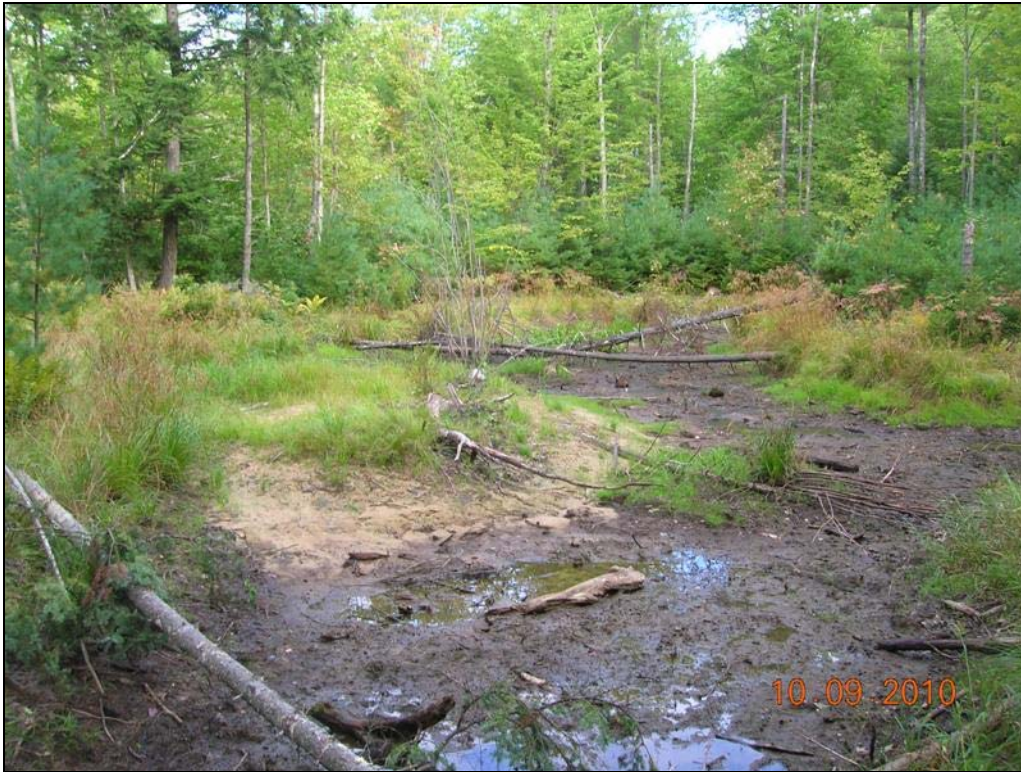
Photolocation 9 (Year 3). Facing northwest at vernal pool 1, pool nearly dry, 10-September-2010.

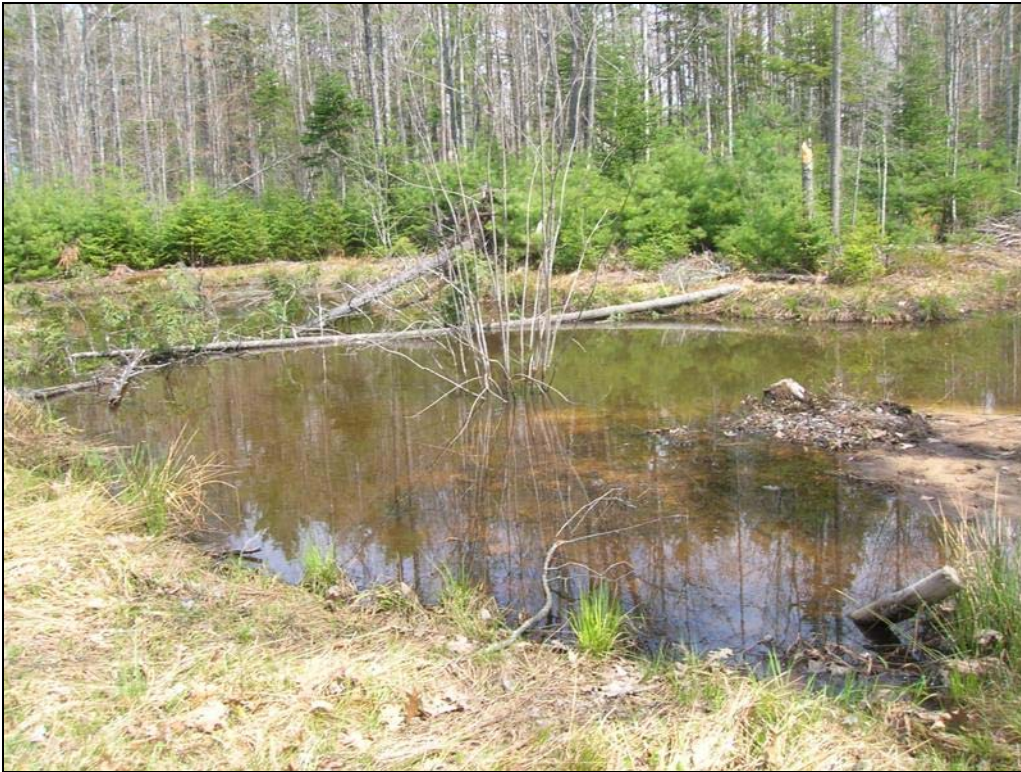
Photolocation 17 (Year 3). Facing northwest over vernal pool one. Note mound from sand addition on right side of photo, 23-April-2010.

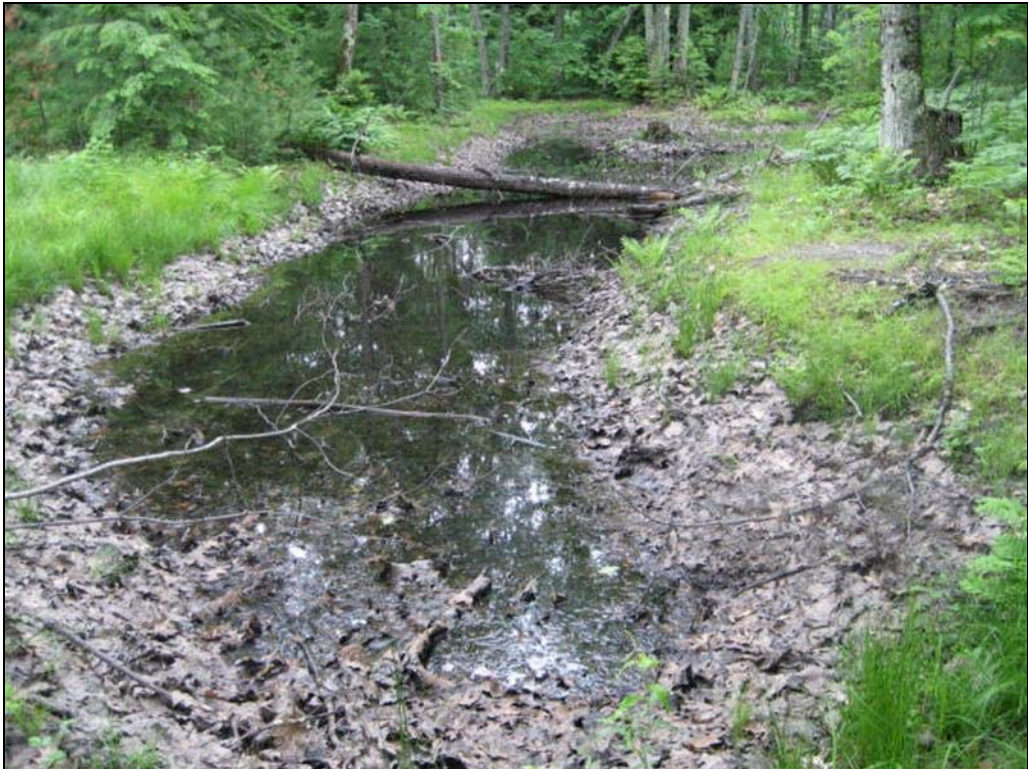
Photolocation 23 (year 1). Facing west at part of pool that remained flooded throughout 2008, 23-June-2009.

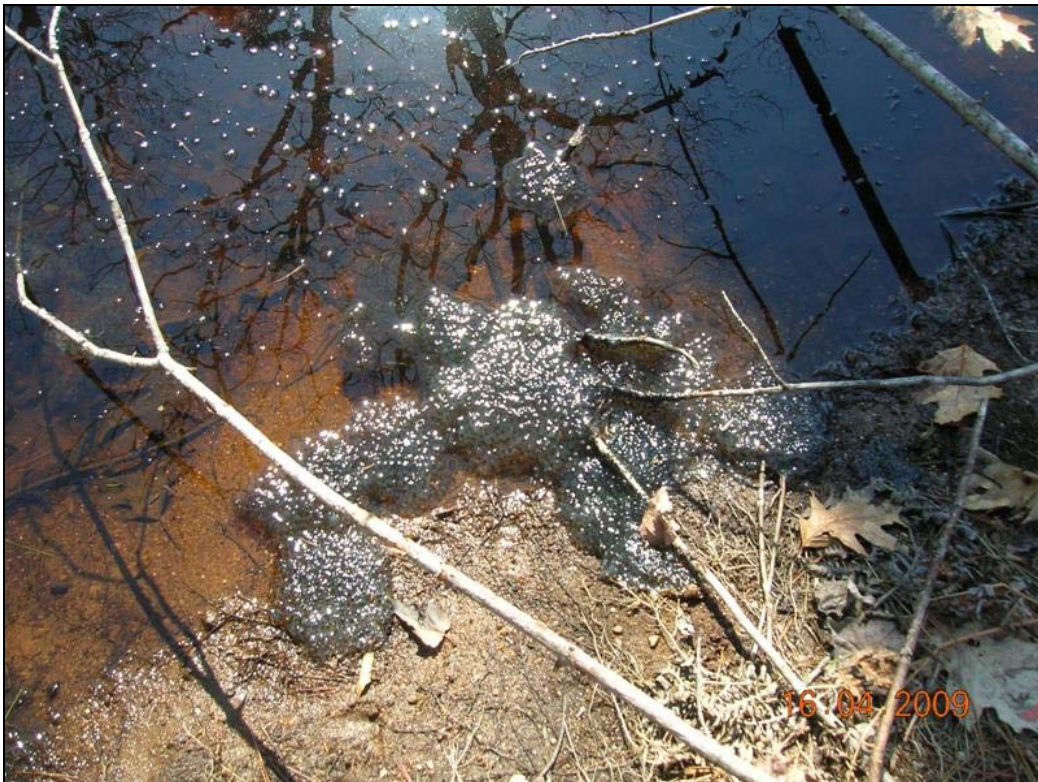
Photolocation 30 (Year 2). Wood frog egg masses desiccating onshore of vernal pool 3, 16-April-2009.

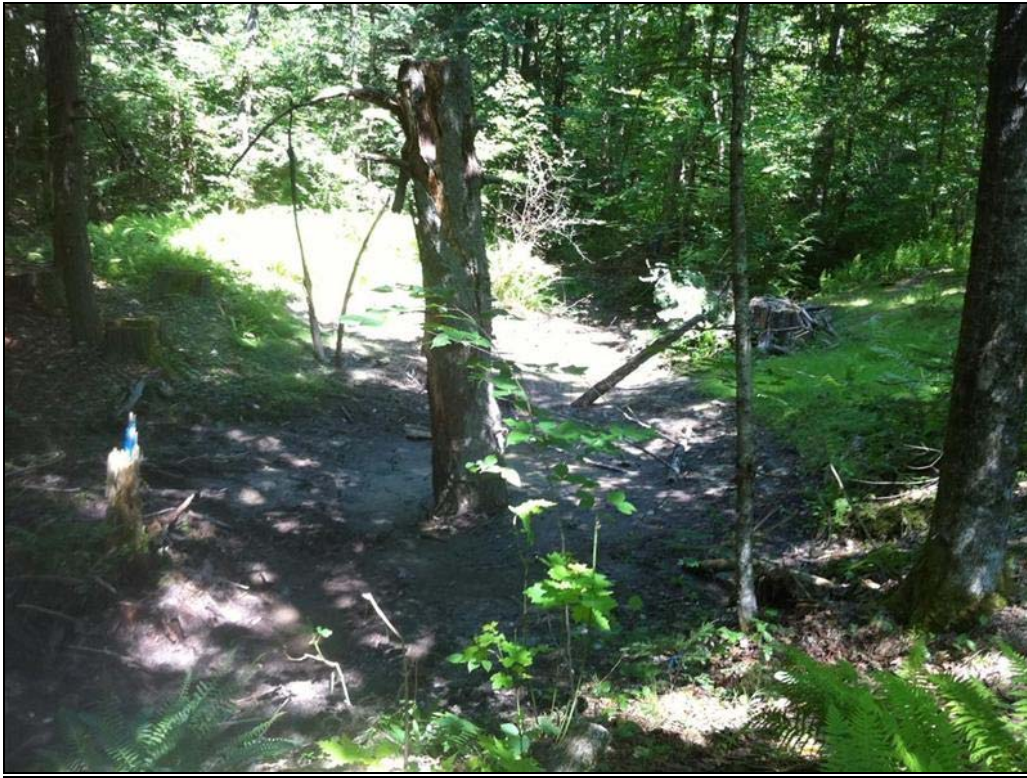
Area identified for vernal pool creation south of current MDOT wetland creation site, 22-July-2010

One additional vernal pool was created in 2010 per recommendations from federal regulators. The construction of the Gorham Bypass had led to partial drainage of a man-made vernal pool habitat adjacent to the project. For compensation, Grondin designed and built a vernal pool habitat southwest of the MDOT wetland creation site on Larrabee. The pool was completed on March 31, 2010. In May, seven spotted salamander egg masses were observed in the created pool. The pool was dry during a site visit in July.
