CONSTRUCTION MONITORING AND AS-BUILT REPORT

On-Site Wetland Mitigation Brewer Lowe's Project Brewer, Maine

MDEP Permit #L-23075-TF-B-N
Corps Permit #NAE-2006-2537

December 2007

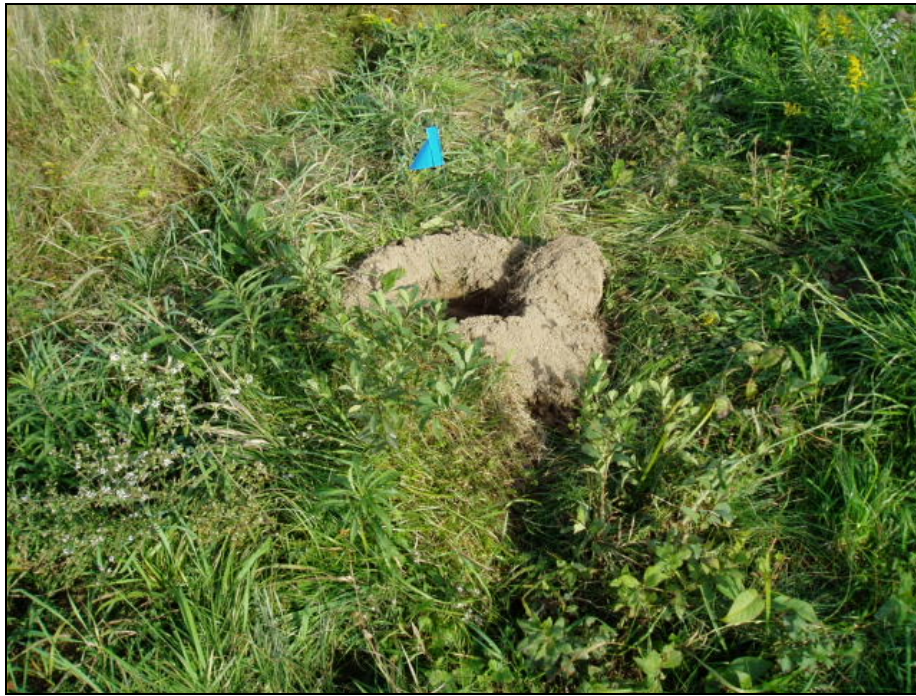
Photo 1. Augered planting hole, showing vegetative conditions at the time of planting.
Stantec, October 1, 2007.

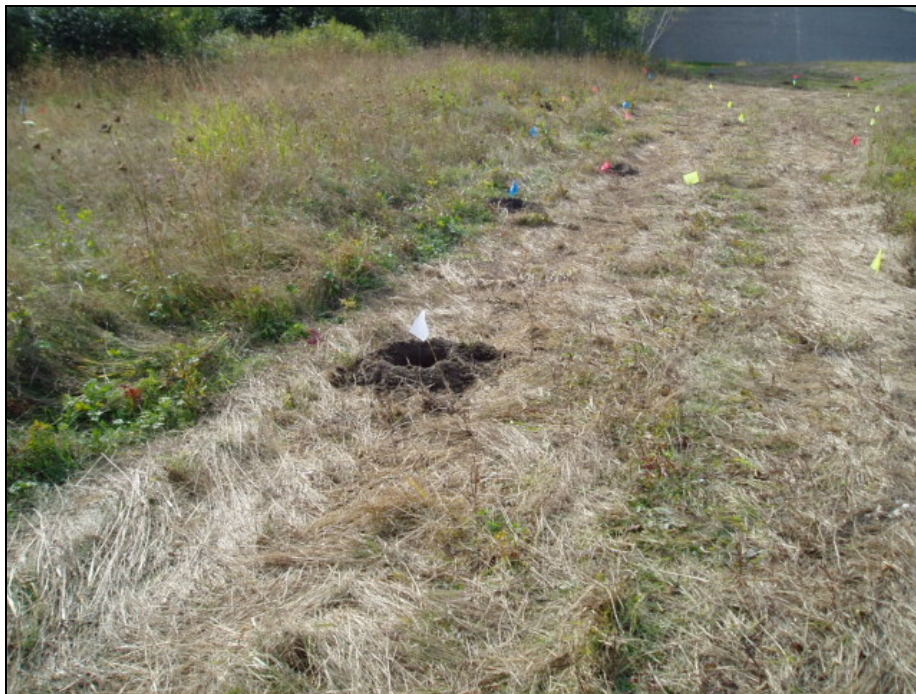
Photo 2. Augered planting holes, showing vegetative conditions at the time of planting.
Stantec, October 1, 2007.

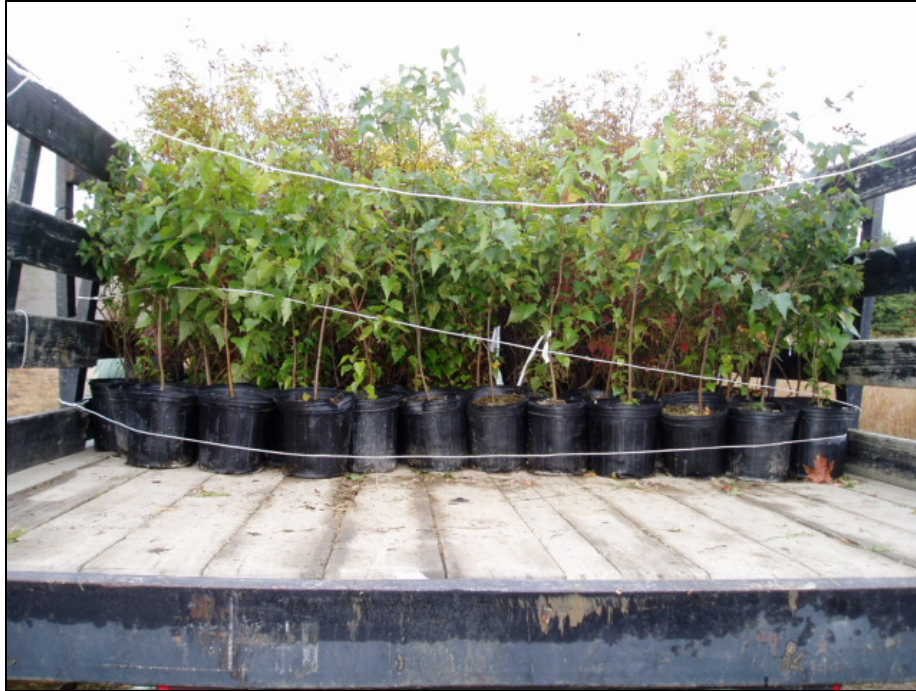
Photo 3. Some of the trees and shrubs upon delivery to mitigation site. Stantec, October 1, 2007.

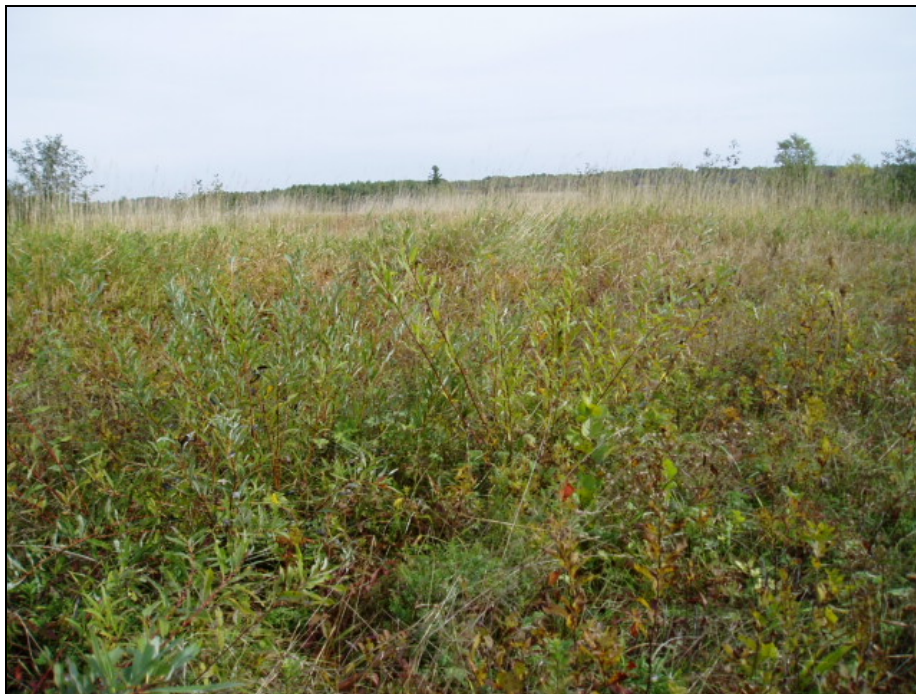
In years past, both sides of the main swale were mowed annually, which prohibited the natural growth of shrubs. In the summer of 2007, the north side of the swale was mowed but the south side was not. Because of this, many volunteer shrubs had become established on the south side of the swale, including willows, dogwoods, alders, and other native wetland shrub species. These plants ranged from one to three feet or more in height. To avoid competition, an effort was therefore made to install the mitigation plantings in areas that did not have this dense, natural shrub growth. It is anticipated that the natural shrub growth on both sides of the swale will supplement the plantings and accelerate the establishment of the planned shrub and forest communities at the site. The attached photos illustrate typical shrub growth

Photo 4. Existing shrub and herbaceous on un-mowed, south side of main swale. Note density and size of natural willow regeneration. Plantings were not installed where these conditions existed. Stantec, October 1, 2007.

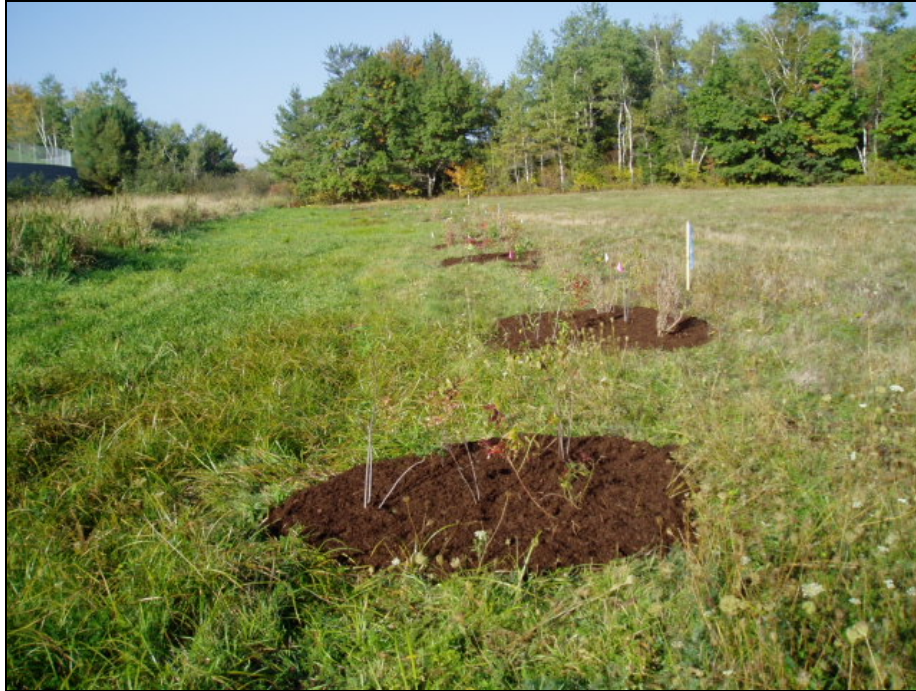
Photo 5. Plantings installed on north side of main swale along property line. Note bark mulch and mowed conditions on this side of swale. Stantec, October 4, 2007.

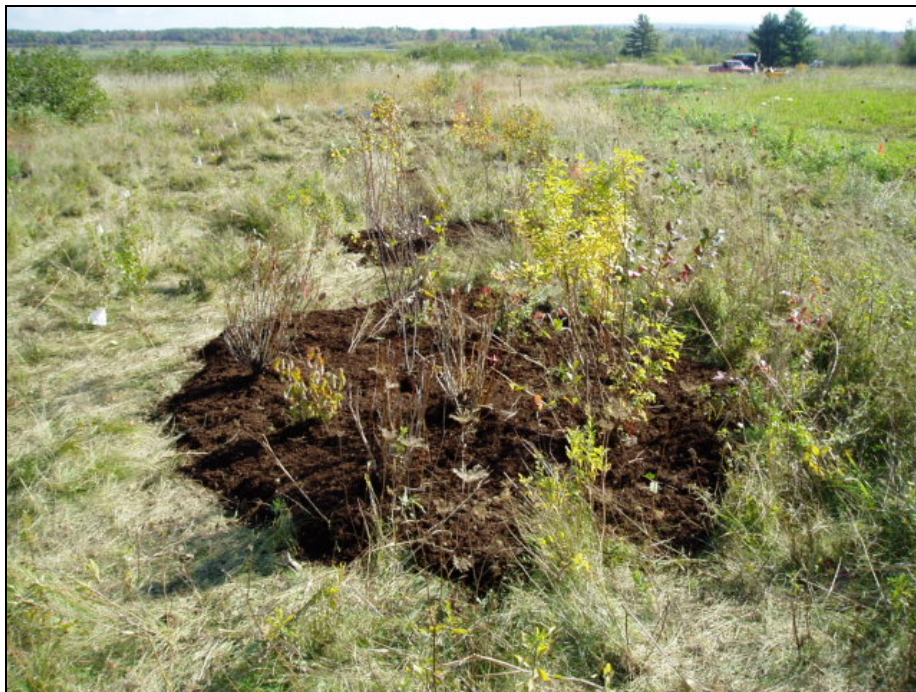
Photo 6. Plantings installed on south (un-mowed) side of main swale. Stantec, October 4, 2007.

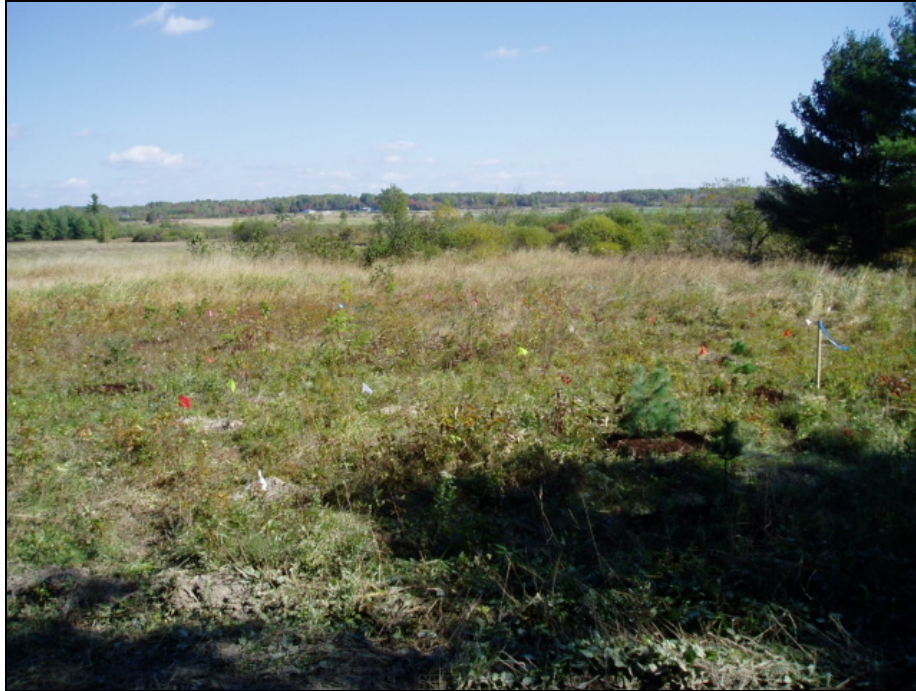
Photo 7. Plantings and natural shrub growth on south (un-mowed) side of main swale. Stantec, October 4, 2007.

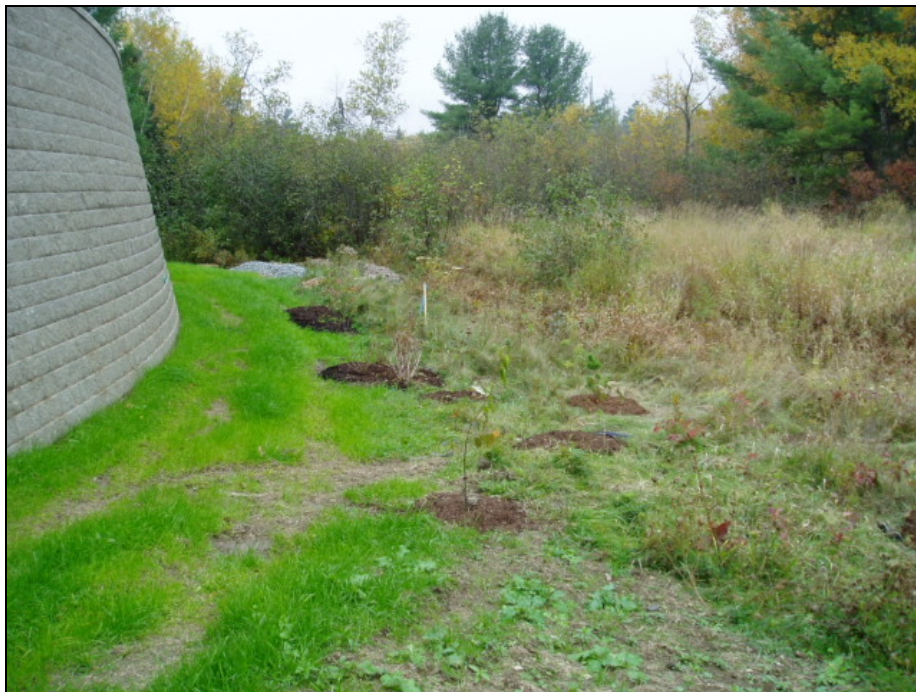
Photo 8. Plantings and natural shrub growth on south (un-mowed) side of main swale along the wall on west side of mitigation area (looking west). Stantec, October 19, 2007.

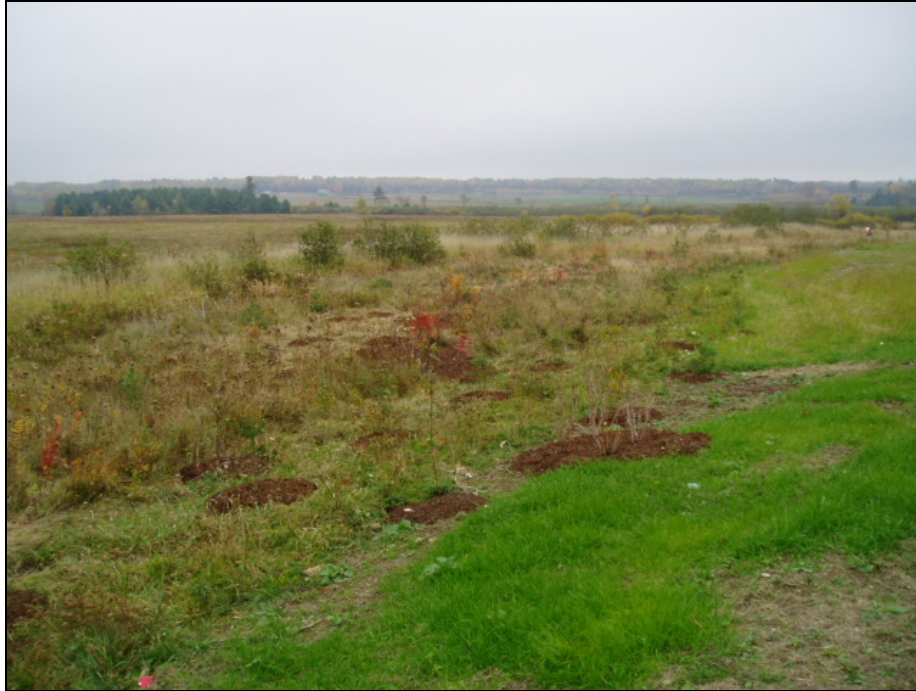
Photo 9. Plantings and natural shrub growth on south side of main swale near the constructed wall on west side of mitigation area (looking east). Stantec, October 19, 2007.

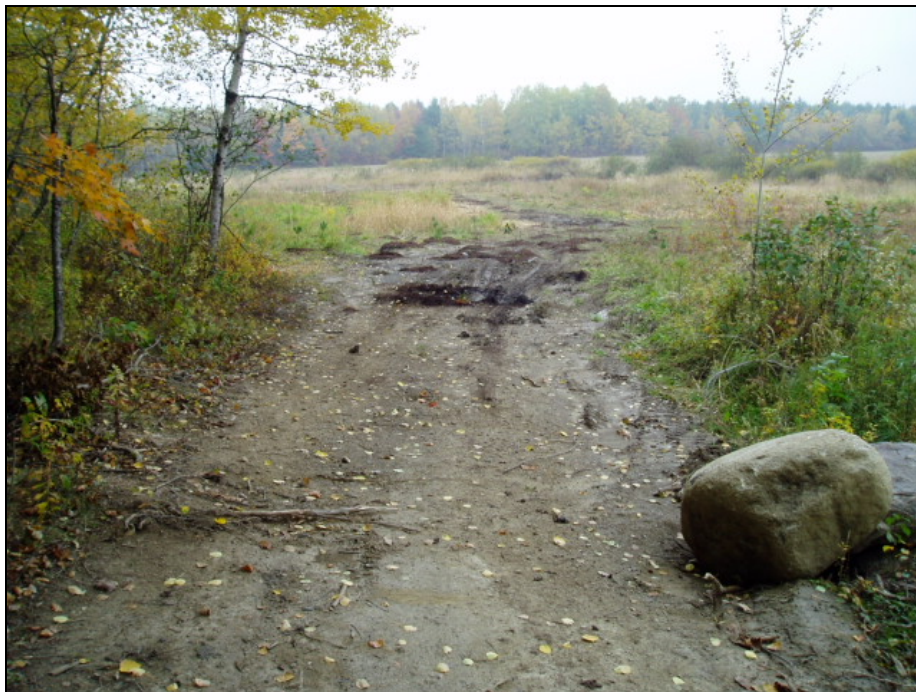
After plants were installed and mulched (i.e., on or about October 5), the planting contractor placed boulders across the dirt access road into the site. The barrier was deemed necessary because the site had recently been used by four-wheel drive trucks "playing" in a mud hole they had formed in the main swale of the mitigation area. When Stantec returned to the site on October 19, they found the boulders had been moved out of the way, and there was additional damage to the site by the four-wheel drive vehicles. Over 85 of the newly installed plants had been run over and the rutted areas and mud hole was larger. Stantec contacted Sargent that day to discuss ways of keeping unauthorized vehicles out of the mitigation area in the future.

Photo 10. Access point that was blocked with boulders. Boulders were moved by unauthorized vehicles. Note plantings in background that were run over. Stantec, October 19, 2007.

Sargent immediately replaced the boulders and monitored access to the site. At one point, Sargent caught up with someone whose vehicle had become stuck in the field adjacent to the mitigation area (i.e., on an abutting property and not within the mitigation area). Sargent informed the person that it was important to stay out of the mitigation area, and asked that he please respect the fact that Lowe's has blocked access to the site to protect a re-vegetation effort. The person was also asked to relay the same message to anyone he knew who might try to access the site. As of November 14, 2007, the boulder barrier was still in place and Sargent has not seen any further unauthorized access to the mitigation area.

After October 19, Sargent also installed signs along the back (north) property line of the mitigation area indicating that no mowing was allowed beyond the signs. The signs are on posts spaced every 50 to 100 feet apart. The intent of this measure is to show the adjacent landowner where the property line is and keep the mowers out of the mitigation area. Sargent indicated that they will also place a sign at the access road boulder barrier indicating no vehicles beyond that point.

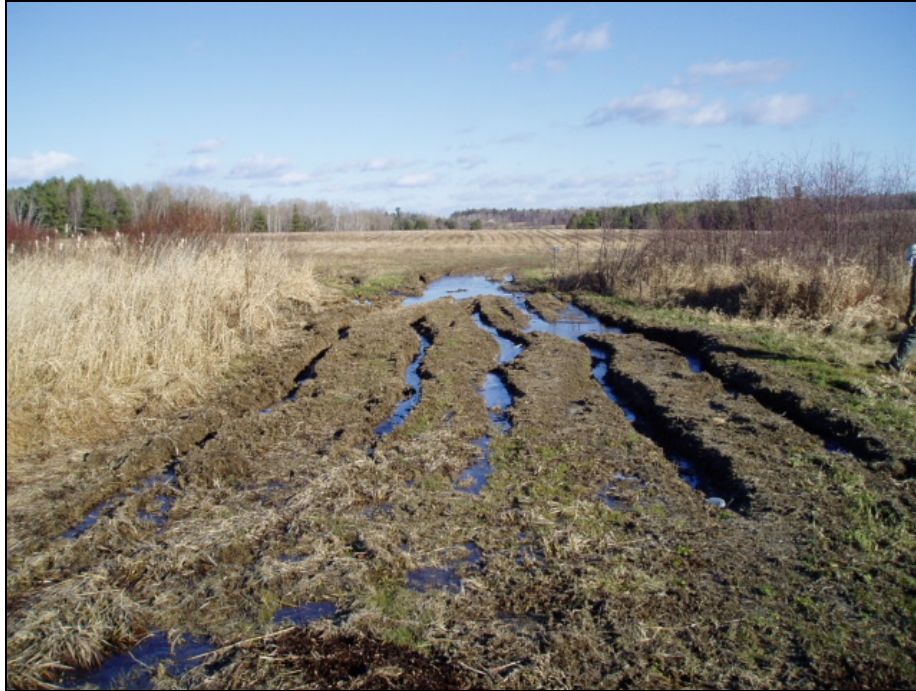
Photo 11. Rutted section of central swale, looking north, before repair.
Stantec, November 30, 2007.

The rutted swale crossing (i.e., the "mud hole") was repaired and stabilized on November 30, 2007. At the direction of a Stantec wetland scientist, Sargent used a mini-excavator to drain the water-filled ruts, restore a single drainage channel in the swale, and generally re-grade the rutted area. Exposed soils were then covered with straw mulch. Photos 11 and 12 illustrate conditions at the mud hole before and after this repair work was completed.

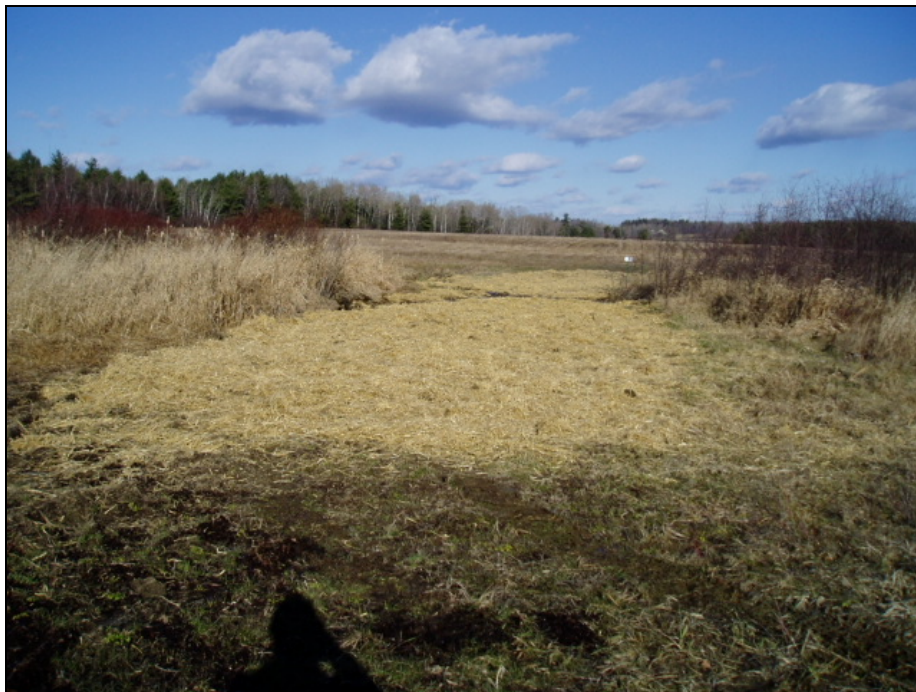
Photo 12. Rutted section of central swale, looking north, after repair.
Stantec, November 30, 2007.
