Re: Cabela's (New England Expedition Scarborough LLC) Wetland Mitigation Project at Larrabee Farms Wetland Mitigation Site – YEAR THREE (2010) MONITORING REPORT

PROJECT TITLE: The Gateway at Scarborough (Cabela's): Larrabee Farms Wetland Mitigation Project

ATTACHED MITIGATION REPORT TITLE: The Gateway at Scarborough (Cabela's): Third Year Wetland Mitigation Monitoring Report

Monitoring Report : Year 3 of 10 years

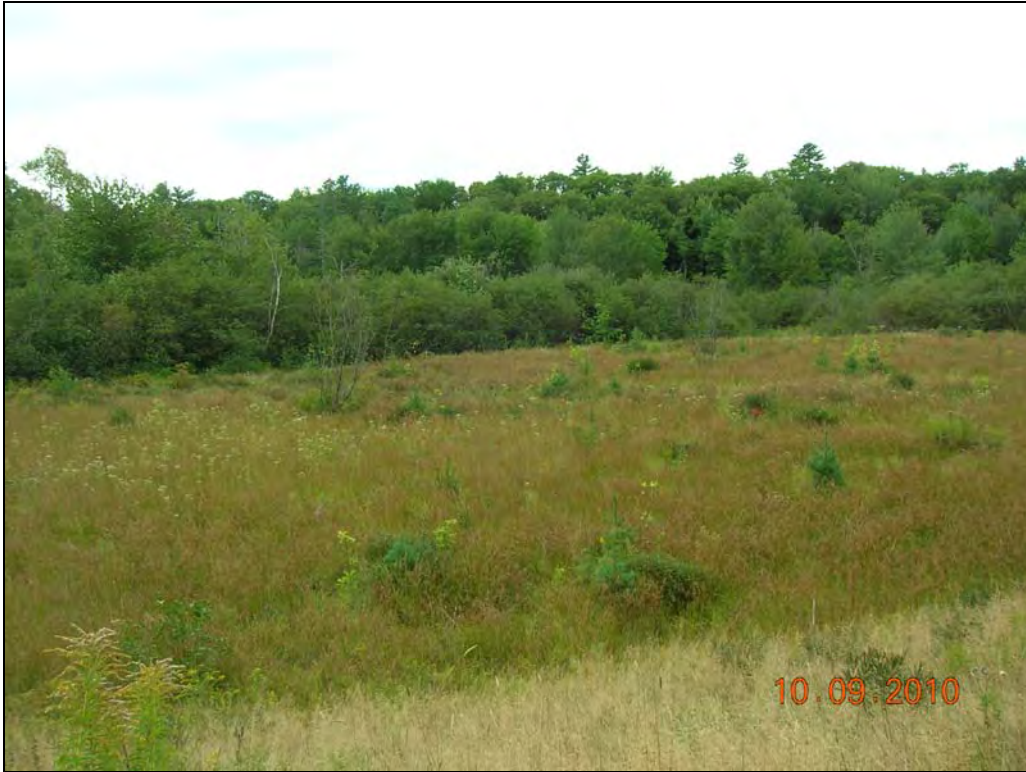
Photo 1 (Year 3). Facing south towards southeastern wetlands creation cell, 10-Sept-2010.

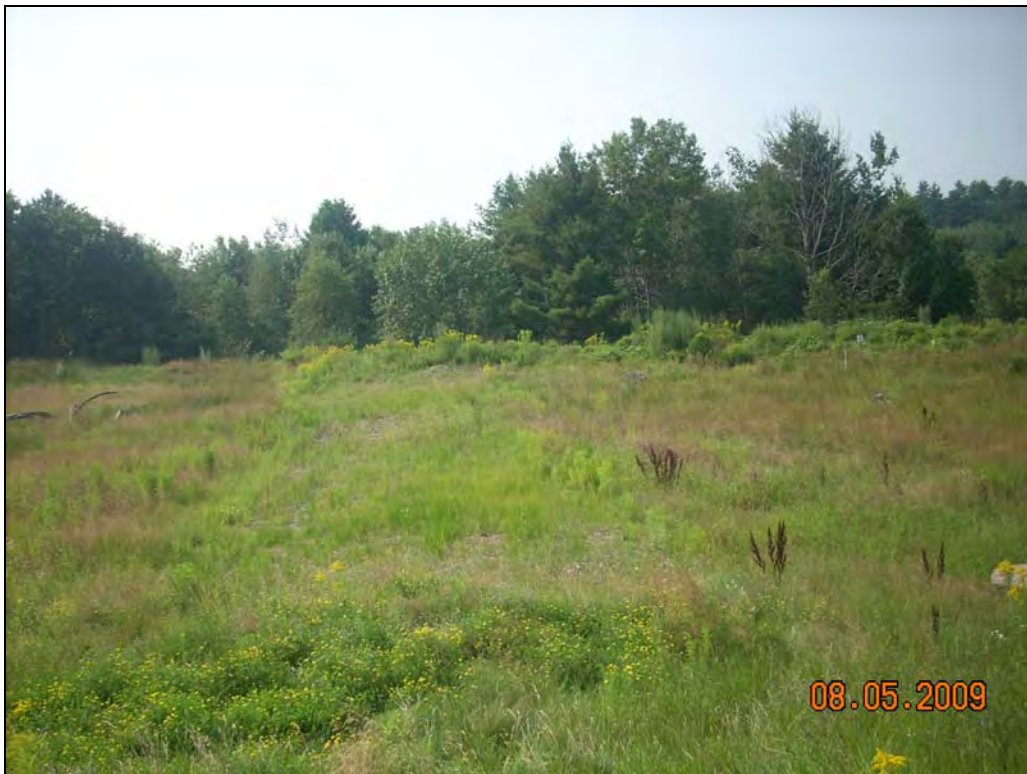
Photo 2 (Year 2). Facing south towards former location of separator berm which was a spillway between upper two cells. The berm was removed in the spring of 2009, 05-Aug-2009.

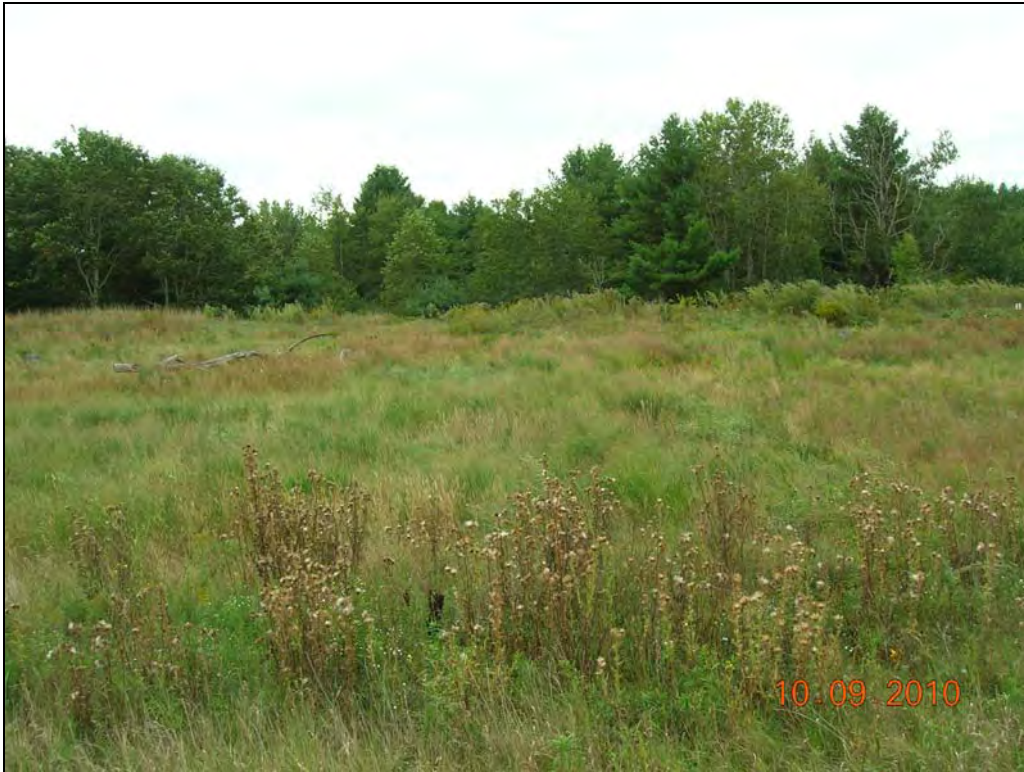
Due to the removal of the berm in between the upper cells and the addition of the rip rap spillway directing excess surface flow from the road and quarry in 2009, the PEM creation areas continue to show signs of improved hydrology. Monitoring in the summer of 2010 seems to indicate that the improved hydrology is now permanent and adequate to support appropriate wetland conditions.

Photo 2 (Year 3). Facing south towards former separator berm location. Area now completely re-vegetated, 10-Sept-2010.

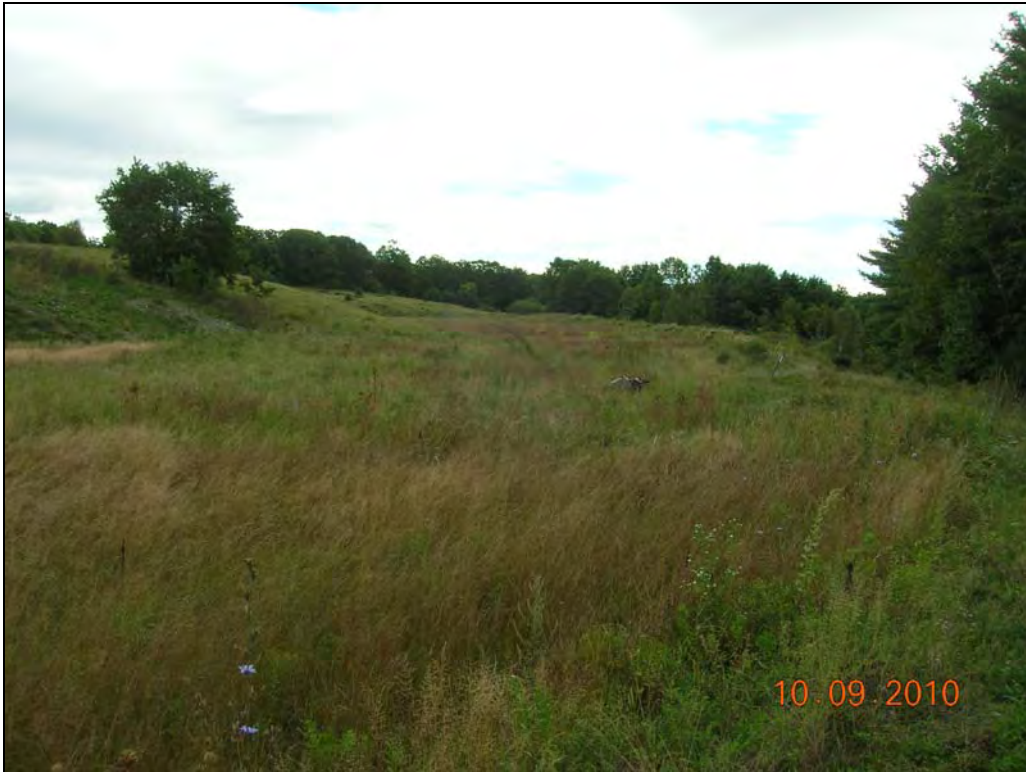
A 0.65-acre extension of the wetland creation site was graded and planted in the winter of 2008 and spring of 2009, respectively. This area was monitored as a part of the whole site for the first time in 2010. The area is already completely vegetated and the planted woody material appears to be healthy and growing. Overall, a saturated hydrologic regime was noted with some small pockets of inundation in the excavated pits.

Photo 9 (Year 3). Facing west across upper creation cell from southwestern boundary. Newly created portion in foreground of photo completely re-vegetated, 10-Sept-2010.

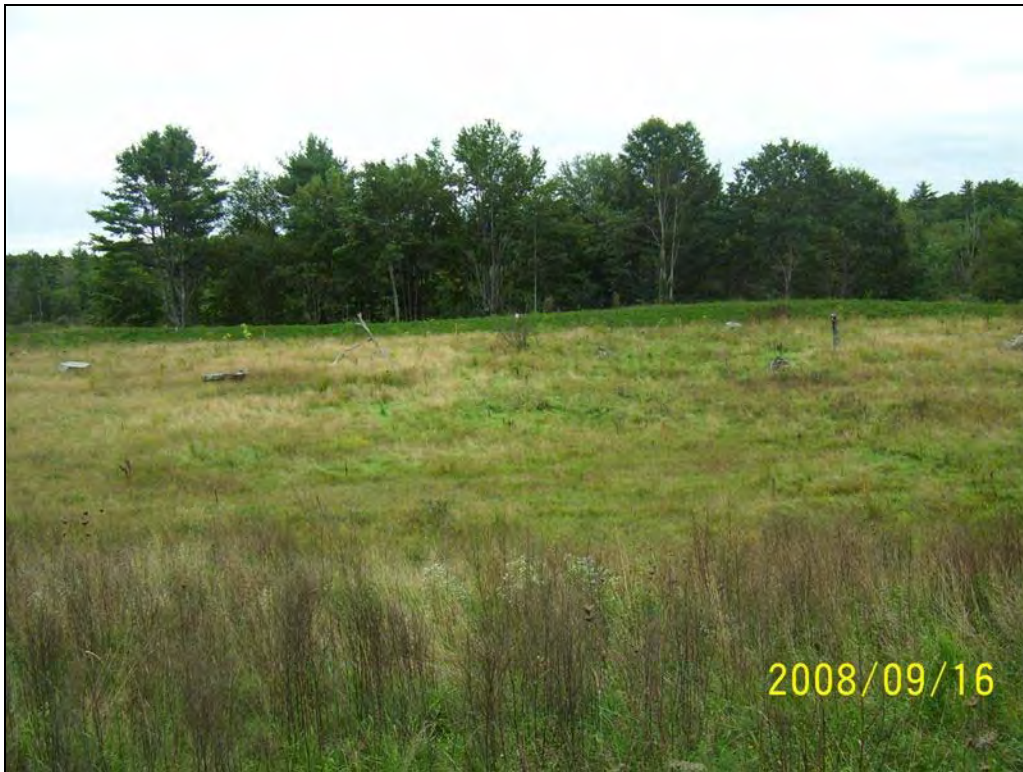
Photo 10 (Year 1). Facing south/southwest across the eastern half of the upper creation cell, planted trees and shrubs are obscured by the herbaceous vegetation and photo washout in this picture, 16-Sep-2008.

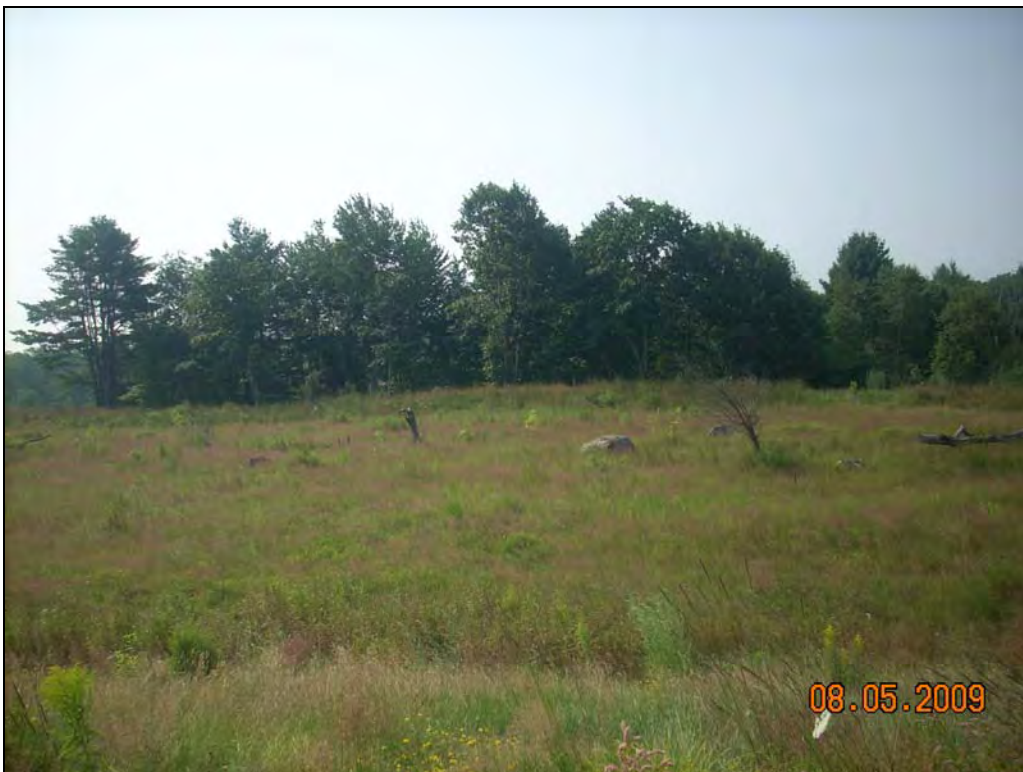
Photo 10 (Year 2). Facing south/southwest across the eastern half of the upper creation cell, planted trees and shrubs are less obscured by the herbaceous vegetation during the 2009 growing season than the 2008 growing season, 05-Aug-2009.
