WETLAND MITIGATION ANNUAL MONITORING REPORT

**RENTSCHLER FIELD PARKING AND TRAFFIC CIRCULATION IMPROVEMENTS
MONITORING REPORT 1 OF 5
USACE PERMIT NO. CENAE-R-2007-2818**

December 17, 2013

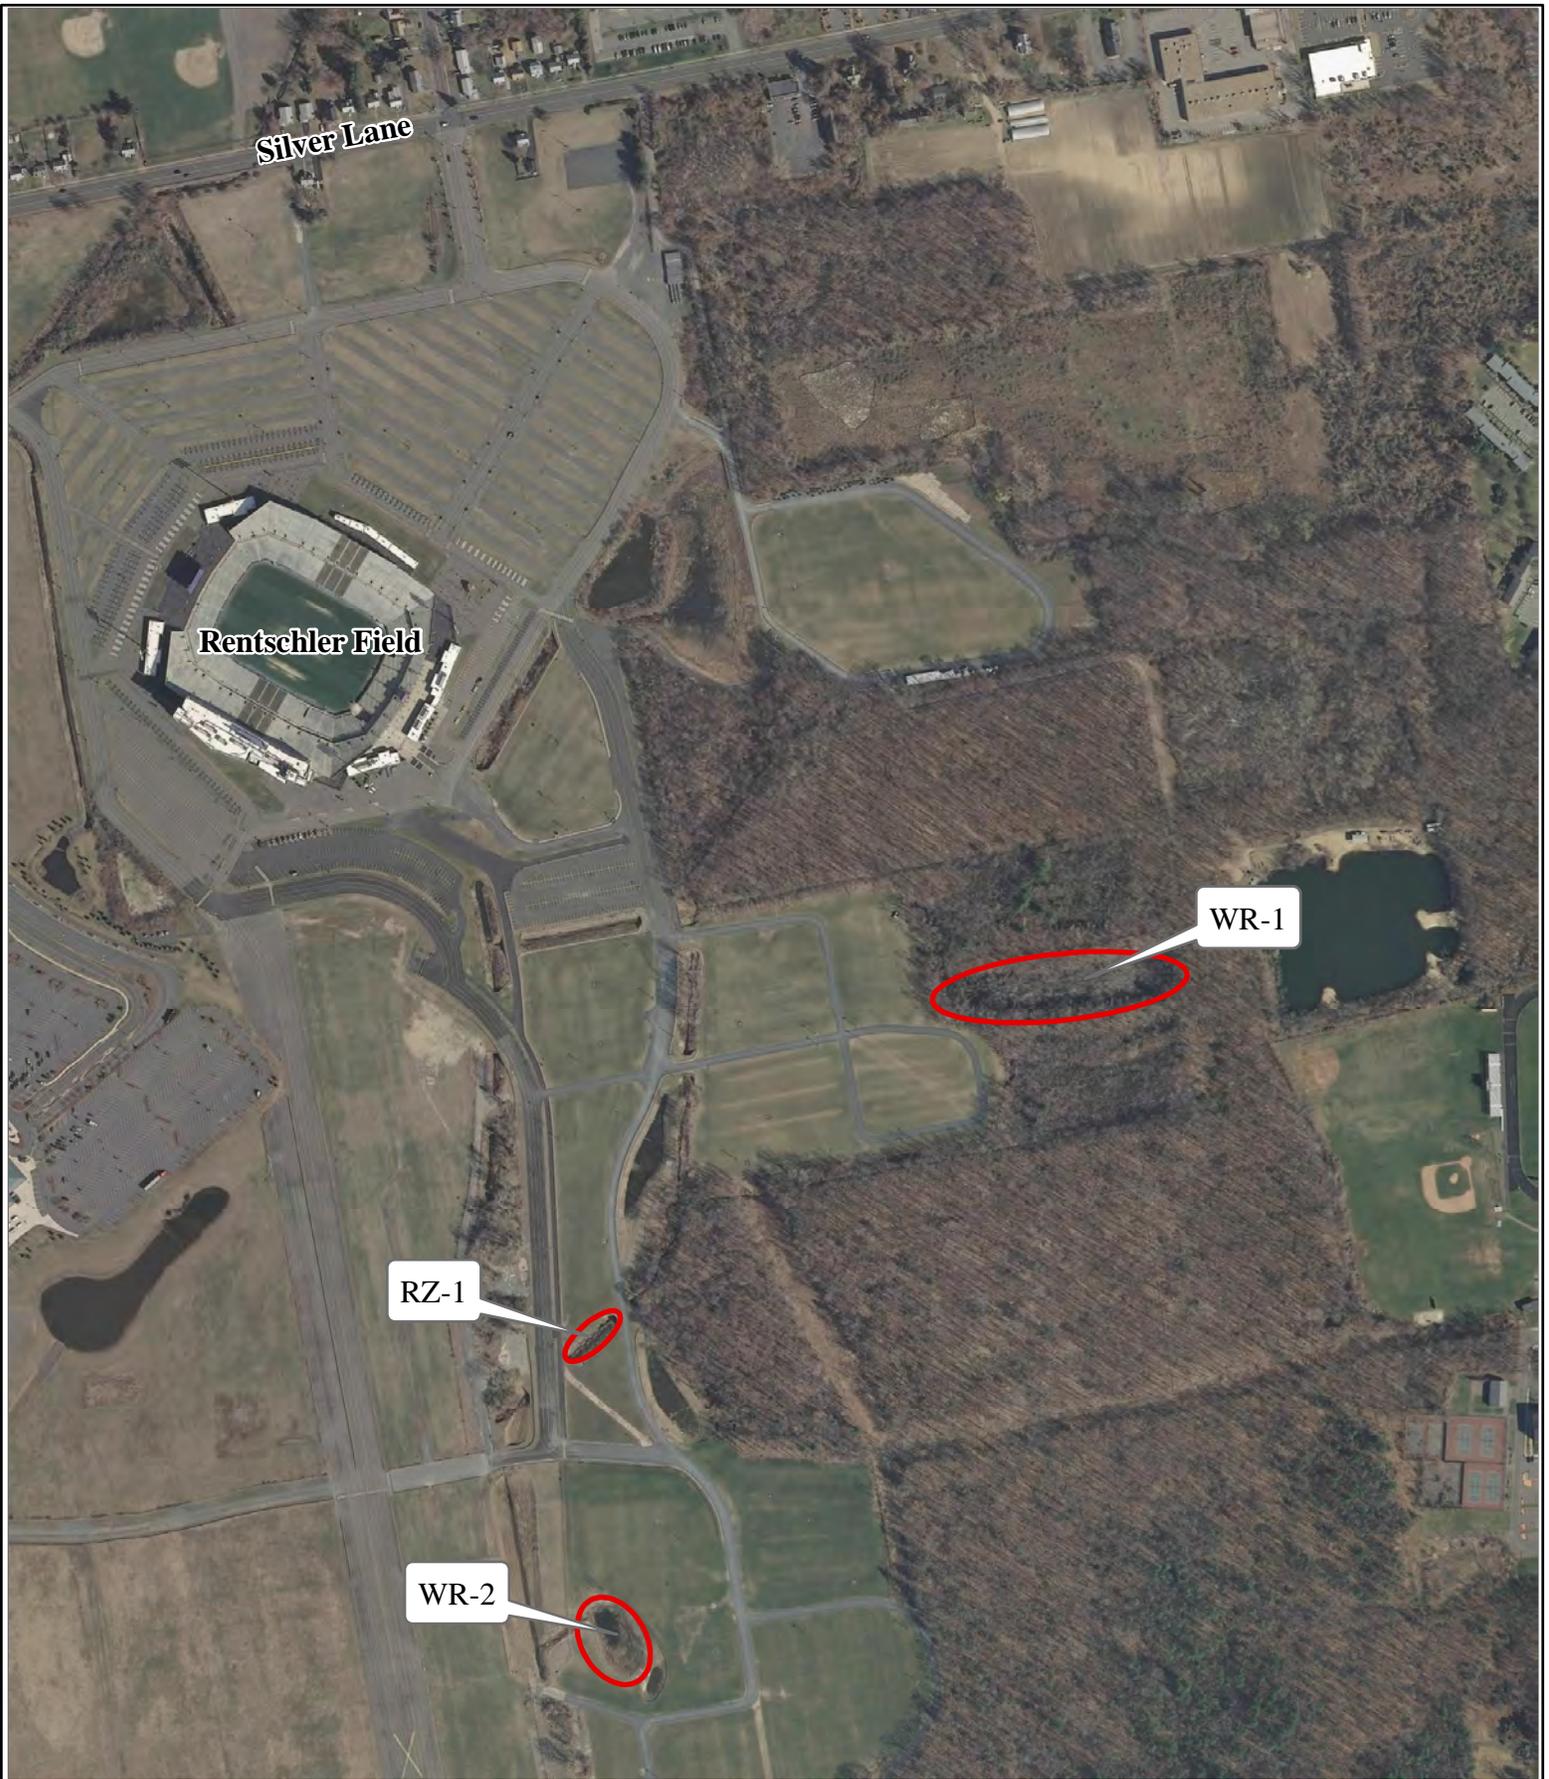
Figure 1: Wetland Mitigation Locations

The wetland and riparian zone restoration projects were implemented in August 2011. Three mitigation sites – WR-1 (2.0 acres), WR-2 (0.2 acres), and RZ-1 (0.1 acres) – were restored in 2011. Figure 1 illustrates the location of the three mitigation sites. Wetland restoration area WR-1 has not been planted to date because of ongoing invasive species (common reed) management within the restoration area. OPM has implemented an intensive invasive species management program within this wetland, and it has been ongoing for the past three years.

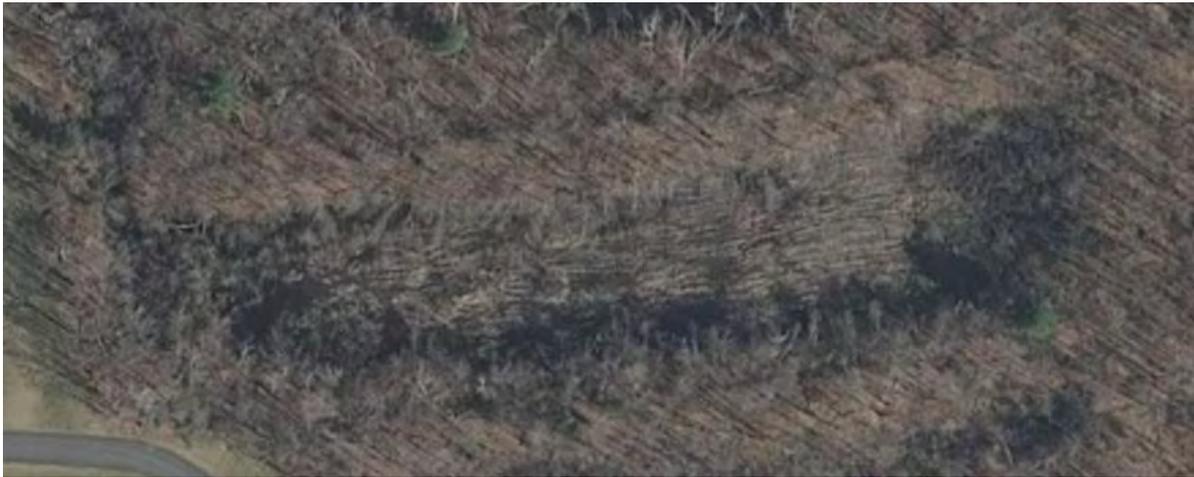
Figure 2 – Wetland Restoration Area WR-1 Spring 2012

Overall, MMI has not observed any major problems within each of the mitigation sites. WR-1 will be treated with herbicide again during spring 2014. OPM is hopeful that the final wetland restoration components to this mitigation site can be completed during 2014, including minor hummock formation and planting. WR-2 is stable, the vegetative plant community is dense, and there are no significant problems within this wetland mitigation area. Common reed stalks were observed near the outlet of this wetland, and these limited number of plant stalks were treated with herbicide known as "Habitat," an Imazapyr-based product, during 2013. The presence of

The vegetation densities vary widely within this wetland because the wetland is currently being managed for the removal of common reed. Native herbaceous plants have begun to colonize portions of the wetland including species such as yellow swamp candles, swamp beggar ticks, and soft rush. Common reed is still present within this wetland, but the overall population has been significantly reduced. Remaining plants appear stressed and have not produced any inflorescence (flower/seed heads) over the past three years. Common reed will be treated again in 2014.

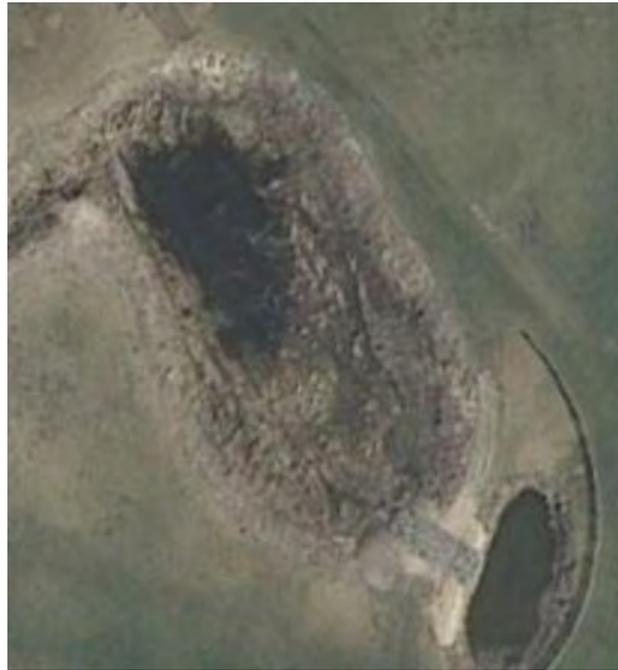
Figure 3 – Wetland Restoration Area WR-2 Spring 2012

WR-2 typically becomes flooded/inundated with approximately one to two feet of standing water during the winter and early spring months. The depth of standing water varies year by year dependent upon precipitation levels during the early spring. For example, the springs of both 2012 and 2013 were relatively dry during the months of March and April; therefore, spring inundation levels within WR-2 were lower than what has been observed in the past. By July, there are a few pools of shallow standing water, and most of the soils within the wetland remain saturated to the surface.

WR-2 is well vegetated with a variety of emergent and wet meadow wetland plant species. The fringes of the wetland have shrubs including speckled alder, buttonbush, highbush blueberry, steplebush, sweet pepperbush, and willows. This wetland has a diverse assemblage of native plant species and offers flowering plants, nectar-producing plants, and seed-producing plants. The vegetation is lush, green, and healthy and is meeting the goals of the mitigation plan. Table 3-1 presents the plant survivability percentages within WR-2 following the first full growing season.

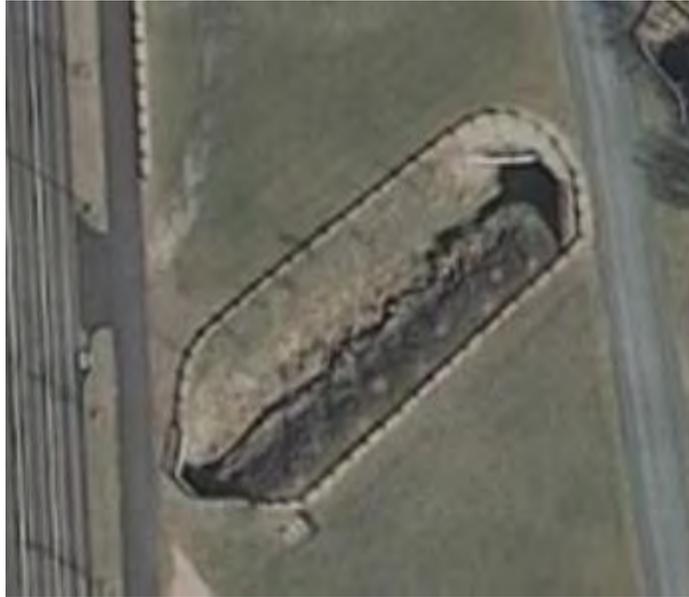
Figure 4 – Riparian Zone Area RZ-1 Spring 2012

The watercourse located within RZ-1 has higher flows during the winter and spring months and lower flows during the late summer. Similar to WR-2, the watercourse experienced unusually low flows during March and April of 2012 and 2013 due to the lack of precipitation. In fact, during the springs of 2012 and 2013, many of the state's watercourses and wetlands were closer to typical July low-flow conditions than typical spring flows.

RZ-1 has well vegetated, stable banks that are predominantly native upland and wetland vegetation. There was a slight modification to the planting plan for RZ-1 made during construction. Black willows were not available at the specified sizes and were substituted with pin oaks. In addition, the quantity and size of the trees used within RZ-1 was modified due to availability. The approved mitigation plan required 50 trees at sizes ranging from five to six feet to be planted along both banks of the watercourse located within RZ-1. Instead, 18 trees were planted that ranged in size from 12 to 15 feet in height and were spaced approximately 12 feet on center from each other to provide appropriate spacing, light, and growth requirements. The trees are growing well and will provide shading of the watercourse over time. Table 3-2 presents the tree planting modifications and first year survival rates.

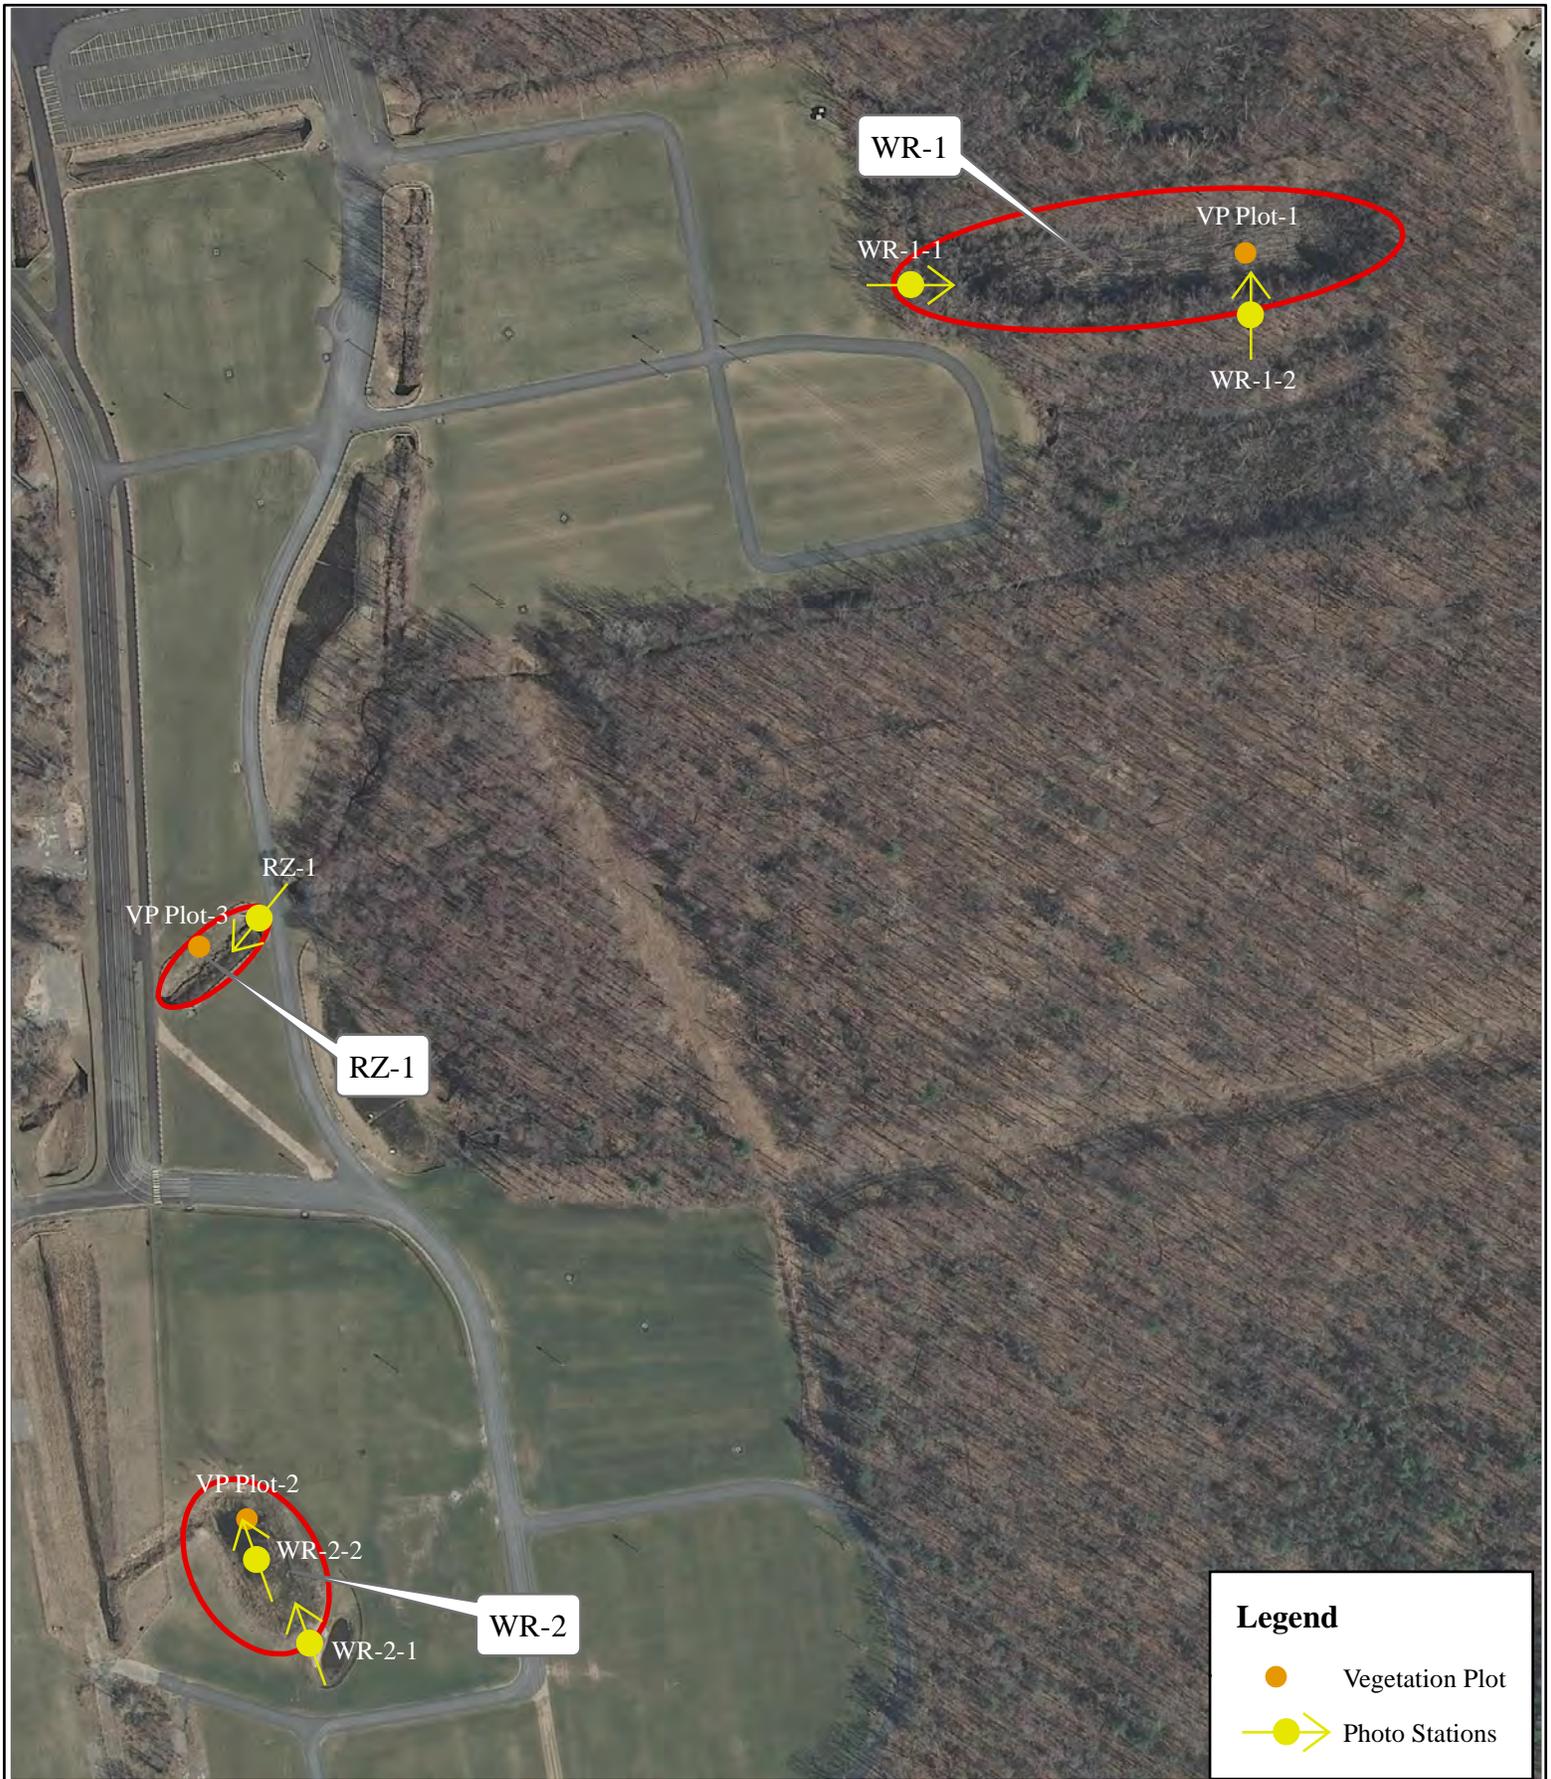
Figure 5: Photo Station and Vegetation Plot Locations

As stated previously, MMI conducted a spring site visit on June 15, 2013 and a late summer site visit on September 23, 2013. MMI established several vegetation plot areas and photo stations within the mitigation areas, and these are illustrated in Figure 5. A photo log of our 2013 site visits is attached as Appendix D.

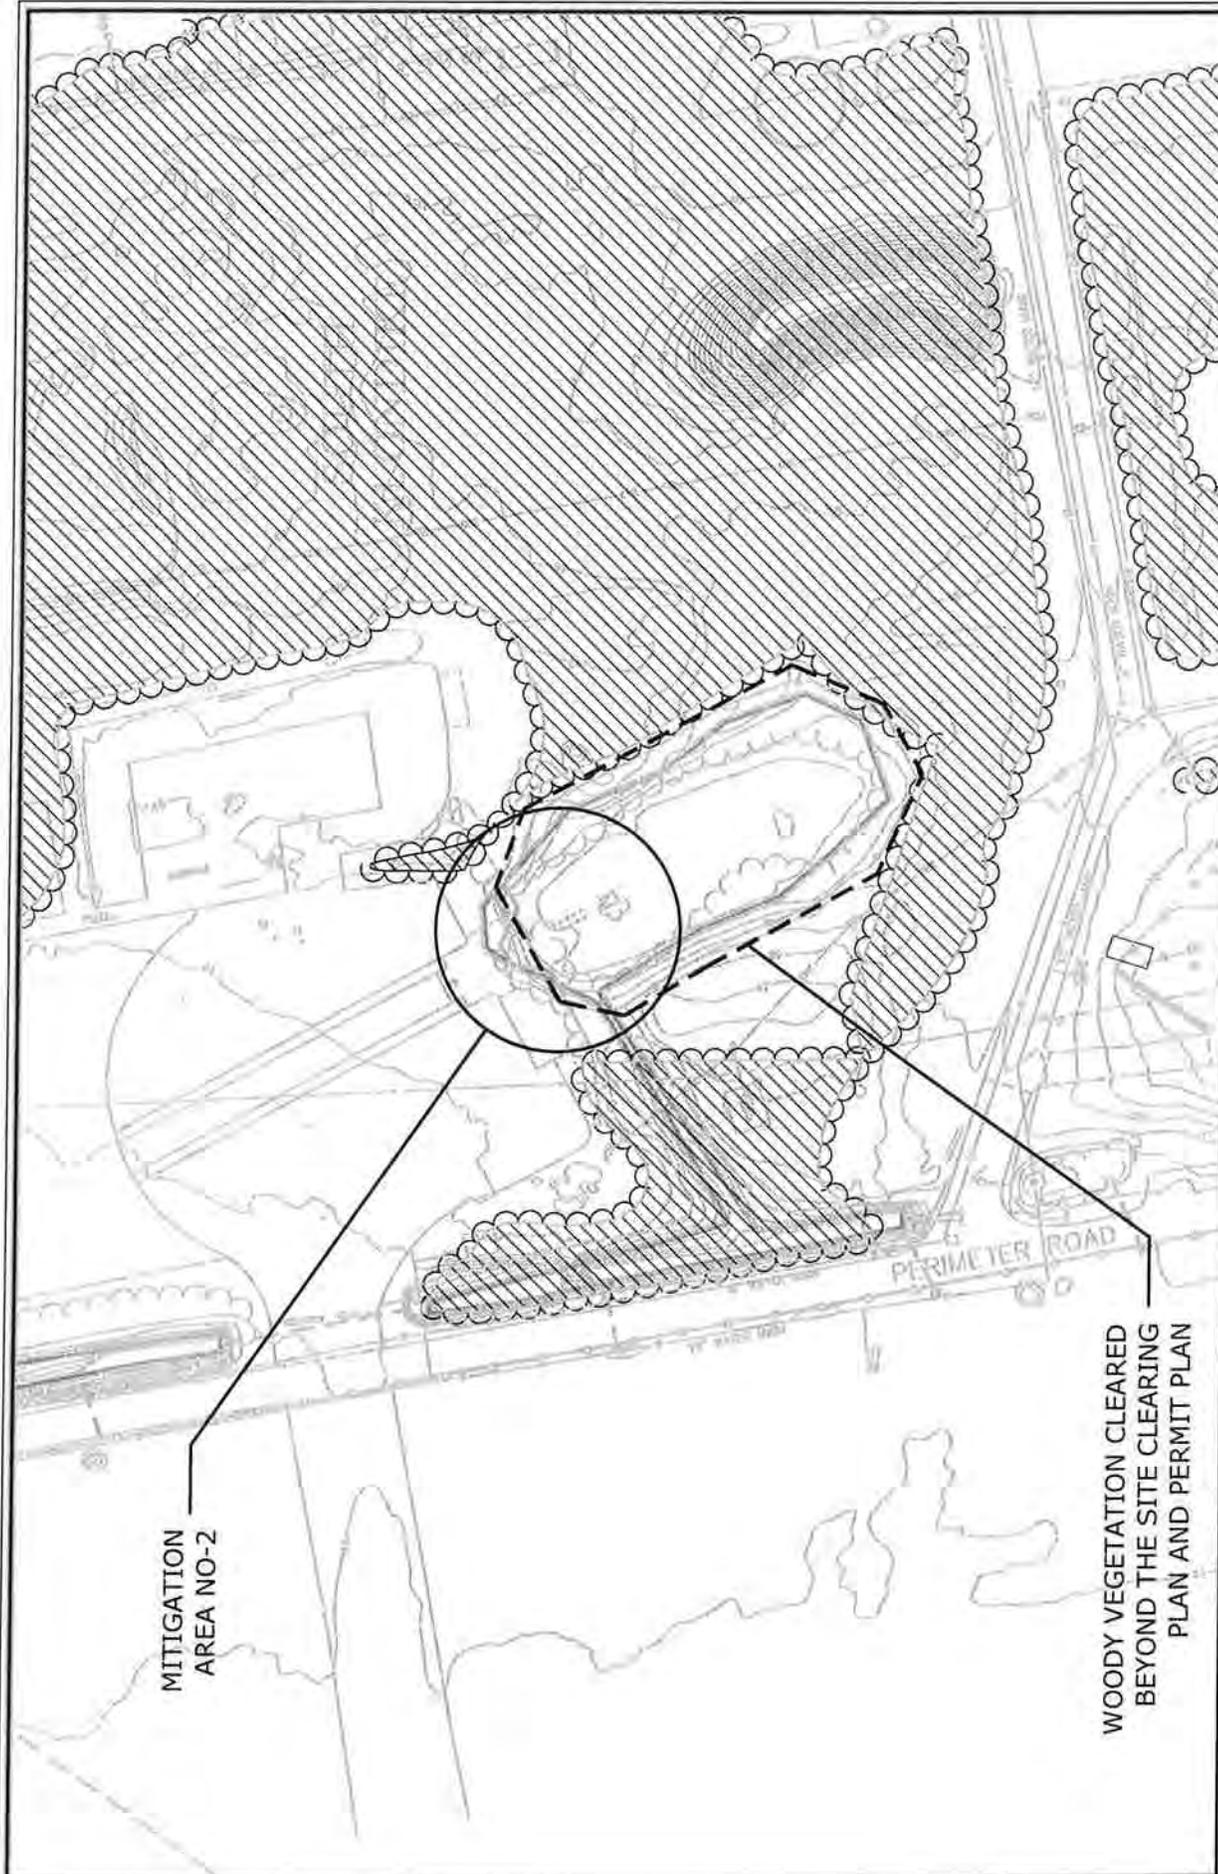
MITIGATION
AREA NO-2

MMI conducted a site walk on February 22, 2010 and found that the tree clearing contractor had accidentally cleared beyond the silt fence and clearing limits as shown on the site clearing plan. A photo log of our site visit is appended. All of the woody vegetation was cut to approximately eight inches in height. Clearing of this vegetation was not part of the final wetland mitigation plan or the state and/or federal wetland permits. At this time, MMI recommends that OPM report this accidental clearing to both the Connecticut Department of Environmental Protection Inland Water Resources Division and the United States Army Corps of Engineers.

WOODY VEGETATION CLEARED
BEYOND THE SITE CLEARING
PLAN AND PERMIT PLAN

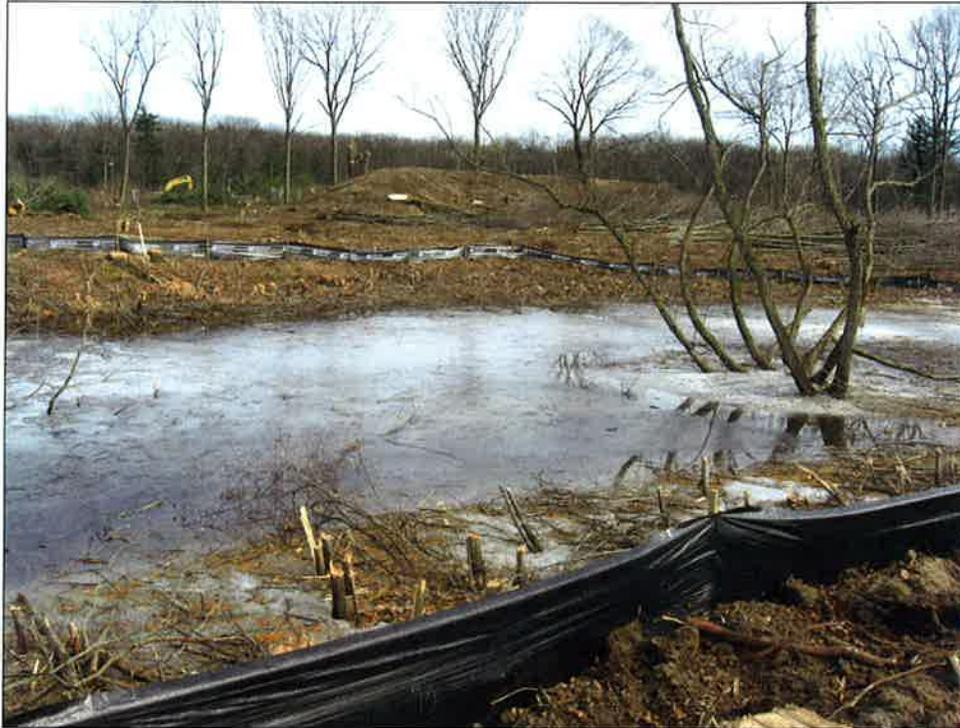
Wetland Basin with cleared vegetation

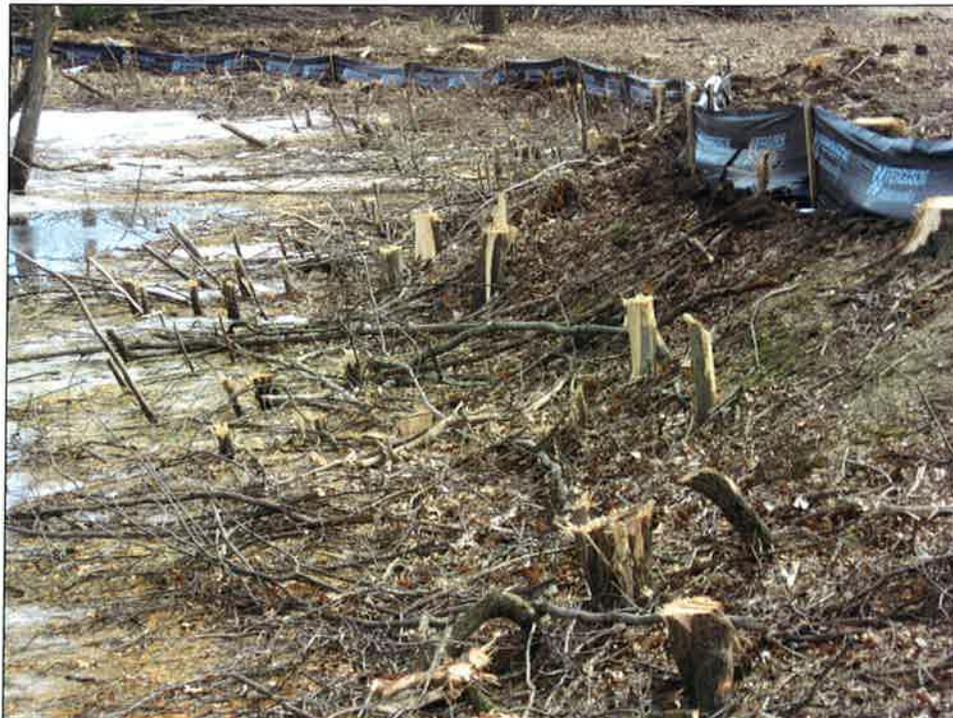
Vegetation cut to approximately eight inch stumps.

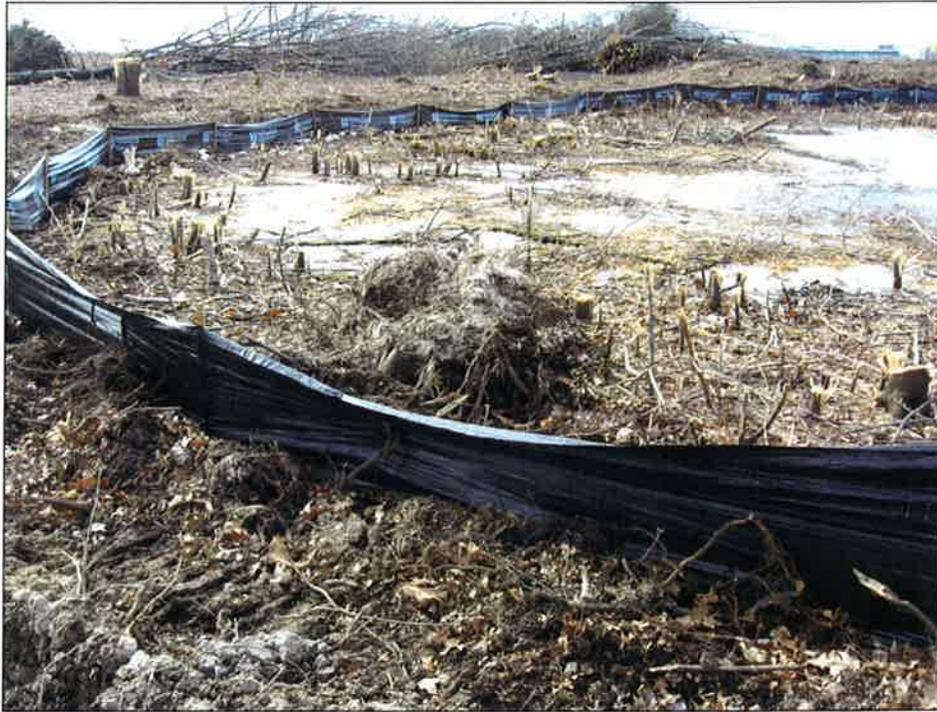
Vegetation cleared beyond silt fence.

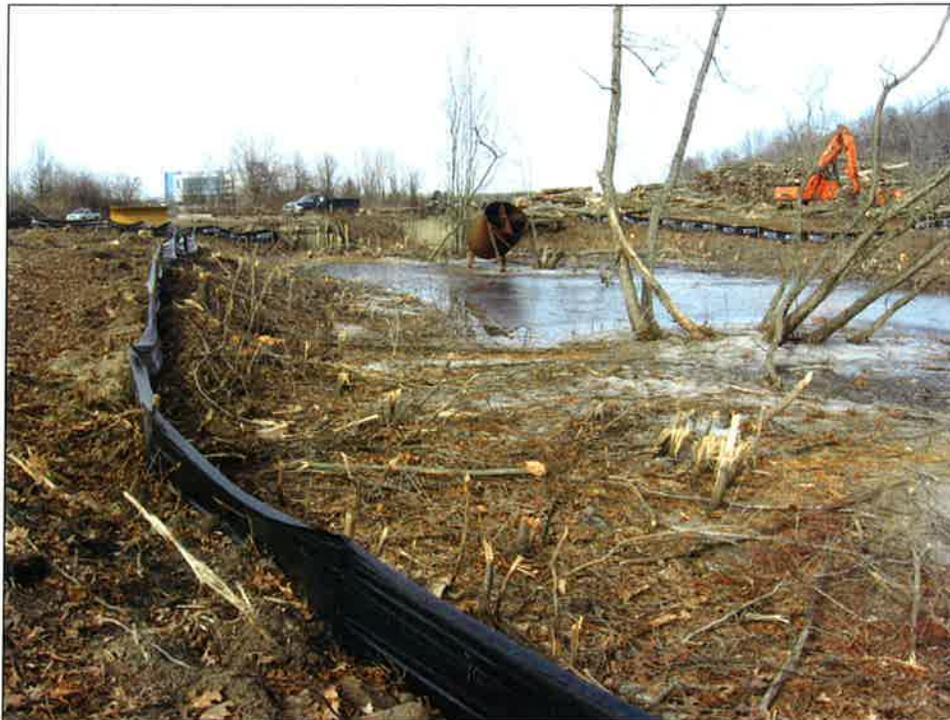
Vegetation cleared beyond silt fence
