# Flood Hazards and the Clean Water Act

VT Dept. of Environmental Conservation  
River Management Program

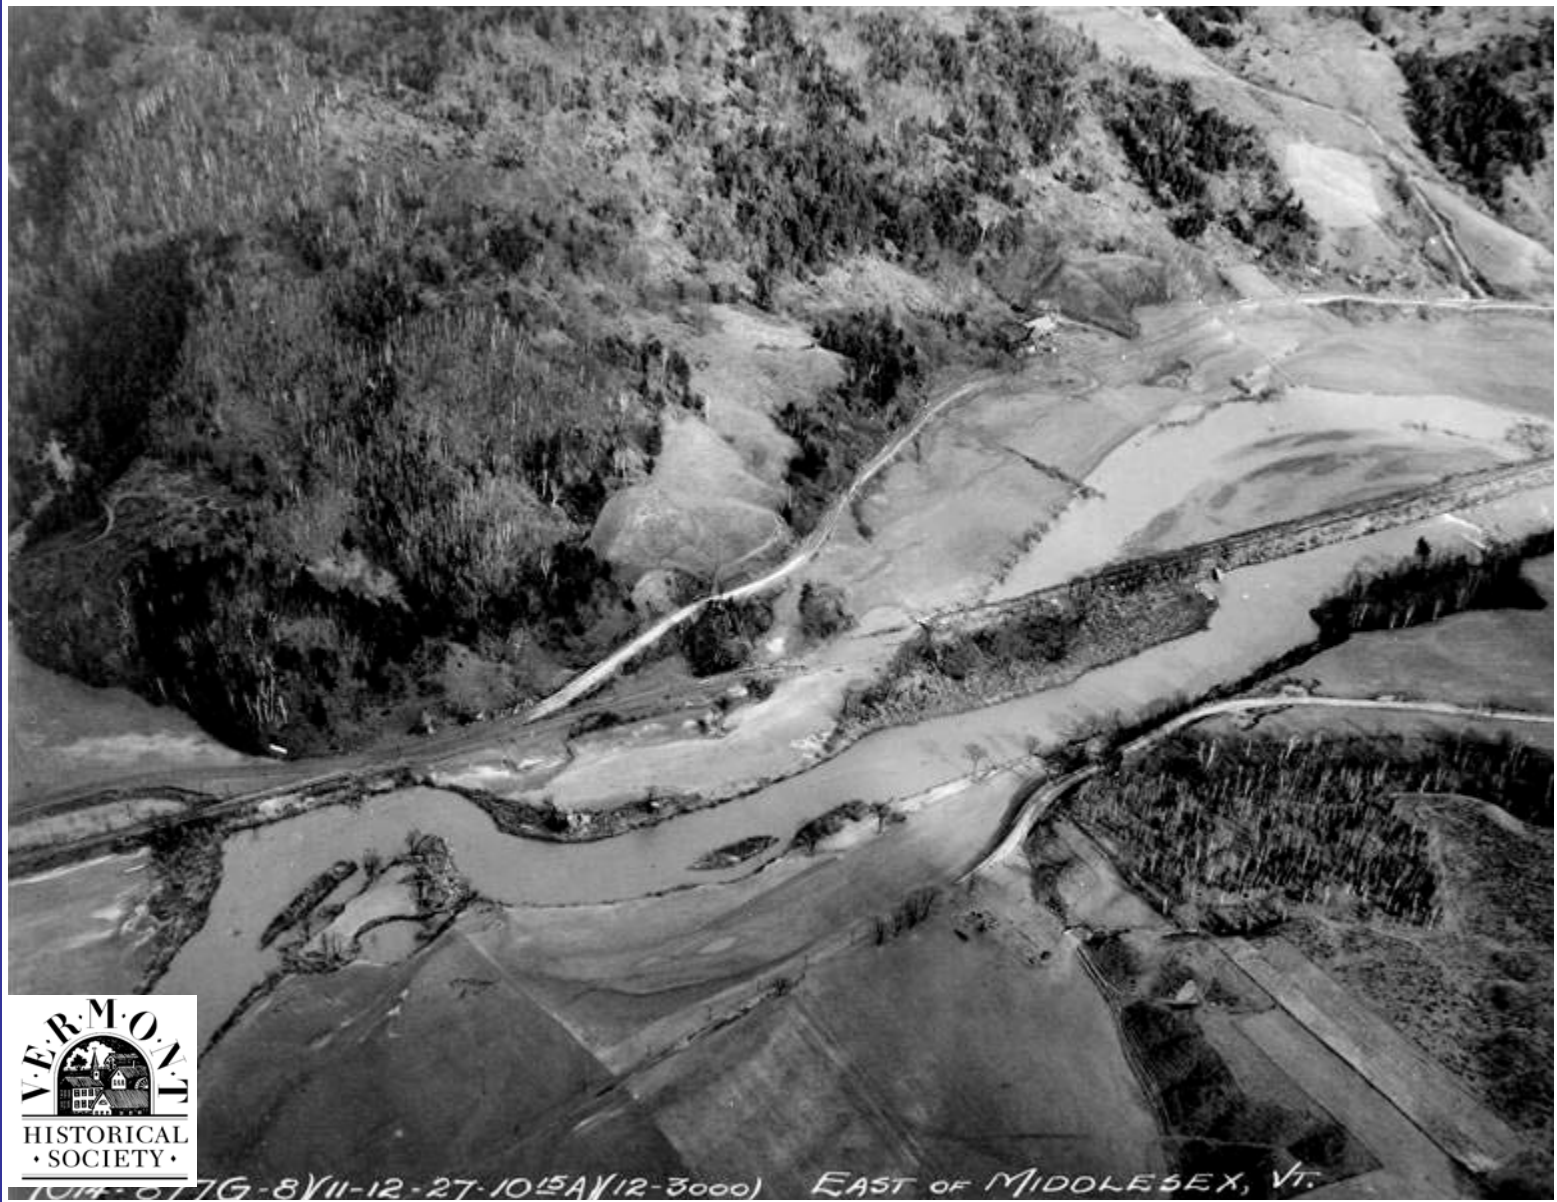
**Truncated (cut-off) meanders, and abandoned flood plain  
to accommodate railroad construction, Winooski River, Middlesex, 1927**

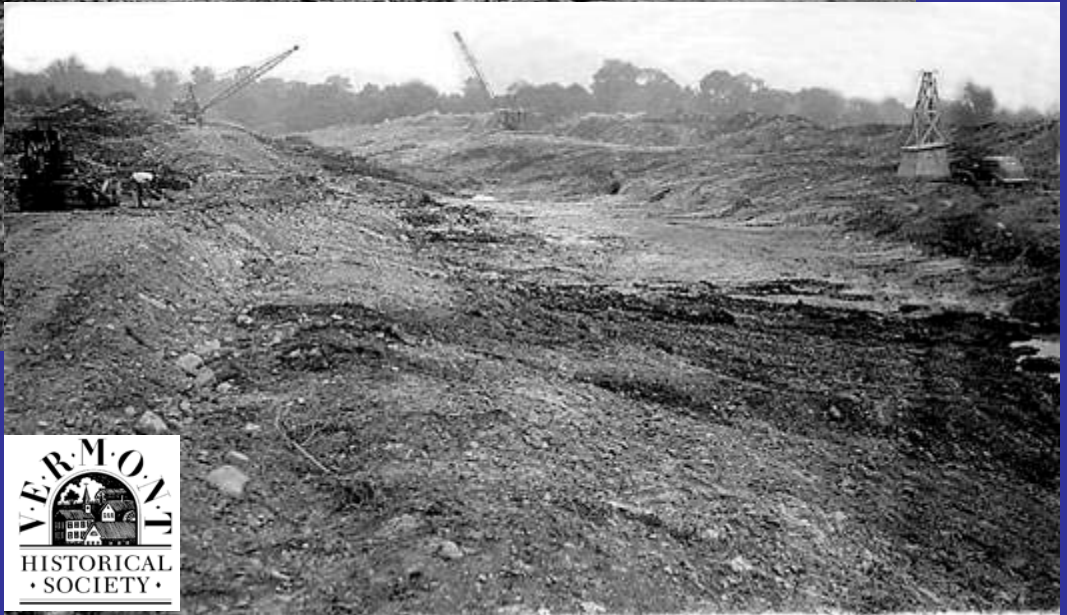
**Post Flood Channelization  
Castleton River, Castleton,  
1927**

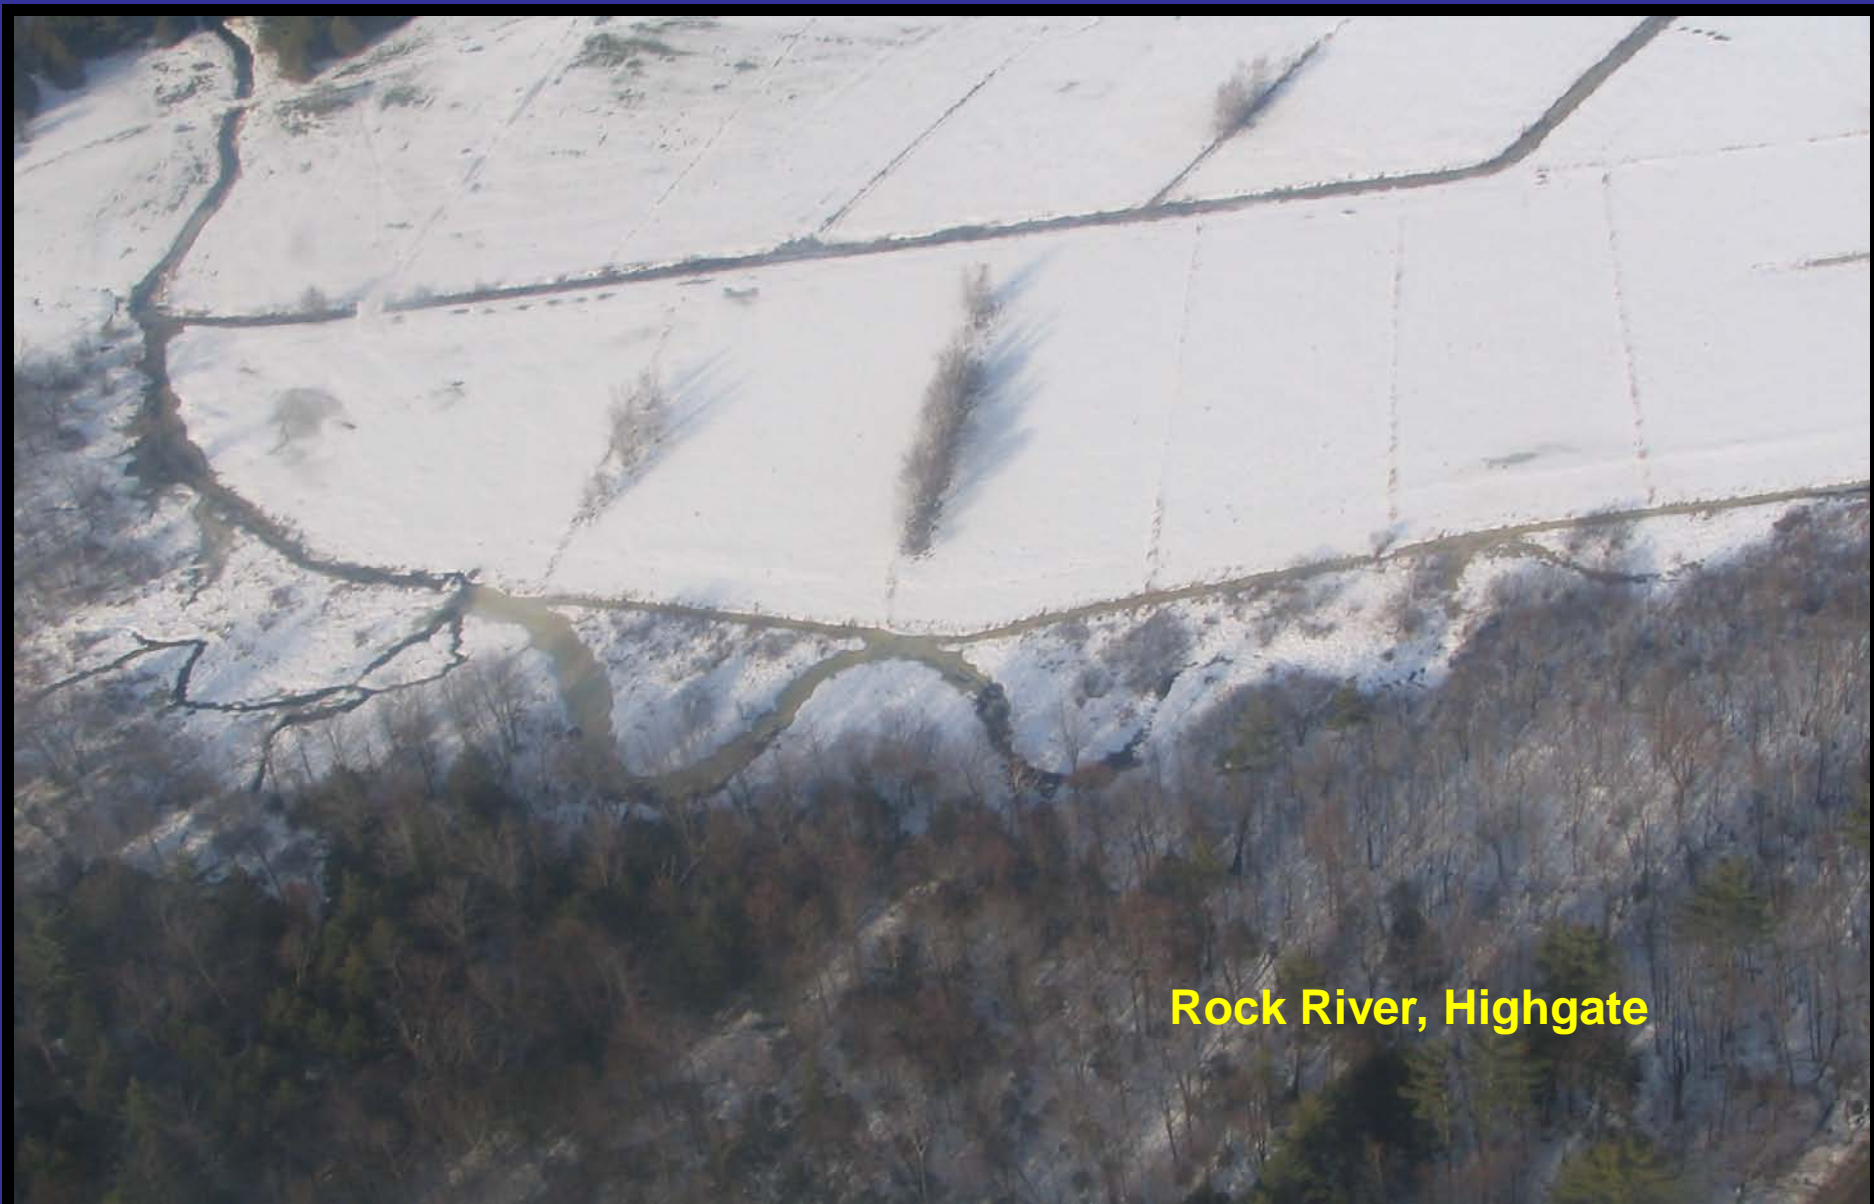
**Up to 75% of Stream Miles have been Modified  
to Accommodate Roads, Railroads, Agriculture and Other Land Uses**

**Rock River, Highgate**

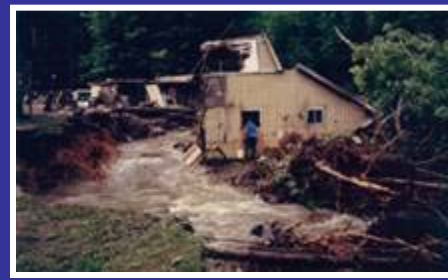
# The Physical Imperatives of Fluvial Systems are Predictable and are Temporally Connected at Time Scales Spanning Generations

After Shumm, et.al.

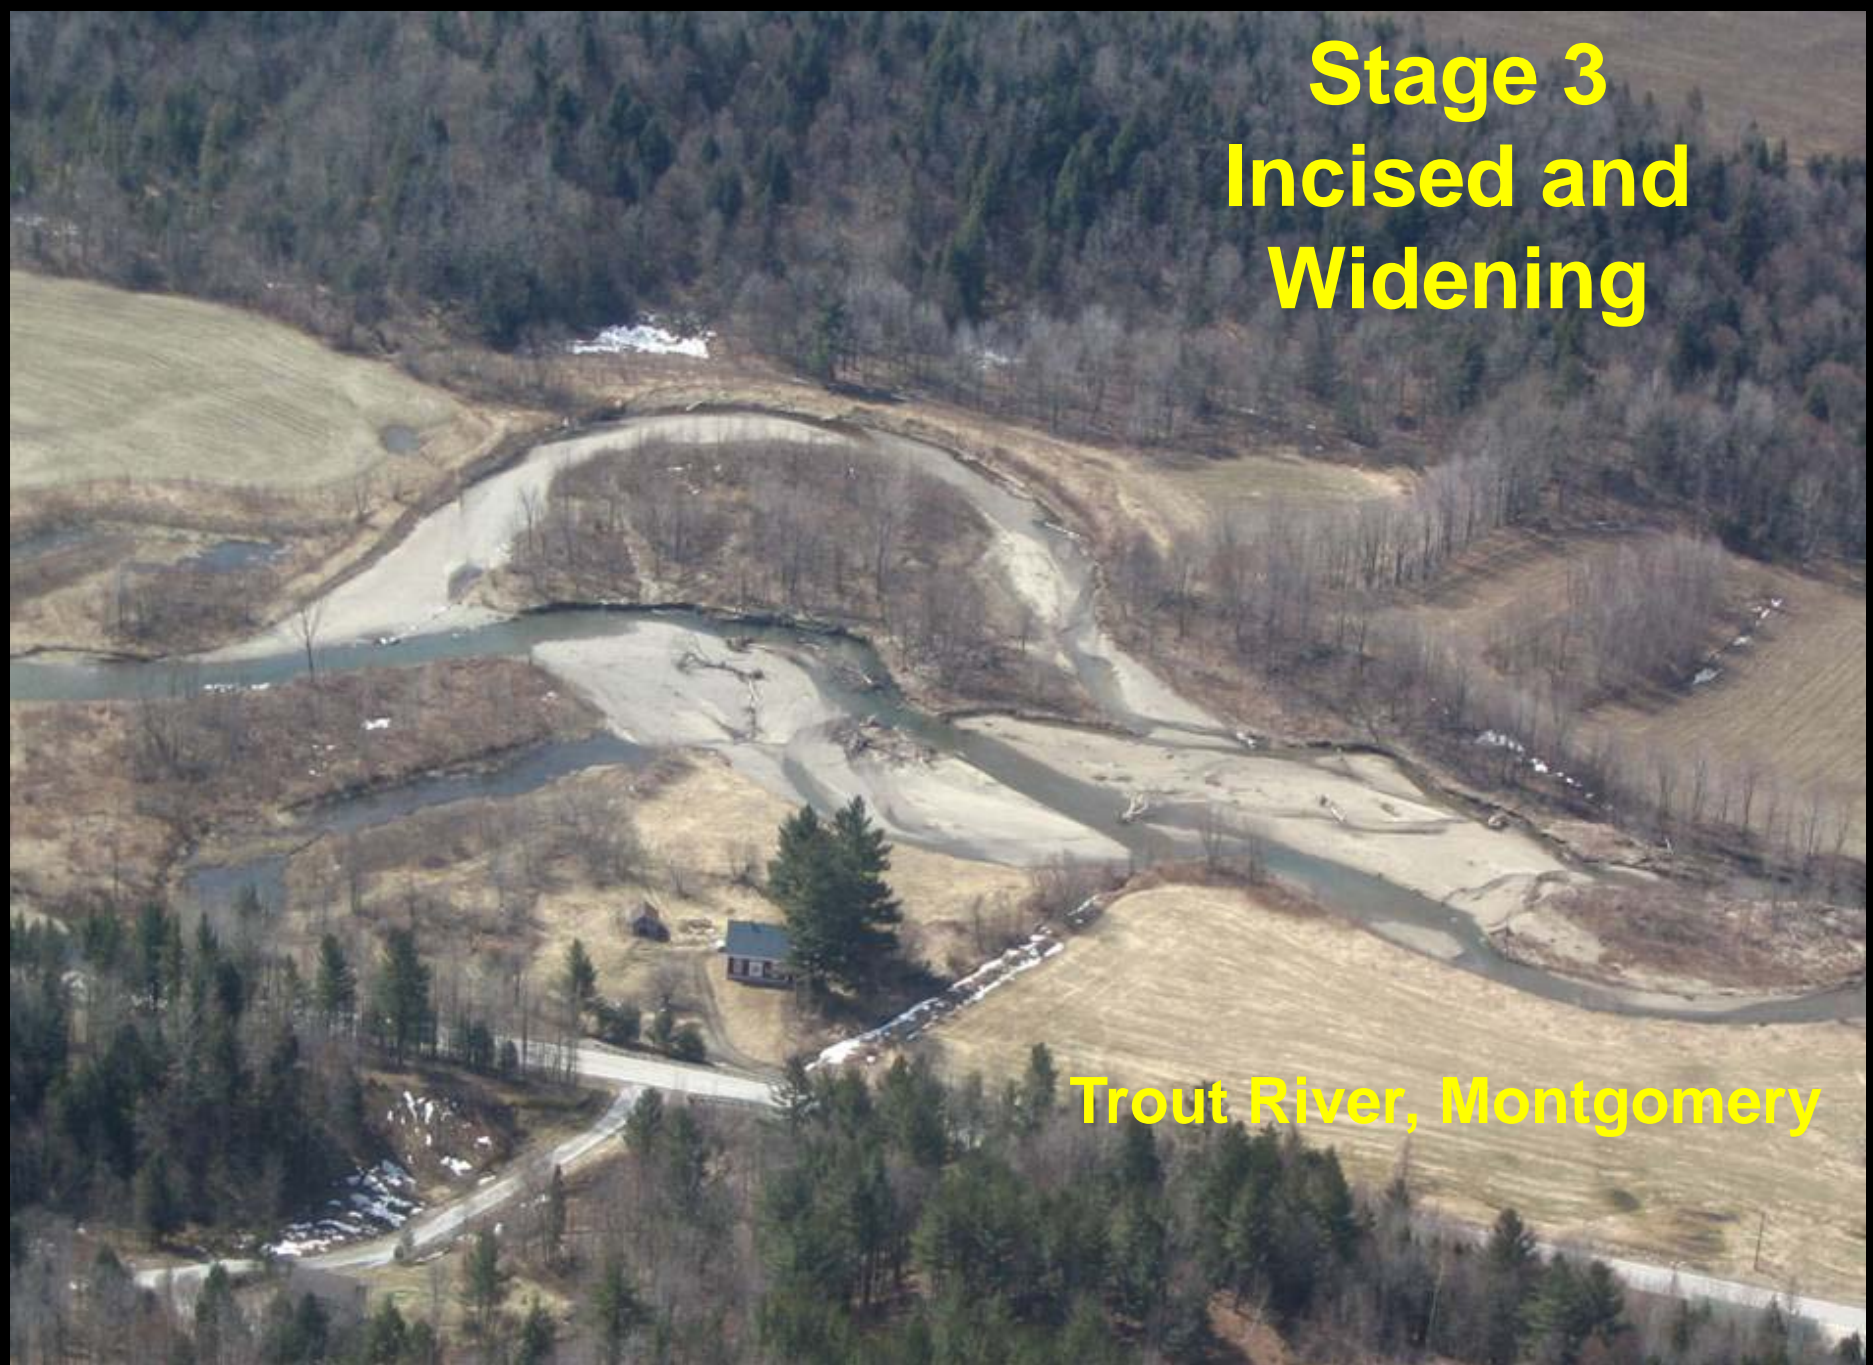
**Stage 3  
Incised and  
Widening**

**Trout River, Montgomery**

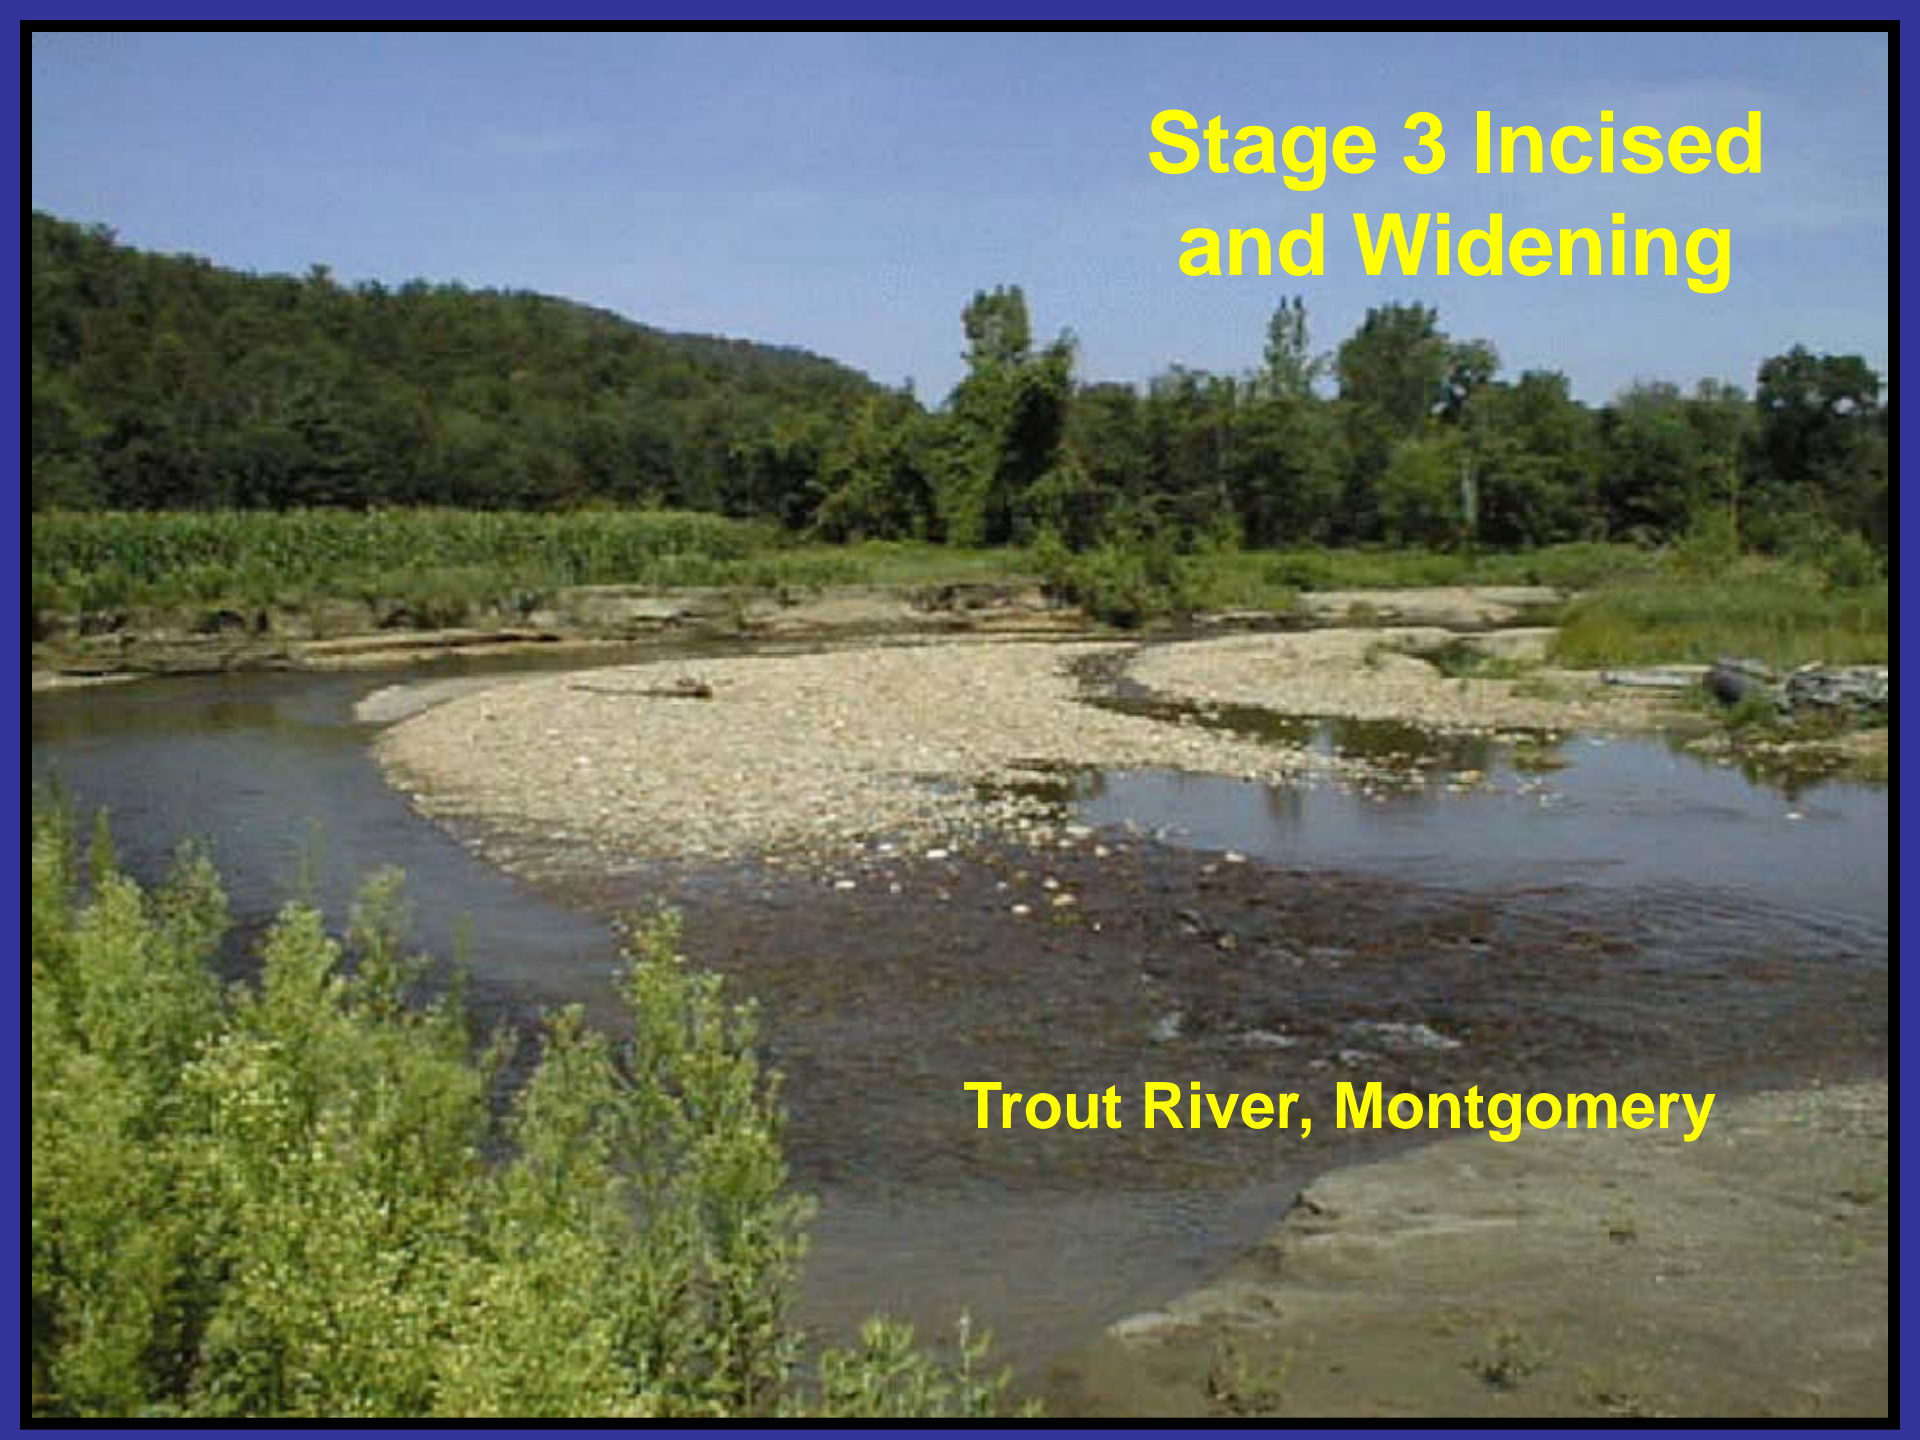
**Trout River, Montgomery**

**Stage 3 Incised  
and Widening**

An aerial photograph showing a river with several sharp meanders flowing through a rural landscape. The river is surrounded by fields, some of which are brown and some green, indicating a transition between seasons. There are scattered farm buildings, including barns and silos, and a few houses. A road or highway runs across the upper part of the image. The overall scene depicts a typical rural river valley.

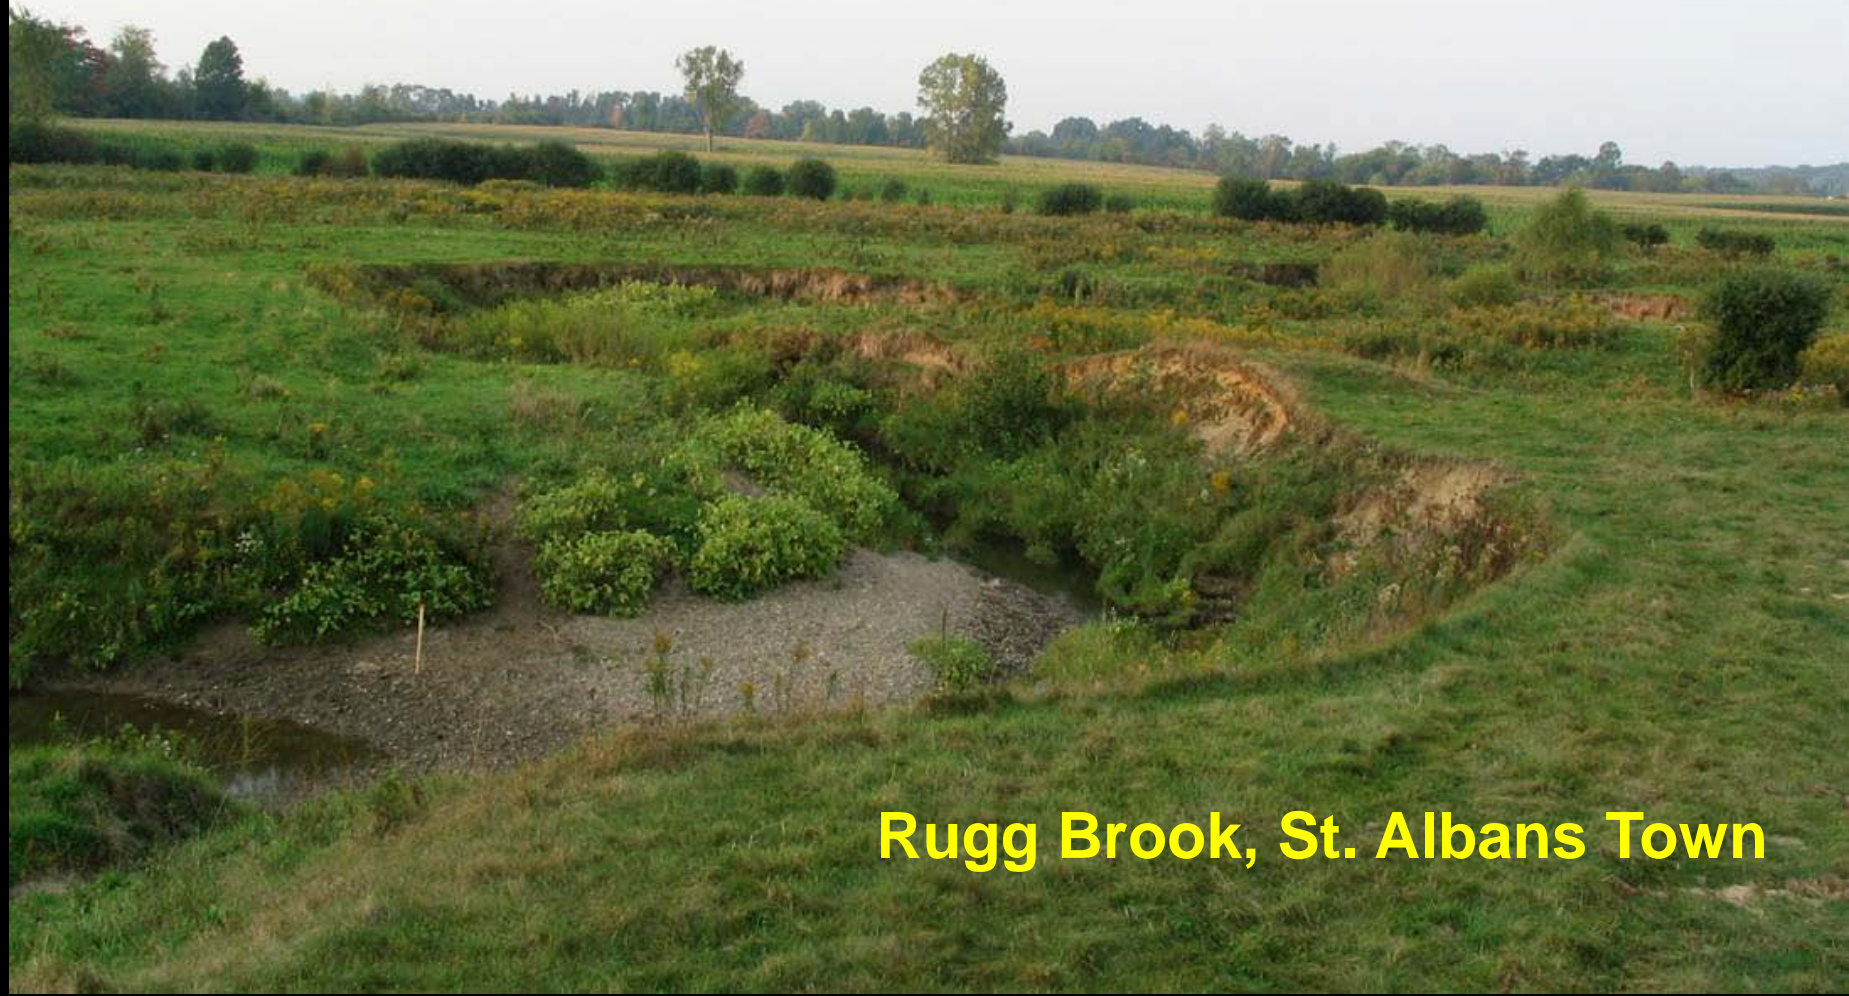
**Rugg Brook, St. Albans Town**

**Formerly an alluvial depositional reach;  
now in Stage 3 incised and widening.  
Dominant sediment regime: production  
and transport.**

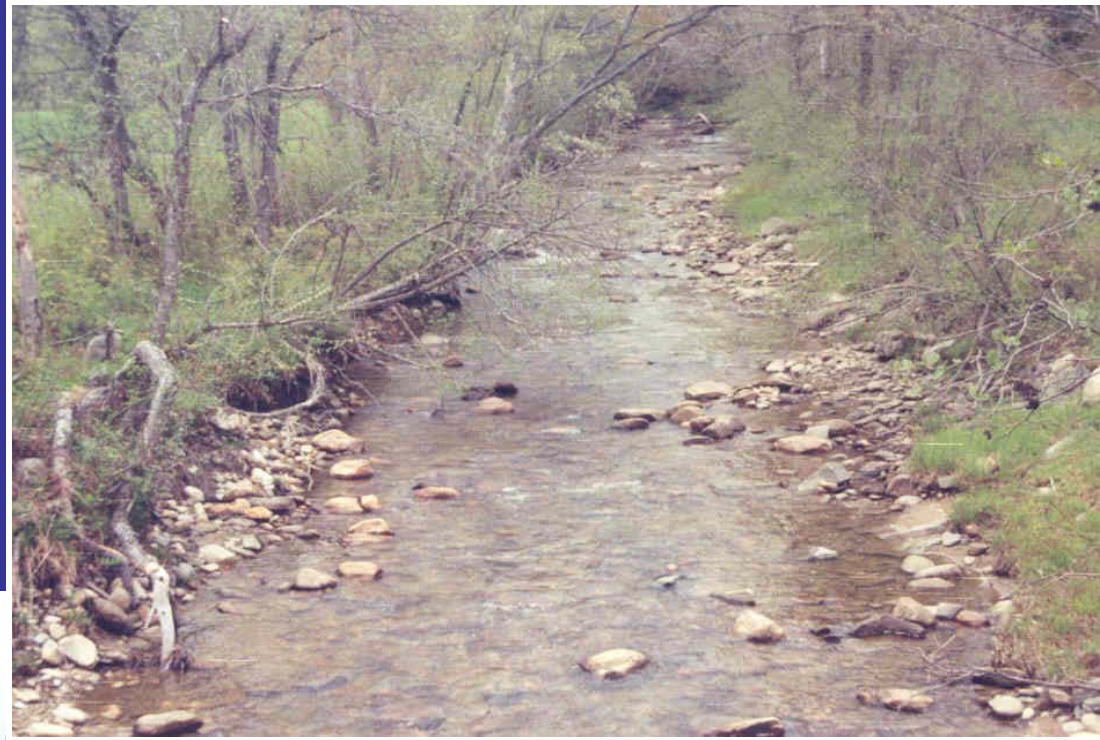
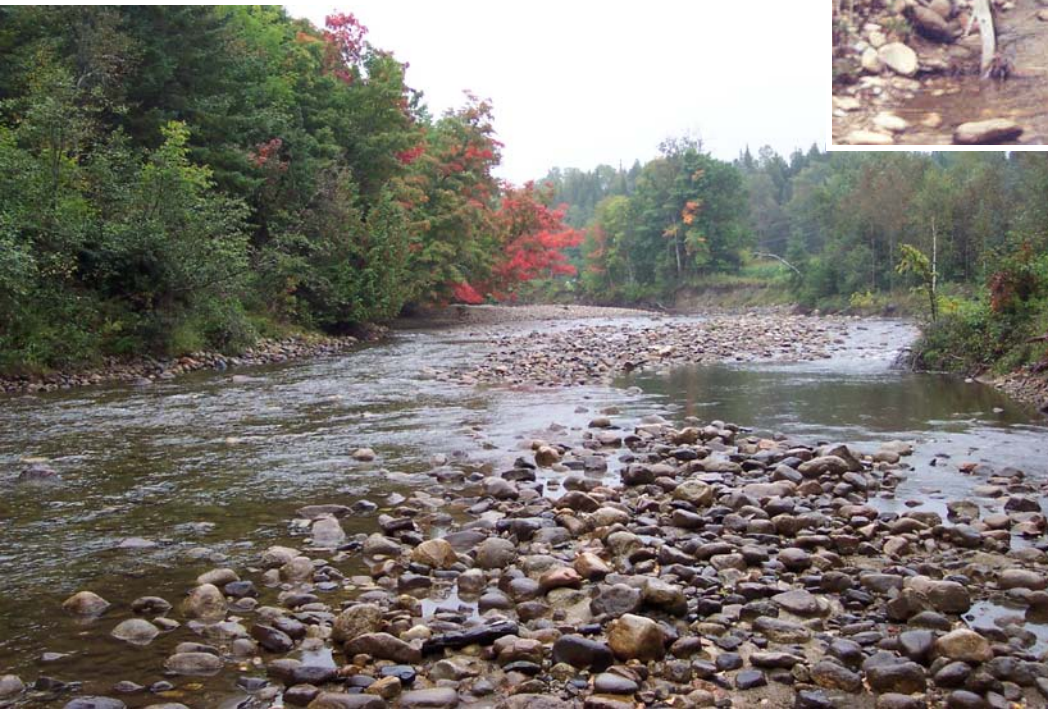
**40%**

Stage III Widening

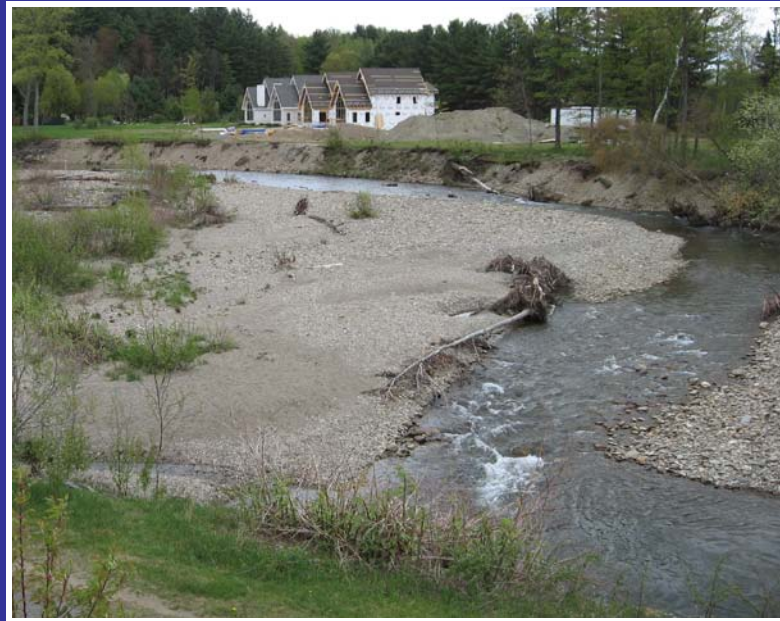
Floods and  
Property Damage

Encroachment

Dredge, Berm  
and Armor

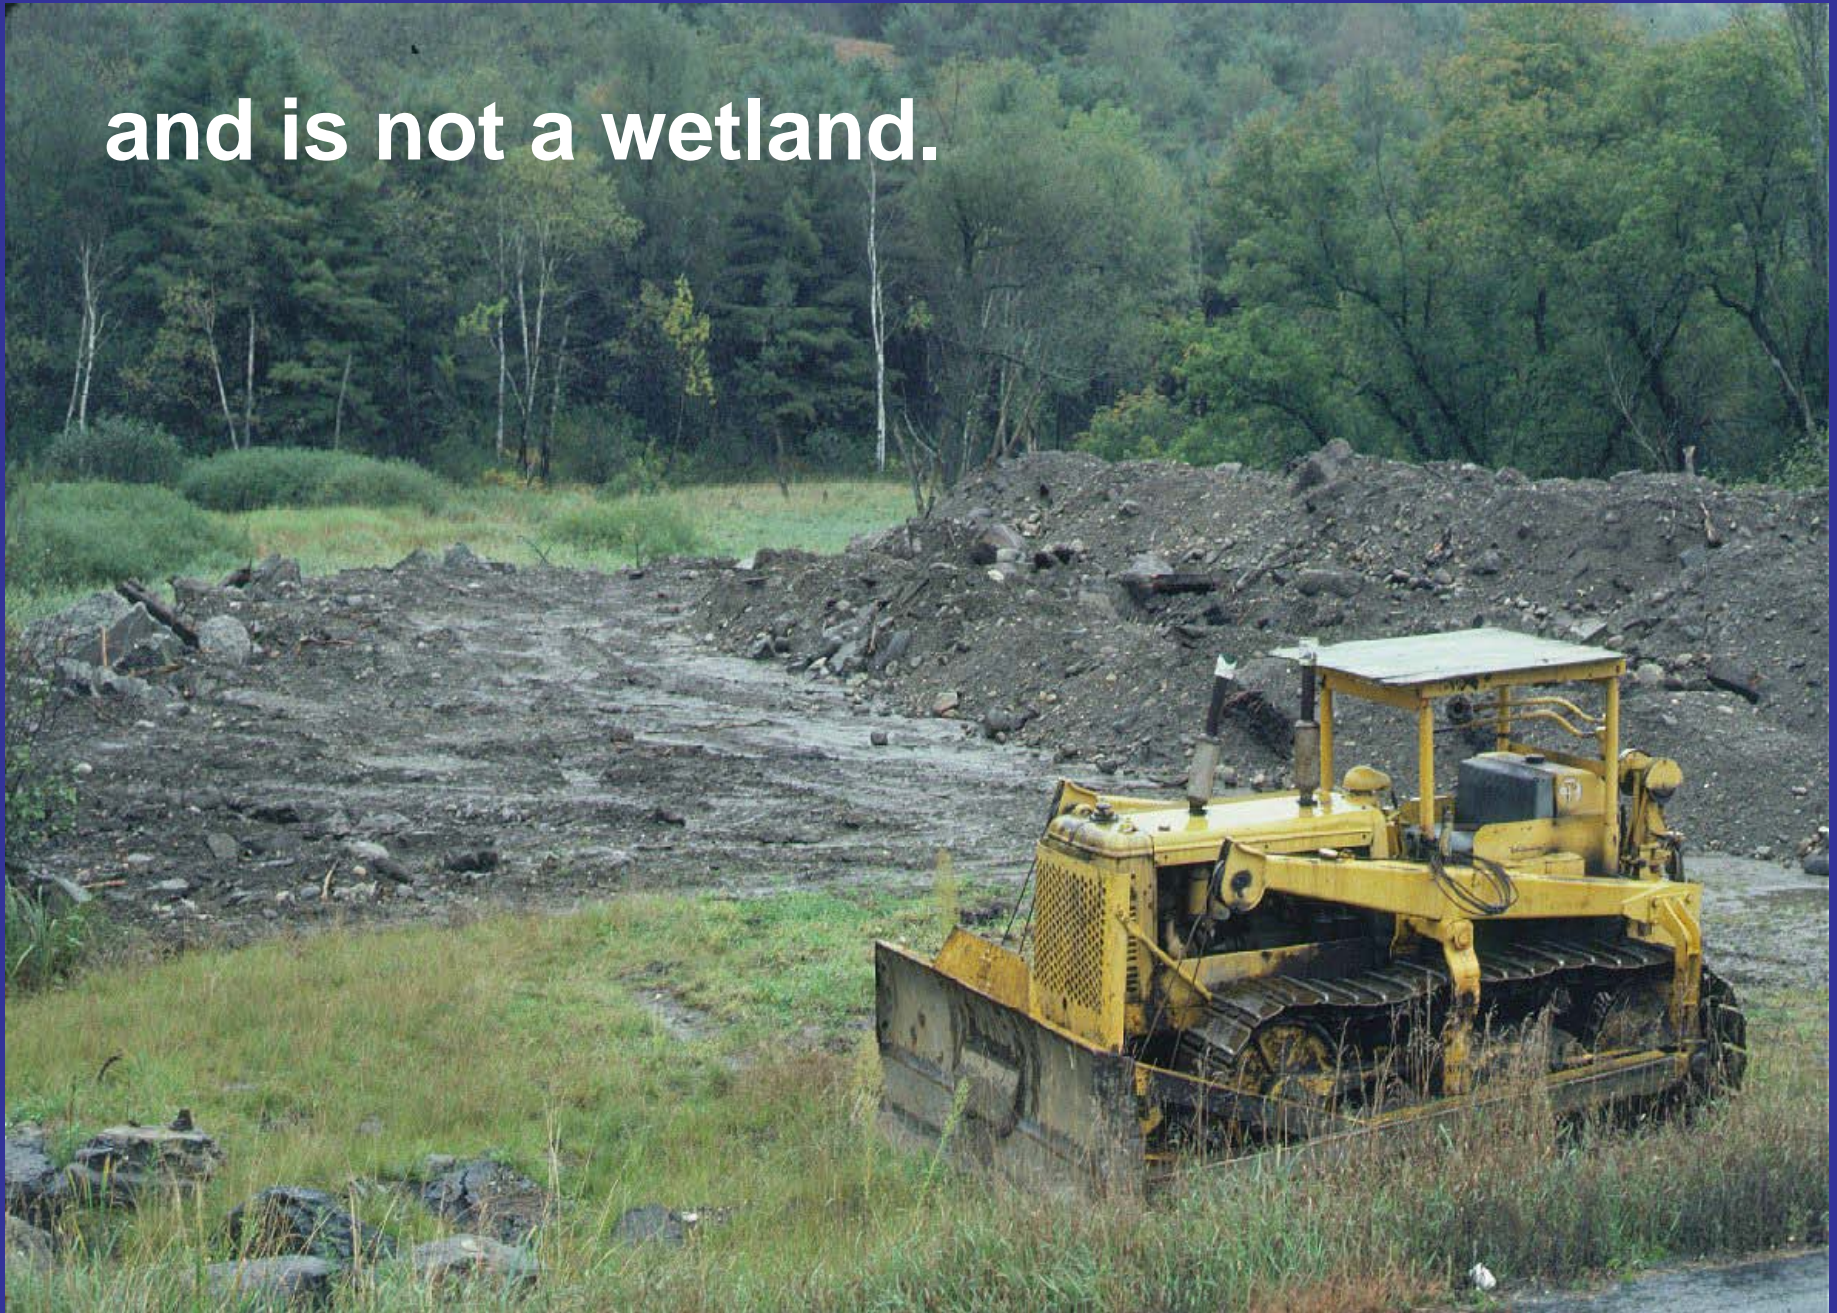
and is not a wetland.

An aerial photograph of the Browns River in Essex. The river is a prominent, winding feature that flows from the upper left towards the lower right. It meanders through a landscape of agricultural fields, some of which are large and rectangular, and areas of dense green forest. The river's path is irregular, with several sharp curves and oxbow-like shapes. The surrounding land is a mix of brownish-green fields and dark green wooded areas. A few small buildings and structures are visible in the upper right quadrant. The overall scene depicts a rural, agricultural setting with a significant natural waterway.
