U.S. Army Corps of Engineers
New England District

Massachusetts
Port Authority
Maritime Department

Boston Harbor Navigation Improvement Project Phase 2 Summary Report

May 2002

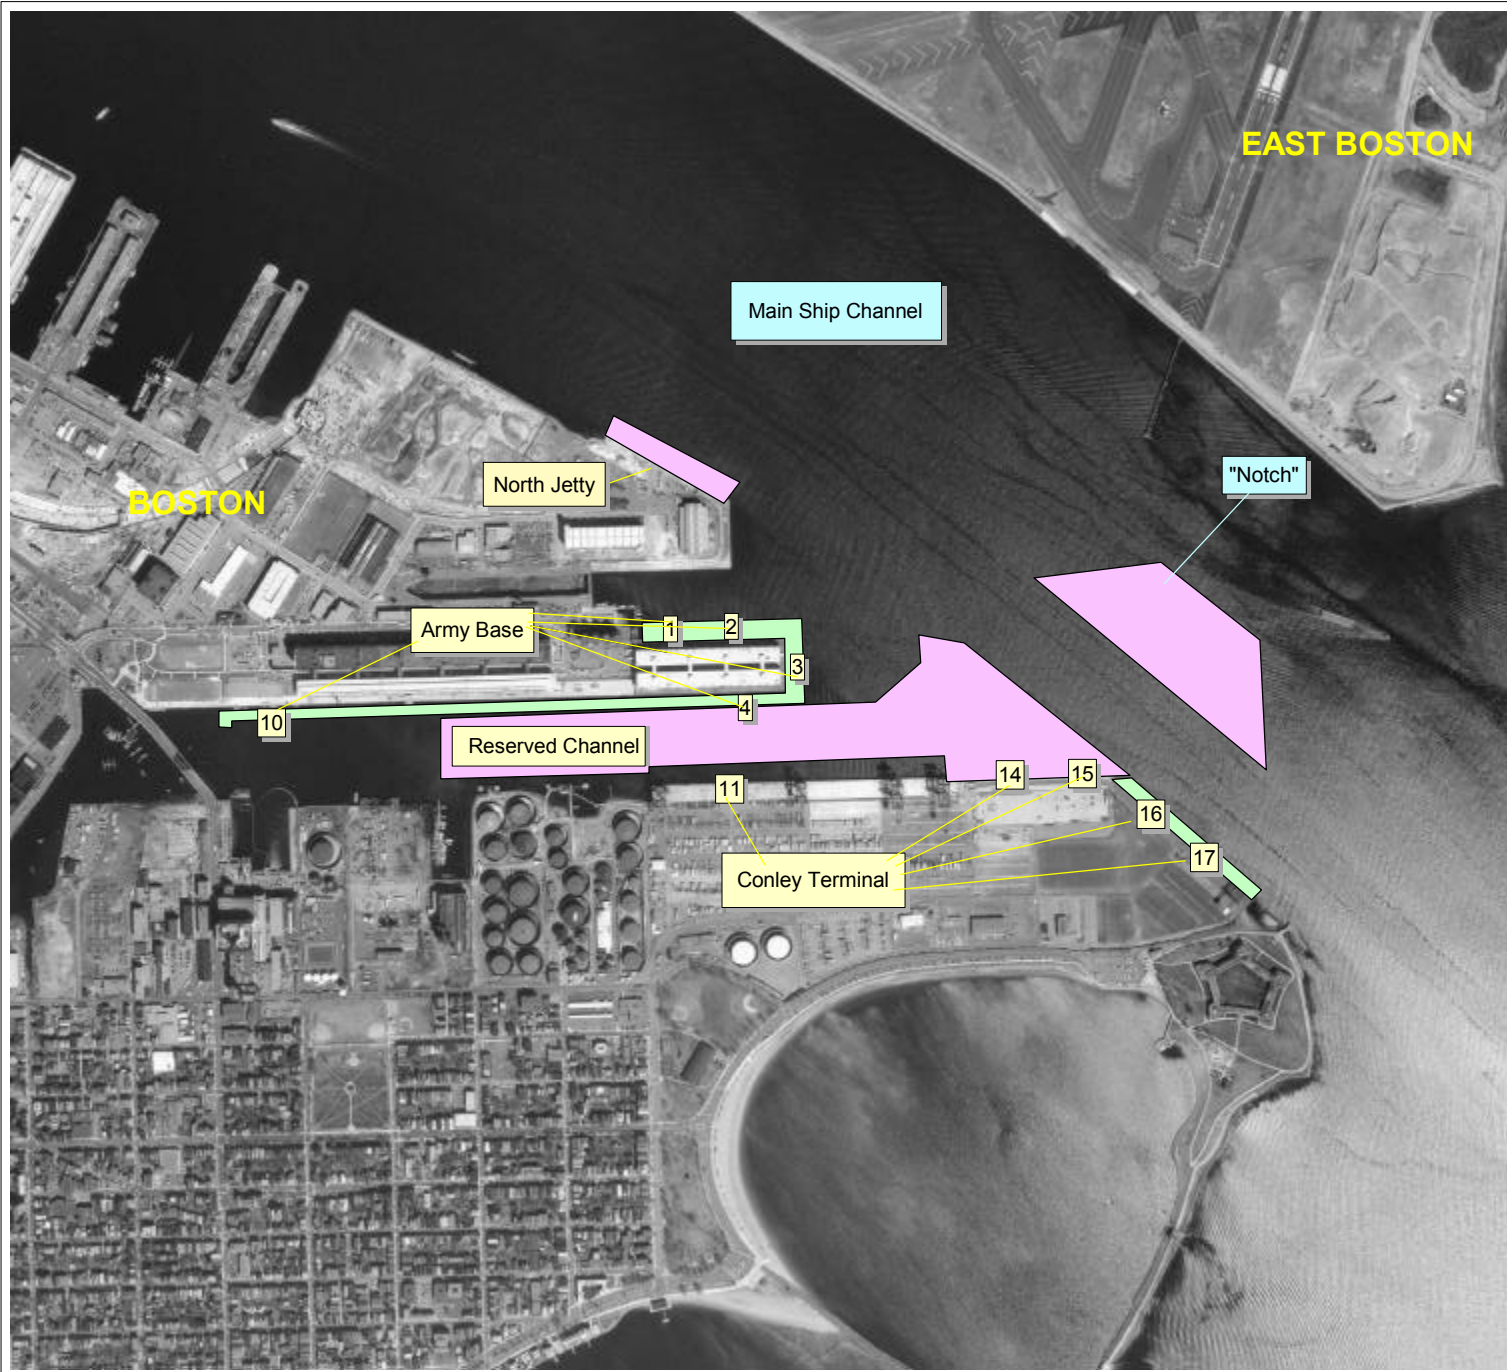
FIGURE 1-3
Dredging Plan with Berth
Areas - Reserved Channel
Area
Boston Harbor Navigation
Improvement Project

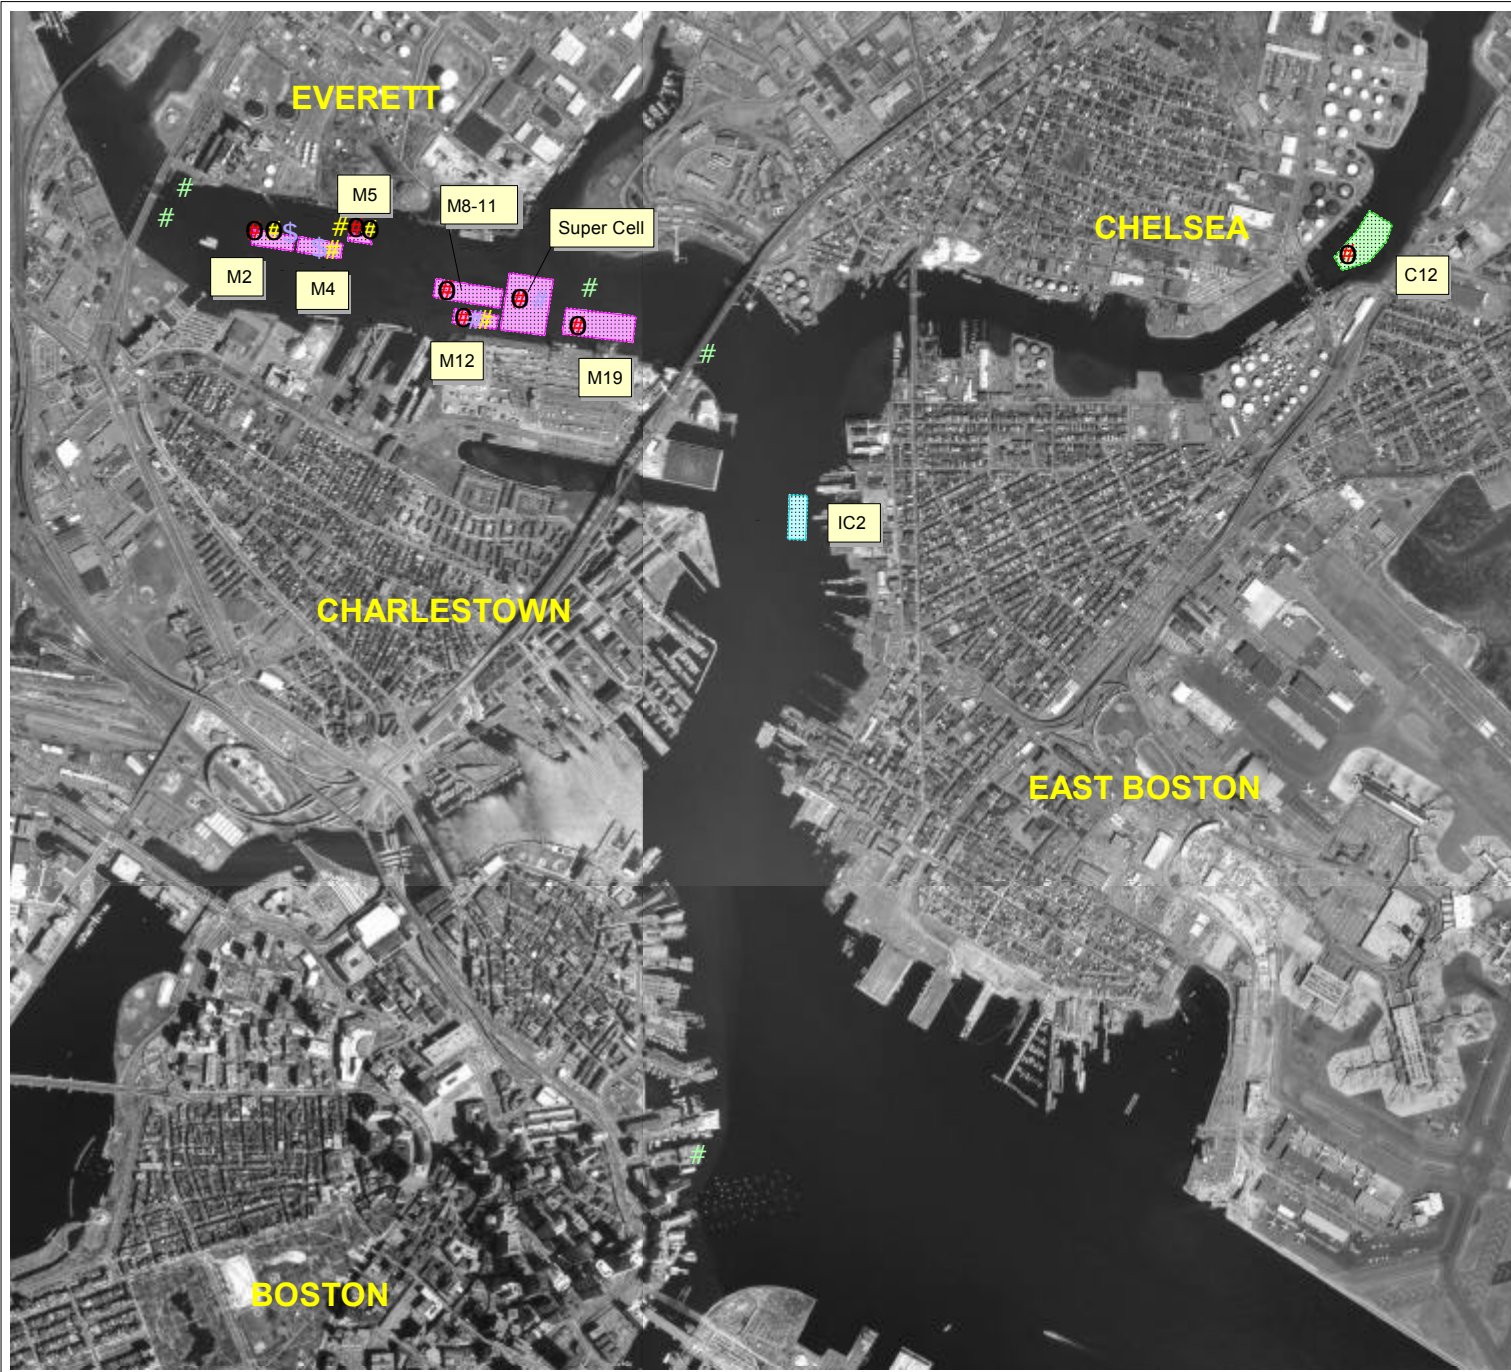
FIGURE 3-1
Water Quality Monitoring
Locations

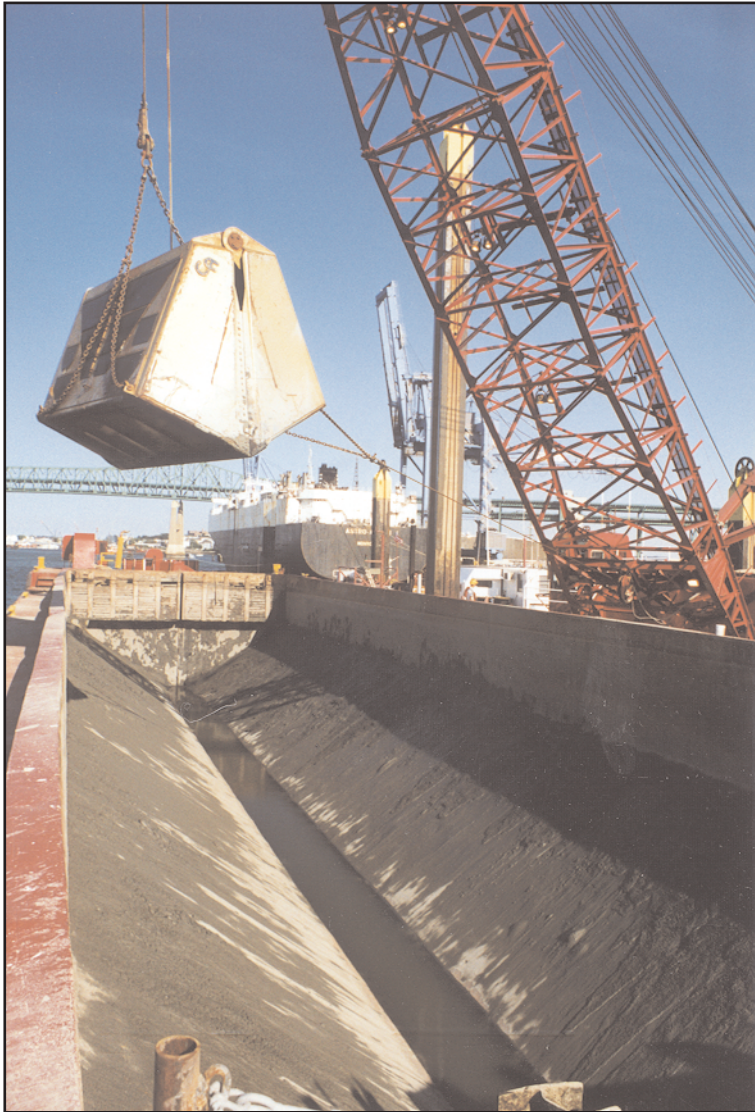
Photo 1
Cable Arm Environmental Bucket in Use
in the Mystic River

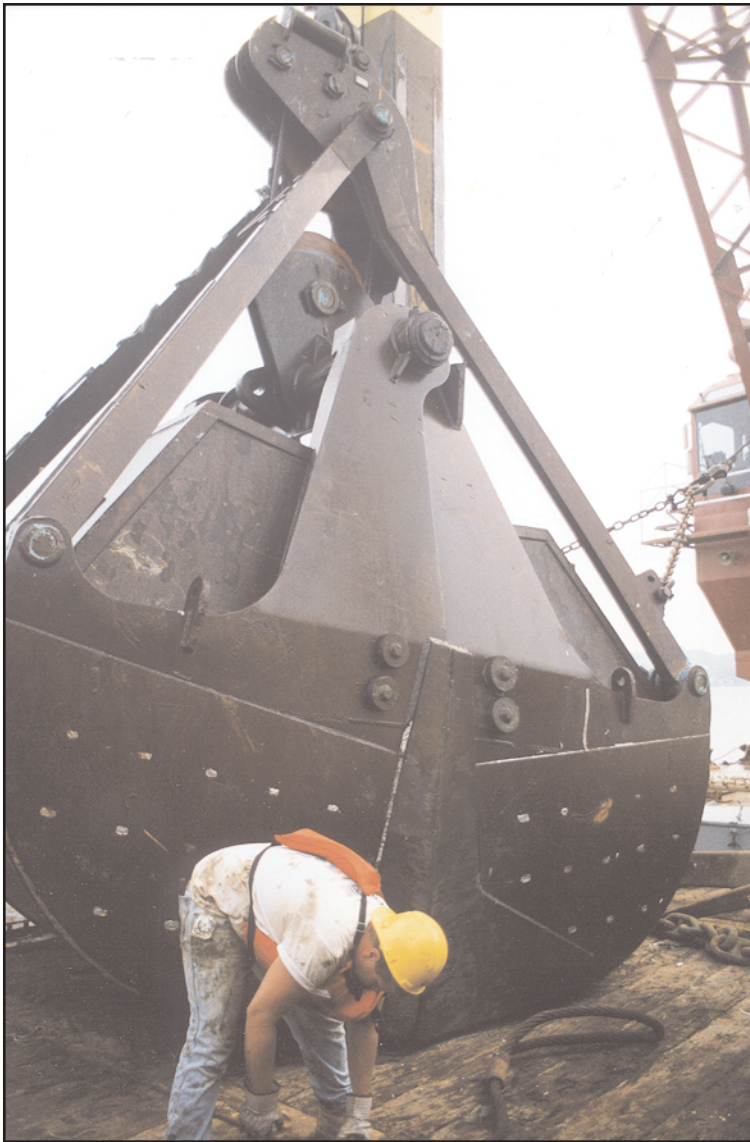
Photo 3
Great Lakes Enclosed Bucket

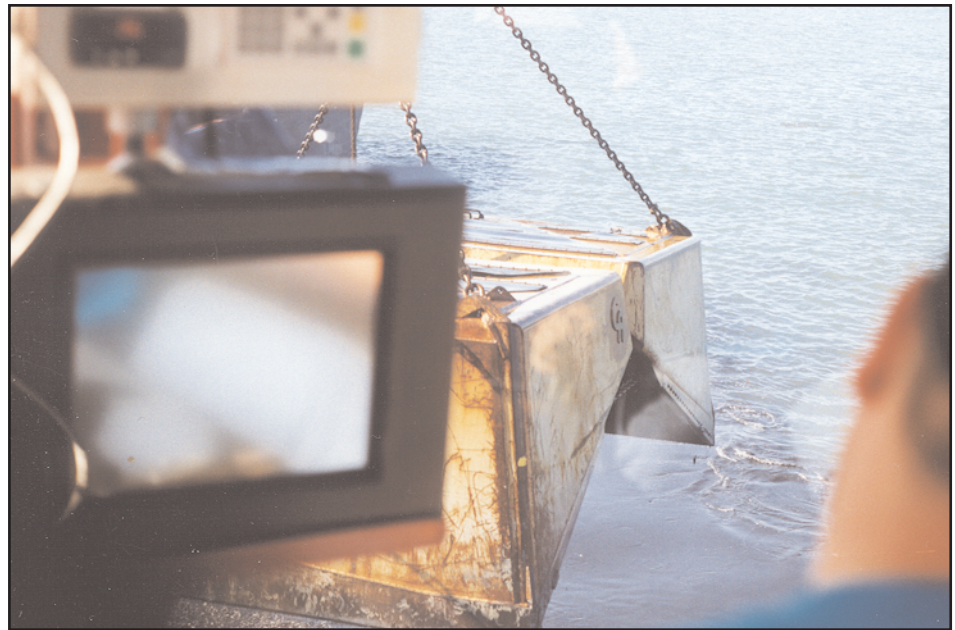
Photo 4
**View from the Dredge Operator's Station of
Cable Arm Environmental Bucket Used in Maintenance Dredging**

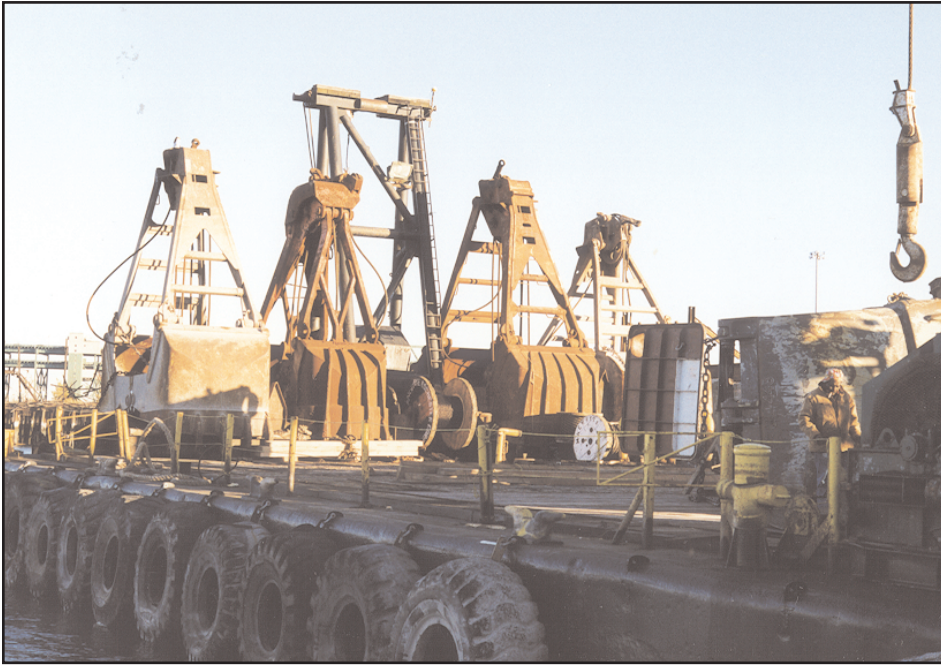
Photo 7
Variety of Buckets Used for Improvement Dredging

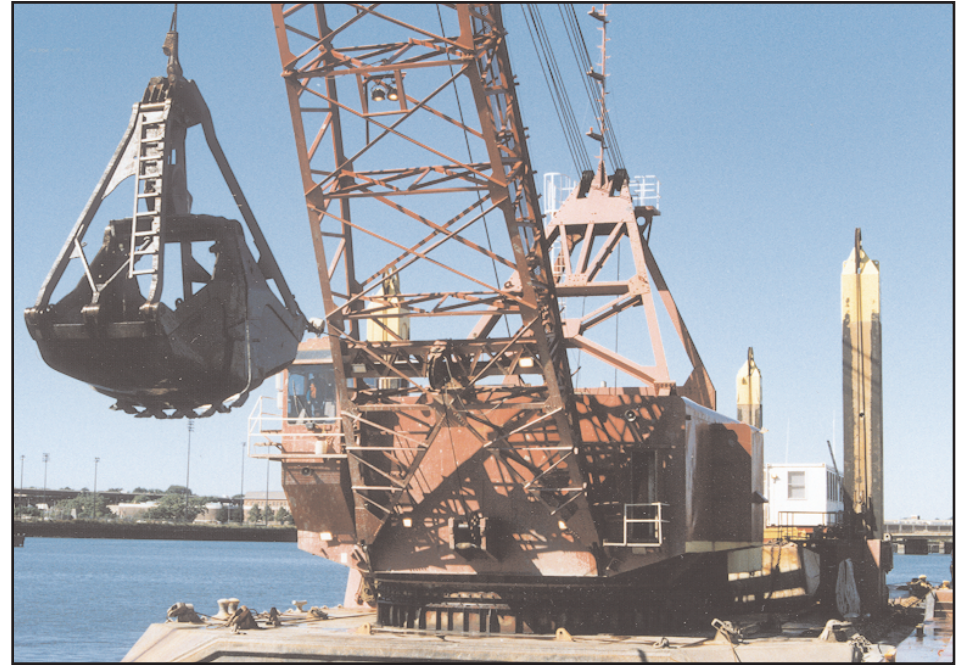
Photo 8
Toothed-Bucket in Use on Great Lakes Dredge 54

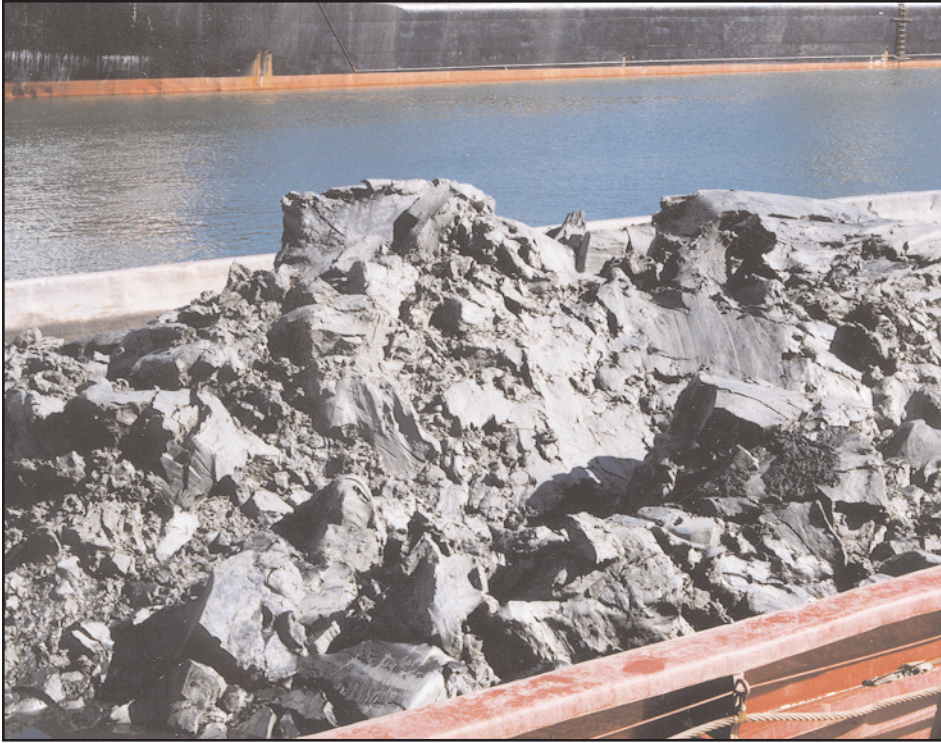
Photo 11
Improvement Material from the Mystic River

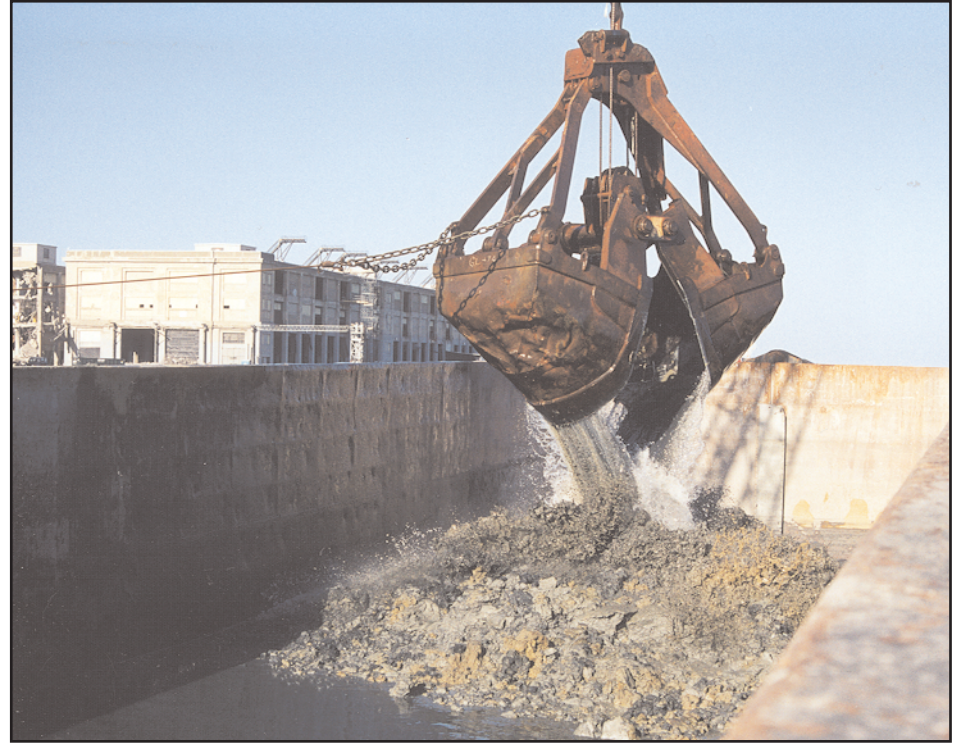
Photo 12
Improvement Material from Reserved Channel

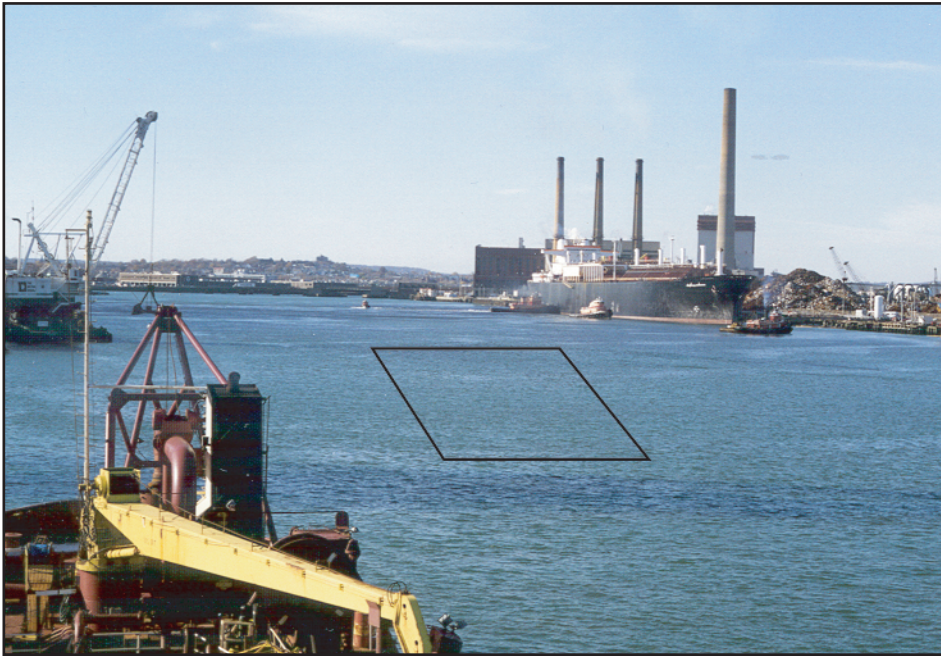
Photo 13
Conceptualized Cell Boundry Within the Mystic River

GLDD used a variety of split-hulled scows for transporting maintenance material to disposal cells. The contract required accurate navigation methods to assure that each scow was located over the CAD cell before release to reduce the potential for missing the cell opening. GLDD used differential GPS with proprietary software that allowed the tug captain to display scow position relative to the disposal cell in real-time on an on-board computer. This was an important feature given that some of the cells were small (very little room for positioning error). In addition, the location of the cells within the active harbor made placement of surface marker floats infeasible (Photo 13).

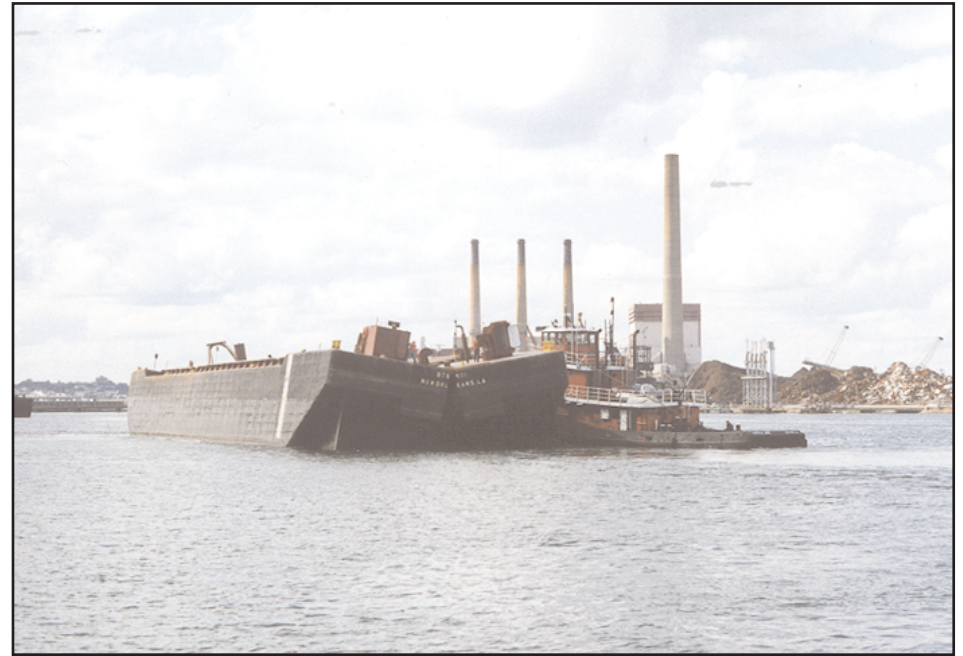
Photo 14
Dump Scow Opening Over Cell Within the Mystic River

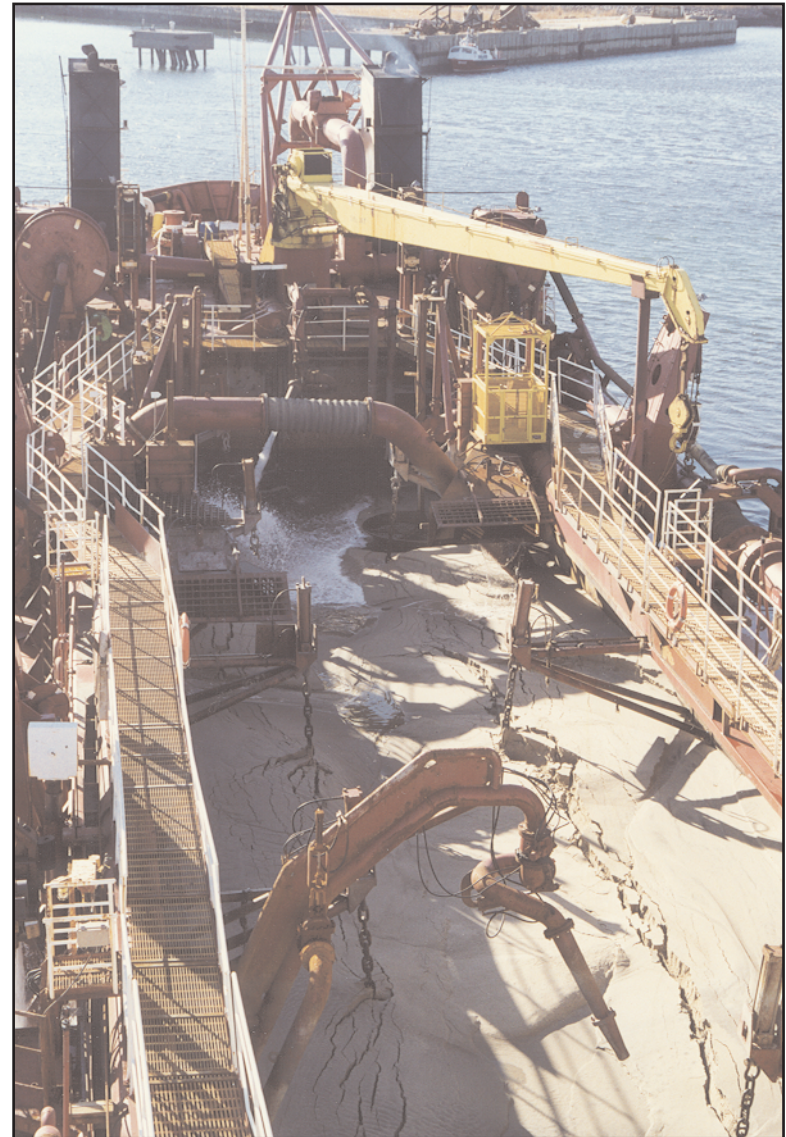
Photo 17
Hopper Dredge Discharging Capping Sand Over Cell M12

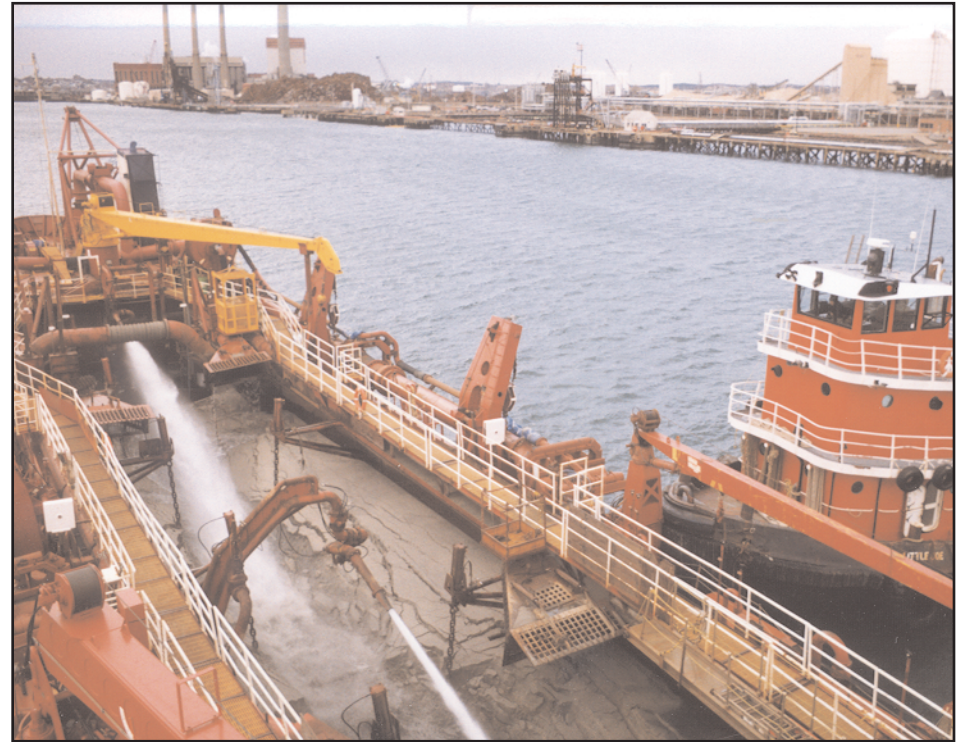
Photo 19
Hopper Dredge Being Pushed Sideways by Tug While Discharging Capping Sand Over Supercell

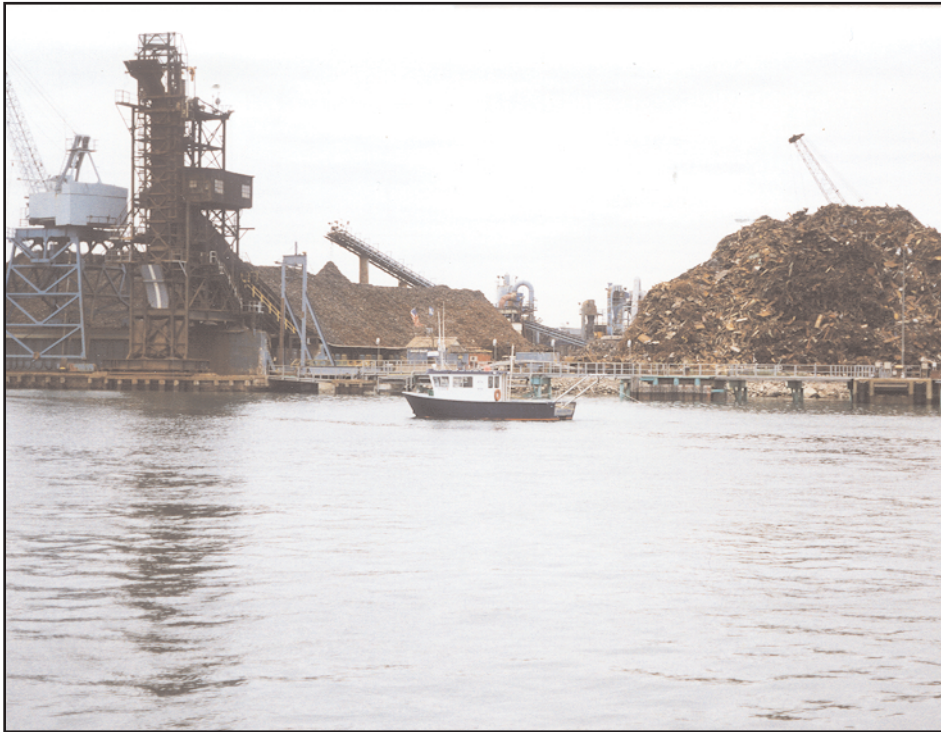
Photo 22
Cap Monitoring Being Performed Over Cell M5 in the Mystic River from the Vessel *Cyprinodon*

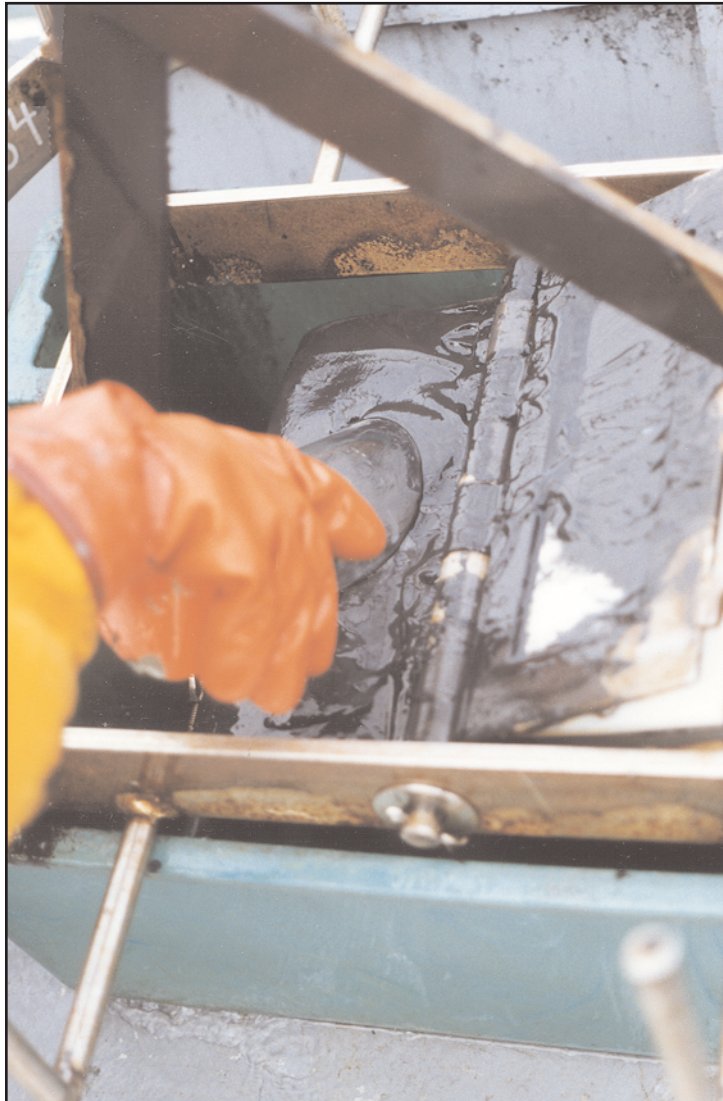
Photo 24
Pre-Capping Grab Sample from Surface of Cell M4

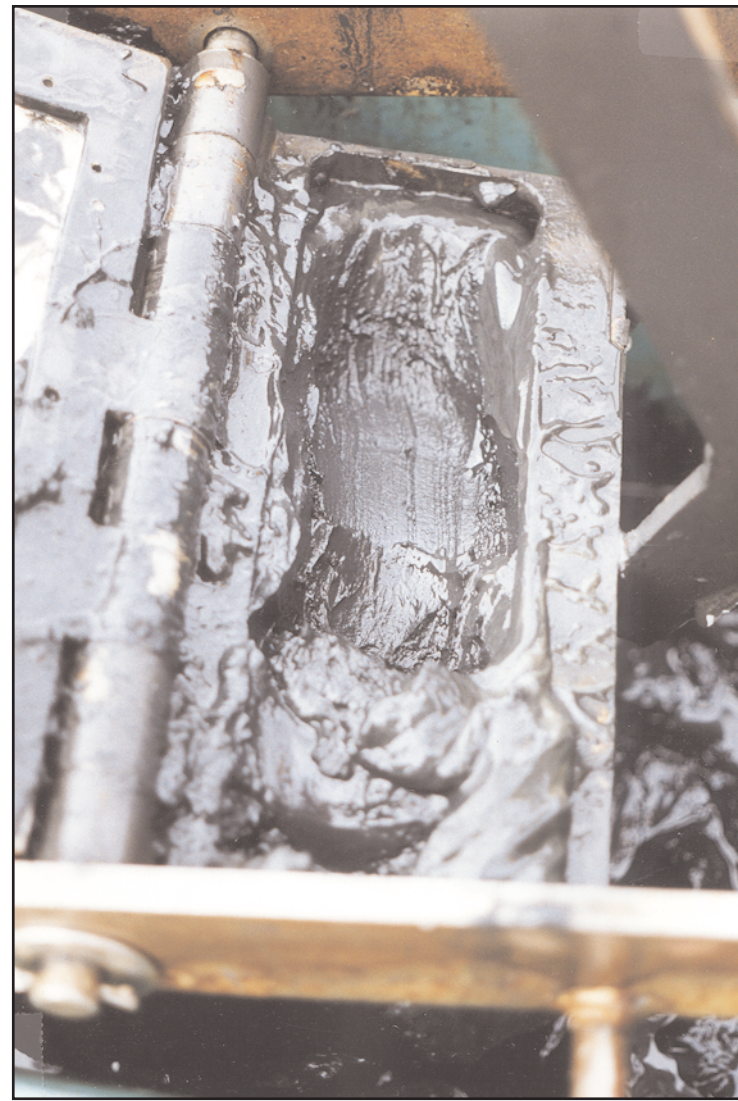
Photo 25
Pre-Capping Grab Sample from Surface of Cell M5

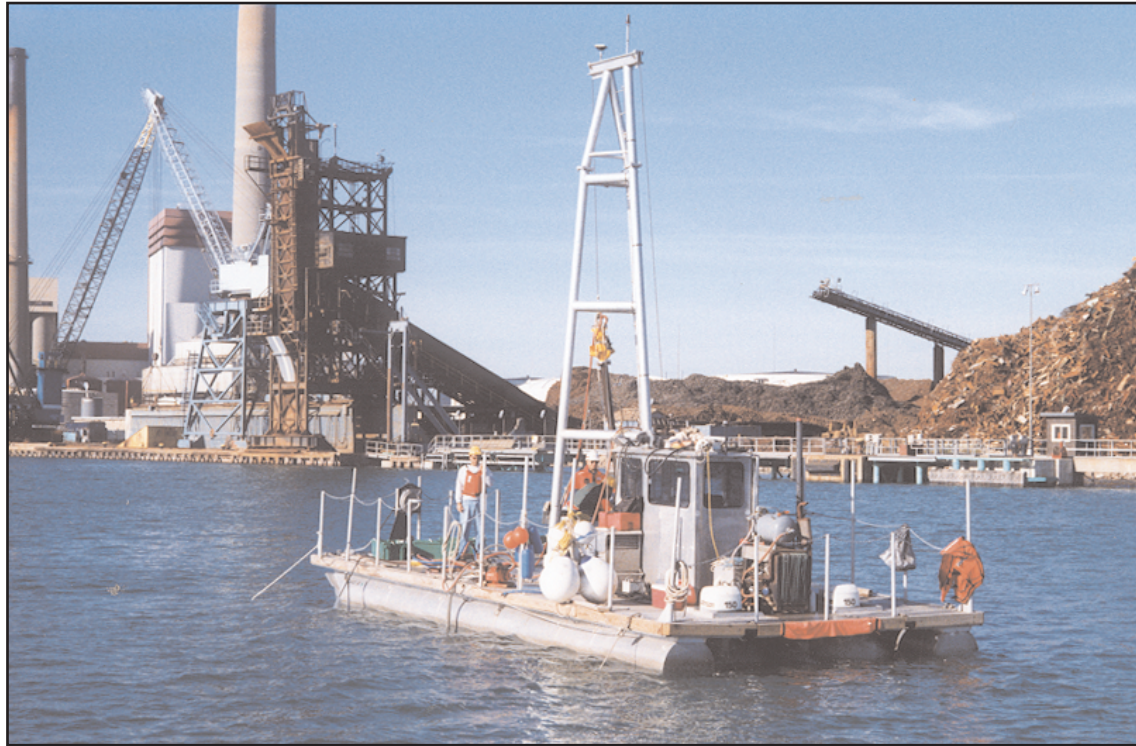
Photo 26
Ocean Surveys Coring Platform Over Cell M5

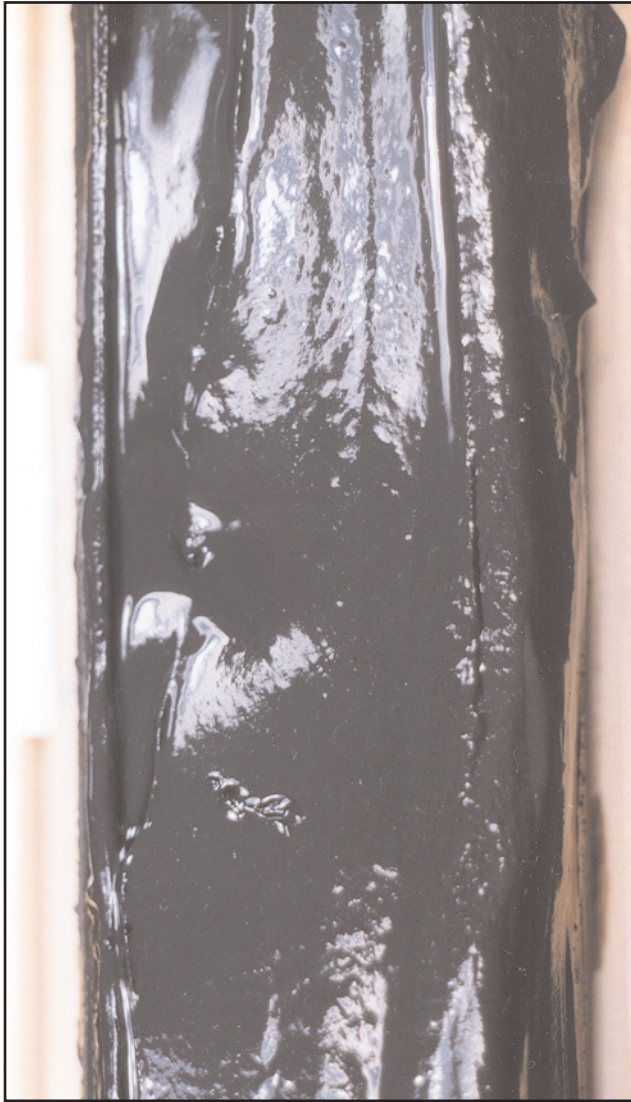
Photo 27
Upper 20 cm Section of Post-Cap Core
from Cell M5

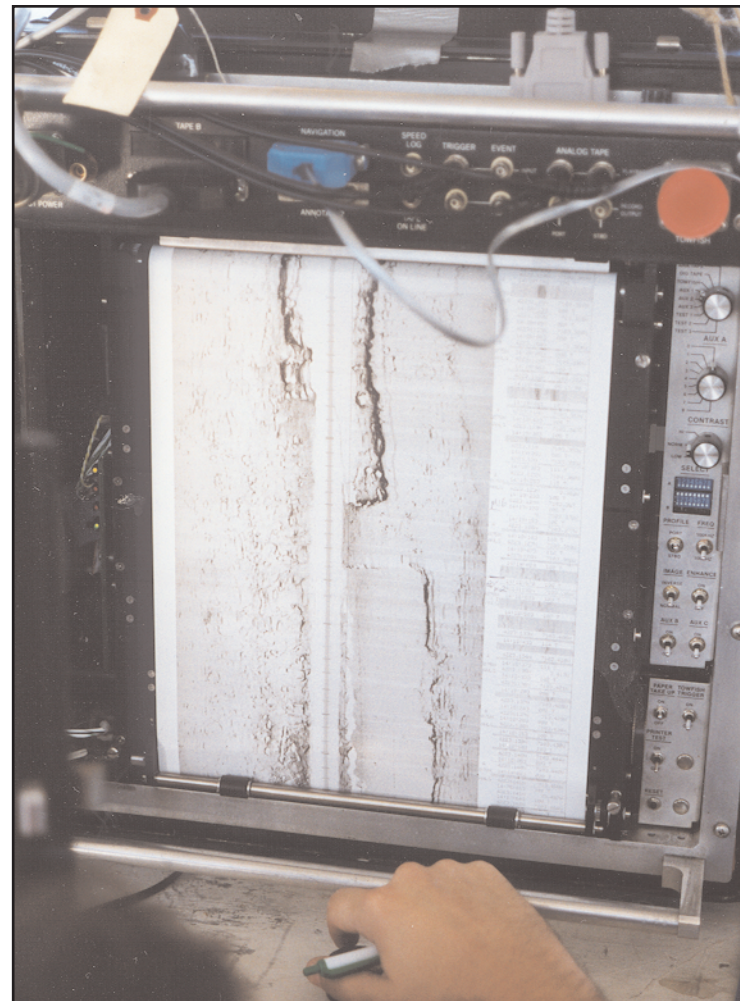
Photo 30
Instrumentation Used in Post-Capping Evaluation

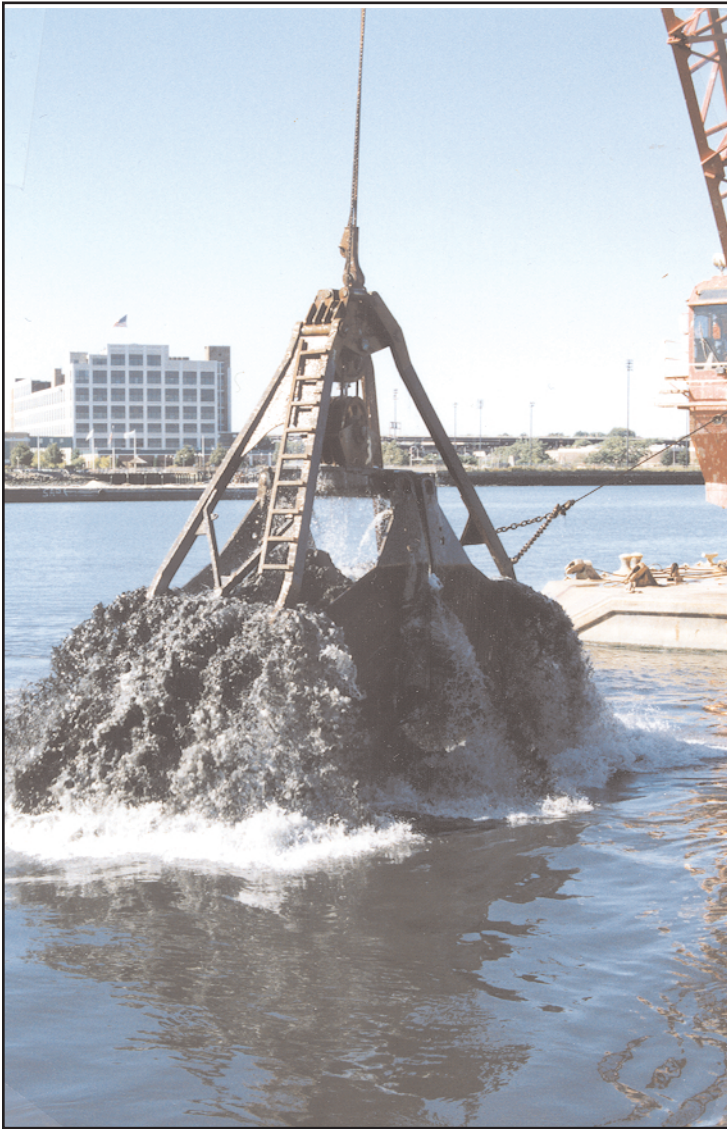
Photo 31
Bucket Exiting Water During Improvement Dredging

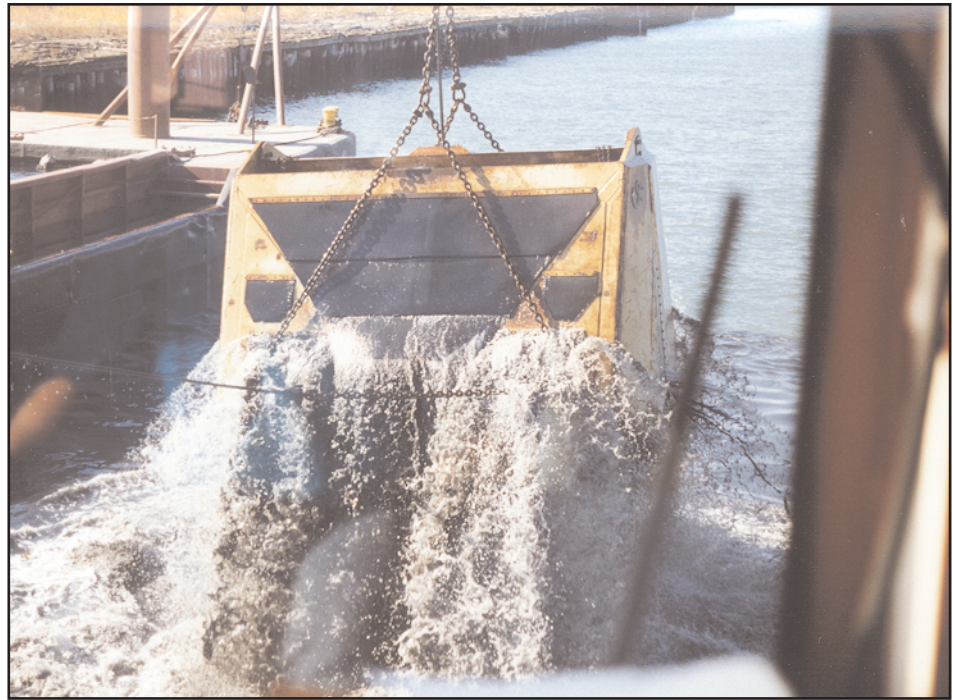
Photo 32
Cable Arm Bucket Exiting Water During Maintenance Dredging

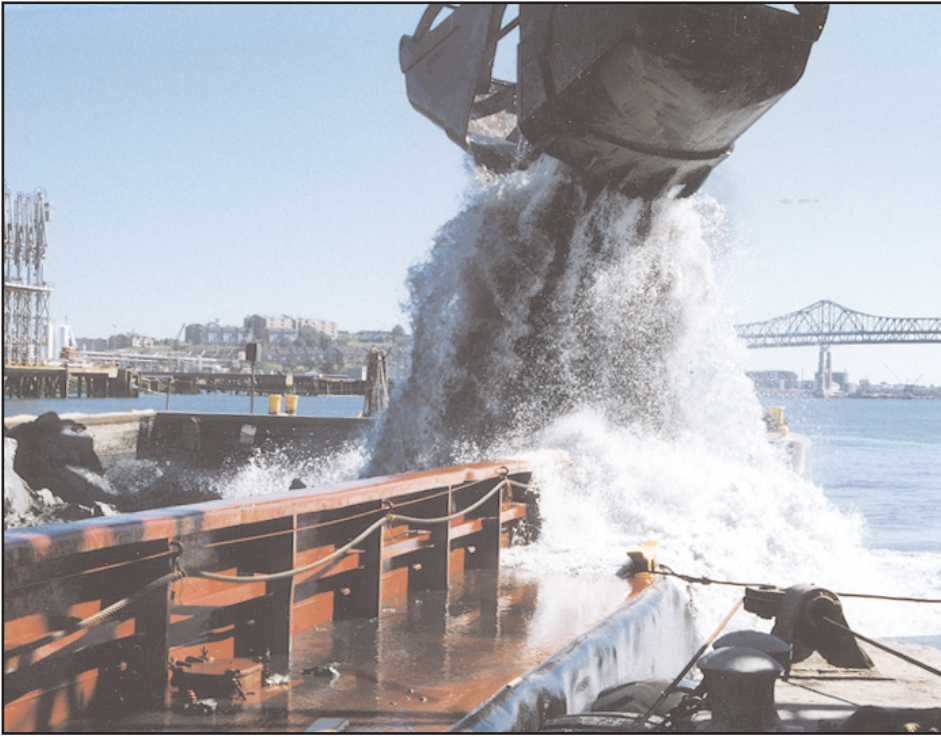
Photo 33
Scow "Washing" During Improvement Dredging

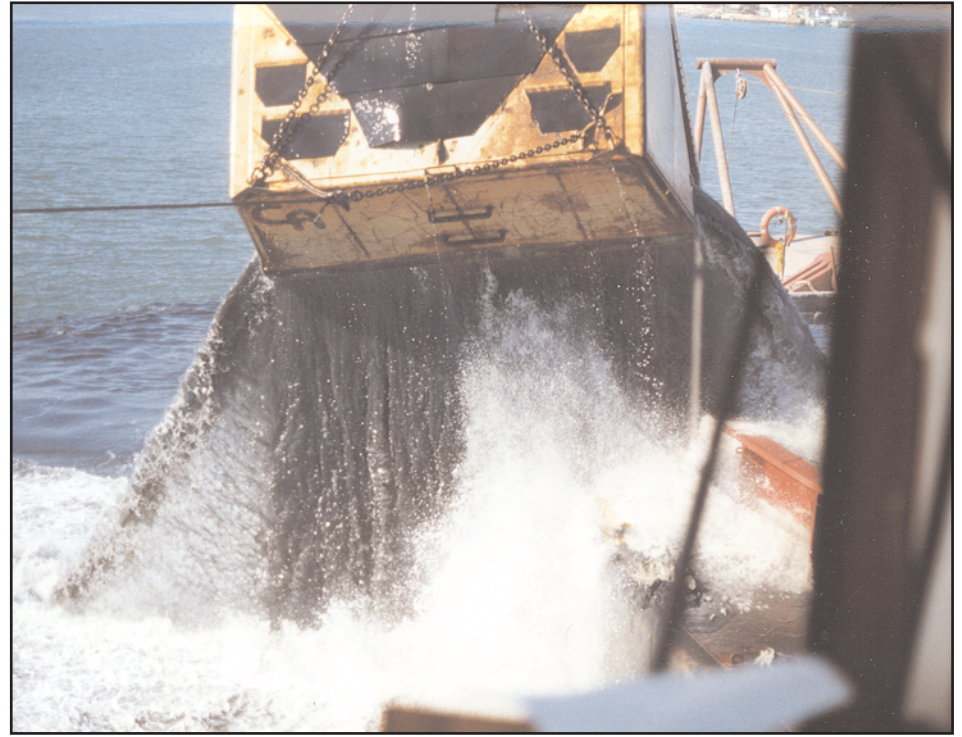
Photo 34
Scow "Washing" During Environmental Dredging

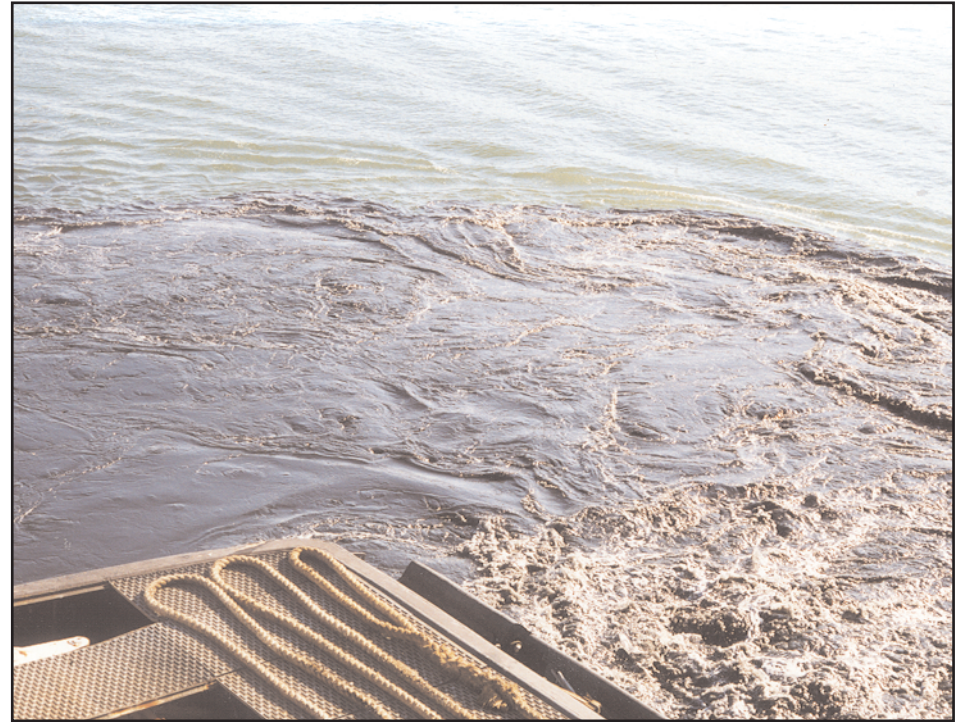
Photo 35
View from Dredge Operator's Station of Turbidity Generated During Maintenance Dredging

Photo 36
Turbidity Generated Behind Tug Maneuvering Over Cell Following Disposal

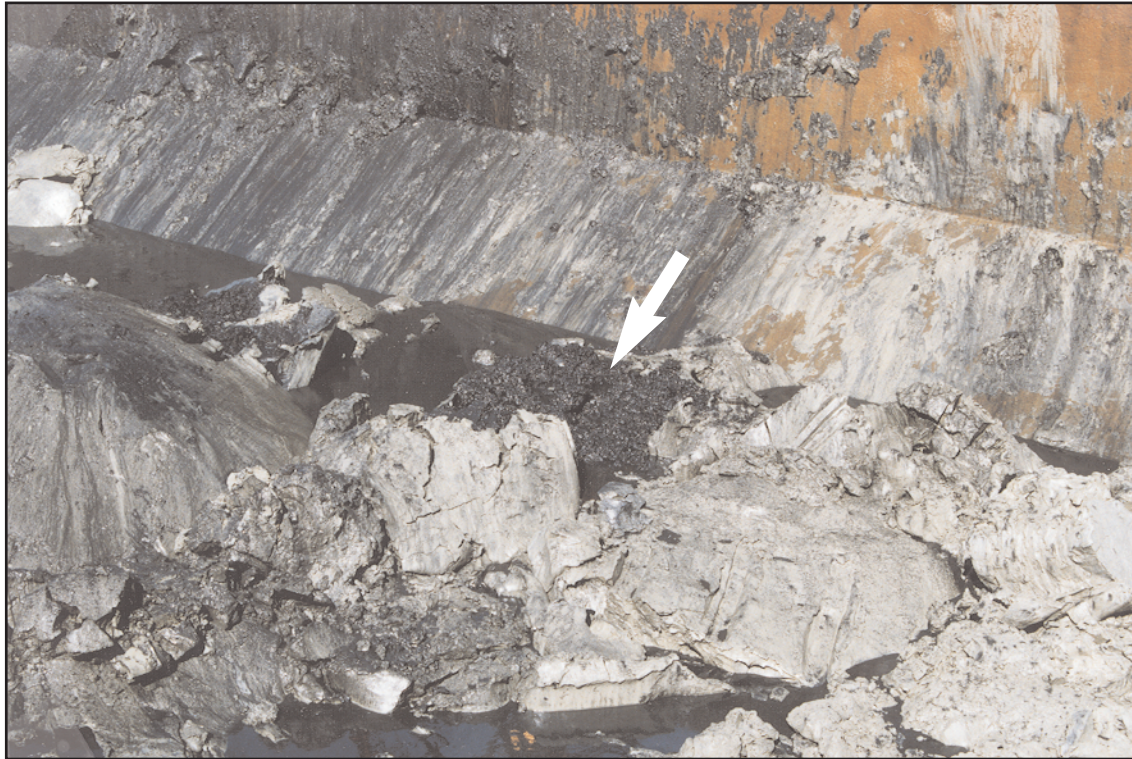
Photo 37
Pocket of Maintenance Material Removed During
Improvement Dredging

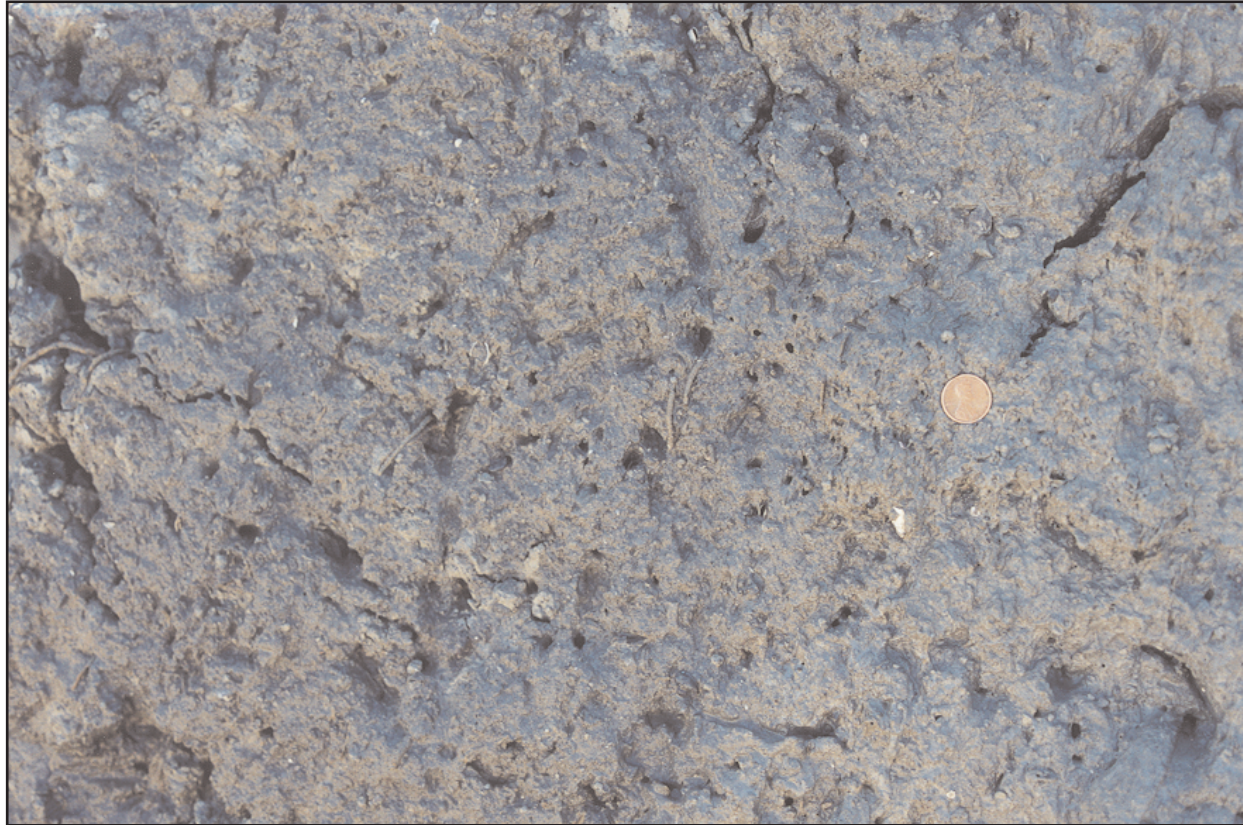
Photo 38
Surface of "First Cut" of Improvement Material Exposed Within
Dump Scow
