### Vermont

## Richford Local Protection Project

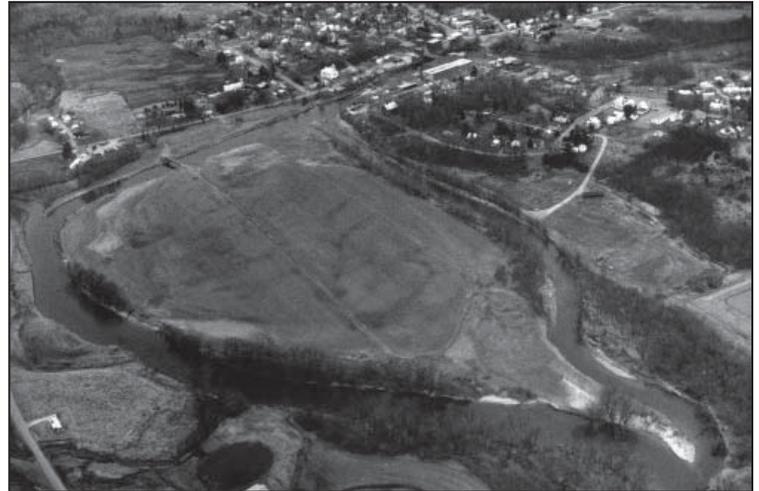
Aerial view of Richford Local Protection Project, located on the Missisquoi River in Richford, Vt., at the confluence of the North Branch and Missisquoi River. The project is in Vermont approximately one mile from the Canadian border. (Click photo for high-resolution version)

- Excavating a new channel through Big Island for 1,870 feet.
- Excavating 2,010 feet of an existing channel. The work begins in the main channel at a point about 860 feet downstream of the Main Street Bridge and extends into the existing stream south of Big Island. The channel is 40 feet wide.
- Constructing a 160-foot-long stone weir on the left bank of the main channel to prevent ice jams.
- Constructing a 350-foot-long stone dike on the right bank of the main channel.
- Removing two shoals at the mouth of North Branch and a small island about 300 feet long in the Missisquoi River.
