INTERIM SURVEY  
OF WESTERN LONG ISLAND SOUND III  
DISPOSAL SITE

CONTRIBUTION #18

May 17, 1982

## INTERIM SURVEY OF WLIS III DISPOSAL SITE

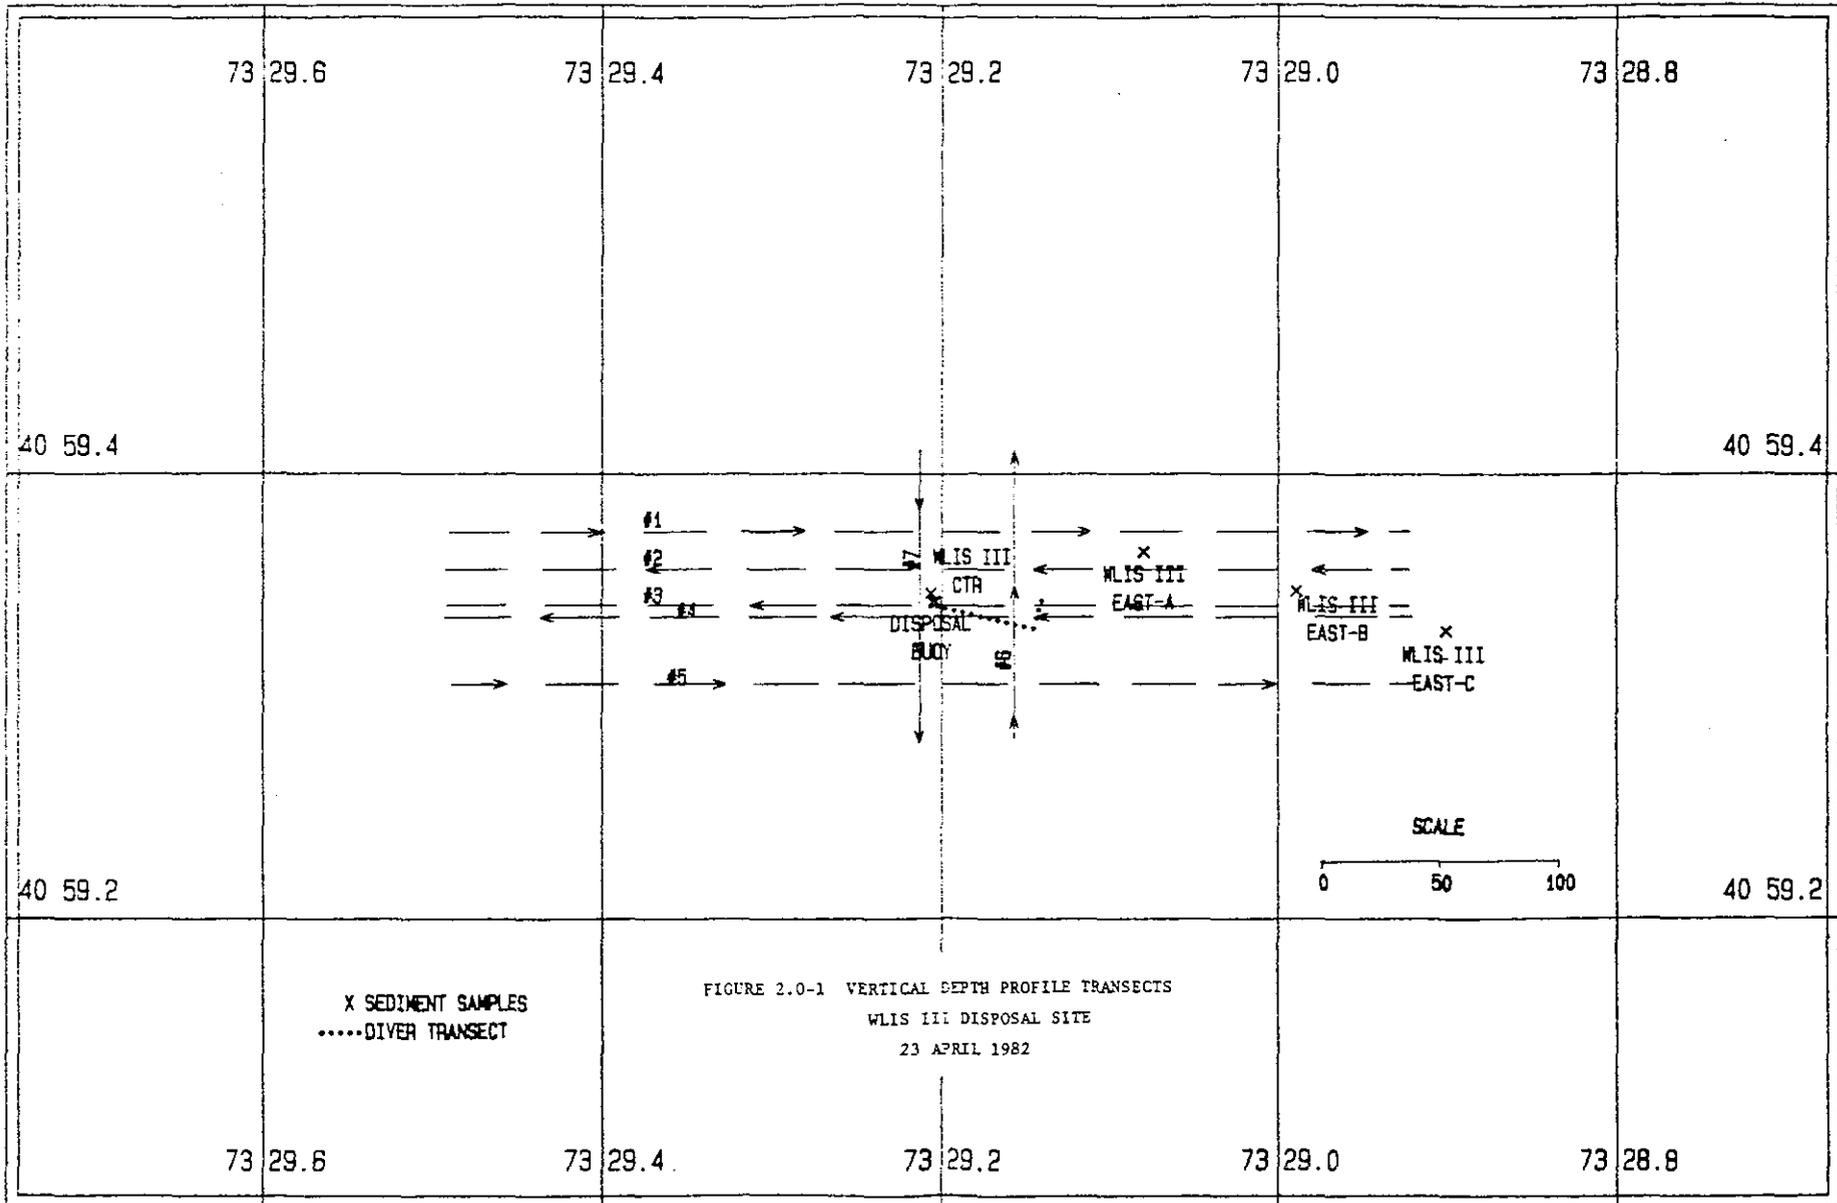
A series of vertical depth profiles were made in the vicinity of the disposal buoy consisting of five east-west transects and two north-south transects as shown in Figure 2.0-1. Navigation control was provided by calibrated Loran-C and depth measurements were made with the 24 KHz EDO fathometer used on all DAMOS surveys. The transects ranged approximately 400 meters east and west of the disposal buoy at distances north and south of the buoy as follows:

Profile	1	50m north
	2	20m north
	3	10m south
	4	20m south
	5	75m south

The two north south profiles were made 10 meters west and 70 meters east of the buoy.

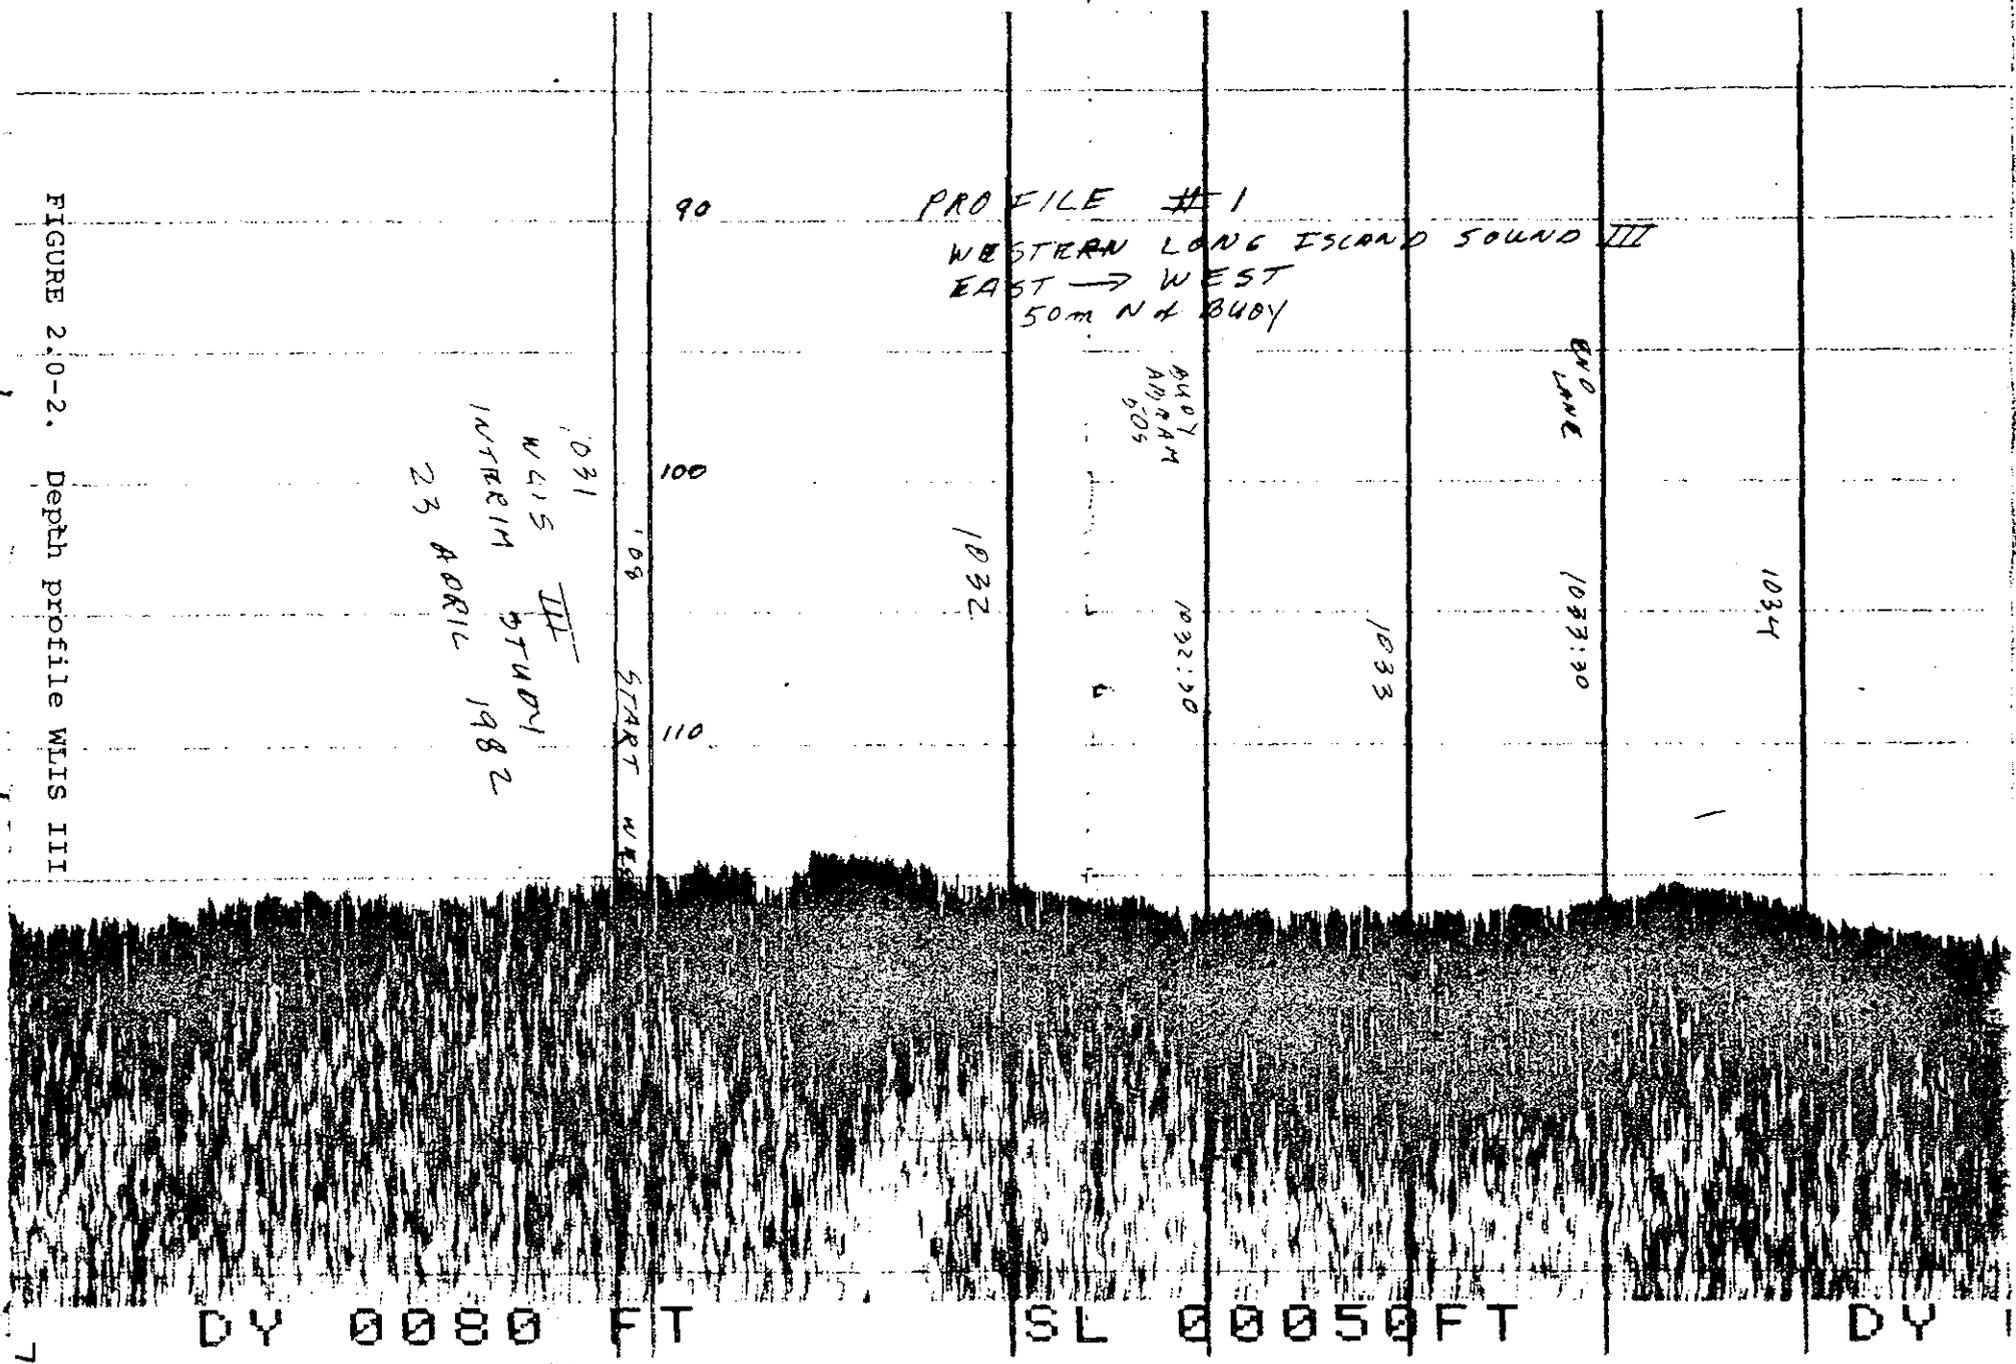
FIGURE 2.0-2. Depth profile WLIS III

Results of the profile measurements are presented in Figures 2.0-2 through 2.0-8. In general, the data indicate that the dredged material has formed a distinct mound immediately south and east of the disposal buoy with maximum thickness approaching 4 meters on profile 3. The mound has a radius of approximately 100 meters in the east west direction, and somewhat less than 50 meters in the north south direction.

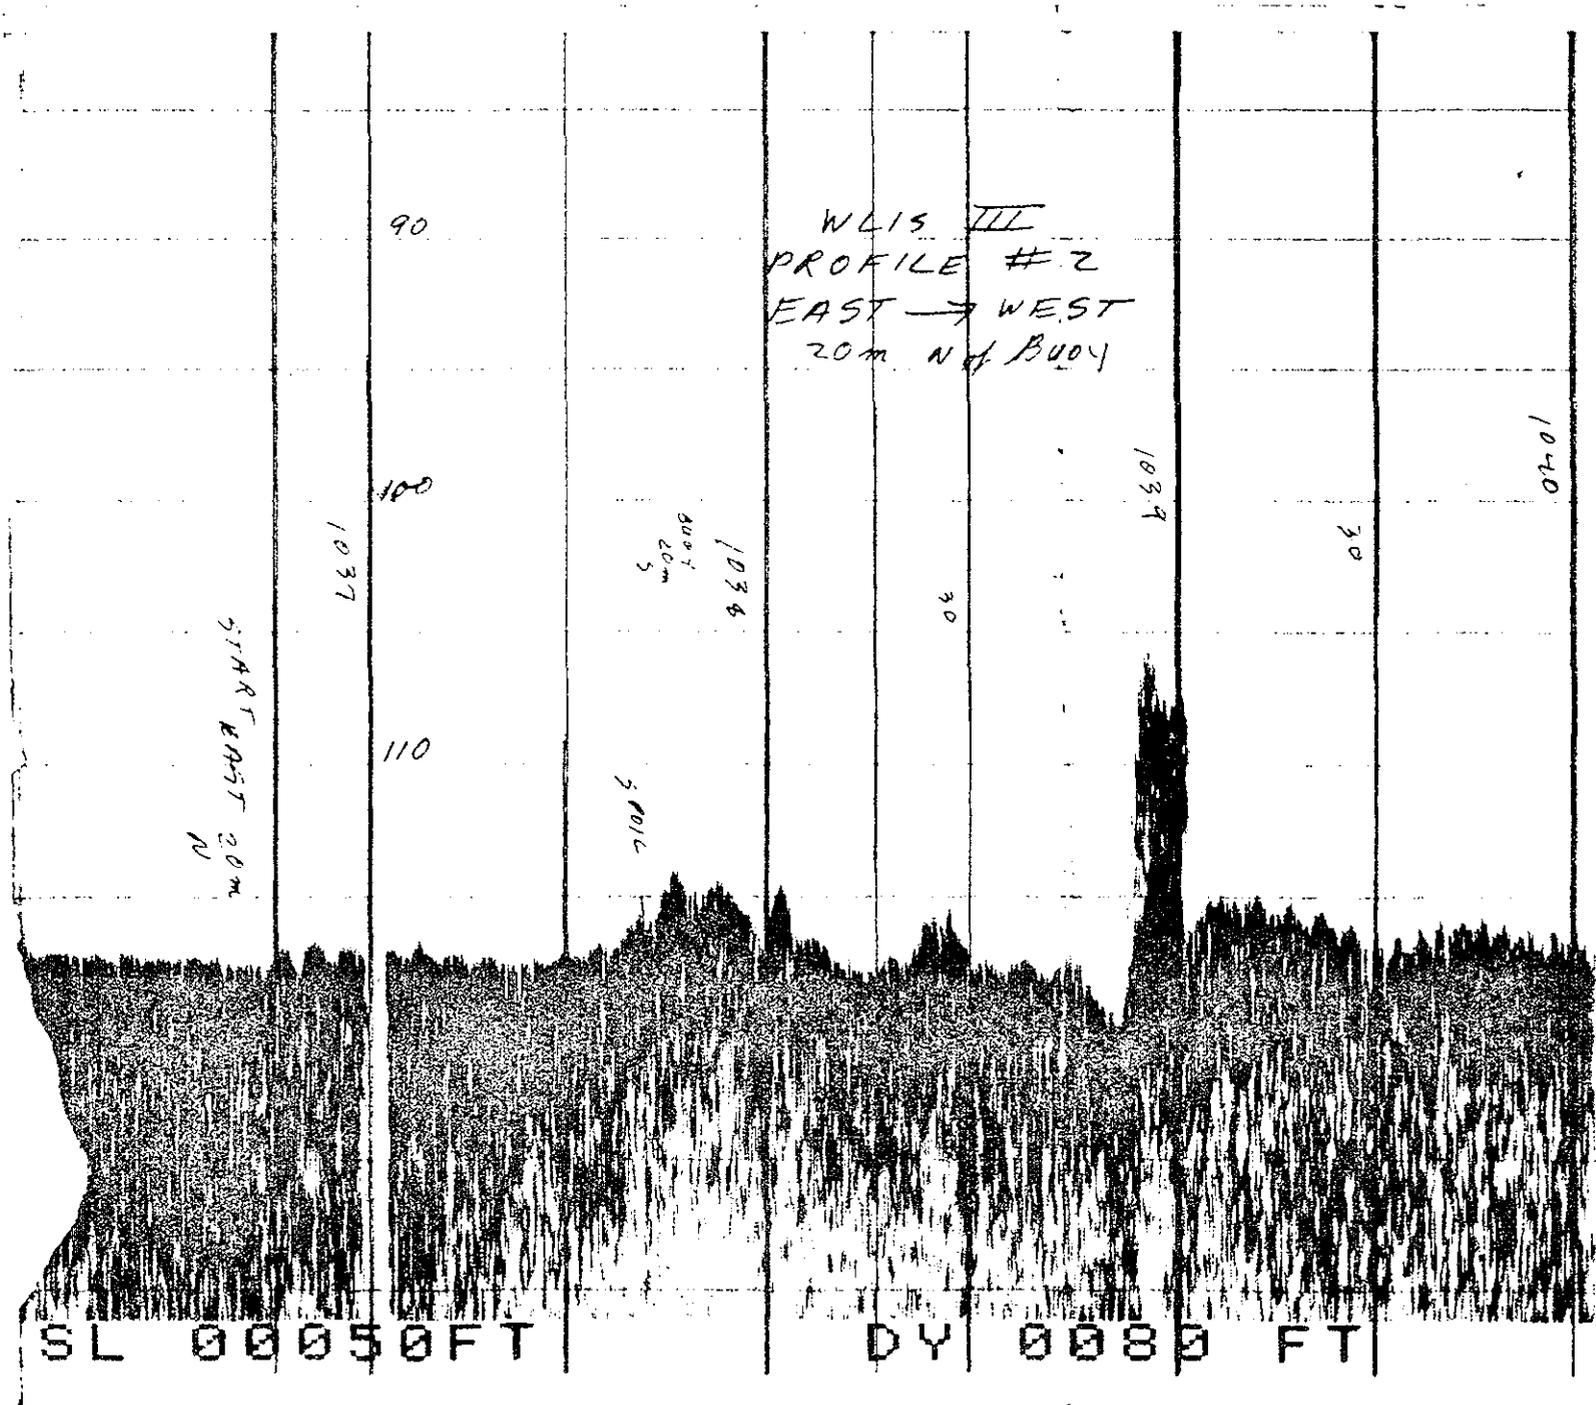
FIGURE 2.0-3. Depth profile WLIS III

An interesting feature was observed in Profile 2 (Fig. 2.0-3) approximately 200m east of the buoy. This feature is approximately 5 meters high, but shows vertical sides indicating it may be a wreck or other man made object. Side scan or diver observations will be used to investigate this formation during a future survey.

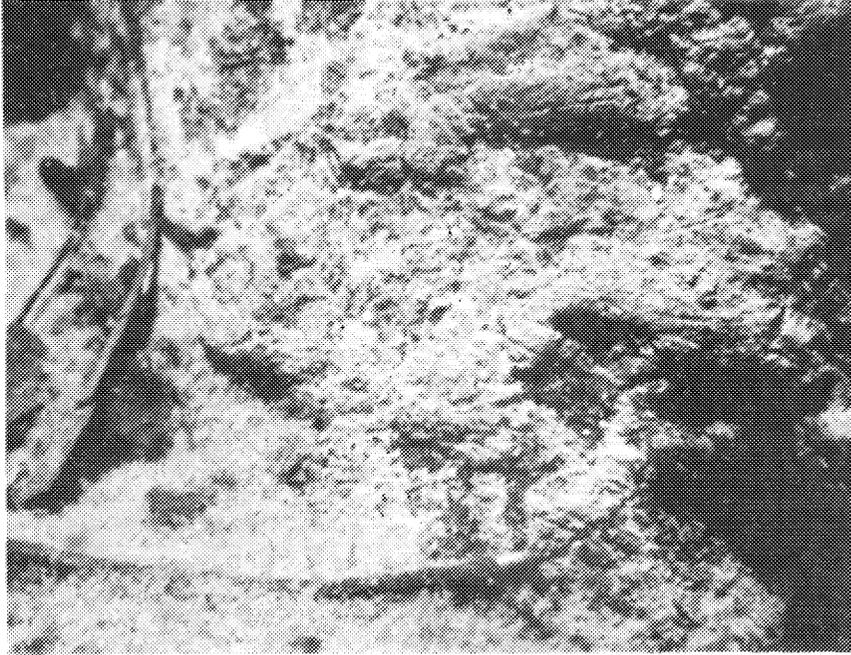
Fig. 1.

- Figure 1. Surface texture typical of cohesive clay mound protruding from soft interspace dredge material. Note evidence of Zostera blades at base and to lee of mound. Horizontal Field of View (HFV) = 9 cm.

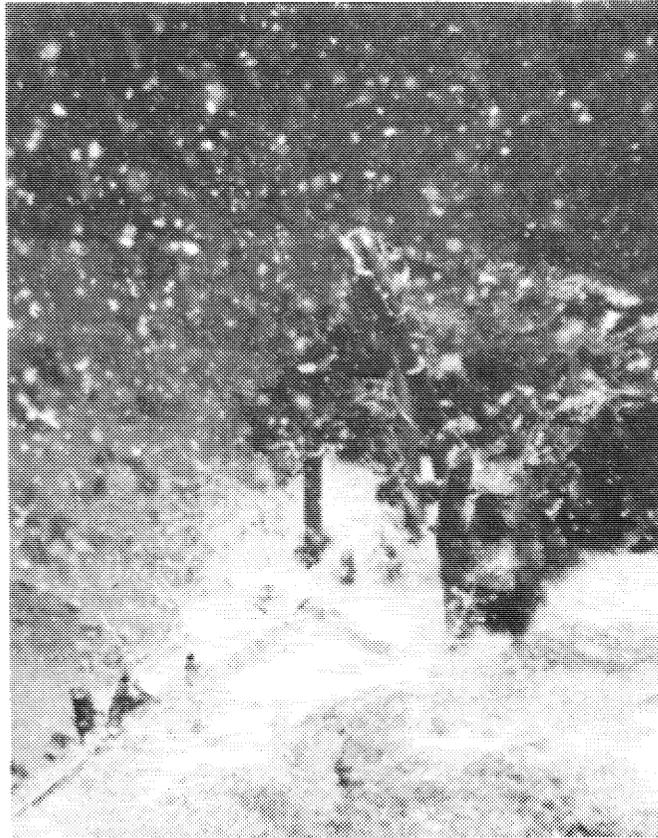
Fig. 2.

- Figure 2. Marsh reed, Phragmites, stalks incorporated in clay material, peat fragments, and high organic debris were characteristics of the disposal pile. HFV = 7 cm.

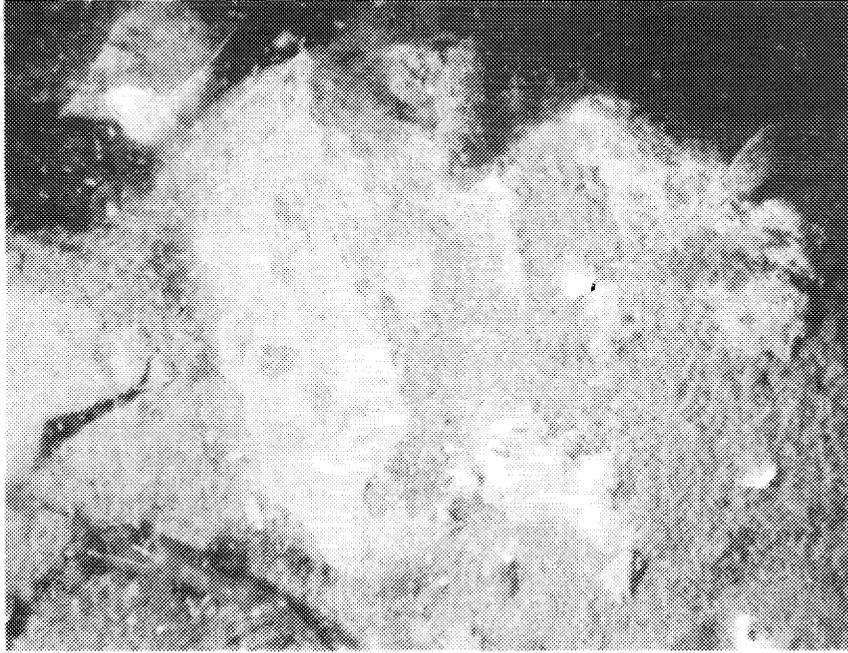
Fig. 3.

- Figure 3. Faceted clay surfaces provide entrapment crevices for nephaloid layer material. Two Nassarius graze the upper mound surface. A Mercenaria valve shows in left background. HFV = 20 cm.

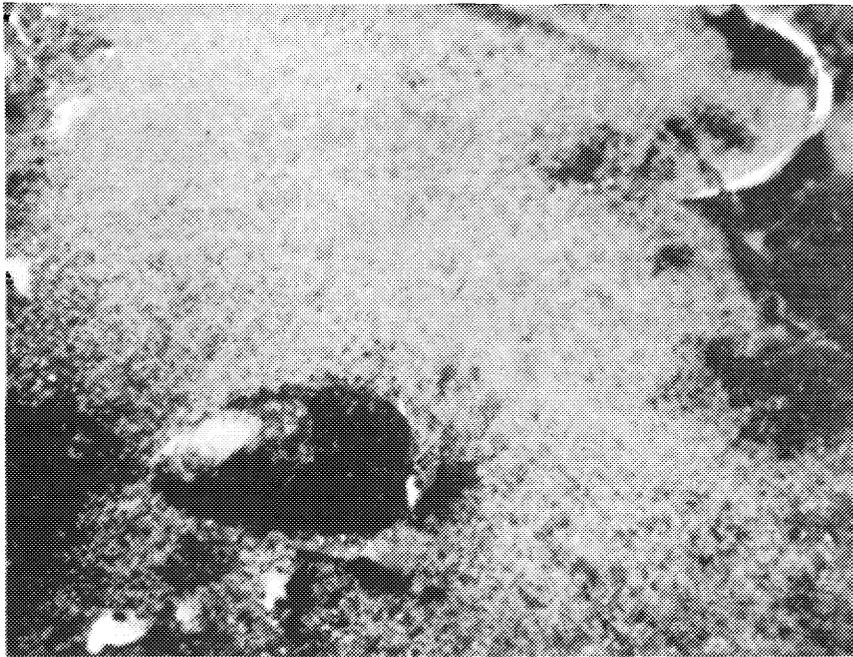
Fig. 4.

- Figure 4. Granular, flocculant nature of natural nephaloid layer is illustrated in close-up photo within depression zones of spoil surface. HFV = 12 cm.

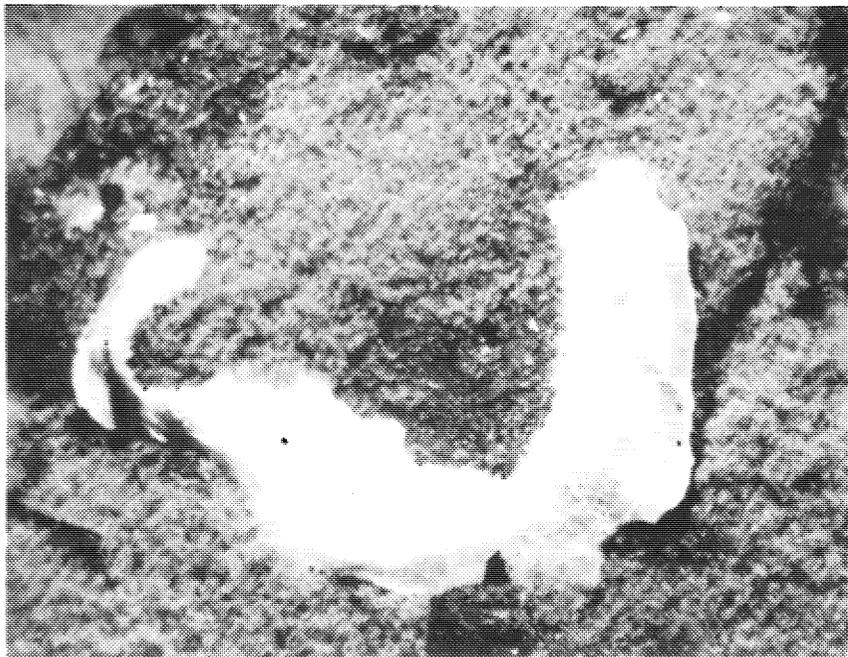
Fig. 6.

- Figure 6. Shell fragments were often bleached white and did not reveal discolorations indicative of origin from H<sub>2</sub>S or petroleum contaminate zones. The overlay of the light-brown nephaloid veneer is evident in this photo, as in previous prints. HFV = 7 cm.

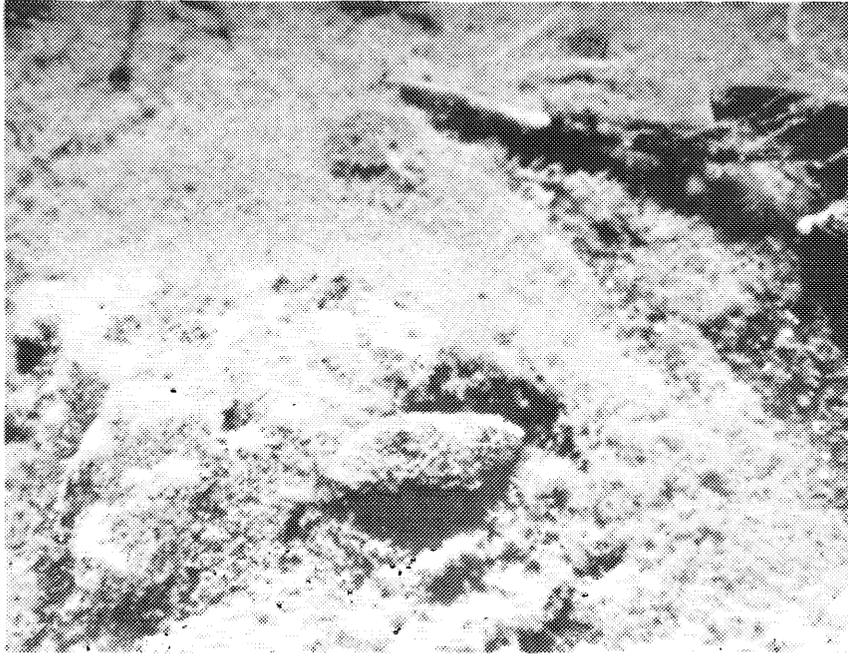
Fig. 7.

- Figure 7. Typical dredge sediment surface conditions - small clay clusters, marsh vegetation, Nassarius presence, and the natural suspension nephaloid layer. HFV - 10 cm.
