Feasibility Study  
Disposal of Dredged Material  
Morris Cove, New Haven Harbor

# Disposal Area Monitoring System Damos

Contribution 36

A FEASIBILITY STUDY OF THE  
DISPOSAL OF DREDGED MATERIAL AT  
MORRIS COVE, NEW HAVEN HARBOR

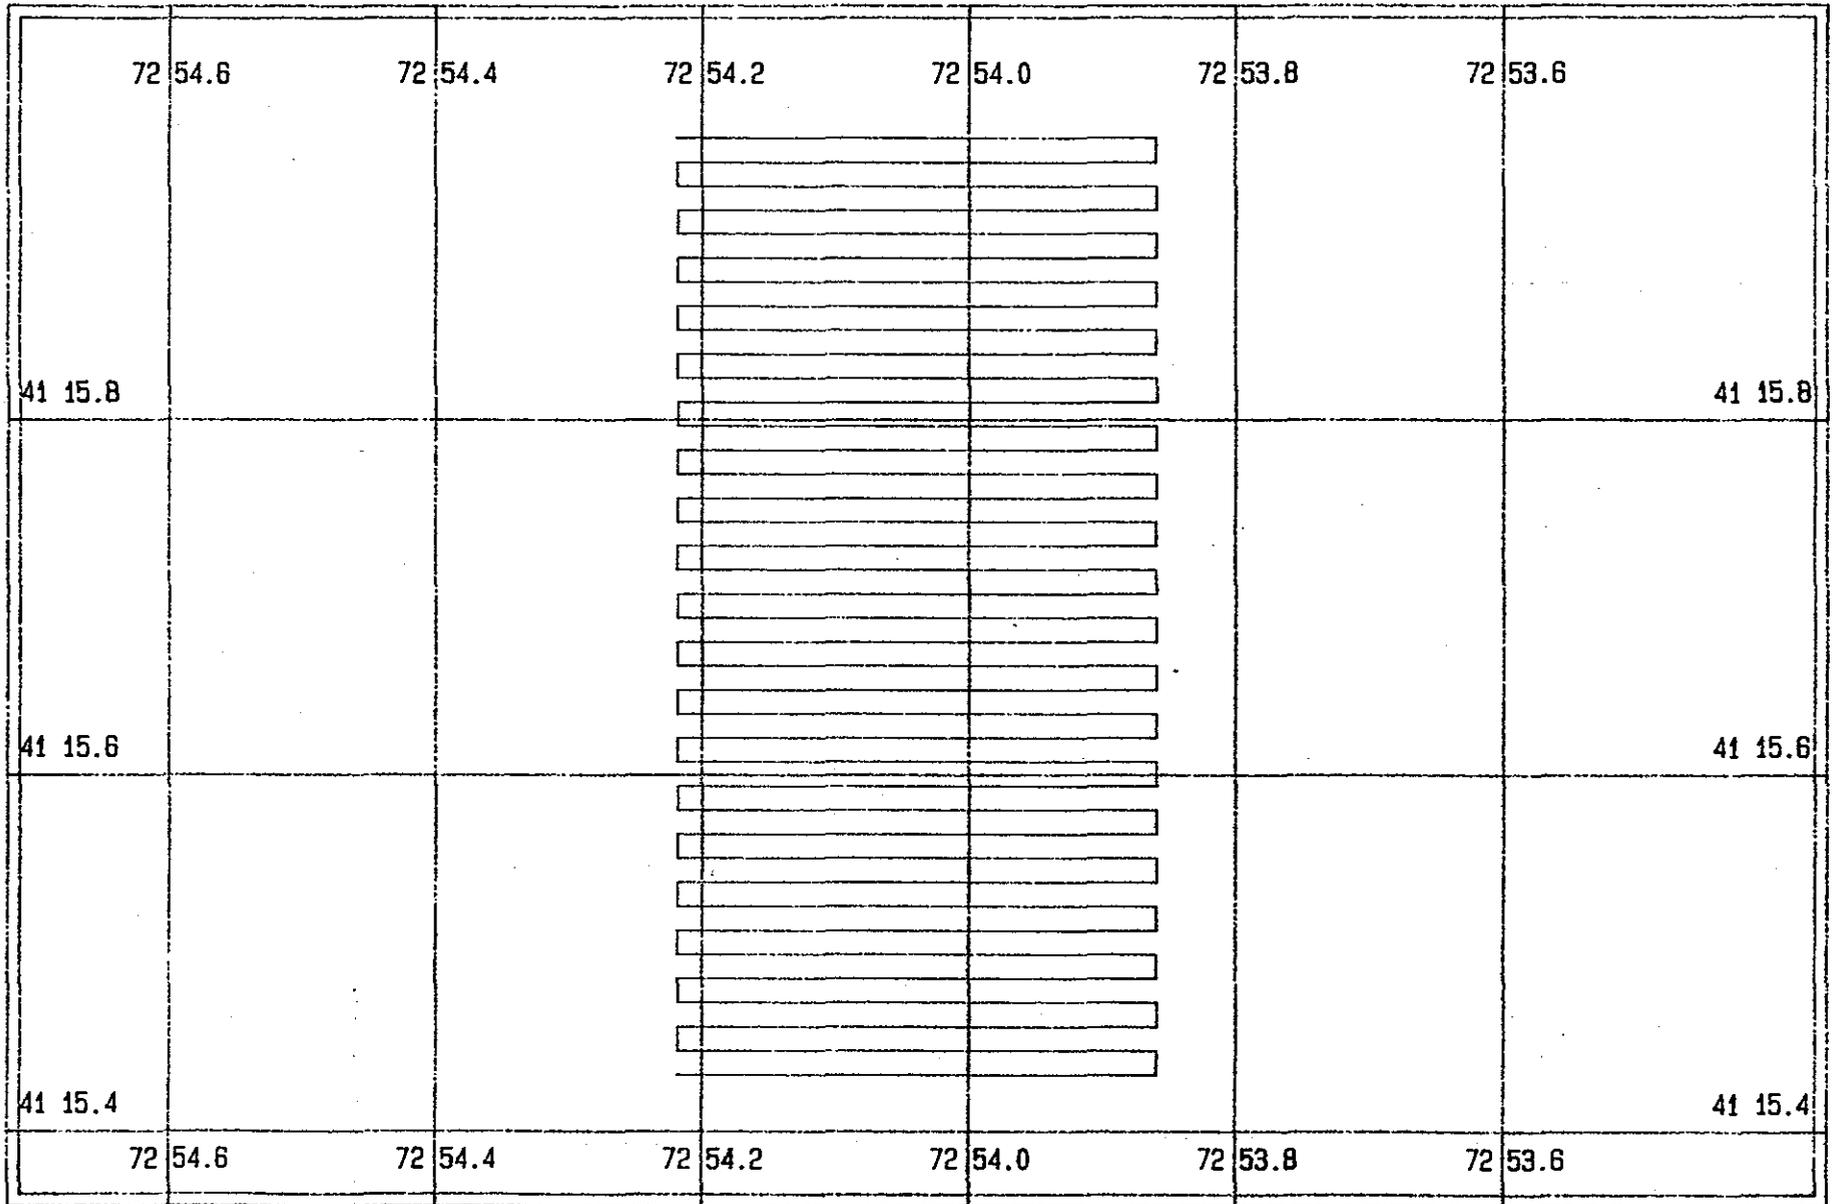
Figure 2.0-1. Bathymetric Survey Lanes

On March 11, 1983 a bathymetric survey of the Morris Cove borrow pit and the surrounding area was performed. This survey was conducted at a 25 meter lane spacing with the 38 lanes running in an east-west orientation as shown in Figure 2.0-1. In order to maintain a high degree of position accuracy, navigation control for this and all other aspects of the cruise was provided by the SAI Navigation and Data Acquisition System. This system utilizes a Del Norte Model 540 microwave positioning system integrated with an Apple II microcomputer to provide a position accuracy of  $\pm 2$  meters. Depth data from a Raytheon Model DE719B recording fathometer with a 200 KHz transducer were input into this microcomputer system via a Raytheon Model SSD-100 digitizer. Shore stations for the Del Norte positioning system were located at Lighthouse Point Light at  $41^{\circ}14.932N$ ,  $72^{\circ}54.254W$  and at New Haven Harbor Lower Range Light at  $41^{\circ}15.640N$ ,  $72^{\circ}56.111W$ .

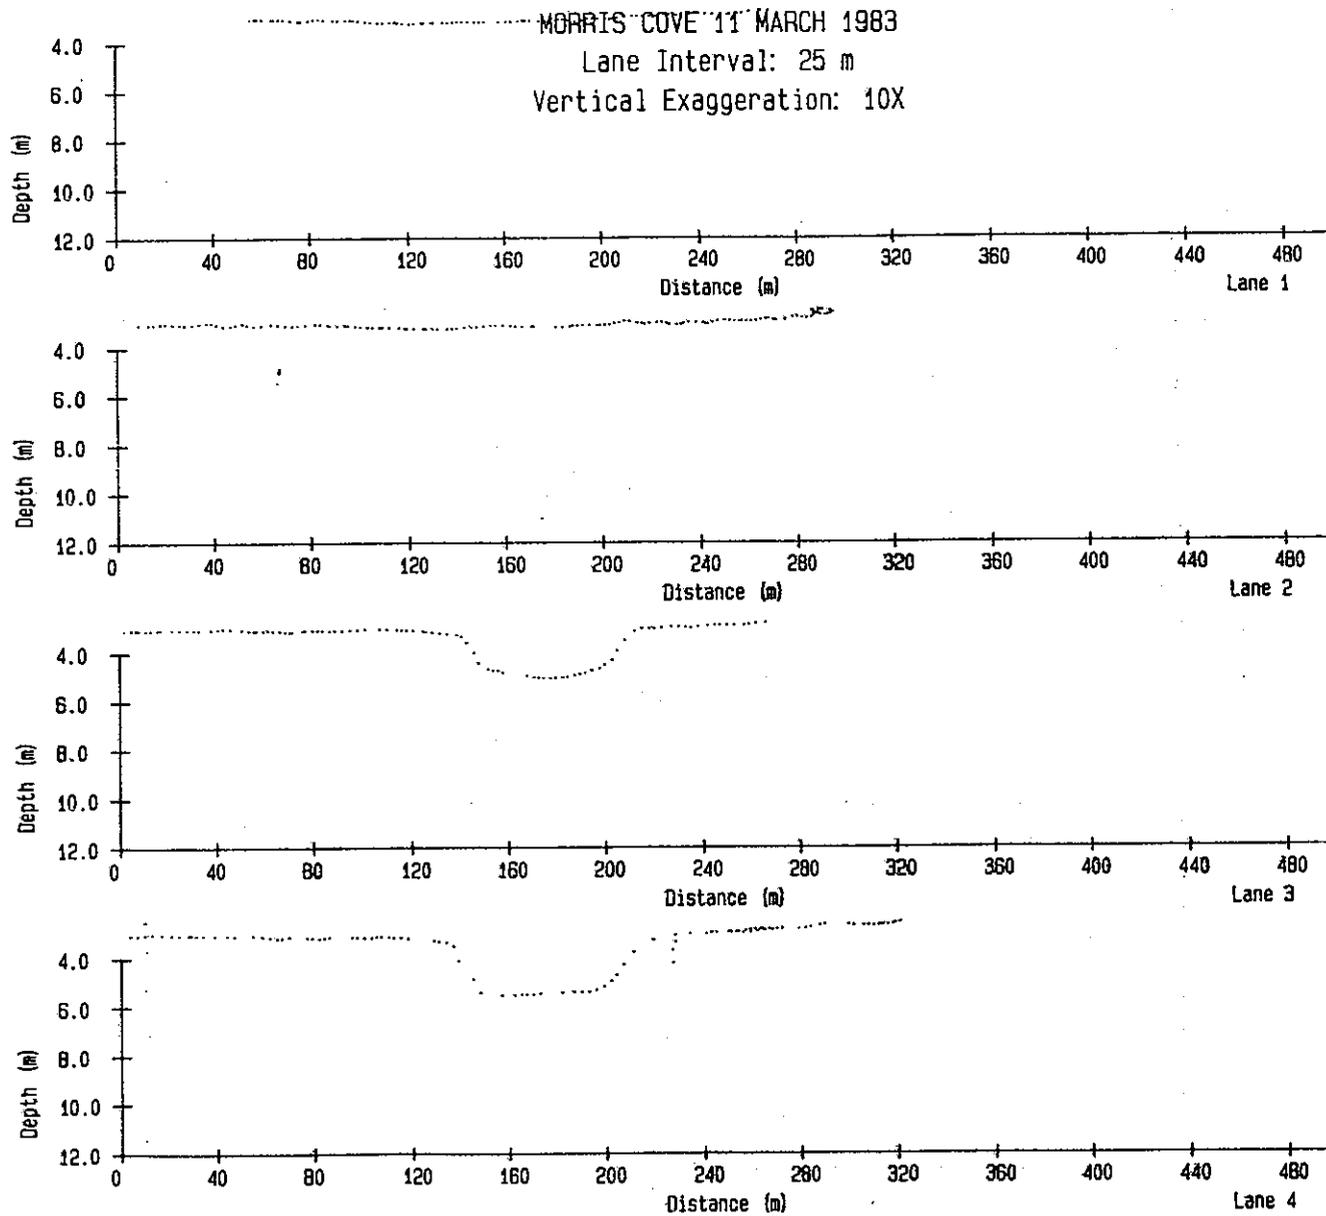
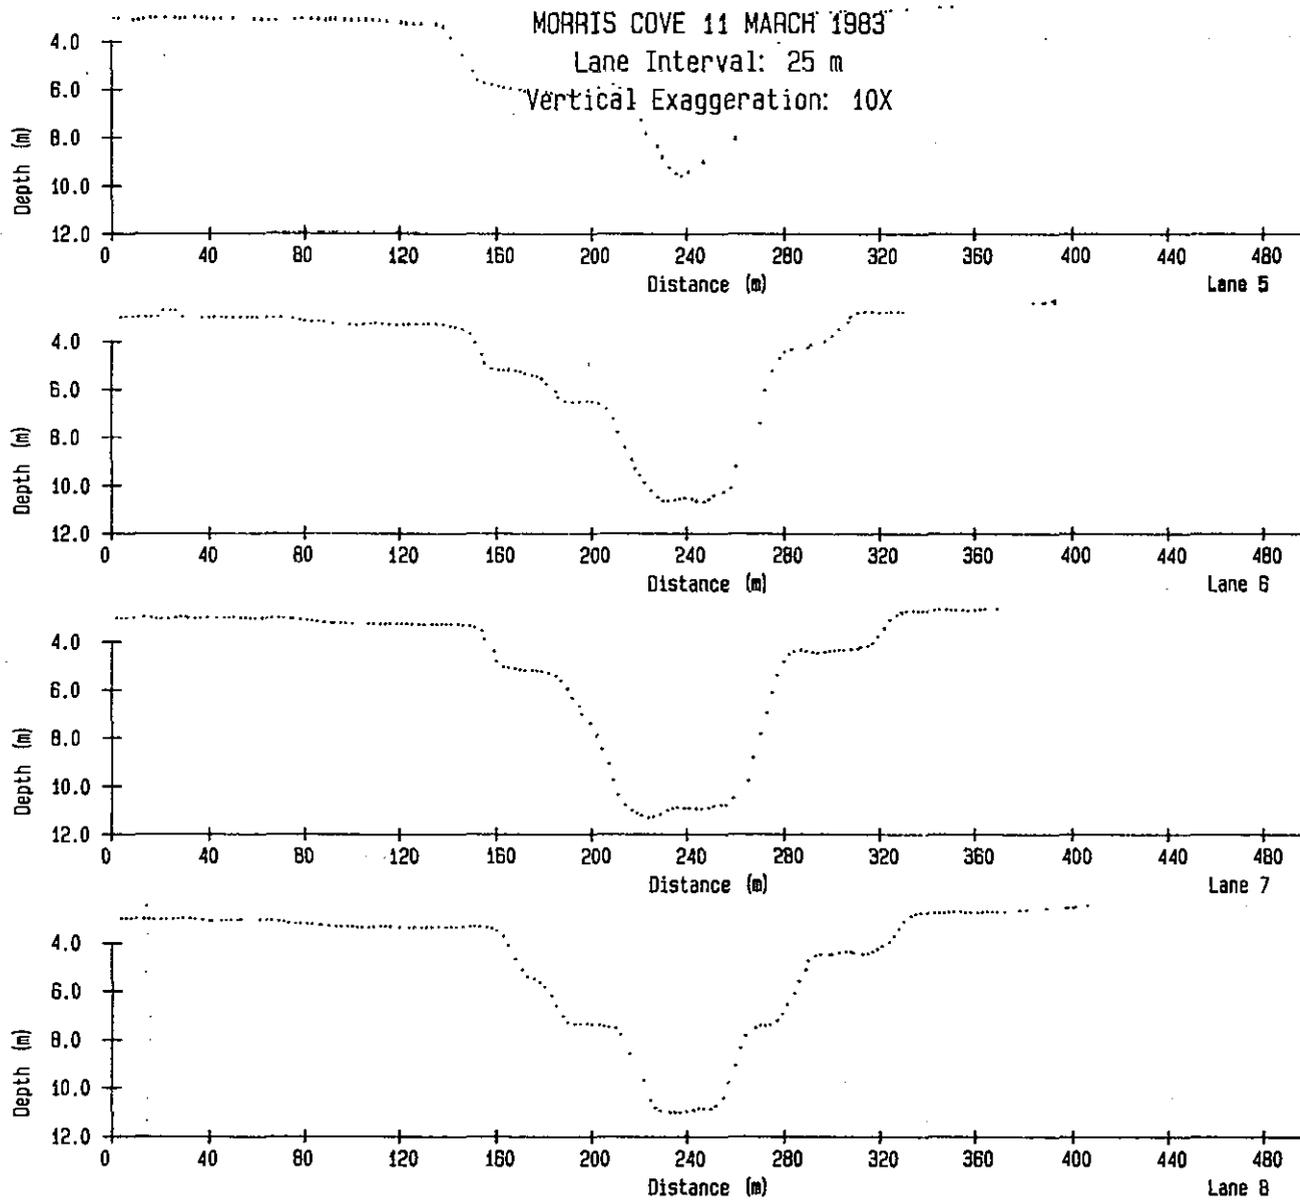
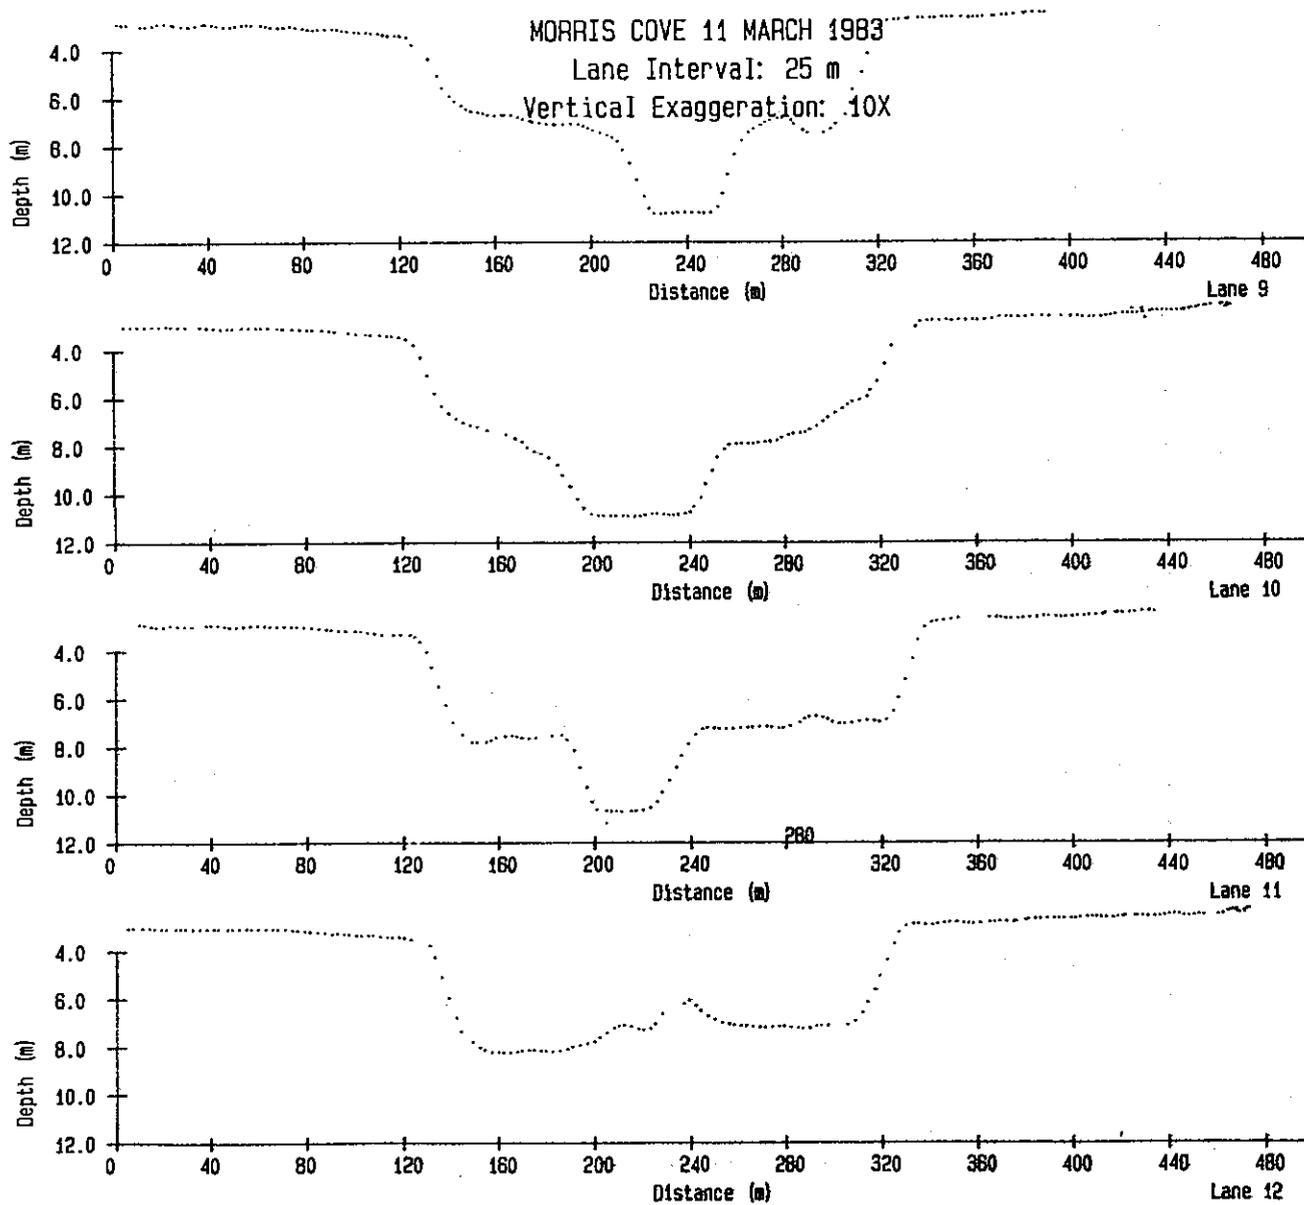
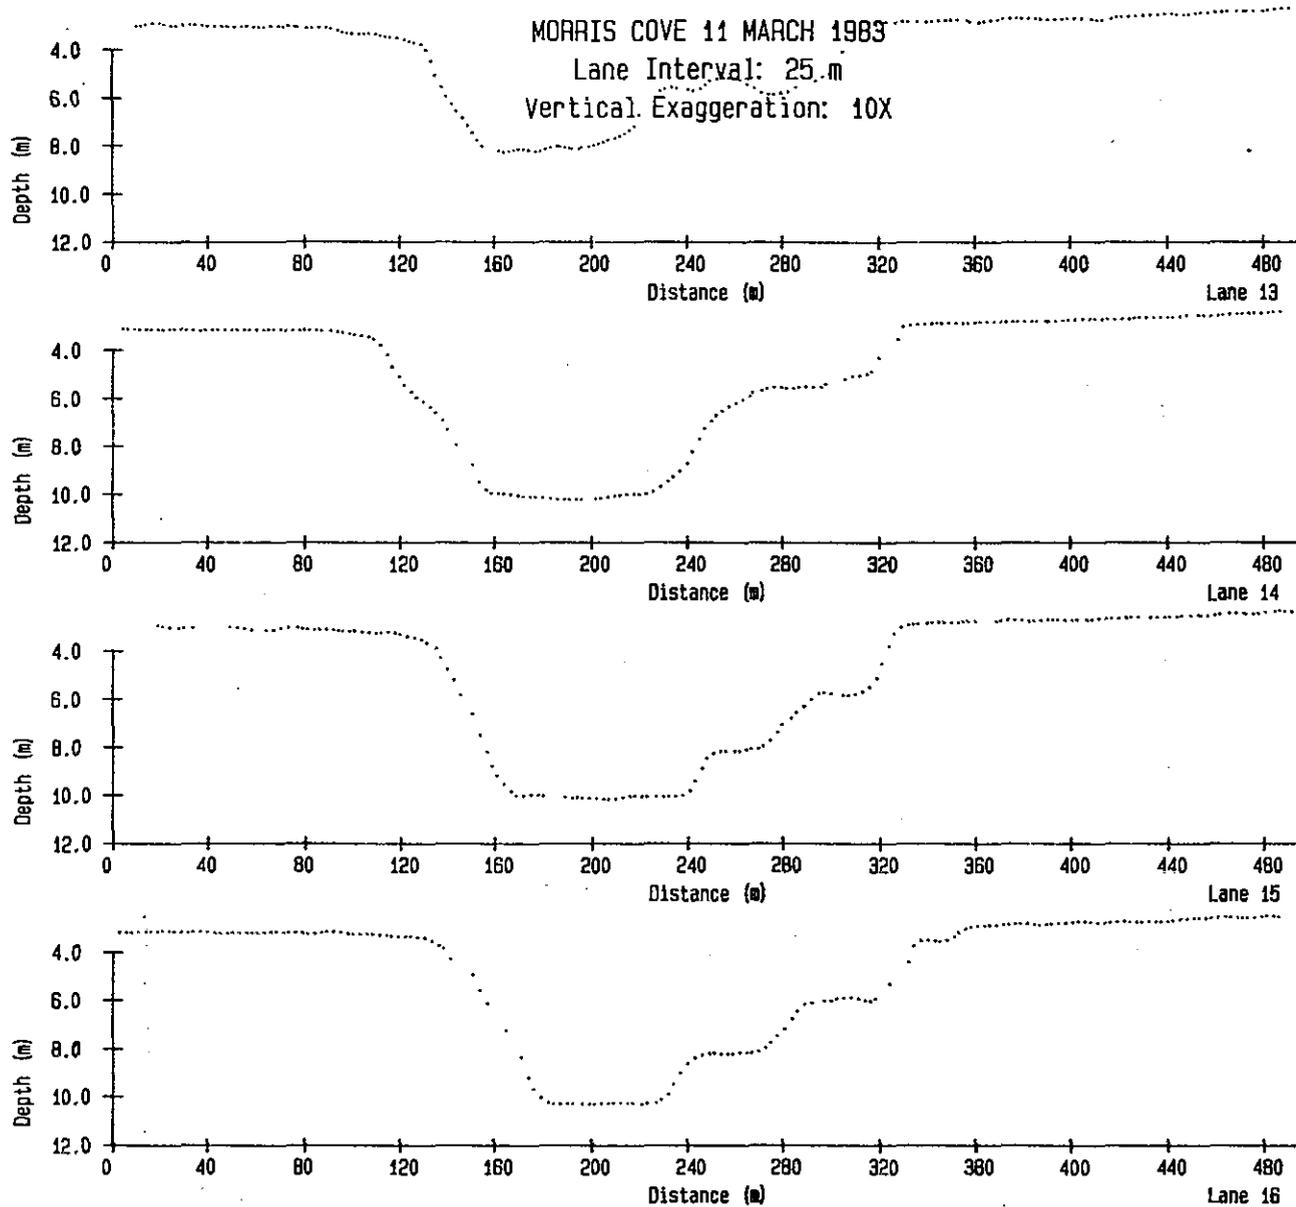
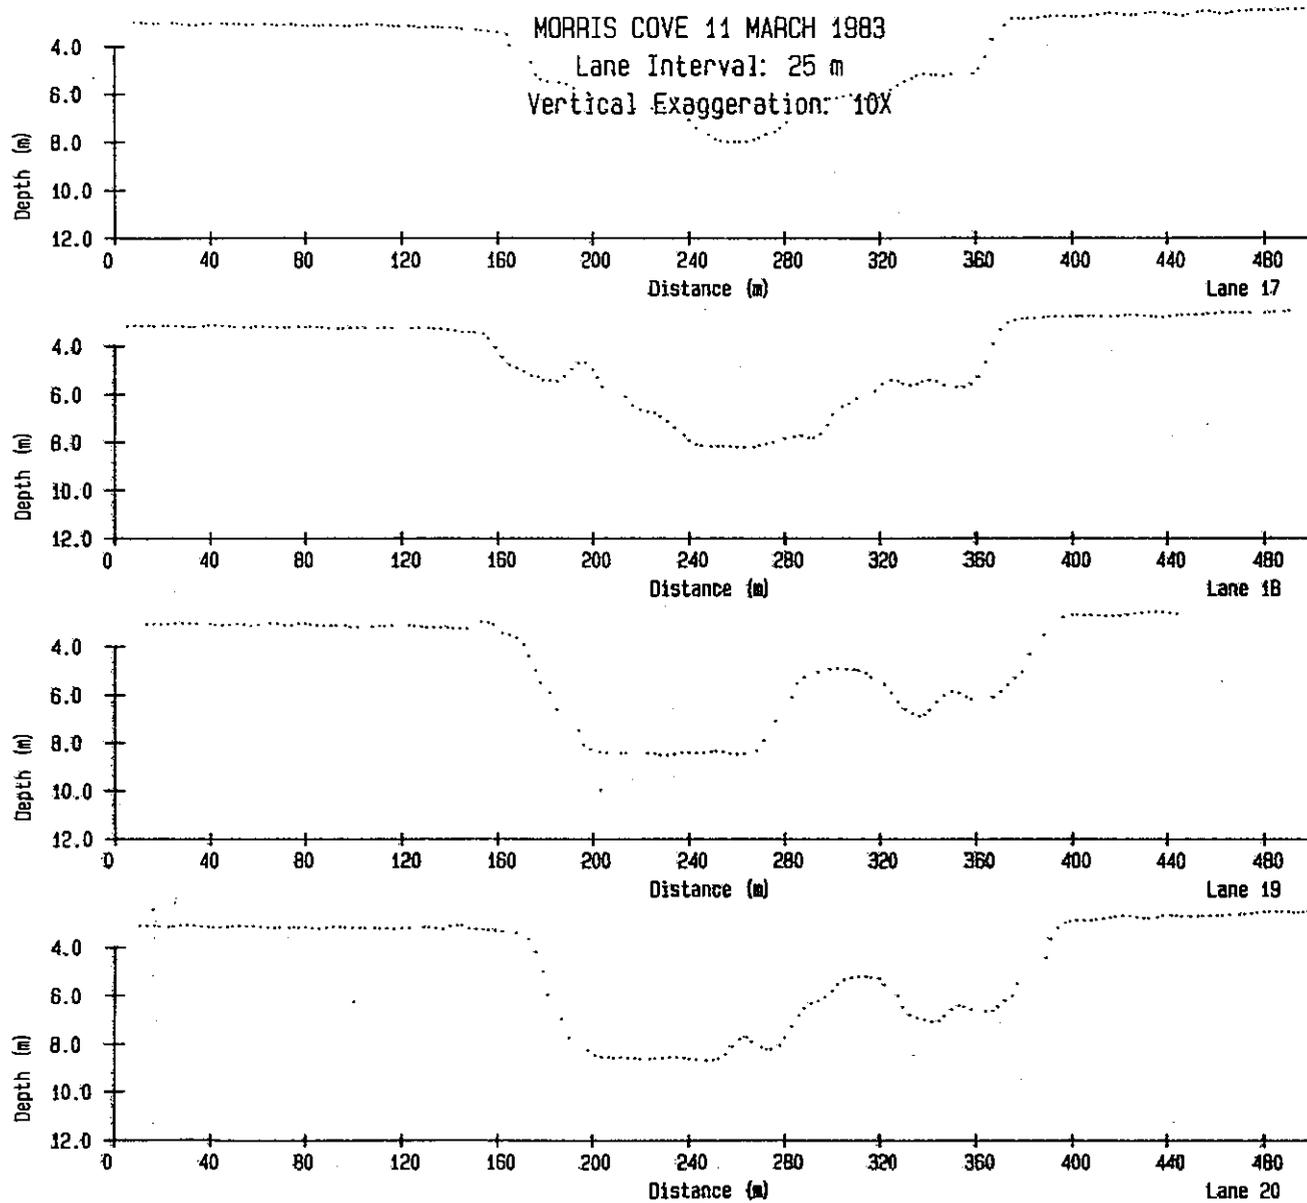
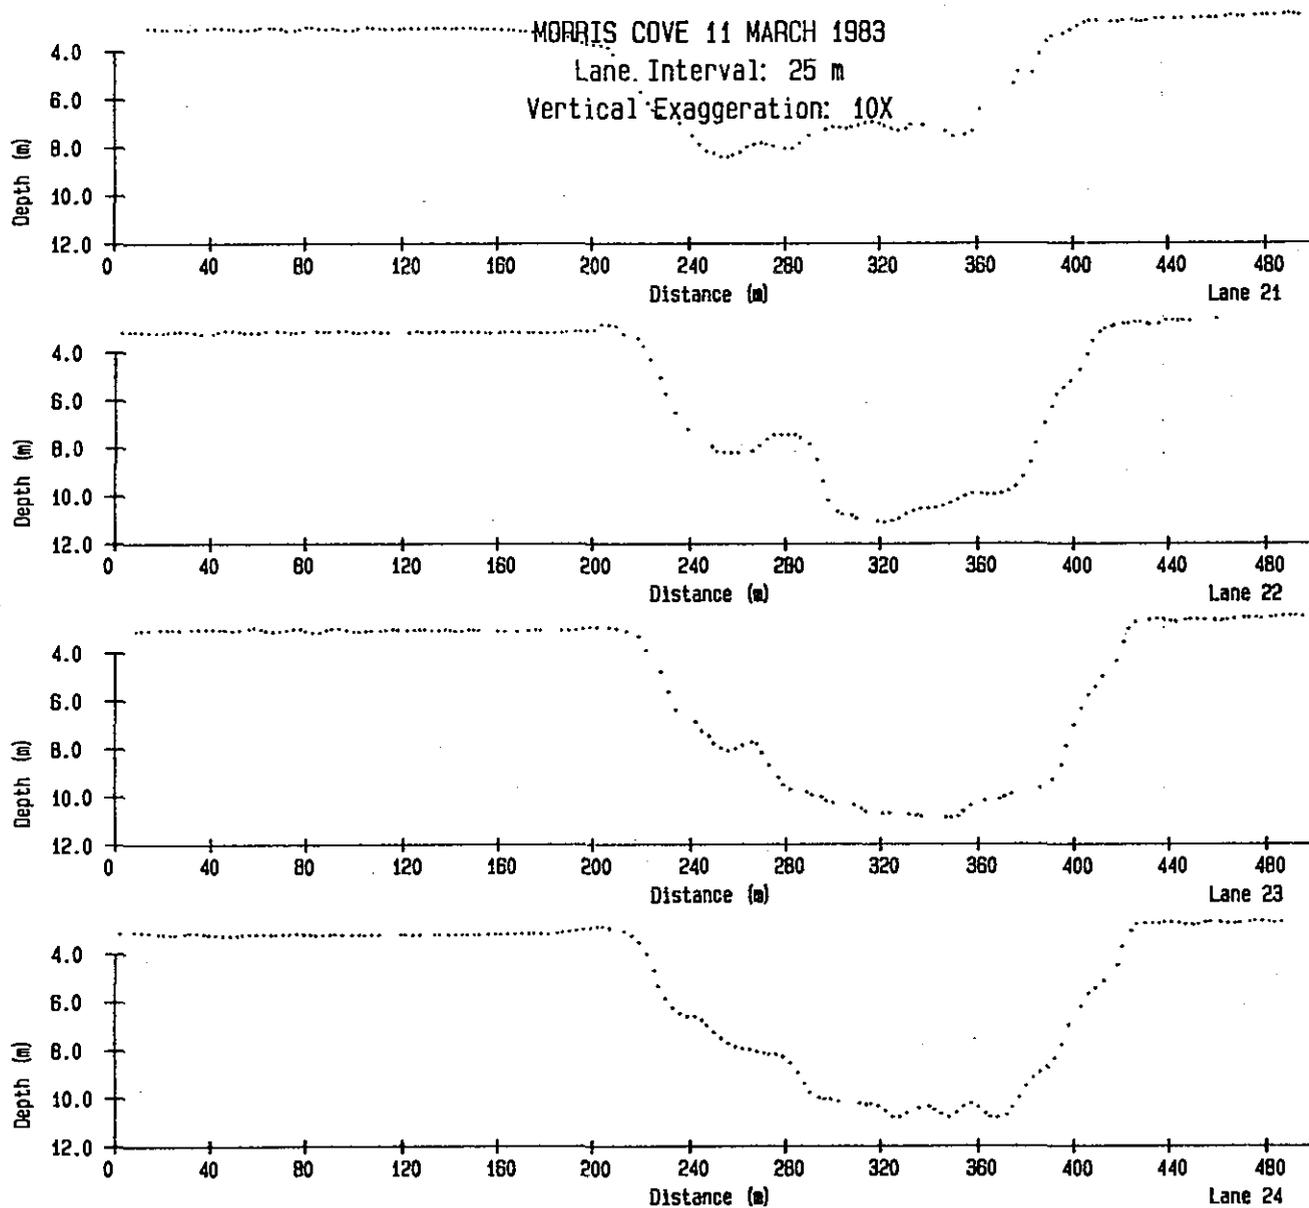
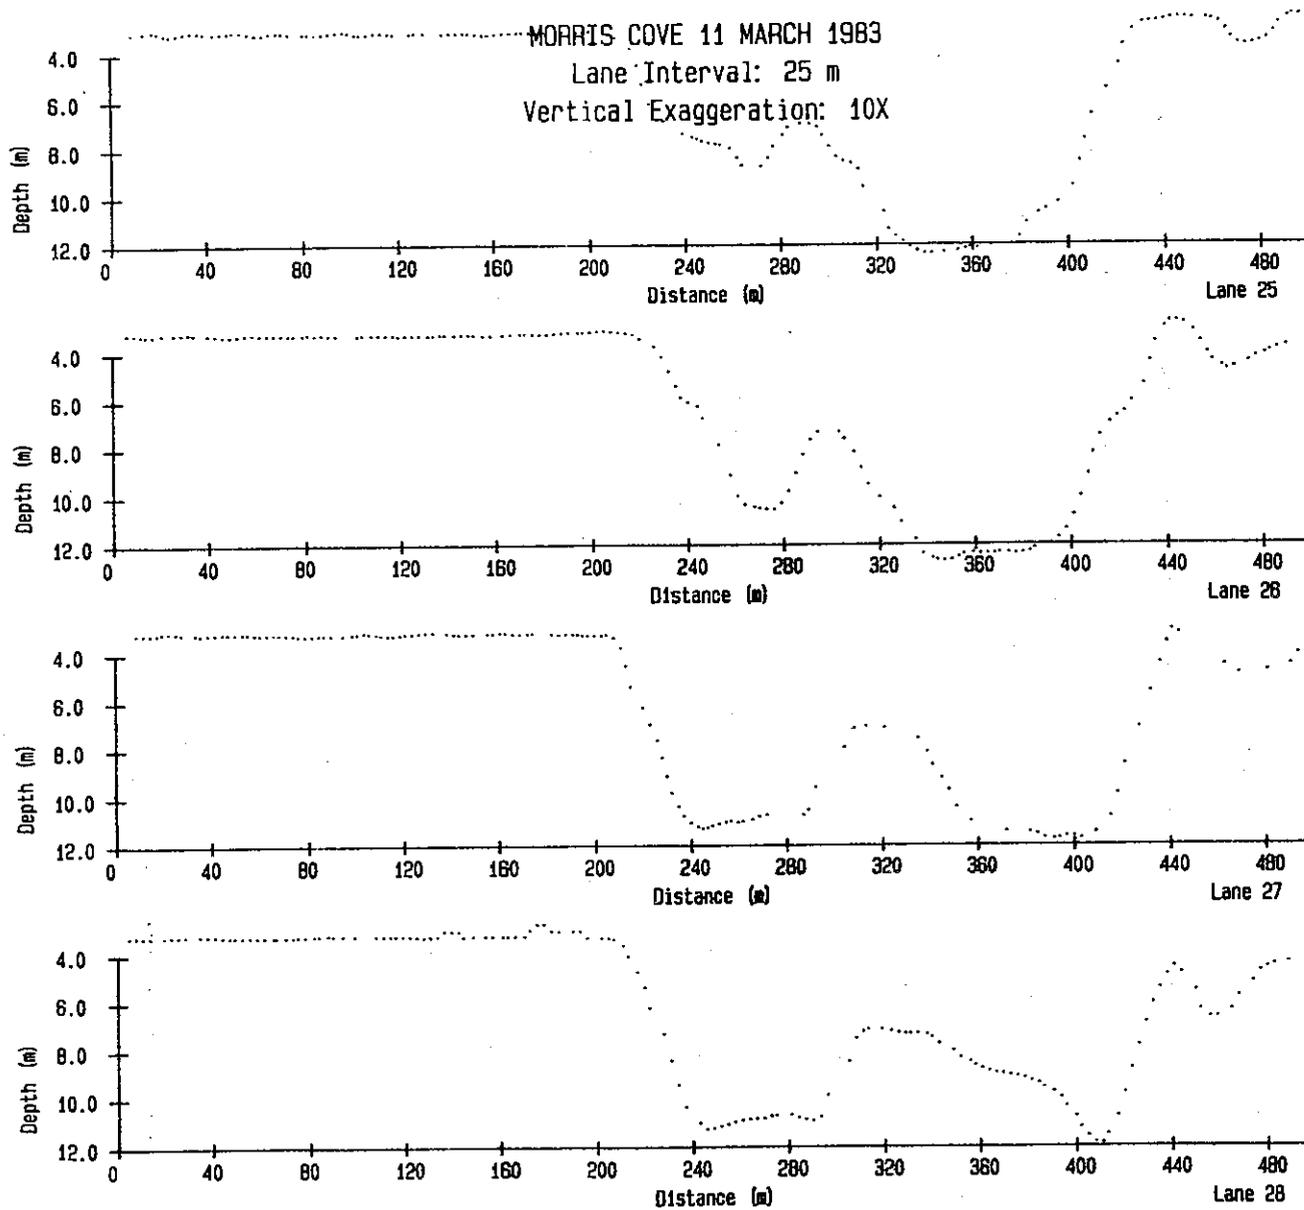
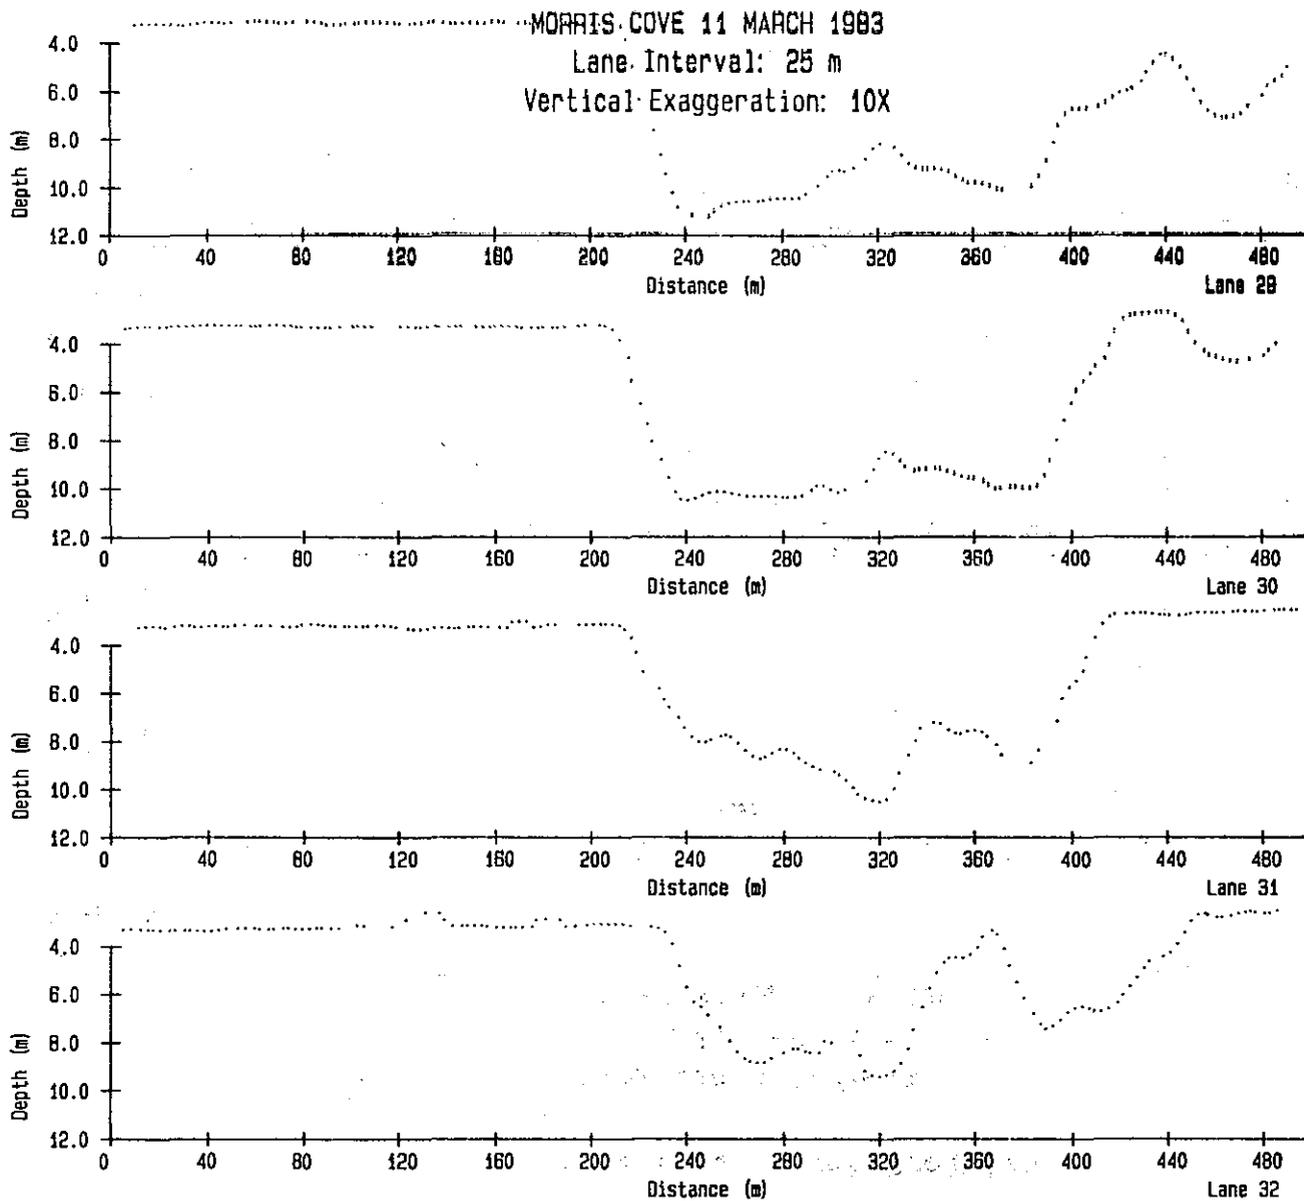
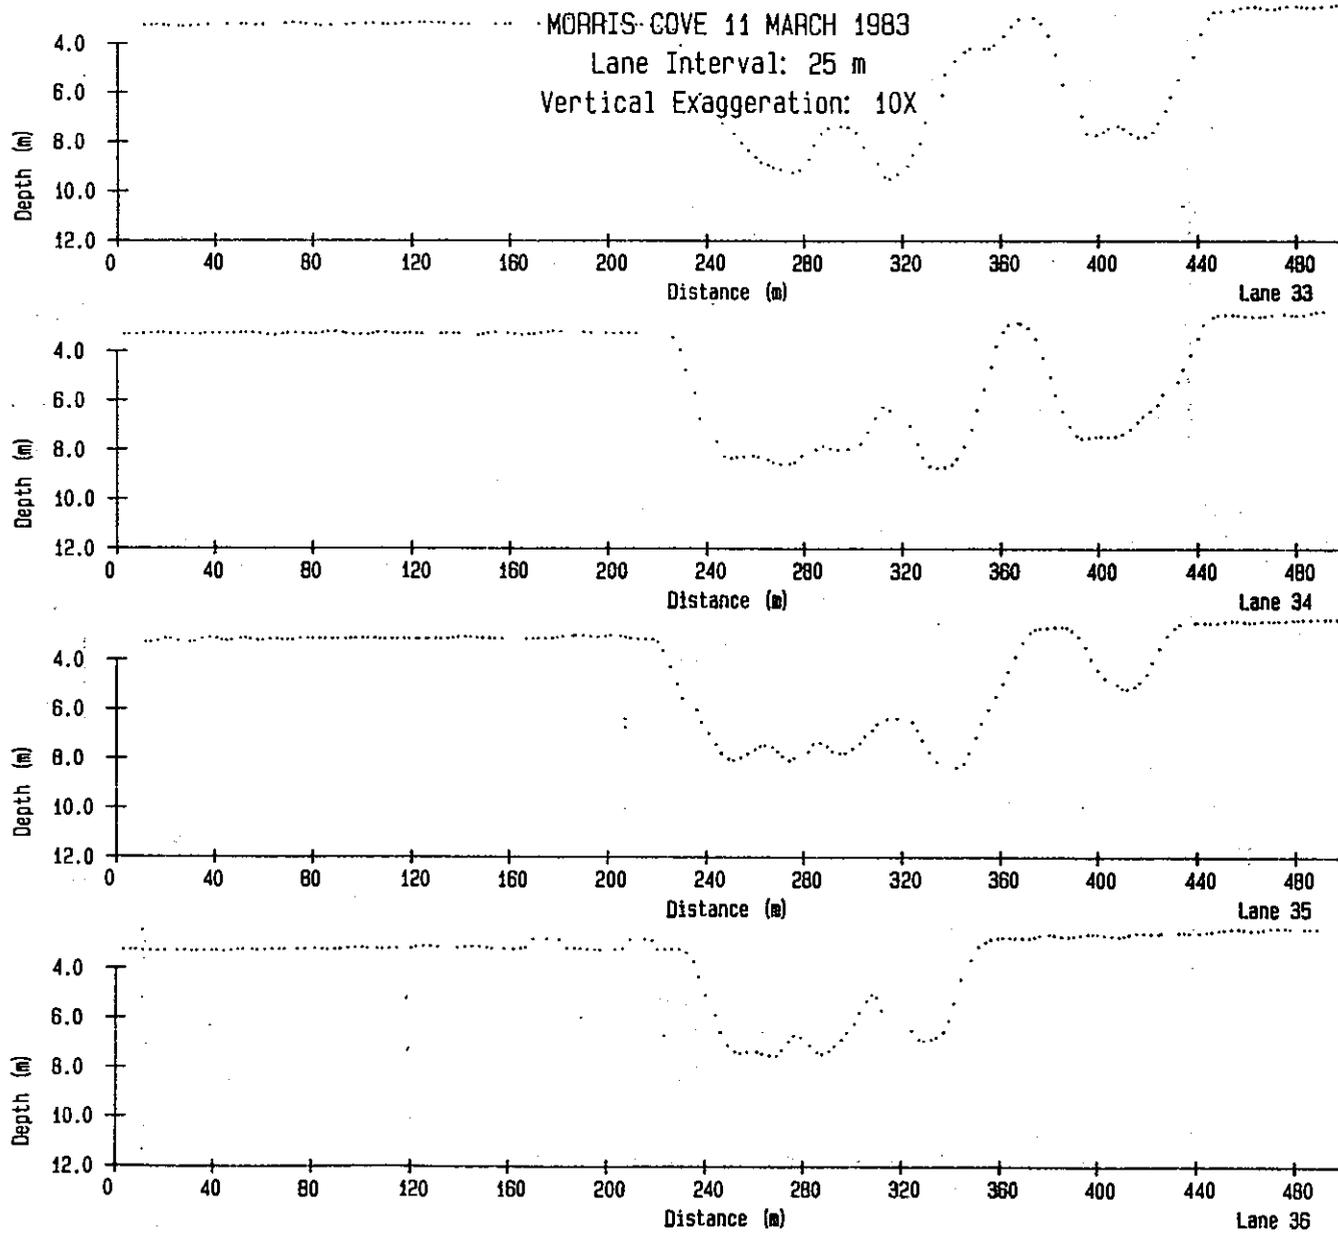
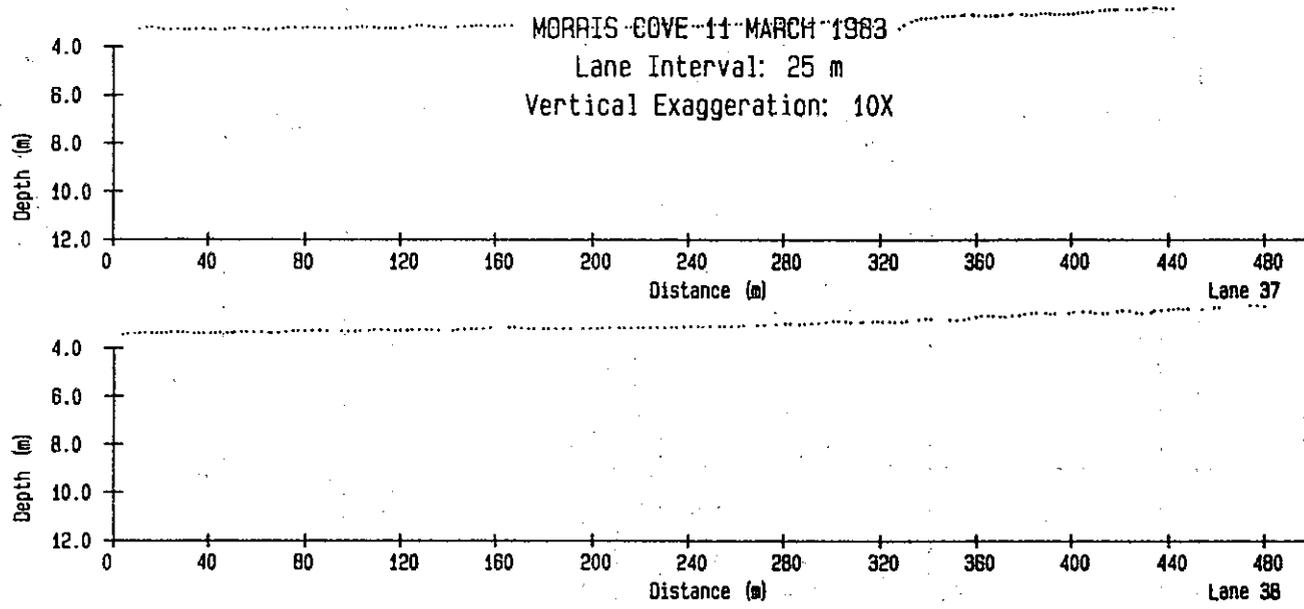
Figure 2.0-2. Depth Profiles

Figures 2.0-2 thru 2.0-11 and contour charts generated from these data are presented as Figures 2.0-12 and 2.0-13. These figures show that the borrow pit is a north-south trending depression which deepens to a maximum depth of approximately 12.5 meters in the south western portion of the feature (lane 26, Fig. 2.0-8). In contrast, the area immediately surrounding the borrow pit may be characterized as flat and featureless with a depth varying from approximately 2.5m at the northern boundaries to about 3.0m at the southern edge of the pit. The width of the borrow pit varies from a minimum of 70m at its northern terminus to a maximum width of approximately 220m across lane 20 (Fig. 2.0-6). Further, while the edges of the borrow pit are generally well defined, there are a few locations notably at the eastern ends of lanes 25 thru 30 (Fig. 2.0-8, 2.0-9) where this boundary is not distinct. The most unusual feature of the borrow pit is the uneven distribution of topography within the pit in the more southern lanes. The profile plots of the northern lanes (lower lane number) show only a single depression in the bottom, while the more southern lanes have profiles which indicate two depressions separated by a rise of as much as 4m (lanes 27 & 28). This topography distribution is most likely the result of material that was not removed during the creation of the borrow pit. Utilizing the volume difference portion of the SAI bathymetric software, it has been determined that 1,207,154 yards<sup>3</sup> (922,990 meters<sup>3</sup>) of material would be required to fill this pit to a level equal to that of the surrounding bottom (Fig. 2.0-14).

Profile plots of the 38 lanes sailed are presented as

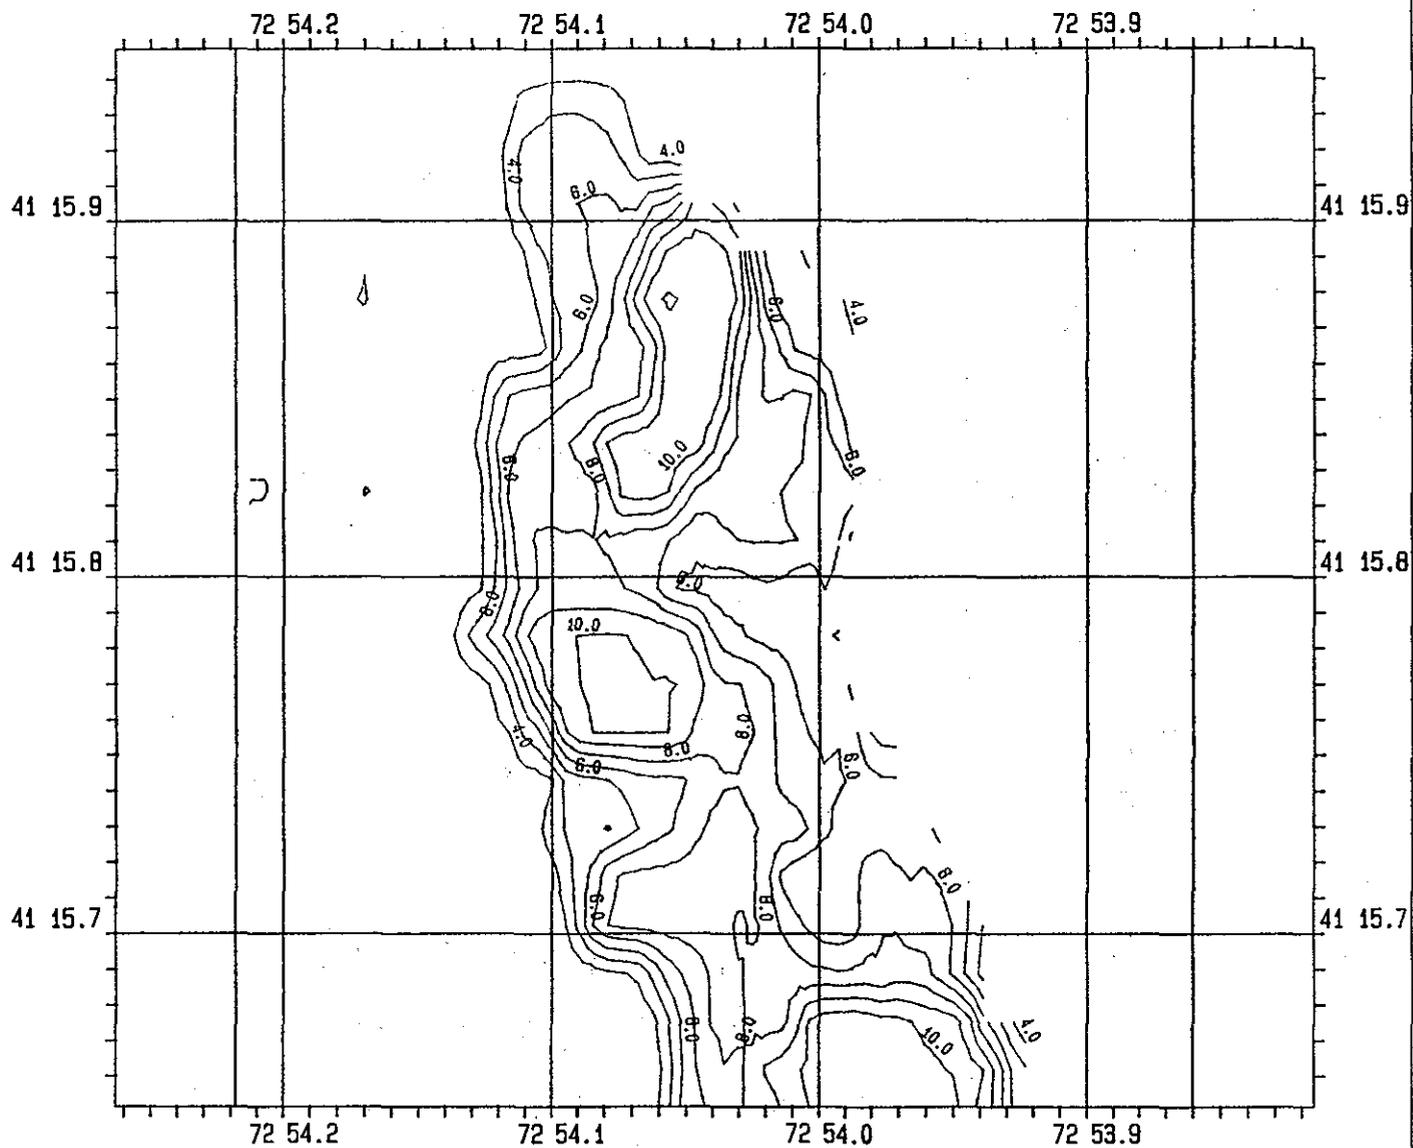
FIGURE 2.0-12

MORRIS COVE  
NORTH  
DEPTH CONTOURS

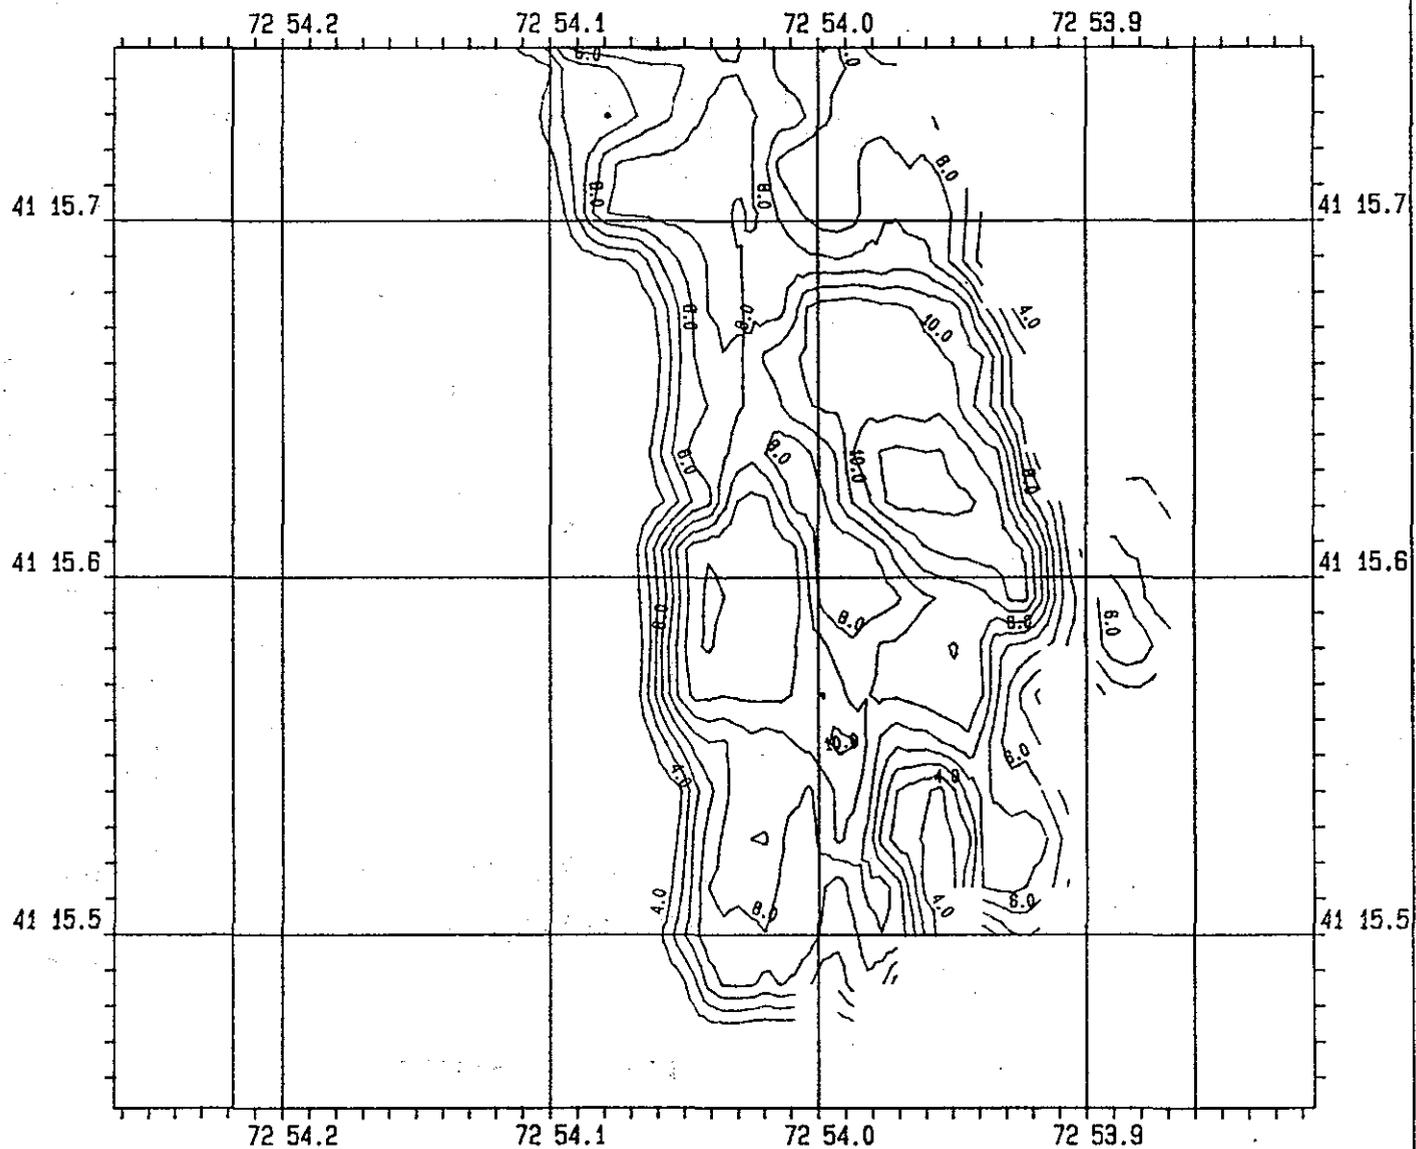
FIGURE 2.0-13

MORRIS COVE  
SOUTH  
DEPTH CONTOURS
