Feasibility Study  
Disposal of Dredged Material  
Morris Cove, New Haven Harbor

# Disposal Area Monitoring System Damos

Contribution 36

A FEASIBILITY STUDY OF THE  
DISPOSAL OF DREDGED MATERIAL AT  
MORRIS COVE, NEW HAVEN HARBOR

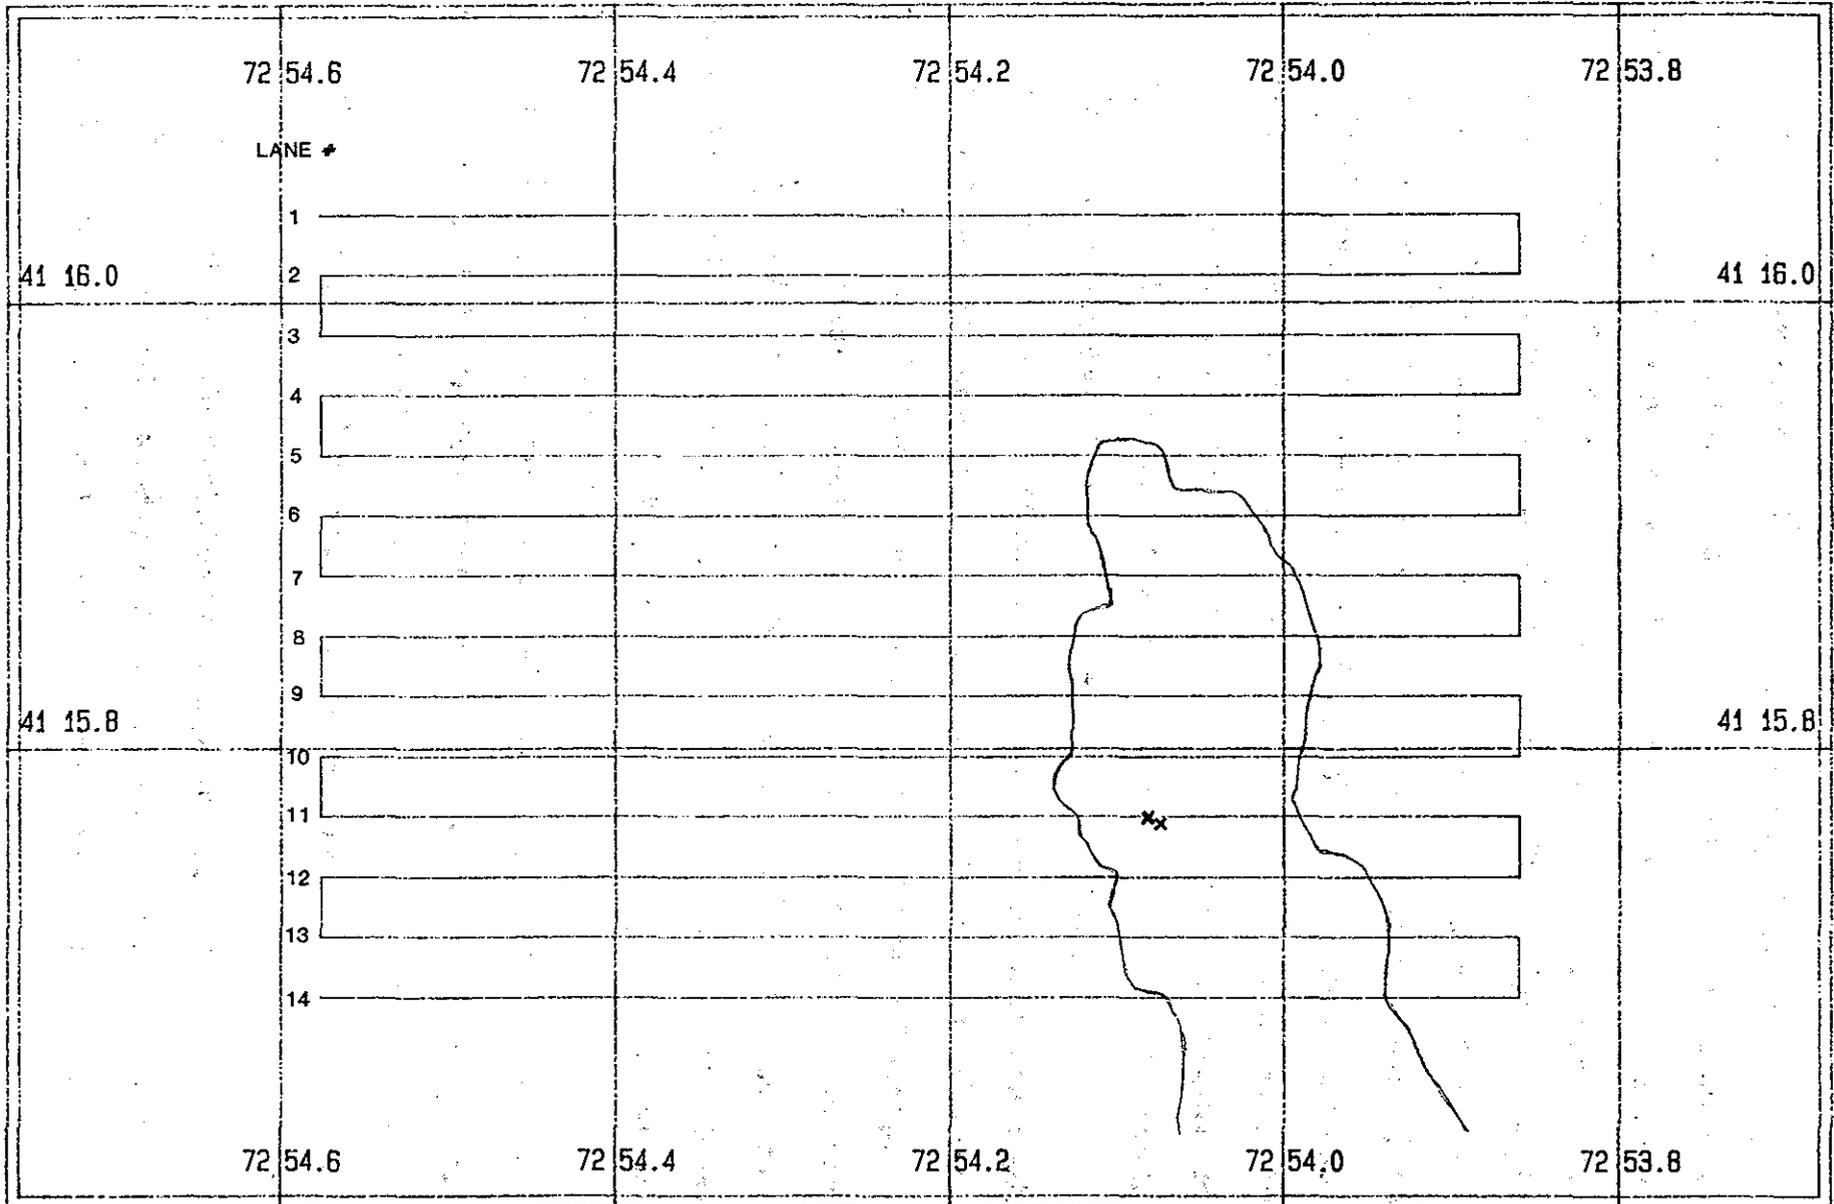
Figure 3.0-1. Dye Study Survey Lanes

began, dye was detected and subsequently determined to be moving in a northerly direction with the incoming tide, despite a very strong northerly wind. As a result, a dye survey was established with east-west lanes separated by 50m so that transects of the plume could be made. This dye survey setup showing the approximate dye release location is shown as Figure 3.0-1.

The dye was released at a continuous rate from a small skiff moored in the approximate center of the borrow pit (see Fig. 3.0-1). Release of the dye commenced at 1600; approximately 1 hour after low tide. For this study, a 5% solution of rhodamine WT dye was pumped at a rate of 0.75 gal/hr. ( $7.886 \times 10^{-7} \text{ m}^3/\text{sec.}$ )

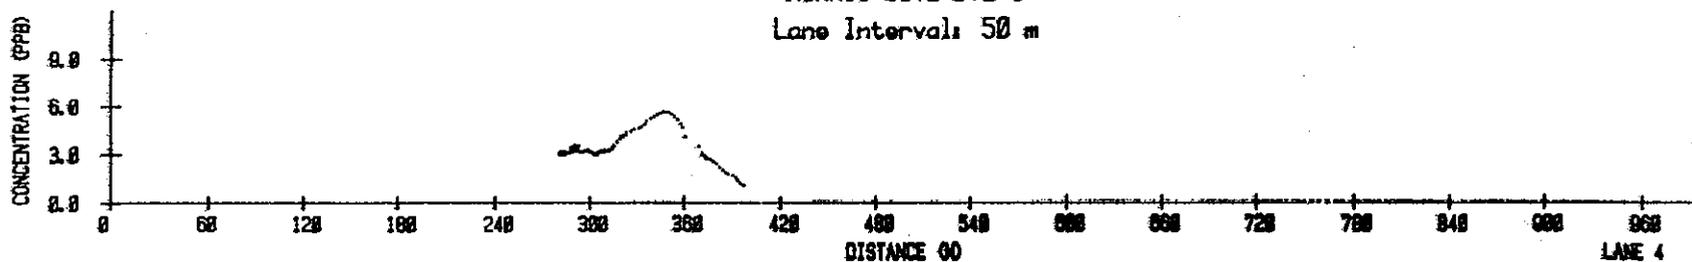
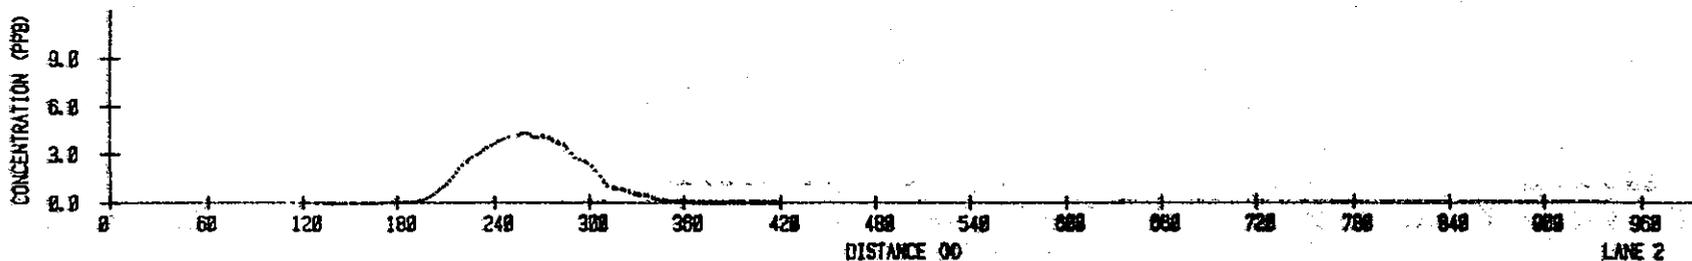
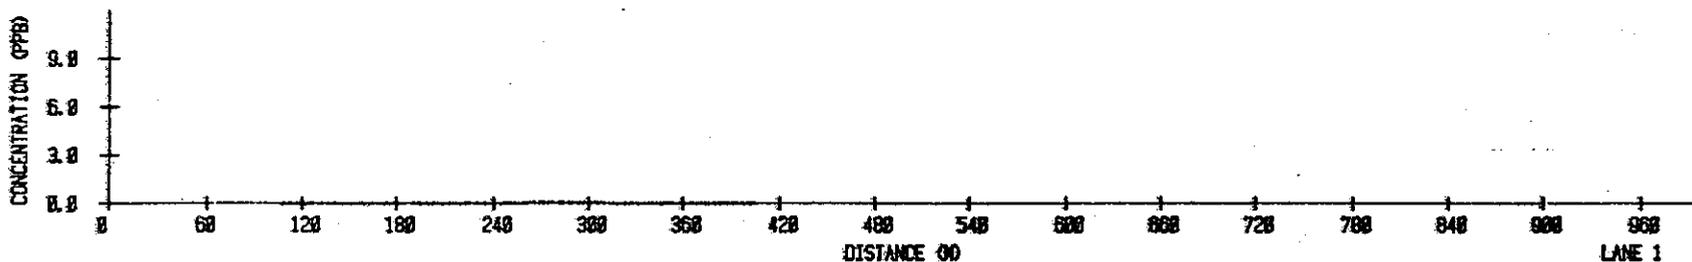
Figure 3.0-2. Dye Concentration

Profile plots of observed dye concentration as a function of distance along a lane from west to east are shown in Figures 3.0-2 thru 3.0-7. Figure 3.0-2 shows the profiles for the Series 1 northerly transects. At this early stage in the dye study it can be seen that no data was observed as far north as lane 1 and that the maximum concentration of approximately 6.0 ppb was in lane 4. Lane 4 is approximately 50m north of the northern edge of the borrow pit.

center of the borrow pit, the dye was carried in a northerly direction by tidal currents. Upon contact with the northern edge of the borrow pit, the dye appears to have been driven upwards towards the surface resulting in maximum concentration being observed in lanes 2 and 4. The edge of the borrow pit is approximately beneath lane 5.

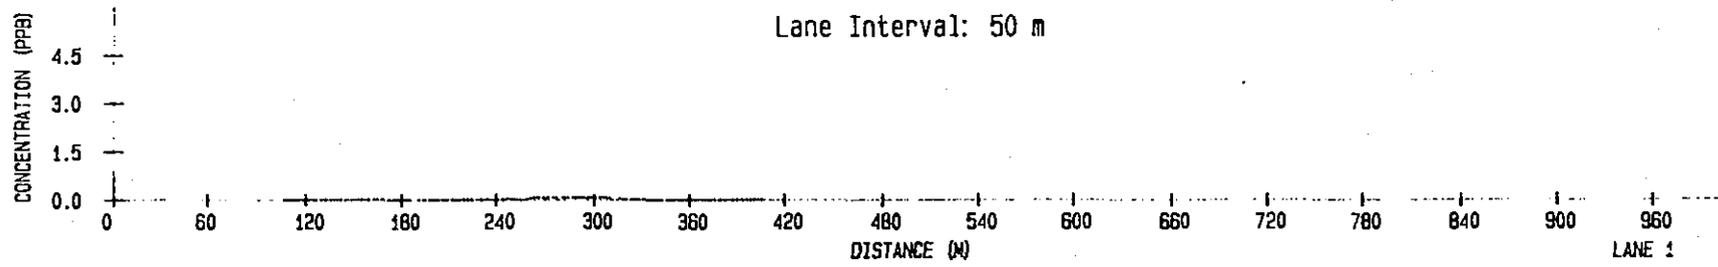
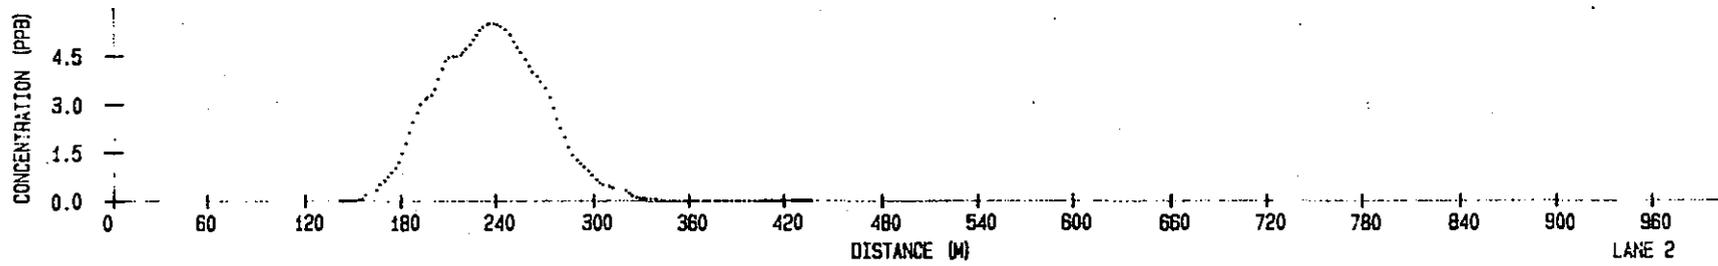
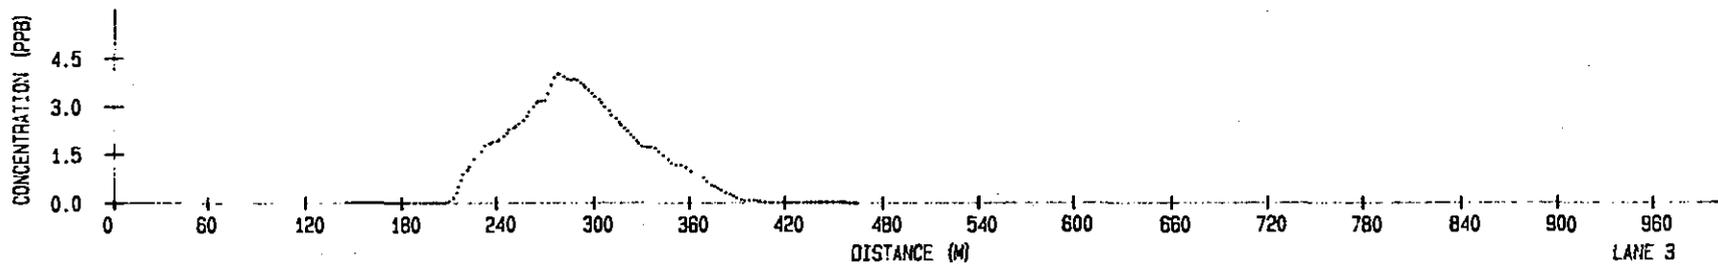
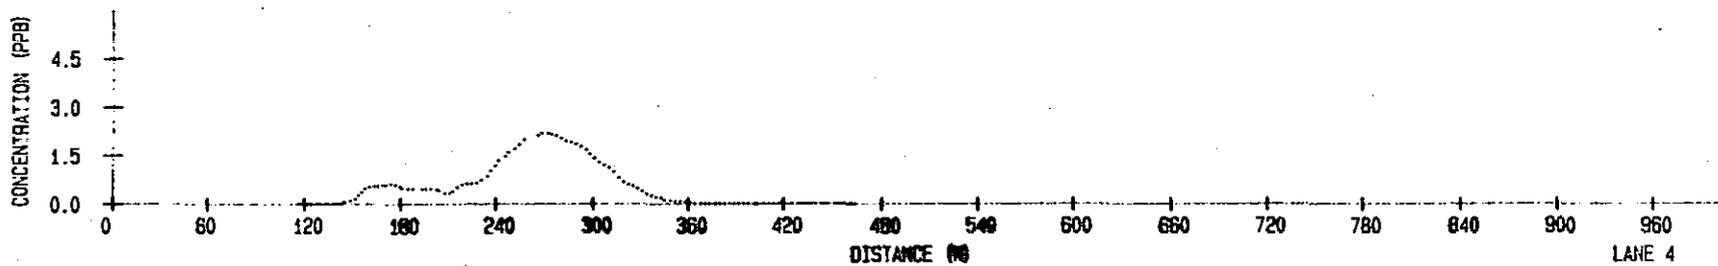
Figure 3.0-3. Dye Concentrations

Profiles of Series 2 southerly transects (Figs. 3.0-3 thru 3.0-5) show a maximum concentration of approximately 6.0 ppb in lane 2 with gradually decreasing maximum values for lanes 3 thru 8. Finally, Series 3 transects show a maximum concentration of only about 2 ppb in lanes 5 and 6 (Fig. 3.0-6, 3.0-7).

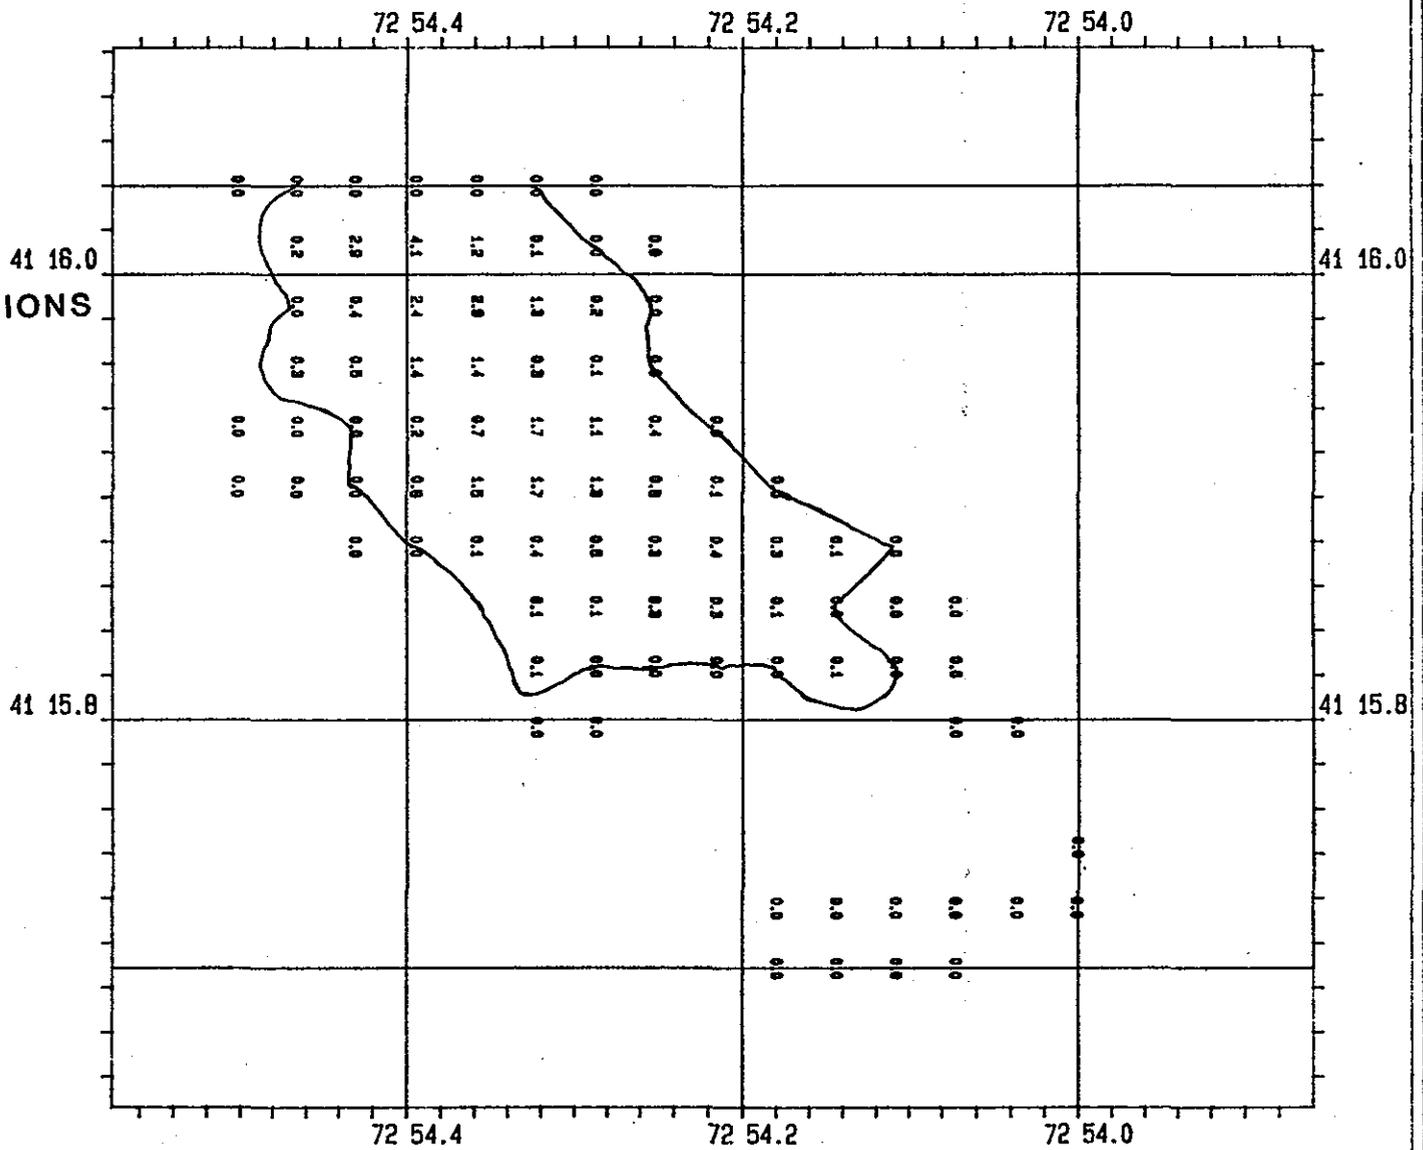
FIGURE 3.0-8

Since Series 2 transects contain the greatest number of lanes with the highest concentration of dye, these data were used to construct a dye concentration contour map of the study area shown in figure 3.0-8. This contour map dramatically shows that maximum dye concentration values were located at the northwest end of the study area, slightly north of the northern edge of the borrow pit. Therefore, these data indicate that despite the presence of a strong northerly wind, the dye was propelled along the bottom by the incoming tidal current until contacting the northern edge of the borrow pit. When this contact was made, the dye was then forced upwards as well as northward under the influence of the tidal currents.

MORRIS COVE  
DYE CONCENTRATIONS  
(PPB)

Using this contour map, it is possible to estimate the percentage of the dye released which was detected by the fluorometer. Assuming that the dye measured by the fluorometer is representative of a column of water 10 feet (3.05m) deep, then 83.4% of the available dye was sampled as part of the Series 2 transects. While the exact percentage of dye seen is not important, the relative magnitude of this number indicates that this sampling technique was valid in determining the current regime in the borrow pit area.

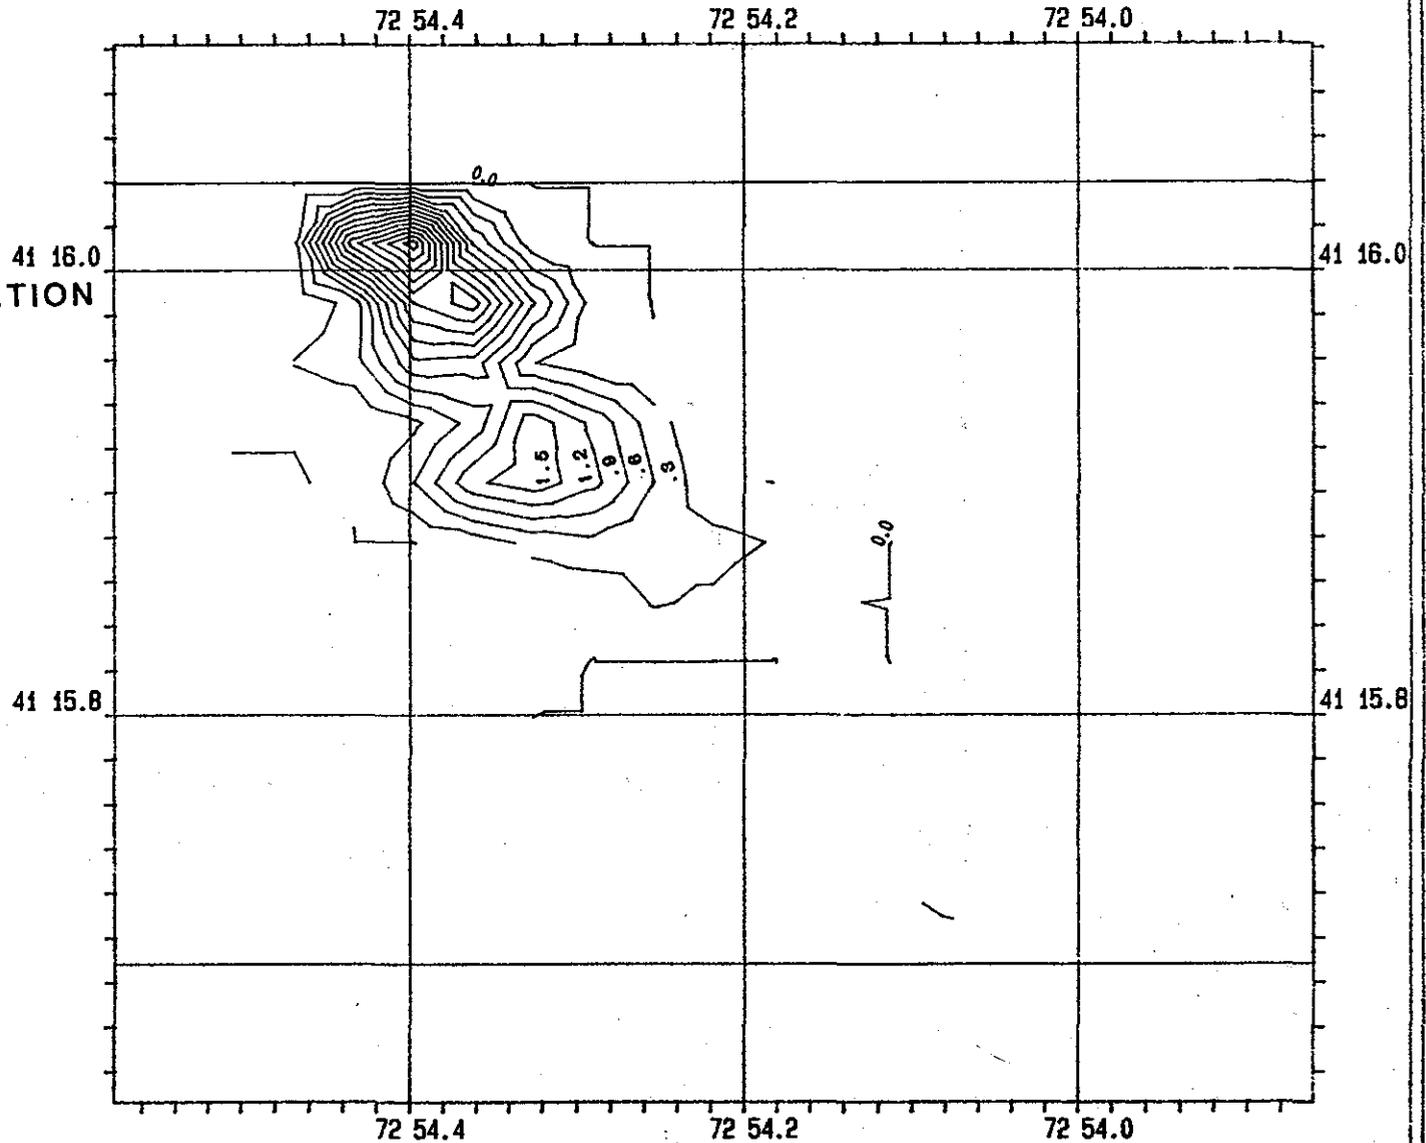
FIGURE 3.0-9

MORRIS COVE  
DYE CONCENTRATION  
CONTOURS

CONTOUR INT.  
0.3 ppb
