THE MANAGEMENT AND MONITORING OF
DREDGE SPOIL DISPOSAL AND CAPPING
PROCEDURES IN
CENTRAL LONG ISLAND SOUND
DAMOS CONTRIBUTION #8

Presented at
Second International
Ocean Dumping Symposium
Woods Hole, MA
16 April, 1980

Presented by
ROBERT W. MORTON, Ph.D.
Science Applications, Inc.
202 Thames St.
Newport, RI 02840

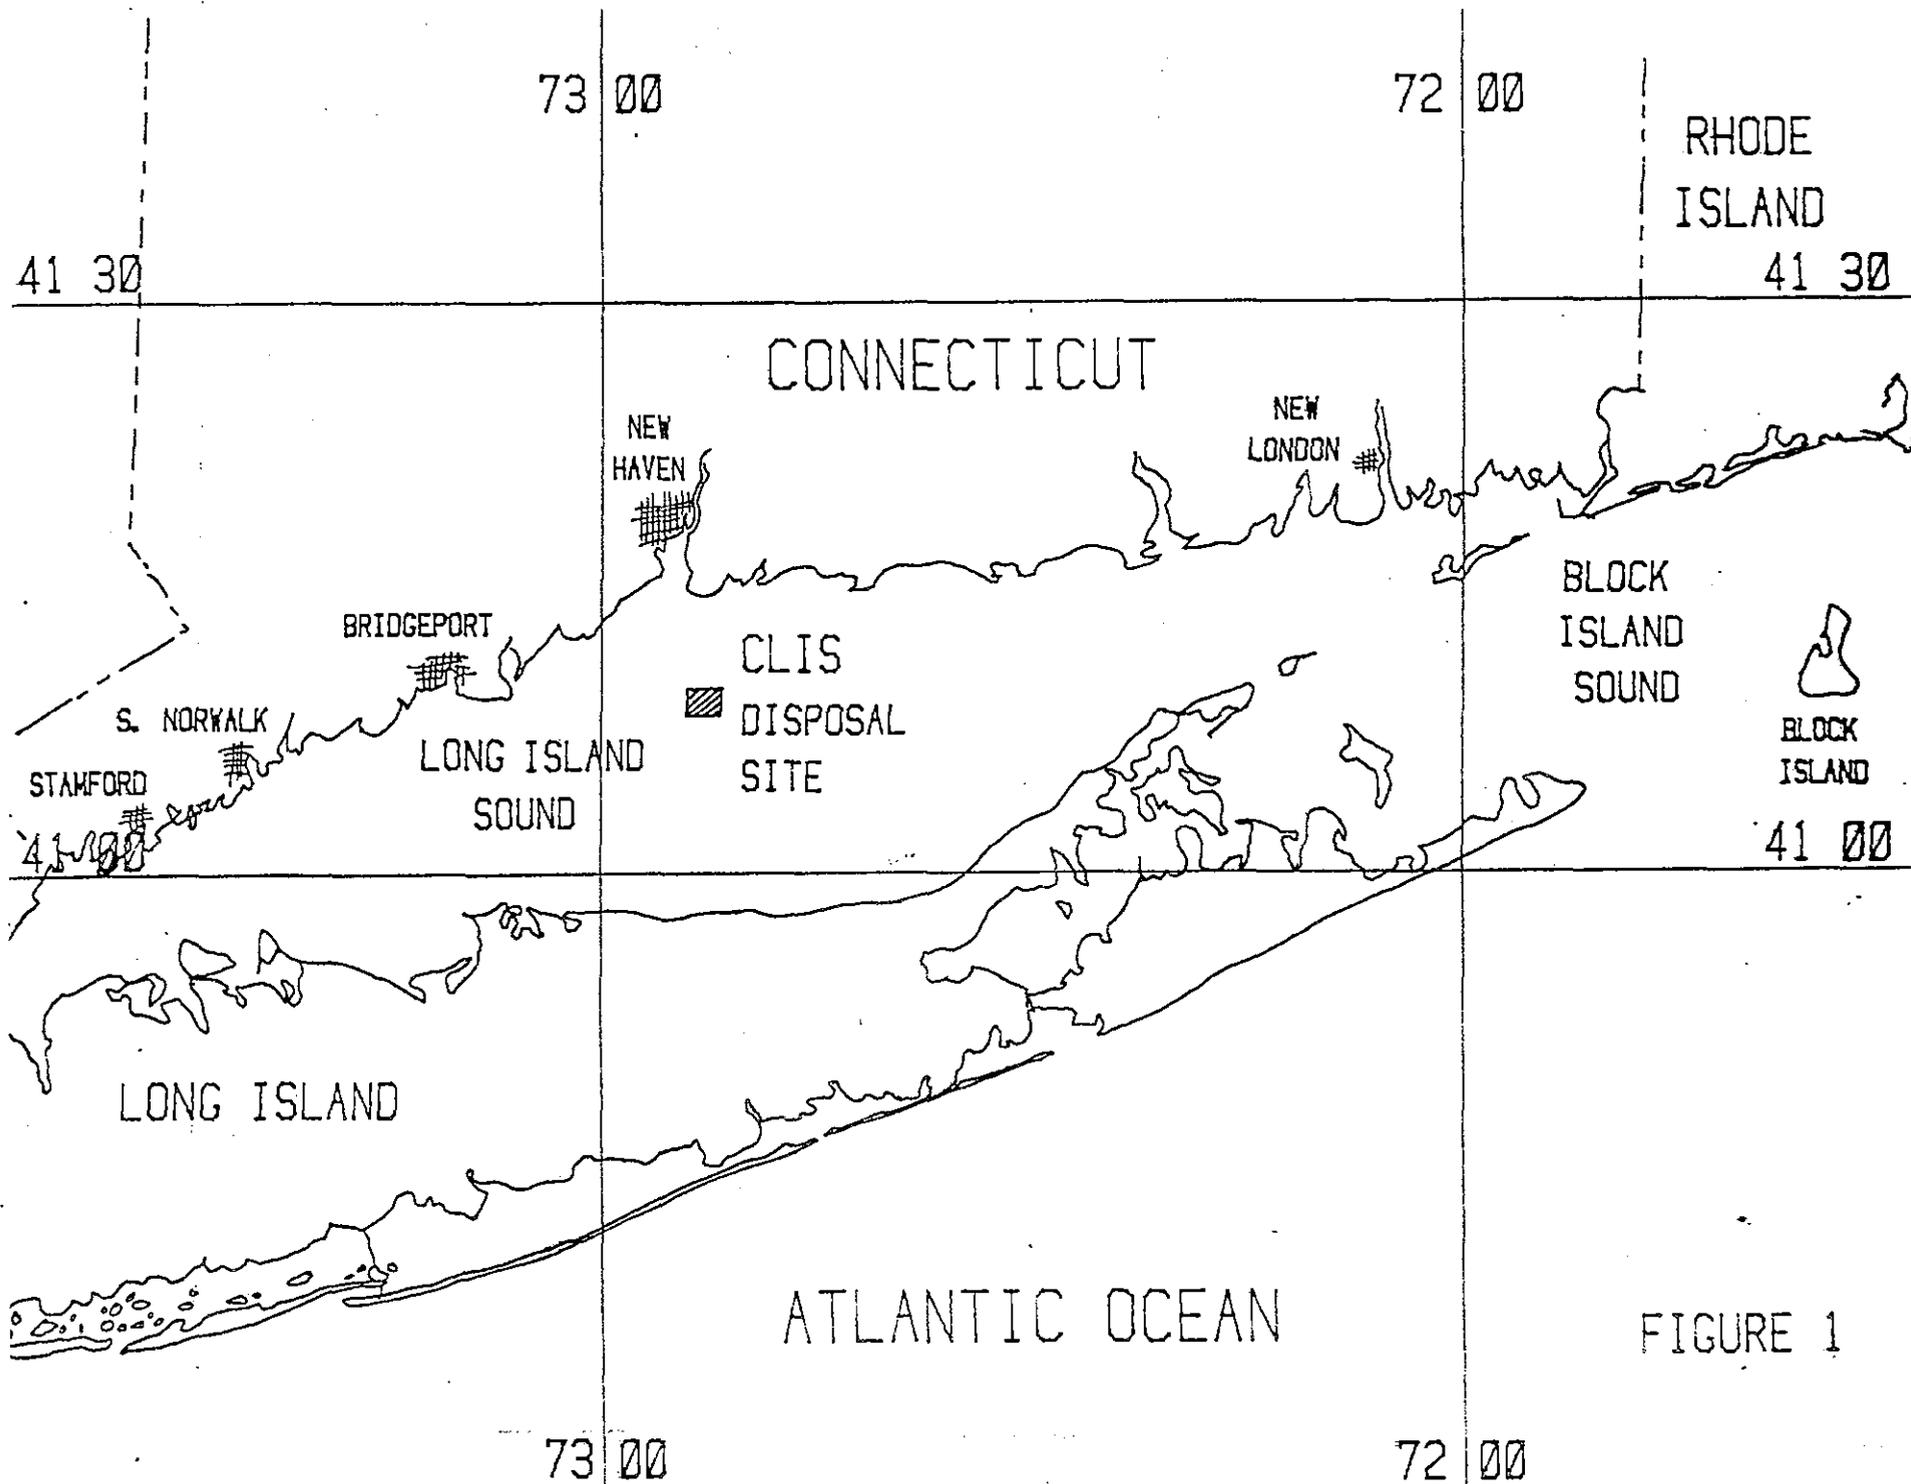
FIGURE 1

The disposal of dredge spoil in Long Island Sound waters has been a controversial and sensitive issue for several years. However, the extreme shoaling conditions that exist in some of the harbors bordering the Sound emphasize the need for a solution to this controversy that will allow dredging of these harbors in a safe and cost effective manner. Because of the large quantities to be dredged, the lack of suitable land sites and the prohibitive costs of diking or transport of spoils to the continental shelf, the New England Division of the Corps of Engineers has undertaken a carefully managed and monitored program of disposal at two sites within the Sound. Dredge spoils from the Thames River are being placed at the New London Disposal Site and spoils from Stamford and New Haven harbors are being placed at the Central Long Island Sound Disposal Site (Figure 1).

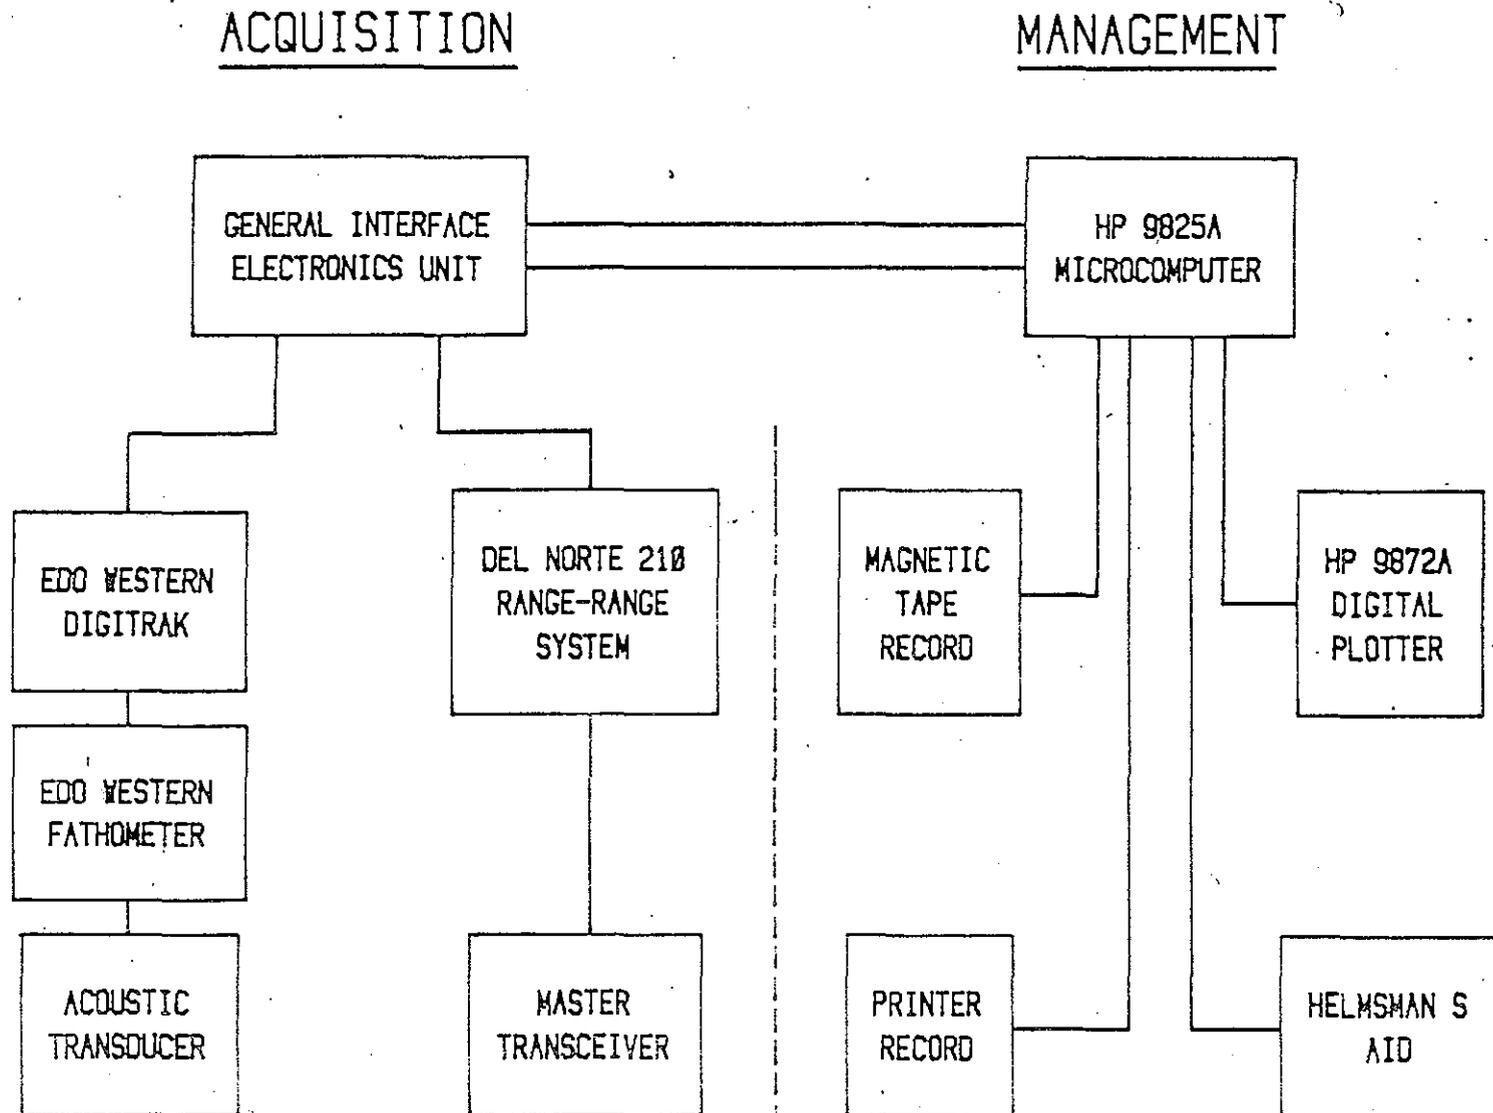
FIGURE 2

A schematic of this data acquisition system is presented in Figure 2. A Hewlett Packard 9825A computer and 9872A plotter were interfaced with a Del Norte Trisponder system, an EDO 4034A fathometer and an EDO 261C Digitrak unit to provide the necessary capabilities. The computer and plotter could also be used to obtain report quality charts of bathymetric data within a short time after

BATHYMETRIC DATA ACQUISITION SYSTEM

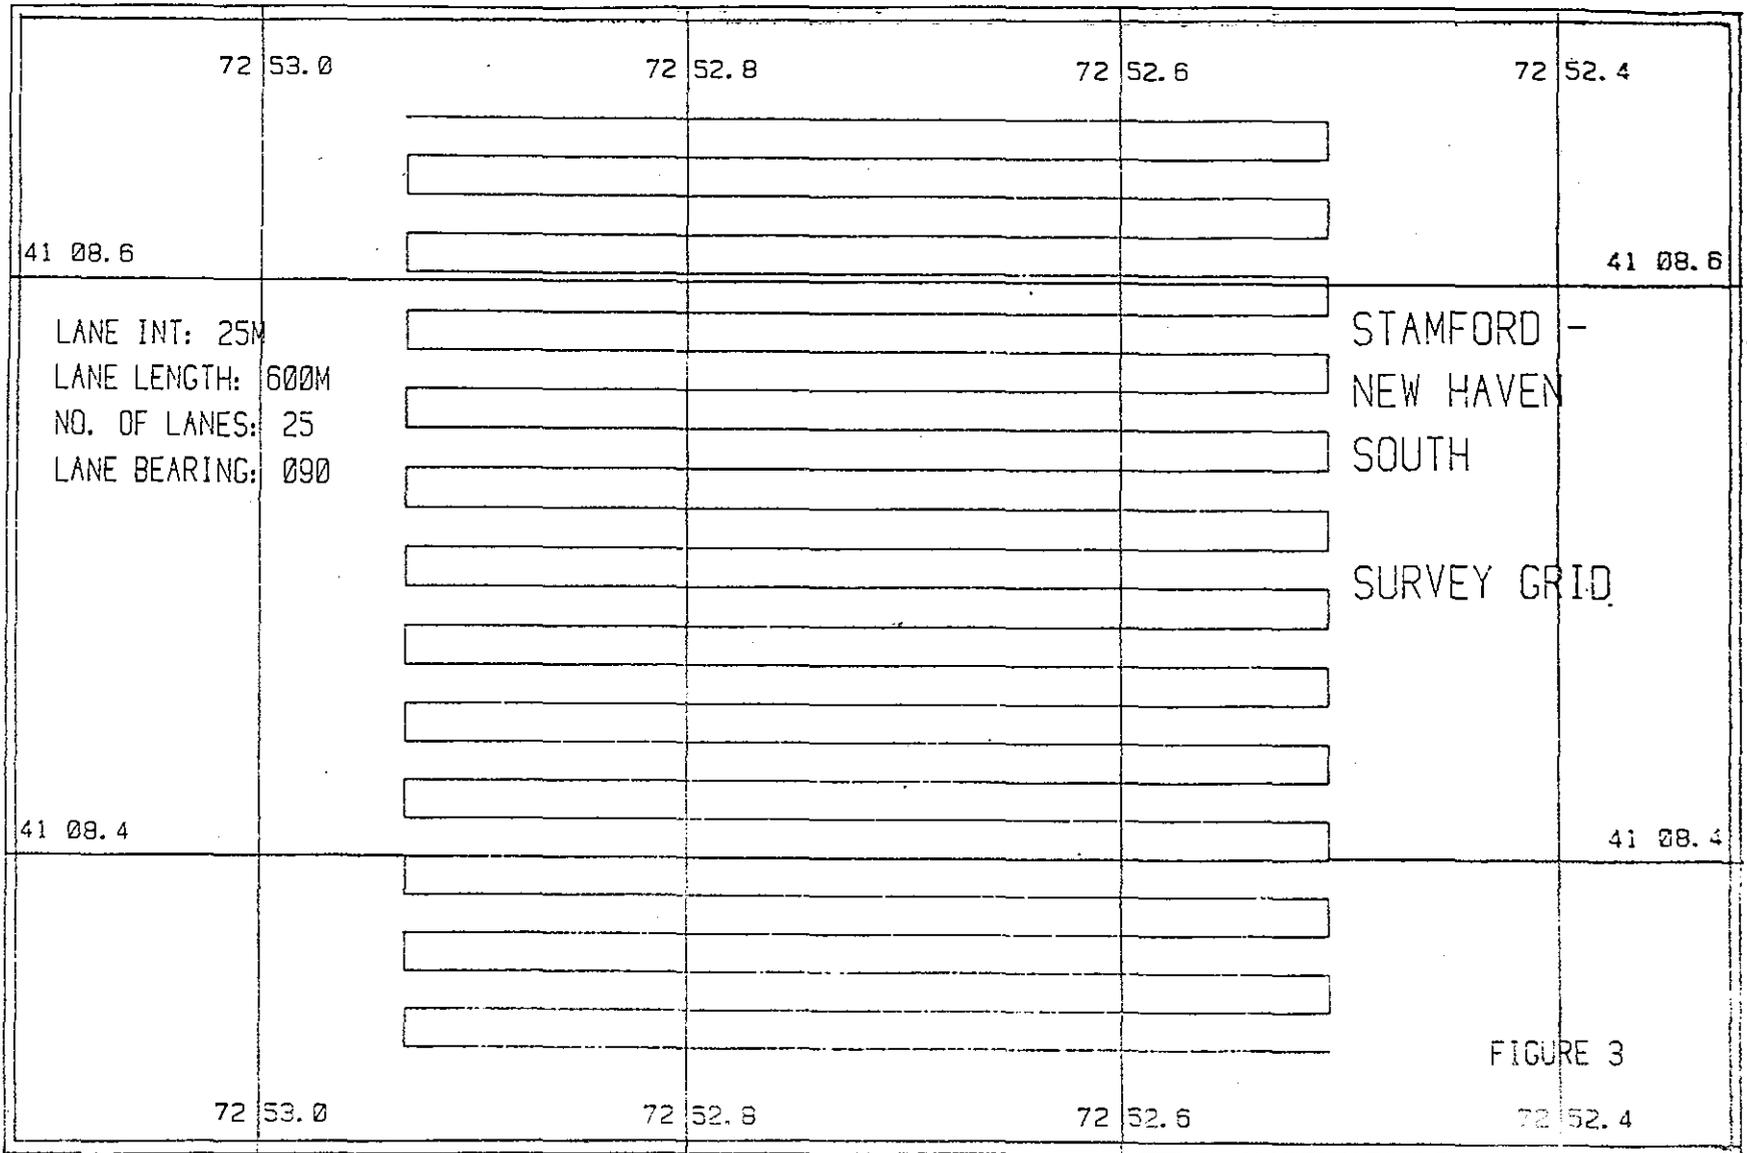
Prior to disposal of dredge spoil at this site, a survey grid was established (Figure 3) consisting of 25 transects, 600 meters long oriented in the east-west direction and spaced 25 meters apart. While conducting the survey, range data were input to the computer which provided steering information to assist the helmsman in maintaining the ship's position relative to the survey grid. Since precision data were required for this work, surveys were only made on calm days and the errors in steering the ship were generally less than 5 meters either side of a given transect (Figure 4). This navigation precision was necessary for comparing replicate surveys because slight errors in position can cause large errors in depth over sloping bottoms.

A survey grid similar to that shown in Figure 3 was established at both the north and south disposal sites with the disposal buoy centered in the 600 x 600 meter square survey area. Prior to disposal, background surveys were run on these tracks. Two baseline surveys were made at the south site on January 20 (Figure 7) and March 19 (Figure 8), and a single survey was made at the north site on March 22 (Figure 9). An estimate of the precision of the volume calculation technique was made by comparing the difference between the two southern surveys (Figure 10). This volume difference was approximately 2700m^3 which is only marginally greater than the error expected from theoretical considerations. Furthermore, the contour difference chart (Figure 11) indicates the errors are random since all contours are + or - .2m or zero and show no consistent pattern over the survey area.

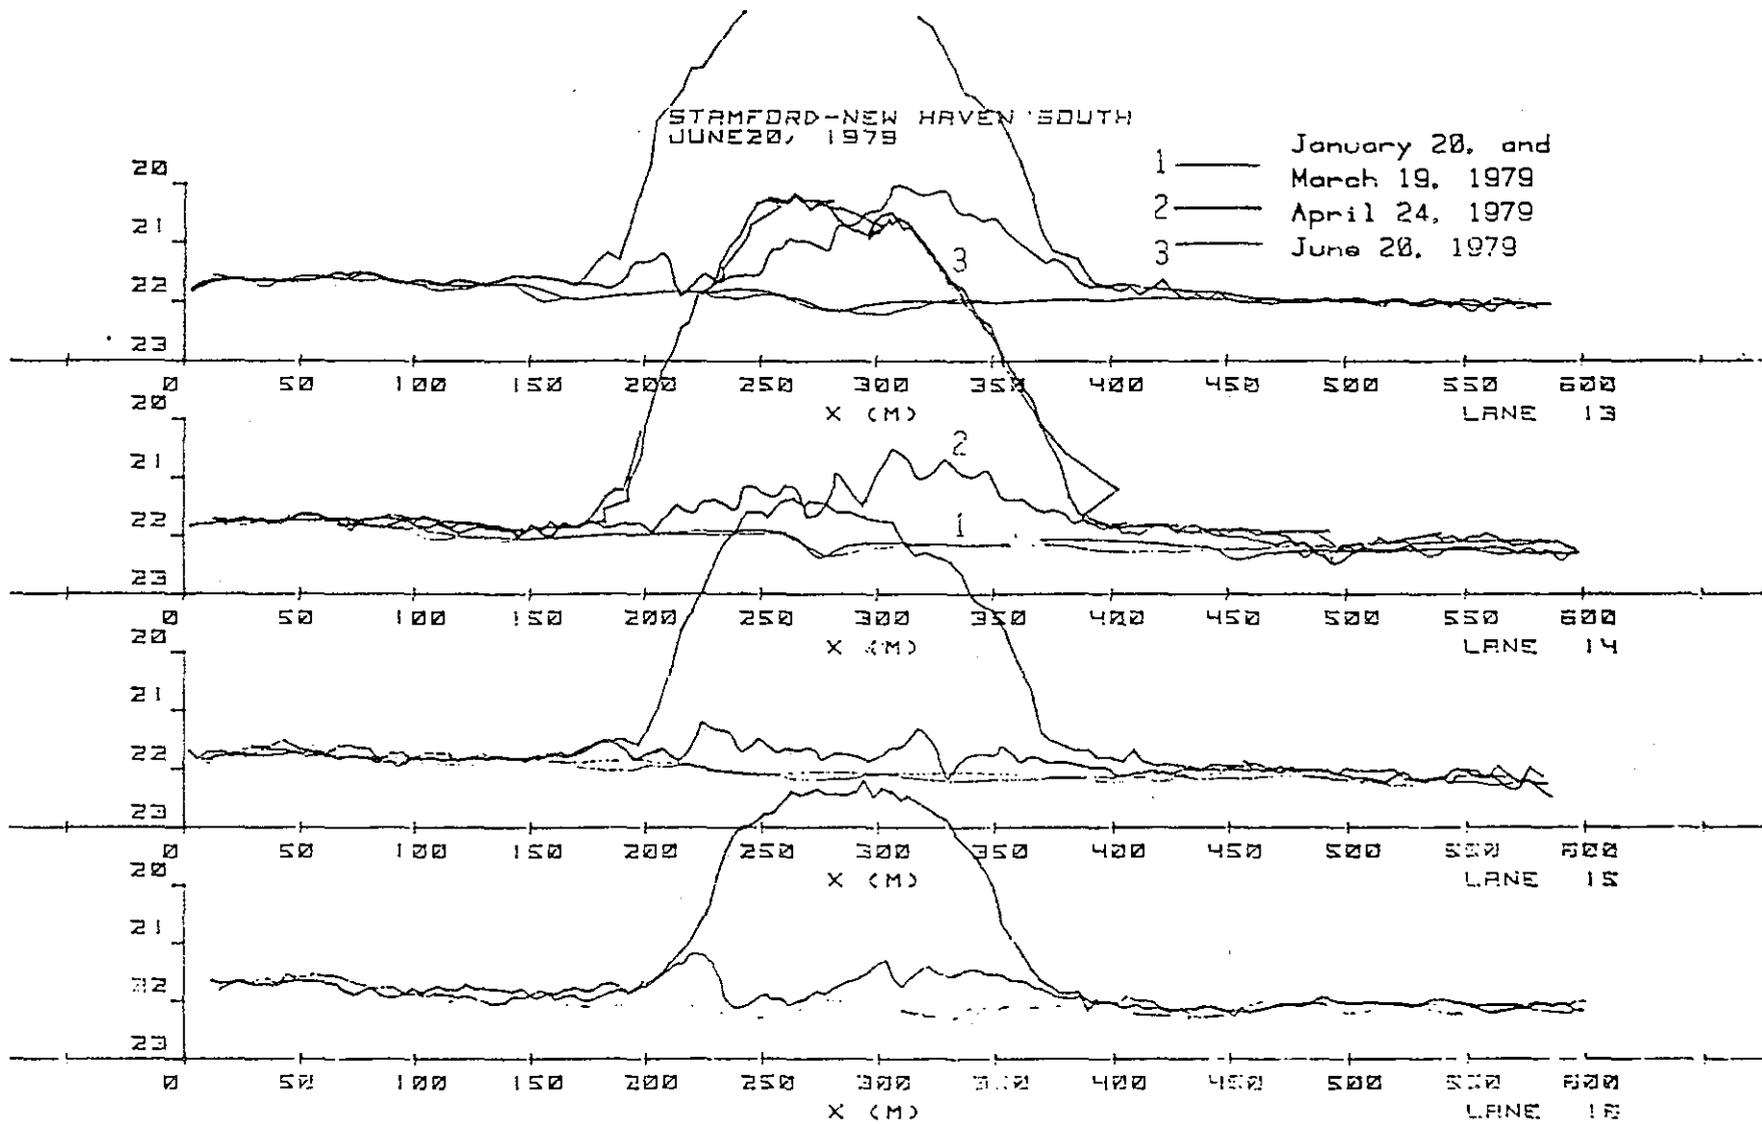
FIGURE 5

Figure 5 presents a sequence of these profiles for representative transects across the spoil mound at the southern New Haven disposal site. Assuming no significant change (i.e. deposition or erosion) in the depth of the ambient bottom at some distance from the spoil mound then the precision of the depth measurements between surveys can be evaluated by comparing these profiles at the extremities of the transect. From an examination of Figure 5, it is apparent that no significant differences exist between sequential surveys at this site and ,therefore, adequate precision between surveys was attained.

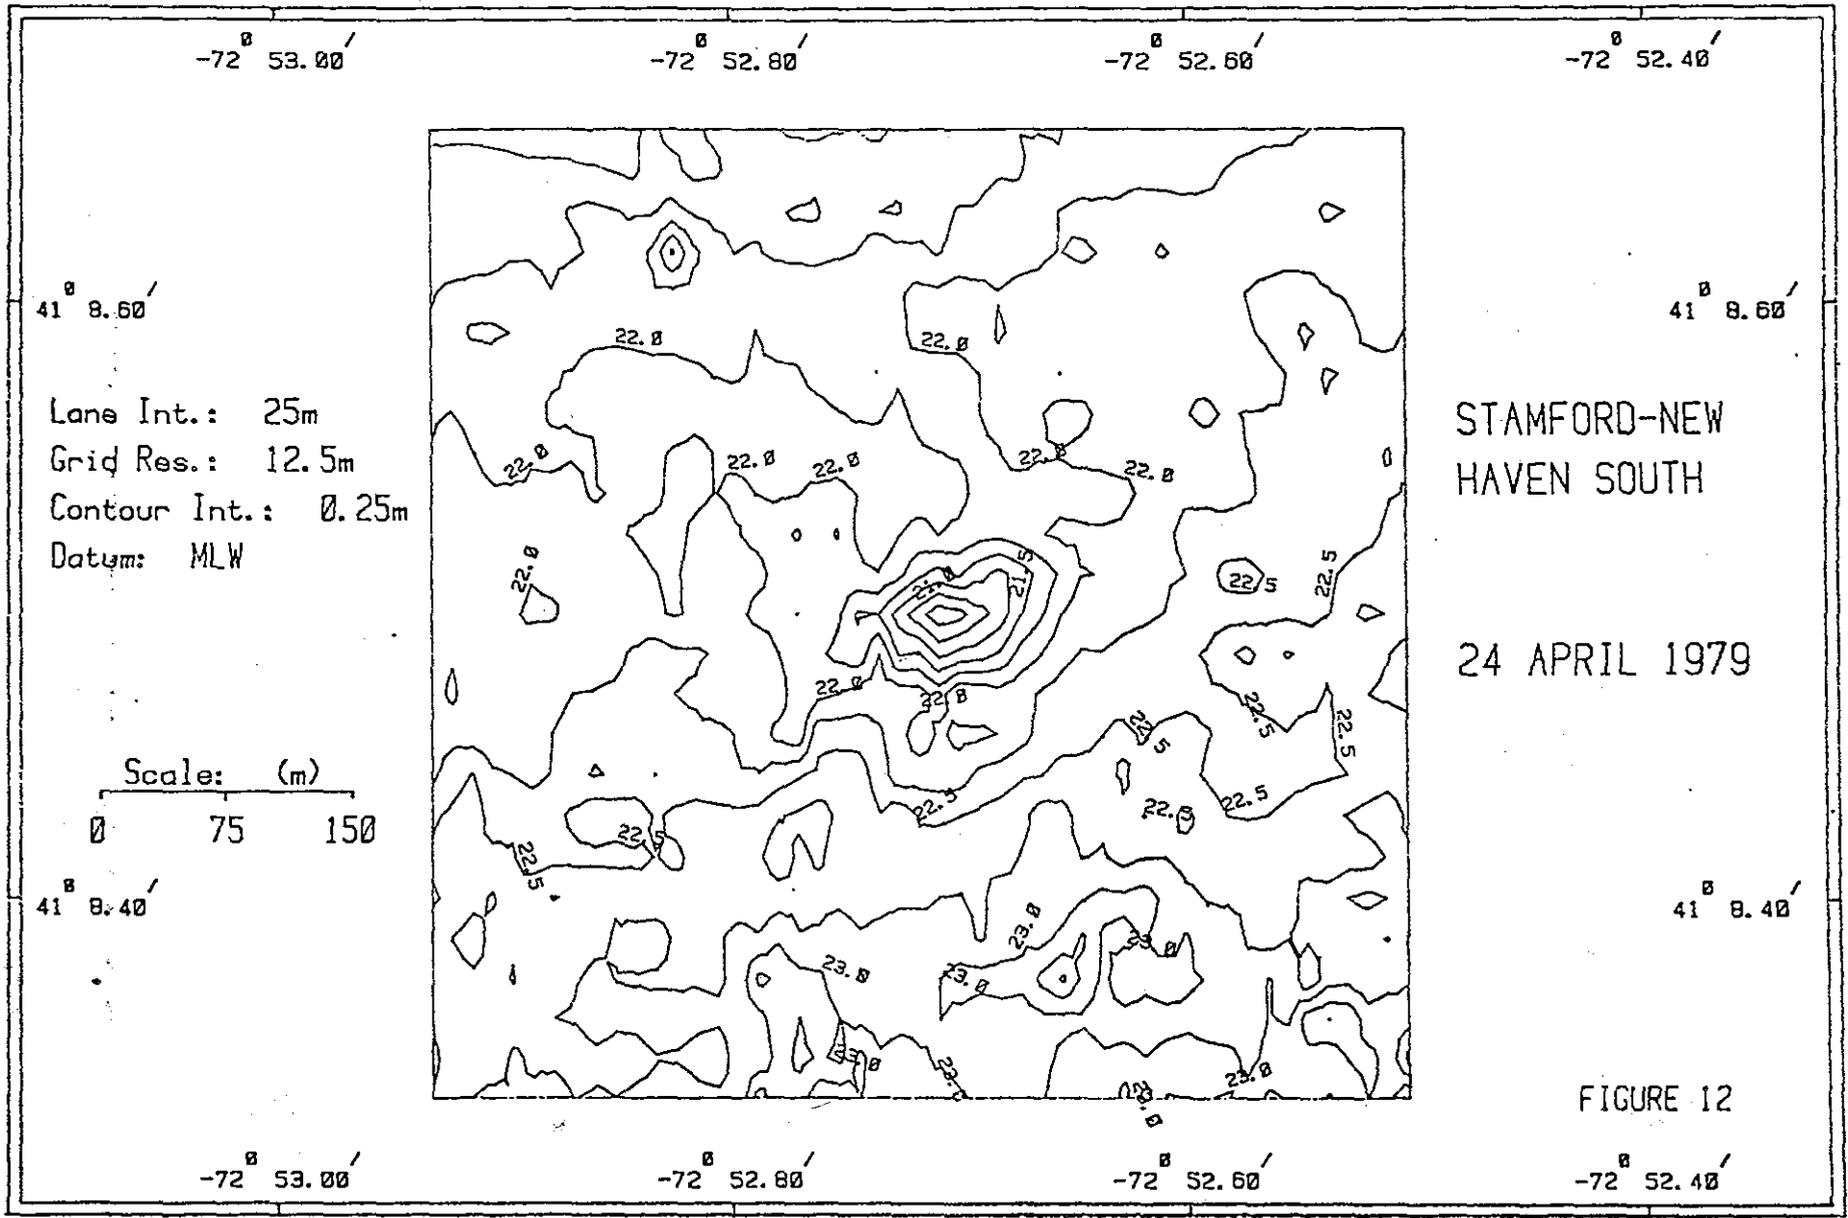
FIGURE 12

STAMFORD-NEW
HAVEN SOUTH

24 APRIL 1979

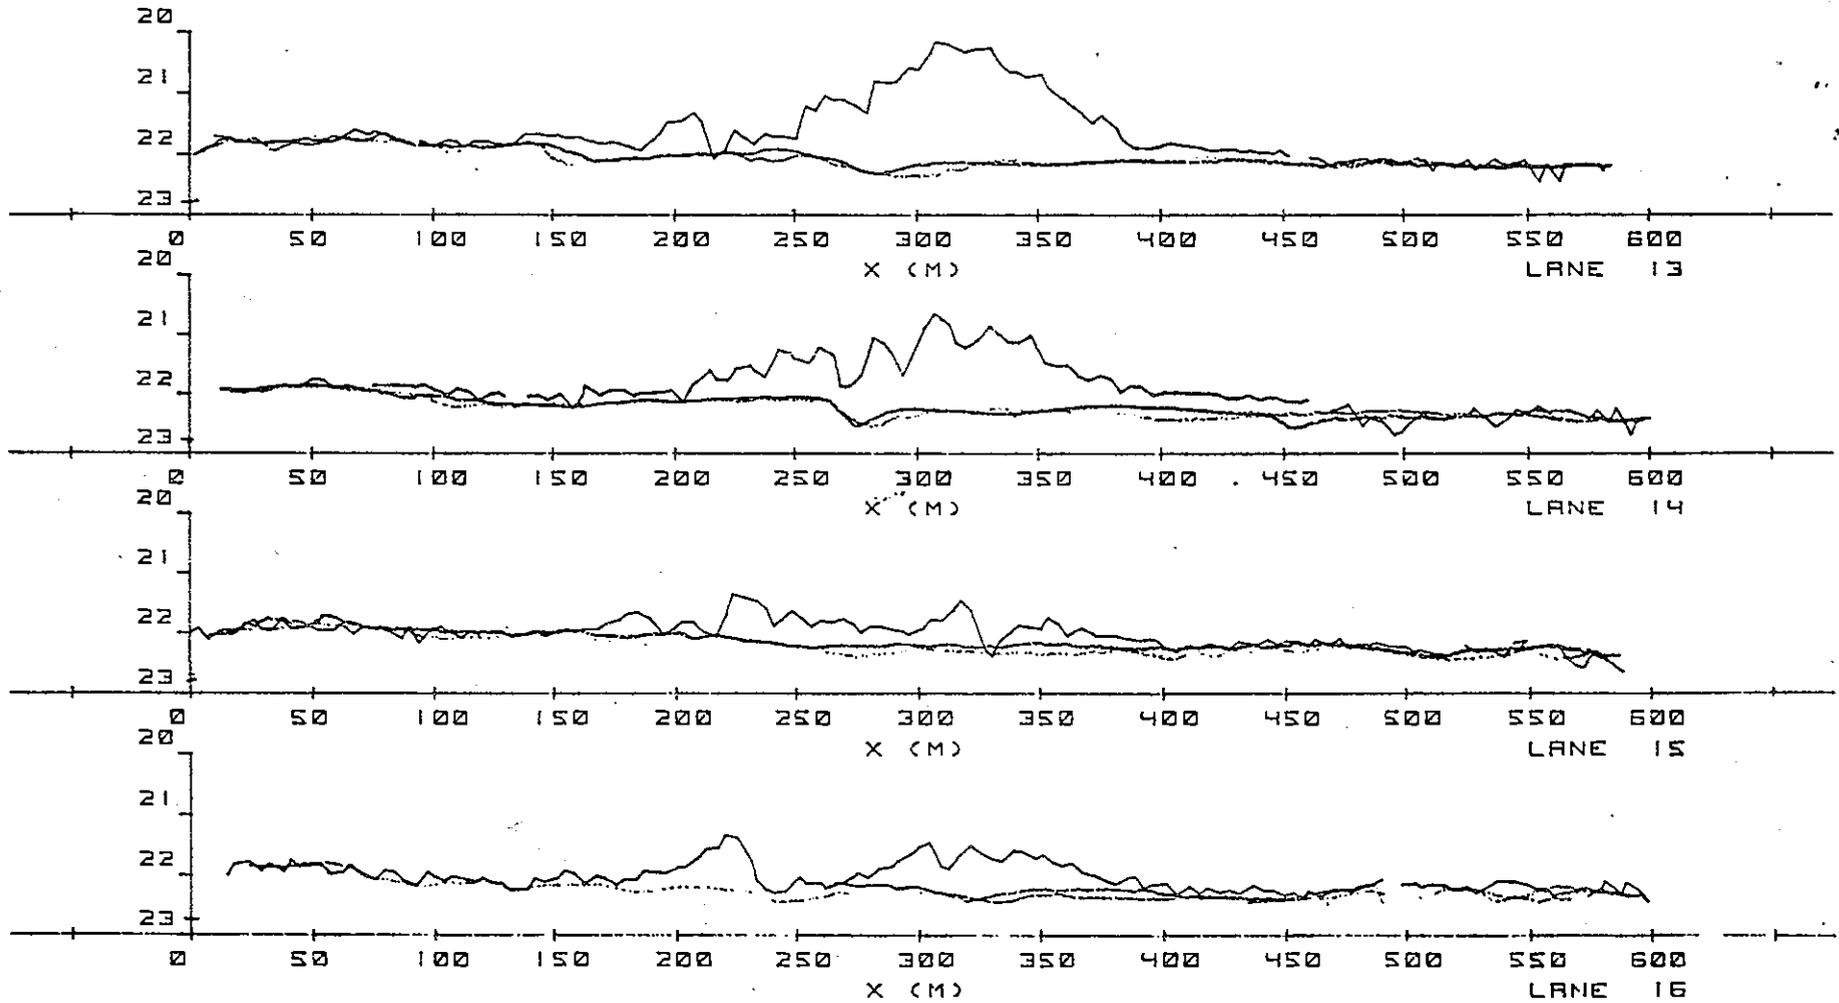
FIGURE 13

Close examination of the vertical profiles for lanes 13-16 (Figure 13) indicates that the topography of this mound is quite variable, and thicknesses of two meters relative to the initial bottom are present. It is important to note that contouring, by its

STAMFORD - NEW HAVEN SOUTH
24 APRIL 79
LANE INTERVAL: 25M
VERTICAL EXAGGERATION: 25X
DATUM: MLW

nature will smooth and decrease the topographic expression of the spoils and while overall volumes are accurate due to averaging of all depths measured, specific features smaller than the grid size can not be accurately resolved. These features can be assessed in the vertical profiles, but only within the accuracy of navigation between successive surveys.

The rough topography exhibited in the vertical profiles was substantiated by diving observations and attributed to the cohesive nature of the spoils. Toward the margins of the spoil mound, specific barge loads could be identified as separate topographic features.

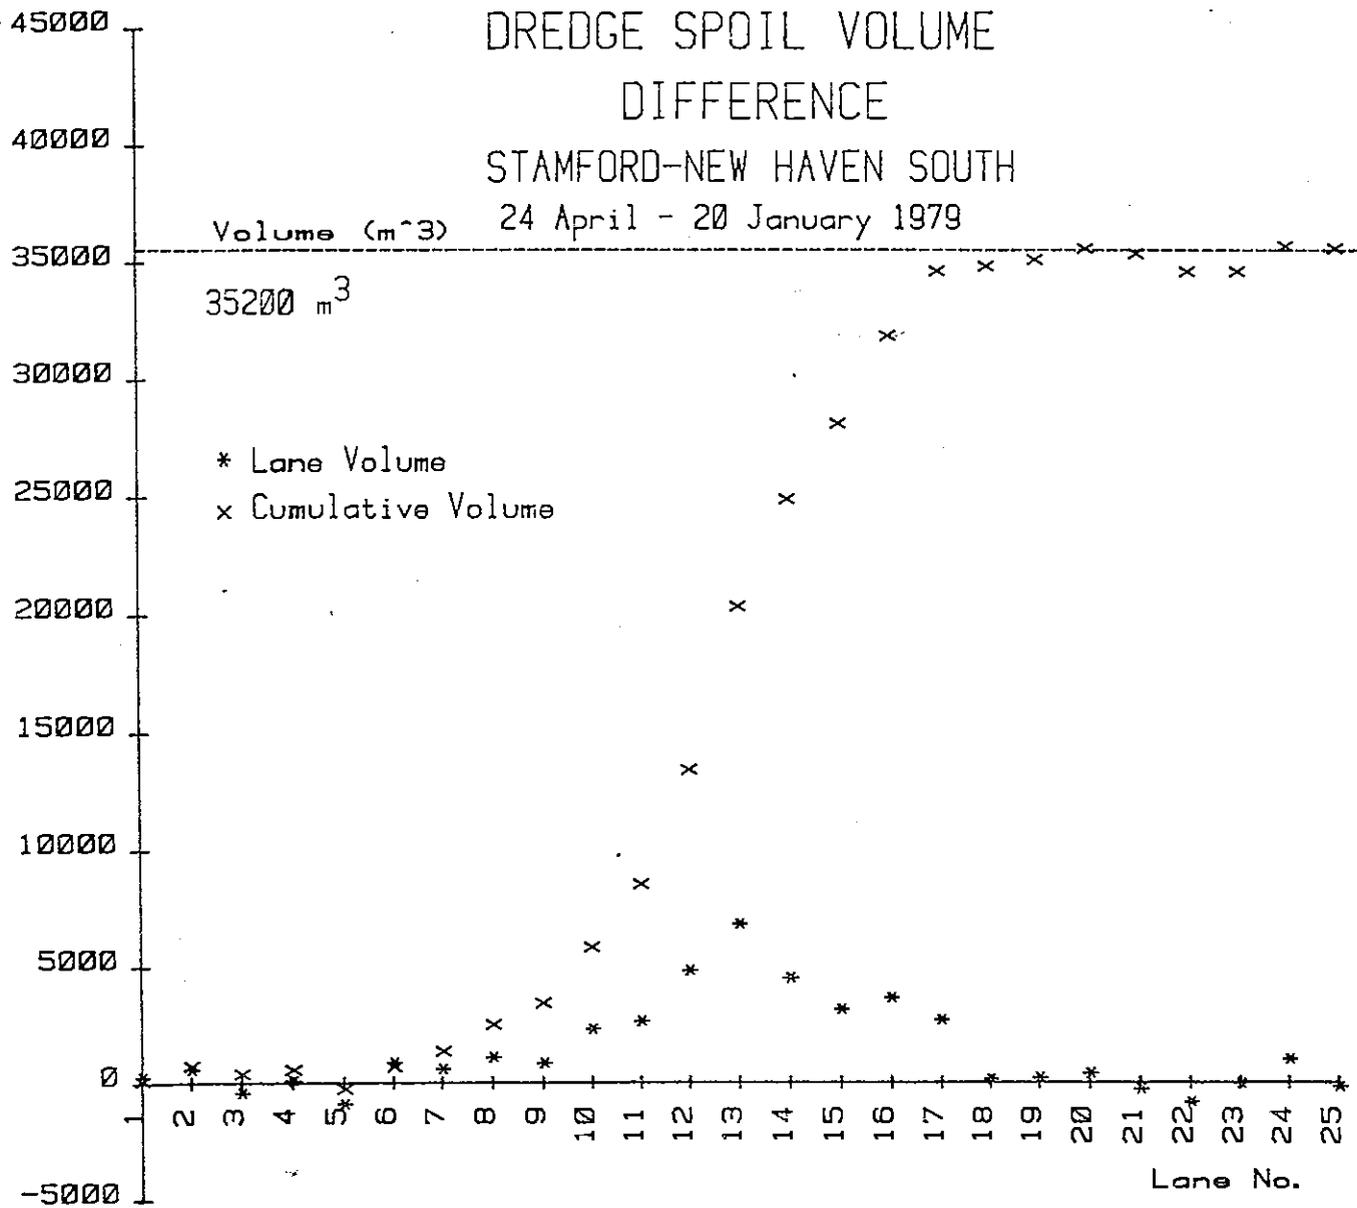
FIGURE 14

Calculations of total Stamford spoil detected relative to the January baseline survey (Figure 14) resulted in a volume of 34,259 m³ or approximately 90% of the estimated volume deposited. The contour difference chart (Figure 15) indicated that there was additional material present beyond the immediate spoil mound and it was possible that significant amounts of spoil might not be detected by acoustic measurements.

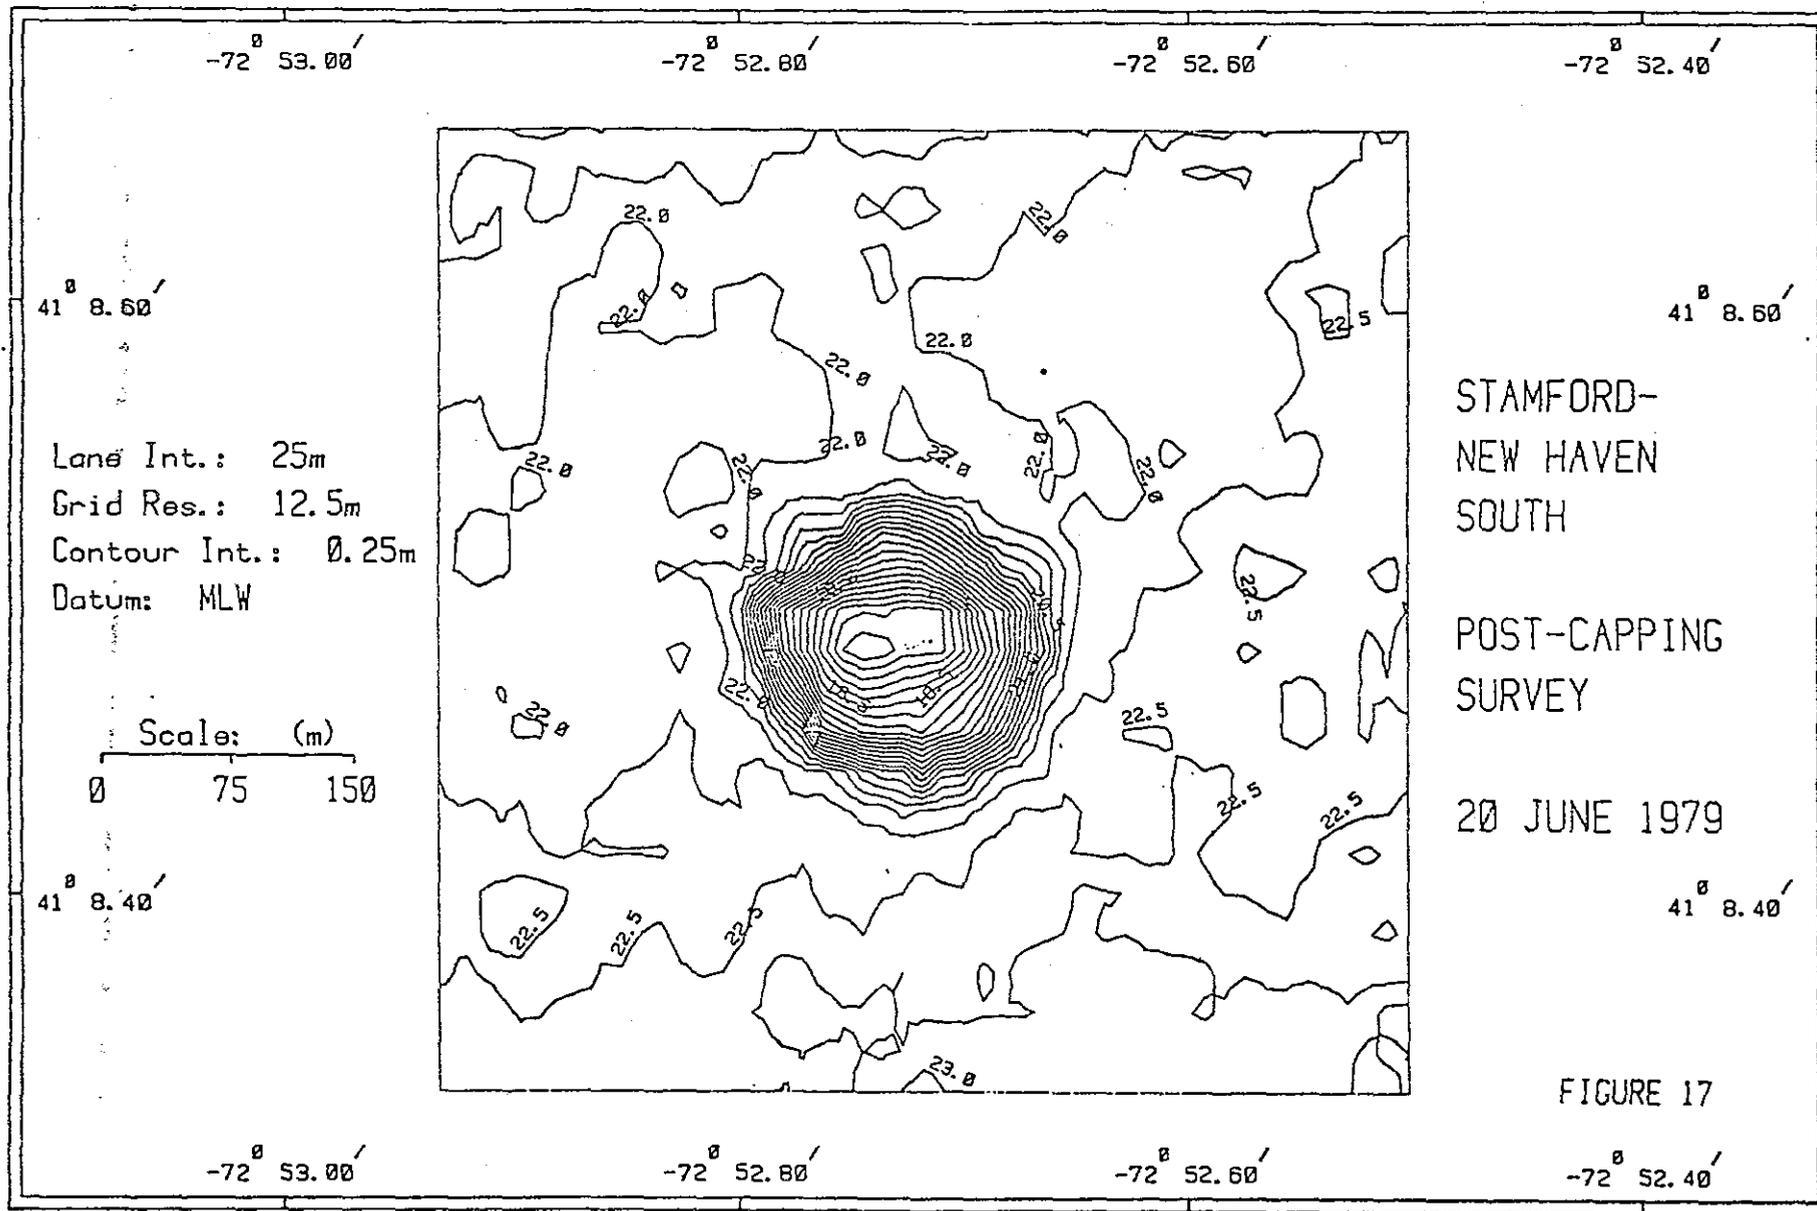
FIGURE 17

As described earlier, silt from New Haven Harbor was dumped on the Stamford material at the south site and sand from the breakwater area was used to cap the northern site. All capping procedures were completed by June 22, 1979. On June 20, a survey was made of the southern site (Figure 17) to determine the success of the silt capping operation. The contour chart and the vertical profiles (Figure 5) both indicated a distinct mound had developed at the disposal site with a minimum depth of 16 meters and a thickness of up to 4 meters over the Stamford spoils. Because the silt material from New Haven was cohesive, the resulting spoil mound did not have extensive spreading. Although the vertical profiles indicate all Stamford material was capped, future operations with silt should be designed to spread the capping sediment and reduce

the thickness to some extent. The volume of New Haven spoil dumped at the south site was estimated at 76000m^3 from scow load measurements, of which 72000m^3 , or 95%, was accounted for by volume calculations.

Evaluation of long term changes in the shape and volume of the spoil mounds requires an initial baseline for comparison similar to that used in the operational monitoring phase of the project. For post disposal studies the June 20 survey of the southern site (Figure 17) and the June 22 survey of the northern site (Figure 18) were used.

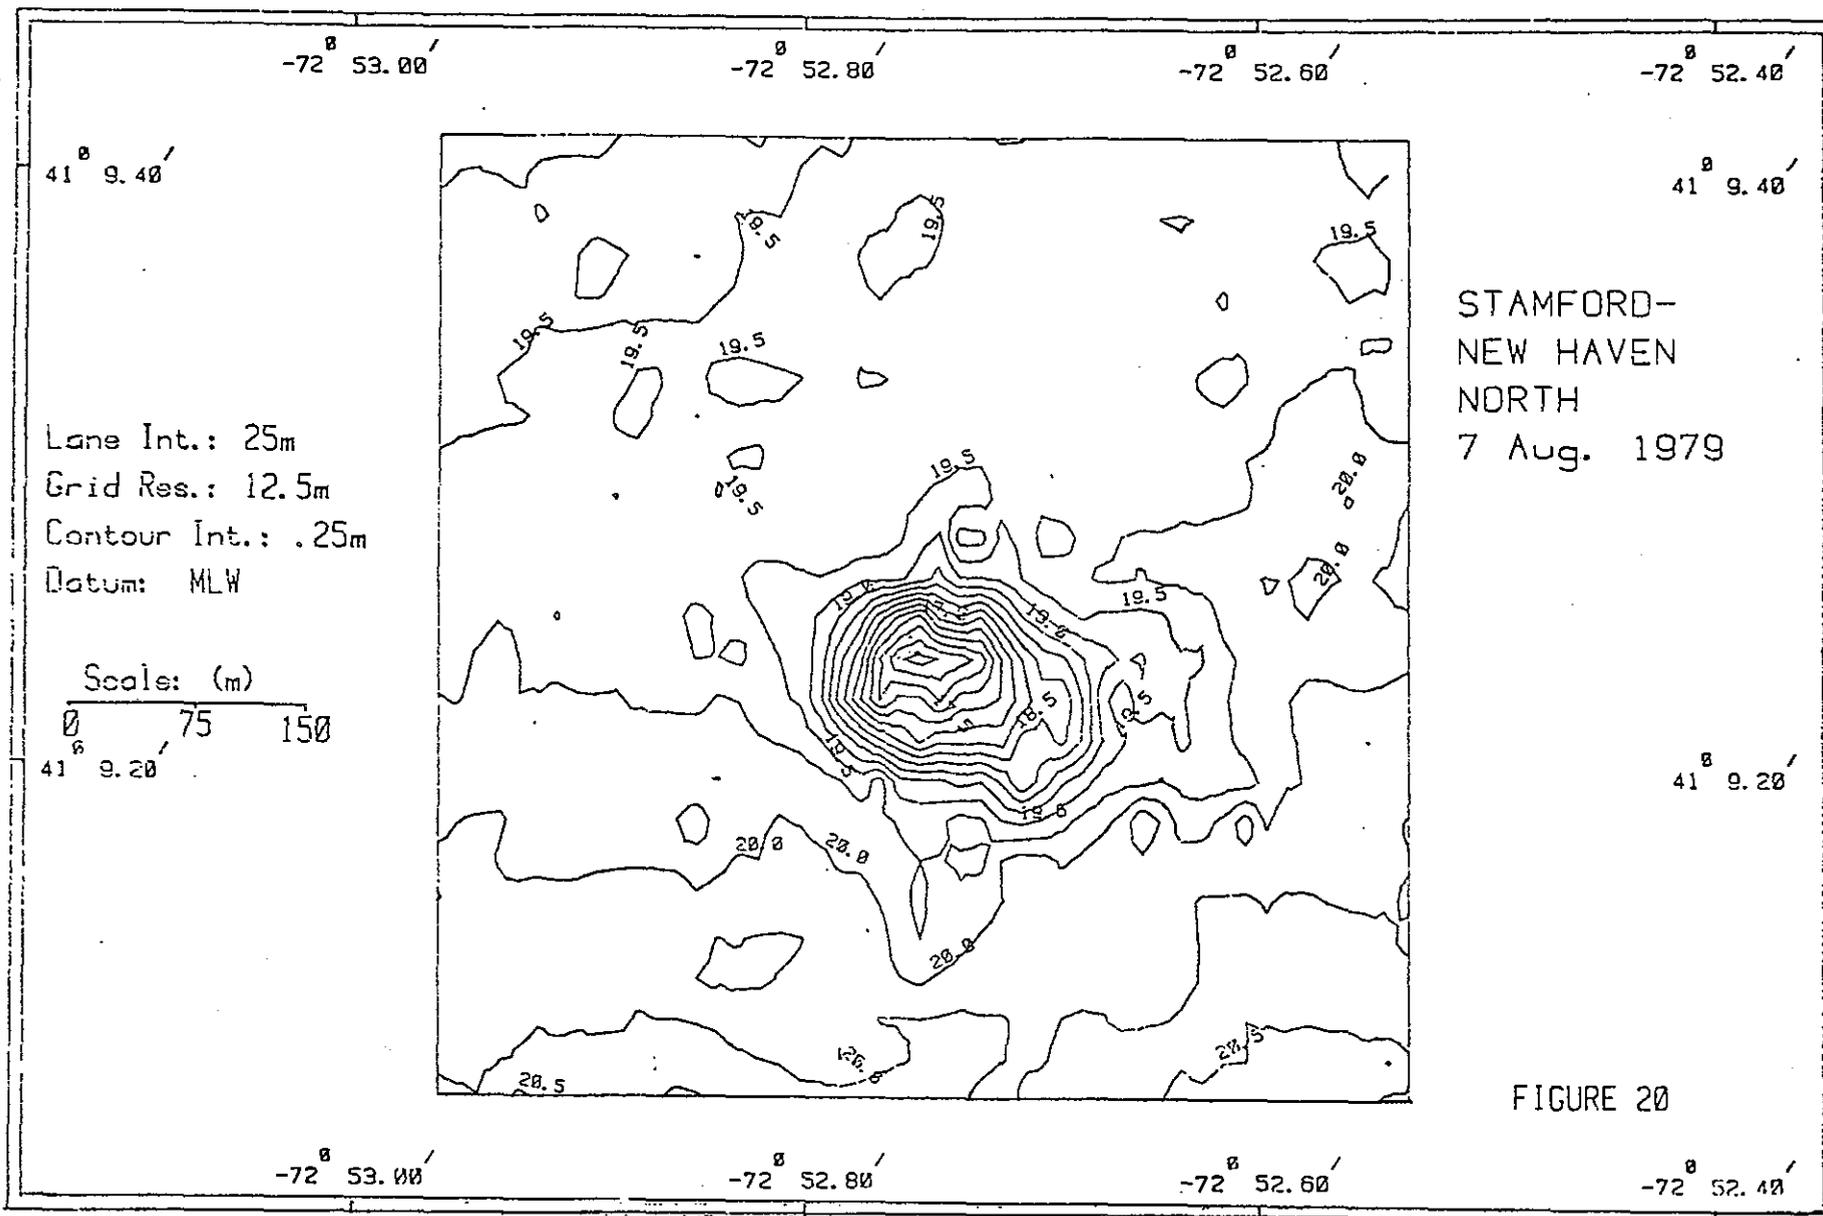
On 7 August 1979, a bathymetric survey (Figure 20) of the North disposal site was conducted that indicated there were no major changes in the topography of the spoil mound. Examination of the vertical profiles (Figure 21) supports this conclusion. In all cases, except Lane 13, the overall topographic features are consistent, however, the mound has settled or compressed slightly increasing the depth by approximately 20 cm. Calculation of volume differences between these surveys indicates that only Lane 13 has an

Stamford-New Haven North

7 August 1979

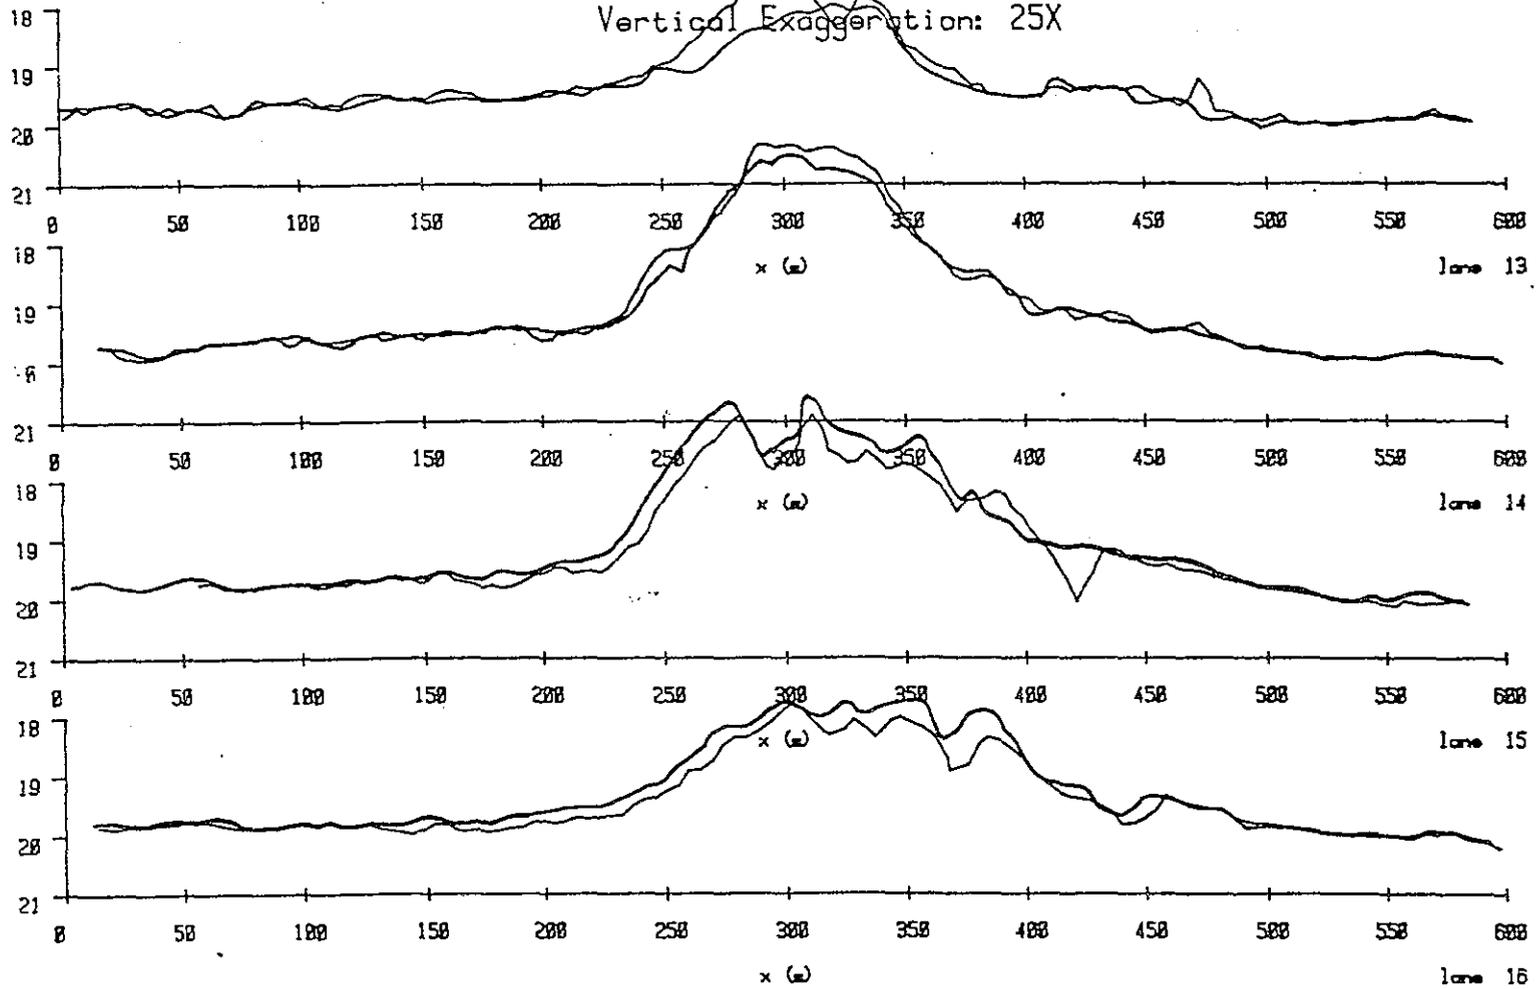
FIGURE 21

Lane Interval: 25m

Vertical Exaggeration: 25X

increase in volume while other lanes over the mound show a decrease. Total loss for the entire survey area was approximately 1700 m³ which was less than the 2400 m³ previously cited as the resolution of the survey procedure.
