THE MANAGEMENT AND MONITORING OF
DREDGE SPOIL DISPOSAL AND CAPPING
PROCEDURES IN
CENTRAL LONG ISLAND SOUND
DAMOS CONTRIBUTION #8

Presented at
Second International
Ocean Dumping Symposium
Woods Hole, MA
16 April, 1980

Presented by
ROBERT W. MORTON, Ph.D.
Science Applications, Inc.
202 Thames St.
Newport, RI 02840

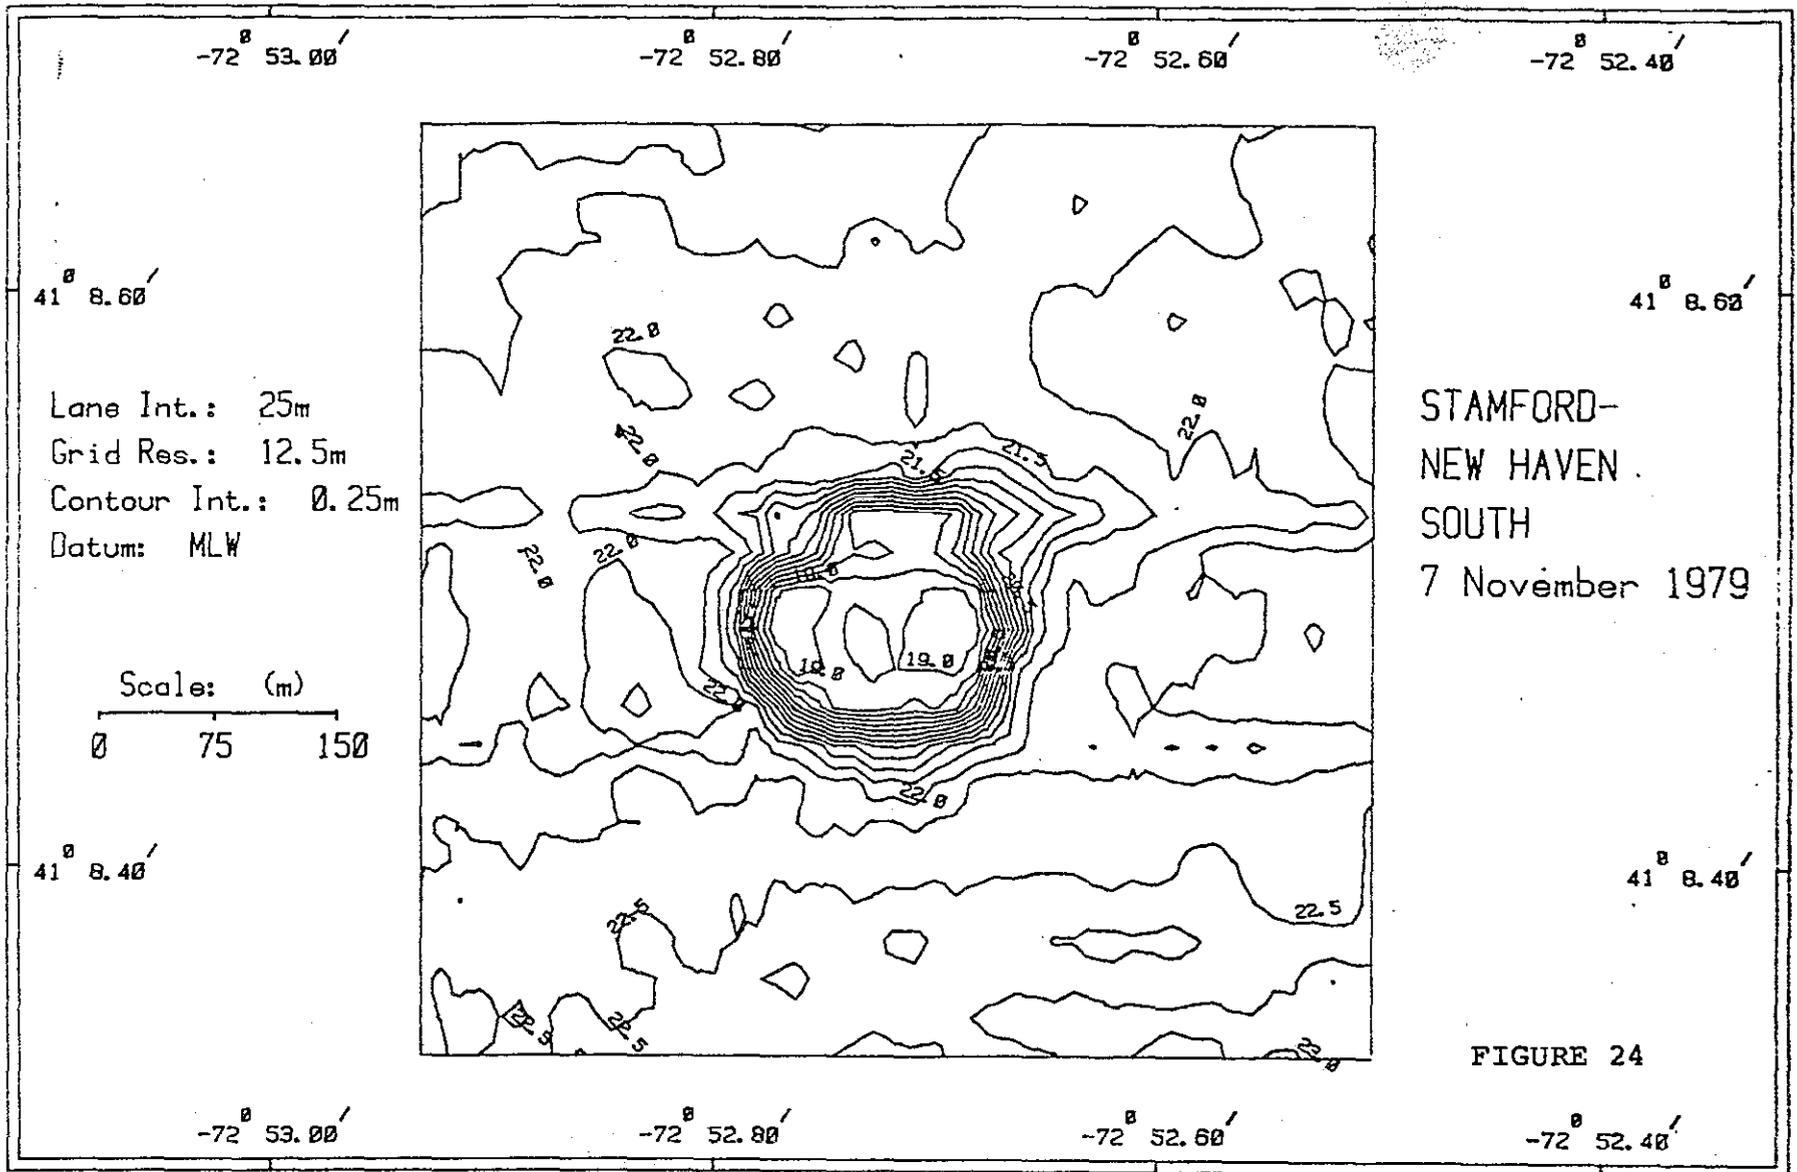
FIGURE 24

Following the August surveys an additional 6000 m³ of clean-up material from Stamford harbor was deposited at the southern site and a survey was conducted on November 7, 1979, to evaluate changes resulting from the addition of these spoils (Figure 24). The results of that survey showed a major change in the topography of the spoil mound resulting from the loss of approximately 10,000 m³ of spoil from the top of the mound. Vertical profiles across the center of the mound (Figure 25) revealed a flat surface at 19 meters which was also readily apparent on the contour chart (Figure 24) indicating that approximately 2 meters of spoil had been removed. Some of that material was present, particularly on the northeast margin of the mound where slumping of spoils had occurred, however, the build-up of material in that area cannot account for all the missing spoils. Although this loss of material did not expose any Stamford spoil, further investigations were initiated to determine the causes of spoil movements and to evaluate conditions at the other sites.

STAMFORD-
NEW HAVEN
SOUTH
7 November 1979

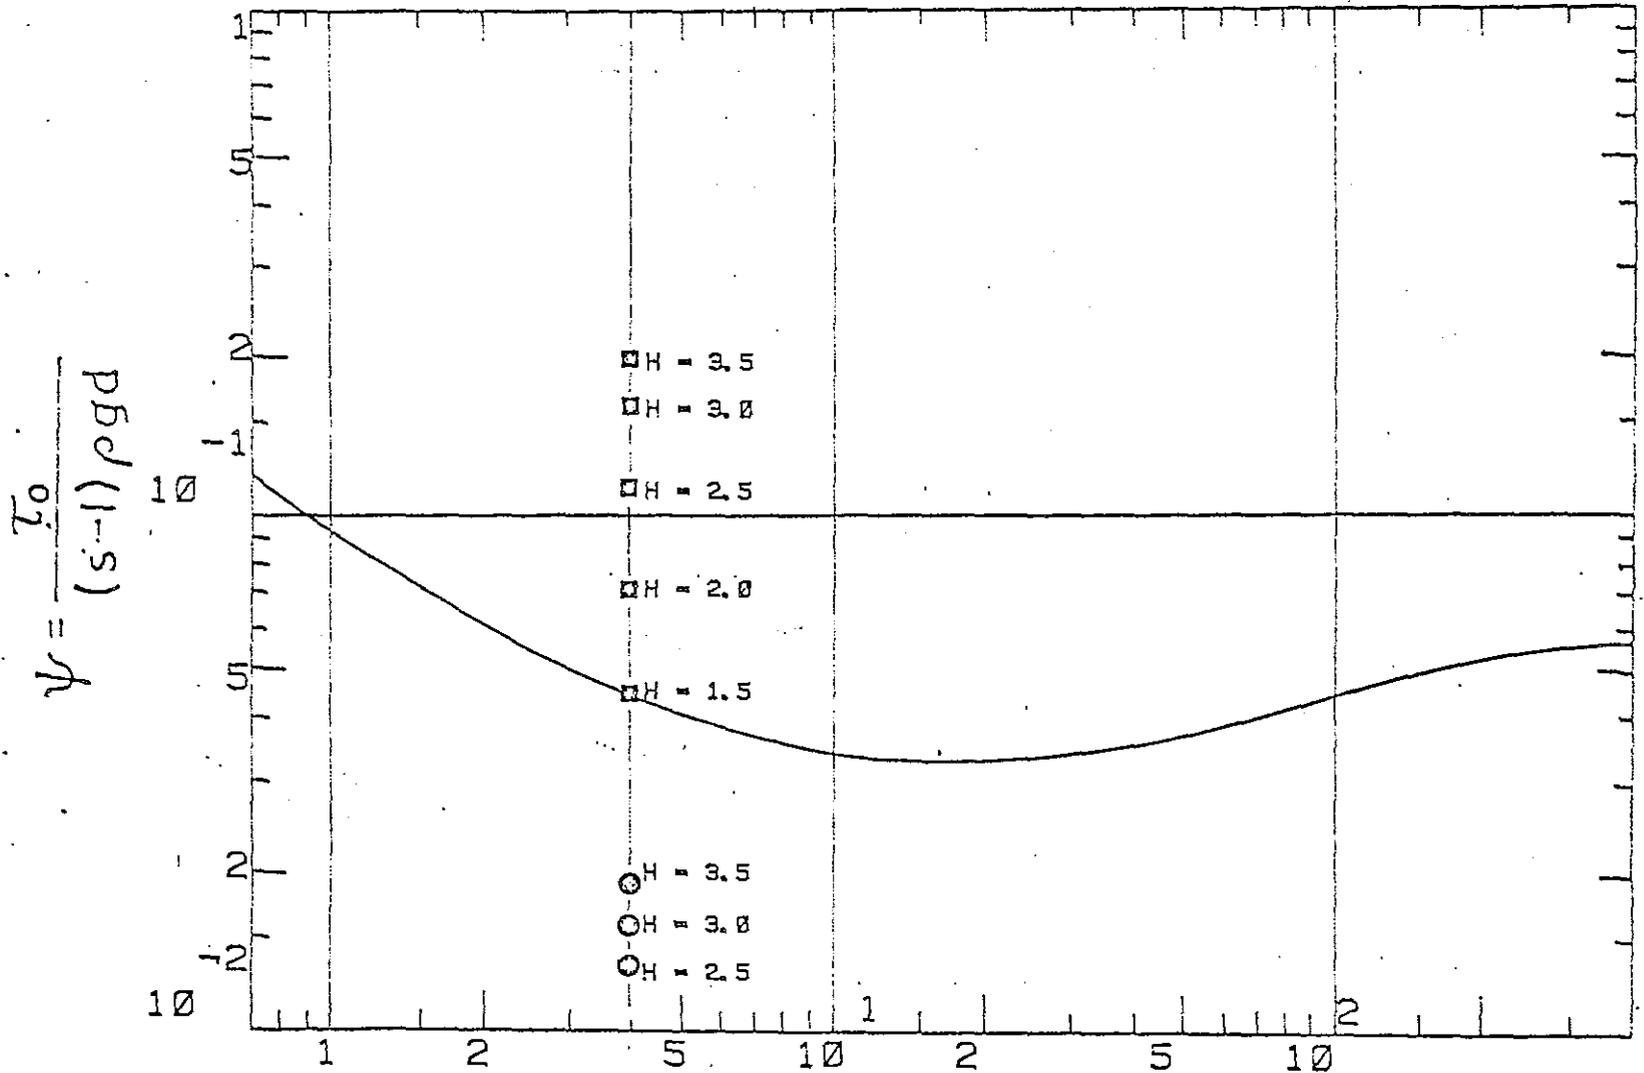
FIGURE 27

The calculated shear stress values for large roughness height are near or exceed the critical value for all tested wave heights at both periods (Figure 27 & 28). In contrast, the shear

MODIFIED SHIELDS DIAGRAM (MADSEN & GRANT, 1970)
 WAVE PERIOD T = 4.0 SEC.

stress developed over the surface of smaller roughness never exceed the critical value. Consequently, we can conclude that the high roughness factor resulting from the clumps of cohesive sediment on the south site create a greater stress and may cause sediment motion under storm wave conditions, while the smoother surfaces of the other spoils mounds produce significantly smaller stress values thus insuring the stability of the spoils even at shallower depths.

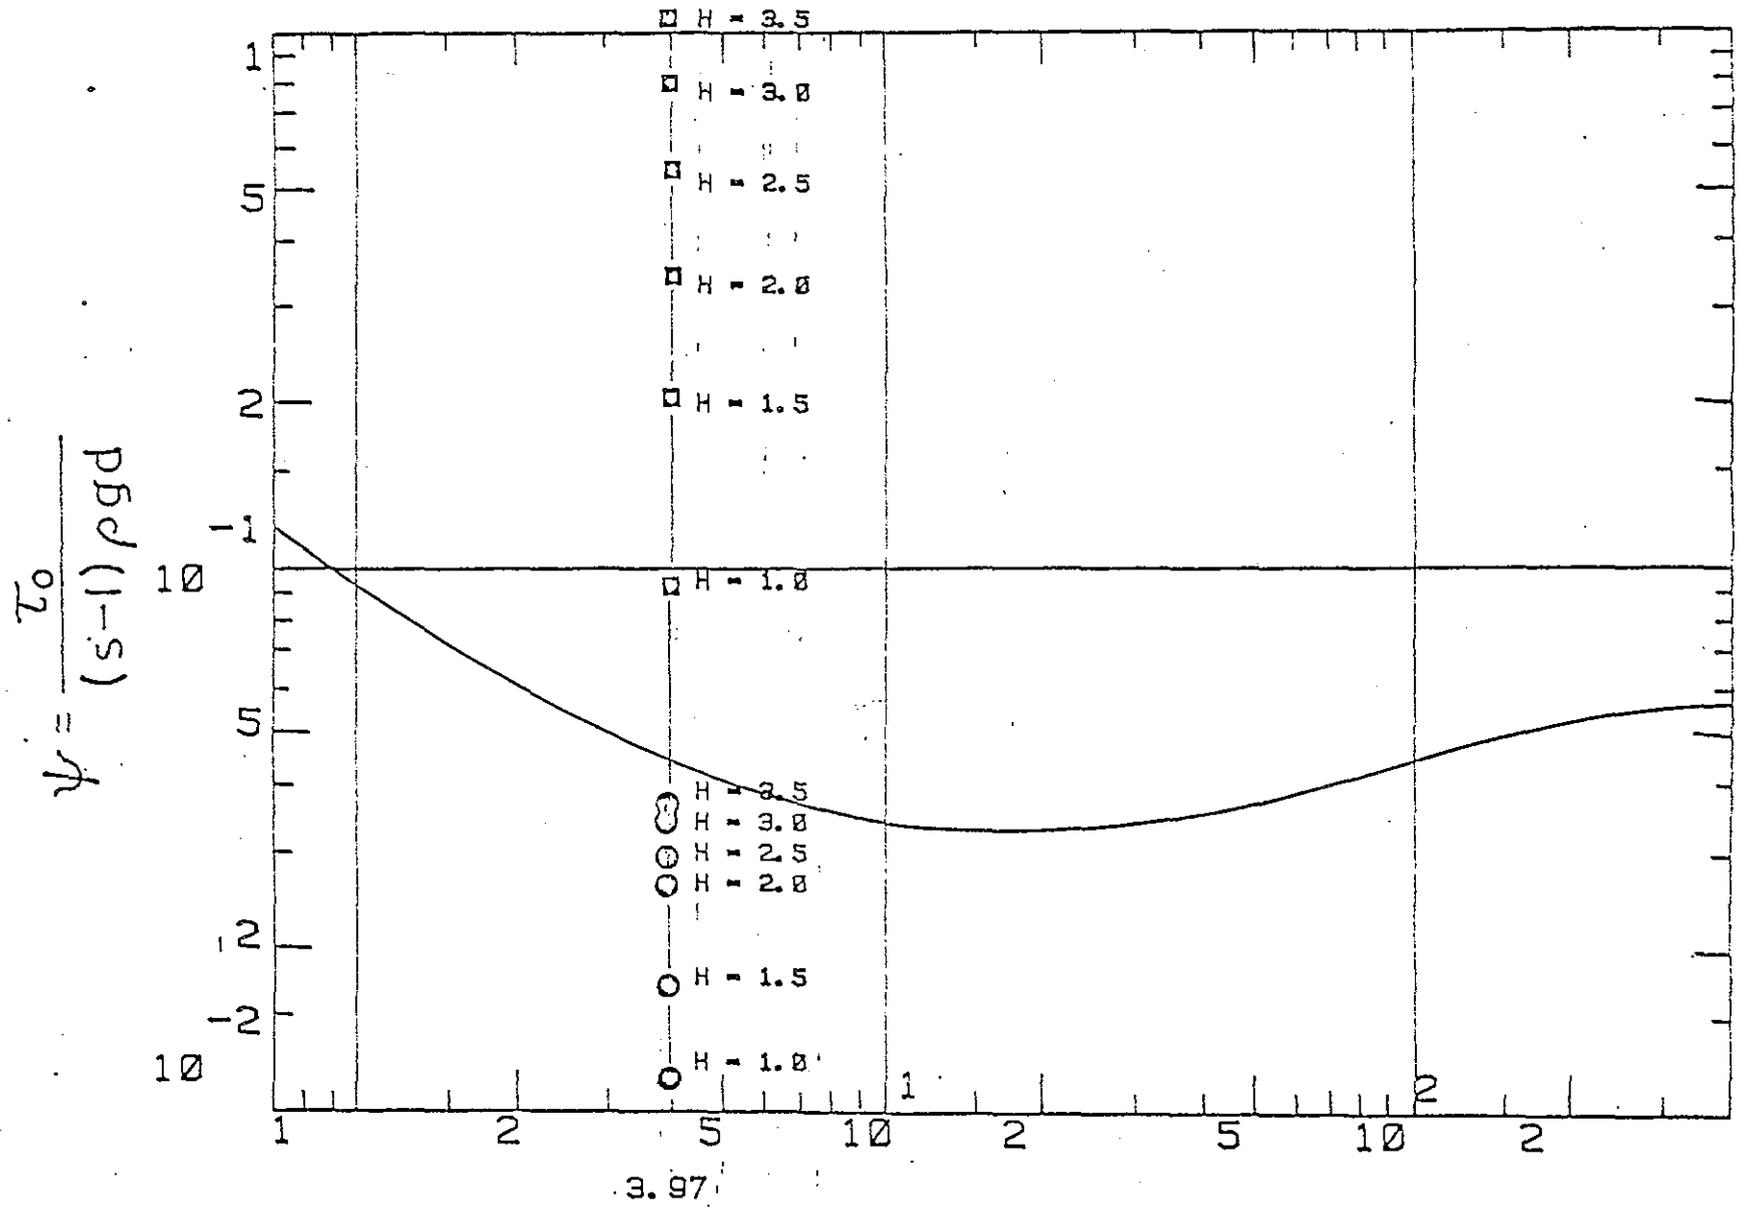
FIGURE 28

MODIFIED SHIELDS DIAGRAM (MADSEN & GRANT, 1970).
 WAVE PERIOD T = 4.5 SEC.
