An Investigation of the Dispersion  
of Sediments Resuspended by  
Dredging Operations in New Haven Harbor

# Disposal Area Monitoring System DAMOS

Contribution 112  
November 1996

**US Army Corps  
of Engineers**  
New England Division

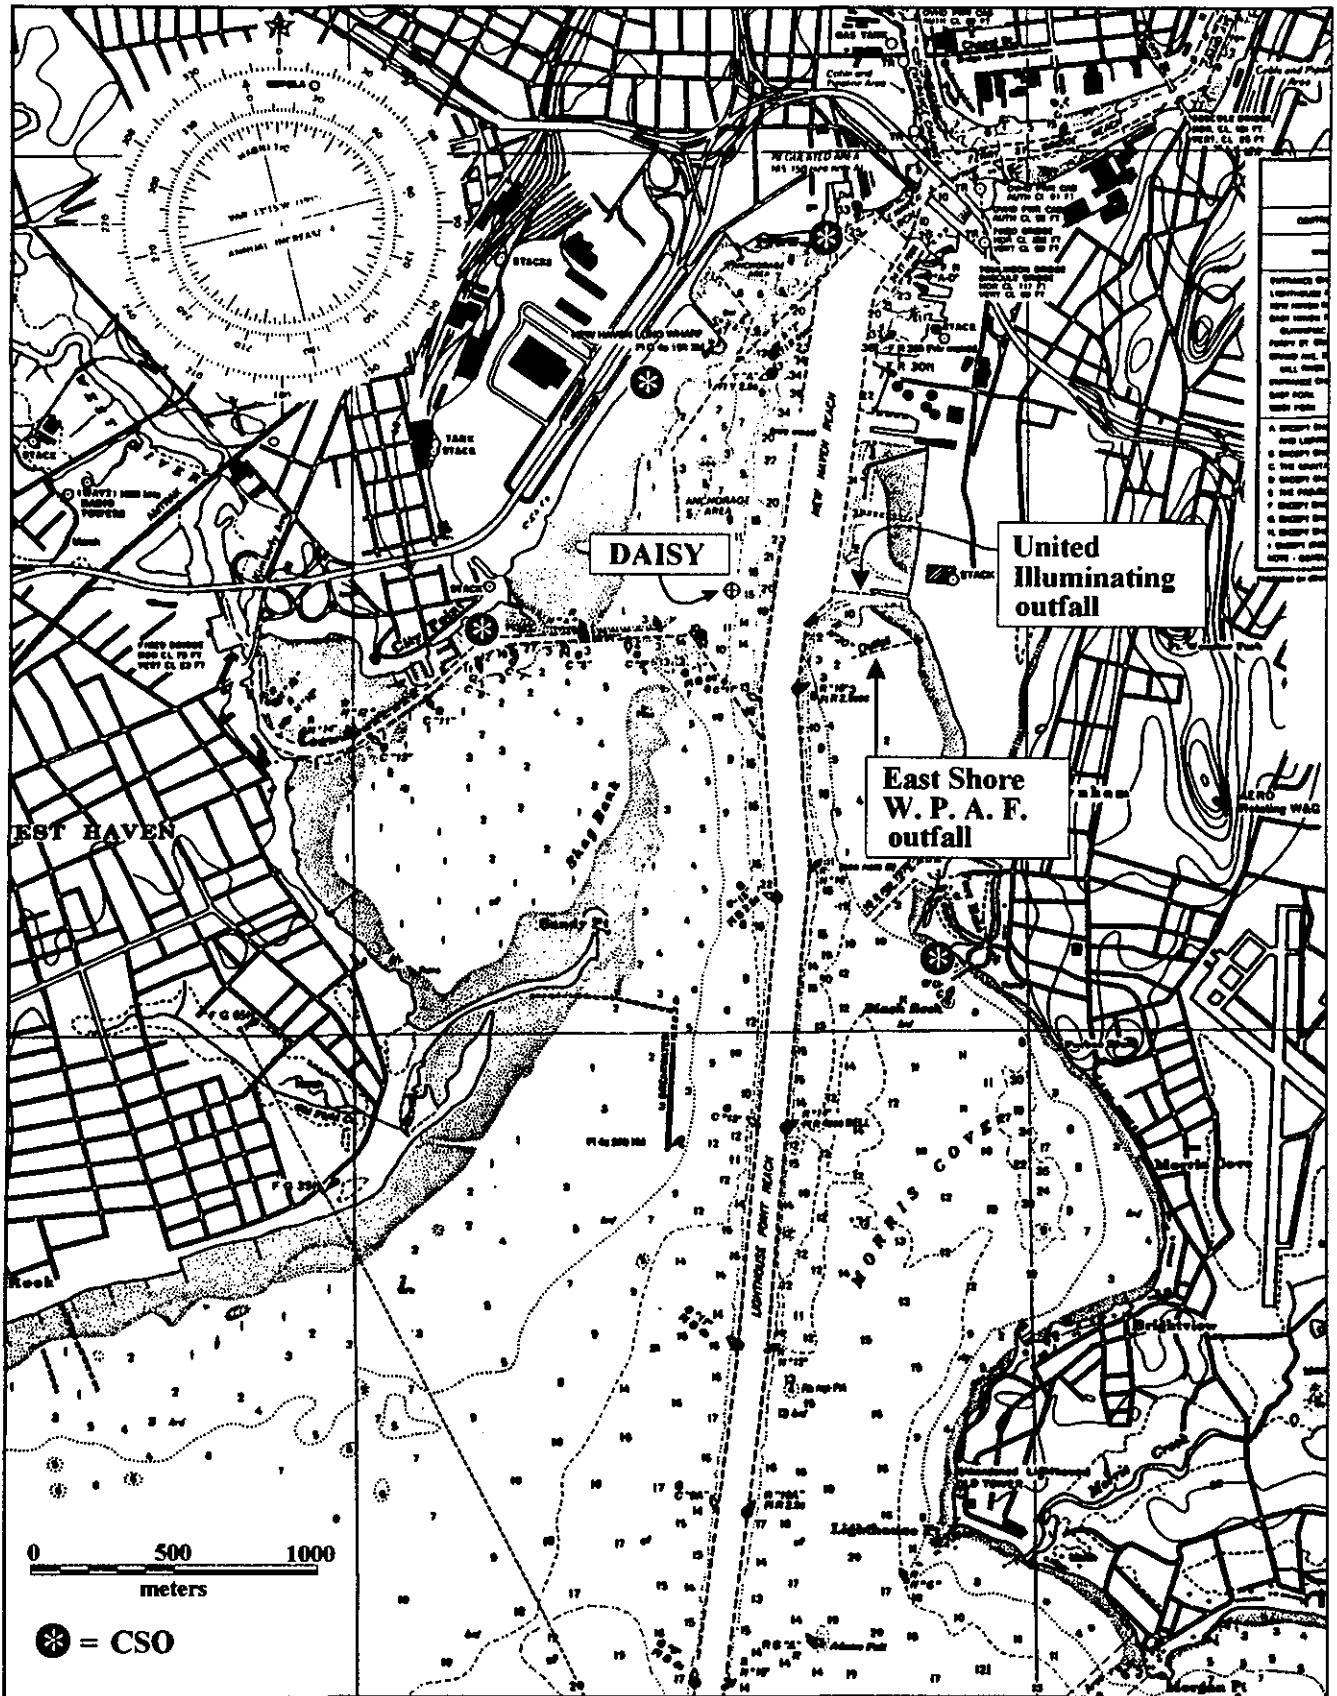
Figure 1-1. Bathymetric chart of the study area, New Haven Harbor, CT (from NOAA Nautical Chart #12371 - Scale 1:12, 800)

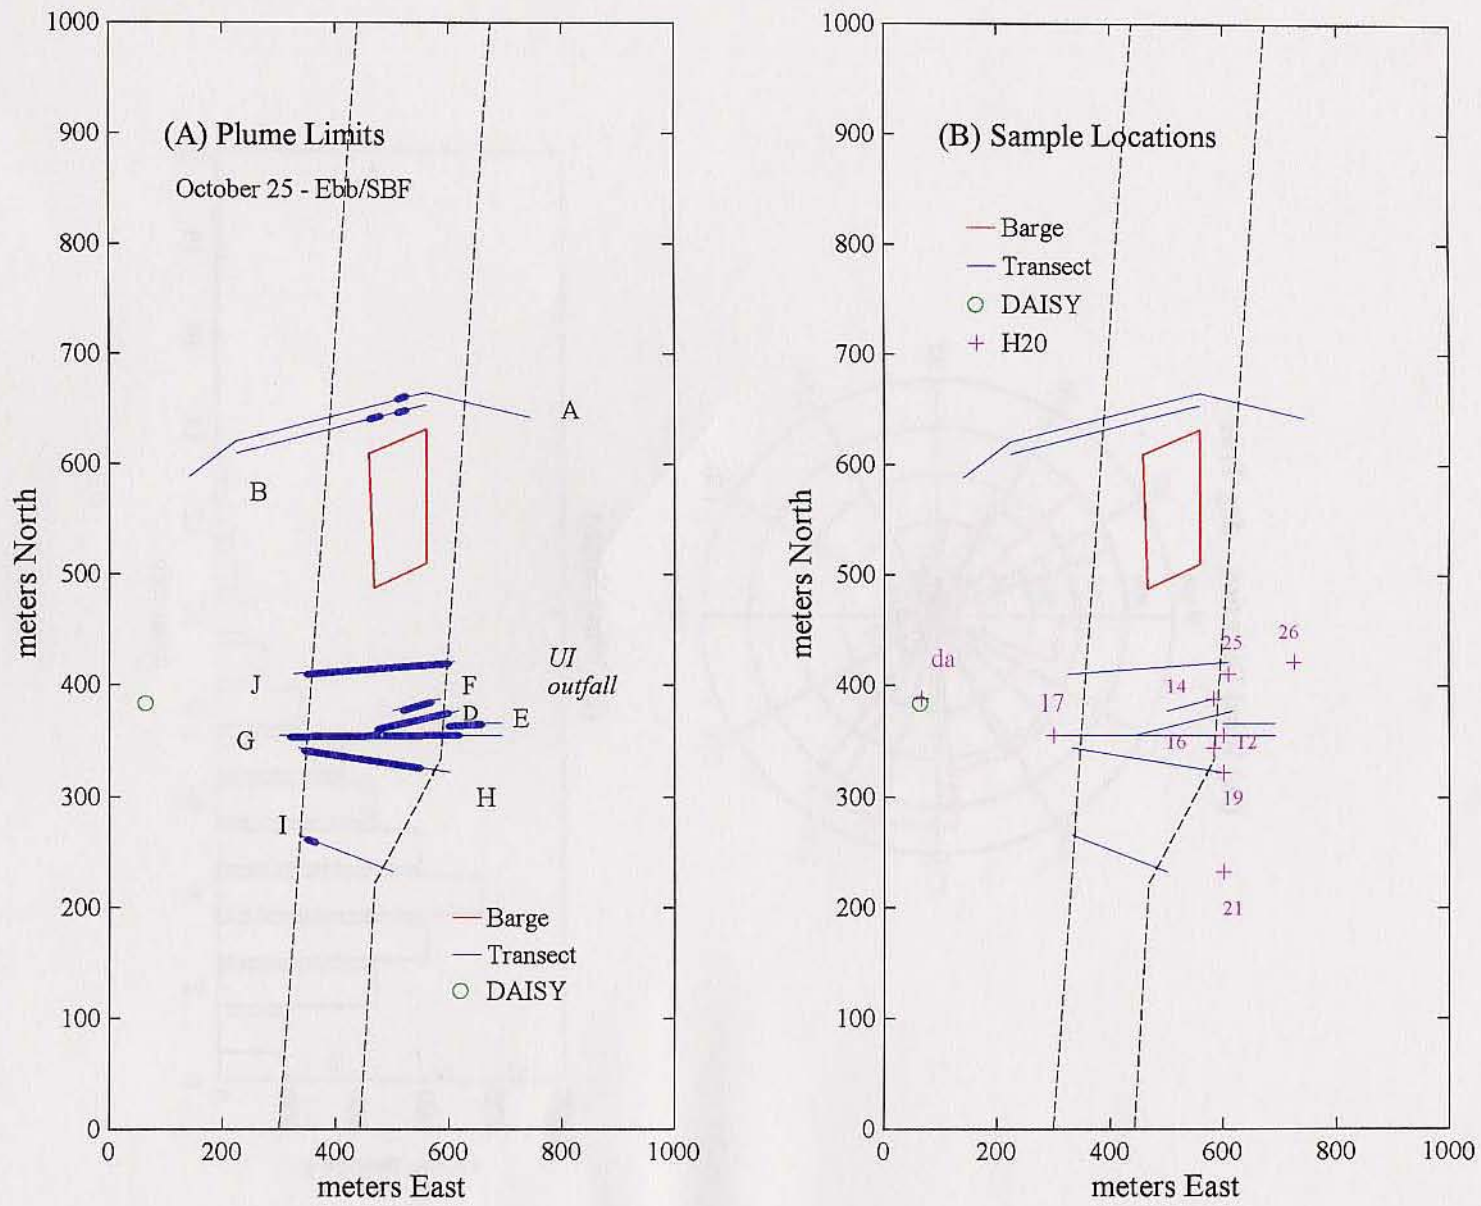
**Figure 3-6.** (A) October 25, 1993 barge position and transect locations with the occurrence of the plume delineated on each transect; (B) barge position and transects with the location of water samples

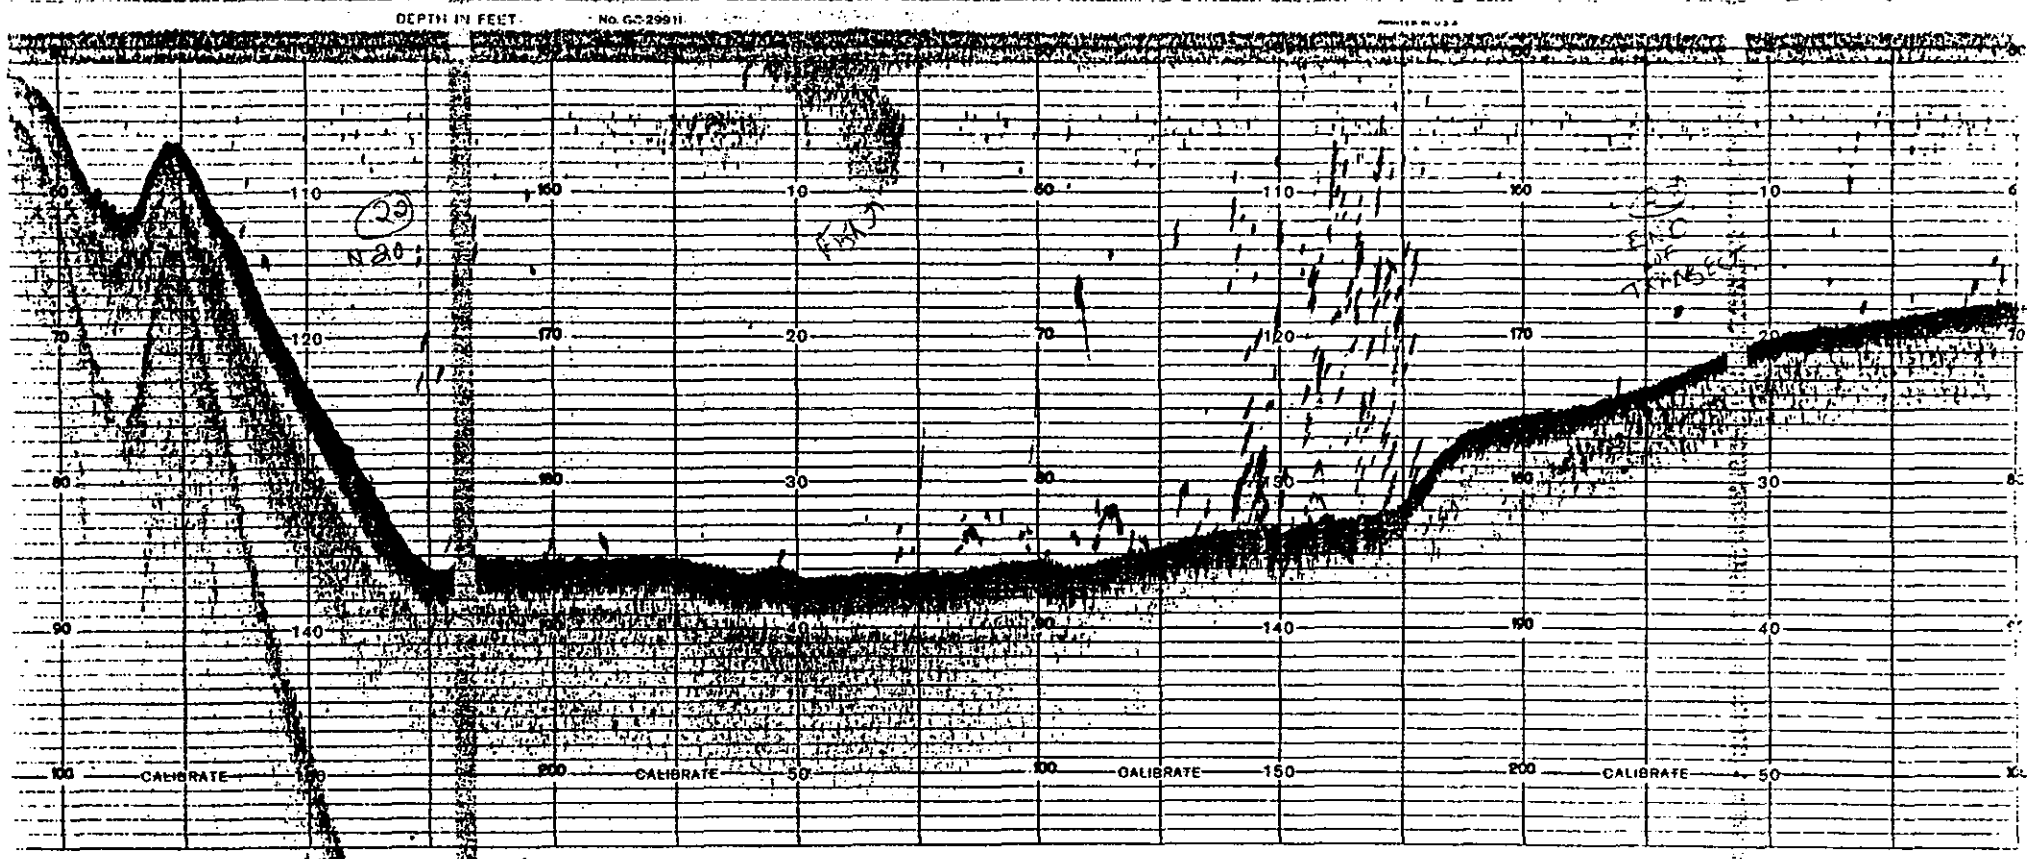
**Figure 3-7.** Echo sounder trace of Transect I showing patches of plume 250 meters downstream of the barge on October 25. The profile runs east to west.

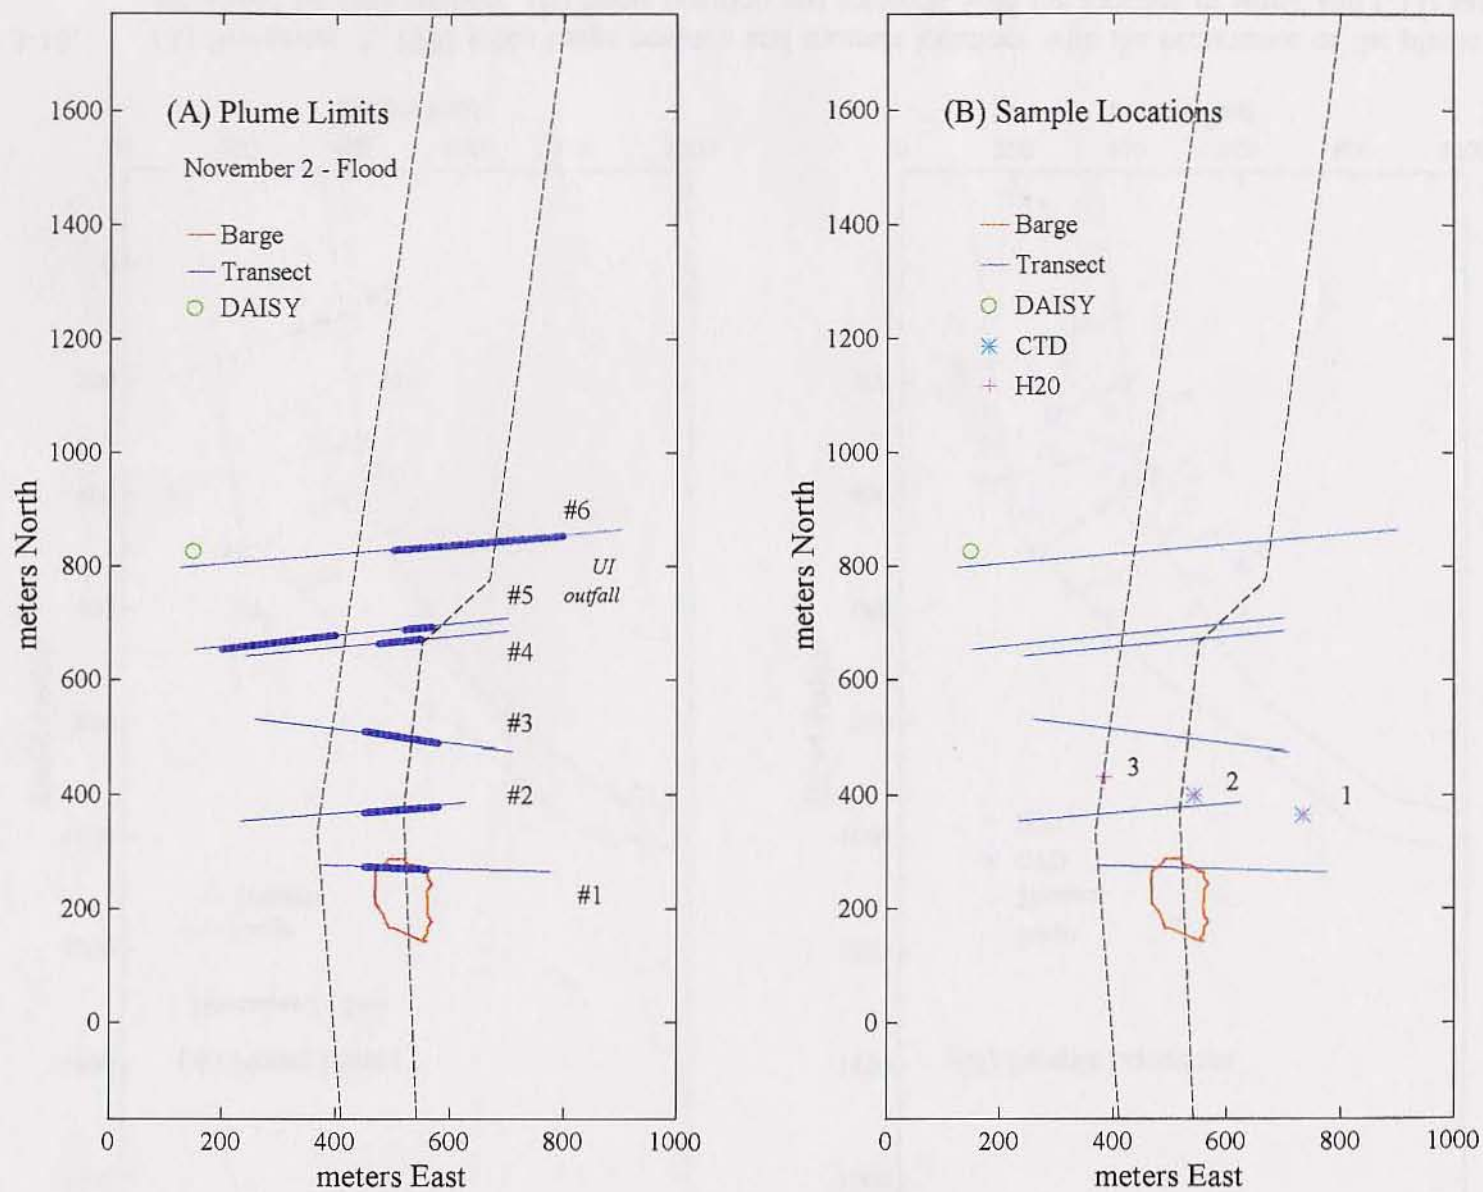
**Figure 3-9.**

(A) November 2, 1993 (flood) barge position and transect locations with the occurrence of the plume delineated on each transect; (B) barge position and transects with the location of water and CTD samples

Two surveys were completed on November 2. A survey was run during maximum flood while the dredge was stationed south of the Gateway Marine Terminal (Figure 3-9) and another survey was conducted during the early ebb, after the barge moved north of the terminal (Figure 3-10). The flood survey indicated that the plume extended northward for approximately 400 meters. The United Illuminating outfall, located approximately 600 meters north of the barge, obscured the plume signal, and plume tracking in this region was terminated. A small patch of the plume was observed to the west of the main channel, in 6 meters of water, 400 meters north of the barge (Figure 3-11). The survey run during the beginning of the ebb shows that considerably smaller patches of the plume were advected along the channel for a distance of approximately 250 meters south of the barge (Figure 3-12). A small patch was observed 150 meters north of the barge, possibly a relict from the previous flood. Dredge operations stopped and started throughout the survey, which may explain the smaller, more variable nature of the patches. The CTD data, collected during the early ebb, shows only slight density stratification (2-3 psu) within the top 2 meters, due mainly to the proximity to upstream sources of fresher water, i.e., the Mill and Quinnipiac Rivers. Surface to bottom temperature differences were less than a degree.

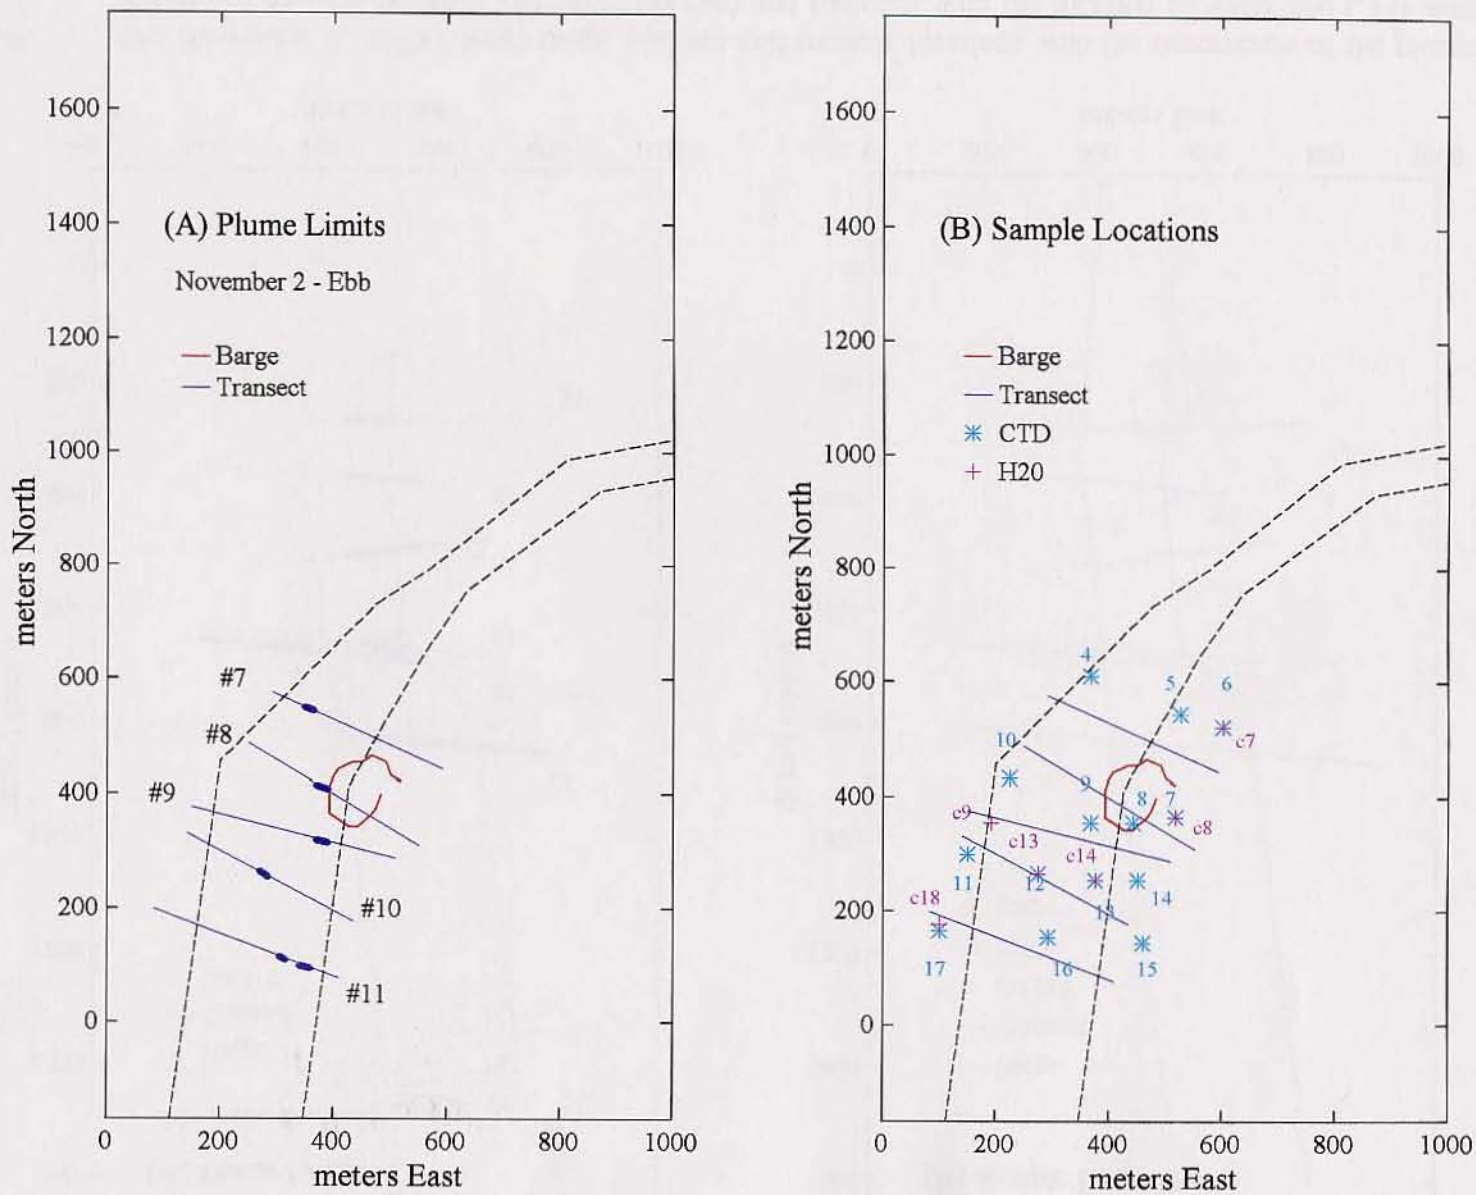
**Figure 3-10.** (A) November 2, 1993 (ebb) barge position and transect locations with the occurrence of the plume delineated on each transect; (B) barge position and transects with the location of water and CTD samples

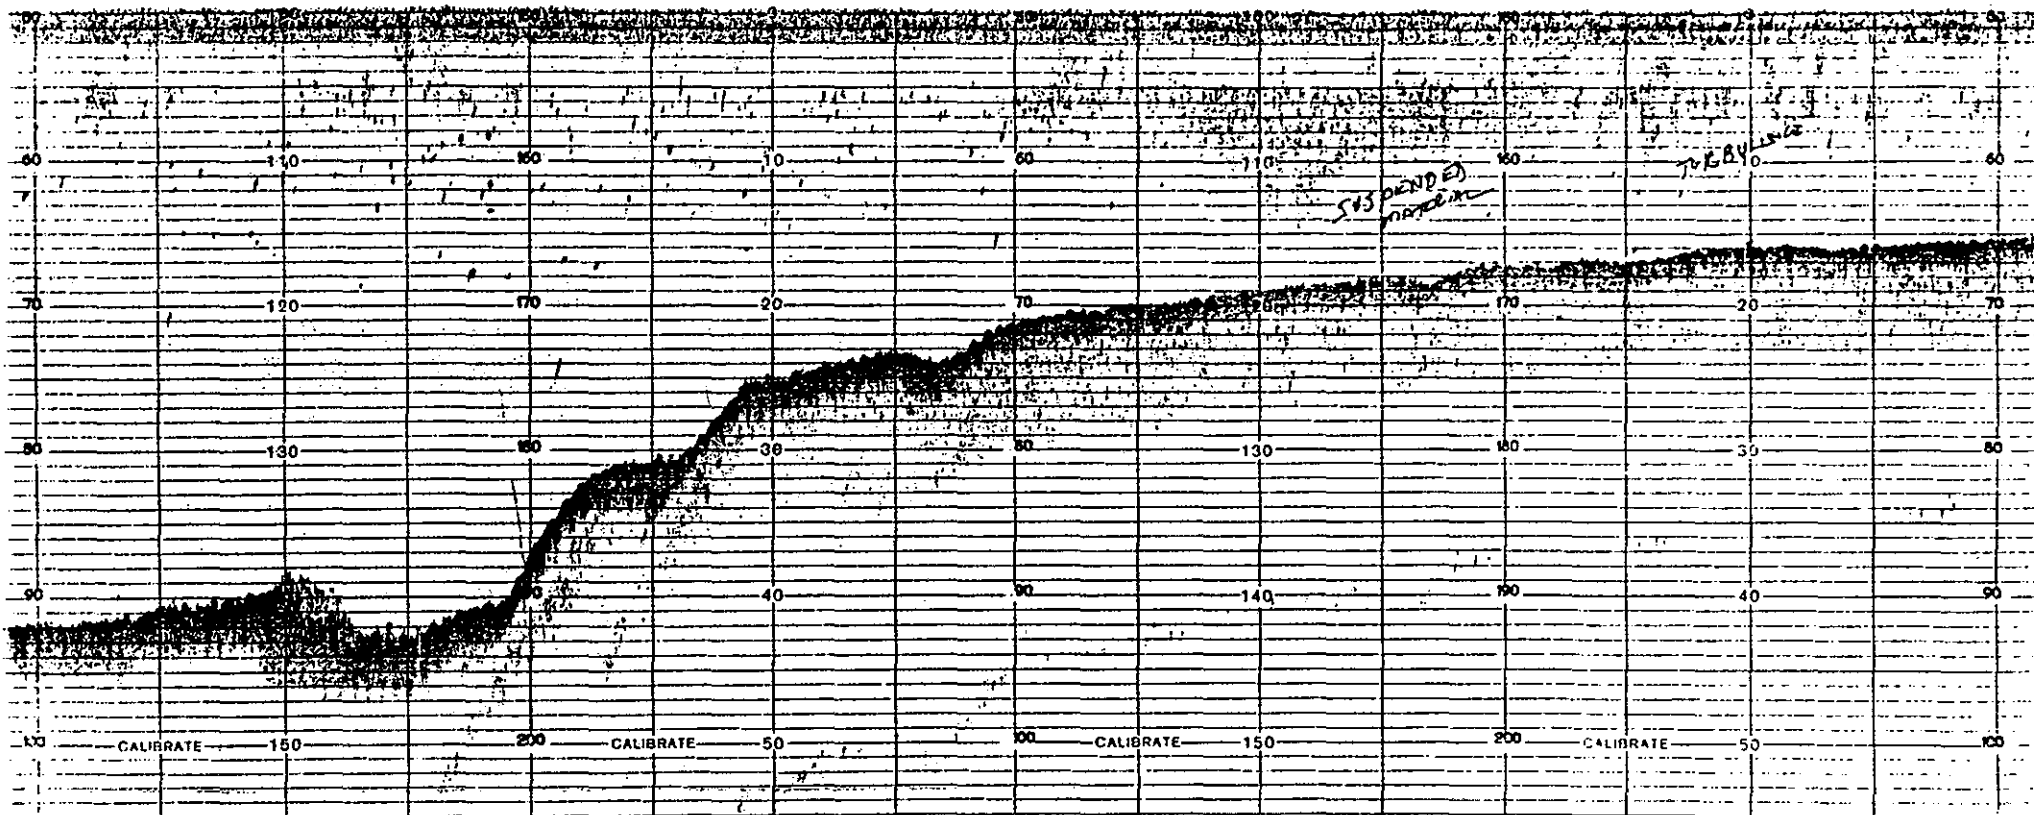
Figure 3-11. Patch of the plume observed while running Transect #5, 400 meters downcurrent and out of navigation channel, November 2. Profile runs east to west.

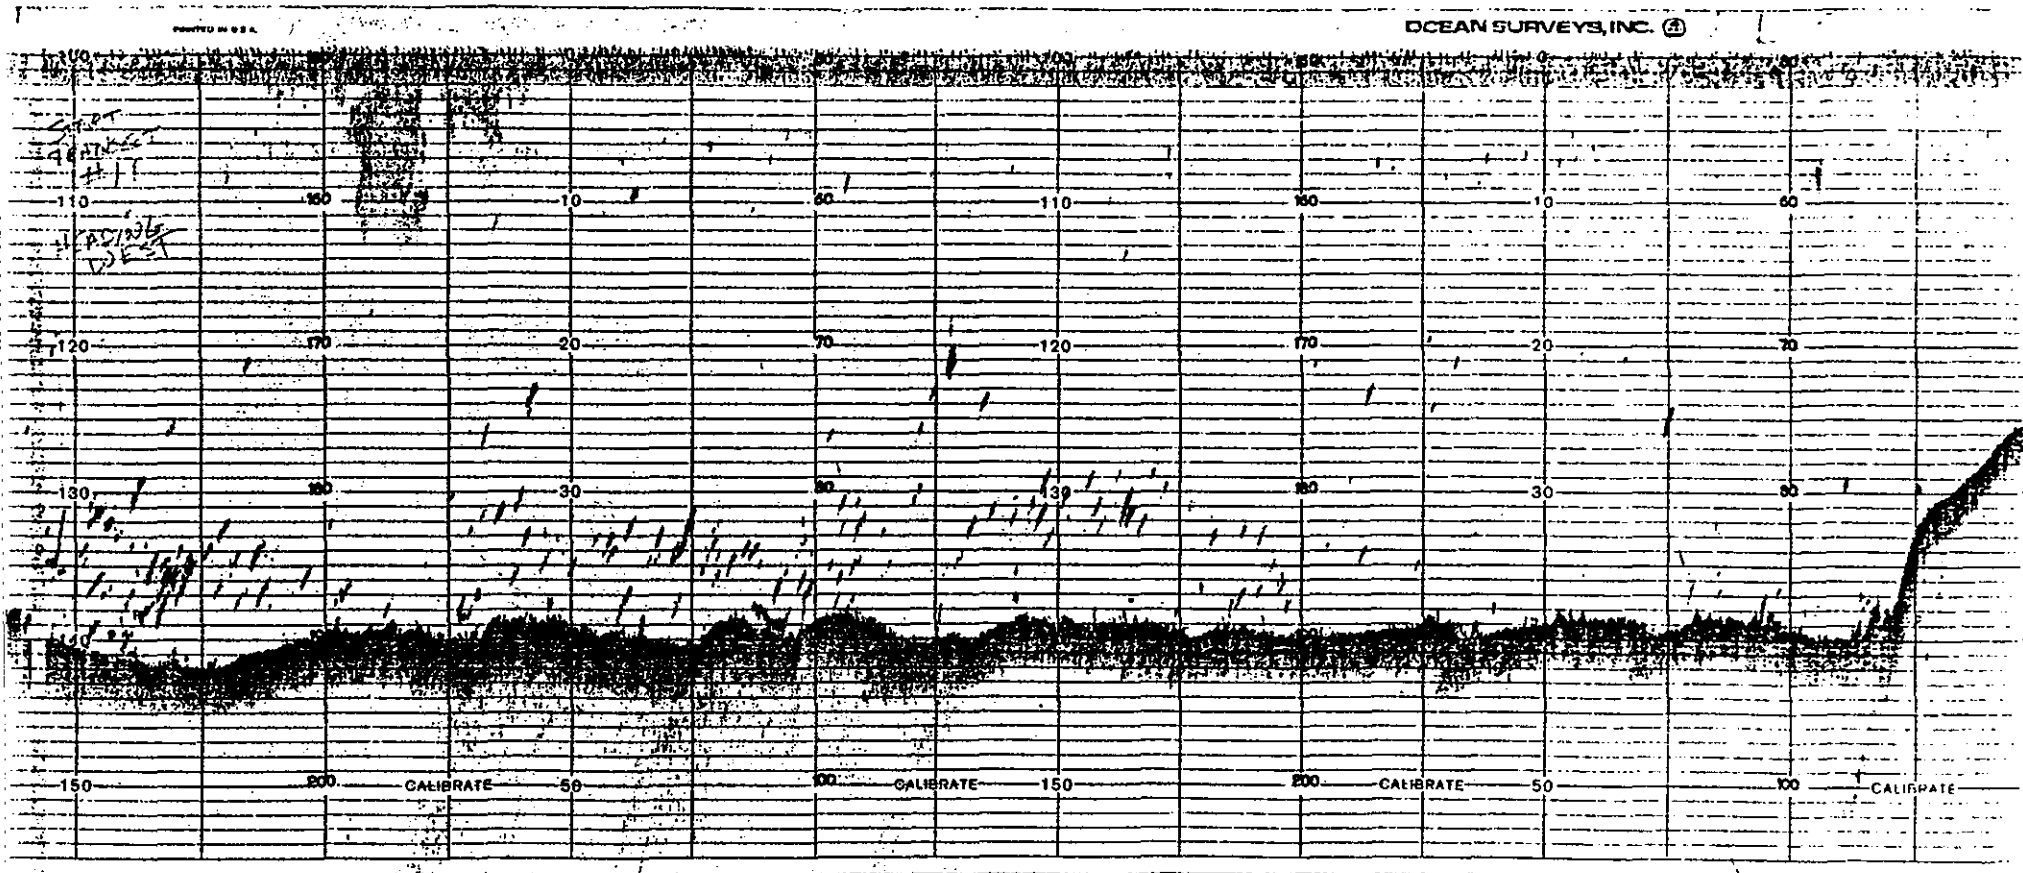
Figure 3-12. Transect #11, showing a plume patch that has been advected 250 meters downcurrent along the eastern side of the navigation channel. Profile runs east to west.

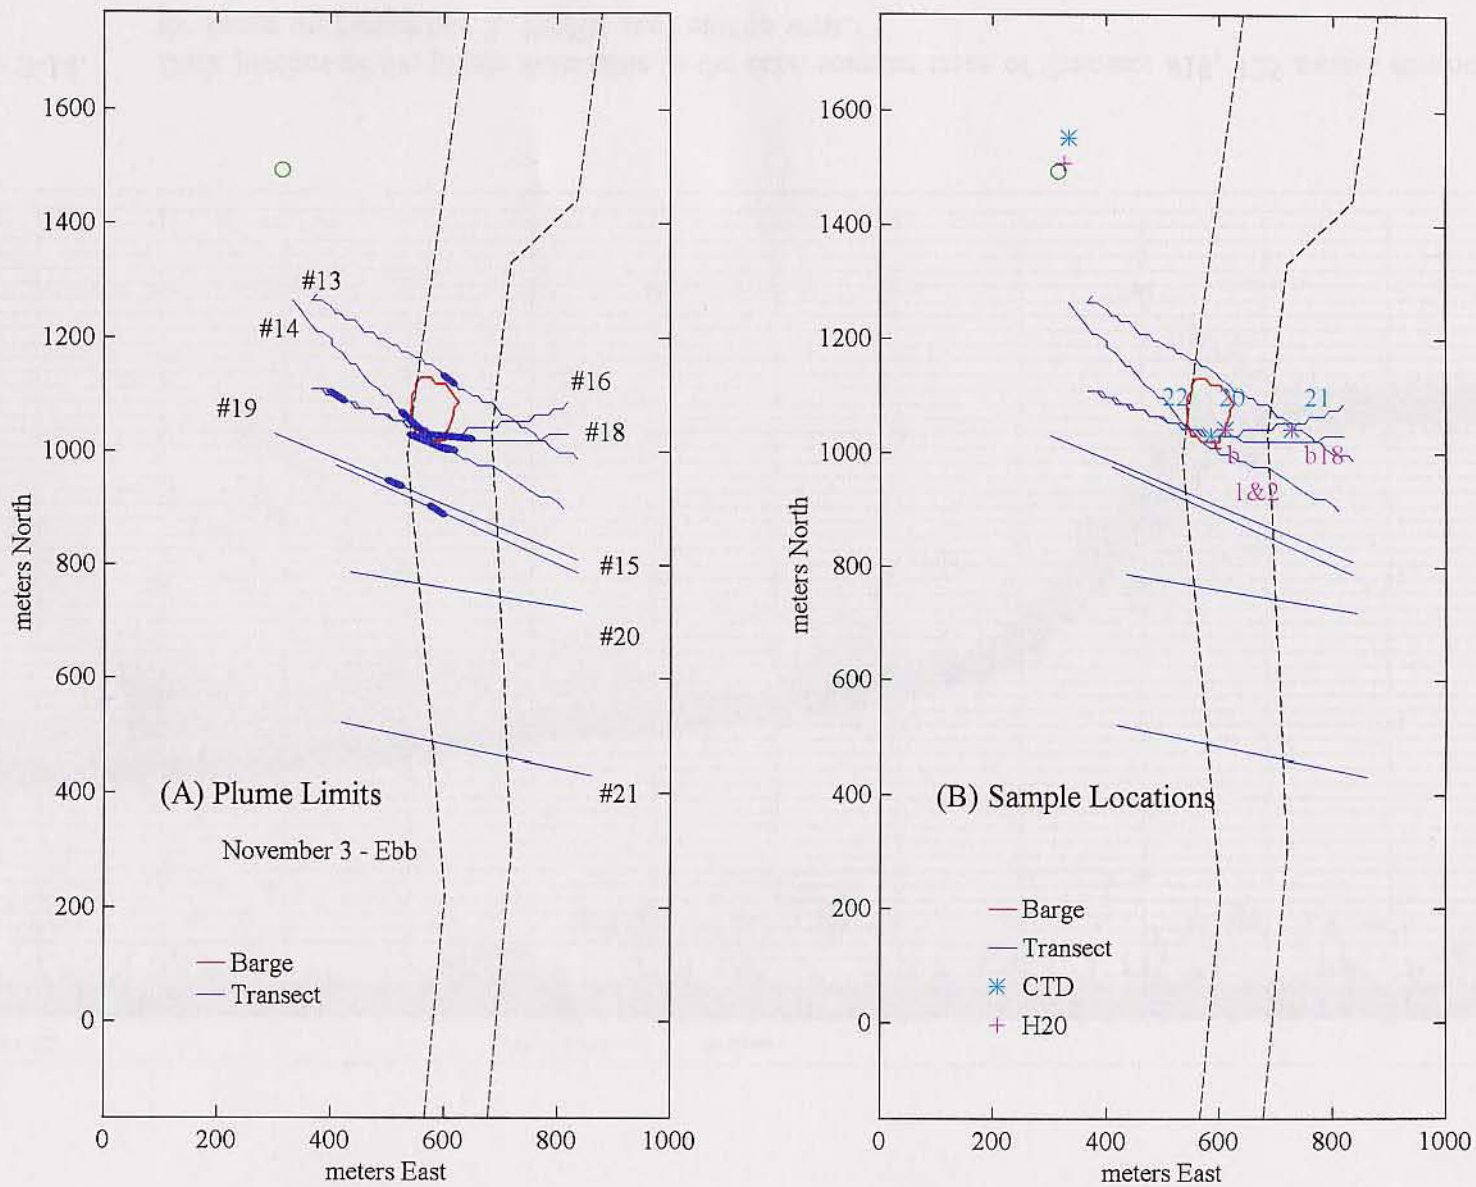
**Figure 3-13.** (A) November 3, 1993 barge position and transect locations with the occurrence of the plume delineated on each transect; (B) barge position and transects with the location of water and CTD samples

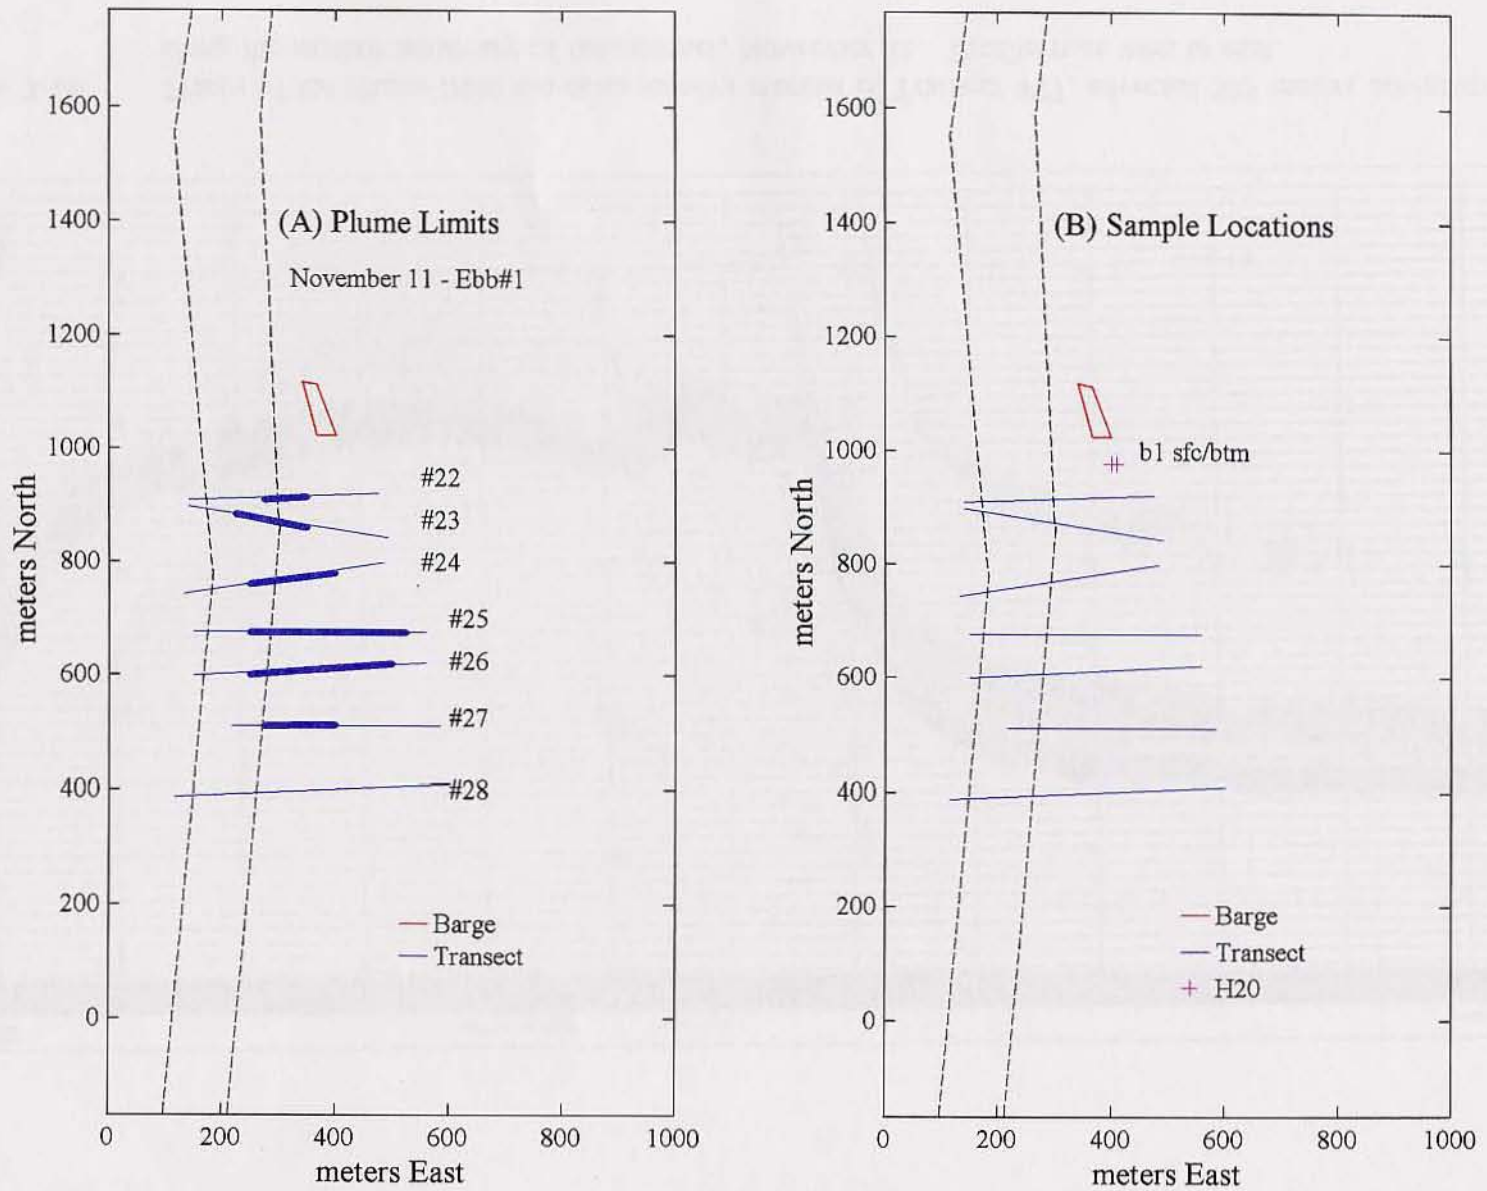
**Figure 3-15.** (A) November 11, 1993 (first ebb survey) barge position and transect locations with the occurrence of the plume delineated on each transect; (B) barge position and transects with the location of water samples

The dredge was located near buoy "16" (Figure 3-15) during two ebb surveys conducted on November 11. Results of the first ebb survey, run during maximum ebb currents, indicated that the plume traveled approximately 525 meters downstream along the east bank of the channel (Figure 3-16) with excursions of 200 meters eastward onto the adjacent shoals. The second survey (Figure 3-17), during the latter half of the ebb, shows the plume again hugging the east bank for a distance of only 200 meters (Figures 3-18). Currents were slack by the end of the last transect. The majority of the plume observed during this second survey resides in deeper water with only minimal excursions (within 50 meters) over the adjoining shallows. Plume distributions in this area display some of the characteristics of a density current, i.e., a gravitationally induced density contrast between the sediment-laden plume and ambient waters (Figure 3-19). CTD casts, taken between the two surveys, indicate a well mixed water column with negligible stratification.

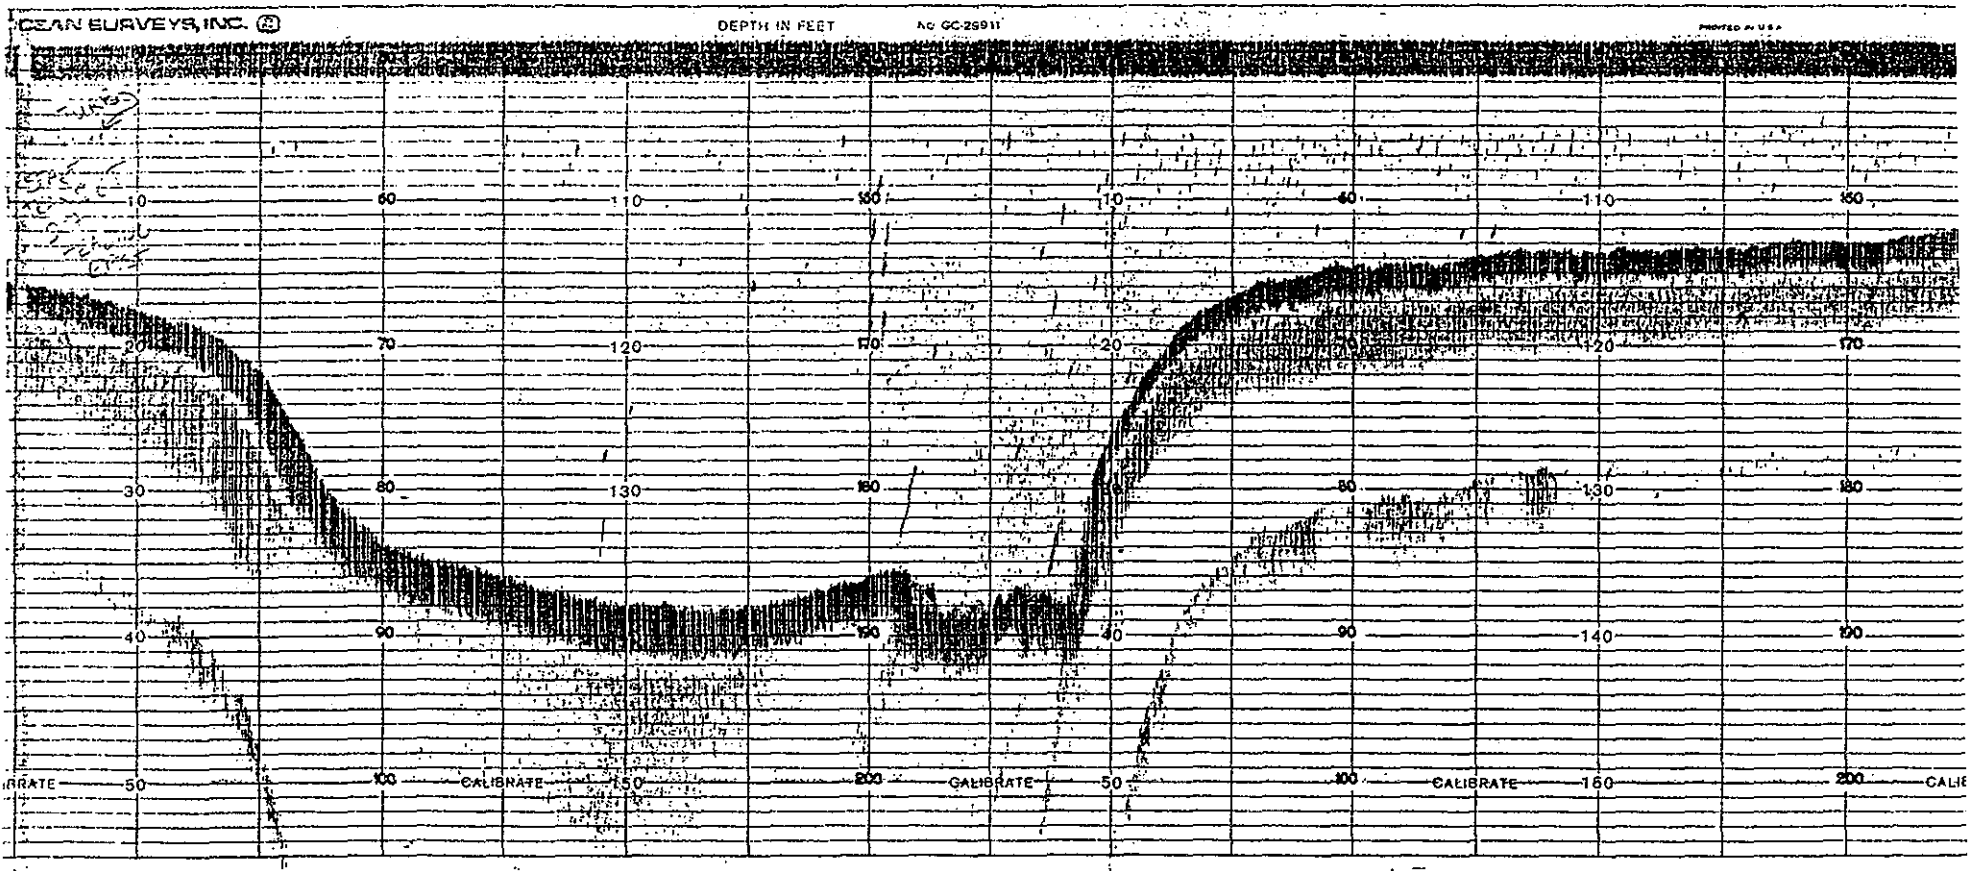
**Figure 3-16.** Traces of the plume from the echo sounder records of Transect #27, advected 525 meters downcurrent along the eastern boundary of the channel, November 11. Profile runs west to east.

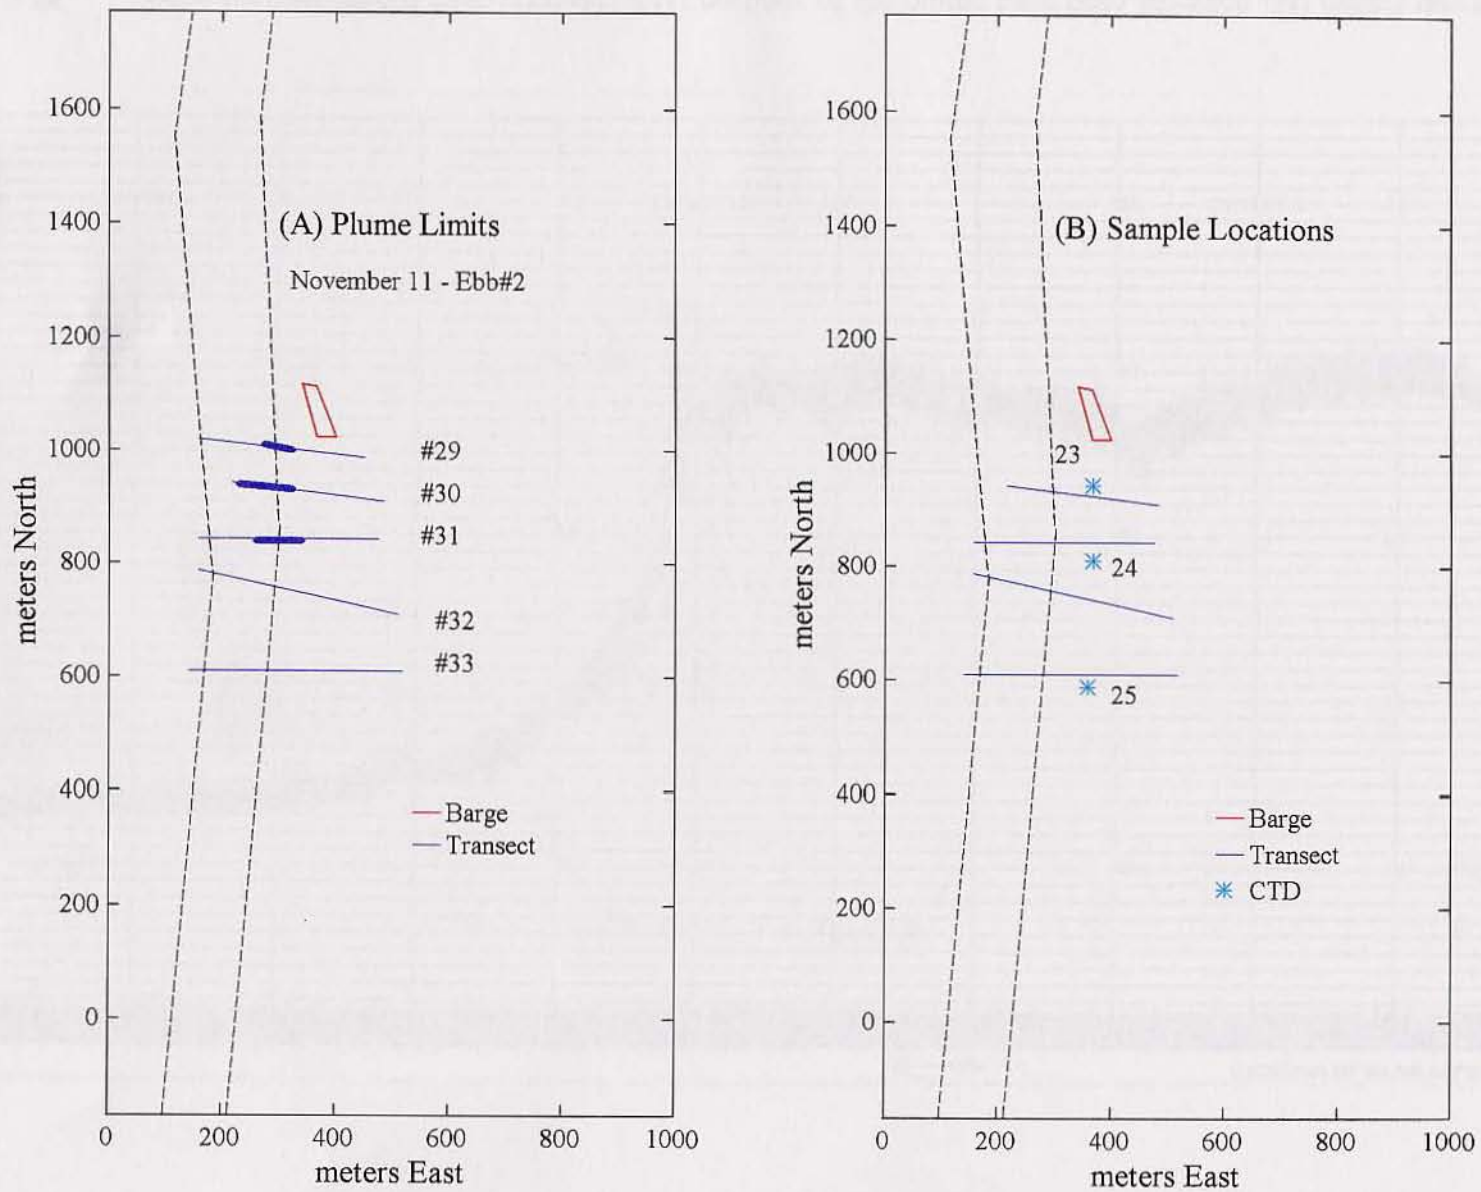
**Figure 3-17.** (A) November 11, 1993 (second ebb survey) barge position and transect locations with the occurrence of the plume delineated on each transect; (B) barge position and transects with the location of water samples

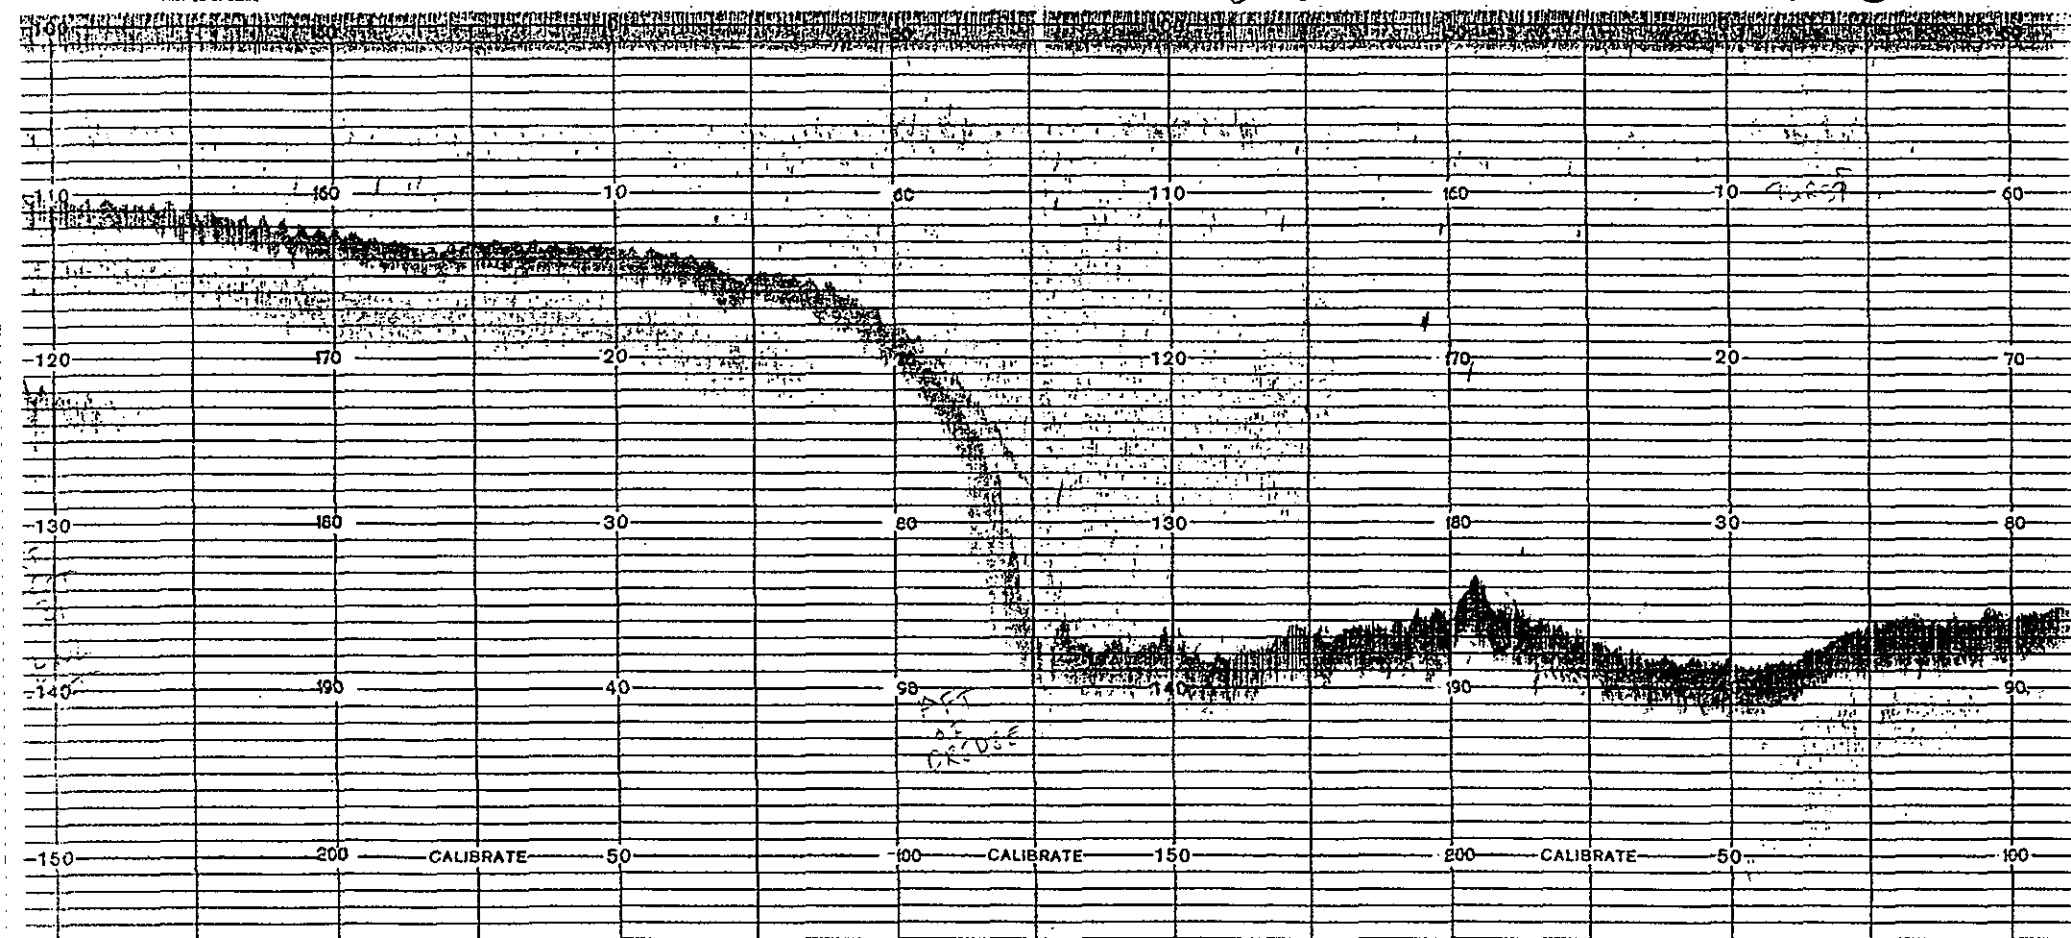
Figure 3-18. Echo sounder record from Transect #31; portions of the plume have been advected 200 meters downstream along the eastern flanks of the channel, November 11. Profile runs east to west.
