An Investigation of the Dispersion  
of Sediments Resuspended by  
Dredging Operations in New Haven Harbor

# Disposal Area Monitoring System DAMOS

Contribution 112  
November 1996

**US Army Corps  
of Engineers**  
New England Division

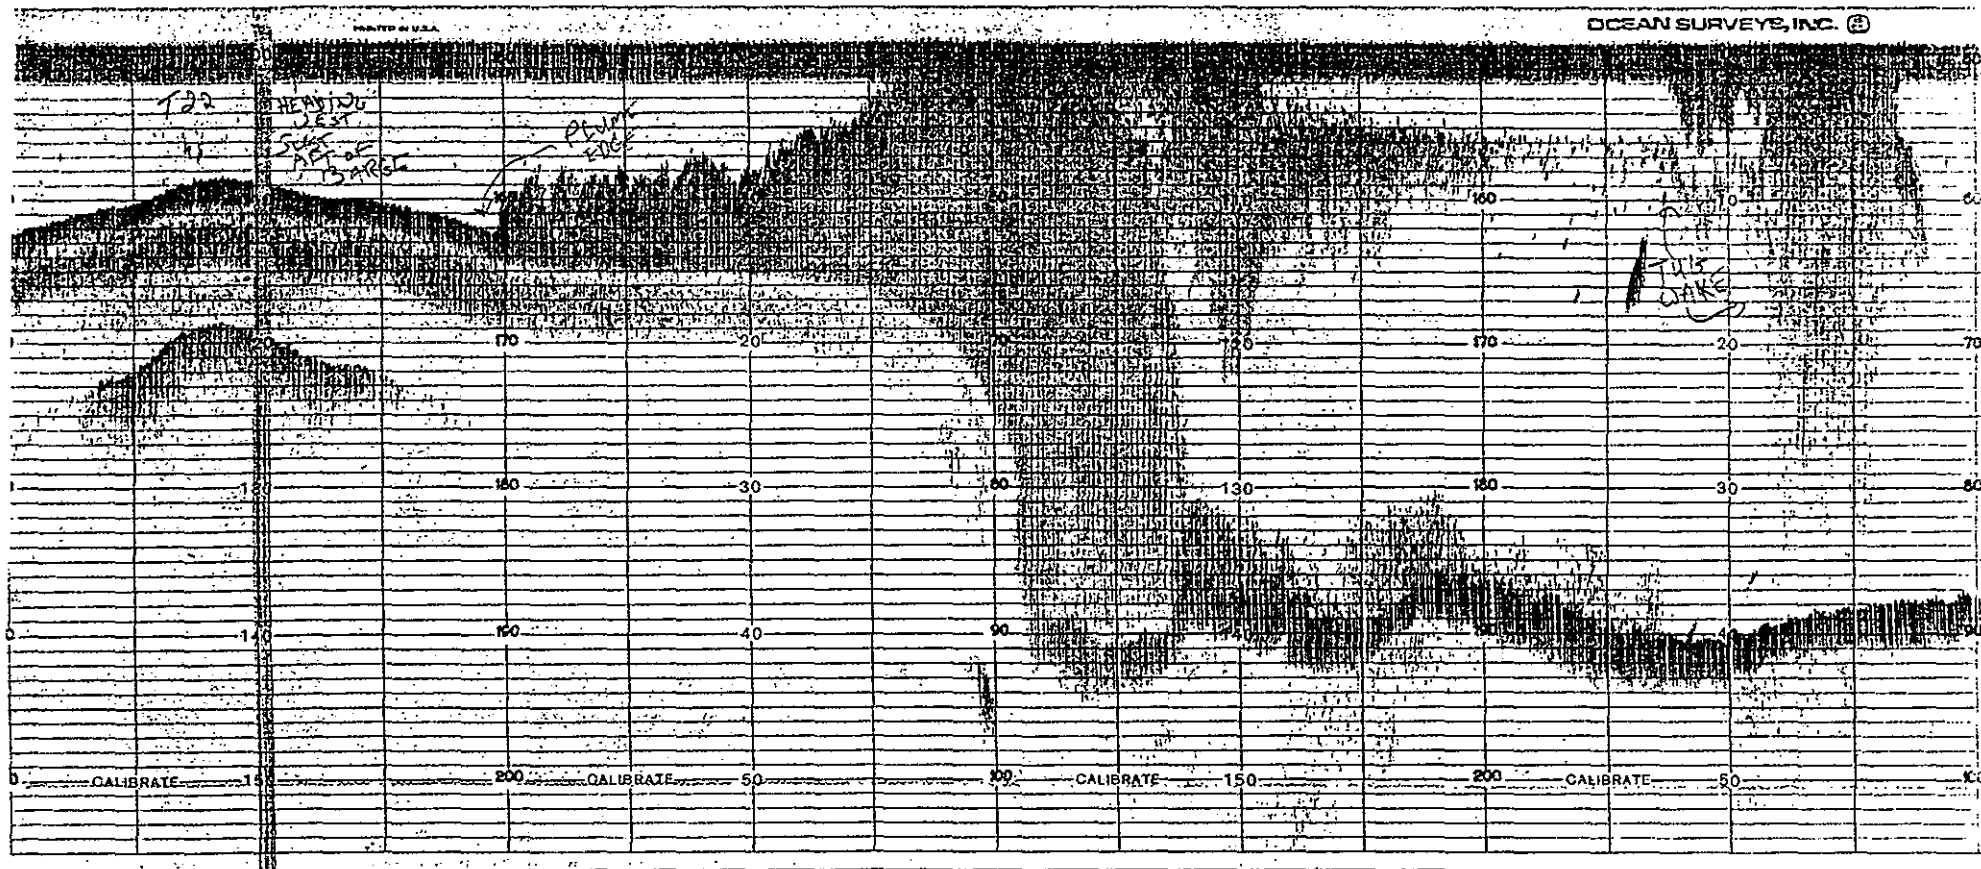
Figure 3-19.

Echo sounder trace from Transect #22, just aft of the barge on November 11, showing an example of the dredged sediment plume with characteristics of a density current. Profile runs east to west.

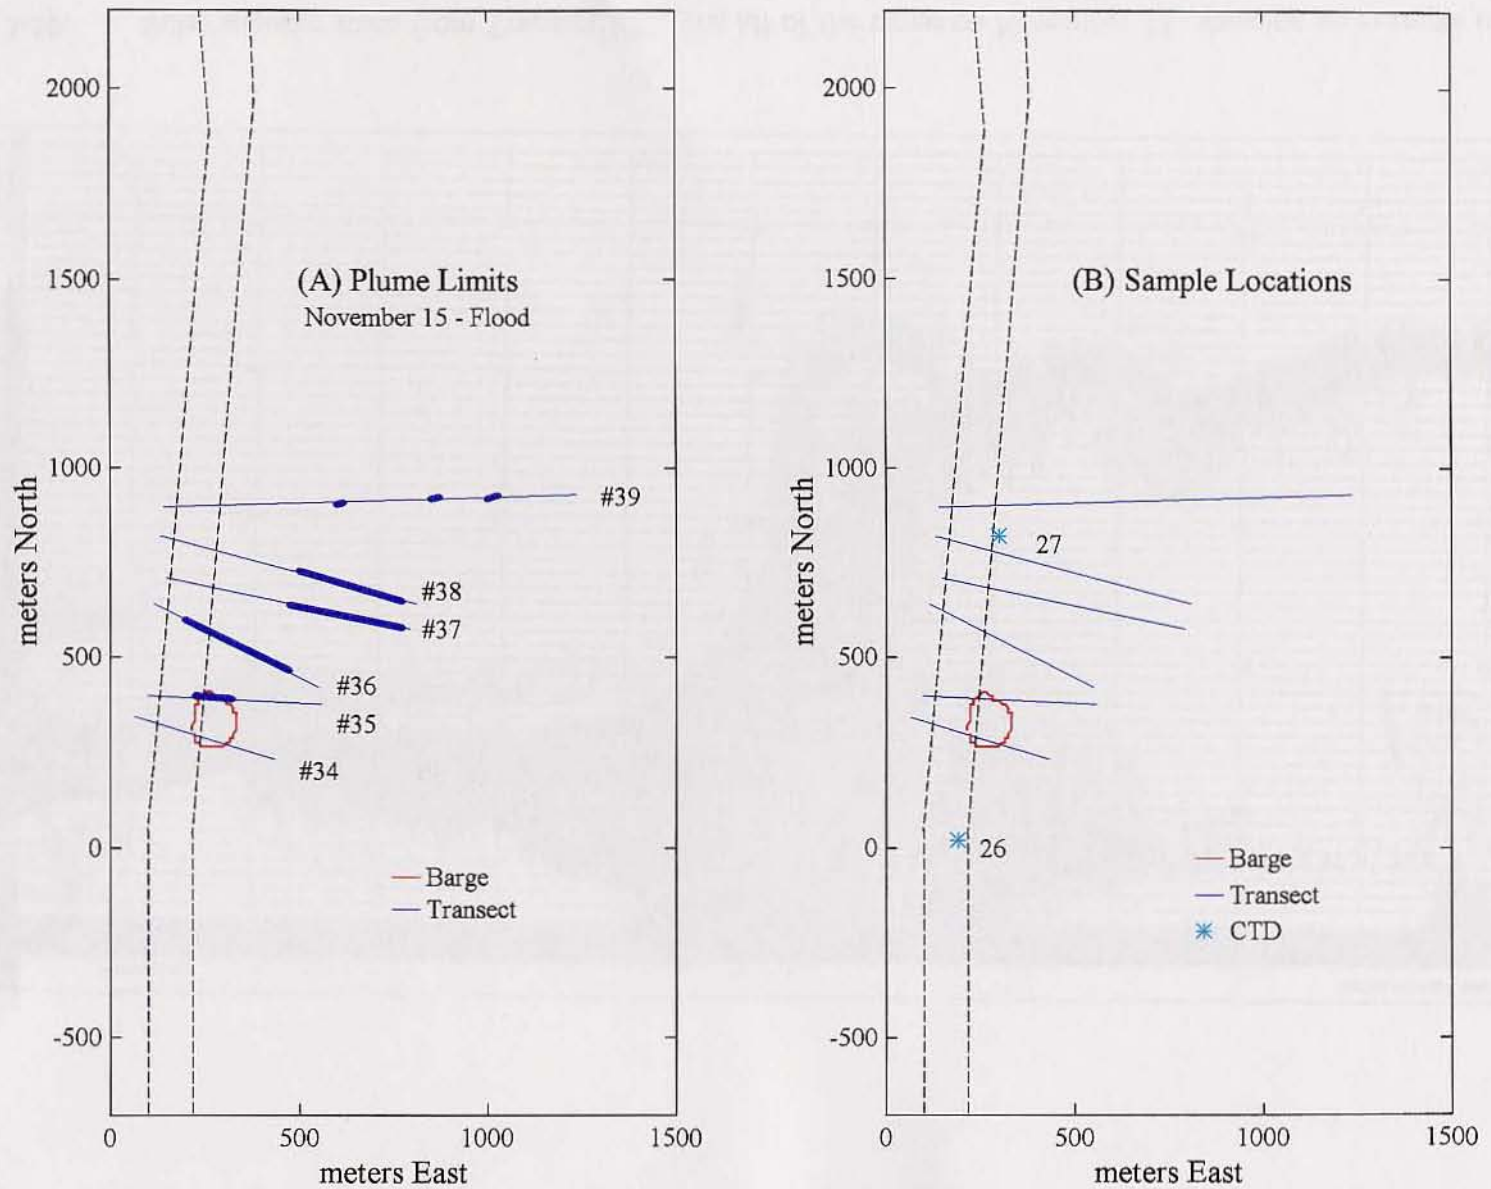
**Figure 3-20.** (A) November 15, 1993 barge position and transect locations with the occurrence of the plume delineated on each transect; (B) barge position and transects with the location of water samples

Only one survey near the end of the flood tide was attempted on November 15 due to deteriorating weather conditions (Figure 3-20). The barge was located to the west of Morris Cove on the eastern edge of the navigation channel. Patches of the plume were observed in the echo sounder record as far as 900 meters northeast of the barge, outside of the channel in Morris Cove (Figures 3-21). The plume protruded onto the shoals a maximum distance of 700 meters from the east edge of the channel. The CTD profiles show minimal vertical density stratification, indicating a homogenous water column. By the next day, November 16, the dredge had moved north about 300 meters, still along the eastern edge of the navigation channel (Figure 3-22). One survey was completed just before maximum ebb. Remnants of the plume were observed in Morris Cove, east of the channel, approximately 700 meters downstream of the barge (Figure 3-23). Plume traces were poorly defined and difficult to interpret during this survey. The CTD data, collected along the axis of the channel, show weak vertical and horizontal density gradients.

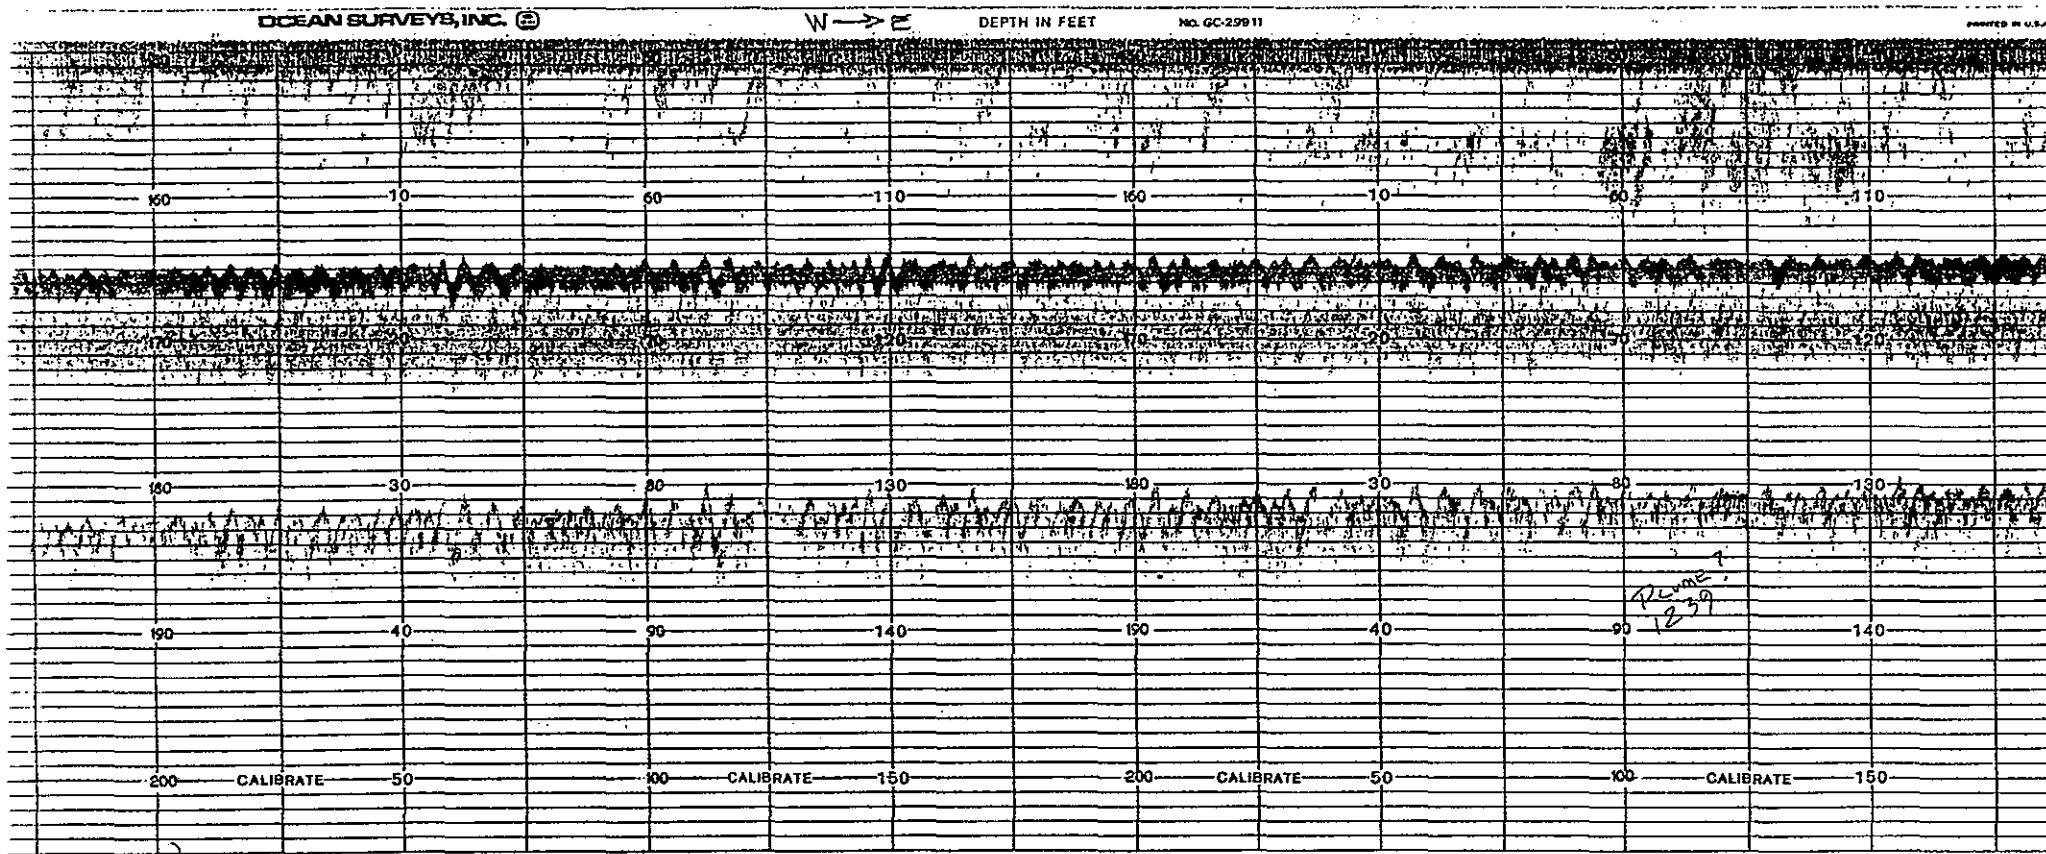
Figure 3-21. Patches of the plume observed in the shoal areas of Morris Cove, 650 meters northeast of barge operations. Profile is from Transect #39 recorded on November 15, and runs west to east.

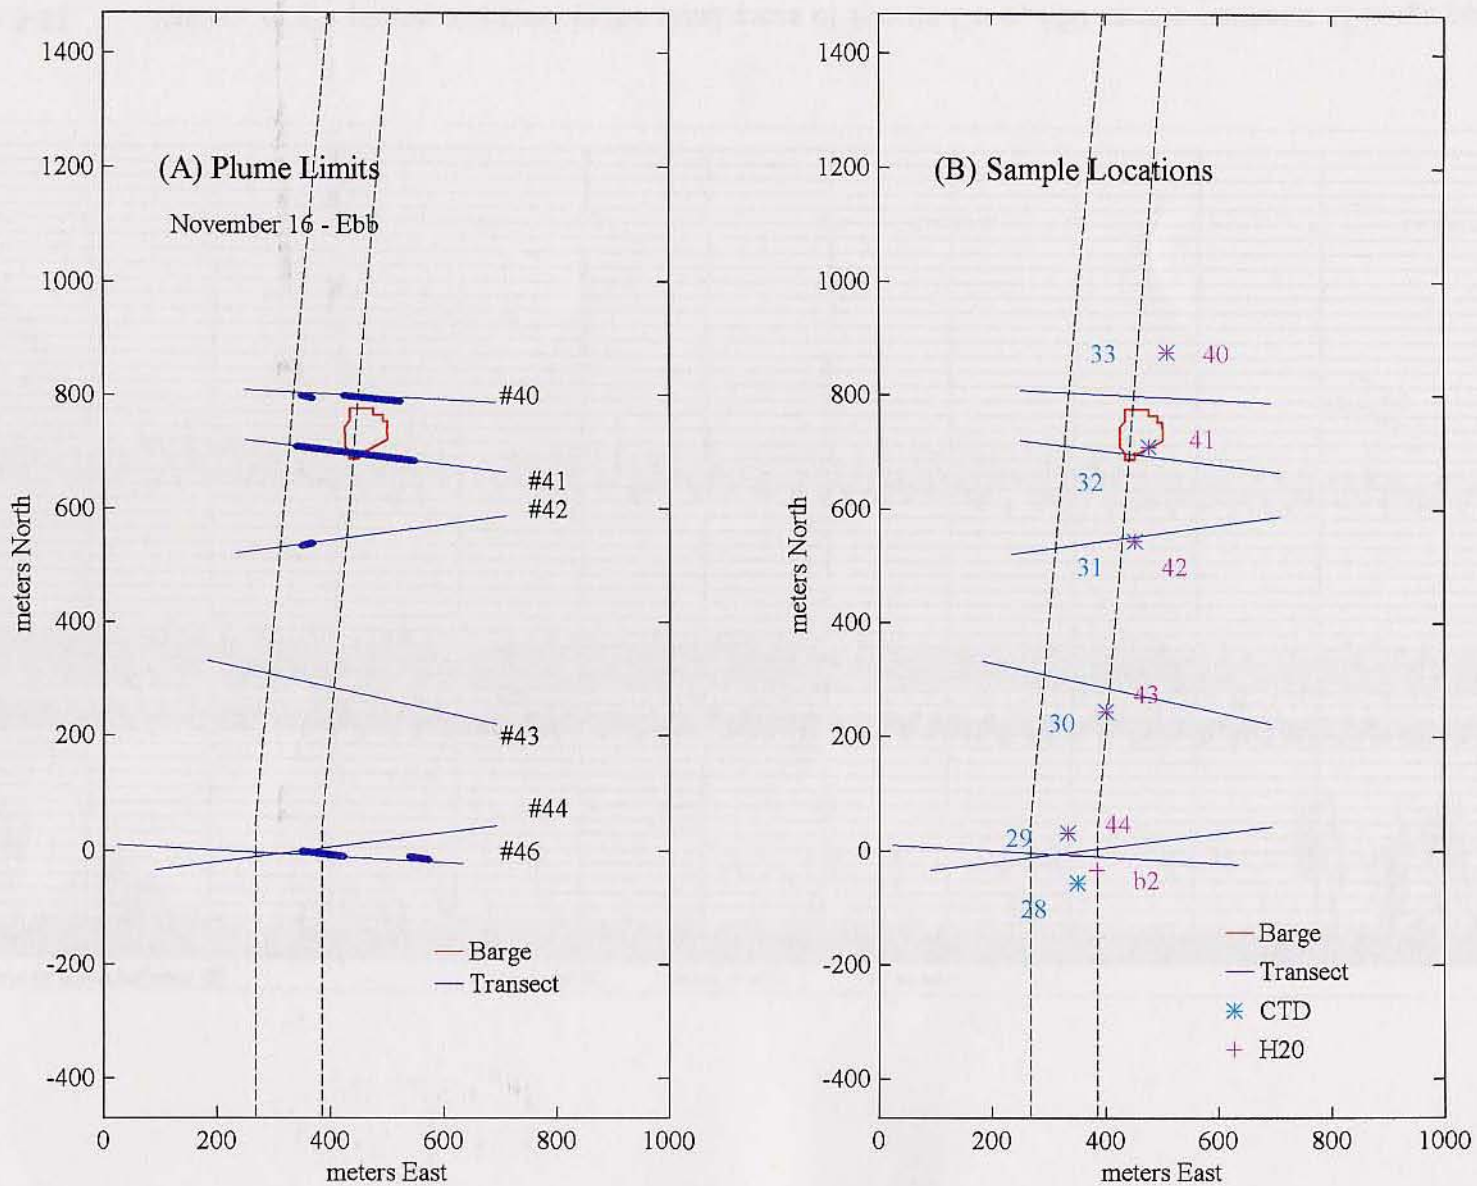
**Figure 3-22.** (A) November 16, 1993 barge position and transect locations with the occurrence of the plume delineated on each transect; (B) barge position and transects with the location of water samples

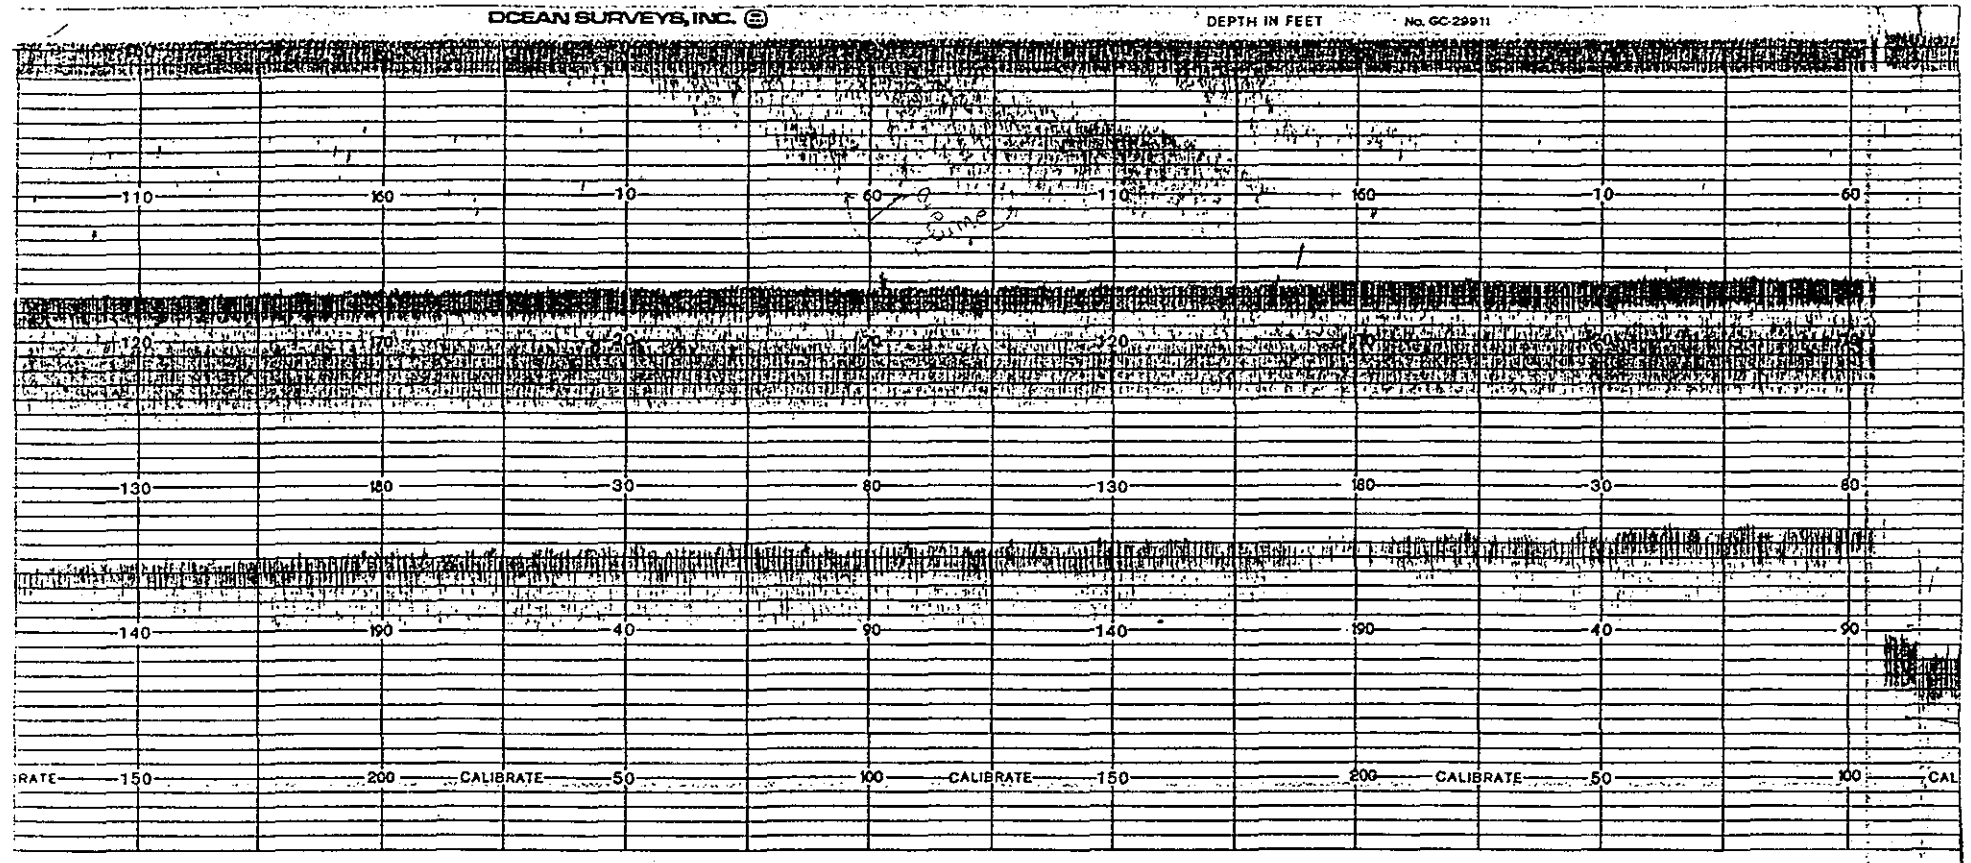
Figure 3-23. Patches of the plume observed outside of the navigation channel, in Morris Cove, 700 meters downcurrent of the barge. Profile is from Transect #46 recorded on November 16, and runs west to east.

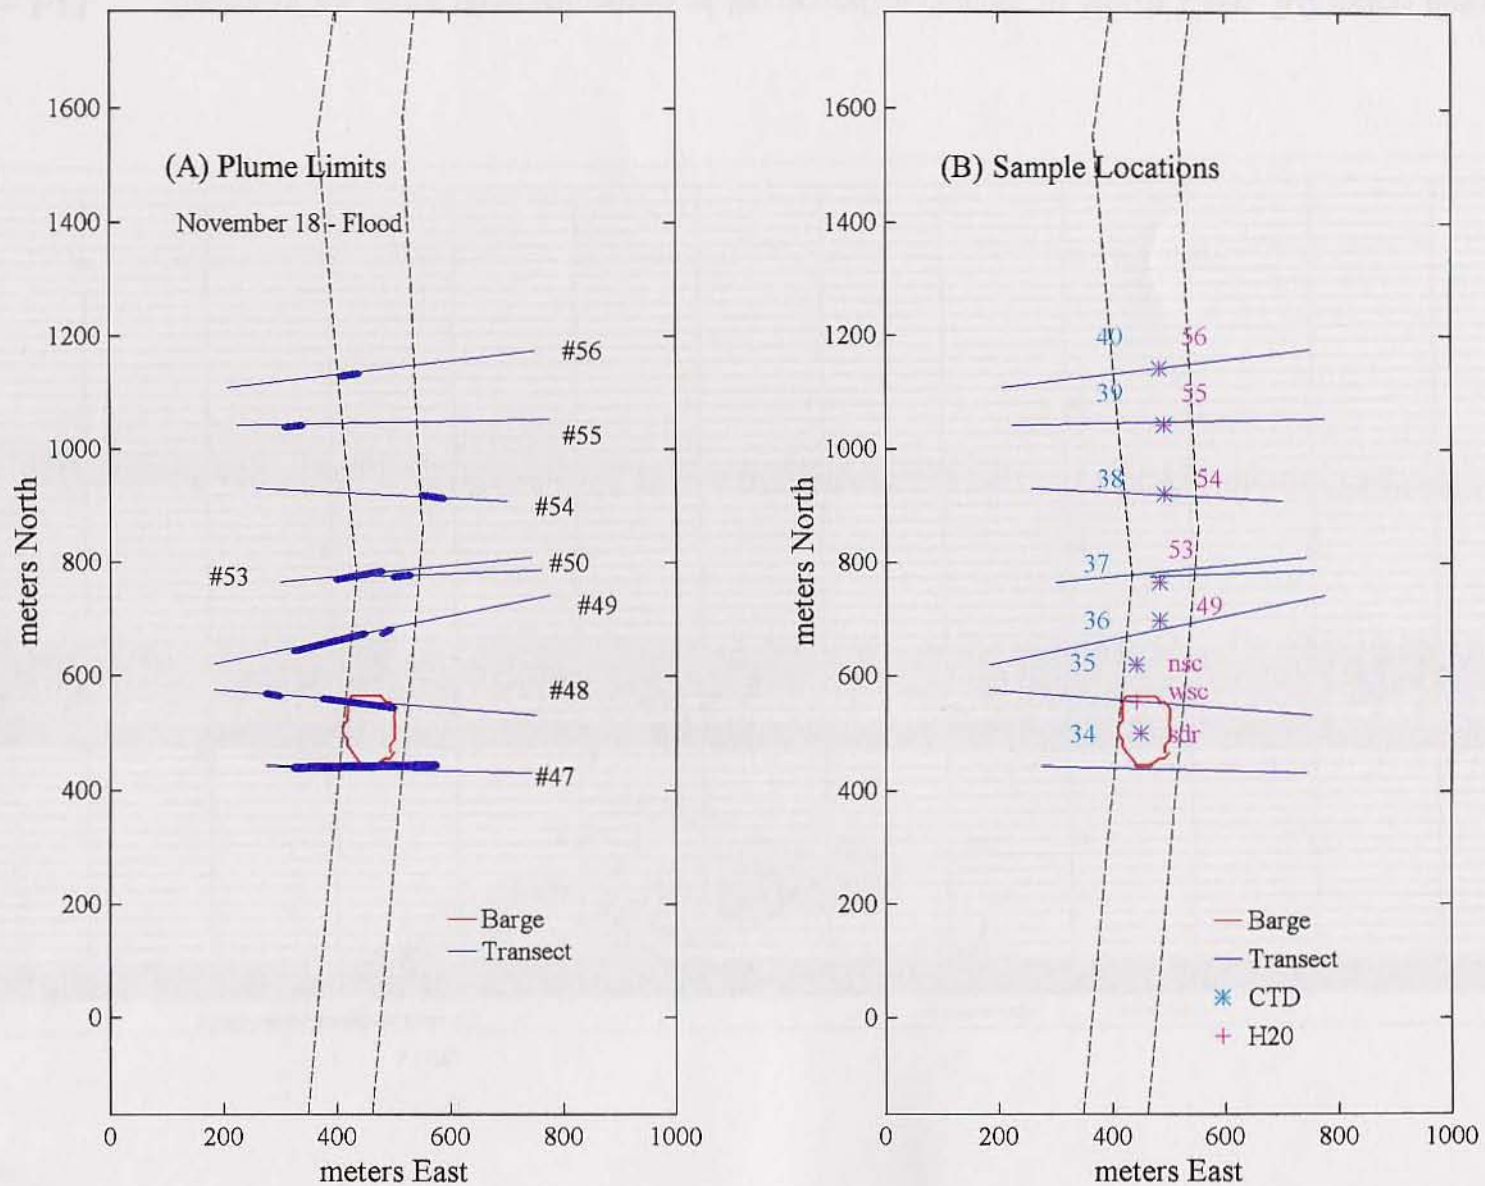
**Figure 3-24.** (A) November 18, 1993 barge position and transect locations with the occurrence of the plume delineated on each transect; (B) barge position and transects with the location of water samples

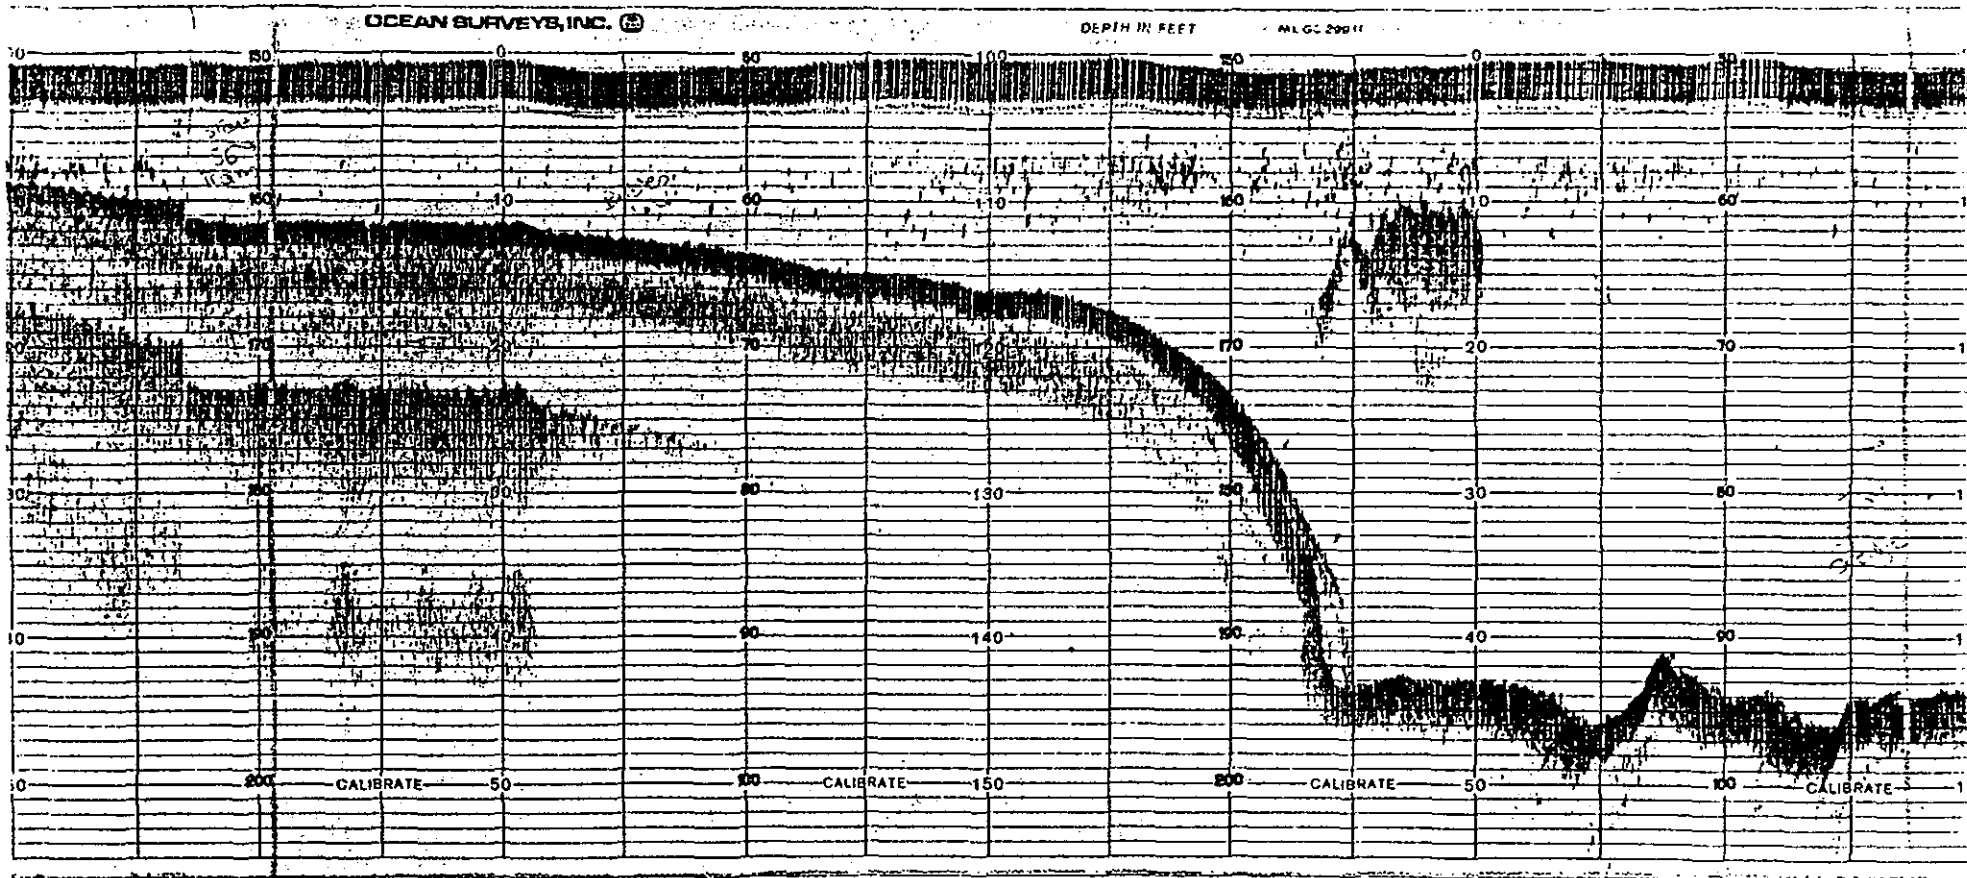
**Figure 3-25.** Traces of the plume observed 575 meters downcurrent, on the eastern side of the channel. Records are from traces obtained on November 18, Transect #56. Profile runs east to west.

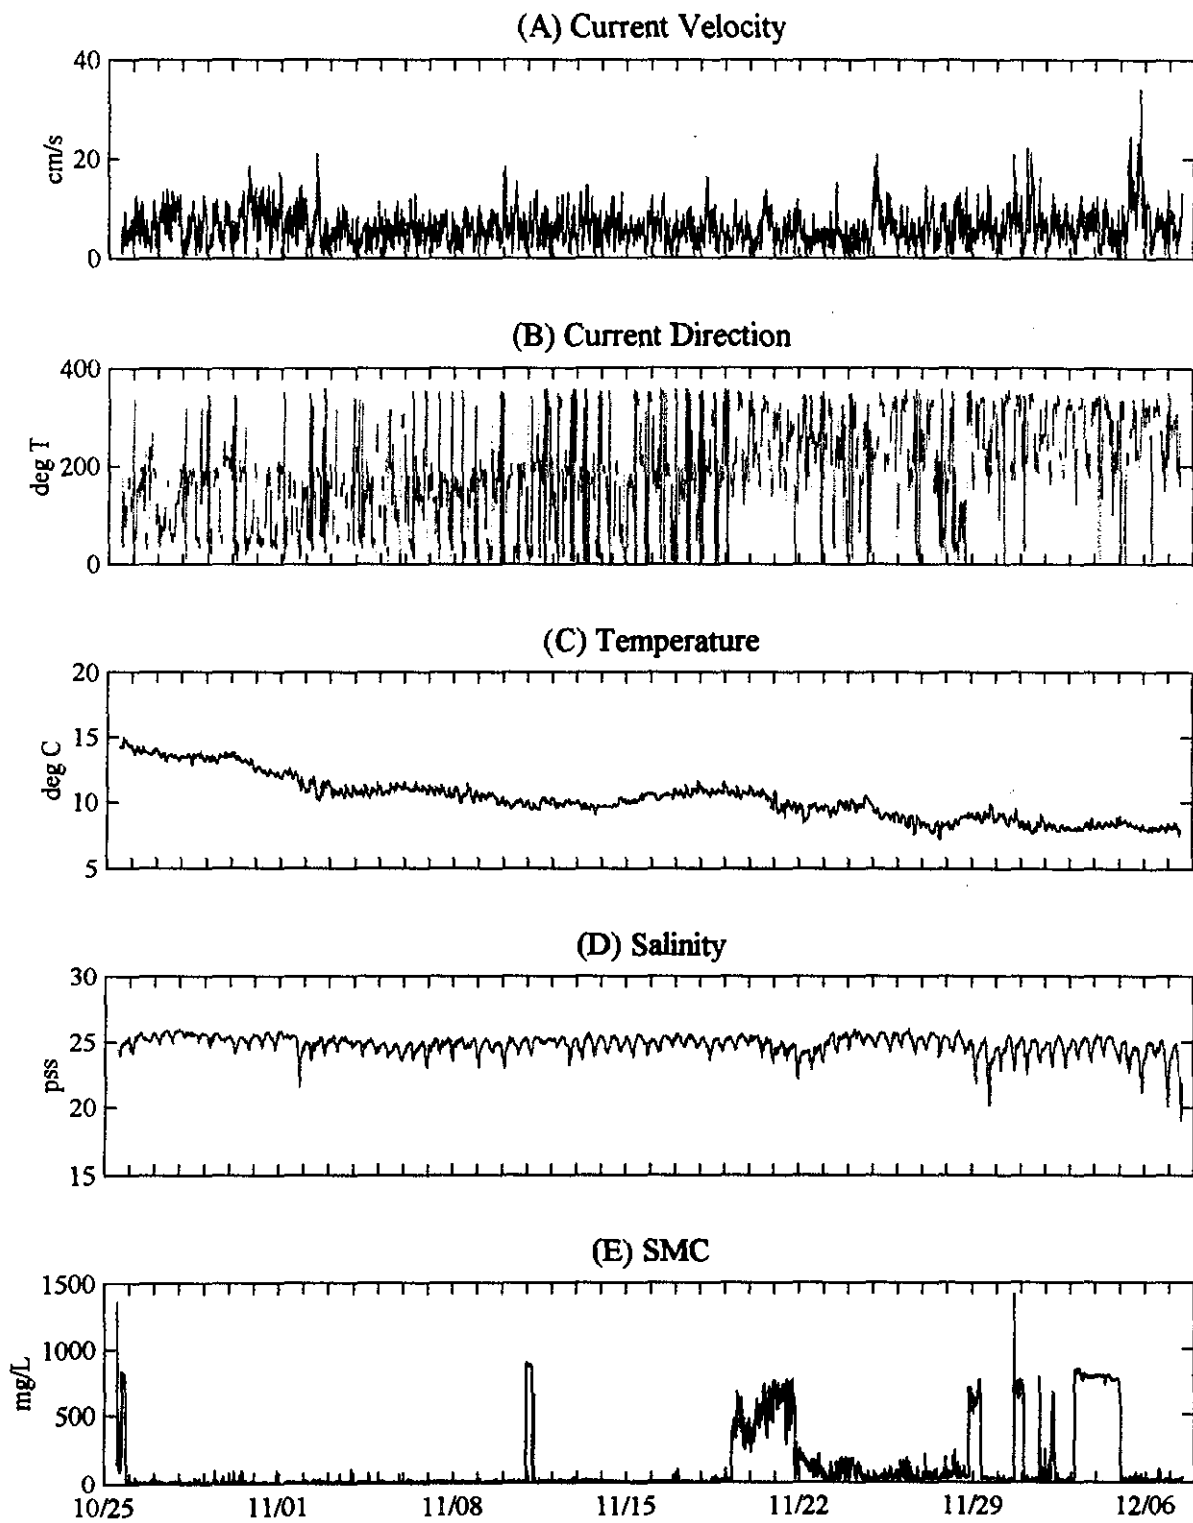
**Figure 3-26.** Time series plots for the complete DAISY deployment period, October 25 to December 7, 1993

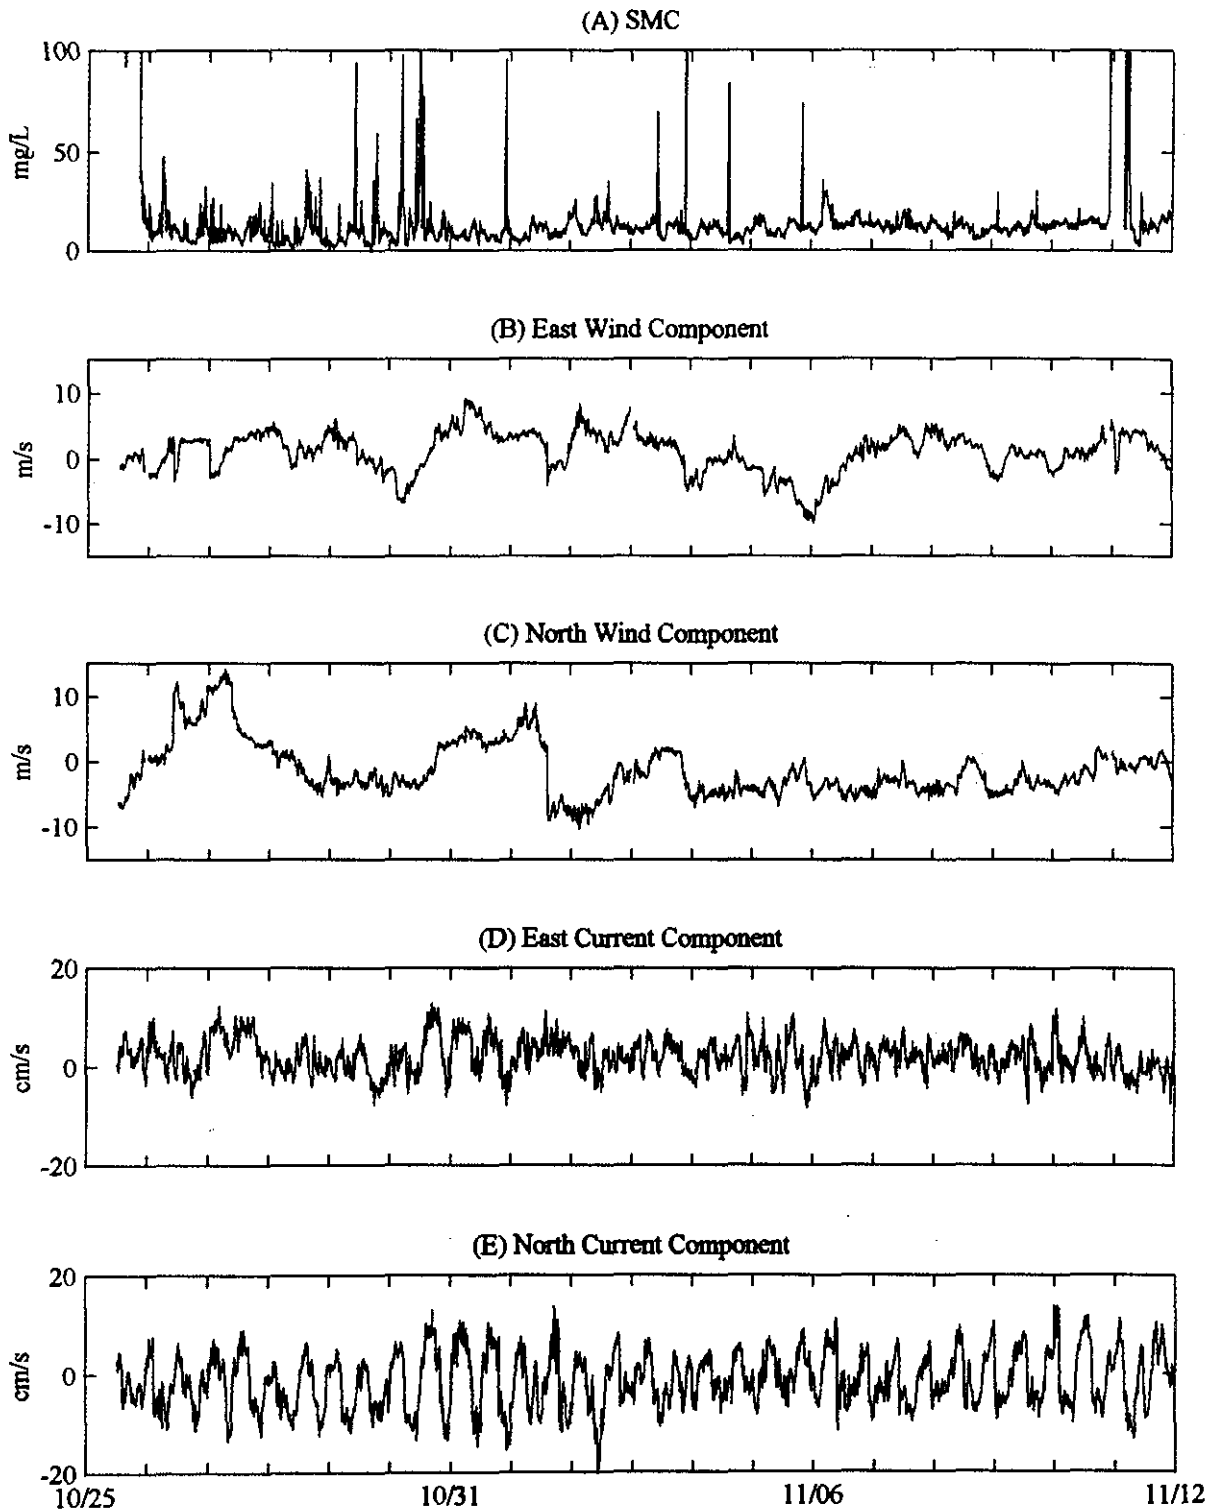
**Figure 3-30.** The suspended material concentration data compared with wind and current data for the first half of the deployment, October 25 to November 11, 1993

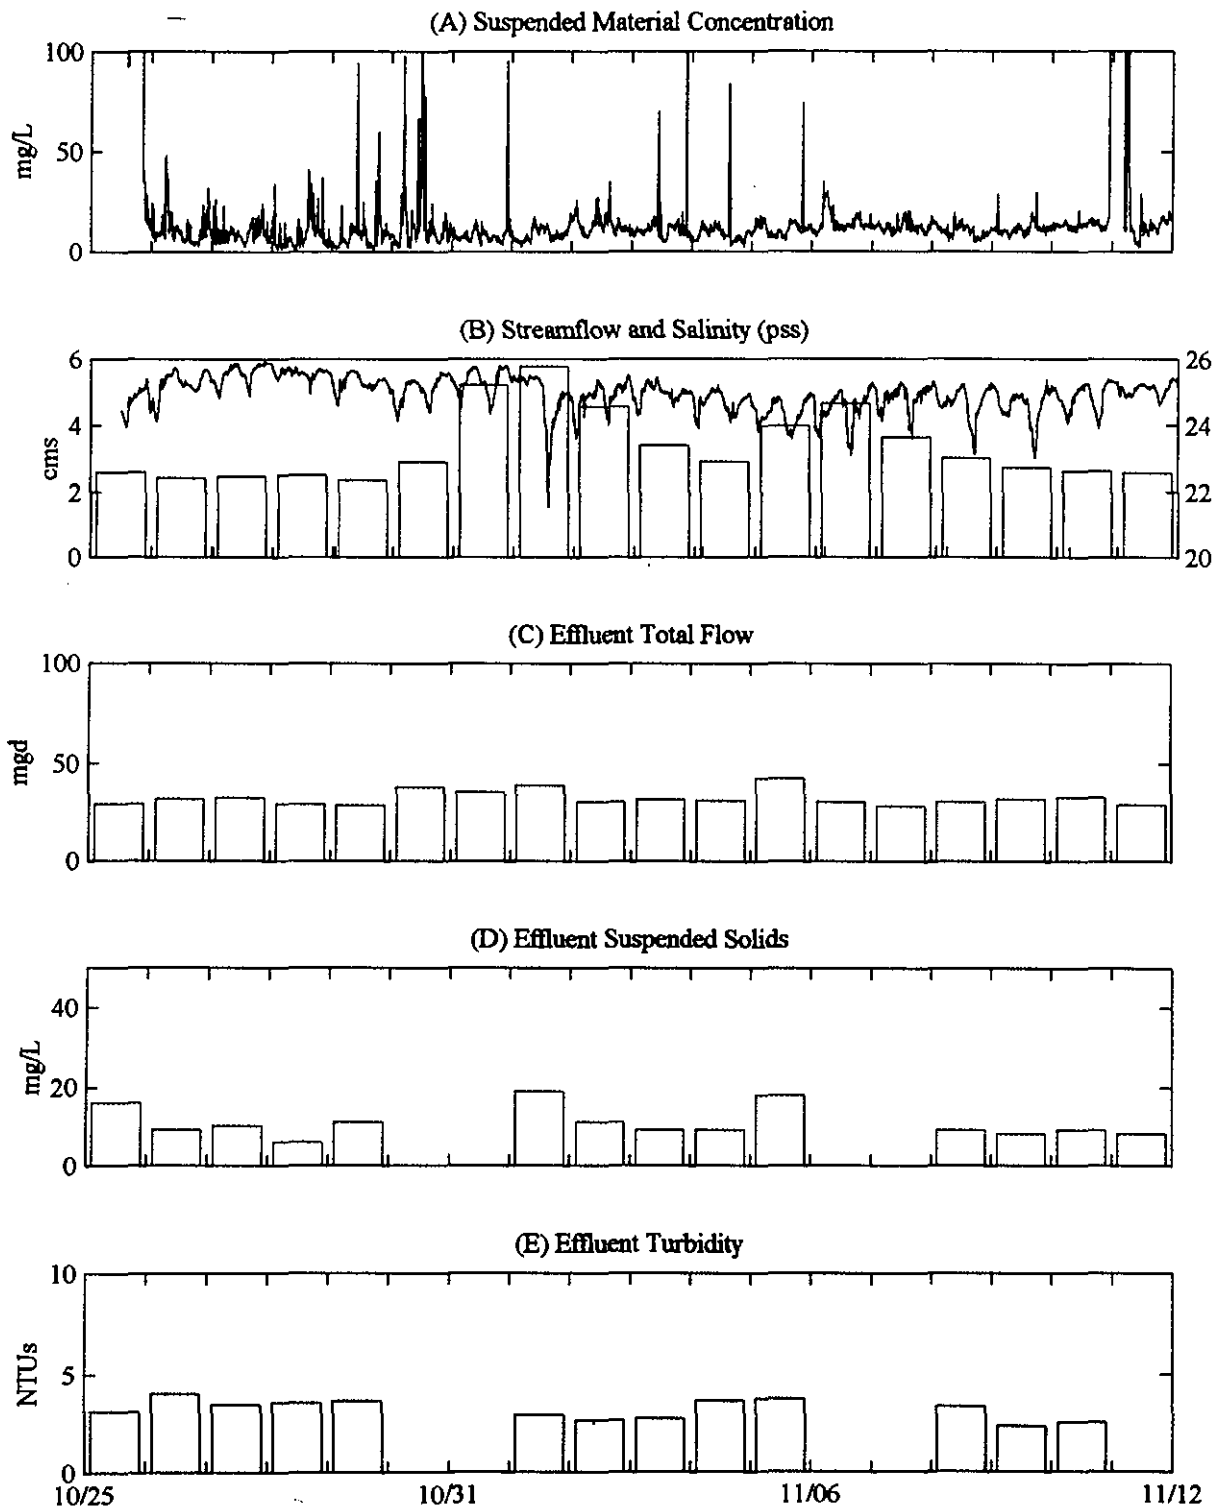
**Figure 3-31.** The suspended material concentration data compared with stream flow and effluent from the East Haven Pollution Abatement Facility for the first half of the deployment, October 25 to November 11, 1993

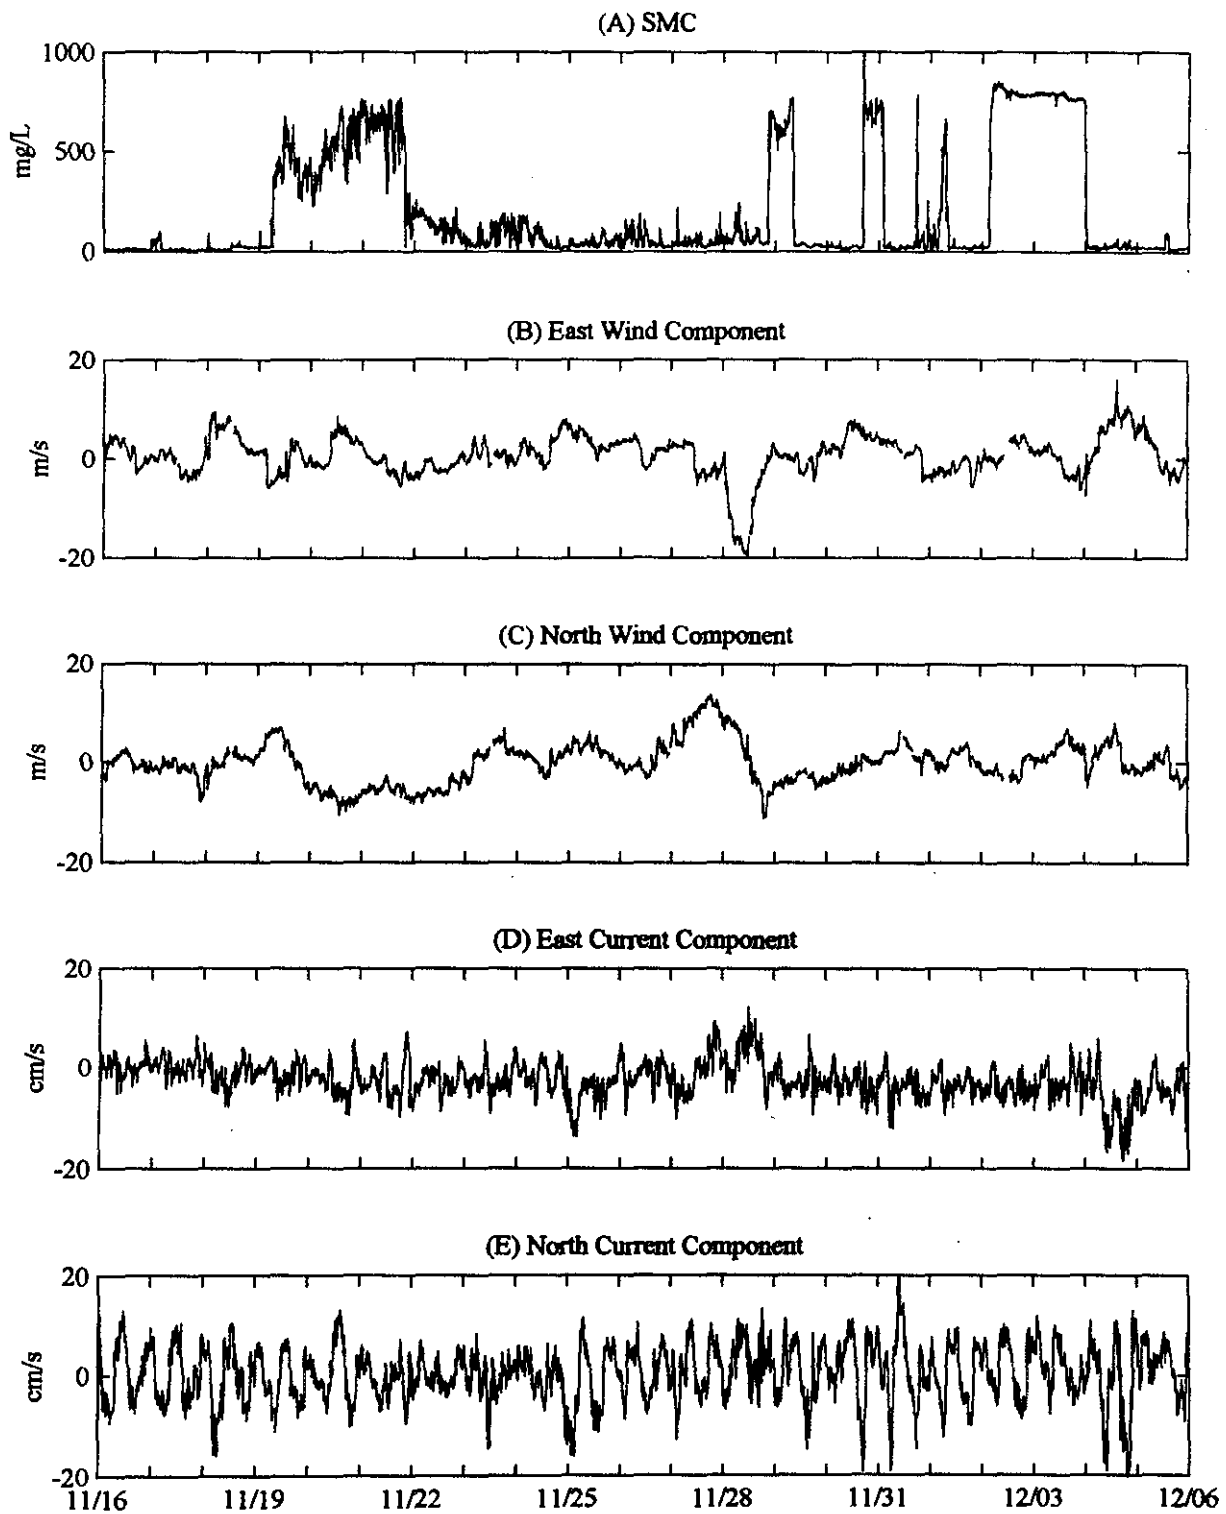
**Figure 3-32.** Enlargement of the period during which the largest SMC perturbations were observed, November 16 to December 6, 1993. Concentration data are compared with wind and current data.

During the latter half of the DAISY deployment period (November 11 to December 7, 1993) several major events are recorded in the suspended material concentration data. These disturbances differ substantially in character from those that were observed during the first part of the deployment. In contrast to the short duration, spiky perturbations of the first deployment, the perturbations of the second deployment were longer lived and significantly larger in amplitude. These events also had a residual effect in that the average background concentrations increased to near  $20 \text{ mg}\cdot\text{l}^{-1}$  (Figure 3-32; A).

The first sustained event, beginning on November 19, persisted for more than three days and increased concentrations to more than  $700 \text{ mg}\cdot\text{l}^{-1}$ . These concentrations exceed the maxima indicated by water samples taken in the vicinity of the operating dredge (Table 3-3). The dredge was working in Reach 5, 1 km south of the DAISY site. We believe this perturbation was not simply the result of dredge-induced resuspension. Even when the barge was operating much closer to the DAISY (Figures 3-6; A, 3-9; A, 3-10; A), resuspension events of this magnitude were not observed in the data (Figure 3-30; A). The dredge did move into Reach 2 on November 21, and may have contributed some amount of material to the final day of the event and possibly slowed the recovery of the system. Again, both the echo sounder and DAISY data indicate that the dredging process is incapable of producing such large amplitude and persistent perturbations at any site removed from the immediate dredging point. A more typical data record would show the sharp short-duration spikes in the suspended material concentrations (as seen in the first part of the deployment), not the long duration, high concentrations records observed here. There is no indication of increased stream flow (Figure 3-31; B) contributing to the suspended material field. However, effluent data from the nearby East Shore Water Pollution Abatement Facility (Figure 1-1) does show a significantly higher discharge of suspended solids (Figure 3-33; C) on November 19, a Friday, which could be the source material for the event. Records are not kept on weekends at the municipal facilities, and it may be that the higher than average effluent flow continued

After November 21 suspended material concentrations decreased from the maxima, although instantaneous values often exceeded  $100 \text{ mg}\cdot\text{l}^{-1}$  resulting in average values significantly above the pre-perturbation levels. Included in this portion of the record are several short duration perturbations most probably caused by the inshore migration of materials resuspended by dredging in progress within Reach 2. Again, the majority of the perturbations during this period show characteristics different than those expected for dredge-induced perturbations. This may be the result of a residual effect from the previous three-day event, increasing the overall background concentrations.

On November 29 another large amplitude perturbation was observed, persisting for approximately 24 hours which does correlate with an increase in river discharge 3-5 times larger than the average flow. The salinity record shows a decrease of nearly 6 units on the practical salinity scale during the event (Figure 3-33; B). Records from the East Shore Water Pollution Abatement Facility (WPAF) do not indicate that there was a substantial contribution from this waste facility. However, there are 24 CSOs which discharge into upper New Haven Harbor; four of the largest ones are located south of the Tomlinson Bridge (Figure 1-1). Thus, although the data does not show significantly elevated effluent levels from the East Shore Facility, there may be a considerable contribution from the CSOs to the observed high concentrations. Potentially augmenting the increased river flow and CSO discharges, winds during the previous two days averaged above  $10 \text{ m}\cdot\text{s}^{-1}$ , and reached maximum speeds of  $20 \text{ m}\cdot\text{s}^{-1}$  from the south. There is enough fetch to produce waves that would resuspend sediments at 4 meters depth, which then would have settled as the winds dropped and shifted to the north throughout the following day, possibly contributing to the high concentrations recorded. There is a similar event which occurred during the latter part of the day on November 30, again, possibly the result of stream flow 1.5 to 2 times higher than average, increased CSO input, and northerly winds.

The final and highest concentrations recorded during the entire deployment period spanned two days—December 2 and 3. No major stream flow events were recorded during this time. Winds were initially northerly but shifted to the east during the second day with speeds less than  $10 \text{ m}\cdot\text{s}^{-1}$ . There appears to be no significant contribution from the East Shore WPAF effluent. Although a northerly wind seems to have induced elevated suspended material concentrations in previous events, it is not likely that the winds produced the observed increase during this two-day period. A  $700 \text{ mg}\cdot\text{l}^{-1}$  perturbation, persisting for
