An Investigation of the Dispersion  
of Sediments Resuspended by  
Dredging Operations in New Haven Harbor

# Disposal Area Monitoring System DAMOS

Contribution 112  
November 1996

**US Army Corps  
of Engineers**  
New England Division

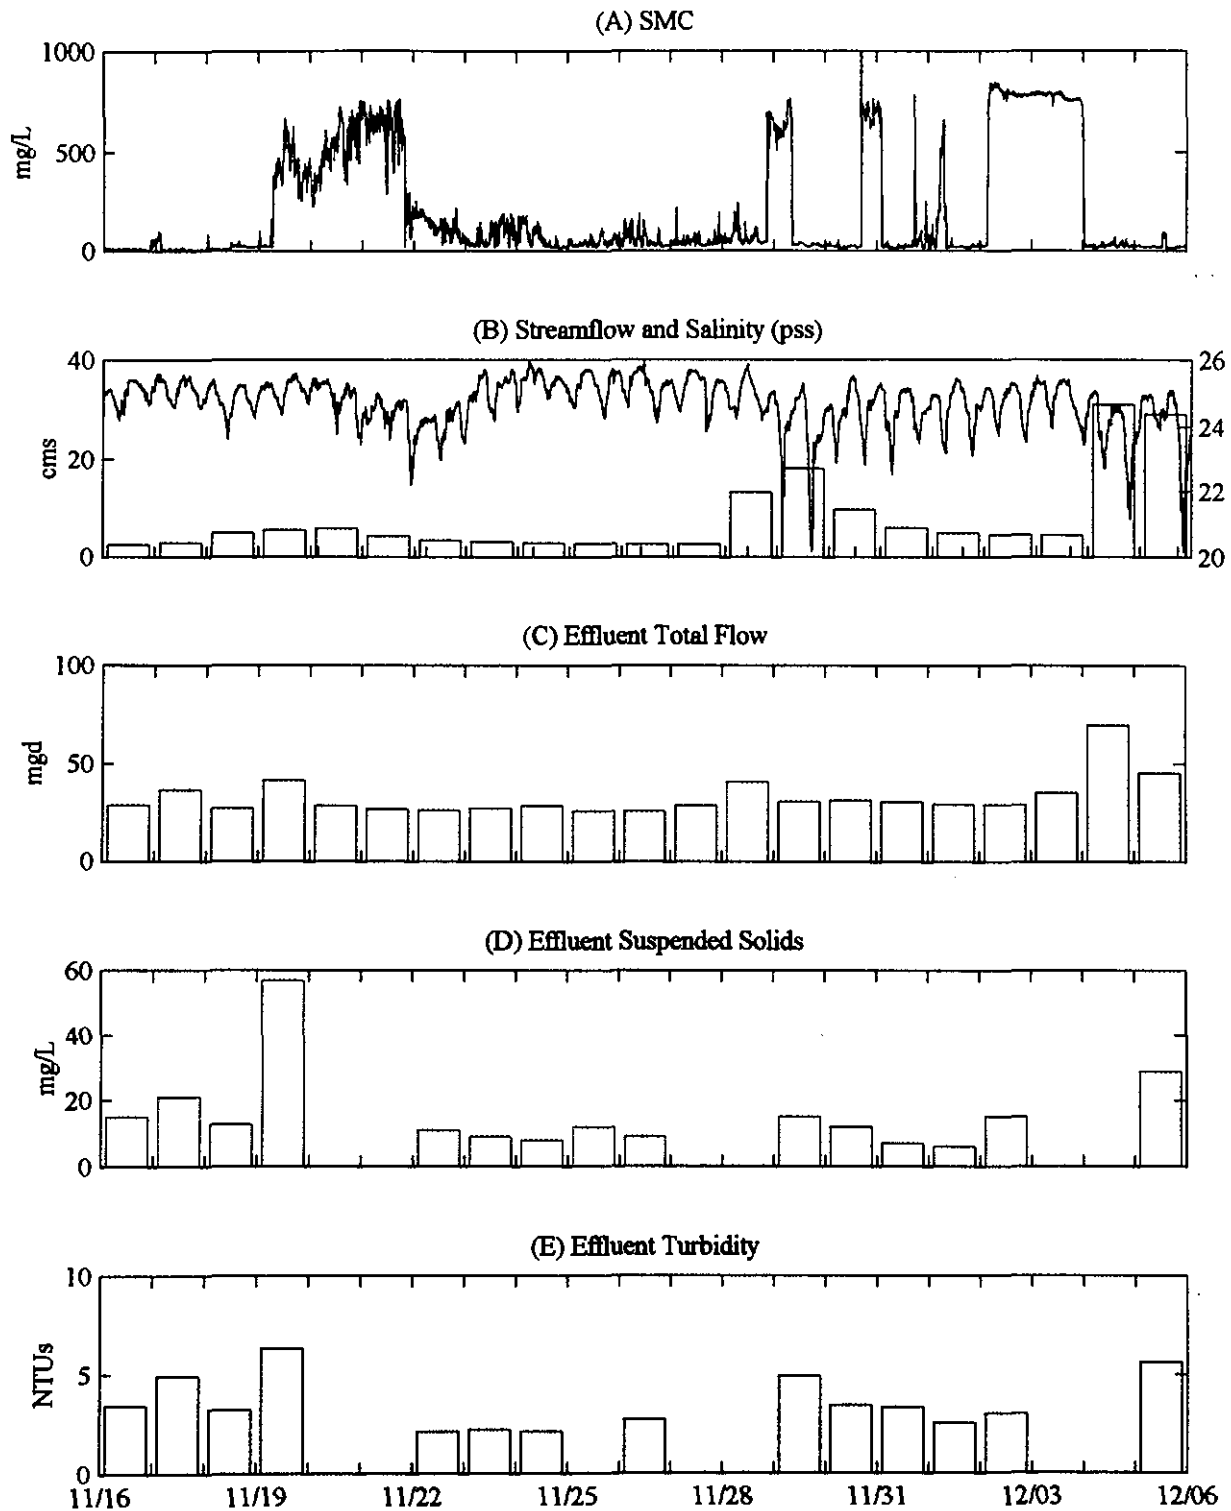
**Figure 3-33.** The suspended material concentration data compared with stream flow and effluent data obtained from the East Haven Pollution Abatement Facility for the period November 16 to December 6, 1993
