Monitoring Cruise  
at the Boston Lighthouse Disposal Site,  
August 1994

Contribution 113  
August 1996

US Army Corps  
of Engineers  
New England Division

Report No.  
SAIC No. 328

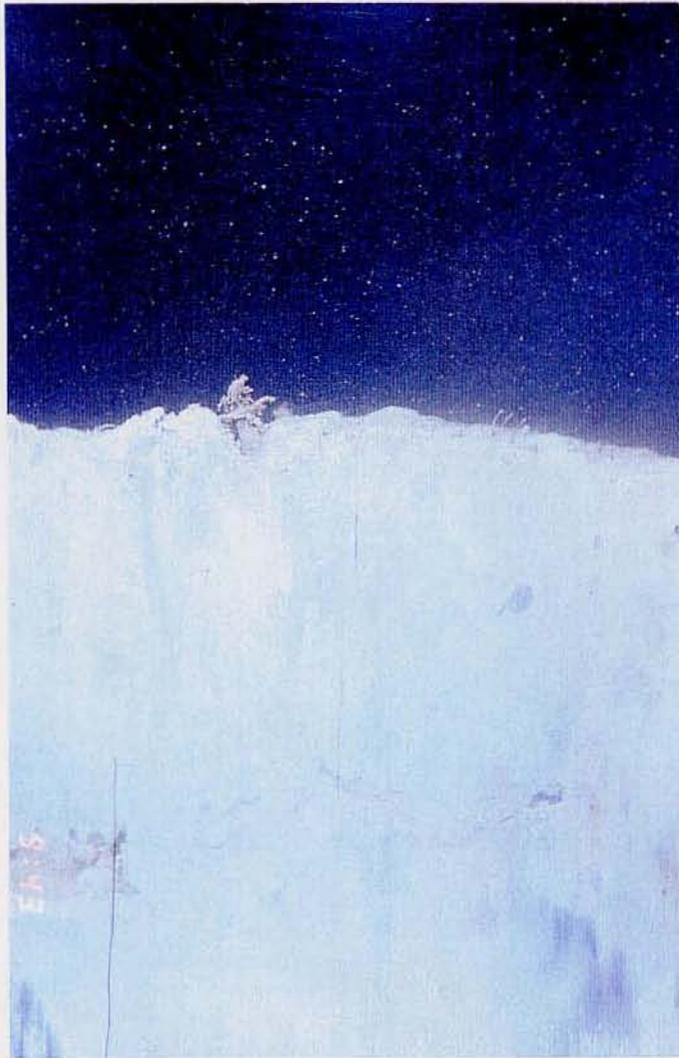
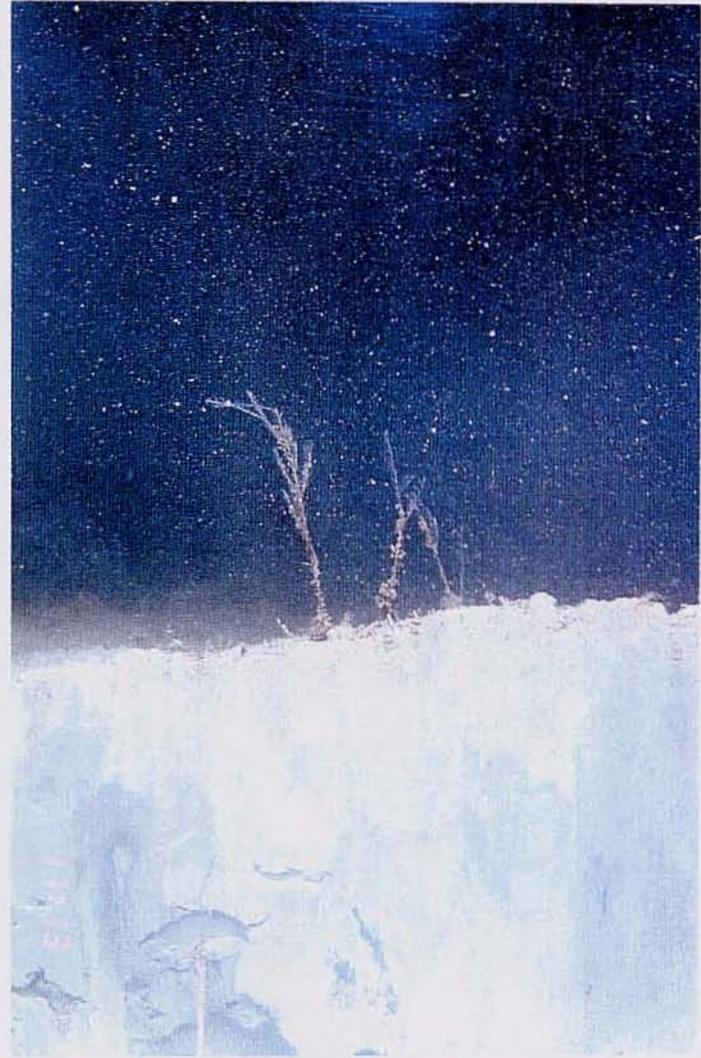
**Figure 3-2.** Light gray, high reflectance Boston Blue Clay located at Stations C3-10 (A) and C2-7 (B). Note the large pellet-filled burrow (A) and the actively feeding Stage III polychaete (B).

Dredged material was observed at five of the six transects sampled (Figure 3-1; Appendix). Dredged material in the REMOTS® photographs appeared in two forms: 1) dark silty material typically found in dredged material throughout New England and 2) Boston Blue Clay (Figure 3-2, A and B). Boston Blue Clay, formed from silt and clay particles in glacial melt water, is a common constituent of material dredged from Boston Harbor (Camp, Dresser, and McKee, Inc. 1991). In most cases dredged material appeared as a horizon below a sandy mud layer of reworked sediments several centimeters thick and extended below camera penetration (Figure 3-3). However, in two instances (Figure 3-2, A and B) the sandy layer was very small or absent, and dredged material was near the sediment-water interface.

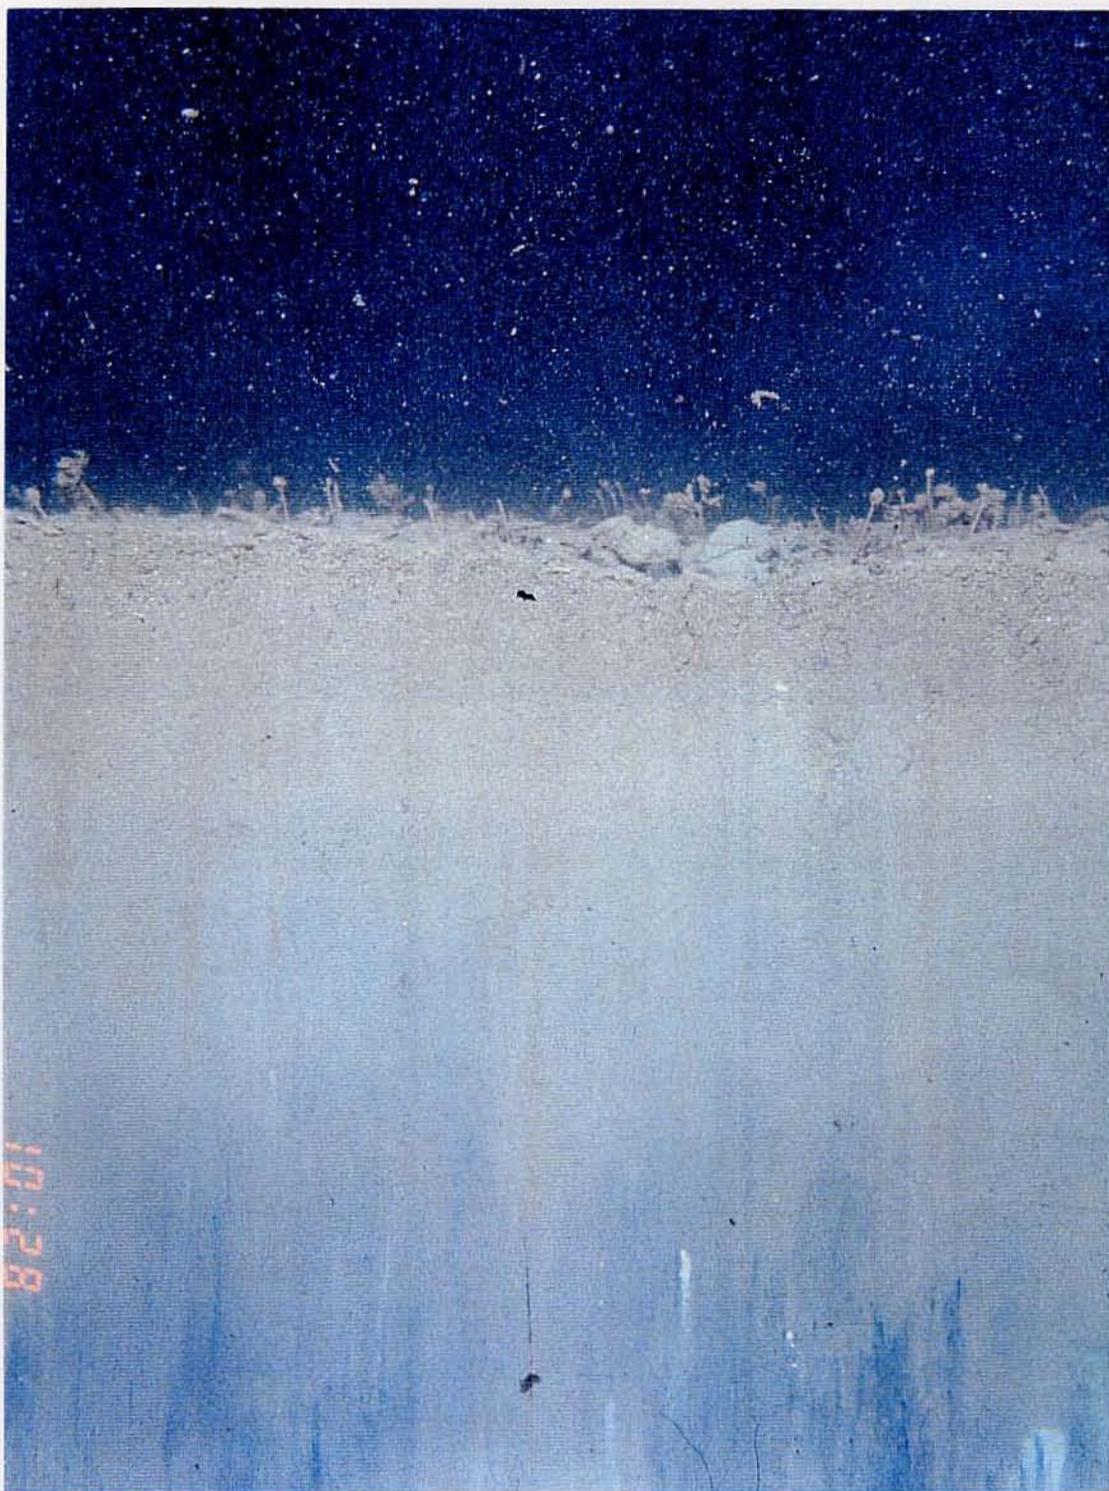
**Figure 3-5.** Example of a thick RPD (4 cm) observed at Station C3-1

shallowest RPD depth measured was 0.73 cm, and the deepest was 4.76 cm (Figure 3-5). Because of shallow camera penetration, the RPD was deeper than penetration and could not be measured in 11 photographs. Of these eleven photographs, prism penetration ranged from 0.5 to 2 cm in 4 photographs, 2 to 3 cm in 6 photographs, and greater than 8 cm in one photograph.

Despite the healthy benthic community at BLDS, the RPD values are relatively shallow. Normally, the combined activity of the subsurface burrowing Stage III organisms, the sedentary tube-dwelling polychaetes, and surface-dwelling Stage II infauna served to transport oxygen into the sediments resulting in relatively deep RPD depths. While irrigating their tubes, sedentary tube-dwelling polychaetes pump high dissolved oxygen concentration seawater out of the tube bottoms directly into the sediments, forcing a unidirectional upward displacement of interstitial fluid. However, the net diffusion of dissolved oxygen from seawater injection and subsequent advective porewater transport will be less where there is high sediment oxygen demand (SOD). With high SOD, oxygen that is transported across the sediment-water interface is rapidly consumed by microbial respiration and oxidation reactions. The observed RPD depths of only a few centimeters at BLDS, combined with a well-established infaunal deposit-feeding community (Figure 3-5), suggest that BLDS sediments have relatively high SOD.

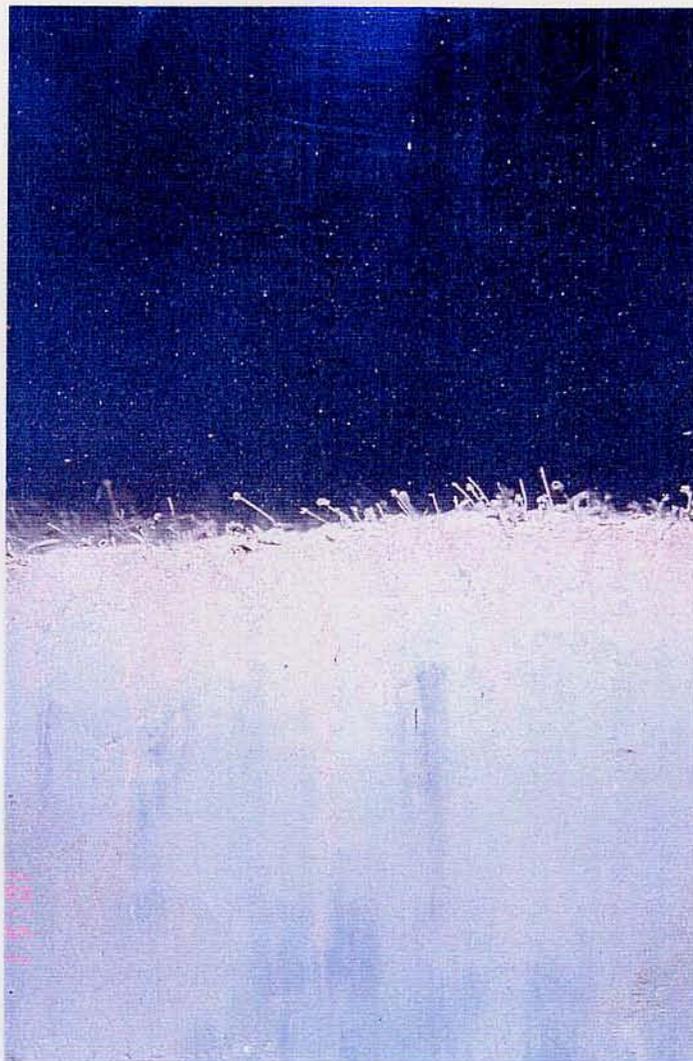
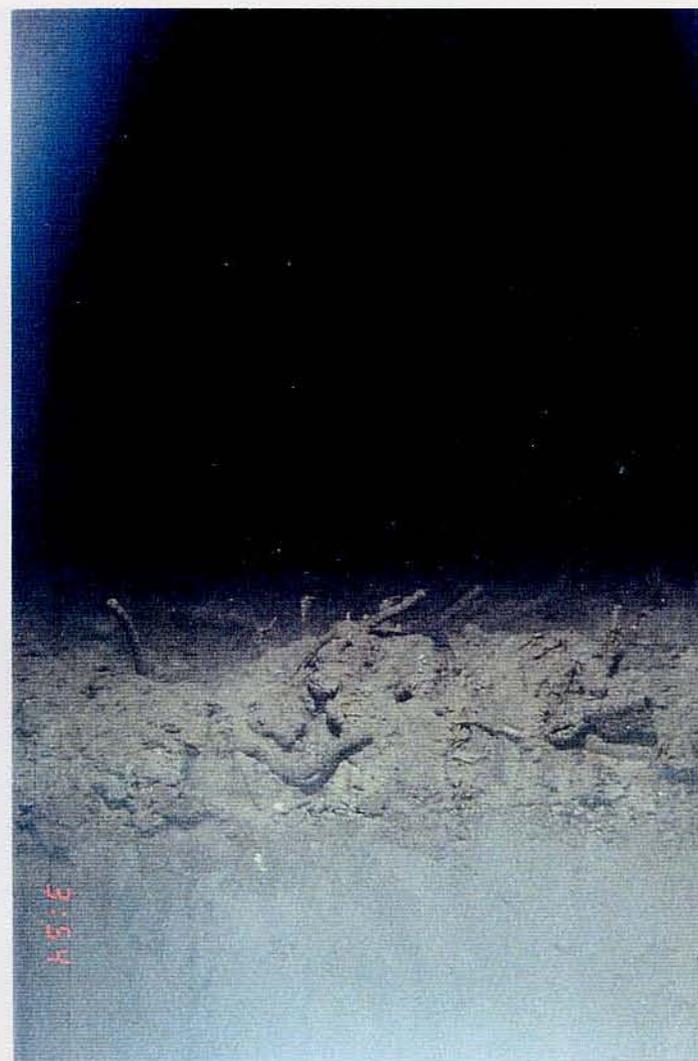
**Figure 3-6.** Surface sediments at BLDS colonized by Stage II “stick-building” amphipods (Family Podocercidae; A) and Stage III tube-dwelling polychaetes (B)

Sediments at BLDS contained a relatively robust benthic community. Infaunal communities were dominated by the Stage II-on-Stage III class. Surface sediments at all stations were populated by stick-building amphipods (Family Podocерdiae; Figure 3-6, A). Sedentary polychaete tubes extended above the sediment-water interface at varying densities throughout the study area (Figure 3-6, B). Below the surface Stage II community, evidence of an abundant Stage III community was commonly observed as burrowing polychaetes (Figures 3-3 and 3-2, B) and/or subsurface feeding voids (Figure 3-7). Pelletized sediments, indicative of actively feeding infauna, were found near the sediment-water interface as well as inside feeding voids. Infaunal species were not limited to polychaetes; a bioturbating caudate holothurian *Molpadia oolitica* was photographed at C2-10 (Figure 3-8). In addition to infaunal species, several epifaunal species were observed including large mud anemones, hydroids, and bryozoans.

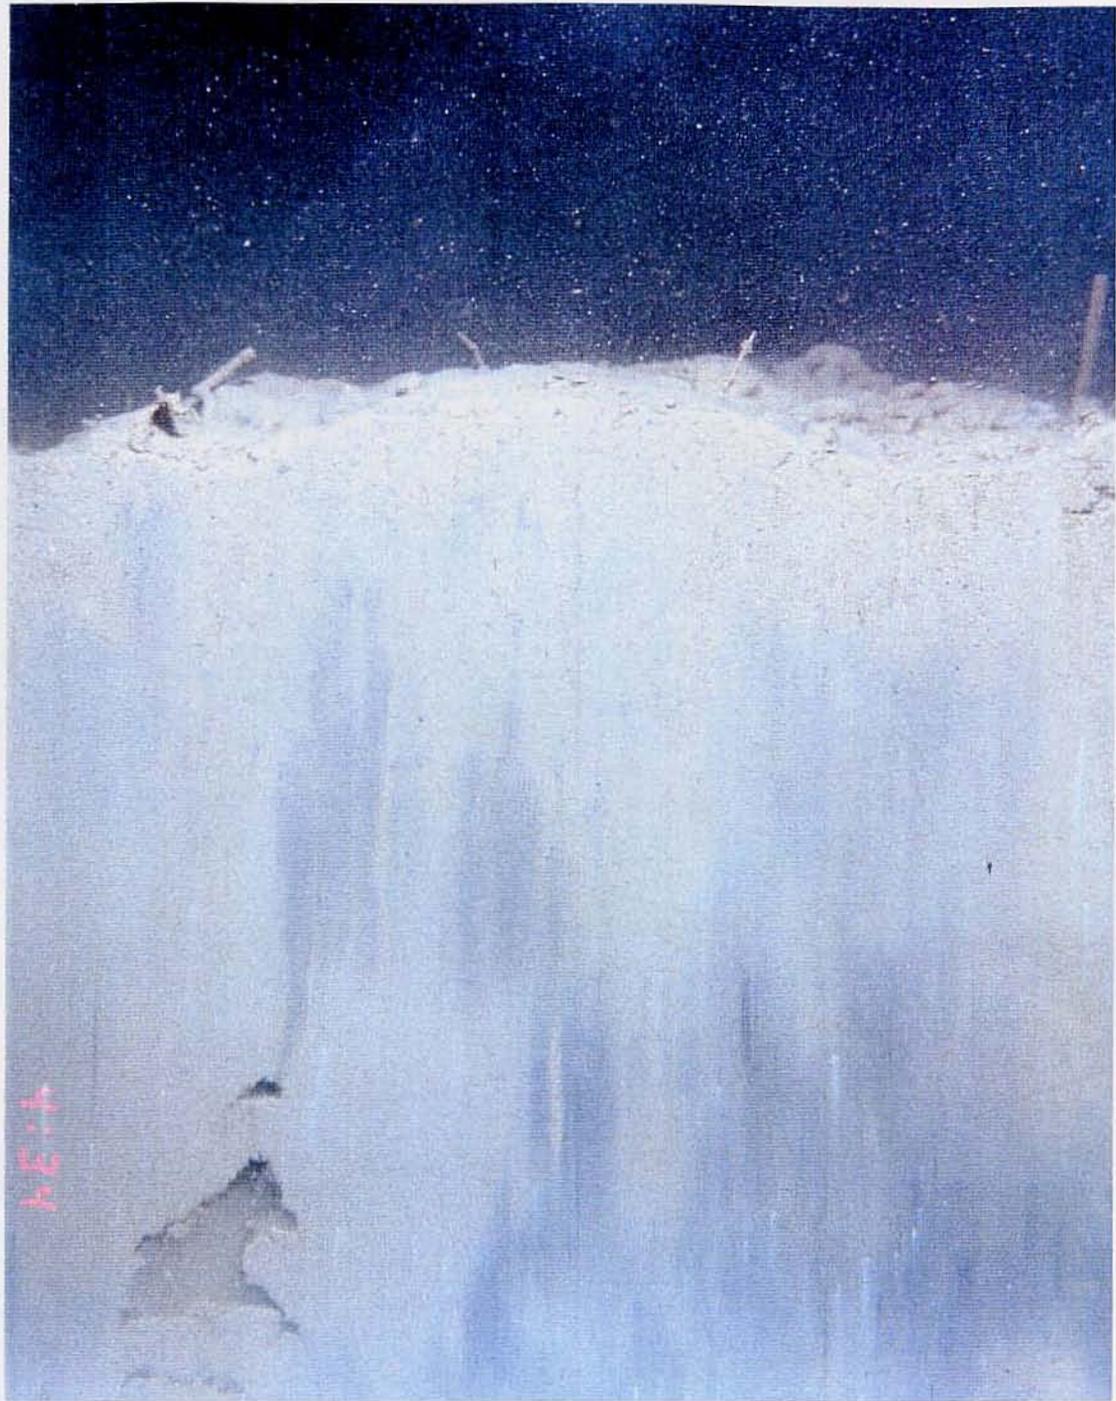
**Figure 3-7.** Water-filled feeding void below the RPD at Station C6-4; note the halo of oxygenated sediments surrounding the void

In addition to the abundant benthic community, several pieces of information from the sedimentary structure suggested a healthy benthic habitat has persisted for some time. Numerous water-filled voids were observed in subsurface sediments (Figures 3-2 and 3-7). These voids were created by the feeding activity of head-down deposit feeding Stage III organisms. A halo of oxidized sediments, which surrounded the voids, suggested recent

active feeding. In addition, several of the voids contained coarse-grained particles that were presumably discarded during particle-selective feeding habits (Figure 3-7).

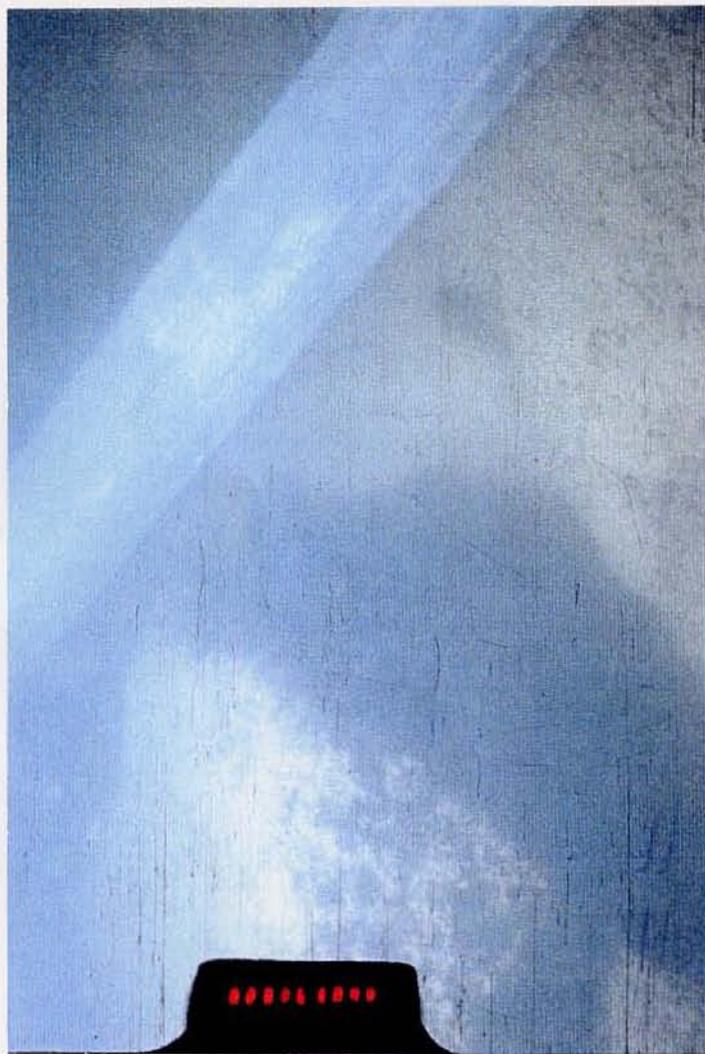
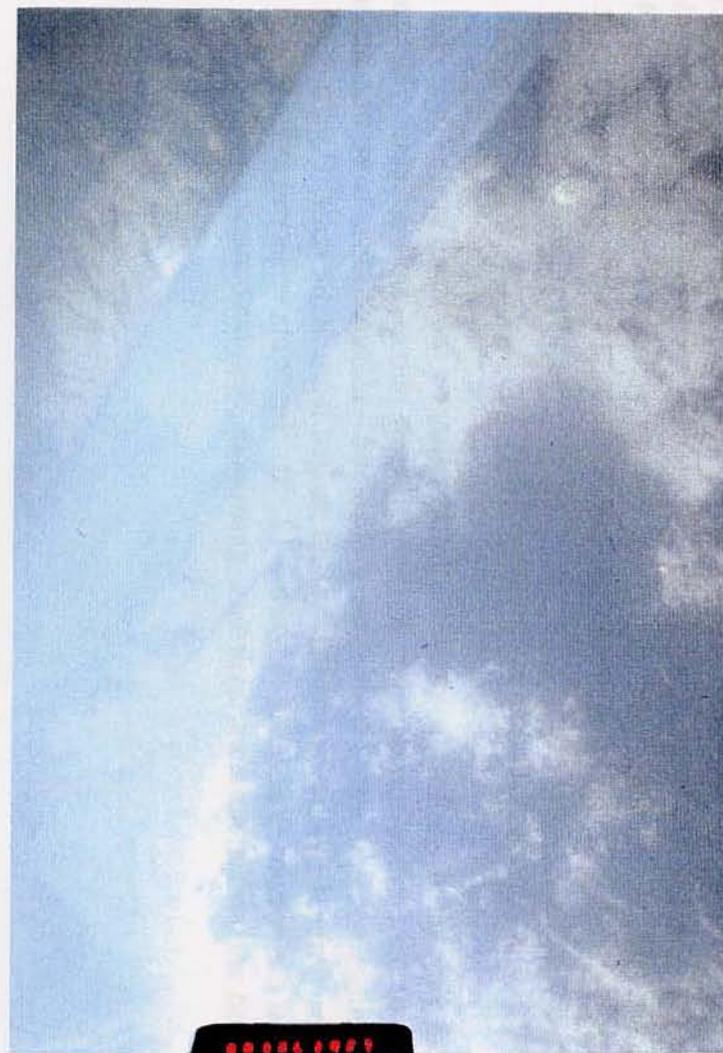
**Figure 3-11.** Possible construction debris—large, sharp-angled, silt-covered rocks observed in plan view photographs from transects C1 (A) and C4 (B)

material targets, the plan view photographs revealed areas of cobble and larger sharp-edged rocks (Figure 3-11). The sharp angularity of the rocks, and their presence at a known disposal site, suggest that they may be construction debris. More solid evidence that transect C4 contained construction debris was found while sieving one of the grab samples. A small rounded piece of concrete with two planar sides was found in the grab sample from Station C4-5. This small piece probably was bored from a larger slab either for blasting or attachment of lifting cables.

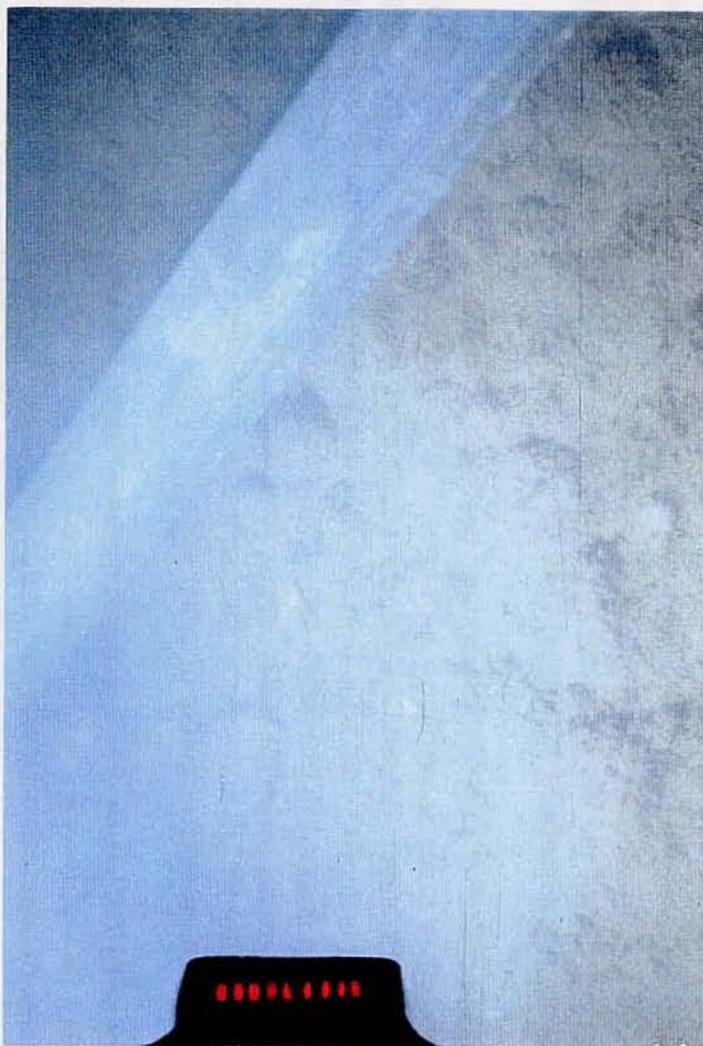
**Figure 3-12.** Heterogeneous distribution of surface polychaete tubes ranging from a dense carpet (A) to nearly absent (B)

Plan view photographs also provided information on the small scale horizontal distribution of the benthic community. In the plan view photos, both sedentary infaunal polychaete tubes and epibenthic species were observed. Infaunal tubes were present at all six transects. Tube distribution was patchy and ranged from dense mats (Figure 3-12, A) that carpeted the bottom to absence (Figure 3-12, B). Epifauna observed at BLDS included mud anemones, seastars, hydroids, gastropods, and bryozoans.
