Monitoring Cruise at the
Massachusetts Bay Disposal Site,
August 1994

Disposal Area Monitoring System DAMOS

Contribution 116
February 1997

US Army Corps
of Engineers
New England Division

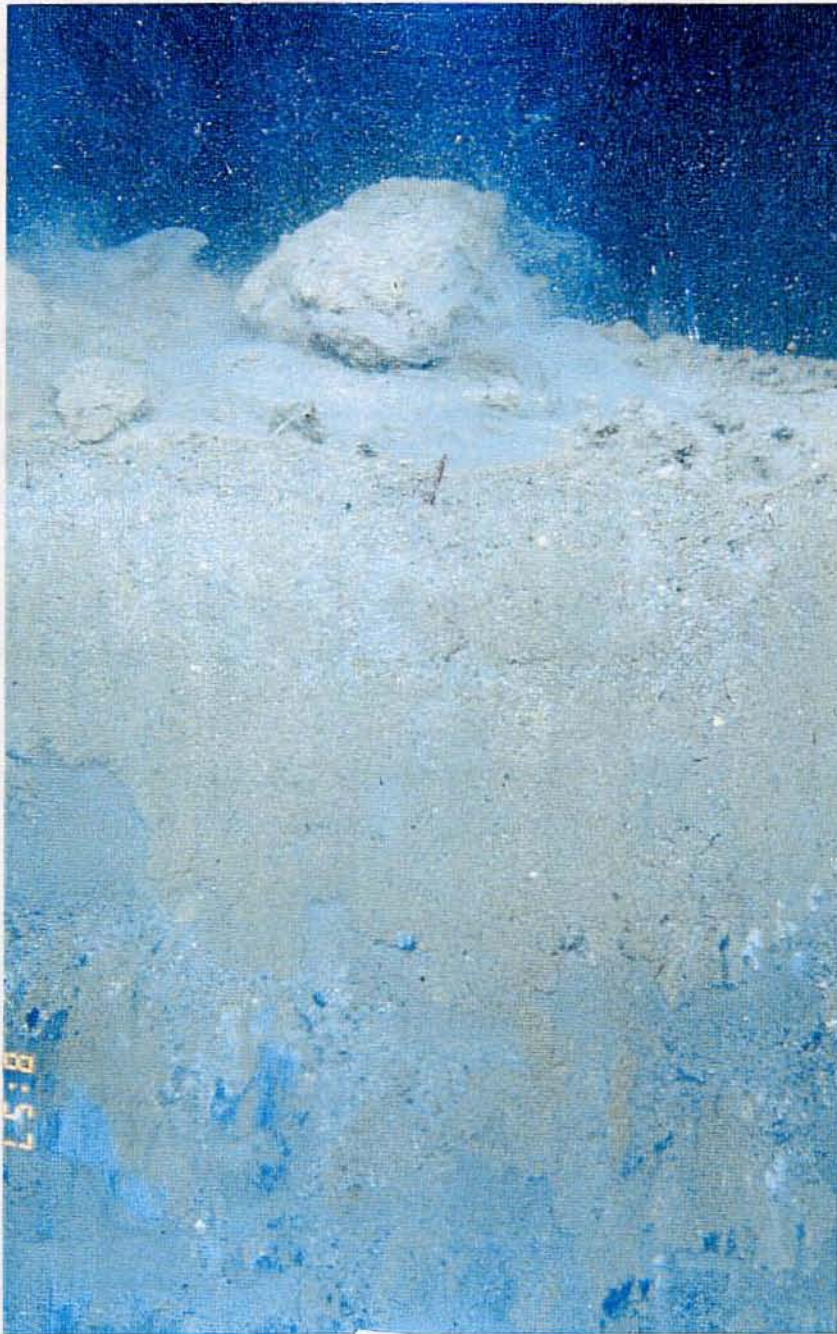
Figure 3-1. REMOTS® photograph at Station 200W, Replicate C, of fresh dredged material disposal at the MDA Buoy Grid

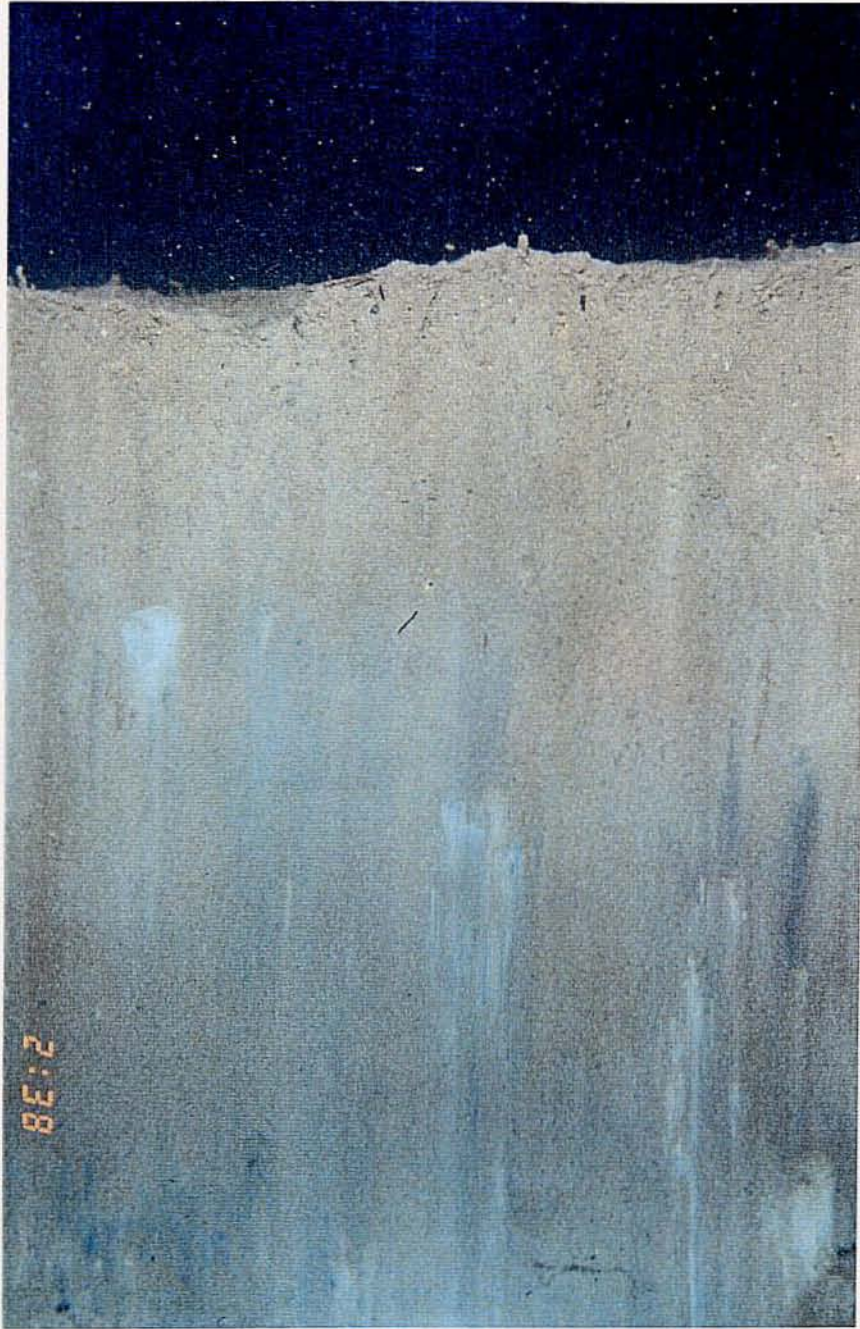
Figure 3-3. REMOTS® photograph at SACS Grid Station 700W, Replicate B, showing traces of Boston Blue Clay

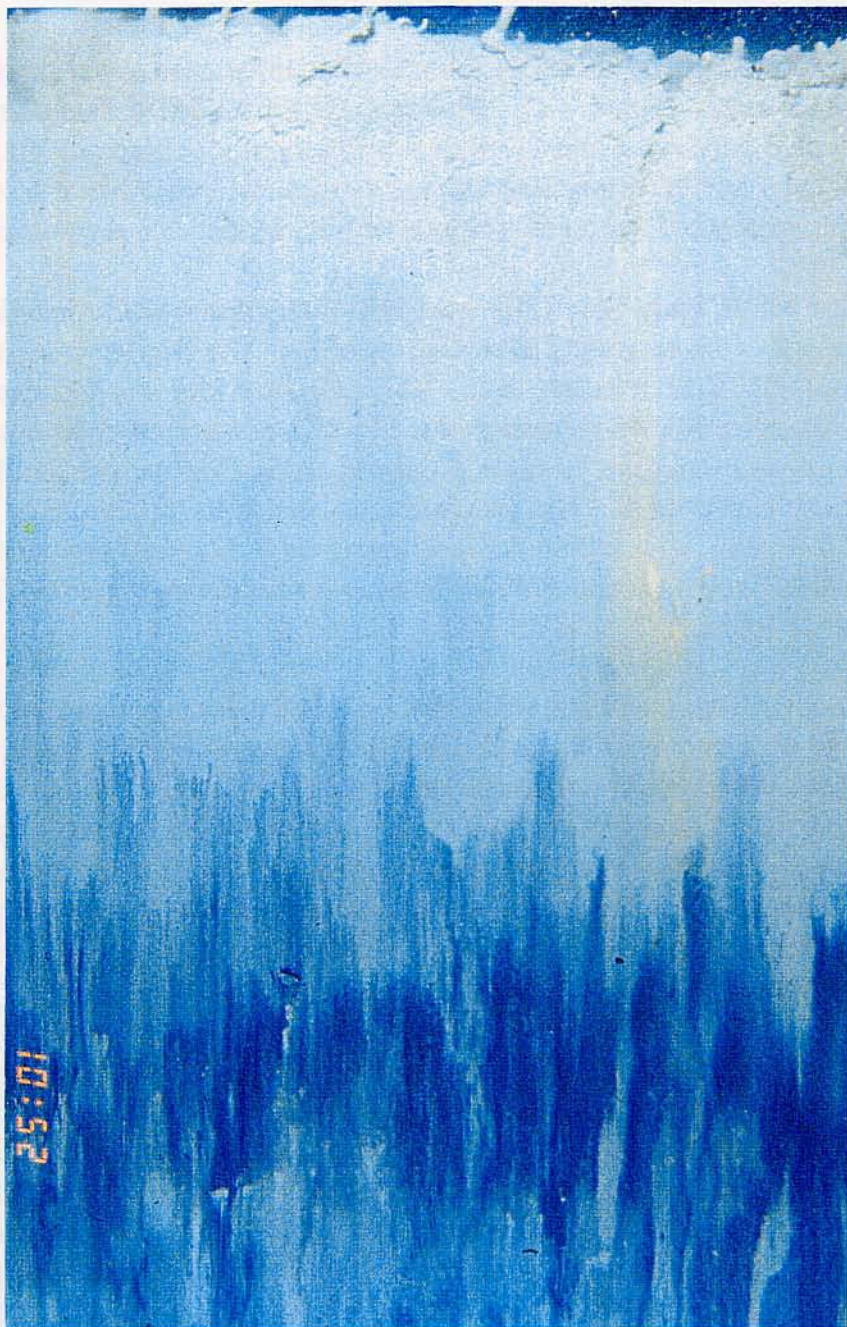
Figure 3-4. REMOTS® photograph at Station 200W, Replicate B, showing evidence of Stage III living over high SOD sediments

Several replicate photographs showed minor evidence of chemical oxygen demand (Figure 3-4) in the sediments as evidenced by reduced mud clasts at 200N and 400N. The presence of methane or overall low oxygen conditions, however, was not noted.

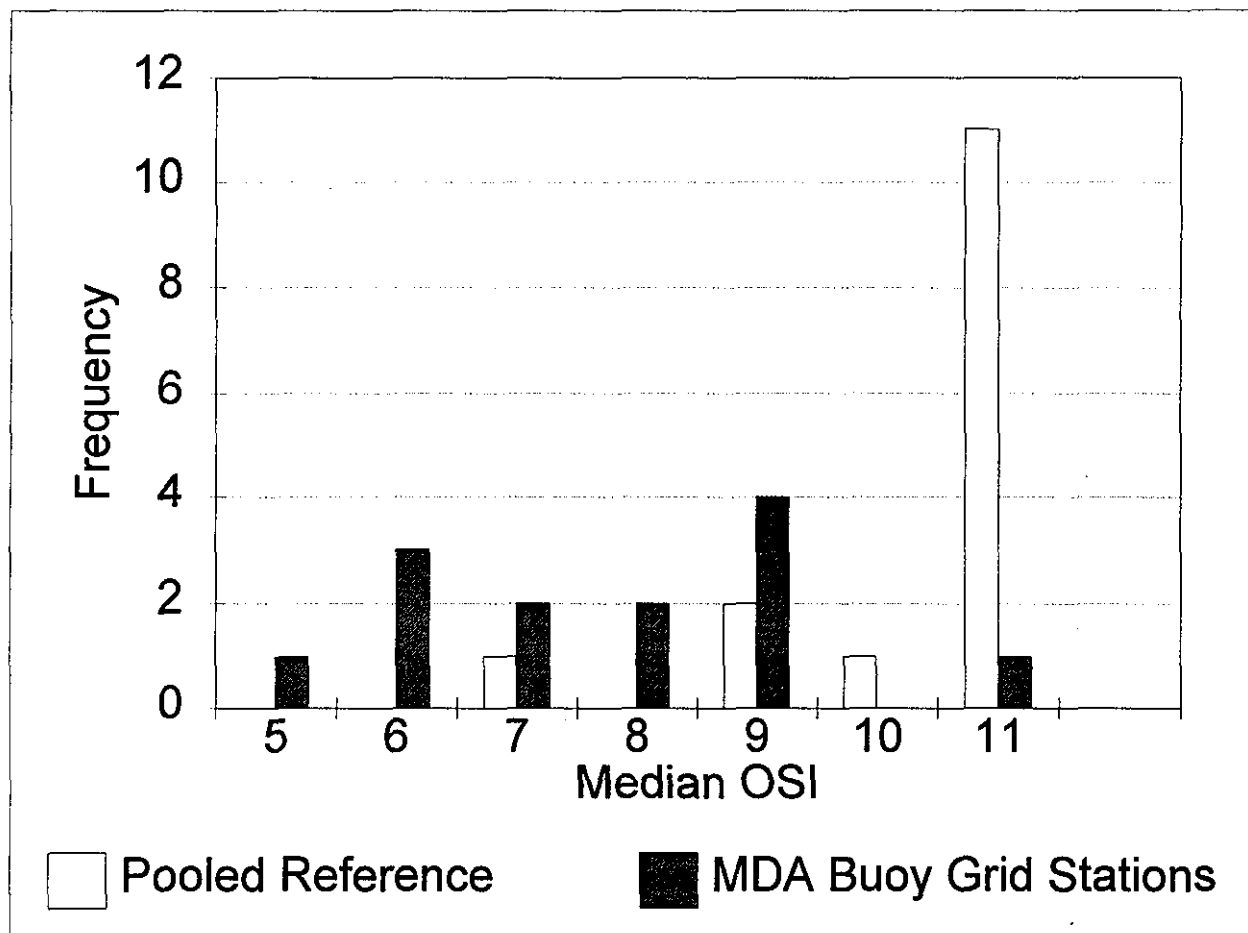
Figure 4-1. OSI at MDA Buoy Grid versus cumulative reference areas

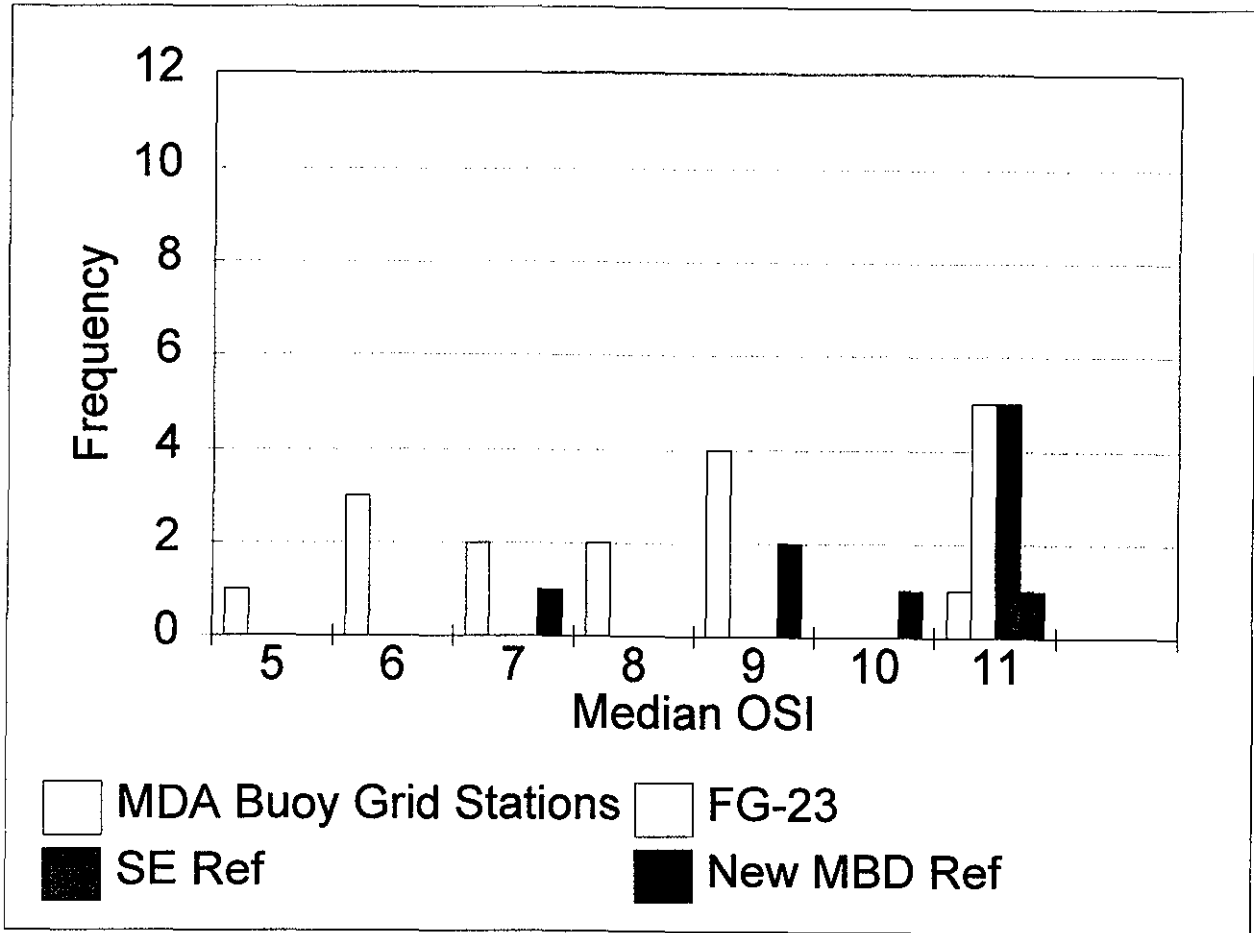
Figure 4-2. OSI at MDA Buoy Grid versus individual reference areas

Median MDA Buoy Grid OSIs were also compared with the individual reference areas (Figure 4-2). These results show that all of the OSIs that were 10 or below came from the new MBD-REF reference area. This reference area was just designated last year to replace a historical MBDS reference area (18-17), considered to be not representative of ambient conditions because of its close proximity to the disposal site and because of previous data collected there. The new reference area is located south of the MBDS, and east of FG-23 (Figure 1-1), within the Stellwagen Bank Marine Sanctuary. The low OSIs reflect thinner RPDs than at the other reference areas; the range is 1.7-4.79 (relative to 5.45-8.01 at FG-REF and 5.53-8.25 at SE; Table 3-2).

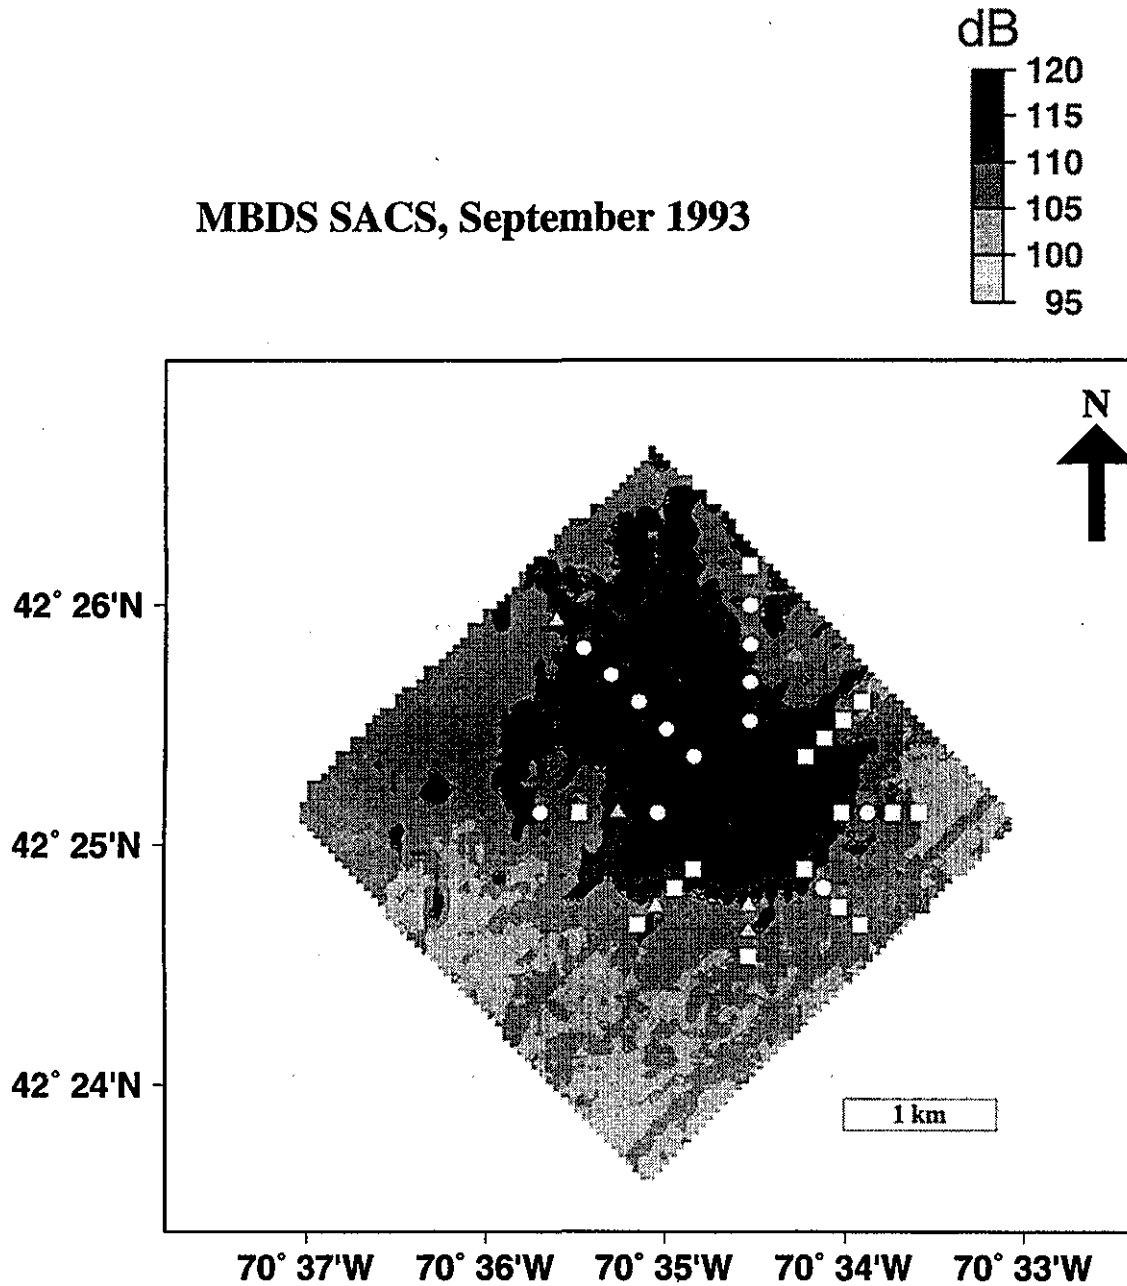
Figure 4-4. SACS data from MBDS baseline survey with locations of SACS Grid stations. Circles indicate dredged material present; squares indicate no dredged material; and triangles indicate mixed results.

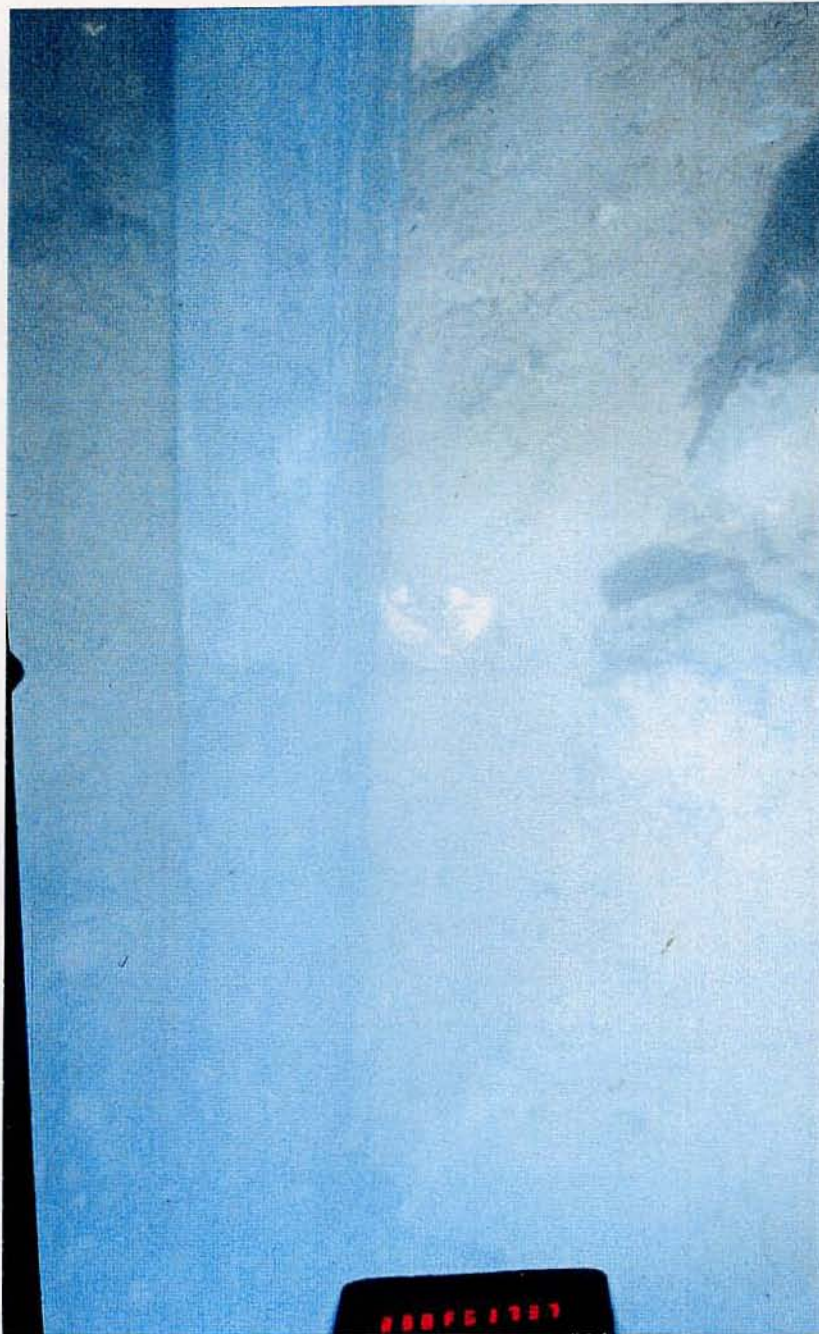
Figure 4-5. REMOTS® plan view photograph at MDA Buoy Grid Station 200N showing evidence of fresh dredged material
