Monitoring Survey at the Cape Cod Bay Disposal Site  
August 2001

# Disposal Area Monitoring System DAMOS

Contribution 144  
March 2003

Report No.  
SAIC-574

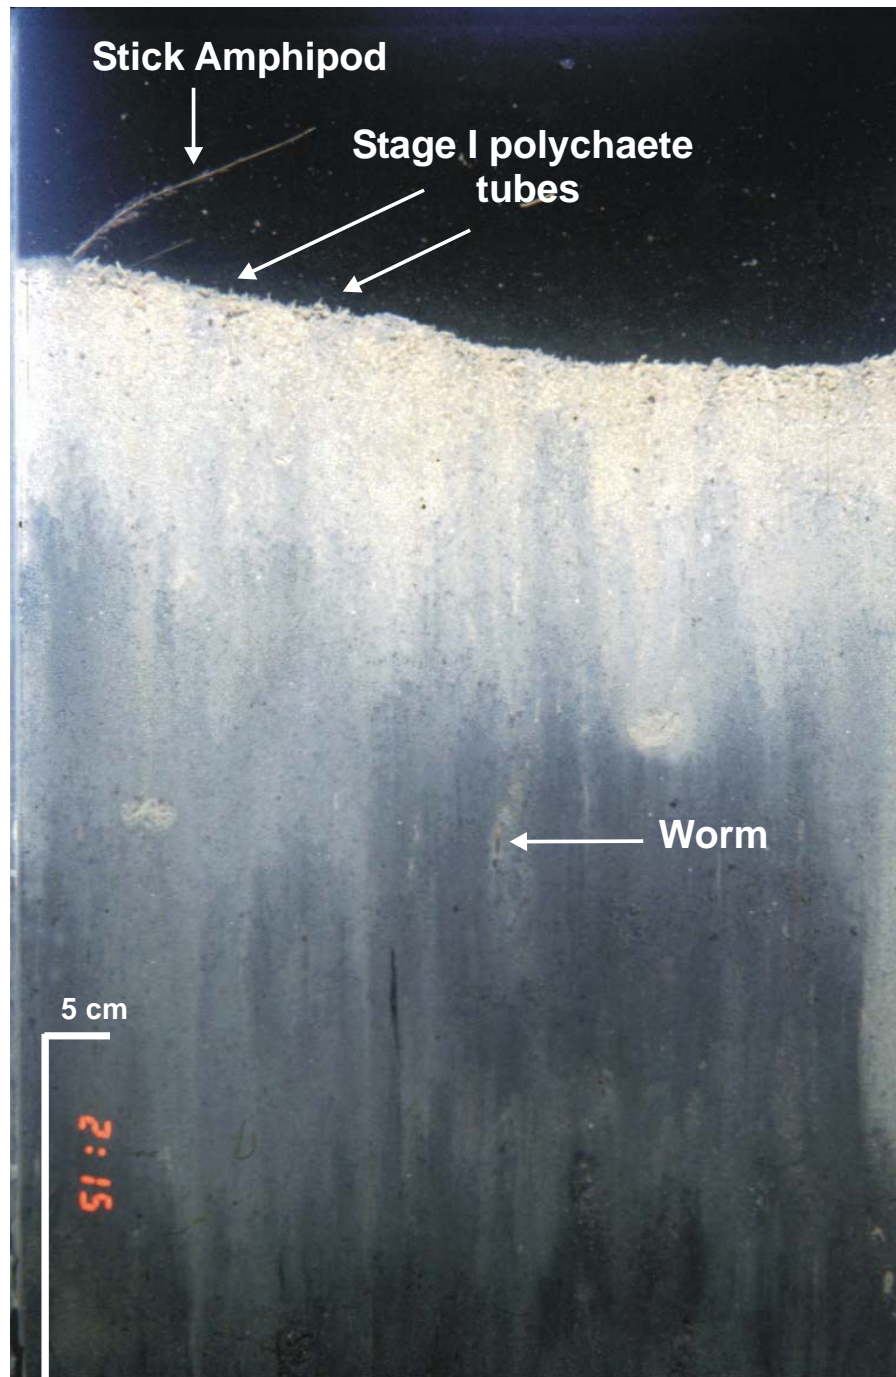
**Figure 3-9.** REMOTS<sup>®</sup> image from Station B100S within Mound B showing a biologically active benthic environment with an amphipod stalk (family Podoceridae) and Stage I polychaetes tubes at the sediment-water interface.

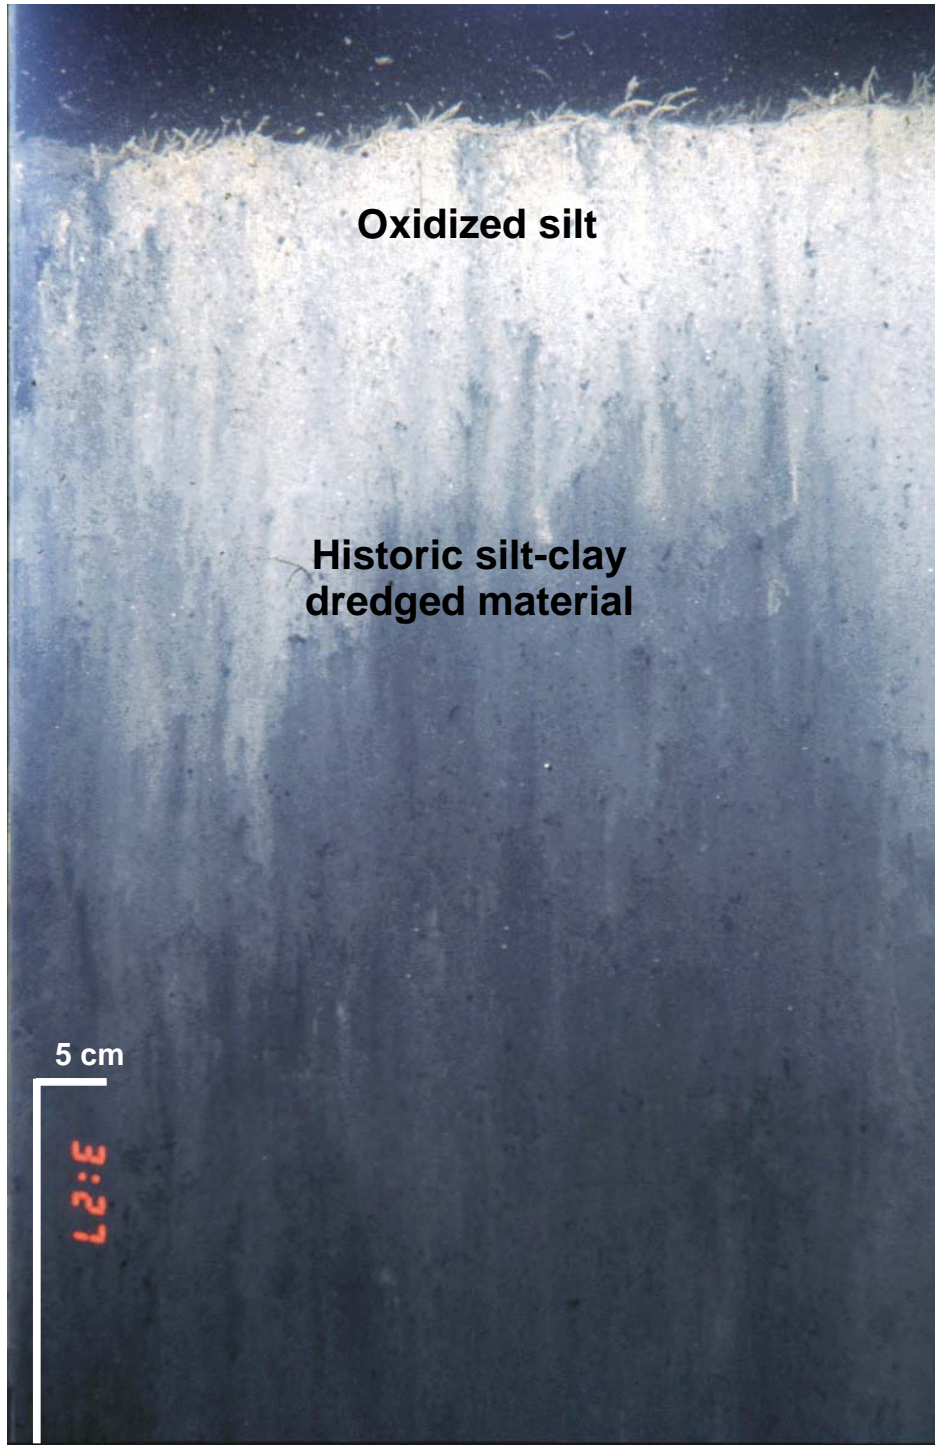
**Figure 3-15.** REMOTS<sup>®</sup> image from Station A100E showing the characteristics of historic dredged material (oxidized silt over black silt-clay) observed over Mound A

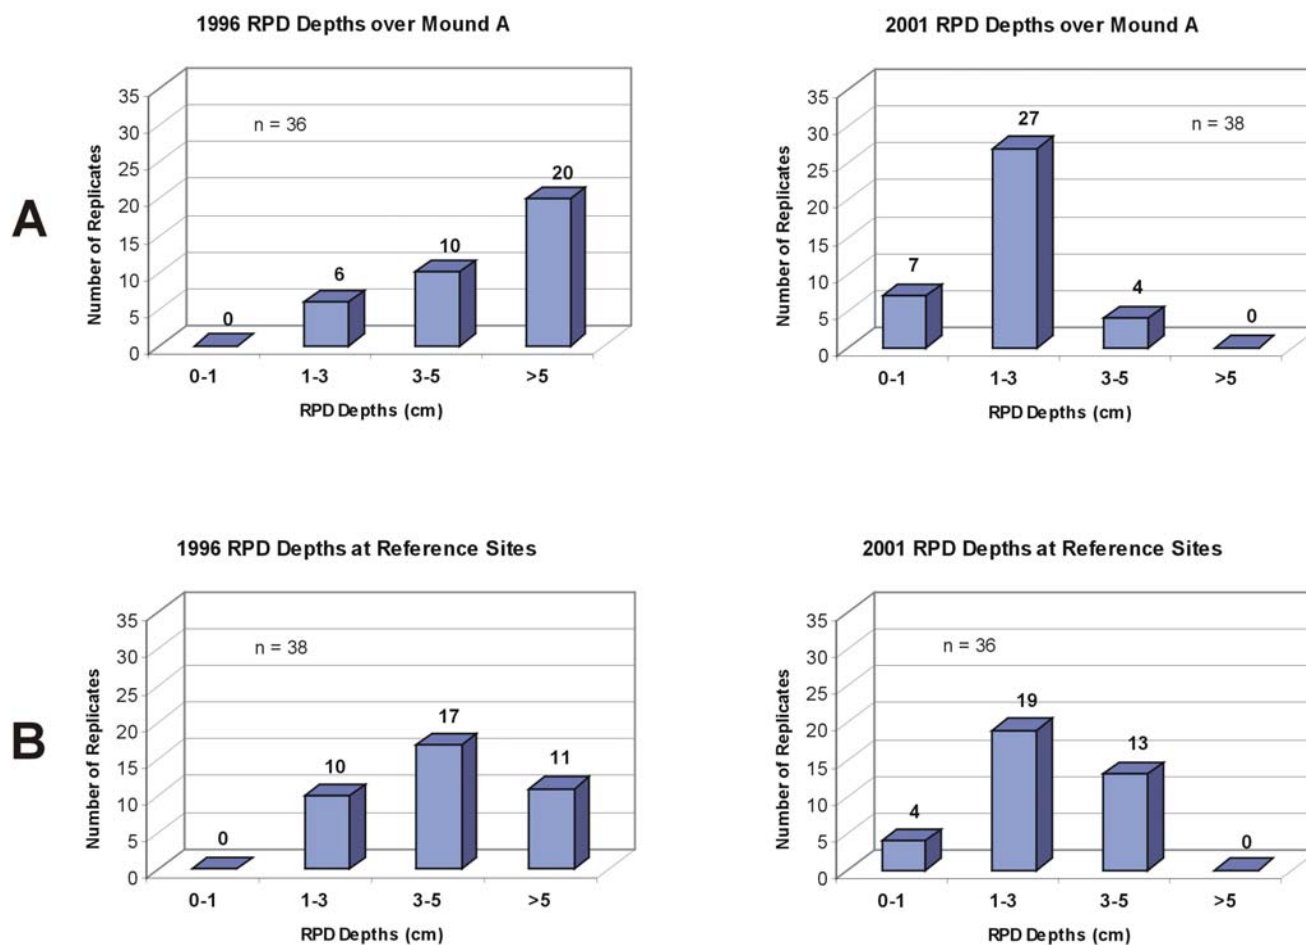
**Figure 4-5.** Histograms comparing number of replicate images collected over Mound A (A) and the CCBDS reference areas (B) displaying RPDs within various depth classes to evaluate changes in depth of sediment oxygenation between the May 1996 and August 2001 surveys.

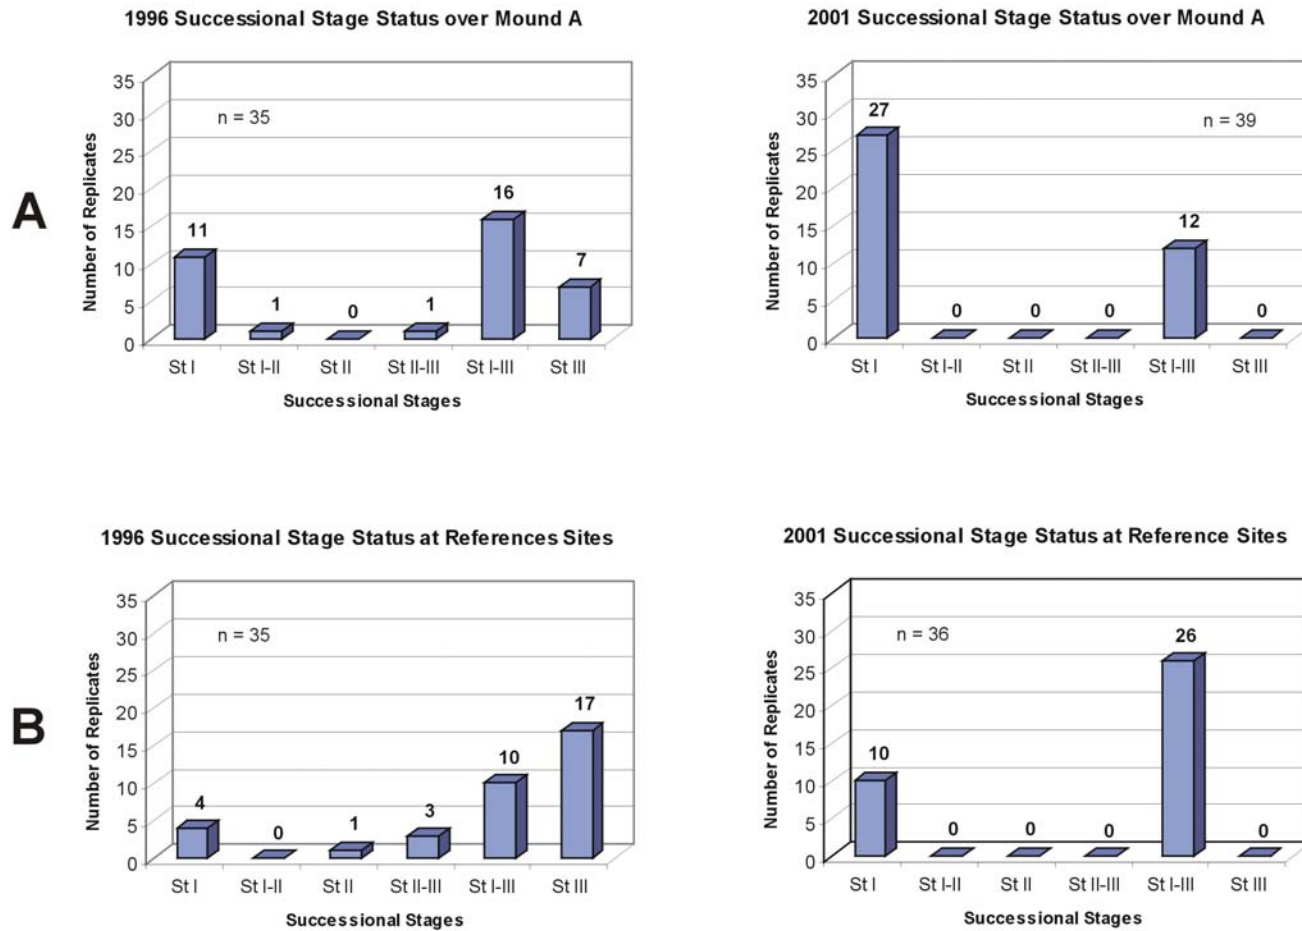
**Figure 4-6.** Histograms comparing number of replicate images collected over Mound A (A) and the CCBDS reference areas (B) displaying biological activity within the various successional stage seres to evaluate changes in benthic recolonization status between the May 1996 and August 2001 surveys.
