# Disposal Area Monitoring System DAMOS

**MONITORING SURVEY AT THE  
ROCKLAND DISPOSAL SITE  
SEPTEMBER 2003**

**CONTRIBUTION #156**

ENSR International, CoastalVision,  
Germano & Associates, and CR Environmental

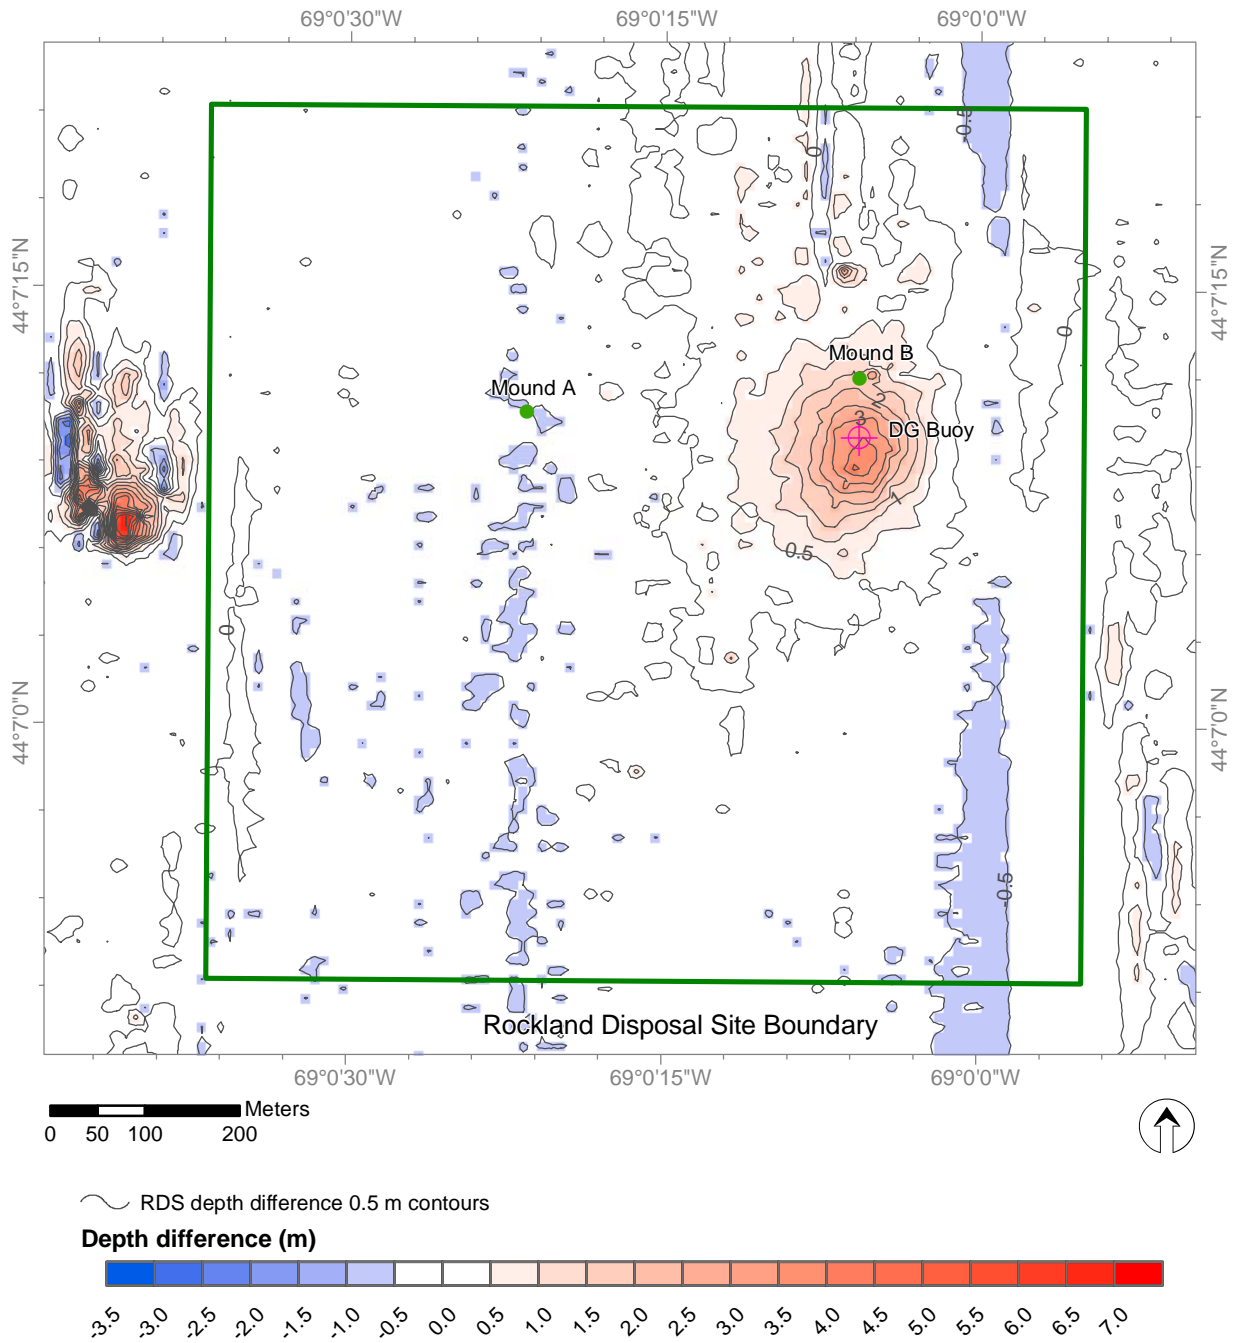
**Figure 3-5.** Depth difference contour chart: September 2000 vs. September 2003 survey results (at 0.5 m contour interval)

The depth difference between the 2000 and 2003 surveys was plotted for a smaller area at 0.5-meter contour intervals to better characterize the mound (Figure 3-5). The disposal mound was roughly conical in shape, with a maximum height of approximately 4 m and an approximate diameter of 220 m (Figure 3-5). The average slope of the mound was 3%, with a maximum slope near the top of 6%.

Other features that were apparent in the depth difference plots include apparent changes in the area of the rock outcrop to the west of RDS, in the deepest portion of the trough at the northern edge of the study area, and in a series of north-south trending features across the study area (Figures 3-4 and 3-5). These differences are likely measurement and processing artifacts, rather than actual bathymetric differences between the two surveys. We attribute the apparent differences to several factors including accuracy limitations of single-beam bathymetry in areas of steep slope (e.g., near the rock outcrop to the west and the trough to the north) and differences in bathymetric data processing methodology (e.g., the 2003 survey data set utilized a local tidal correction, whereas the 2000 survey utilized NOAA tidal measurements at Portland, ME).

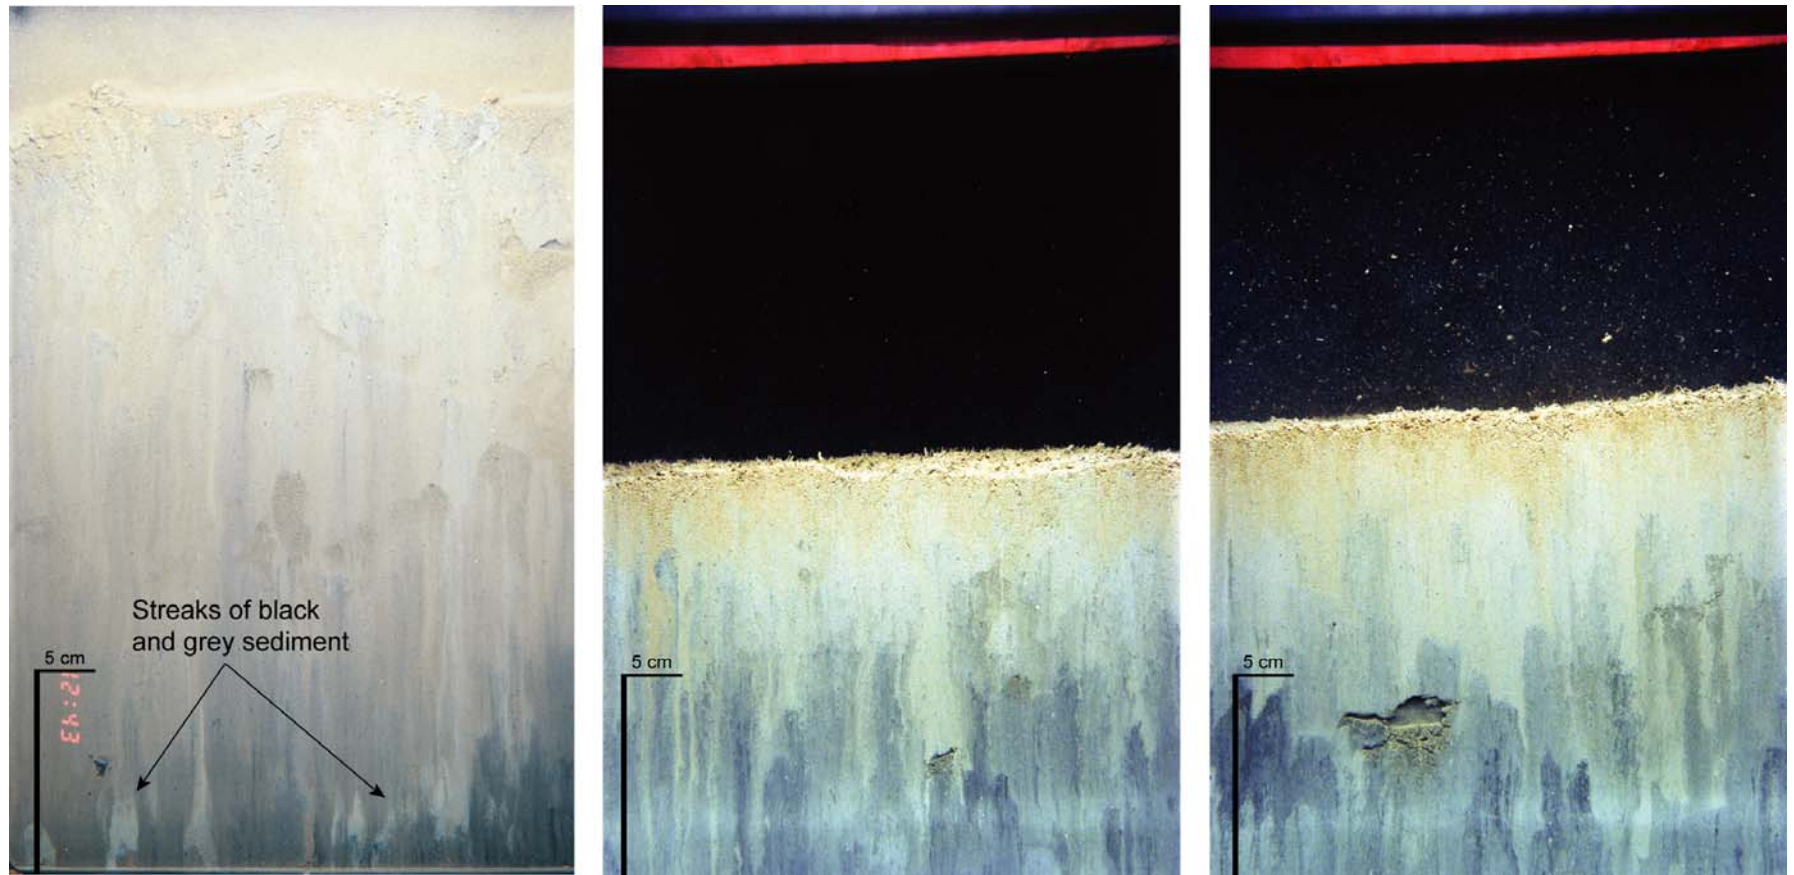
**Figure 4-1.** SPI images obtained at Station I7 in the September surveys of 2000 and 2003 compared to East Reference Area Station ER2. Deeper penetration of the SPI camera in 2000 (left) revealed streaks of black and gray sediment at depth that were interpreted as evidence of an old dredged material layer exceeding the camera's imaging depth. Such evidence was not observed in the 2003 survey; the sediment at Station I7 (center) appeared similar to the ambient sediment at the reference area (right).
