Monitoring Survey at the Western Long Island Sound Disposal Site  
June 2004

# Disposal Area Monitoring System DAMOS

Contribution 161  
September 2005

**MONITORING SURVEY AT THE  
WESTERN LONG ISLAND SOUND DISPOSAL SITE  
JUNE 2004**

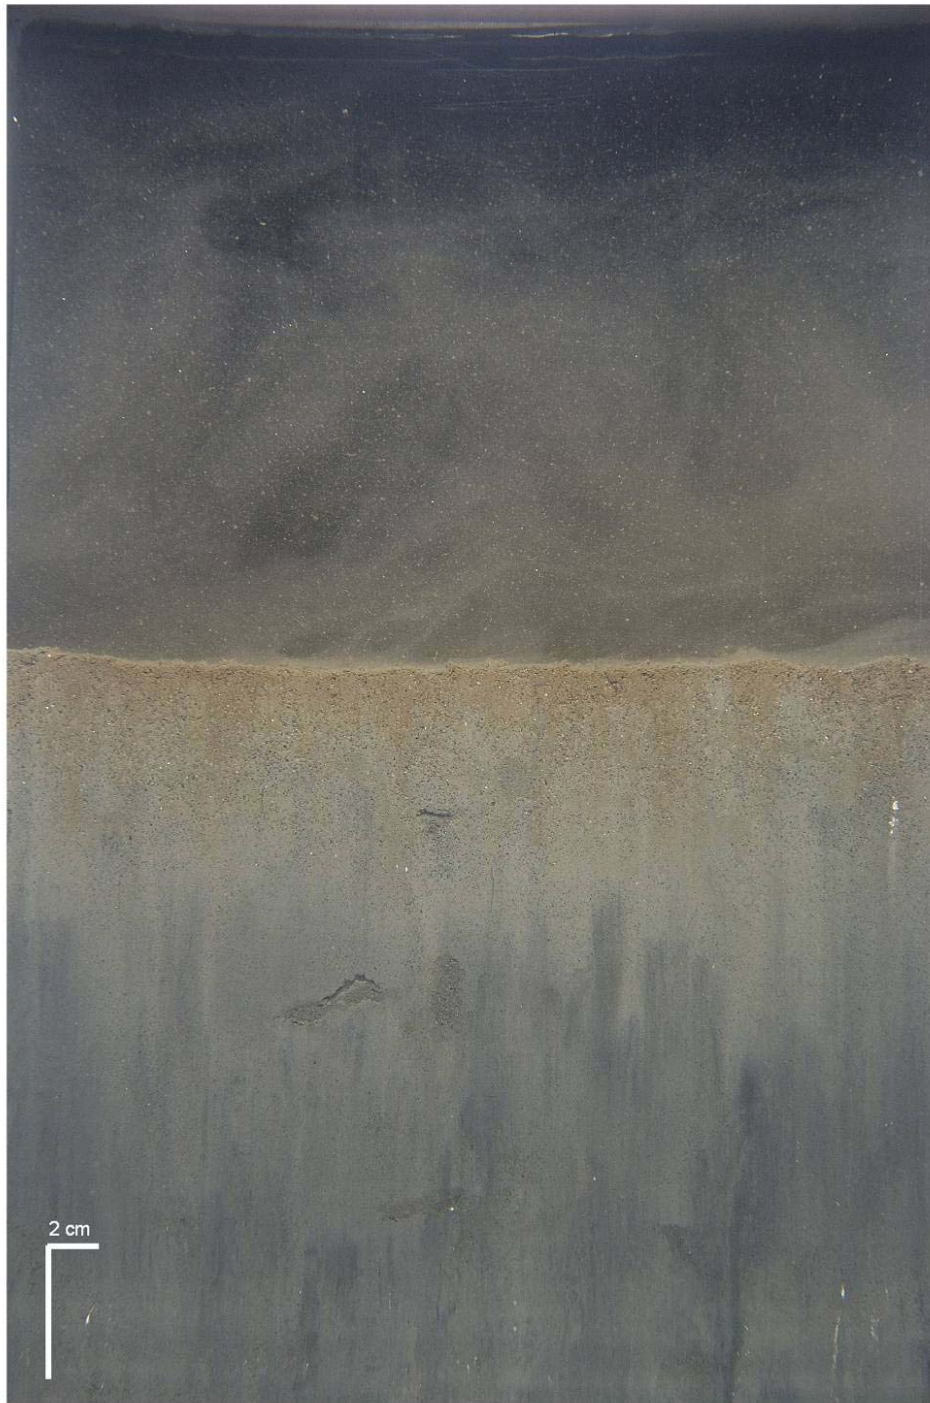
**Figure 3-5.** Sediment-profile image from Station S-03 showing a surface layer of silty, very fine sand on top of a mud ( $\geq 4$  phi) facies.

The sediment grain-size major mode at all stations was primarily fine-grained sediments ( $>4$  phi), with most of the stations at SW REF and all of the stations at S REF having a surface layer of silty, very fine sand overlying the mud facies (Figure 3-5). This very fine sand layer is typical of conditions seen at SW REF and S REF in previous surveys (SAIC 2002). All of the sediments at the SE REF area stations had a major grain-size mode of silt-clay ( $>4$  phi).

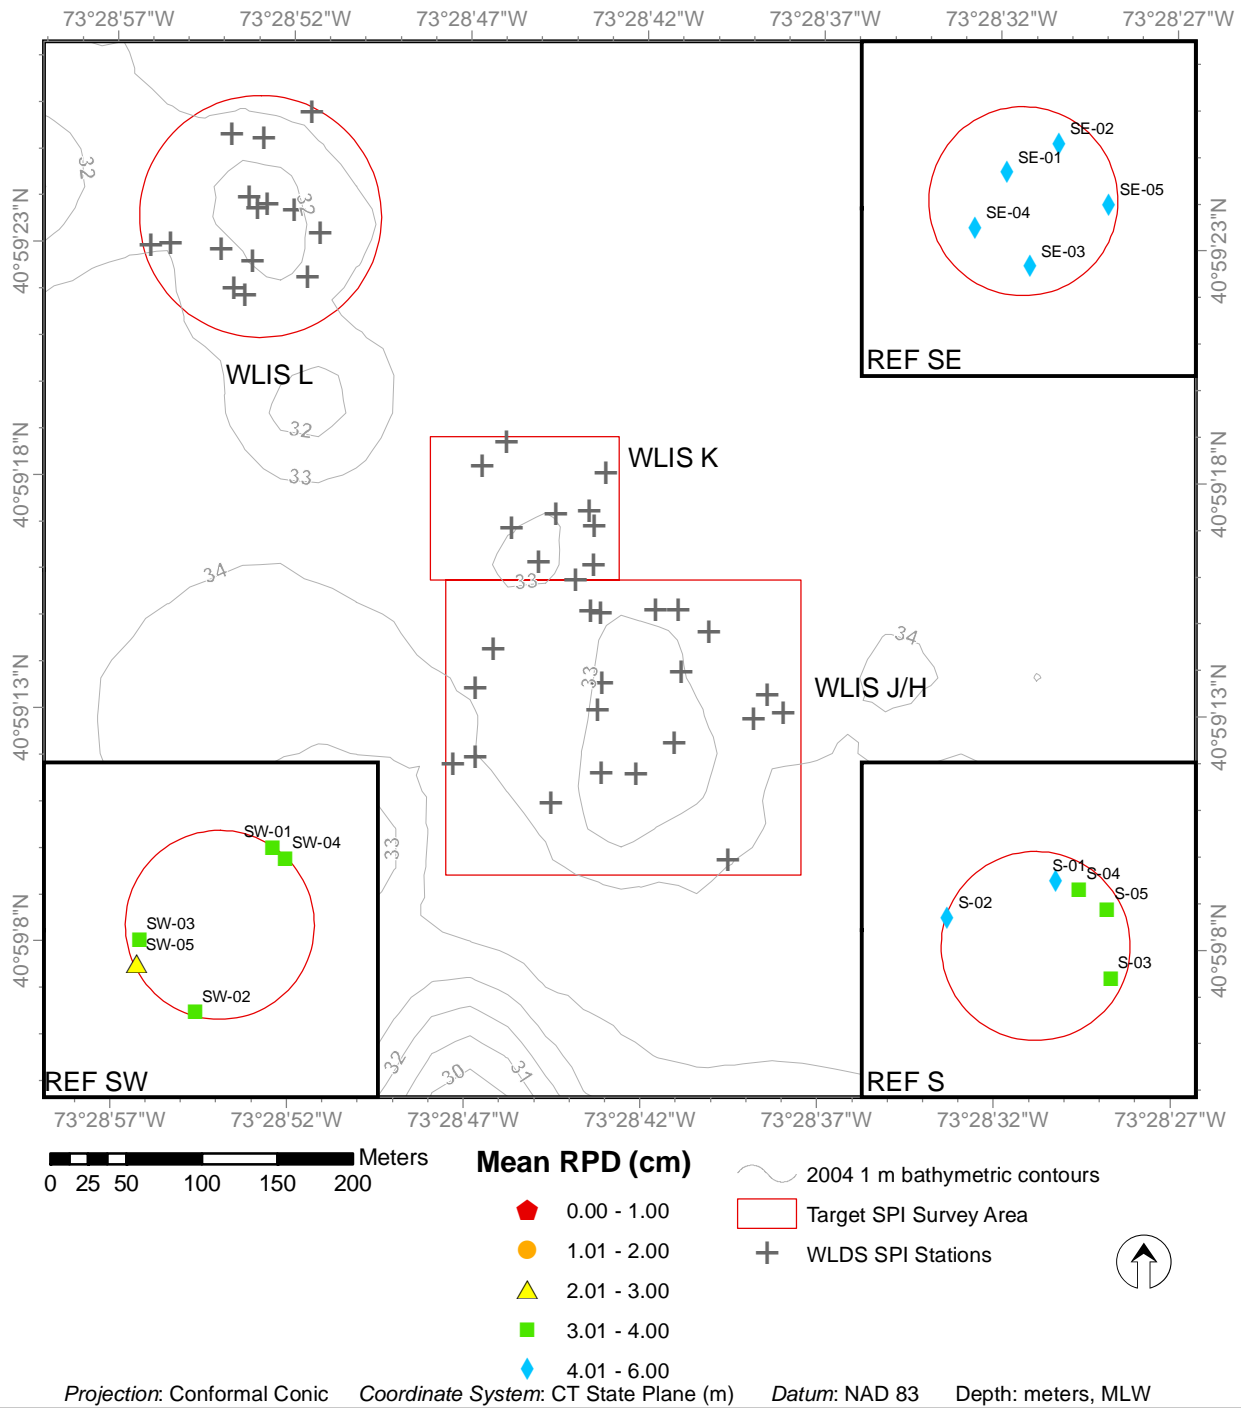
**Figure 3-6.** Distribution of mean apparent RPD depths (cm) at the WLDS reference areas

The overall average for the three reference area's mean apparent RPD depth was 4.0 cm, with station-averages ranging from 2.5 to 5.1 cm (Table 3-1, Figure 3-6). The lack of recent physical disturbance combined with the bioturbational activities of larger, established infaunal taxa were most likely responsible for the relatively thick, oxygenated surface layers of sediment found at the reference stations (Figure 3-7).

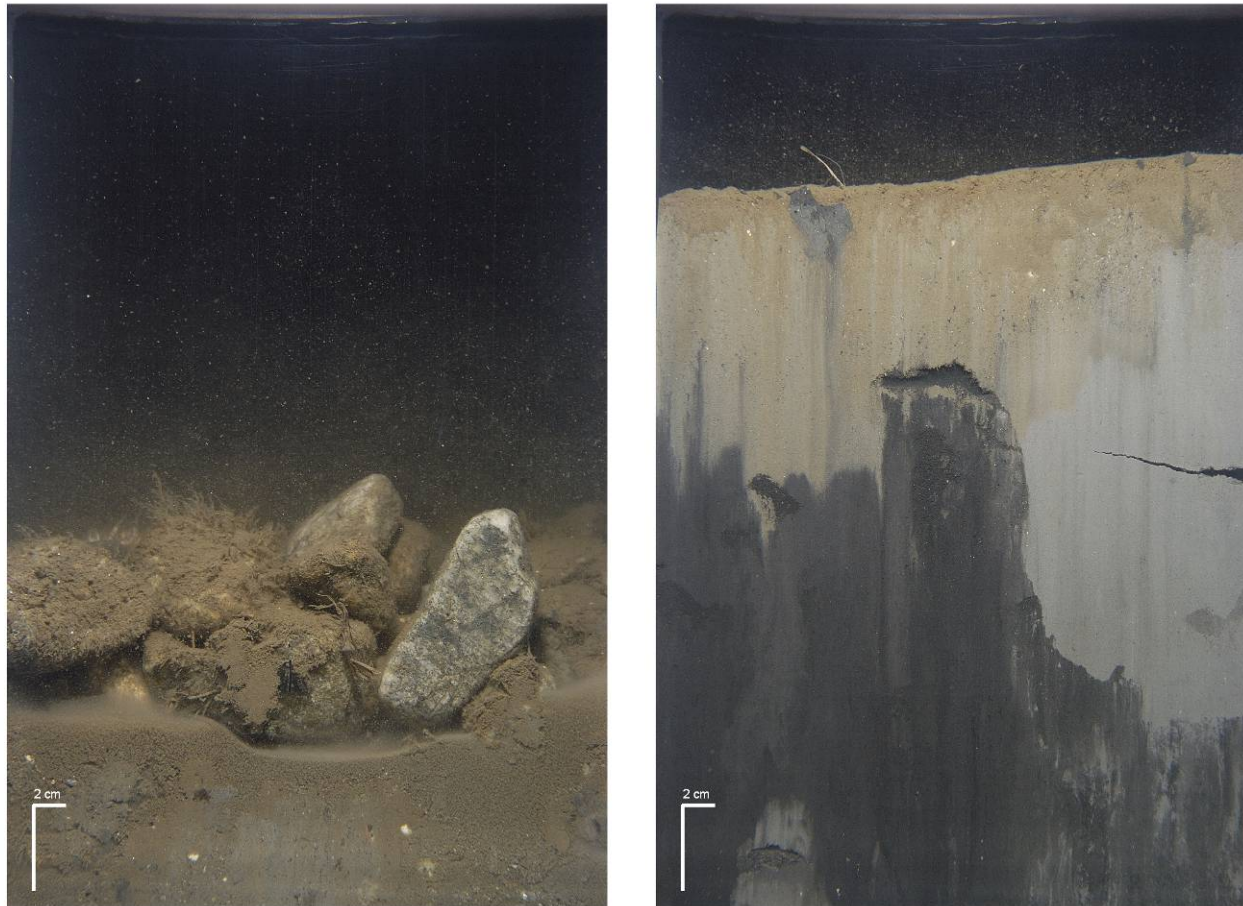
**Figure 3-11.** Images showing the heterogeneity in sediment type from the recent disposal activities, which affected the camera's prism penetration. The layer of cobbles on top of the fine sediments at Station JH-10 (left) allowed the prism to only penetrate the seafloor an average of 4.3 cm. The recently-deposited muds at Station JH-11 (right) were quickly reworked by burrowing organisms (note feeding void in lower left quadrant), helping to lower sediment shear strength and resulting in a prism penetration mean depth of 18.5 cm.

relief was due to physical disturbance associated with the dredged material disposal, either from large clay clumps (Figure 3-9) or cobbles (Figures 3-10 and 3-11) on the sediment surface.

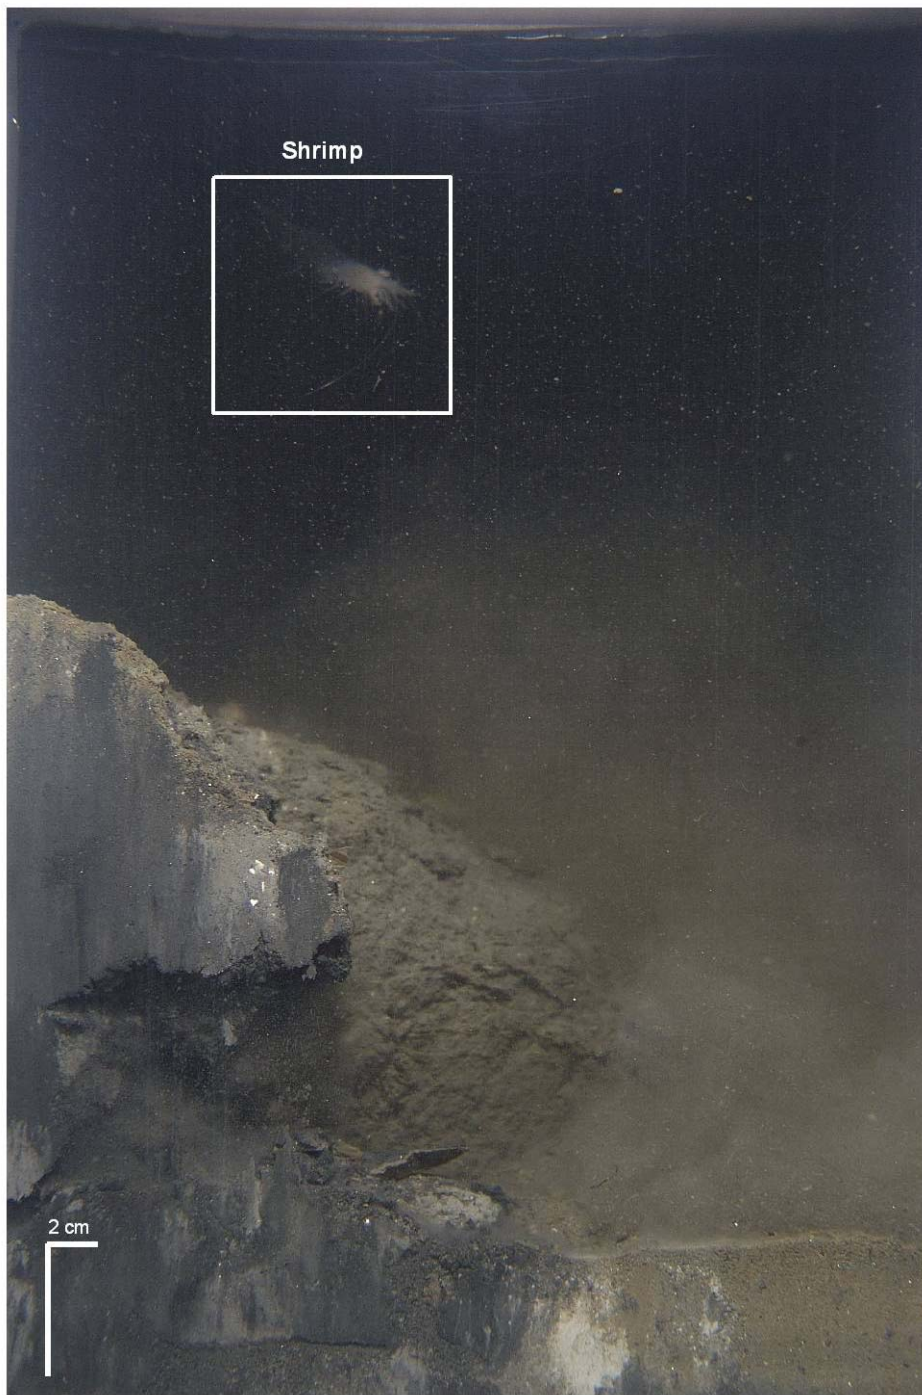
**Figure 3-20.** SPI image from Station L-09 showing large small-scale surface relief from a deposited clay clump; surface roughness elements such as these often provide an attractive habitat/foraging area for mobile epifauna (note shrimp in overlying water).
