Monitoring Survey at the Massachusetts Bay Disposal Site  
September 2004

# Disposal Area Monitoring System DAMOS

Contribution 162  
September 2005

**US Army Corps  
of Engineers**®  
New England District

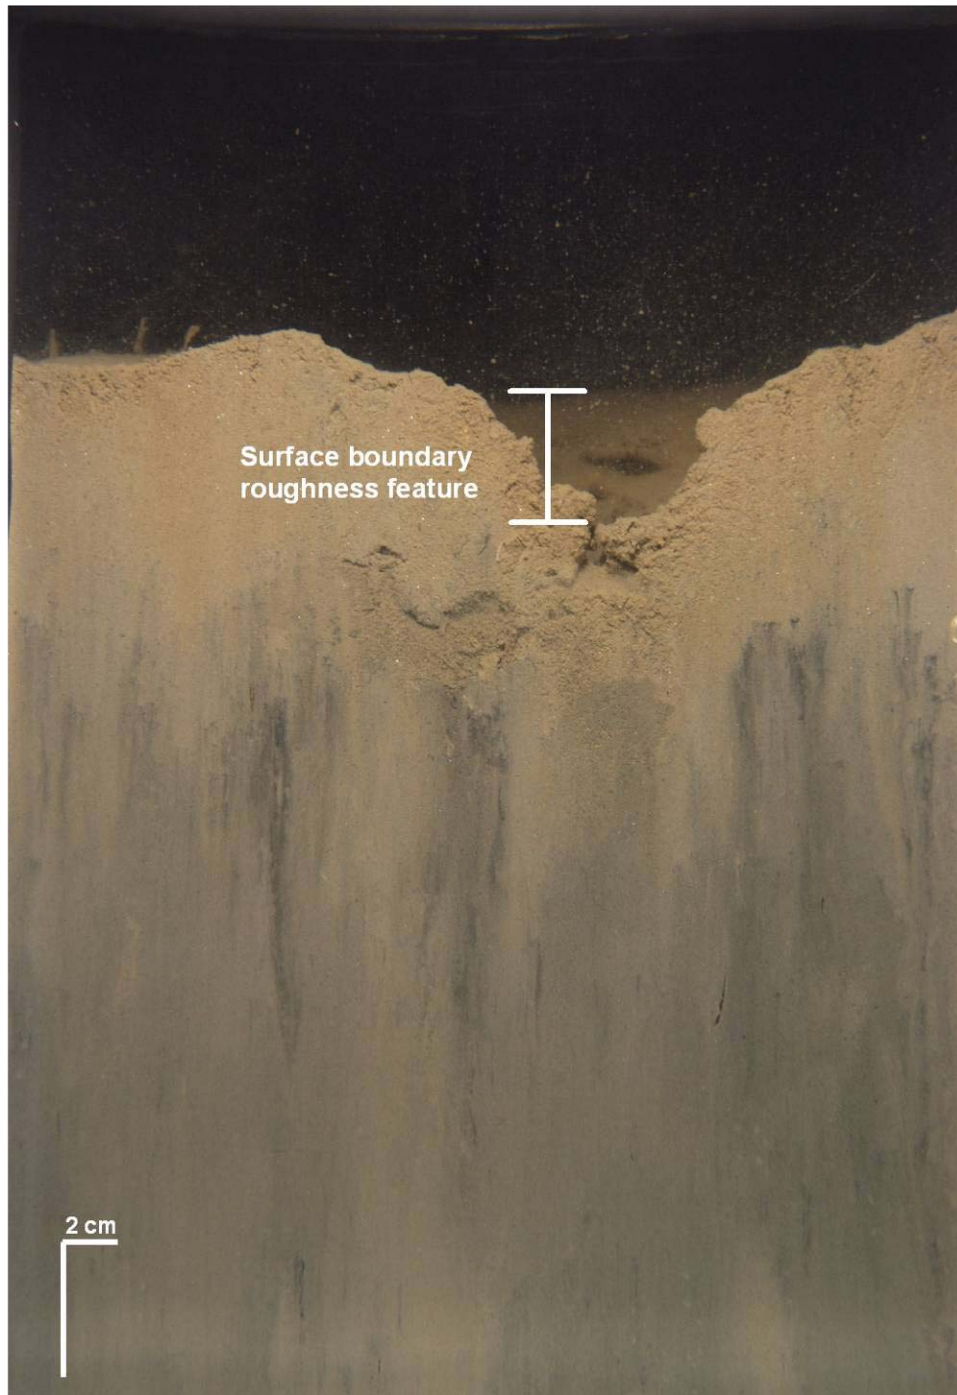
**Figure 3-5.** SPI image from reference area FG23, Station 4 showing a prominent surface boundary roughness feature due to macrofaunal bioturbation.

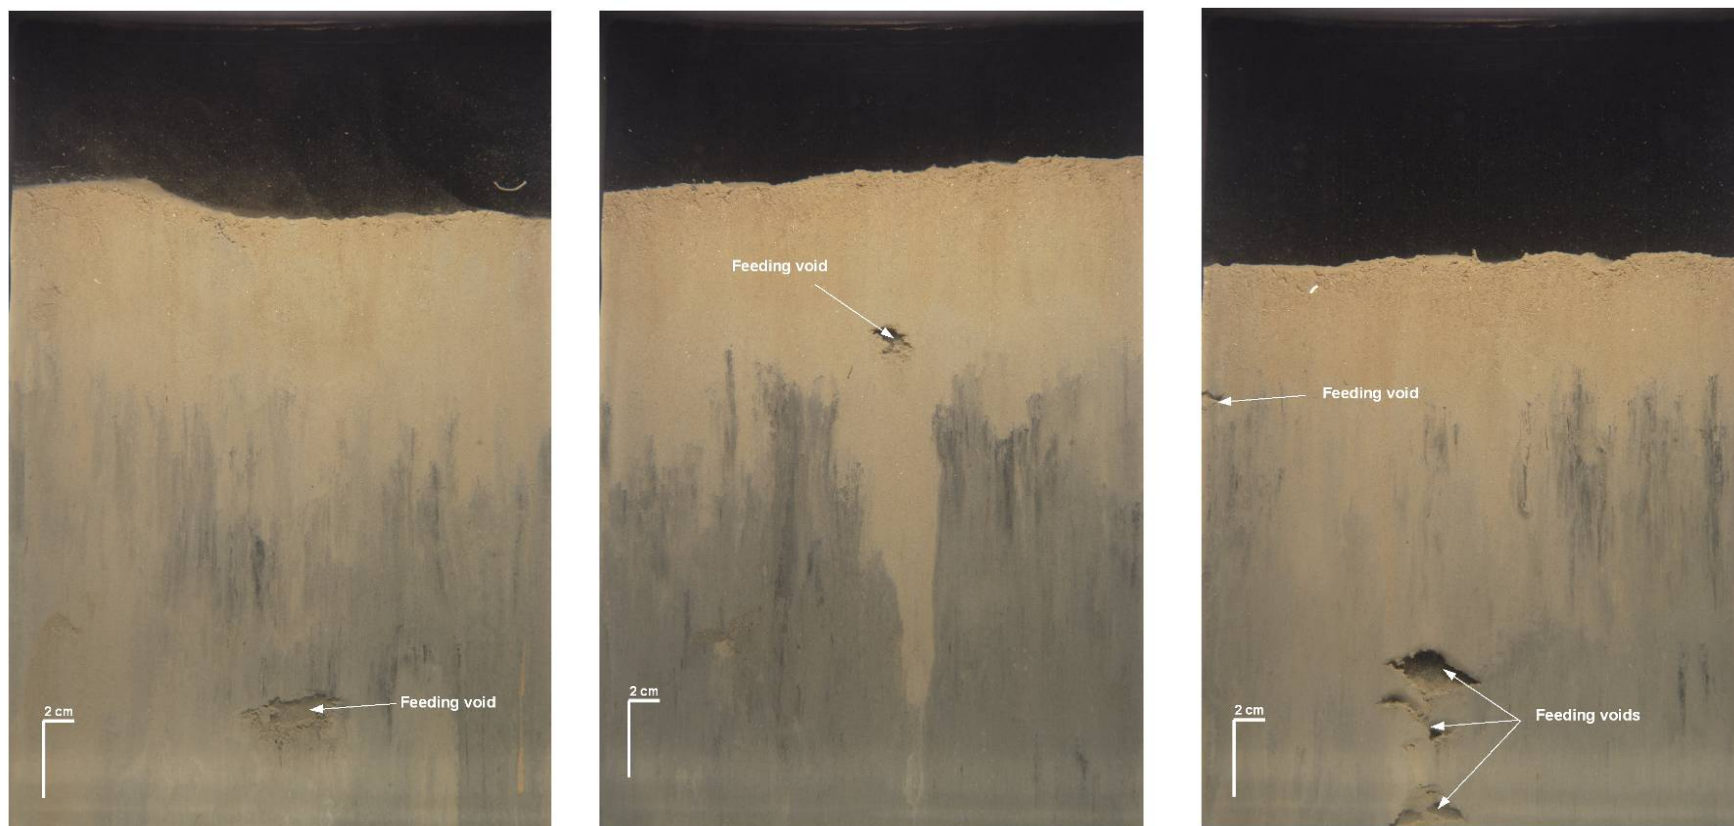
**Figure 3-6.** Deposit-feeding infauna were present in all three reference areas, as evidenced by the prominent feeding voids seen in these SPI images from SE REF (left), FG23 (center), and MB REF (right).

The mean apparent RPD values from the three reference areas ranged from 2.4 to 4.4 cm, with an overall reference area mean value of 3.5 cm (Table 3-1). Mature infaunal assemblages (Stage III taxa) were found in all 46 images analyzed from the reference stations (Table 3-1), and evidence of their sediment reworking activities were prominent in many of the images (Figure 3-6).

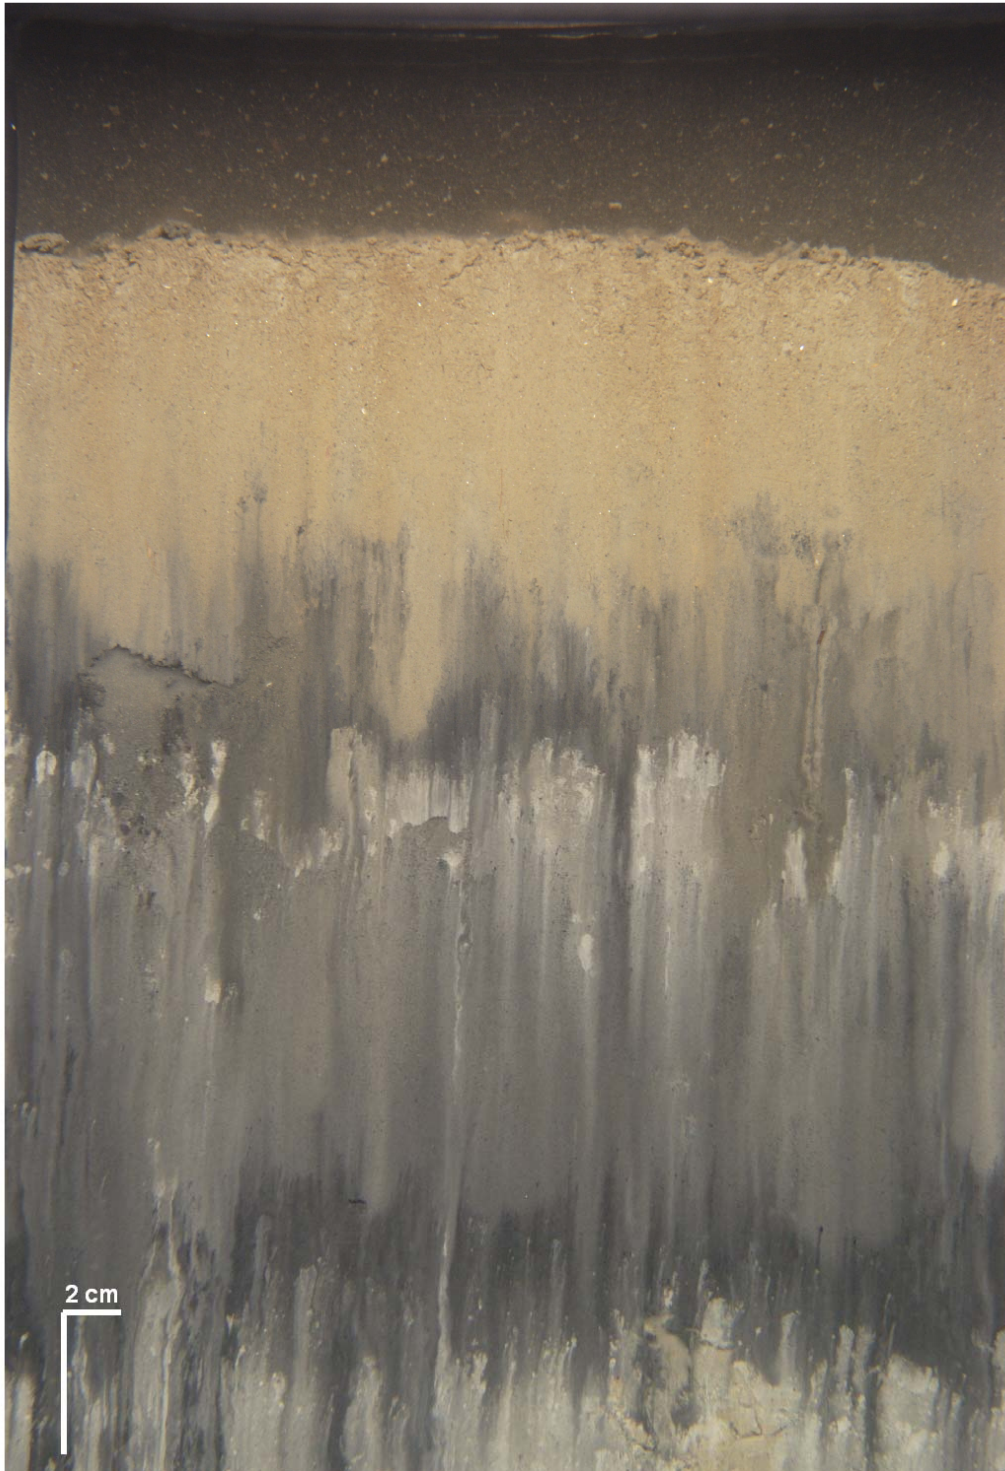
**Figure 3-7.** SPI image from Station C3 showing multiple depositional horizons from past disposal activity.

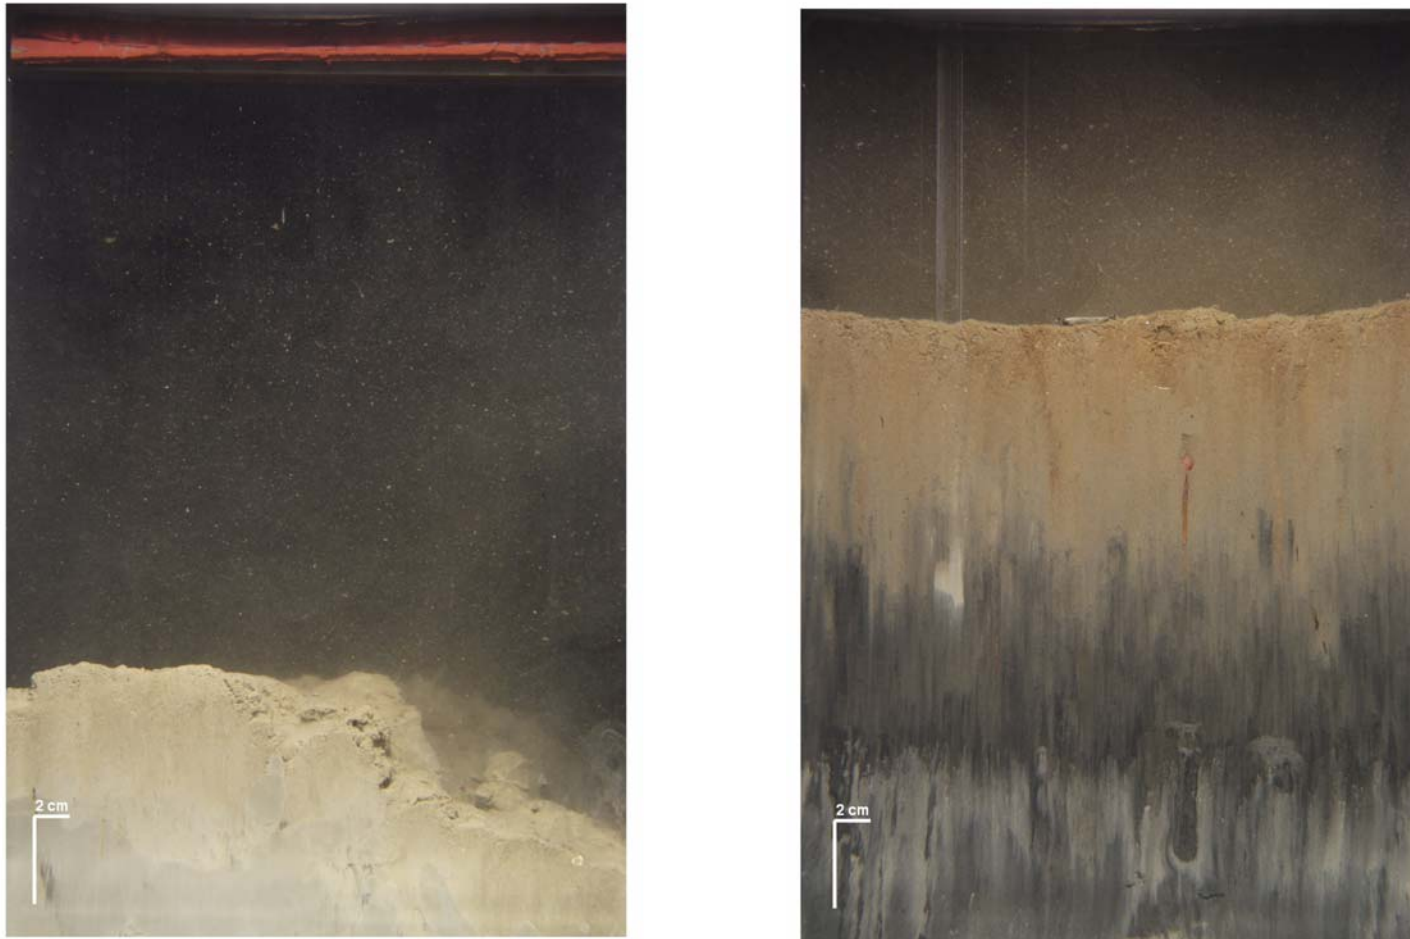
**Figure 3-8.** SPI images showing the difference in camera prism penetration due to the increased amount of Boston Blue Clay at Station C4 (left) versus Station C1 (right); the stop collar settings and amount of lead weights in the camera frame were identical at each station.

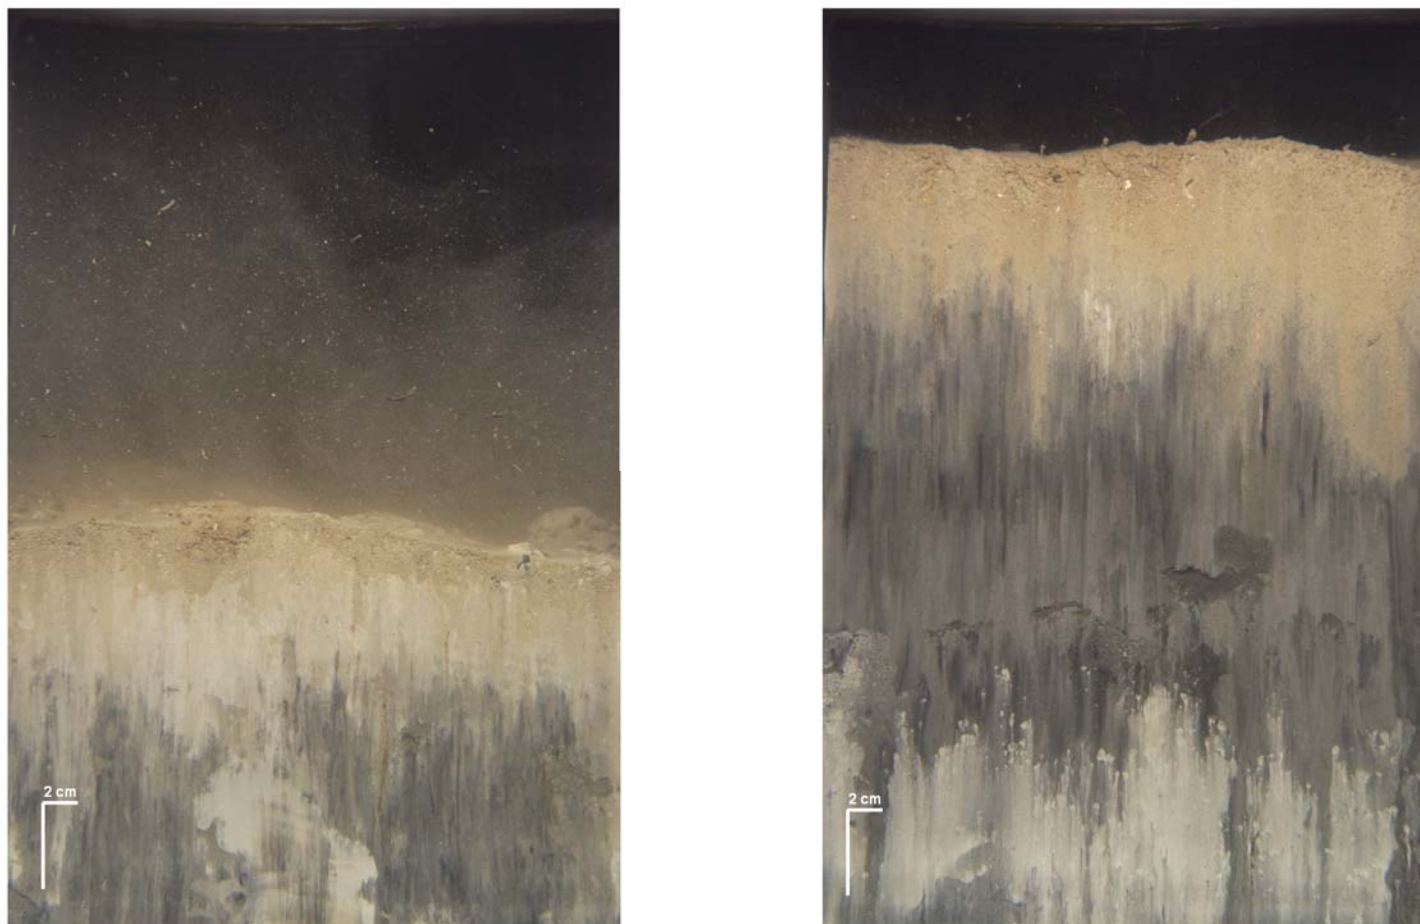
**Figure 3-10.** SPI images showing the effect of the Boston Blue Clay layer on RPD. Note the shallower apparent RPD depth (1.3 cm) at Station C5 (left) as compared with that measured at Station C6 (2.9 cm) because of the cohesive clay layer at the sediment surface.

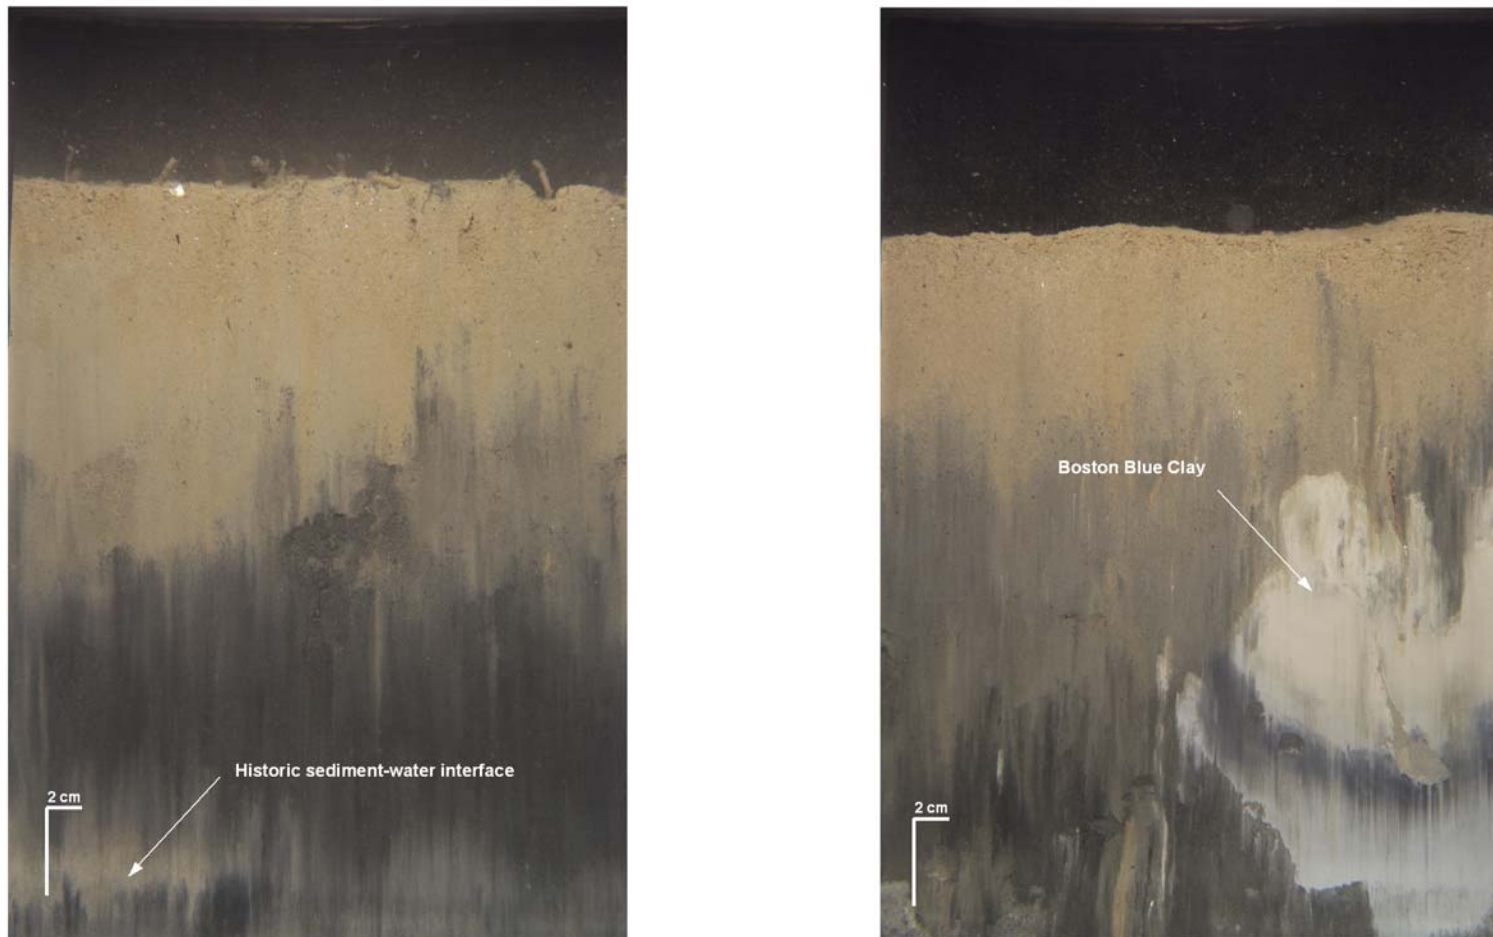
**Figure 3-13.** Evidence of historical dredged material disposal activity at the MBDS-D Mound is still visible after five years as seen by the buried horizon of the former sediment-water interface at Station D1 (left). There was much lower incidence of embedded clasts of Boston Blue Clay (as seen in this profile image from Station D3, right) on this mound as compared with the MBDS-C Mound.

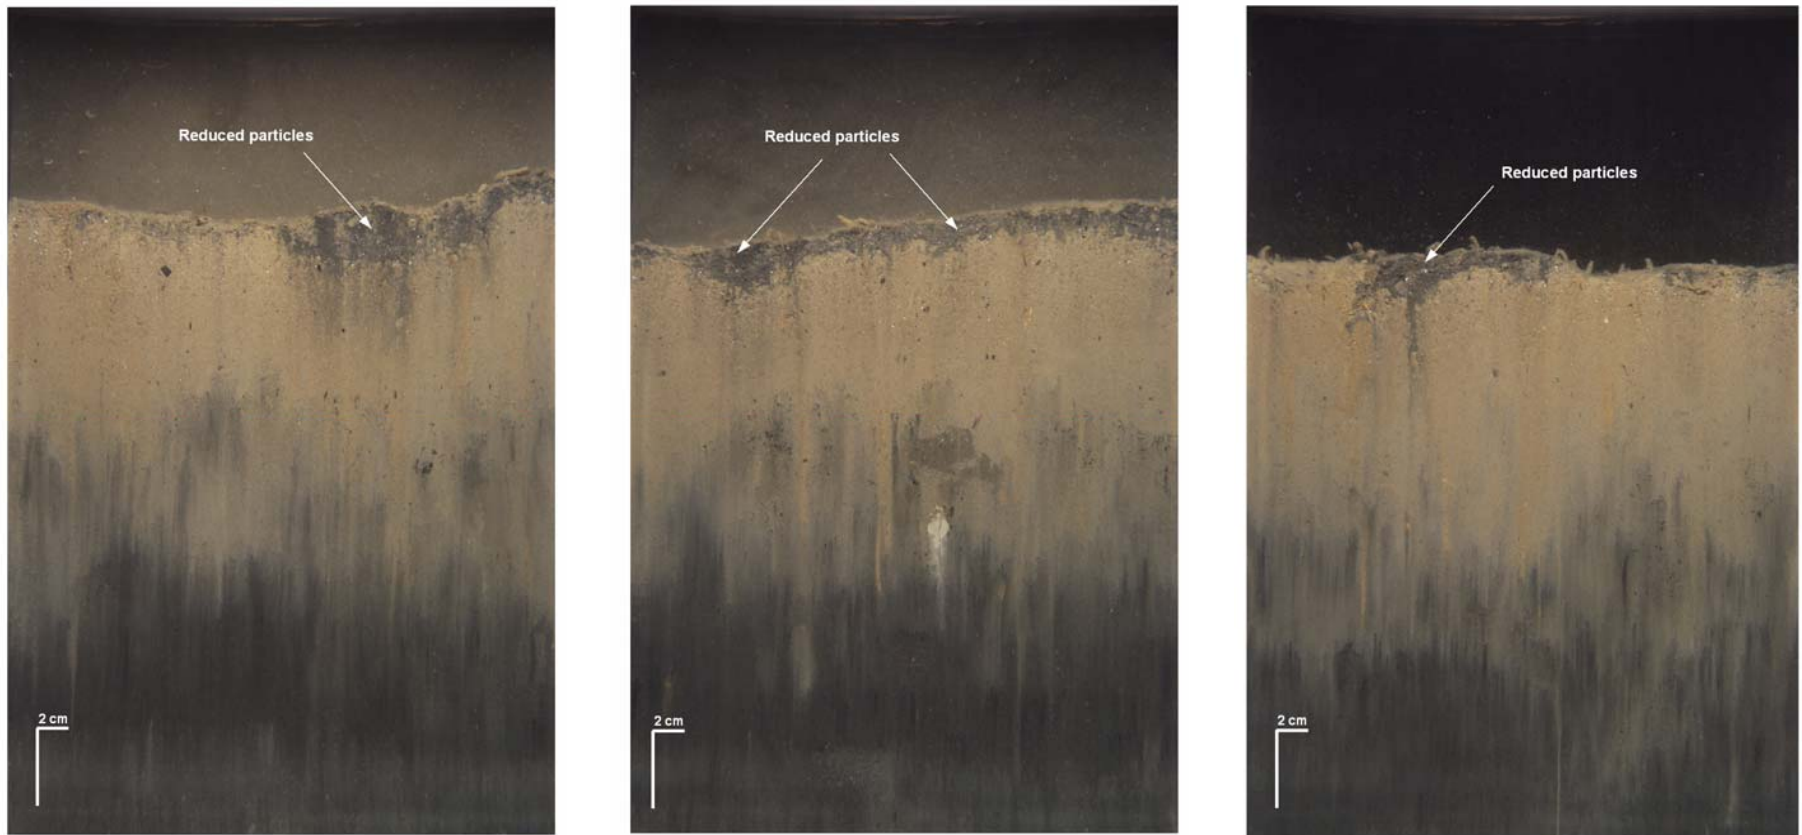
**Figure 3-16.** The bioturbational activities of deposit-feeding infauna are illustrated in these three replicate images from Station D4. The reduced particles from below the oxidized surface layer are being brought to the sediment surface through the feeding activities of larger polychaetes.

All images collected at the MBDS-D Mound showed evidence of mature, deposit-feeding assemblages (Figure 3-15) with secondary succession of Stage I opportunists (Stage I on III communities; Table 3-3). The biological mixing activities of the infauna were quite evident at many of the stations in which reduced, subsurface particles were transported to the sediment-water interface (Rhoads and Young, 1971) (Figure 3-16).
