# Disposal Area Monitoring System DAMOS

Contribution 178  
August 2008

**PROVIDENCE RIVER AND HARBOR  
MAINTENANCE DREDGING PROJECT  
SYNTHESIS REPORT**

**CONTRIBUTION #178**

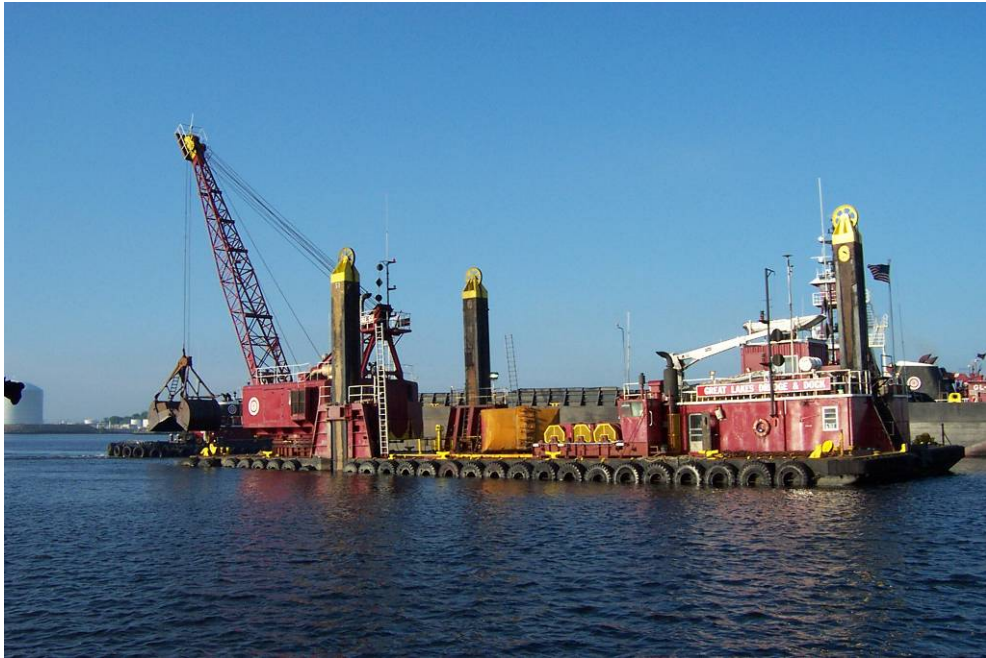
**Figure 3-1.** Example of mechanical dredge (#51) and split-hulled disposal scow used on the PRHMDP

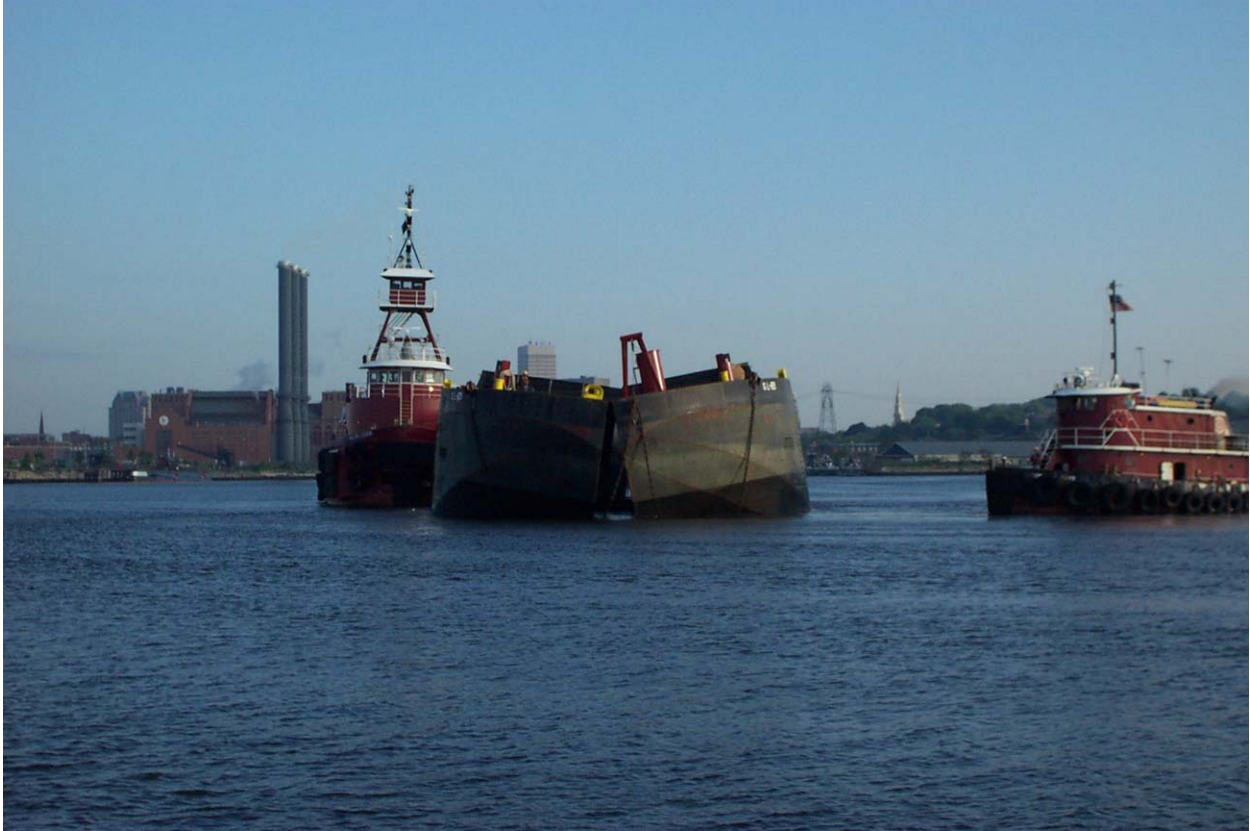
**Figure 3-3.** Attending tugs with split-hull scow initiating disposal into CAD cell in Providence Harbor

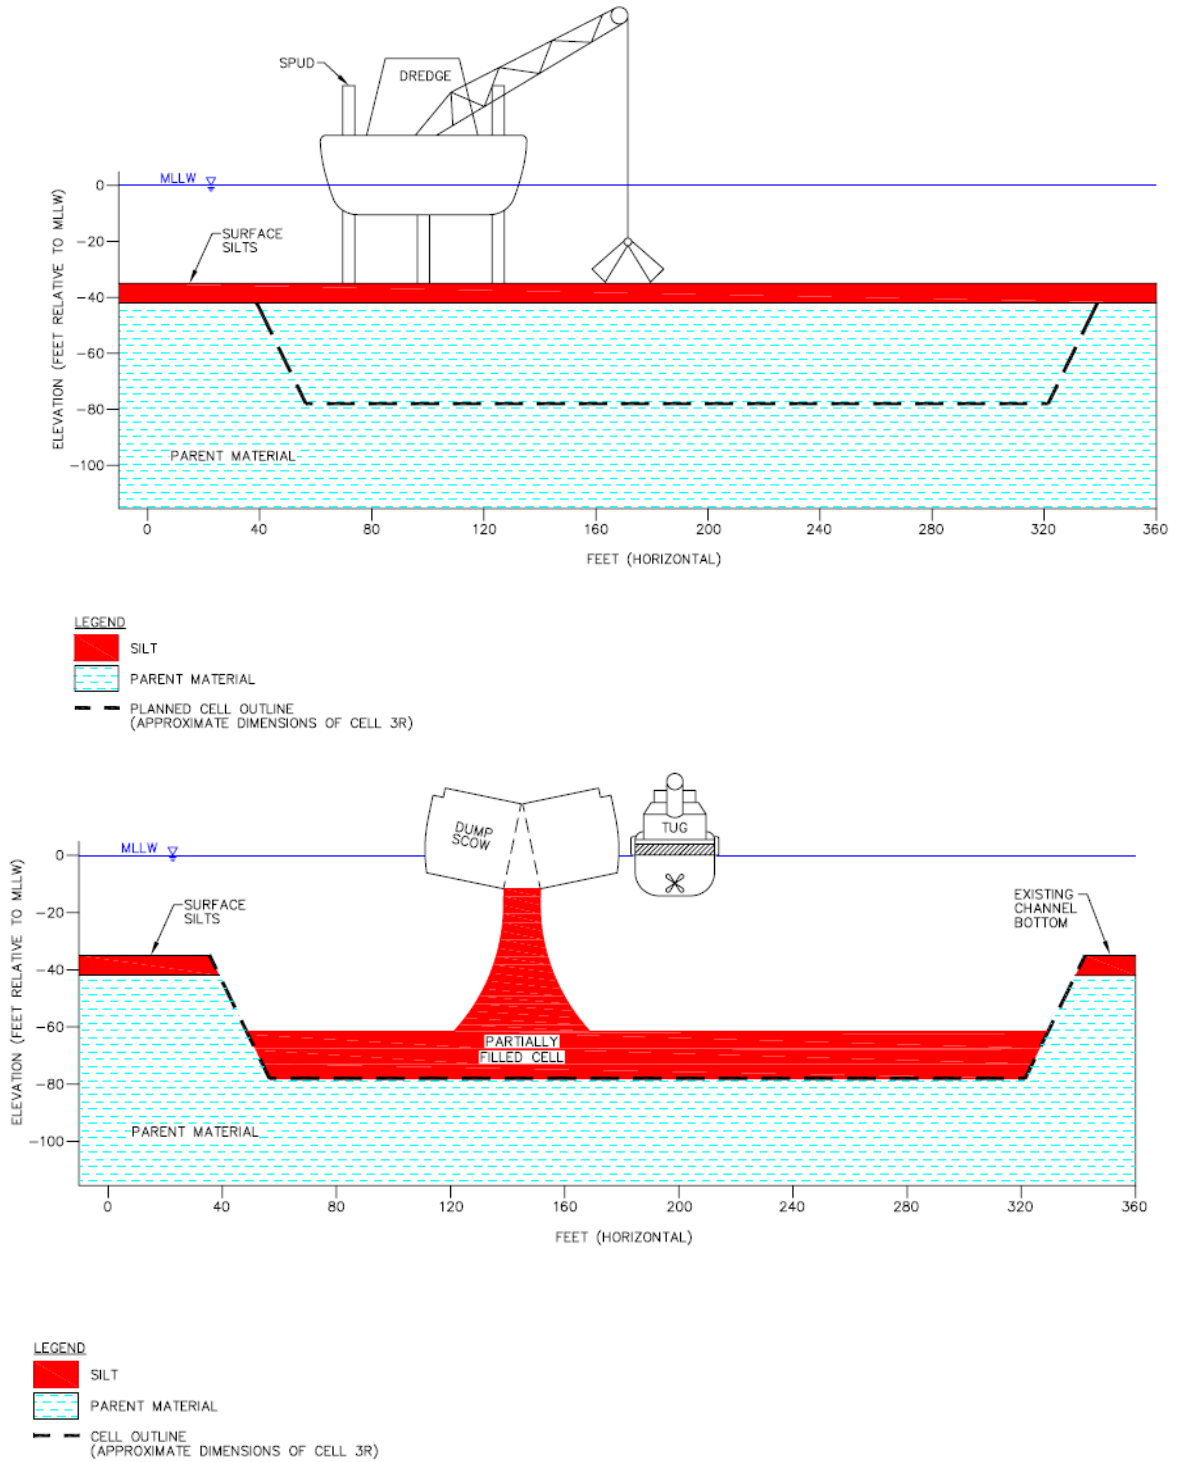
**Figure 3-5.** Schematic of CAD cell construction (top) and CAD cell disposal (bottom)

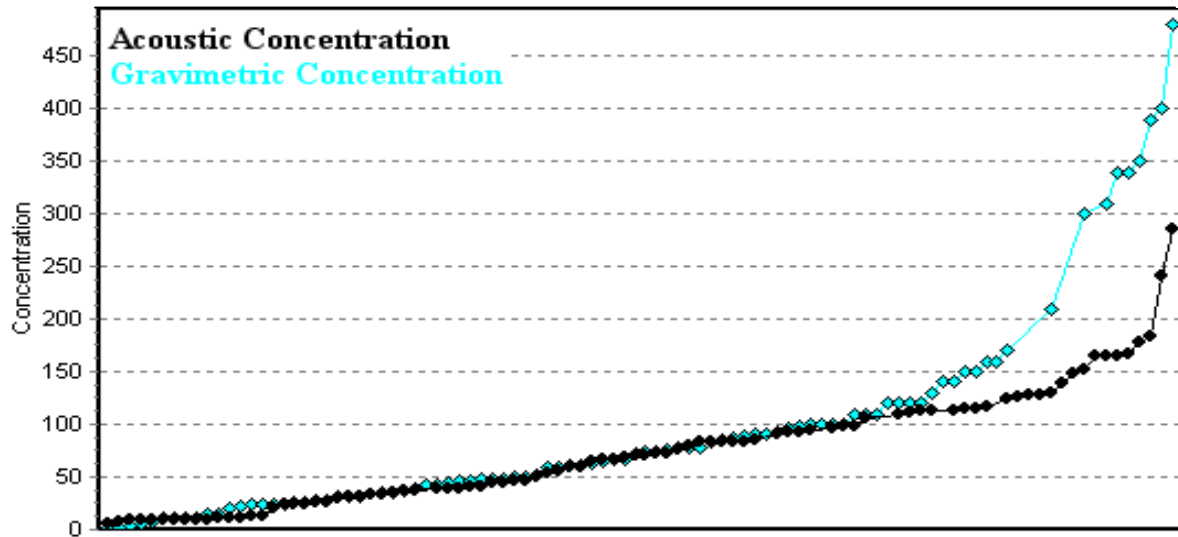
**Figure 4-3.** Comparison of acoustic TSS estimates and direct TSS measurements in rank order (units are in  $\text{mg}\cdot\text{l}^{-1}$ ) (Figure from Reine et al., *in prep*).

difficult. Due to the rapidly decaying plume, it was necessary to collect high TSS samples in close proximity to the operating bucket. However, acoustic backscatter data appeared to be strongly influenced by air entrainment at this location. The eight samples with greatest variability between TSS concentrations and acoustic estimates were taken within 130 ft (40 m) from the point of bucket insertion. Consequently, near-field profiles of TSS should be viewed as likely underestimates, whereas far-field profiles (> 660 ft [200 m] from the source) can be considered to be relatively accurate estimates of TSS concentration. There was also a strong linear relationship between TSS concentration and turbidity (NTU) data sets ( $r^2=0.90$ ).

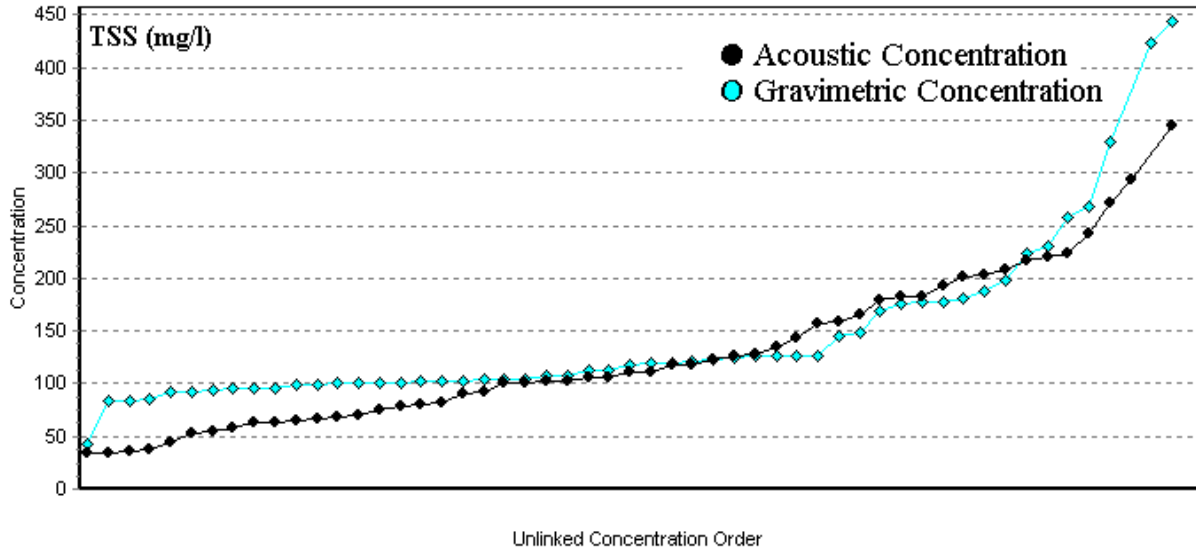
**Figure 4-6.** Comparison of acoustic TSS estimates and direct TSS measurements in rank order (Figure from Reine and Clarke, *in prep*).

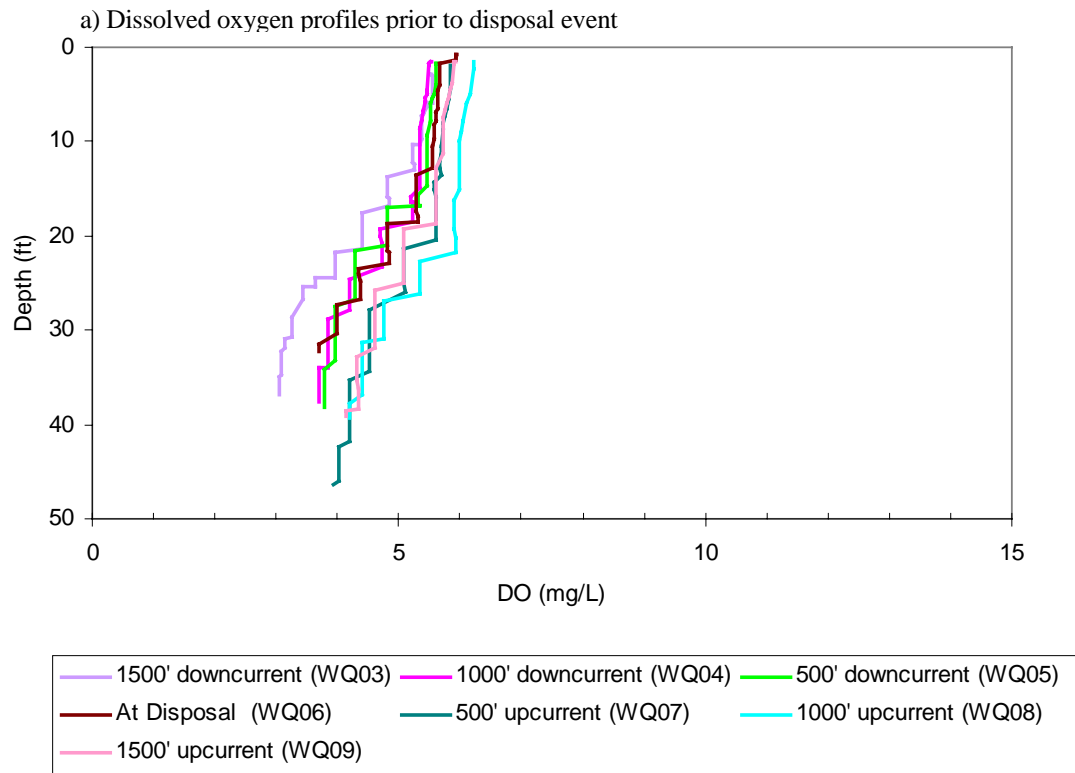
Figure 5 Dissolved Oxygen Profiles  
18 September, Flood Tide Disposal
