Monitoring Survey at the Massachusetts Bay Disposal Site August 2007

Disposal Area Monitoring System DAMOS

Contribution 181
April 2010

**US Army Corps
of Engineers**®
New England District

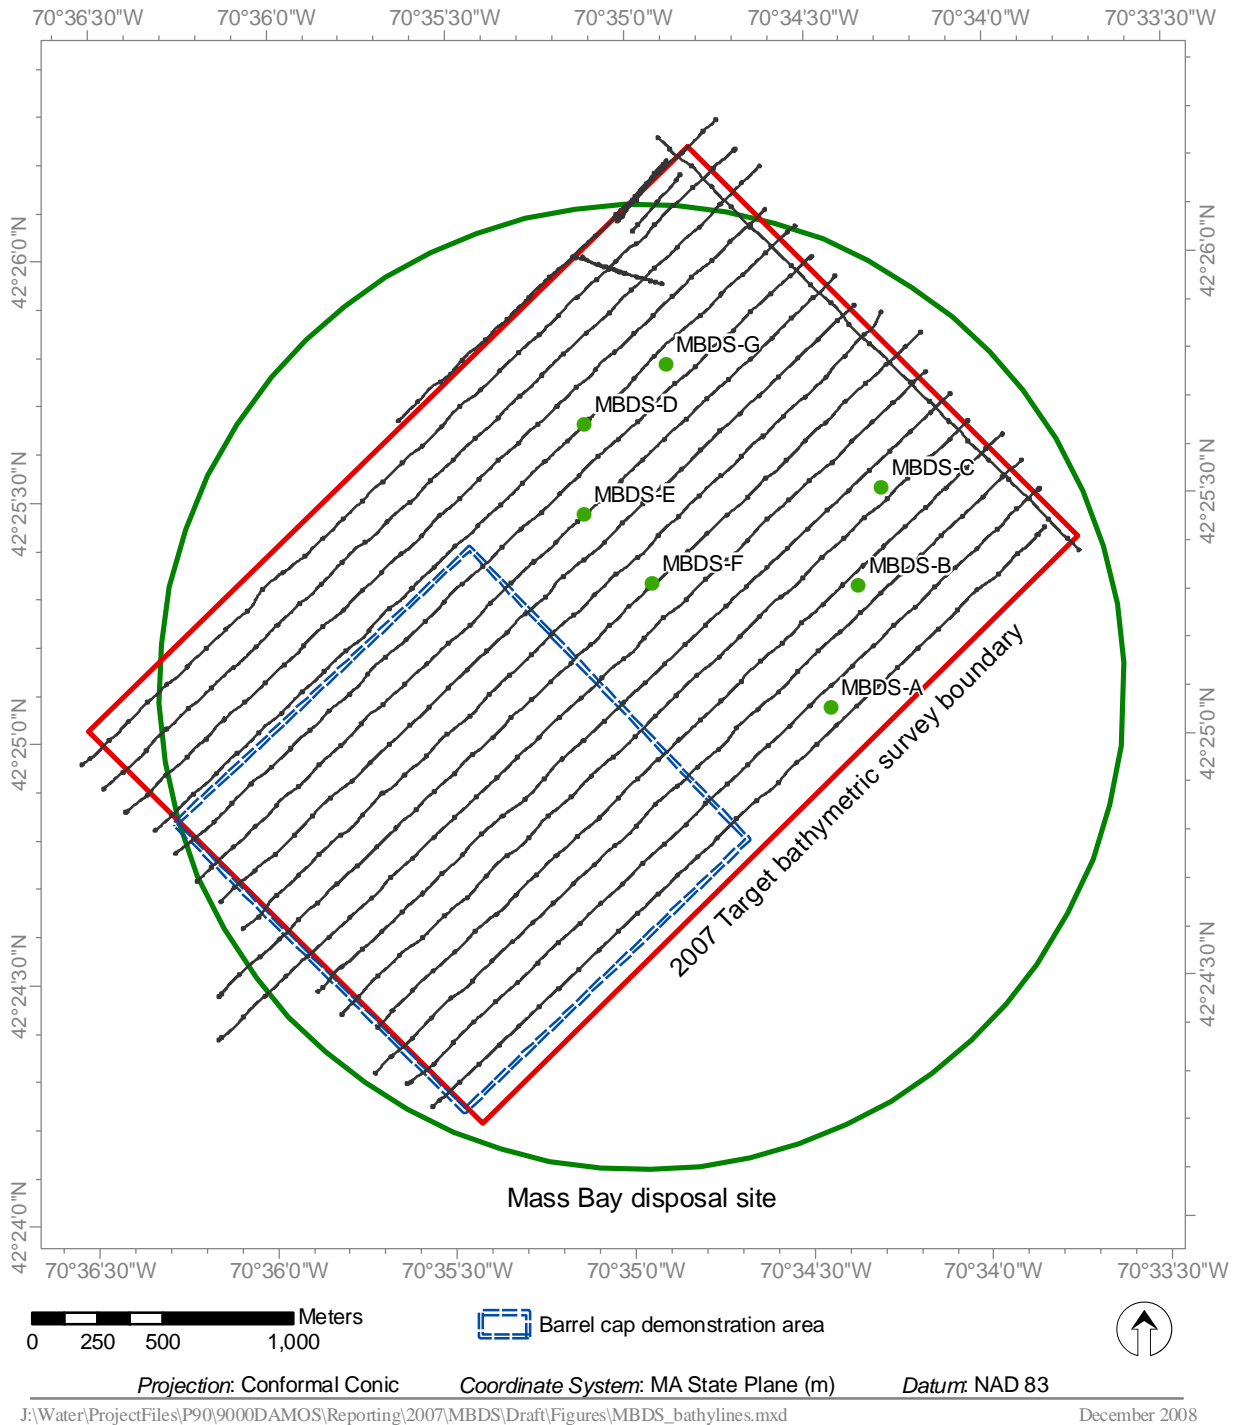
Figure 2-1. MBDS with bathymetric survey boundary and survey lines indicated, August 2007

A total of 16 survey lines, each approximately 125 m apart and oriented in a northeast-southwest direction, were occupied as part of the survey. One additional line was run in a northwest-southeast direction to assess data quality.

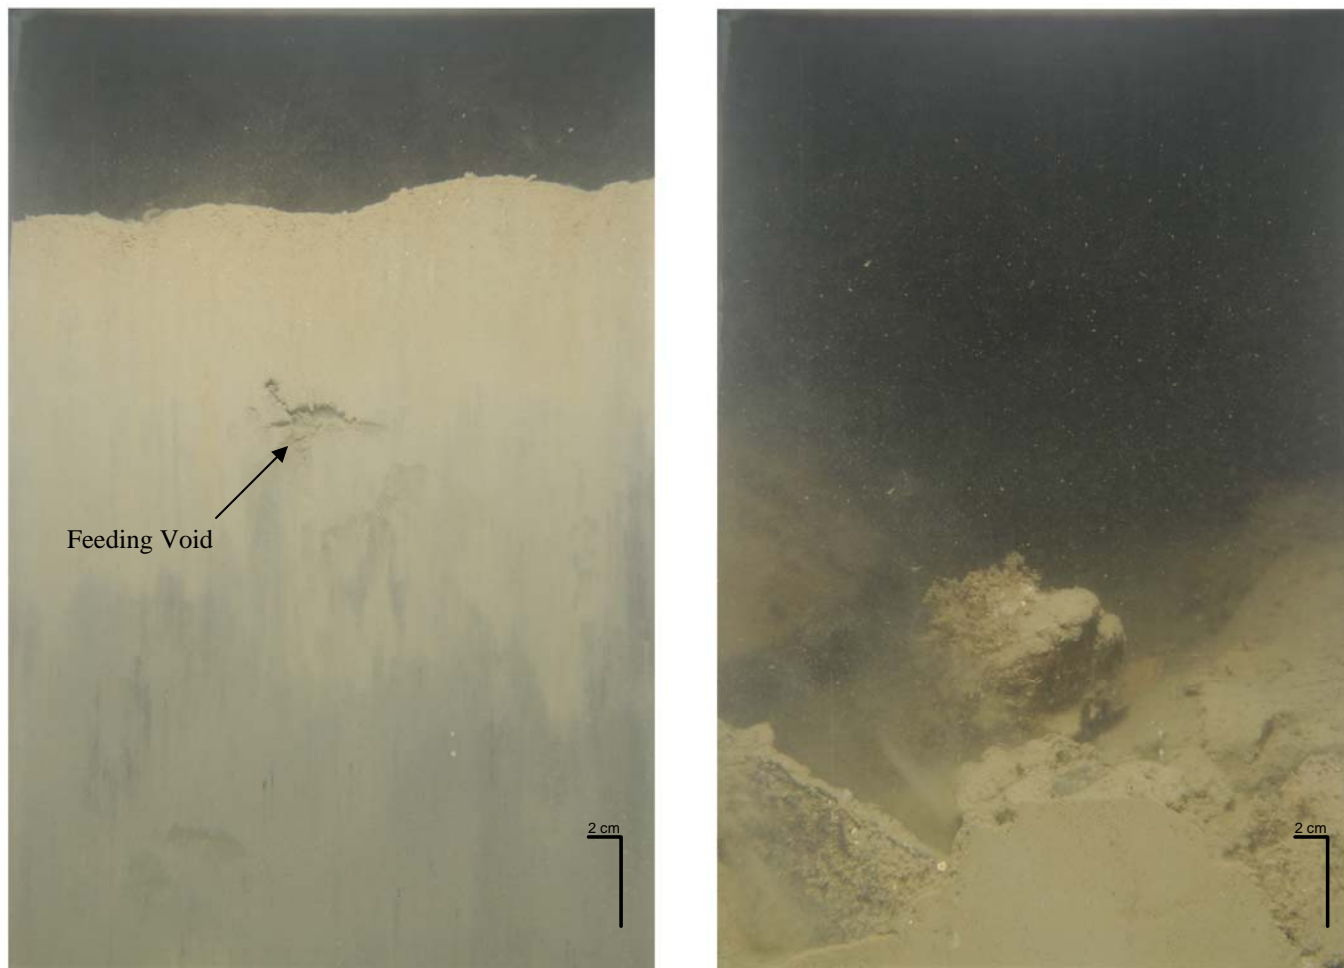
Figure 3-6. Station FG23-2 (left) has a deep well-mixed silt/clay horizon and a feeding void. This image from Station MBDREF-4 (right) had mud-covered rocks on the surface of a silt/clay horizon.

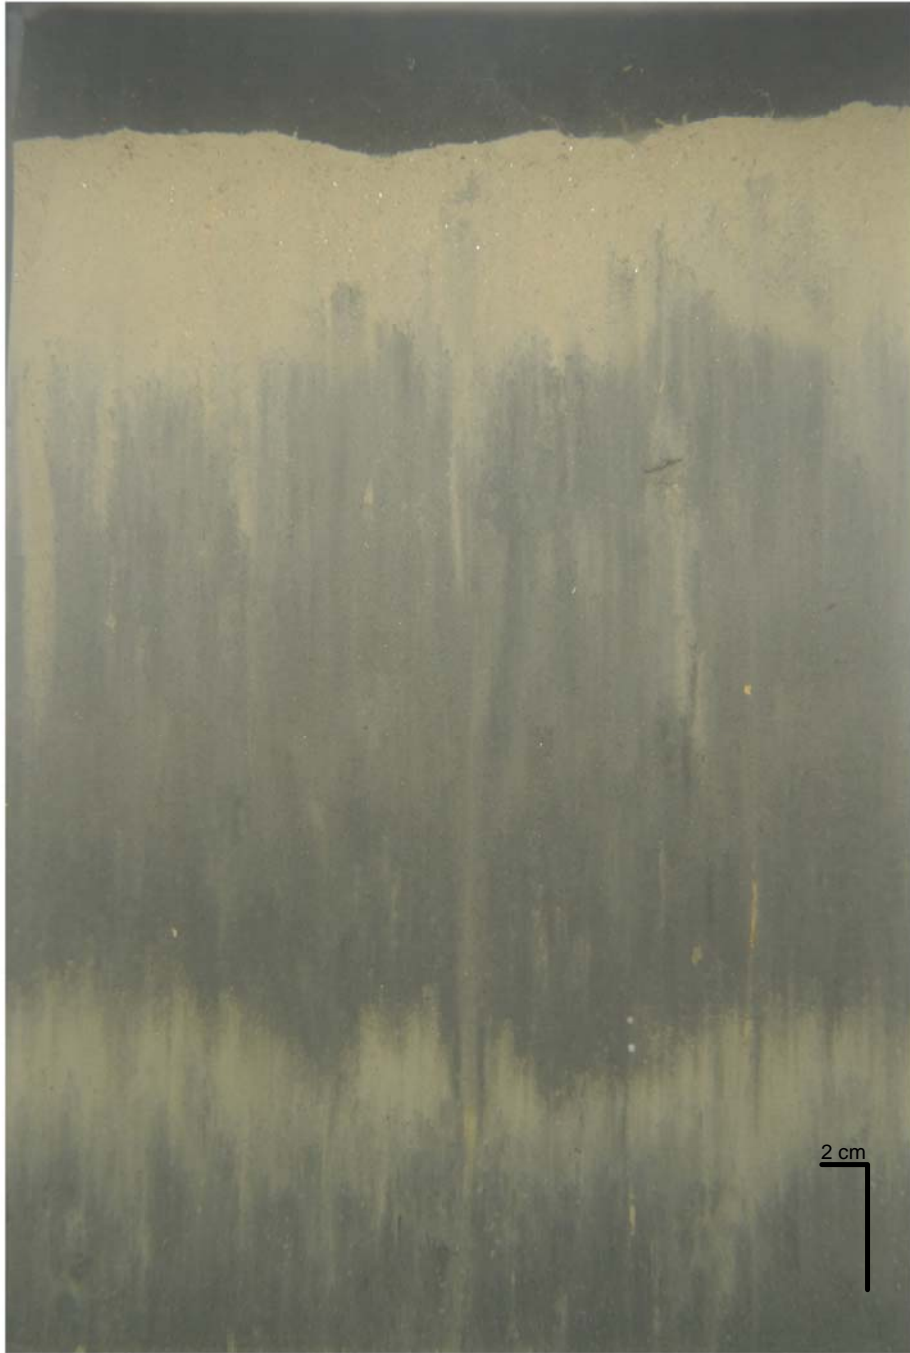
Figure 3-11. SPI image from Station MBDS-E-09 showing multiple depositional horizons from past disposal activity.

All fifteen stations surveyed at the MBDS-E Mound were comprised of fine-grained sediments with a grain size major mode of >4 phi (Figure 3-12, Appendix B). Although clay fabric was visible in some replicates, the majority of images showed dark reduced dredged material and layers of dredged material over older surface material (Figure 3-11).

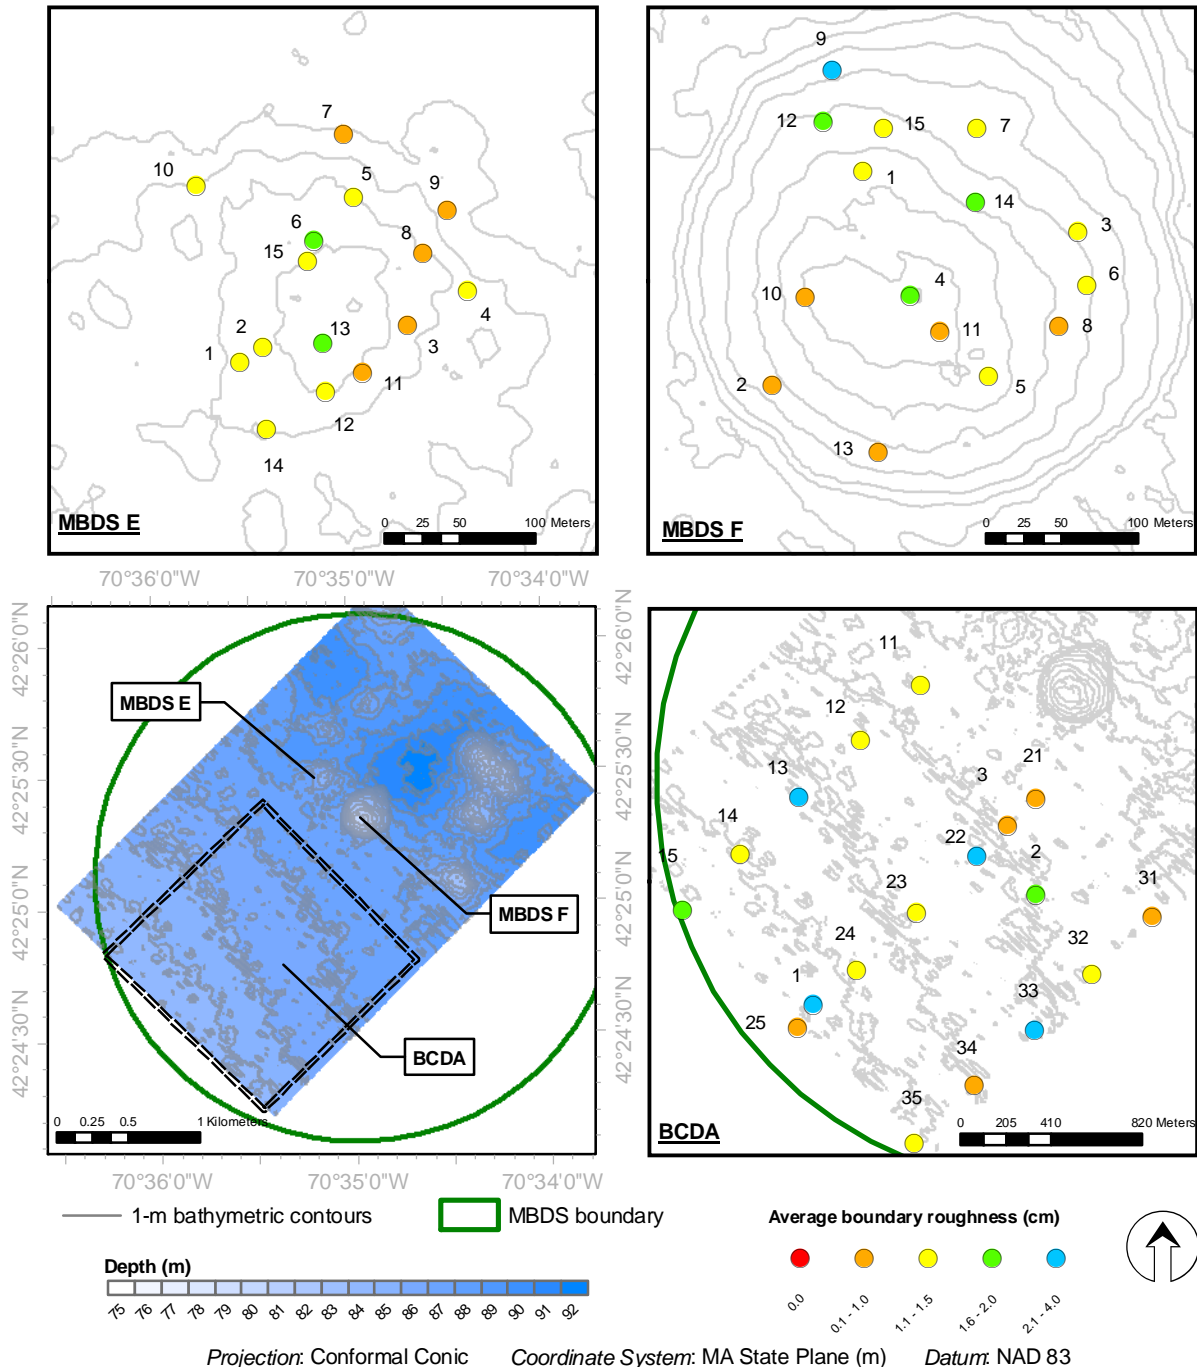
Figure 3-14. Distribution of station-averaged boundary roughness (cm) at MBDS

Average small-scale boundary roughness values ranged from 0.8 to 1.8 cm over the disposal mound, with an overall average of 1.2 cm (Figure 3-14, Table 3-2). The small-scale topographic roughness elements at the MBDS-E Mound were generally biogenic in origin (Appendix B), caused by feeding pits, tubes, or mounds (Figure 3-15, left); however, 13 out of the 45 replicates had mud clasts, and 17 of the 45 replicates had primarily physical boundary roughness elements (Figure 3-15, right). Small, rounded, oxidized mud clasts on the surface are generally the result of some physical surface disturbance, although biological origins are possible. The larger reduced mud clasts were likely caused by sampling artifacts from the camera frame or wiper blade and not due to any transport processes occurring at the disposal site.

Average small-scale boundary roughness values ranged from 0.6 to 3.3 cm, with an overall average value for BCDA of 1.5 cm (Figure 3-14). The majority of the surface roughness elements were of biological origin and due to the presence of burrows and tubes at the sediment-water interface (Figure 3-23).
