Monitoring Survey of the Douglas Island Disposal Site  
 October 2011

# Disposal Area Monitoring System DAMOS

Contribution 191  
 October 2012

**MONITORING SURVEY OF THE  
DOUGLAS ISLAND DISPOSAL SITE  
OCTOBER 2011**

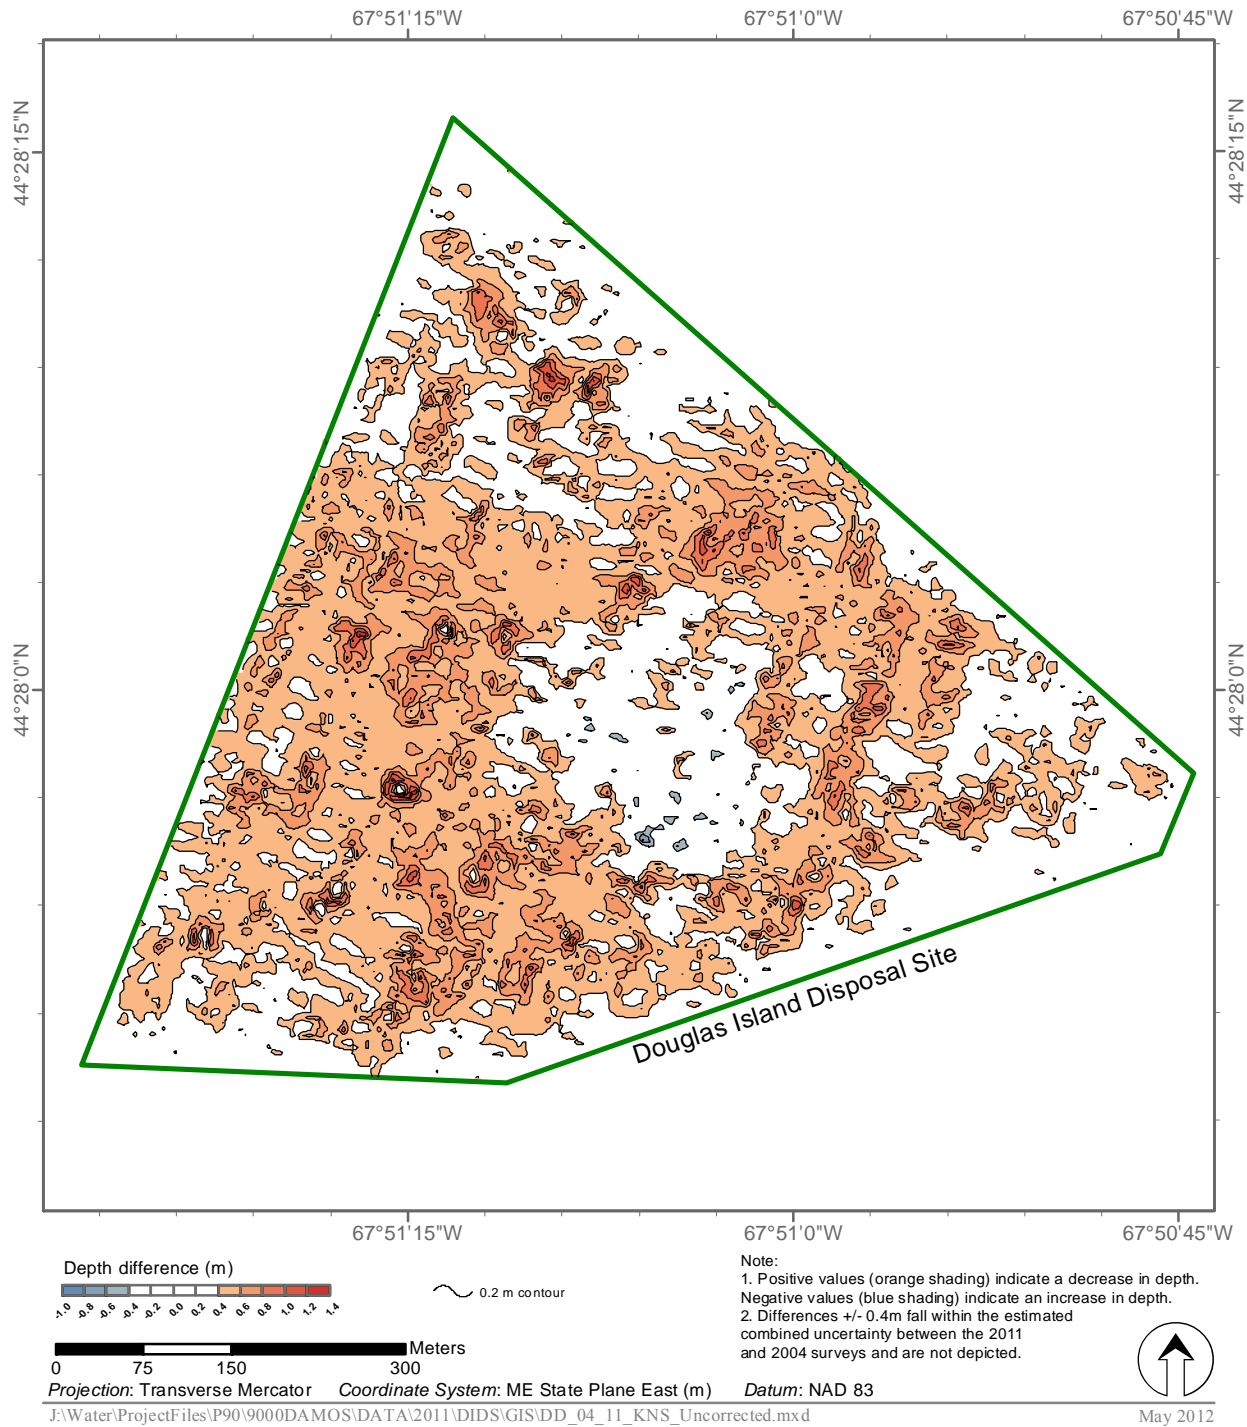
Figure 3-2. Depth differencing of DIDS (between 2011–2004)

Despite continued disposal activity over the historical mound, the net change over the majority of the mound was within the estimated combined error of the bathymetric surveys ( $\pm 0.4$  m). This absence of detectable change is likely the result of the continued disposal activity being offset by the consolidation of the previously placed dredged material, the majority of this consolidation likely occurred within the first year after mound formation. Although the site is in an area of the bay with currents that were noted to have the potential for sediment transport (ENSR 2007), there was no evidence of scour within the 2011 bathymetry. Rather, the bathymetry revealed distinct individual disposal features (Figure 3-1) and preservation of these features indicates limited mobilization of sediments over the site.

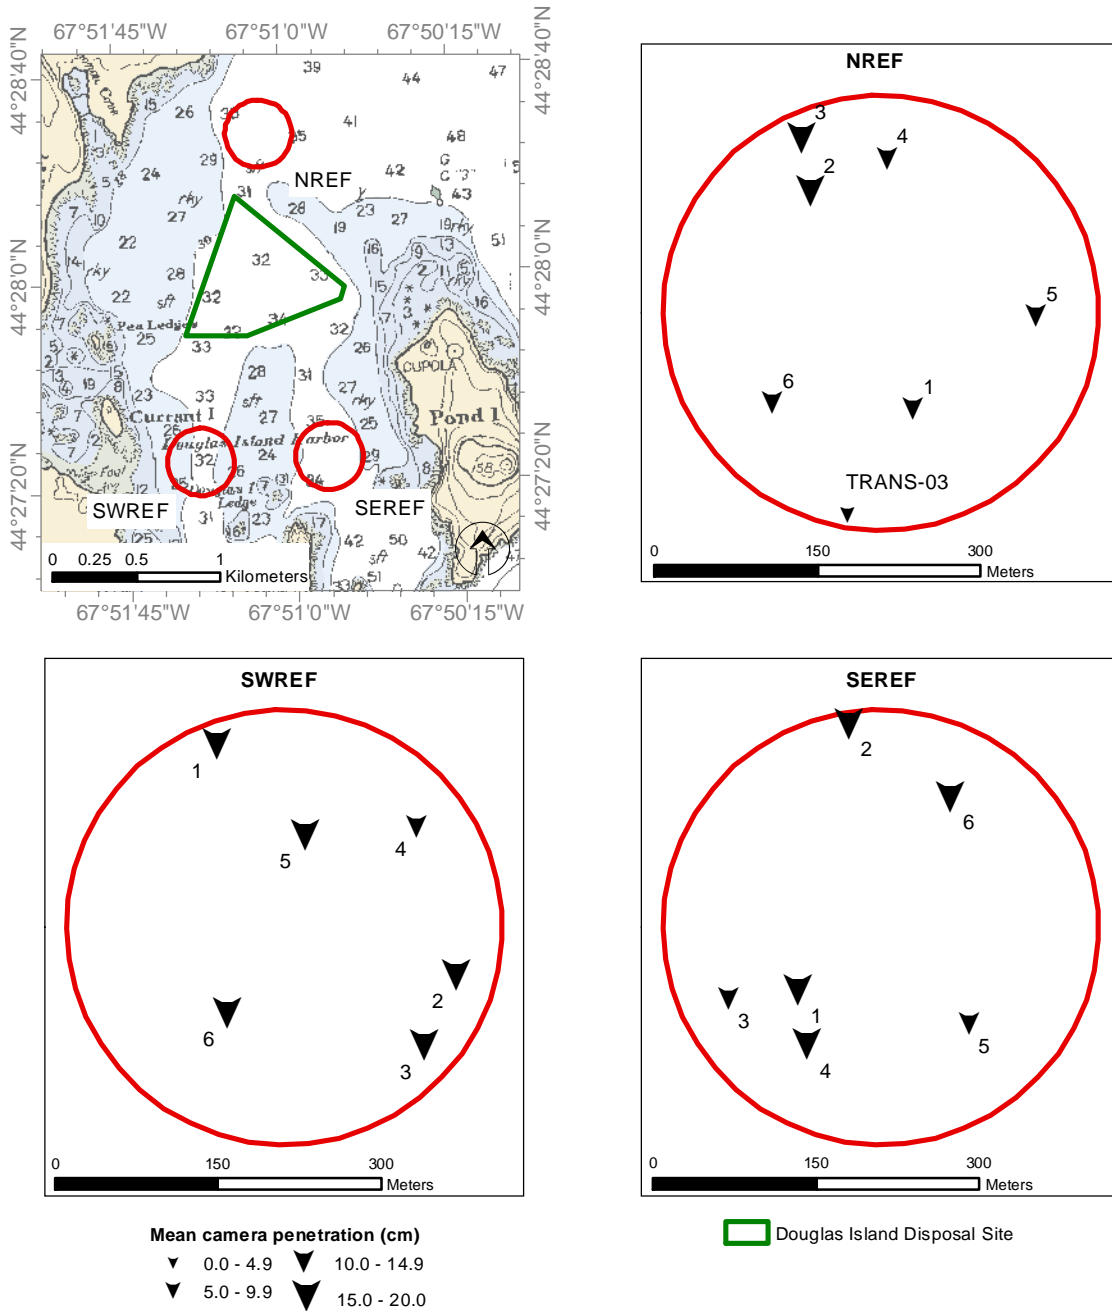
**Figure 3-4.** Map of mean replicate camera penetration depth (cm) at the DIDS reference areas; Numbers next to symbols indicate station ID

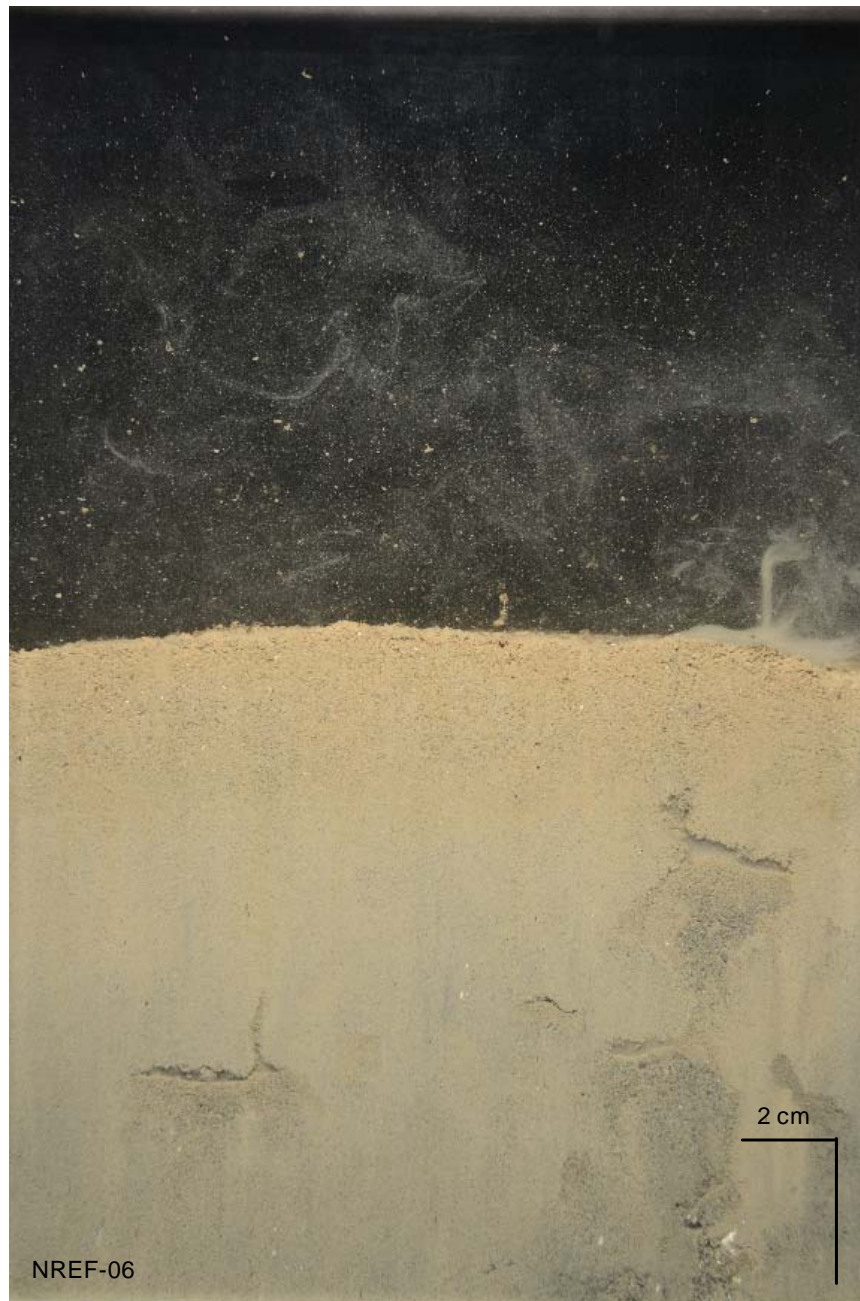
**Figure 3-6.** The small-scale surface topography (i.e., boundary roughness) in this profile image from station NREF-06 was due to the presence of biogenic mounds created by the burrowing and feeding activities of subsurface organisms

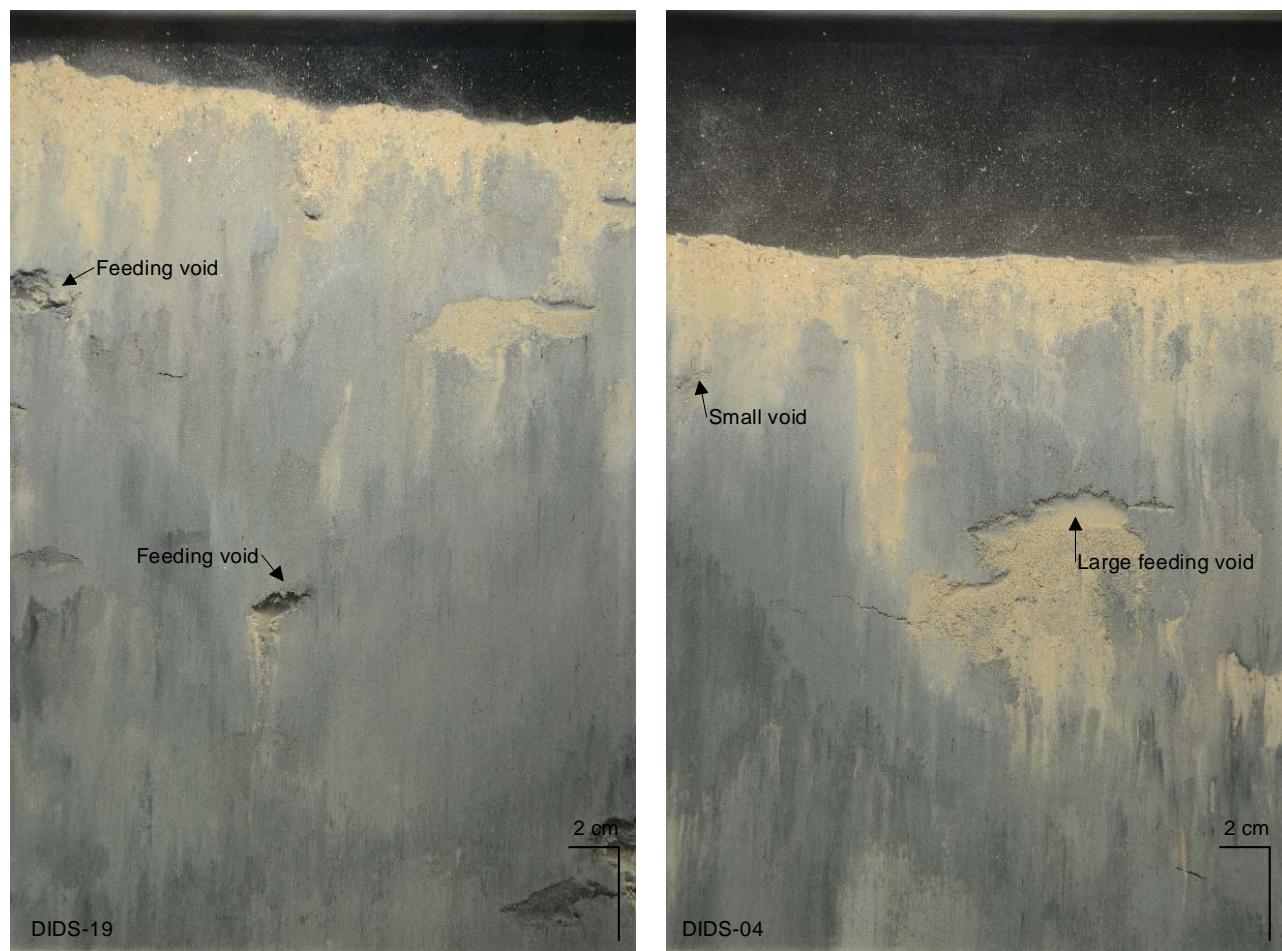
**Figure 3-17.** Profile images from station DIDS-19 (left) and DIDS-04 (right) with extensive subsurface feeding voids

The mean aRPD values at the disposal site stations ranged from 0.8 to 4.7 cm, with an overall site mean aRPD of 2.8 cm (Table 3-2; Figure 3-15). With the exception of one image at station DIDS-10, all of the replicate images obtained at the disposal site stations showed evidence of mature, deposit-feeding benthic taxa (Figure 3-16). The evidence of a well-developed community of Stage 3 taxa (head-down, deposit-feeding invertebrates) included extensive feeding voids, burrows, and/or larger-bodied subsurface organisms observed in the profile images (Figures 3-17 to 3-19).

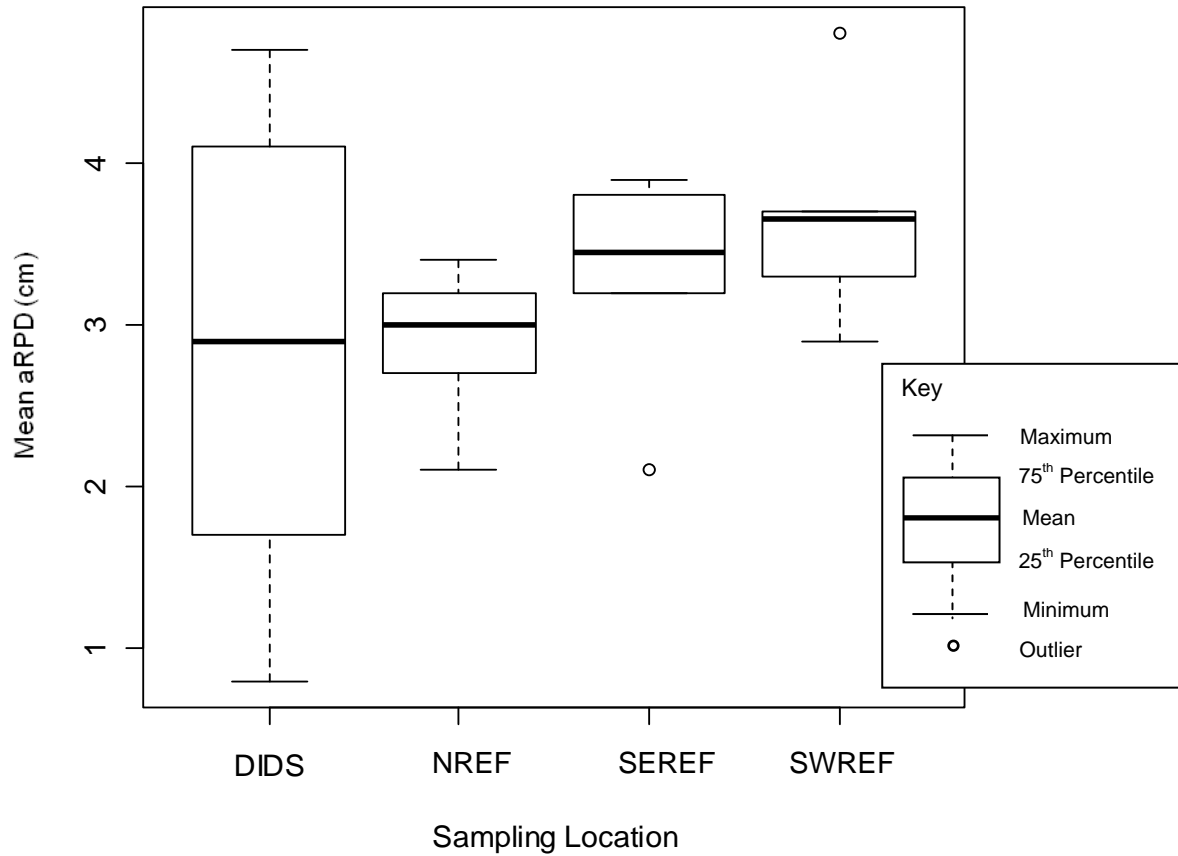
**Figure 3-21.** Boxplots with distribution of station mean aRPD values for DIDS and reference stations, October 2011

The data from all four groups were combined to assess normality and estimate pooled variance. Results for the normality test indicated that the area residuals (i.e., each observation minus the area mean) were not significantly different from normal (Shapiro-Wilk's test  $p$ -value = 0.42). Group standard deviations ranged from 0.5 to 1.3, with the smallest standard deviation occurring at the reference stations (Table 3-3). The variances were found to be significantly different among the four groups ( $p=0.002$  for Levene's test), so a normal  $t$ -interval using separate variance estimates was constructed to determine results of the inequivalence test (Table 3-4, see Section 2.3.5 for description of inequivalence test).
