Monitoring Cruise at the Cape Cod Canal
Disposal Site and Springhill Beach Site,
March 1990 - April 1990

Disposal Area Monitoring System DAMOS

Contribution 84
August 1993

**US Army Corps
of Engineers**
New England Division

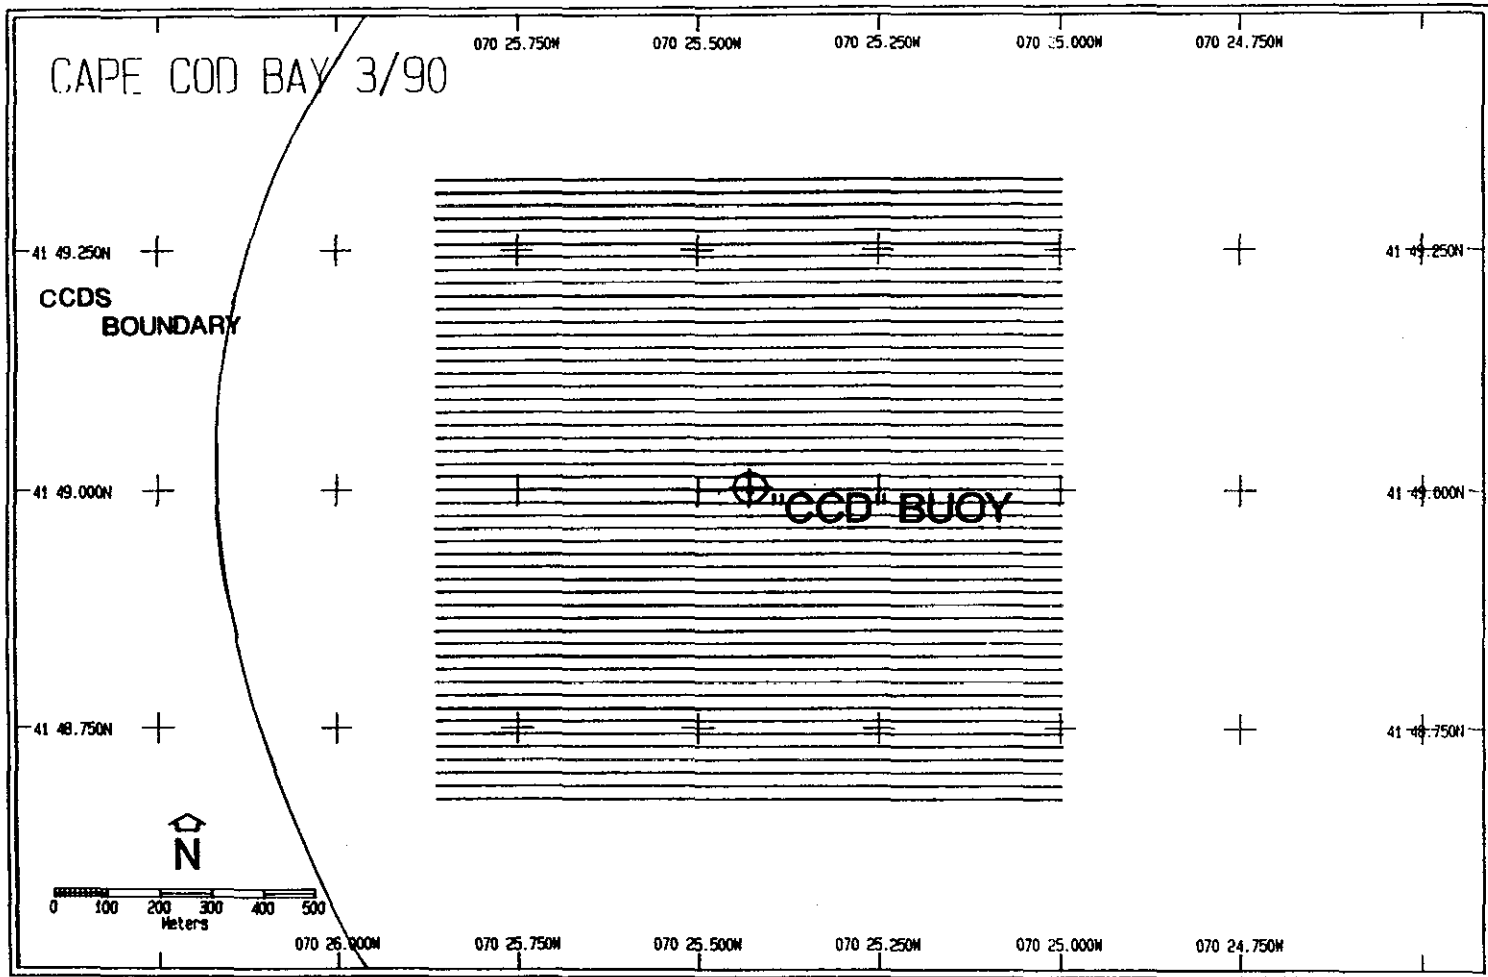
Figure 2- 1. Predisposal bathymetric survey grid used at CCDS indicating the location of the "CCD" buoy and the boundary of the Cape Cod Canal Disposal Site.

One marker buoy, "CCD", was deployed within CCDS at 41° 49.007'N and 70° 25.426'W (Figure 2-1). This location is approximately 600 meters west of the center of the CCDS in approximately 23 m of water.

The predisposal bathymetric survey, conducted at the "CCD" buoy on 22 March 1990, encompassed a 1200 x 1200 m grid with 25 m lane spacing, centered at coordinates 41° 49.000'N and 70° 25.430'W (Figure 2-1). The postdisposal CCDS survey, conducted on 24 April 1990, was extended an additional 300 meters to the east of the predisposal grid encompassing a 1200 x 1500 m grid with 25 m lane spacing (Figure 2-2).

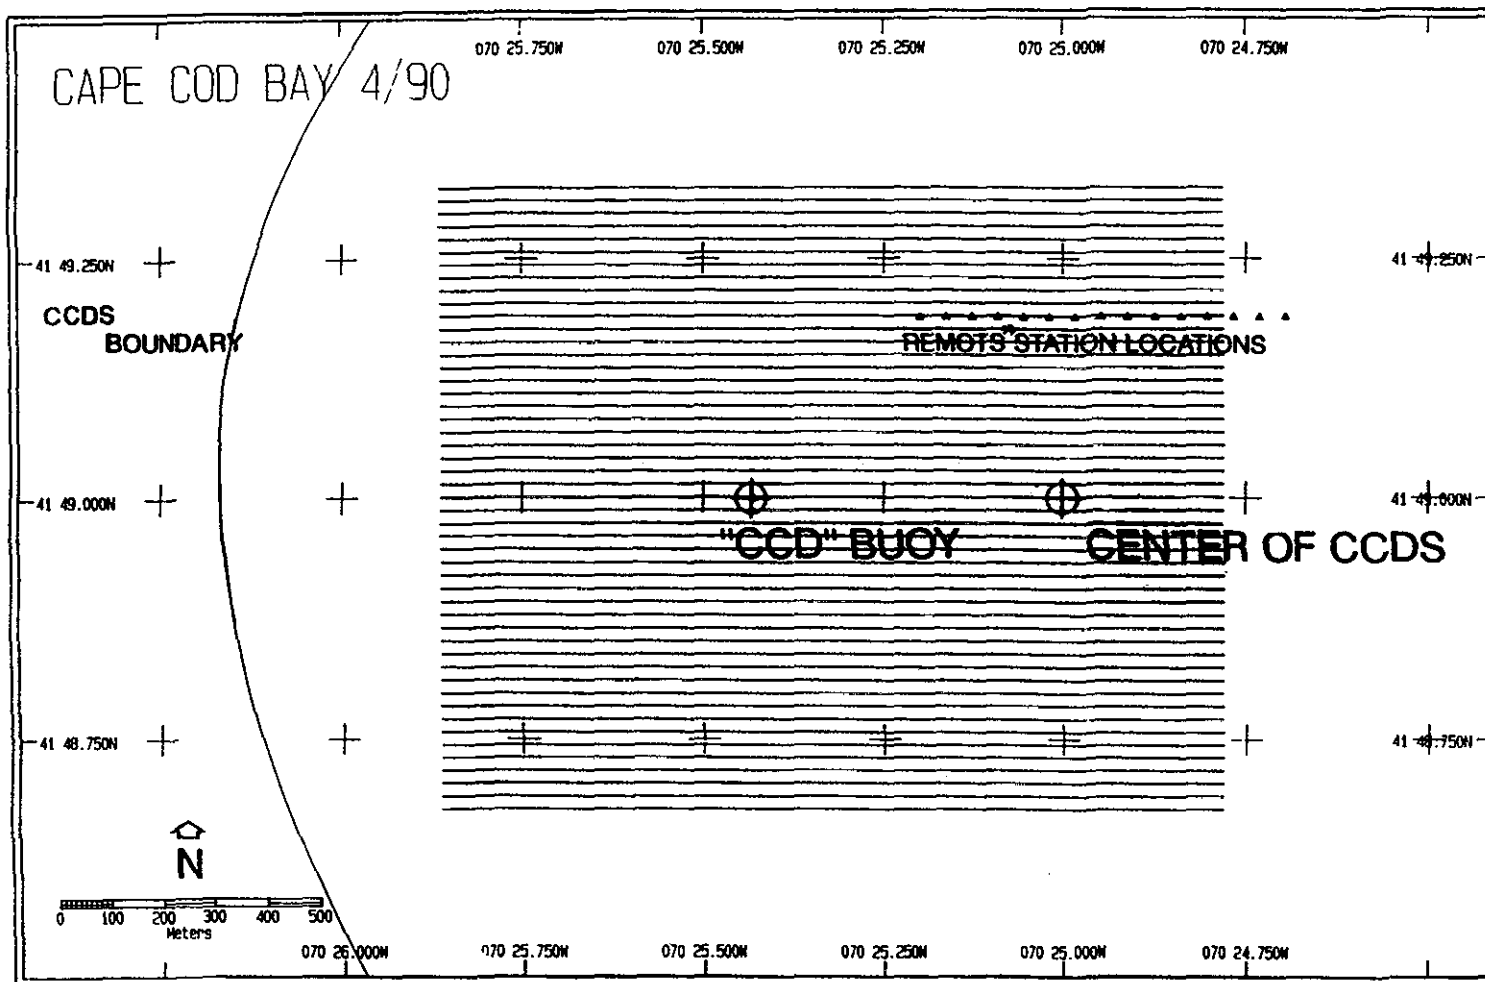
Figure 2-2. Postdisposal bathymetric survey grid used at CCDS indicating the location of the "CCD" buoy, the center of CCDS, and the REMOTS® station locations.

REMOTS® stations were occupied on 25 April. Three replicate photographs were obtained at each of 15 stations (Figure 2-4) situated along an east-west transect through the center of the historical CCDS disposal mound as determined from analysis of the postdisposal bathymetric data. Stations were spaced 50 m apart and extended 350 m east and west of the designated mound center located at 41° 49.189'N and 70° 24.947'W (Figure 2-2).

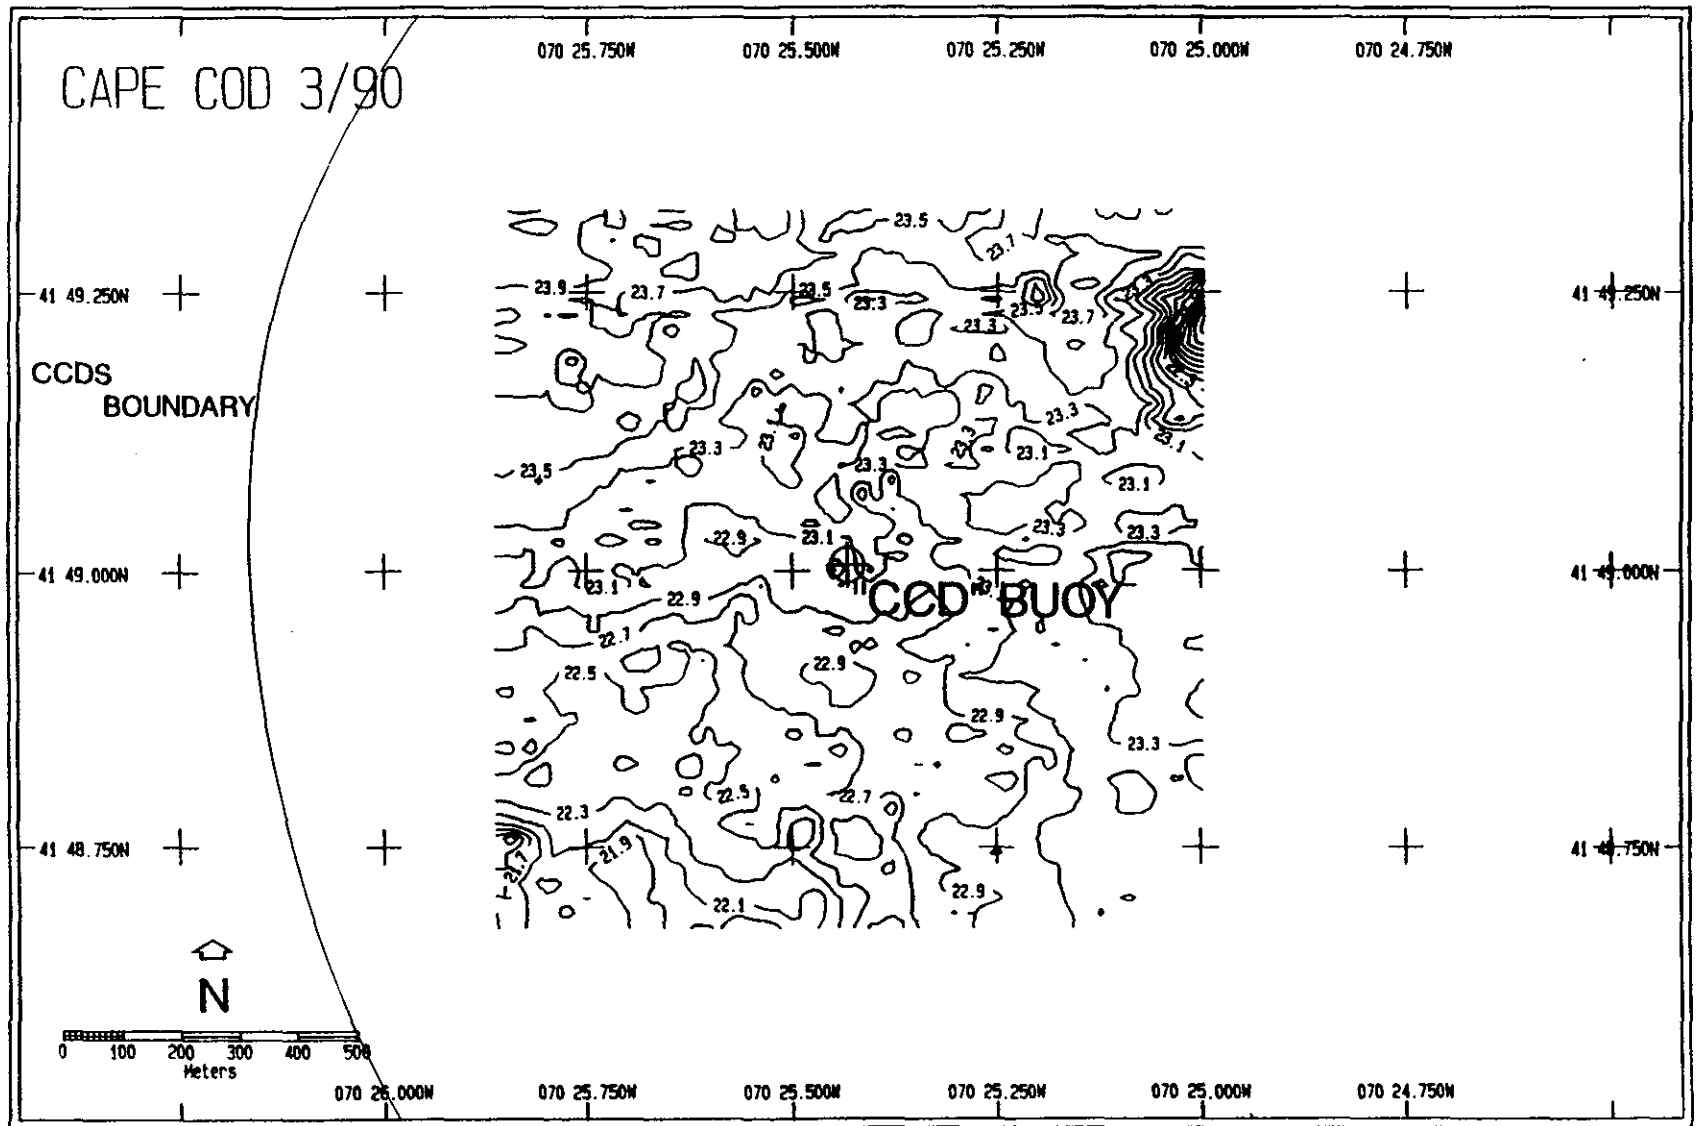
Analysis of the predisposal bathymetry at the CCDS revealed a portion of what appeared to be an historical disposal mound in the northeast corner of the survey grid (Figure 3-1). The postdisposal CCDS survey was extended 300 m eastward in order to delineate more clearly the boundary of this mound (Figure 3-2). Postdisposal analysis indicated the minimum depth of this mound was 19.3 m, approximately 4 m in height compared to ambient water depths of 23 m.

Figure 3-1. Predisposal bathymetric contour chart of area surrounding the "CCD" buoy, March 1990.

The predisposal bathymetry revealed the western portion of an historic mound in the northeast region of the survey grid (Figure 3-1). The postdisposal survey was extended an additional 300 m east in order to delineate the boundaries of this mound more clearly (Figure 3-2). The contour plot indicated that the postdisposal bathymetric survey was extended far enough to include the eastern boundary of this mound; however, REMOTS® sediment-profile analyses indicated that dredged material extended beyond the mound area detectable with bathymetry. It is important to note that the eastern-most REMOTS® station (350E) extended approximately 100 m beyond the postdisposal bathymetric survey area (Figure 2-2). Dredged material was therefore apparent up to at least 350 m east of the center of the mound.

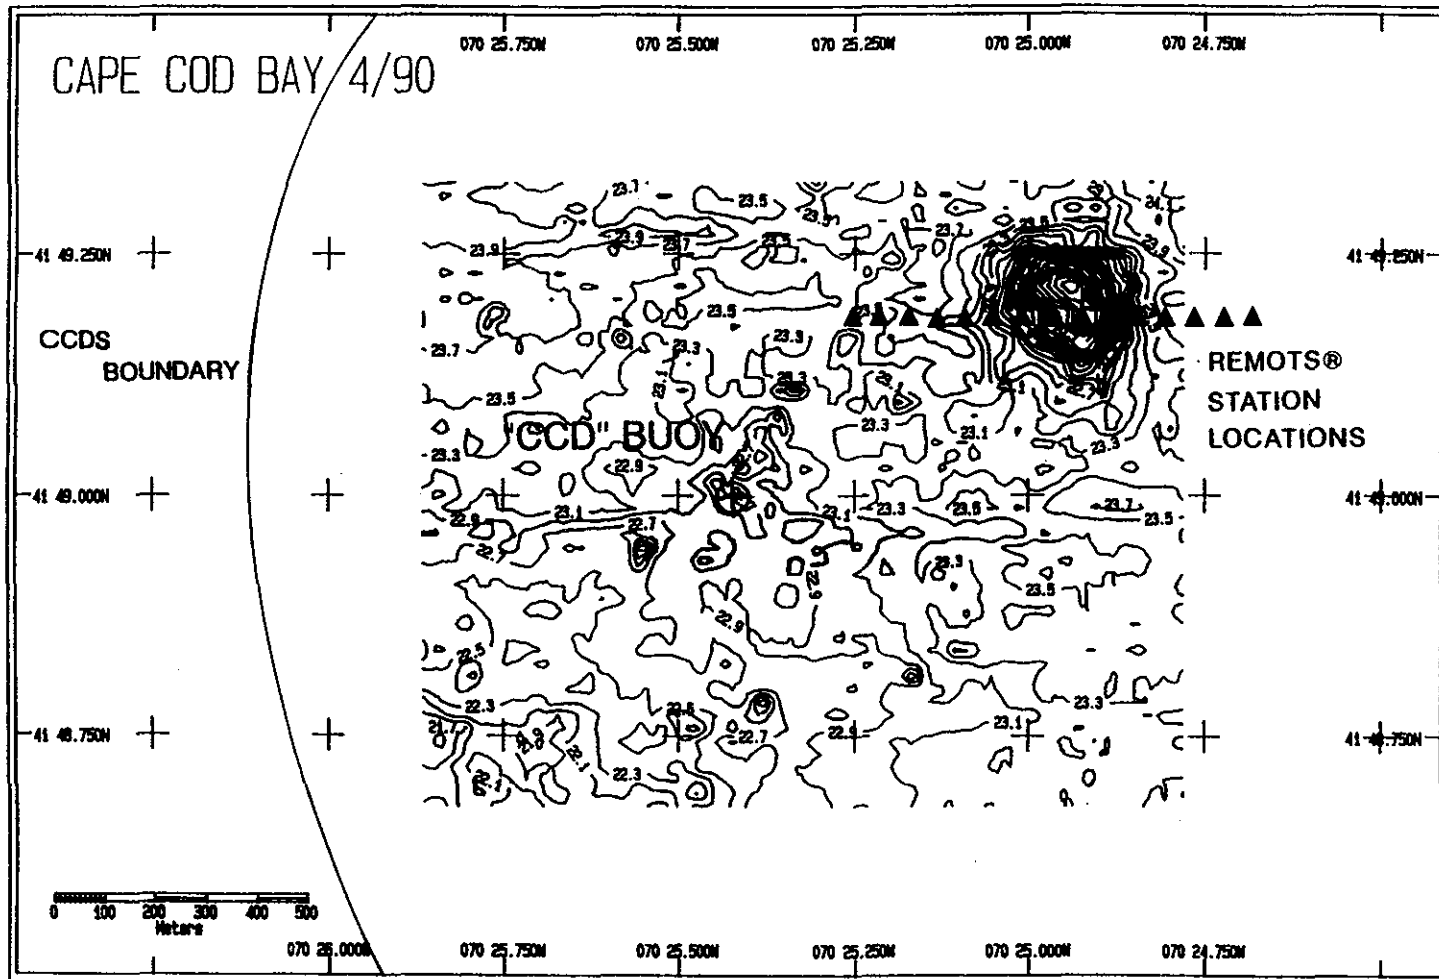
Figure 3-2. Postdisposal bathymetric contour chart of area surrounding the "CCD" buoy, indicating REMOTS® station locations transecting historic CCDS disposal mound, April 1990.

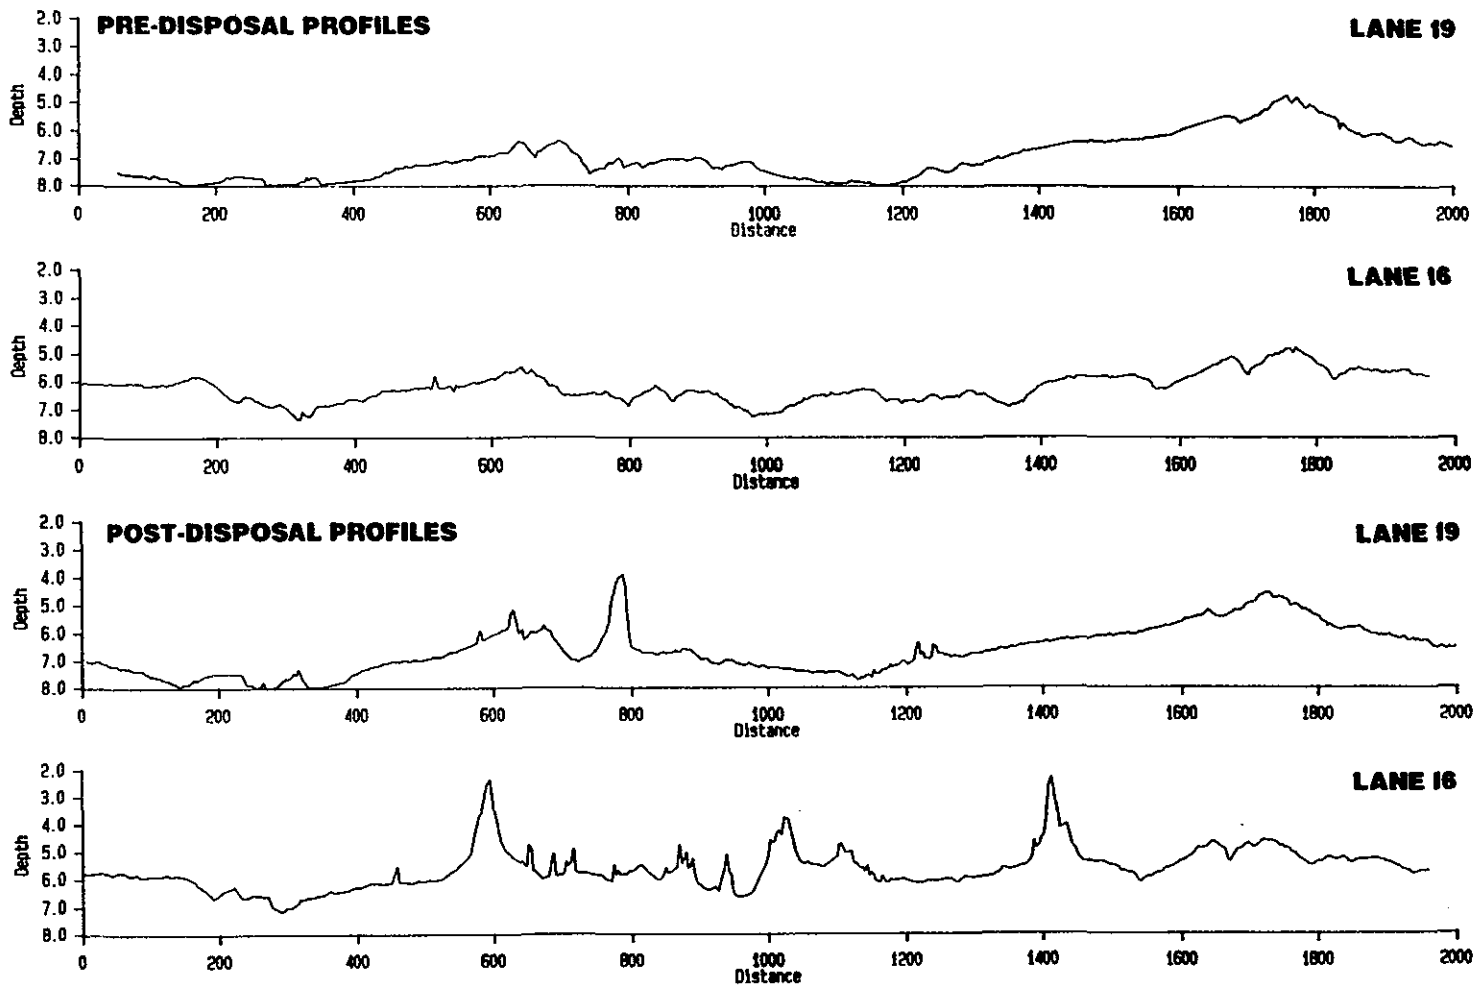
Figure 3-6. Pre- and postdisposal profile plot for lanes 16 and 19 of the Springhill Beach Site survey.

Analyses of pre- and postdisposal depth contour plots of the Springhill Beach Site (Figures 3-4 and 3-5, respectively) indicated a natural shoaling within the survey area from 12.0 m offshore to 1.0 m near-shore. The postdisposal contour plot revealed several areas where disposal activities created shoals. In these areas the depth was reduced from 5.5 m to 3.5 m after disposal. Most of these shoal areas occurred along lanes 16 and 19 of the bathymetric survey grid, north of the buoy positions (Figure 3-6).

Sediments from the Cape Cod Canal dredging operations also were disposed at the near-shore Springhill Beach Site. Pre-and postdisposal bathymetric surveys were conducted at the Springhill Beach Site to assess the distribution of these newly-deposited sediments. The postdisposal bathymetric survey at the Springhill Beach Site showed several individual mounds resulting from disposal activities. The majority of these mounds occurred on lanes 16 and 19 of the bathymetric survey. These lanes were located approximately 125 - 200 m north of the marker buoys deployed at this site. The depth profile plots for lanes 16 and 19 clearly reflected these subsequent changes in topography (Figure 3-6).

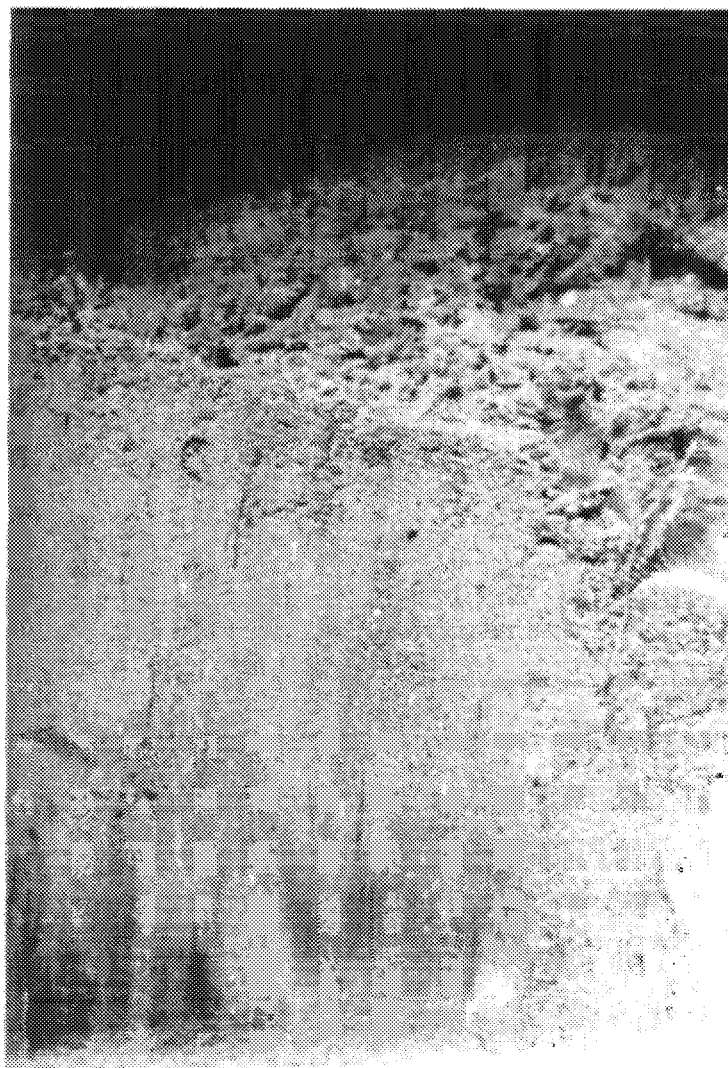
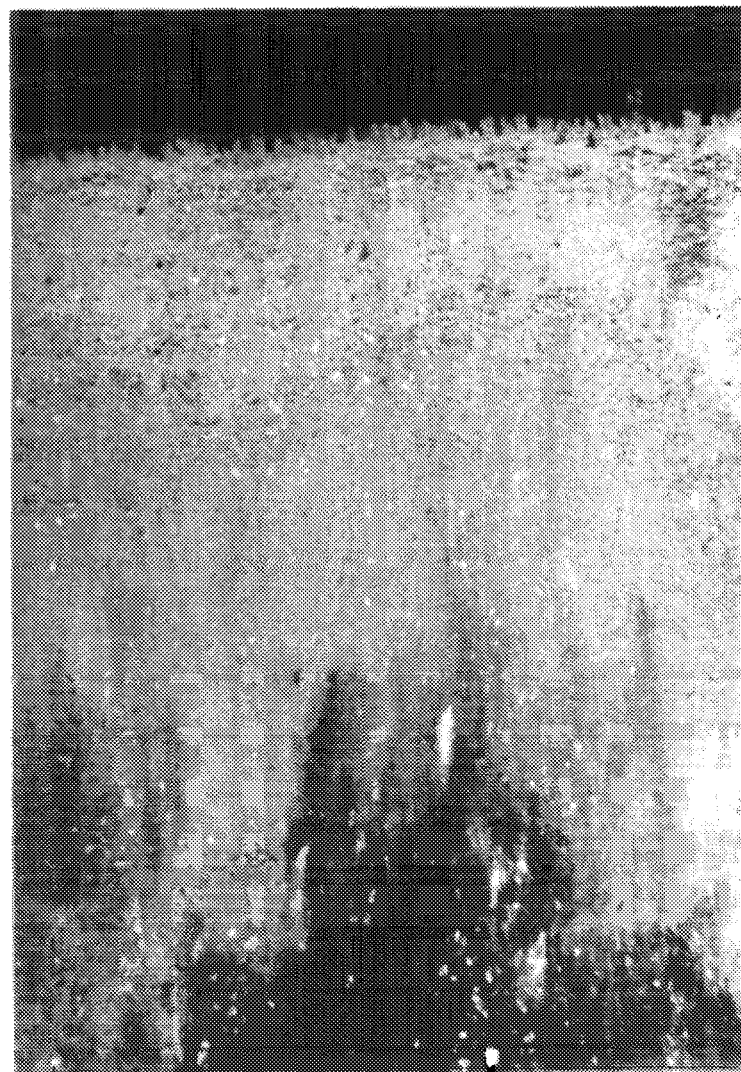
Sediments observed at stations 100W to 150E generally were sorted more poorly (Figure 3-8) than the more homogeneous sediment profiles observed at 350W and 300W (Figure 3-9). Much of the fine sand component at these stations (100W - 150E) appeared to have eroded, leaving behind a layer of shell lag (Figure 3-10). In addition, amphipods and other taxa had reworked the sediment surface extensively and produced a more porous surface layer. The sand appeared to be coarser-grained due to production of grain aggregates by meiofaunal and macrofaunal activities (Figure 3-11).

Figure 3-11. REMOTS® photographs from 300E (A) and 350E (B) showing dense surface tubes and extensive reworking of top centimeters of sediment.

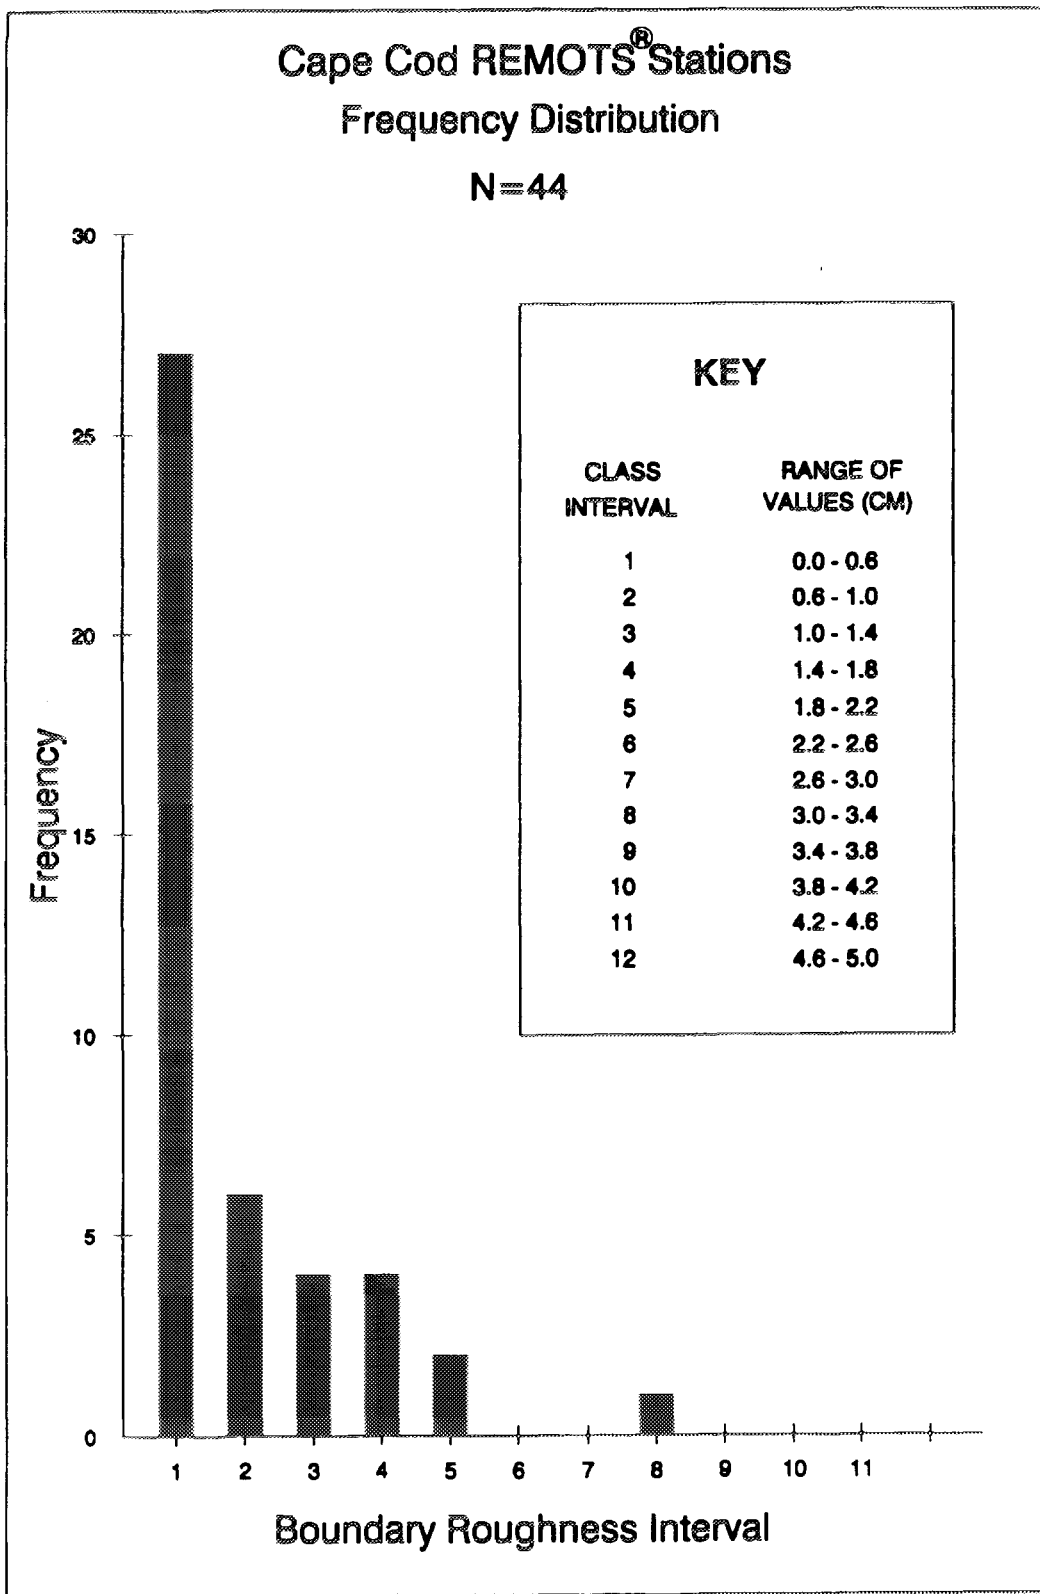
The frequency distribution of small-scale boundary roughness was right-skewed with 61% of the photographs indicating values between 0.0 and 0.6 centimeters (Figure 3-12). This indicates that no significant disturbances had

occurred recently.

Figure 3-12. Frequency distributions of small-scale surface boundary roughness values for all photographs of the REMOTS® transect study of the historic CCDS mound.
