Monitoring Cruise at the Cornfield Shoals Disposal Site
July 1990

Disposal Area Monitoring System DAMOS

Contribution 90
June 1994

US Army Corps
of Engineers
New England Division

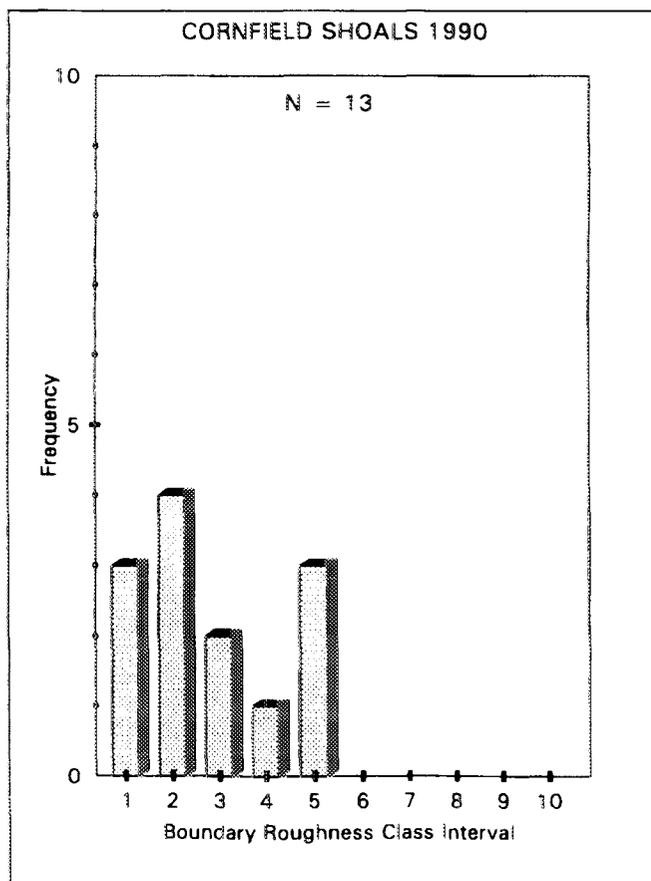
Surface boundary roughness in REMOTS® photographs is the amount of surface relief at the sediment water interface. The origin of this topographic relief may be either physical or biogenic. Small-scale surface boundary roughness values at Cornfield Shoals ranged from 0.0-0.6 cm (class 1) to 1.8-2.2 cm (class 5) with almost equal representation in all classes

(Figure 3-10). On the sandy bottom, this roughness was related to the presence of rippled bedforms. On the dredged material, small-scale boundary roughness was related to the presence of recently deposited dredged material.

Figure 3-10. The mapped small-scale surface boundary roughness values for Cornfield Shoals, 1990.
