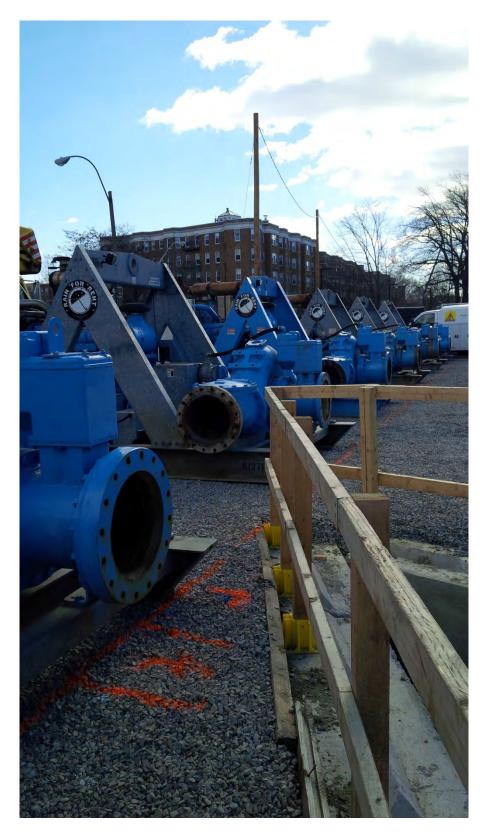
Six pumps in place for the river diversion of the Upper Fens Pond.

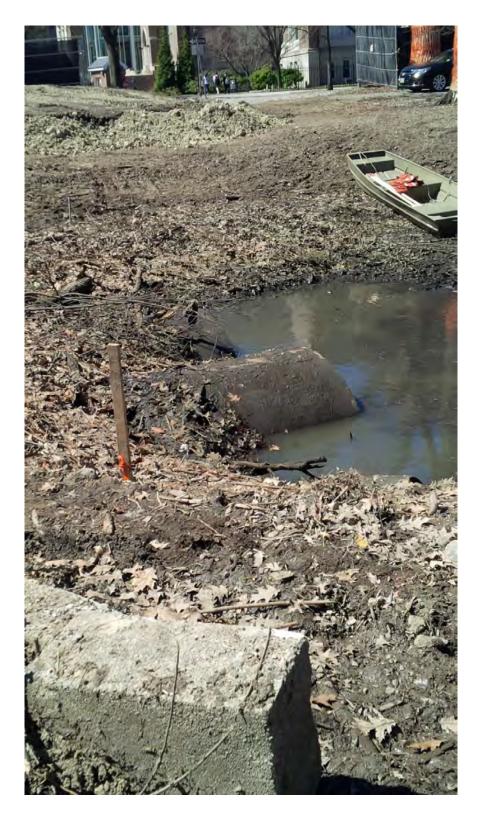
Top of the existing twin 72" culverts between the Upper Fens Pond and Avenue Louis Pasteur appear as the work area is dewatered and river flow is diverted – mid-April 2015.

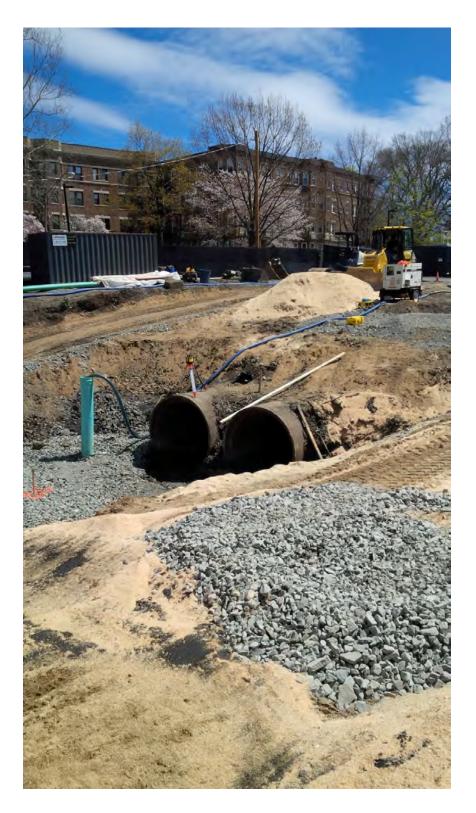
The twin 72" culverts are completely exposed as the Upper Fens Pond is fully dewatered and sediment removal activities have begun – end of April 2015.

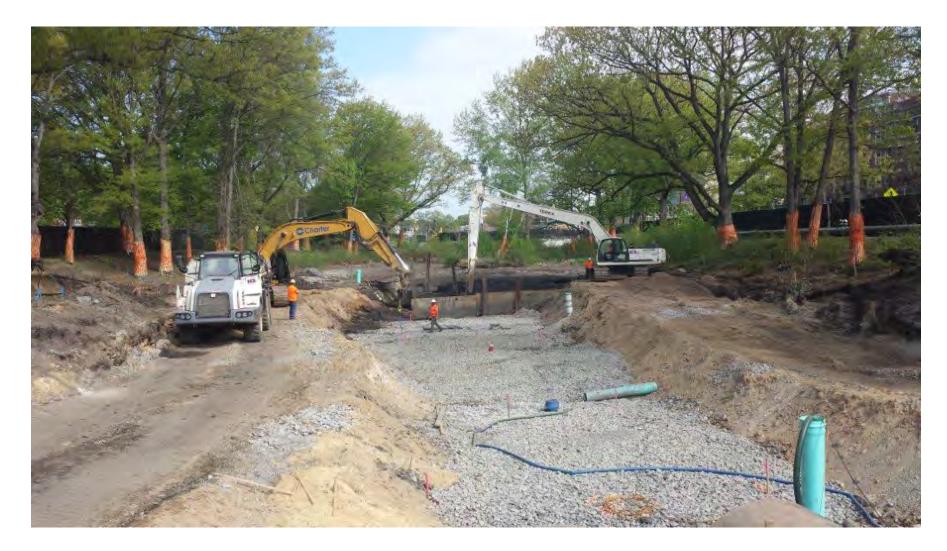
Temporary access roads are constructed on either side of the river bank in order to remove the sediment (black material in the background where the excavators are working) from the river channel bottom – end of April 2015.

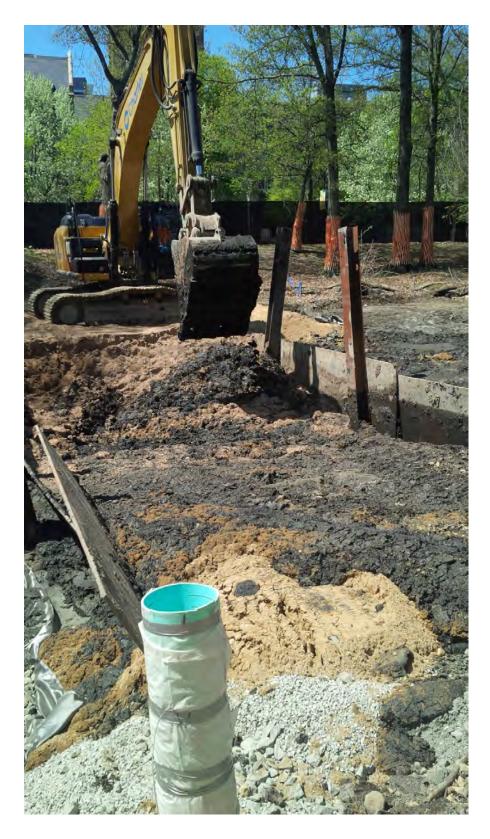
Excavator mixing saw dust into the river sediment to help solidify the material for transport off-site.

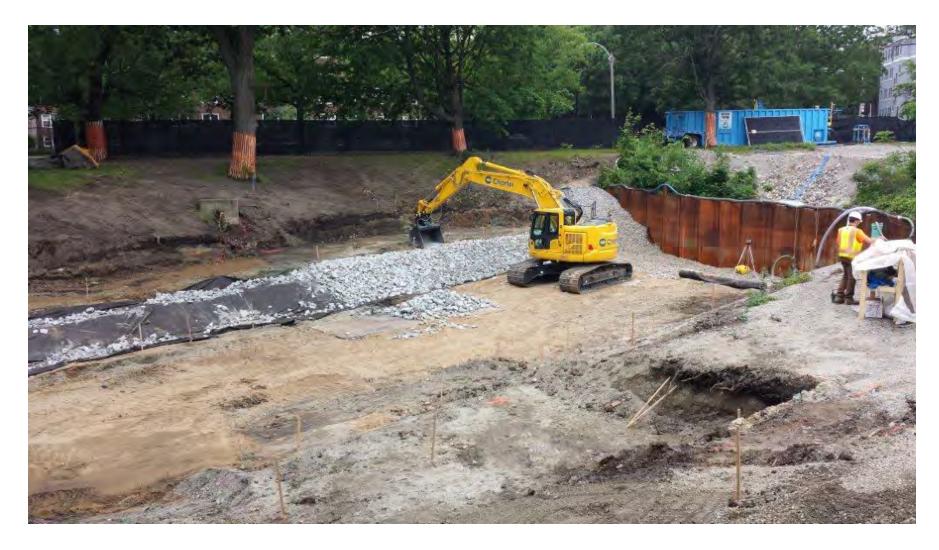
Bank stabilization/construction with stone protection at Upper Fens Pond – early June 2015.

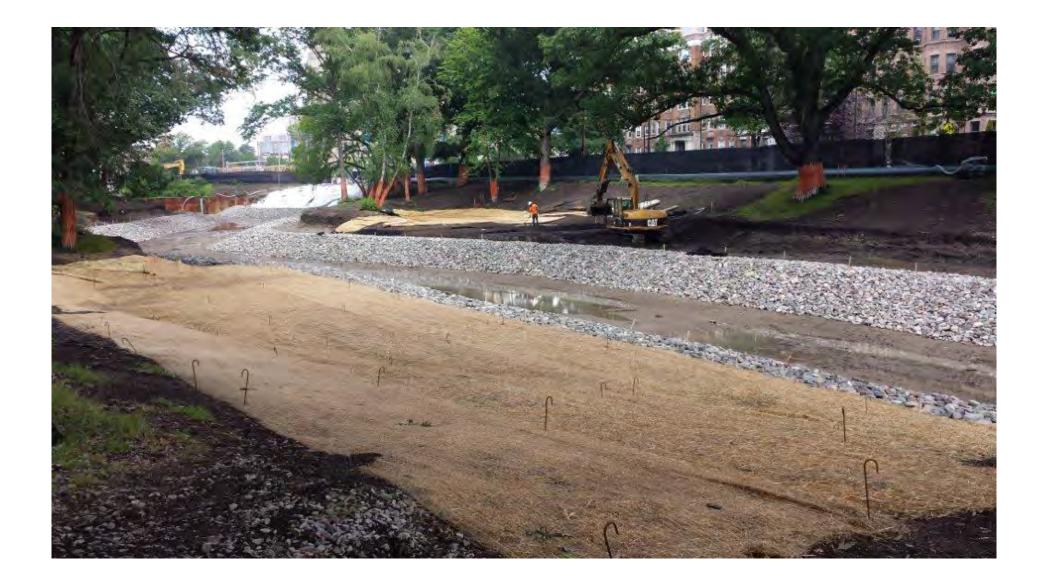
Bank stabilization/construction with stone protection; geocells; loam; and turf reinforcement mattress at Upper Fens Pond – early July 2015.

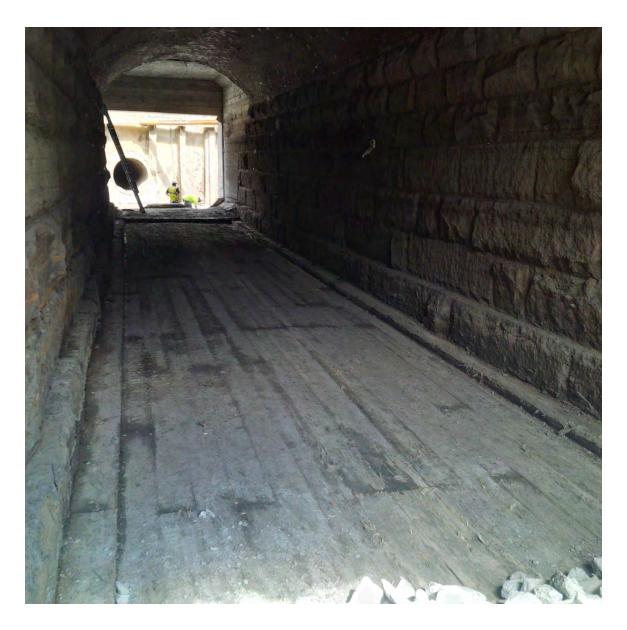
Completed sediment removal from inside the existing Avenue Louis Pasteur culvert revealed an existing timber flooring – late August 2015.

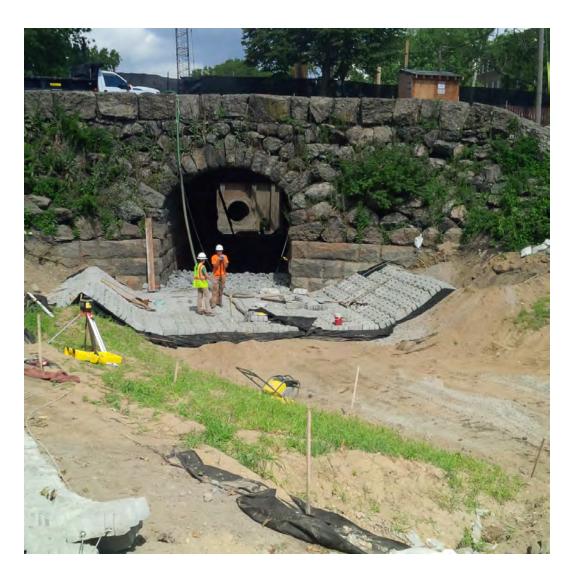
Downstream of Existing Avenue Louis Pasteur – sediment removed from inside the culvert; and installation of the articulated concrete blocks (ACB) has begun – late August 2015.

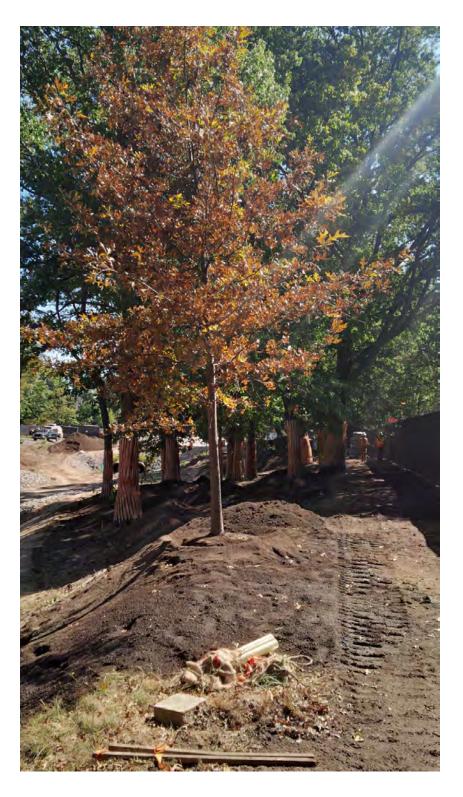
Upper Fens Pond – new tree being planted as part of the bank restoration work – late September 2015.

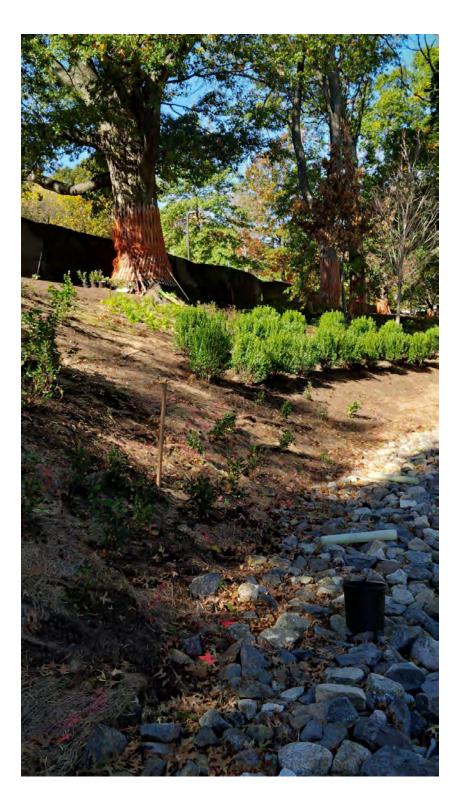
Upper Fens Pond – shrubs and plants being planted as part of the bank restoration work – mid October 2015.

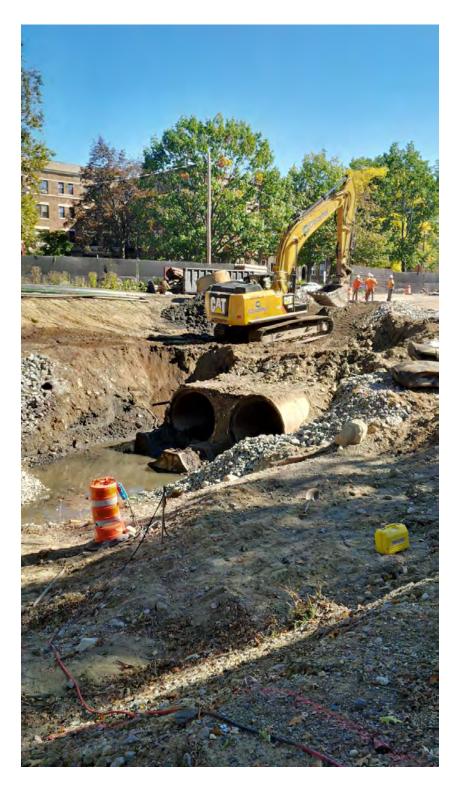
Downstream end of the Upper Fens Pond, where the existing twin 72" culverts begin – note that the excavation to daylight the area between Upper Fens Pond and Avenue Louis Pasteur has begun – mid October 2015.

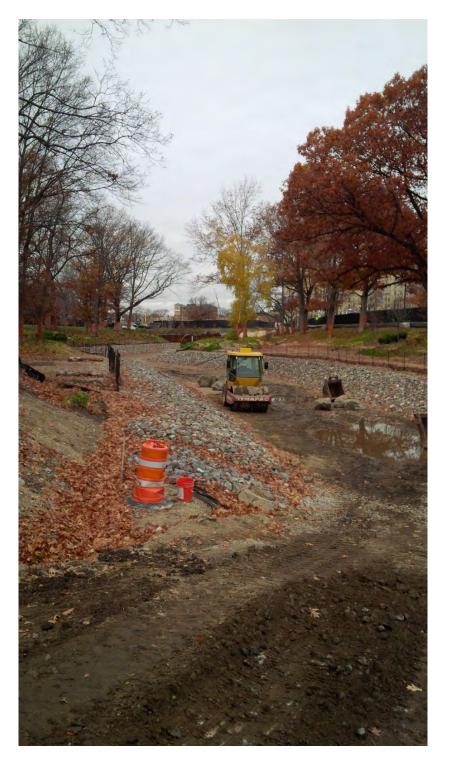
Upper Fens Pond – plantings as part of the bank restoration work in the fall planting season completed – herbivore exclusion fence and habitat boulders installed – early November 2015.

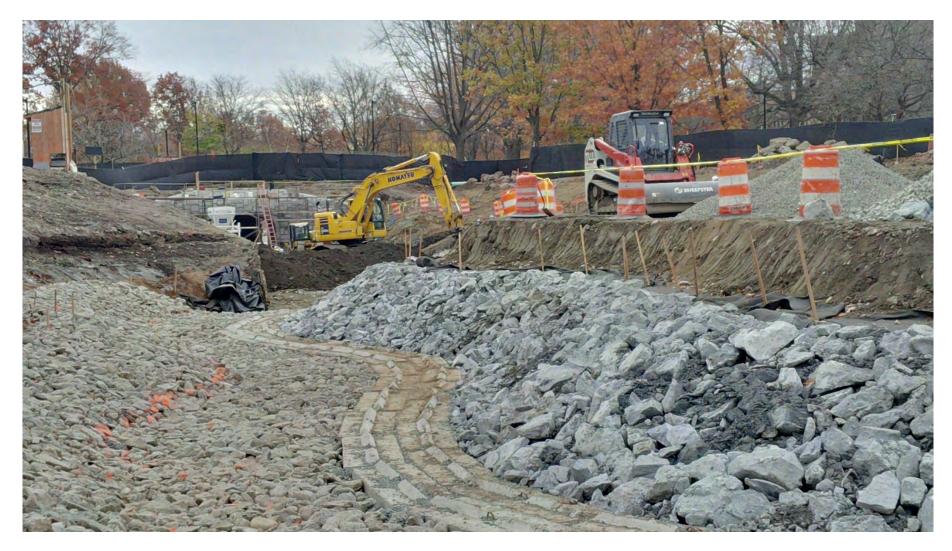
Daylighting of area between Upper Fens Pond and Avenue Louis Pasteur Culvert – note the recreation of the historic Olmstead island (foreground right) starting to take shape – early November 2015

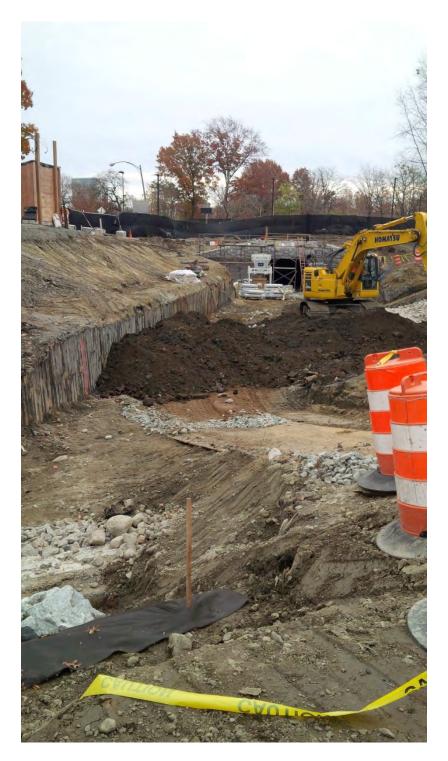
Excavation of the area between Upper Fens Pond and Avenue Louis Pasteur Culvert – note the existing timber piling on the left side which delineates the side of the existing twin 72" culverts that were recently removed as part of the daylighting efforts – early November 2015.

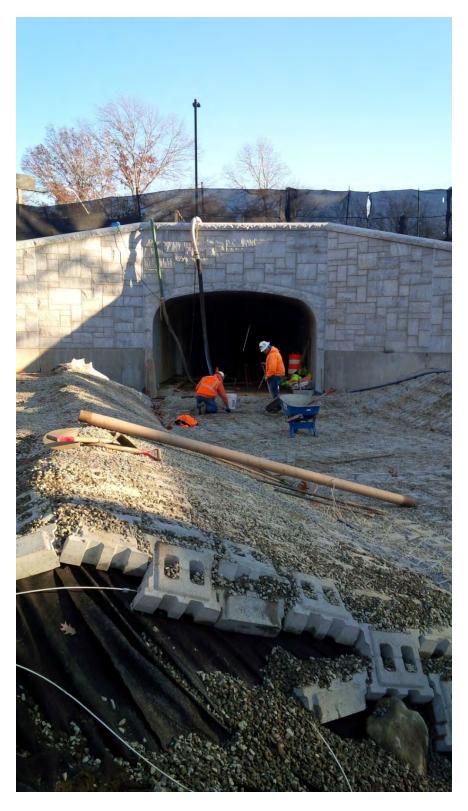
Installation of the articulated concrete blocks (ACBs) at the upstream end of the Avenue Louis Pasteur culvert – early December 2015.

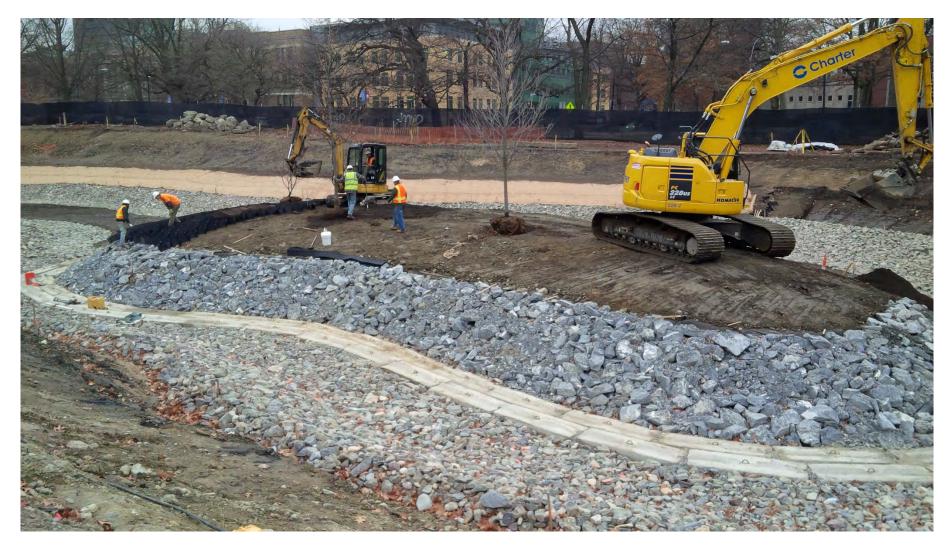
Installation of the geocells and loam and planting of the historic Olmsted Island – early December 2015.

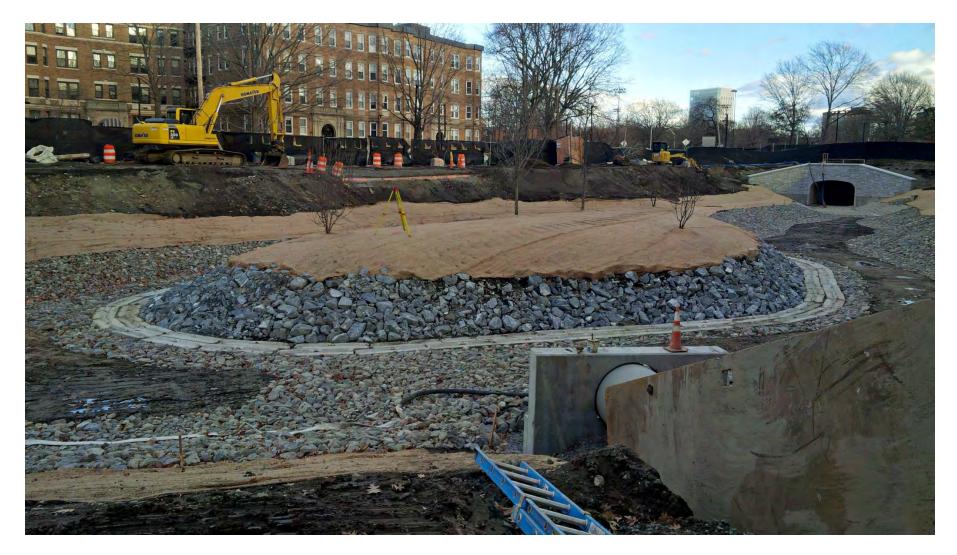
Recreated historic Olmsted Island – with new geocells, loam, and turf reinforcement mattress (TRM) installed and all trees planted – note in the foreground a new headwall and drainage piping being installed on the constructed right bank of the daylighted area – looking downstream at the Avenue Louis Pasteur culvert – mid December 2015.

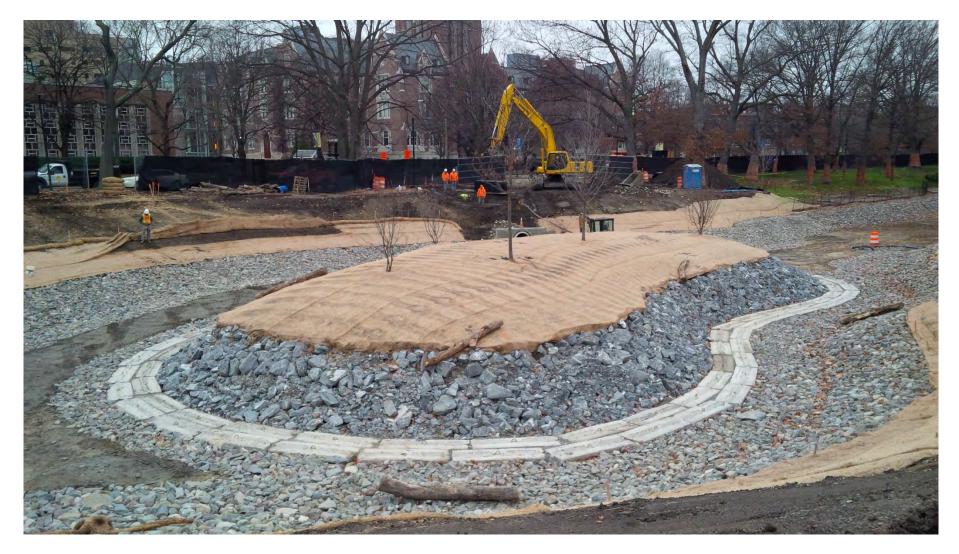
Recreated historic Olmsted Island – with new geocells, loam, and turf reinforcement mattress (TRM) installed and all trees planted – note the habitat logs installed on the island and in the constructed channel – looking cross river towards Simmons College – mid December 2015.

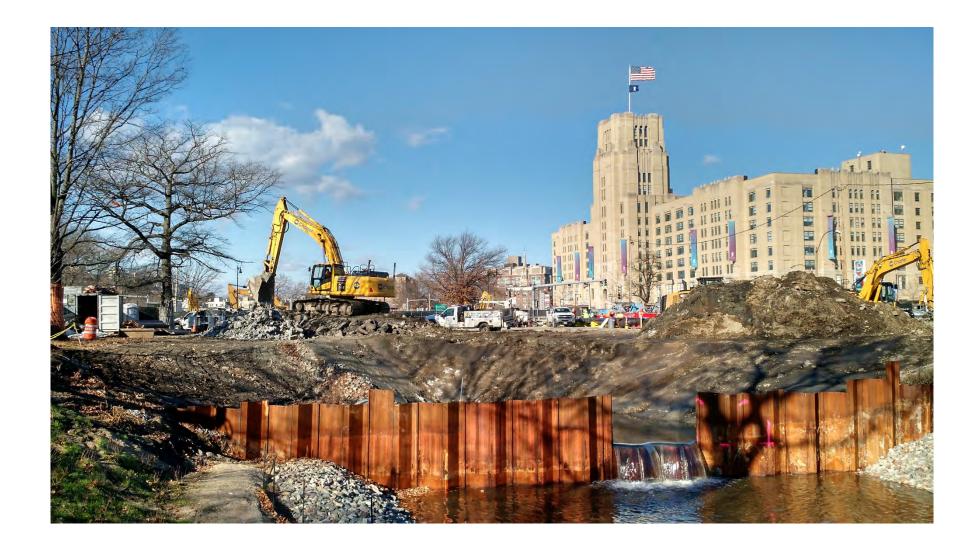
Water flowing over the steel sheeting cofferdam at Upper Fens Pond after the pumps were turned off – note the notch that was cut in the sheeting to allow water to flow slowly back into the pond – looking upstream towards Landmark Center – 19 December 2015.

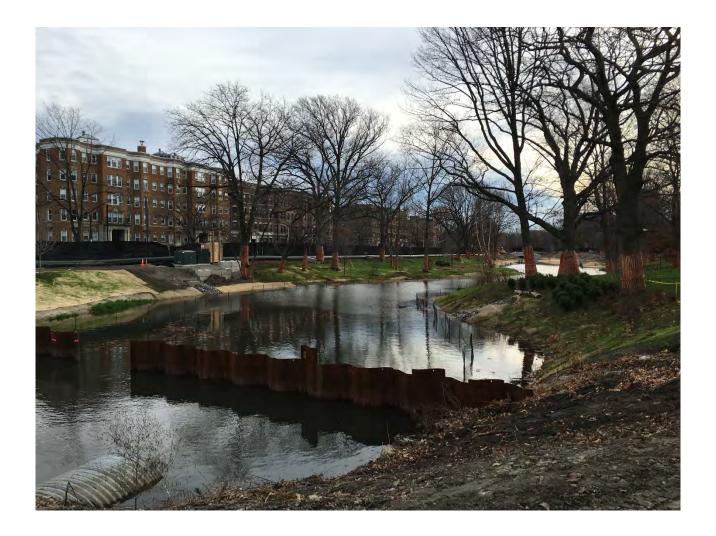
Water flowing over the steel sheeting cofferdam at Upper Fens Pond after the pumps were turned off – note the notch that was cut in the sheeting to allow water to flow slowly back into the pond – looking downstream towards Ave Louis Pasteur – 21 December 2015.

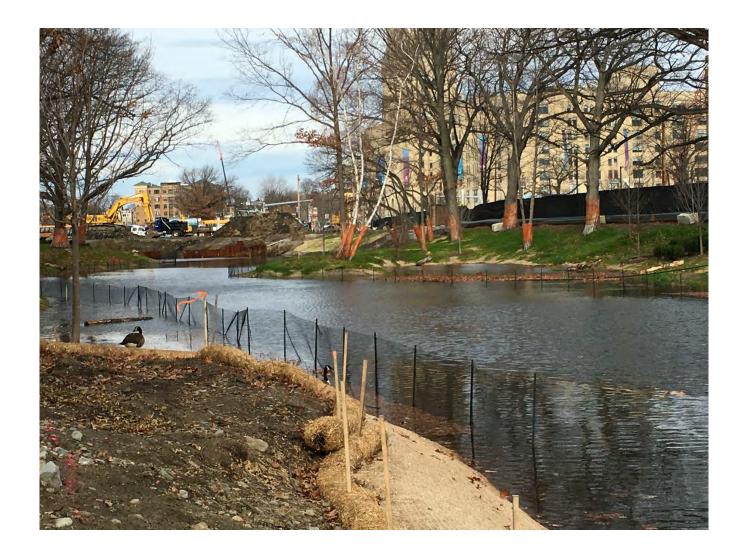
Water flowing in Upper Fens Pond after the pumps were turned off – looking upstream towards Landmark Center – 21 December 2015.

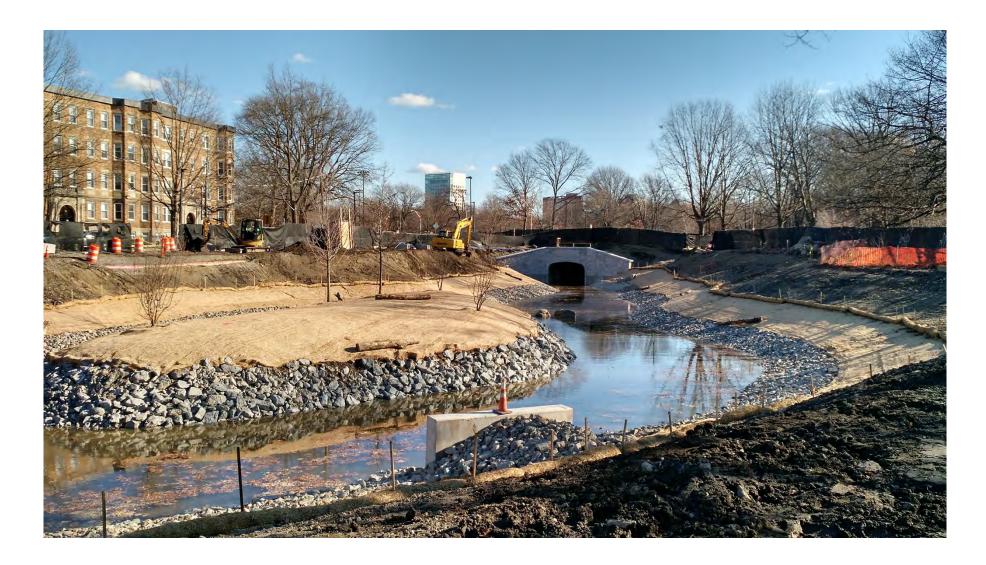
Water beginning to flow around the recreated historic Olmsted Island after the pumps were turned off – looking downstream towards Ave Louis Pasteur – 19 December 2015.

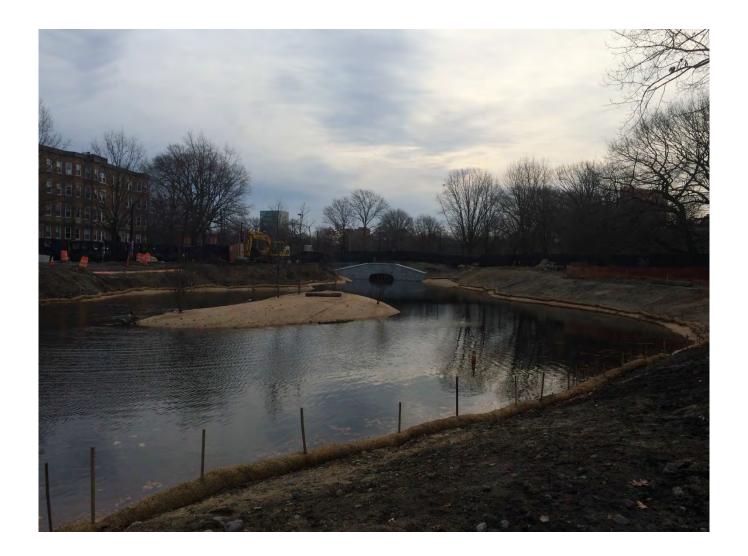
Water flowing around the recreated historic Olmsted Island after the pumps were turned off – looking downstream towards Ave Louis Pasteur – 21 December 2015.

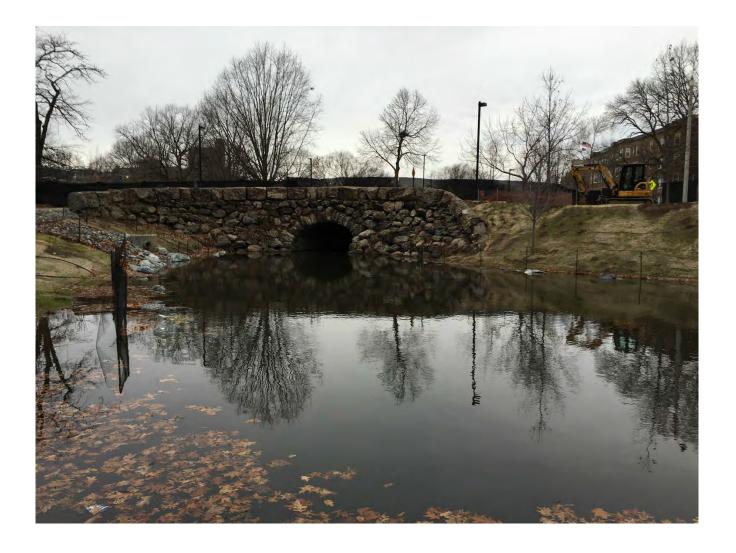
Water flowing downstream of Avenue Louis Pasteur culvert – 21 December 2015.
